# Revitalization of Residential Buildings Dating Back to the Late 19th and Early 20th Century on the Example of “Willa Halina” in Sopot (Poland)

Antoni Taraszkiewicz

Faculty of Architecture, Technical University of Gdańsk, 80-233 Gdańsk, Poland; antarasz@pg.edu.pl

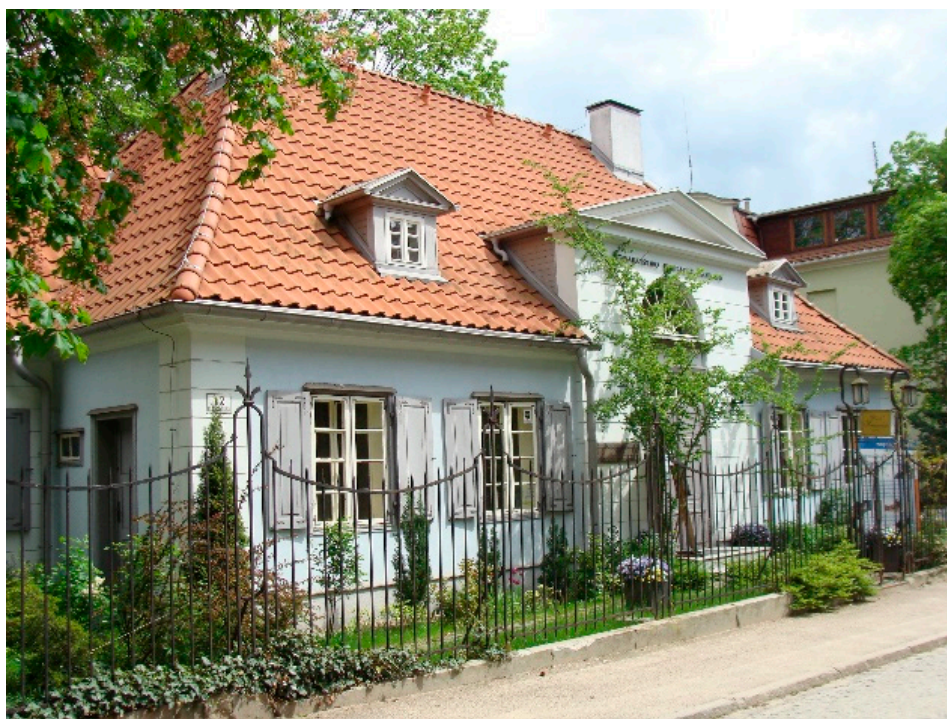
**Figure 1.** Sierakowski Manor House in Sopot. Source: A. Taraszkiewicz.

The oldest preserved monuments in Sopot, which can be classified as “summer” buildings, come from the late 18th and early 19th century and represent classicist forms. They were small, wooden and brick structures of simple shapes (Figure 1).

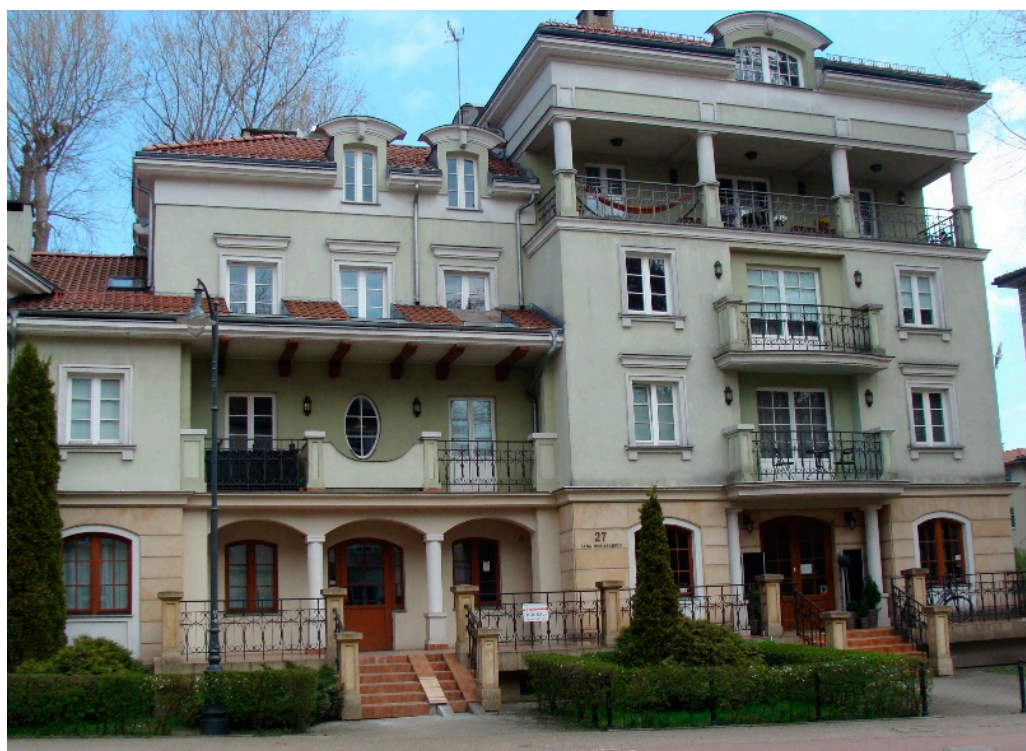
**Figure 3.** Residential building completed in 2003, Jana Sobieskiego street in Sopot. Source: A. Taraszkiewicz.

However, not all investment activities carried out nowadays in Sopot comply with the principles mentioned above. This can be particularly felt in the case of some completely new designs which, drawing directly and unreflectively on the achievements of the past, create “new monuments”. Although these objects are a complement to the urban tissue and not to individual historic buildings, and are set in the eclectic atmosphere of Sopot, they definitely falsify history. An example of this is the newly designed residential building completed in 2001, which is deceptively reminiscent of eclectic solutions from the late 19th and early 20th century (Figure 3).

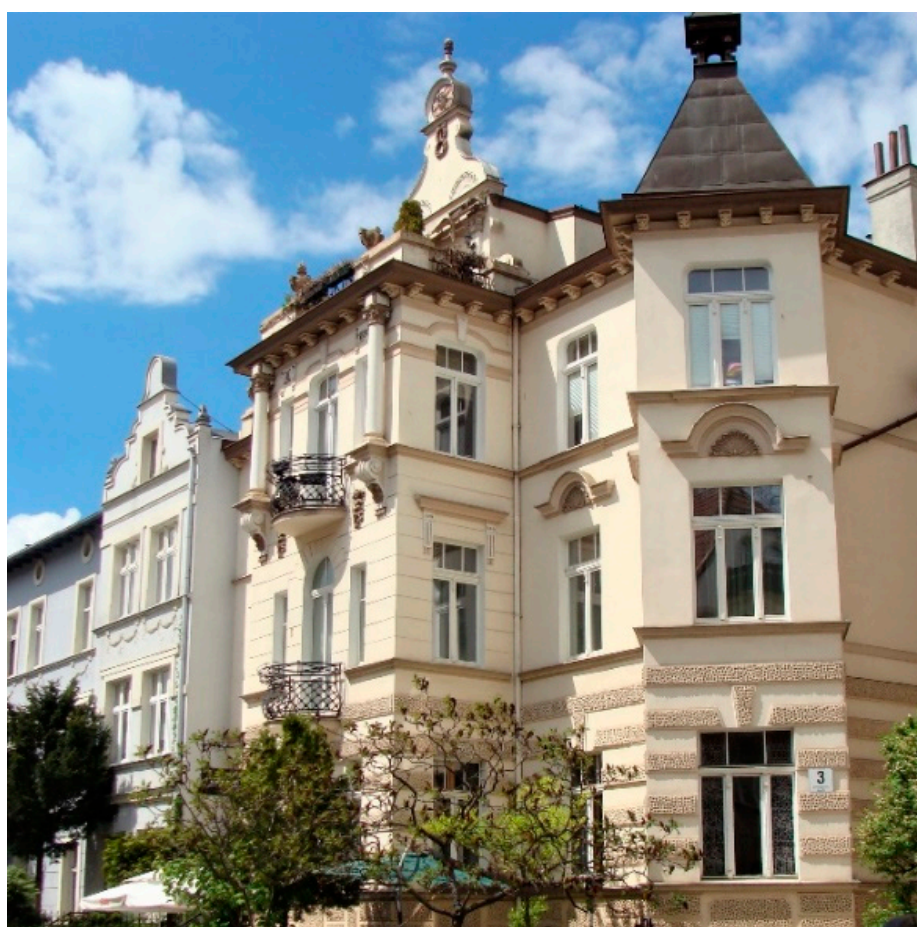
**Figure 4.** Tenement house, Władysława Jagiełły street in Sopot. Source: A. Taraszkiewicz.

In the first of these cases in Sopot, we usually deal with a complete and very blatant violation of the principles of the Venice Charter. Numerous architectural details as well as whole fragments of historical buildings are reconstructed in a way that makes it impossible to distinguish authentic elements from contemporary reconstructions and additions. The magnificent, eclectic Sopot buildings enchant the viewers with their fresh, renewed look, giving a false impression as if they had just been built (Figure 4). This is clearly an unnecessary falsification of history and a harmful blurring of the distinction between the authentic and the reconstructed [31,32].

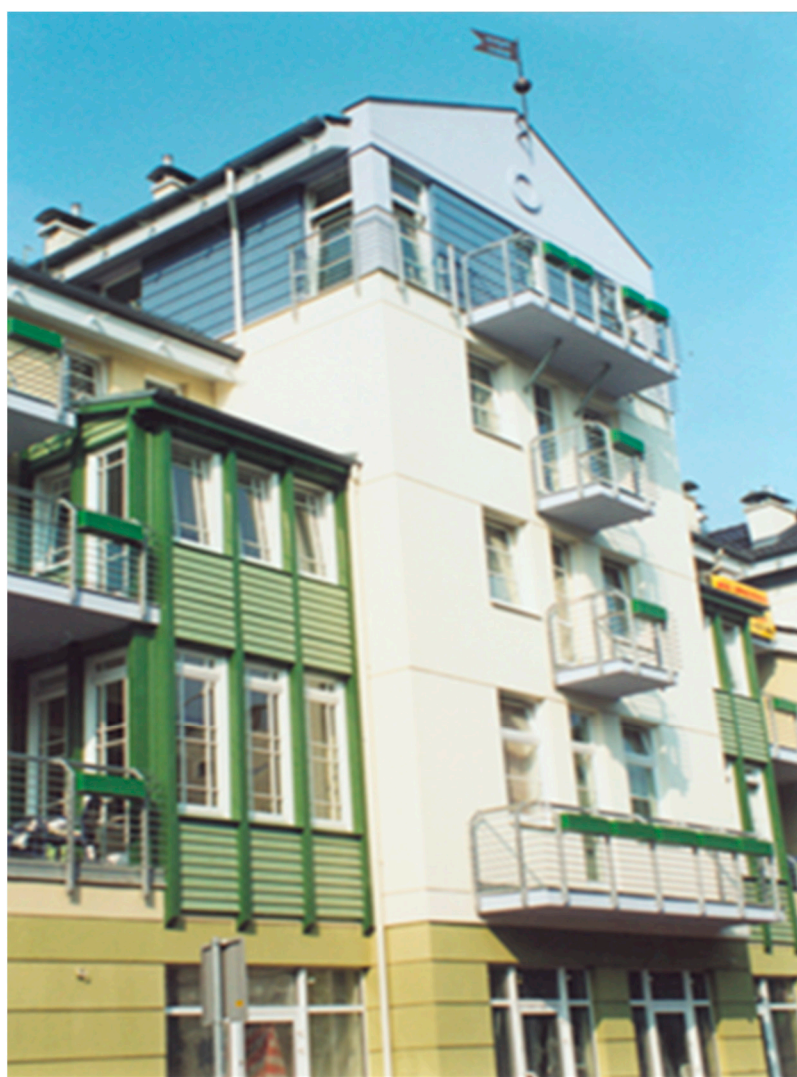
**Figure 5.** Residential building completed in 2002, Ogrodowa street in Sopot. Source: A. Taraszkiewicz.

city conservation services do not agree to this type of activity. The exceptions here are technically degraded historical buildings, whose possibility of expansion and adaptation to contemporary needs is the only way to encourage investors to revitalization activities. An example here is the residential building completed in 2002 at Ogrodowa Street in Sopot, whose contemporary architecture with its mass relates to the historical buildings in the neighbourhood, but through the detail and colouring, it clearly shows the time in which it was created (Figure 5).

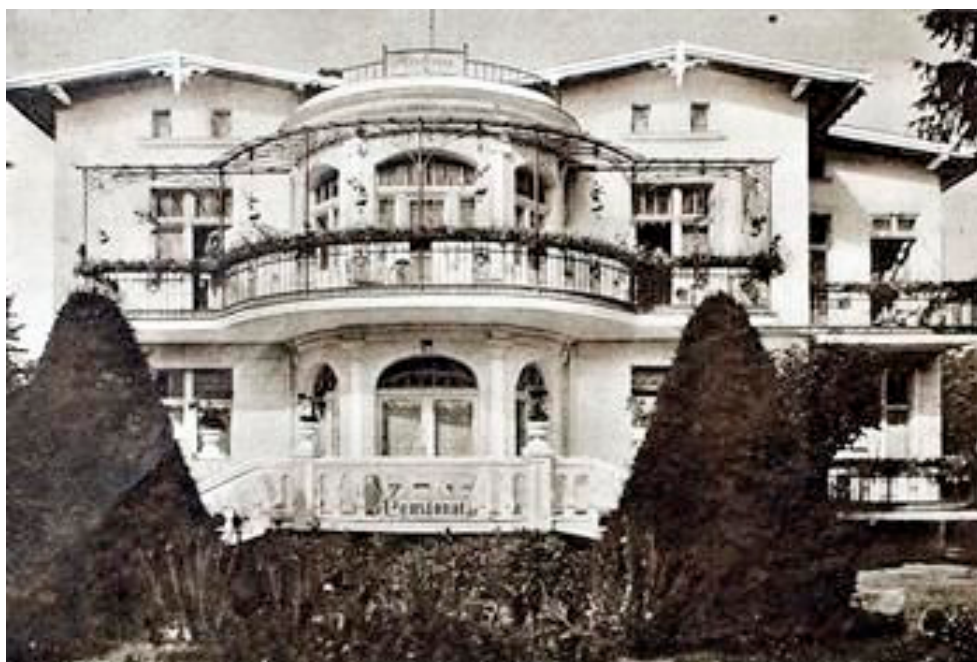
**Figure 6.** Willa Halina seen from the front. Photo from 1934. Source: <http://www.dawnysopot.pl/index.php?content=przewodnikopis&obiekt=willahalina>. (accessed on 29 April 2021).

Erected in 1896, the villa was designed in the eclectic style by Walter Schulz, a well-known Sopot architect and painter of that time, for the investor Hugo Kowalewski, and served as a boarding house. In 1913, the villa was purchased by Władysław Tomaszewski, who also ran a boarding house here named after his wife, Halina [27]. The villa, like all buildings constructed at the late 19th and early 20th century in Sopot, was a romantic combination of neo-Baroque, neo-Renaissance, and neoclassicism with an admixture of regional elements (Figure 6).

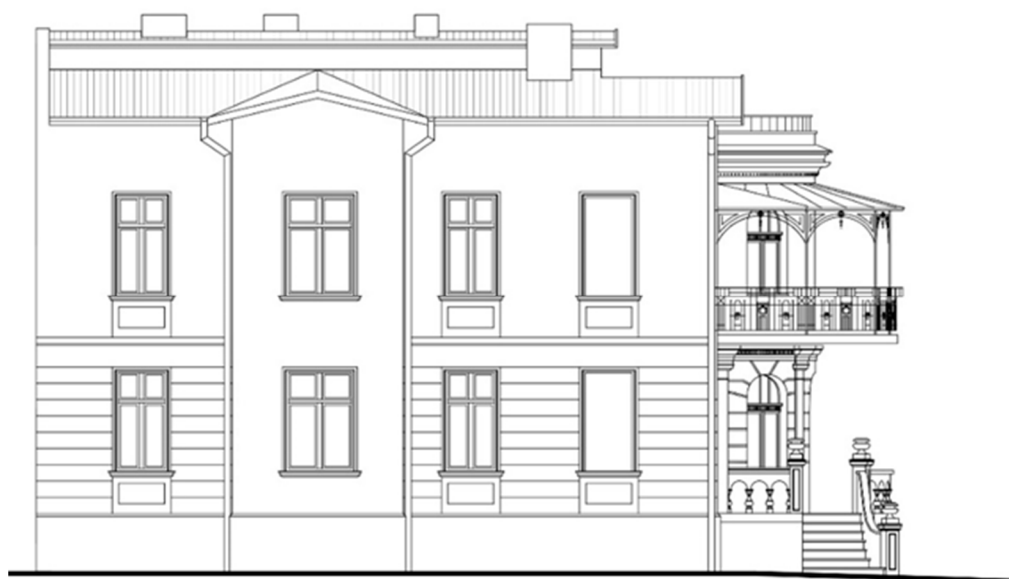
**Figure 7.** Willa Halina side elevation (south). Source: A. Taraszkiewicz.

The side and rear façades of the building were much more restrained in their expression, referring mainly to the Neo-Renaissance with features of the regional architecture (Figure 7).

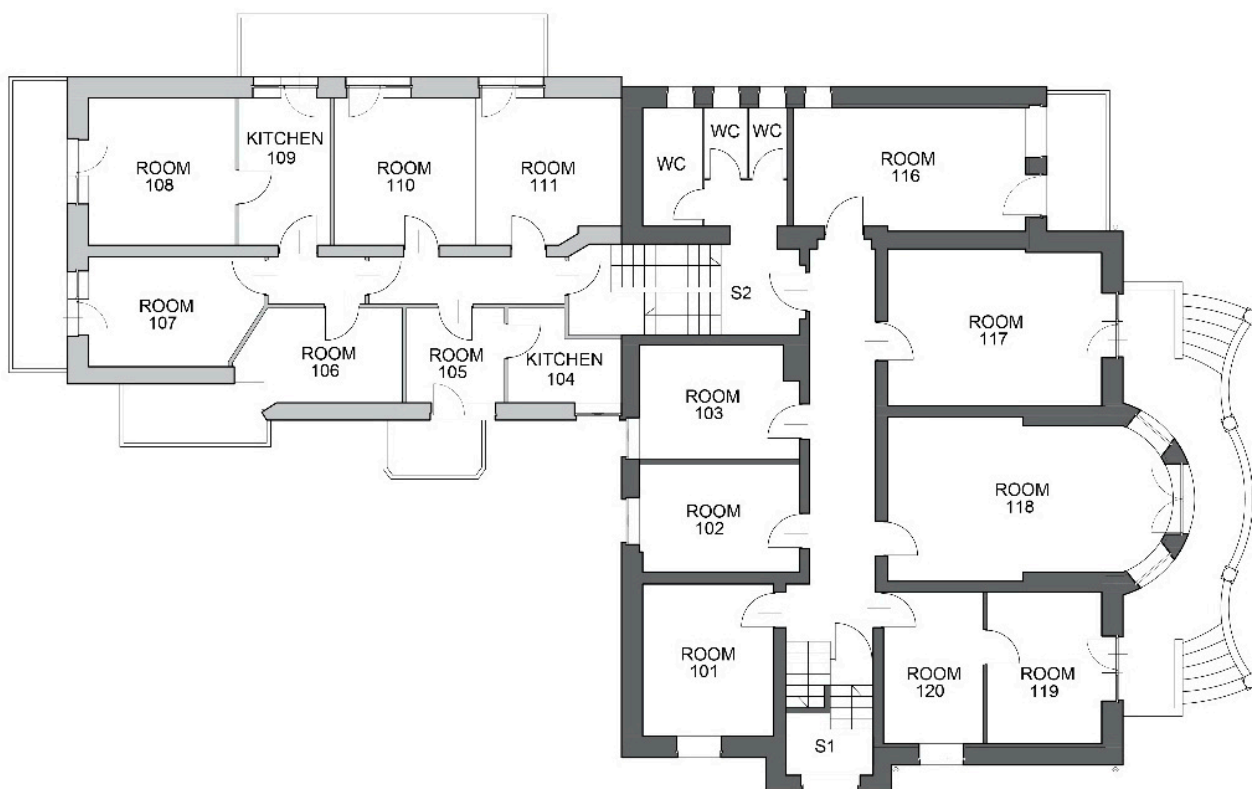
**Figure 8.** Willa Halina ground floor plan; building inventory 1999. Source: A. Taraszkiewicz.

In this condition, the villa survived until World War II. After the war, the villa changed owners several times and served as a multi-family residential building; however, its external appearance has not suffered much damage, apart from minor losses of architectural detail. In the 1950s, the building's interior was functionally divided into several small apartments and an annex of rather low architectural value was added to the villa's western side, creating dissonance with the finished and refined architectural form of the main building (Figure 8).

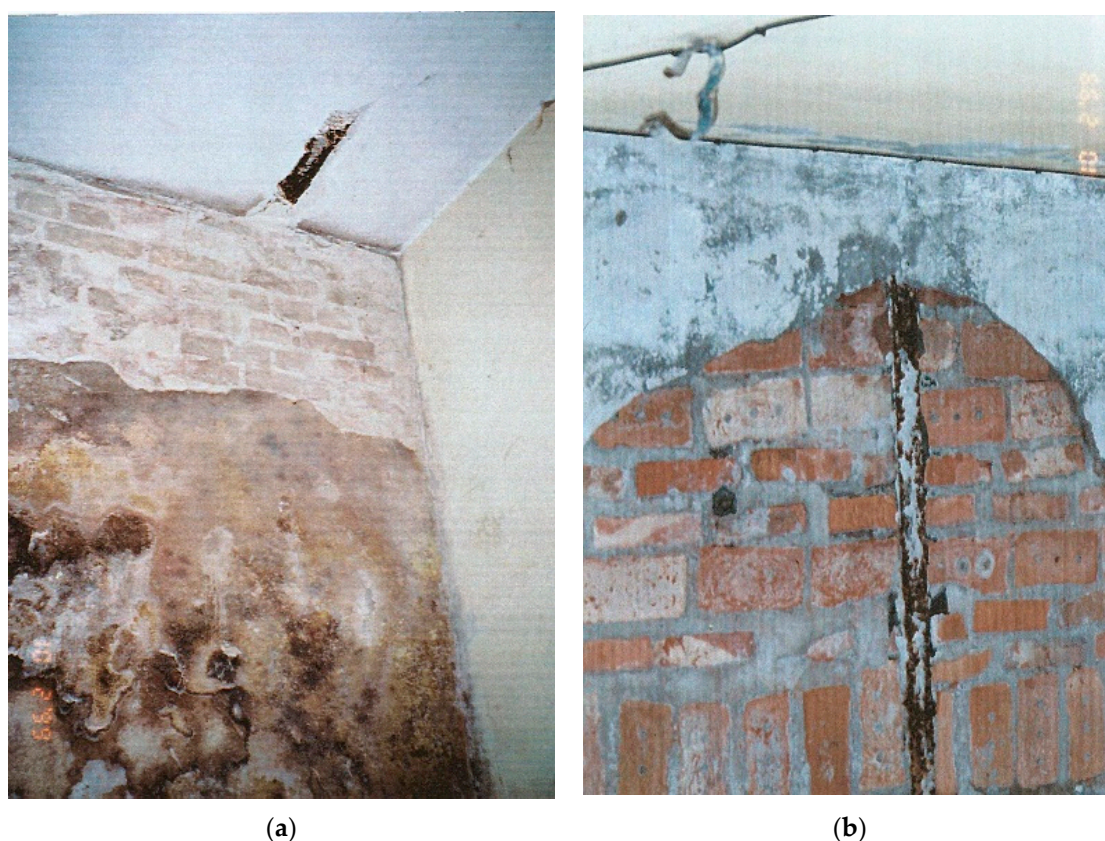
**Figure 9.** Willa Halina, view of degraded structural elements. (a) Mold on the outside wall; (b) moisture and corrosion of internal wall elements. Source: FORT Taraszkiewicz Architekci.

The multitude of users and the lack of proper care for the building caused its technical condition to deteriorate from year to year. There was severe degradation of the wooden ceiling beams and brick walls. There was fungus and severe dampness (Figure 9). Particularly serious technical degradation concerned the annex, whose technical condition could be described as woeful. As a result, by the end of the 20th century, the building was abandoned by residents and awaited revitalization.

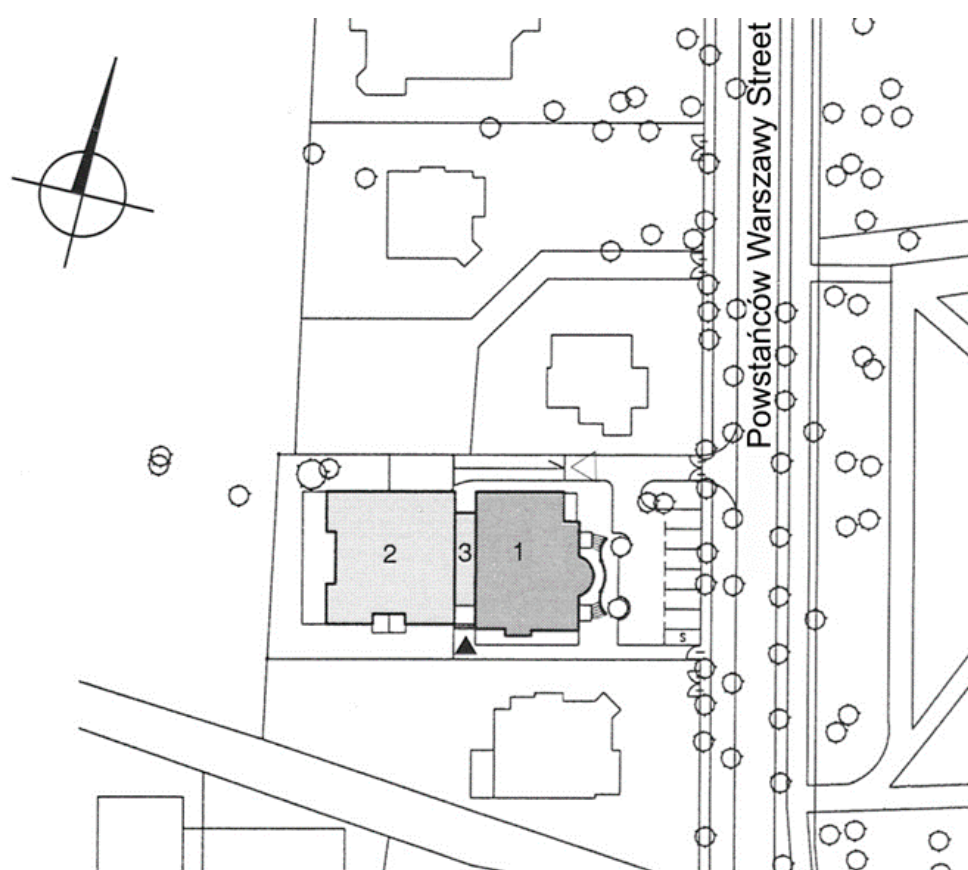
**Figure 10.** Willa Halina—(1) historic body of the building; (2) extended part; (3) Glazed hall. Source: A. Taraszkiewicz.

Between the extended part and the existing, historical building, a glazed entrance hall with a staircase was designed, allowing for exposing (despite the extension) the western elevation of the villa (Figure 10). These elements added to the building have been designed in a way that follows good practice of creating new sections that fit in well with the historic elements and yet are completely different from them, adding new value to existing ones. Such activities have been described in [42–44].

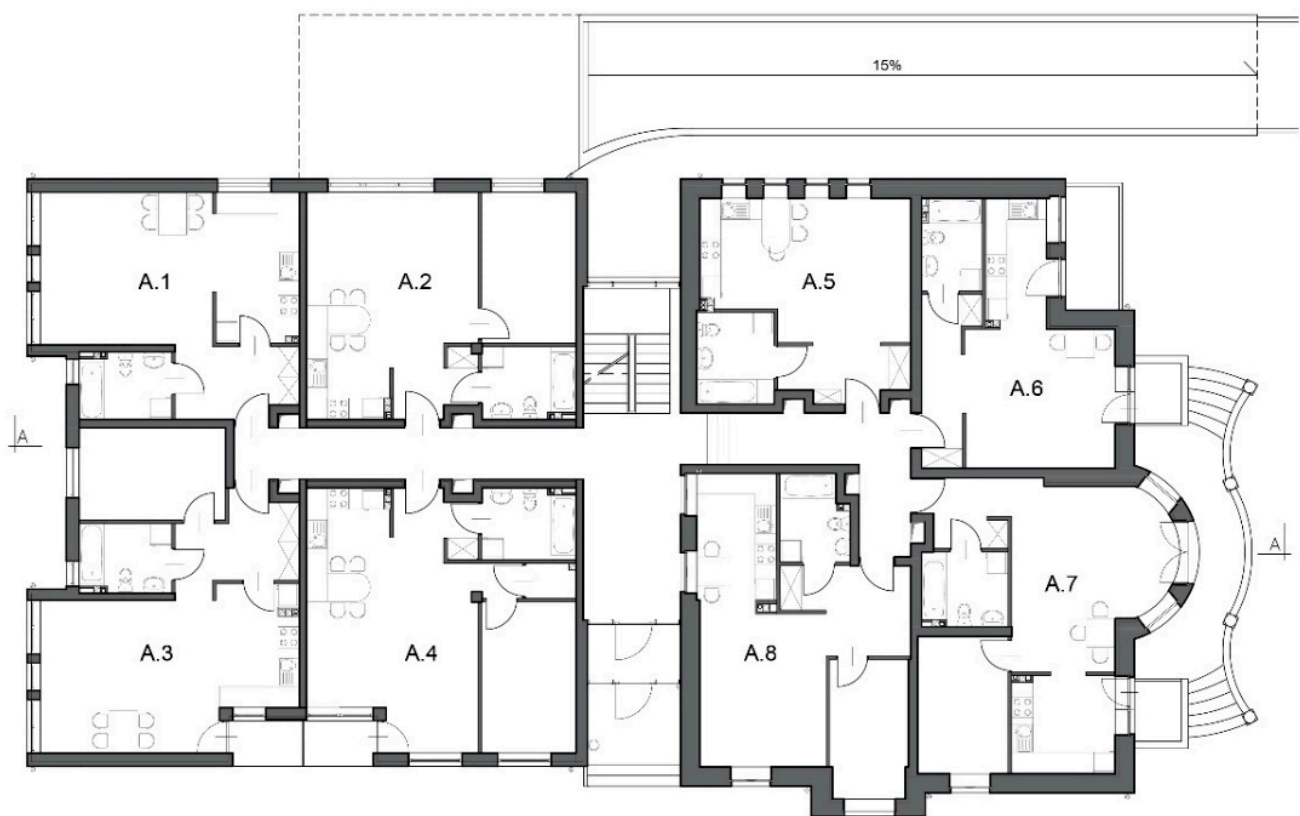
**Figure 11.** Willa Halina extension design; ground floor plan. Source: A. Taraszkiewicz.

Completely technically degraded, devoid of any historical elements, the interiors of the villa were designed in such a way as to enable the arrangement of six modern apartments. In the extended part 11, additional apartments have been designed. The revitalization and extension of the villa were designed in such a way that made it possible to turn it (according to the investor's intention) into a multi-family residential building (Figure 11).

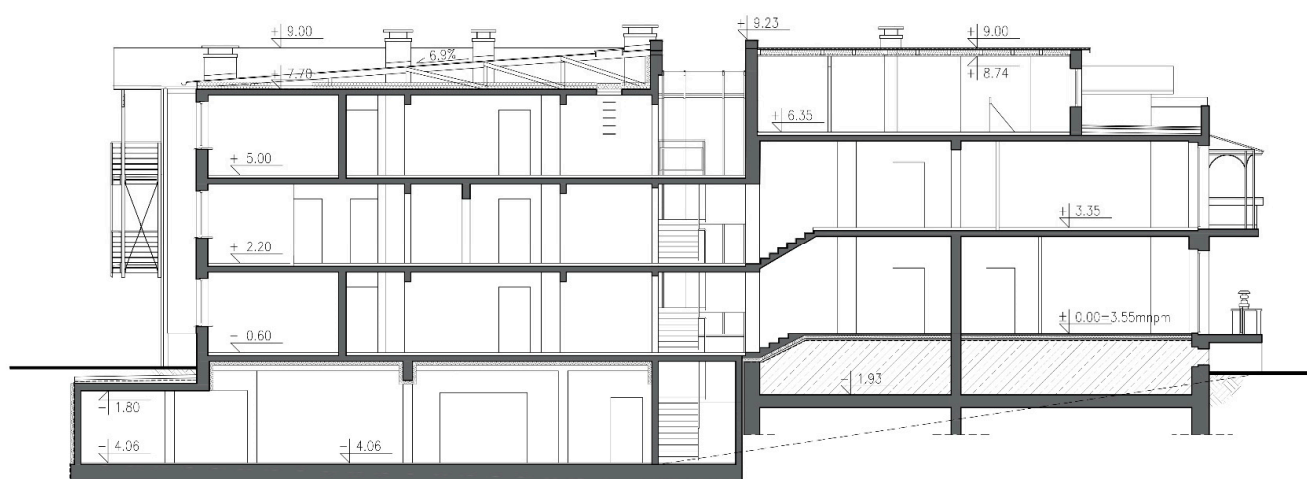
**Figure 12.** Willa Halina, longitudinal section through the building. Source: FORT Taraszkiewicz Architekci.

Many difficult structural decisions had to be made during the design of the villa's revitalization and expansion. These included the replacement of wooden rafter framing damaged by fungus and the replacement of ceilings. The biggest structural challenge, however, was the construction of the underground section in both the historic and the new, expanded part of the building. The high groundwater level caused by the proximity of the sea meant that the low (1.60 m), unusable cellar beneath the historic section was constantly flooded. This condition probably persisted from the beginning of the existence of the villa, due to the lack of waterproofing. On the other hand, excavation of an underground garage for the new part threatened to destabilize the foundations of the existing building, disturb the groundwater system, and create a cone of depression when water would be pumped from the excavations. This situation was remedied by using the diaphragm wall method [45] and the watertight concrete "bathtub" technology [46] in the underground part of the building. Moreover, in agreement with the conservation services, it was decided that the unused basement under the historical part of the building would be "lost" by filling it completely with waterproof concrete. The resulting concrete "plug" stabilized the foundation of the building and eliminated ground water accumulating under it (Figure 12).

From the point of view of the energy balance of the building, it was important to insulate the external walls of the historical part. For reasons of protecting the authentic architectural detail, this could not be done from the outside. It was therefore decided to insulate the external walls of the historical part from the inside. Based on dew point calculations, an appropriate thickness of the insulation layer was assumed, with the use of an additional vapor barrier, which eliminated the danger of water vapor condensation inside the partition [47,48]. The villa's badly deteriorated and inauthentic window woodwork has been replaced with modern, three-pane woodwork (heat transfer coefficient  $U = 0.9 \text{ [W/(m}^2 \times \text{K)]}$ ), designed based on iconographic research, but in a way that clearly shows the contemporary time of its construction. Good thermal insulation of external walls ( $U = 0.20 \text{ [W/(m}^2 \times \text{K)]}$ ), roof ( $U = 0.18 \text{ [W/(m}^2 \times \text{K)]}$ ), and window joinery have become important elements of building operational energy efficiency [49–51].

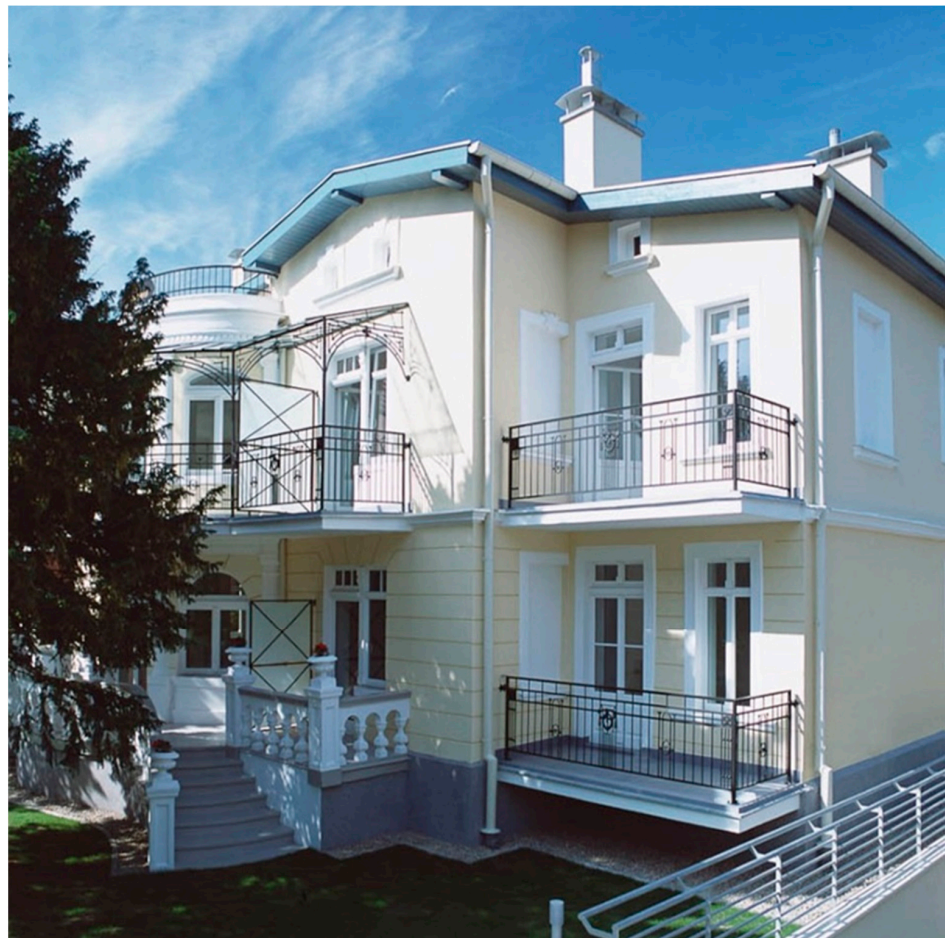
**Figure 13.** Historical part of Willa Halina. Front elevation after revitalization. Source: FORT Taraszkiewicz Architekci.

Utmost care was taken in the revitalization process of the external elevations of the historic part of the villa. As mentioned earlier, the decision was made to renovate the main body of the building, completely preserving its historical external shape and carefully restoring the colors and damaged architectural details. The stratigraphic research showed that the villa had light beige plaster with architectural elements such as cornices, half-columns, and window bands painted white. In the course of revitalization, the original colors were recreated, but where a reconstructed element appeared, the colors were a tone lighter so that the original element could be distinguished from the reconstructed one. Elements of the wooden roof such as rafters and wind braces, as completely new elements, were designed in their historical shape but in grey-blue coloring that differs significantly from the original and from the coloring of similar elements found in other historical buildings in Sopot. The preserved steel elements, such as the balustrades of the balcony or the structure of the glass canopy, were protected against corrosion and painted in graphite colour according to the stratigraphic research. The necessary additions to the steel elements were painted a tone lighter than the original elements to distinguish them (Figure 13).

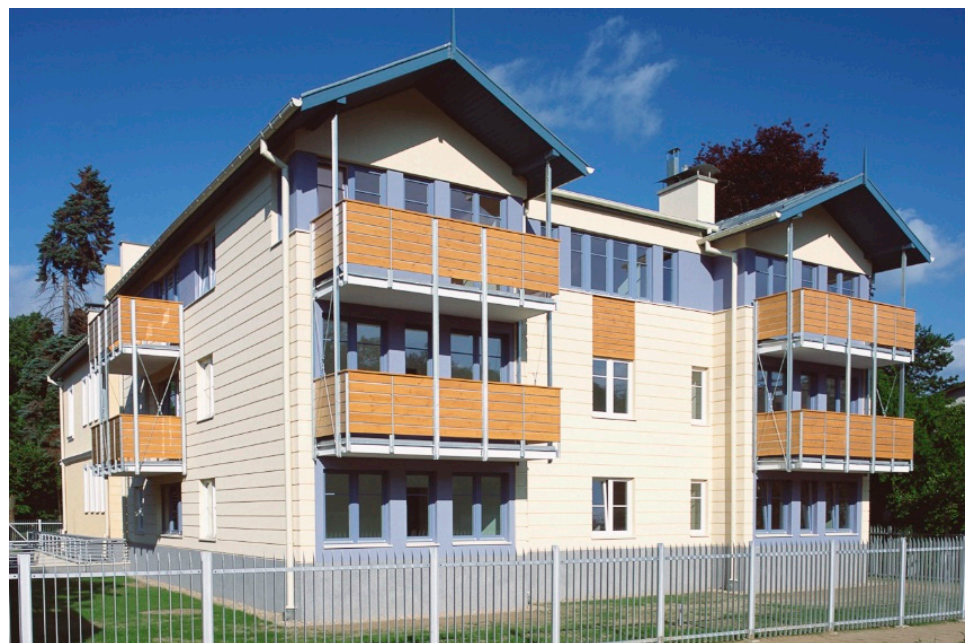
**Figure 14.** Extended part of Willa Halina. Source: FORT Taraszkiewicz Architekci.

The added part was designed in a completely different, modern style. Although the scale and symmetry of the gable façade match the historical part, and although elements from the region's culture appear in it, its spatial solutions are thoroughly contemporary, clearly pointing to the time when the extended part was built. The modern character of this architecture is evidenced by the modern materials and technologies used as well as “fresh” architectural details in the form of elements made of galvanized rolled steel, simple in their form wooden balustrades, or stainless-steel cords linking balcony elements. The entire composition is complemented by strip windows and contemporary colors (Figure 14). Noteworthy here are also: the compact (similar in plan to a square) body of the added part ensuring an optimum energy balance, high-class insulation materials, modern construction technologies neutral for the environment and human health, and emission-free installation systems, including electric heating.

In the case of additions and extensions to historic buildings, it is consistent with the Venice Charter to create new building elements whose atmosphere corresponds to the *genius loci*, but whose architecture is thoroughly contemporary and whose historical references are in no way direct transfers or borrowings from past eras. Such new architectural creations are being created in many European historic cities. The contemporary expression of this architecture is determined by such elements as the articulation of facades, which is characteristic of our times and often draws on the achievements of the international style, contemporary architectural detail, and the modern materials and construction technologies used, which are visible in the facades [30], (Figure 14).

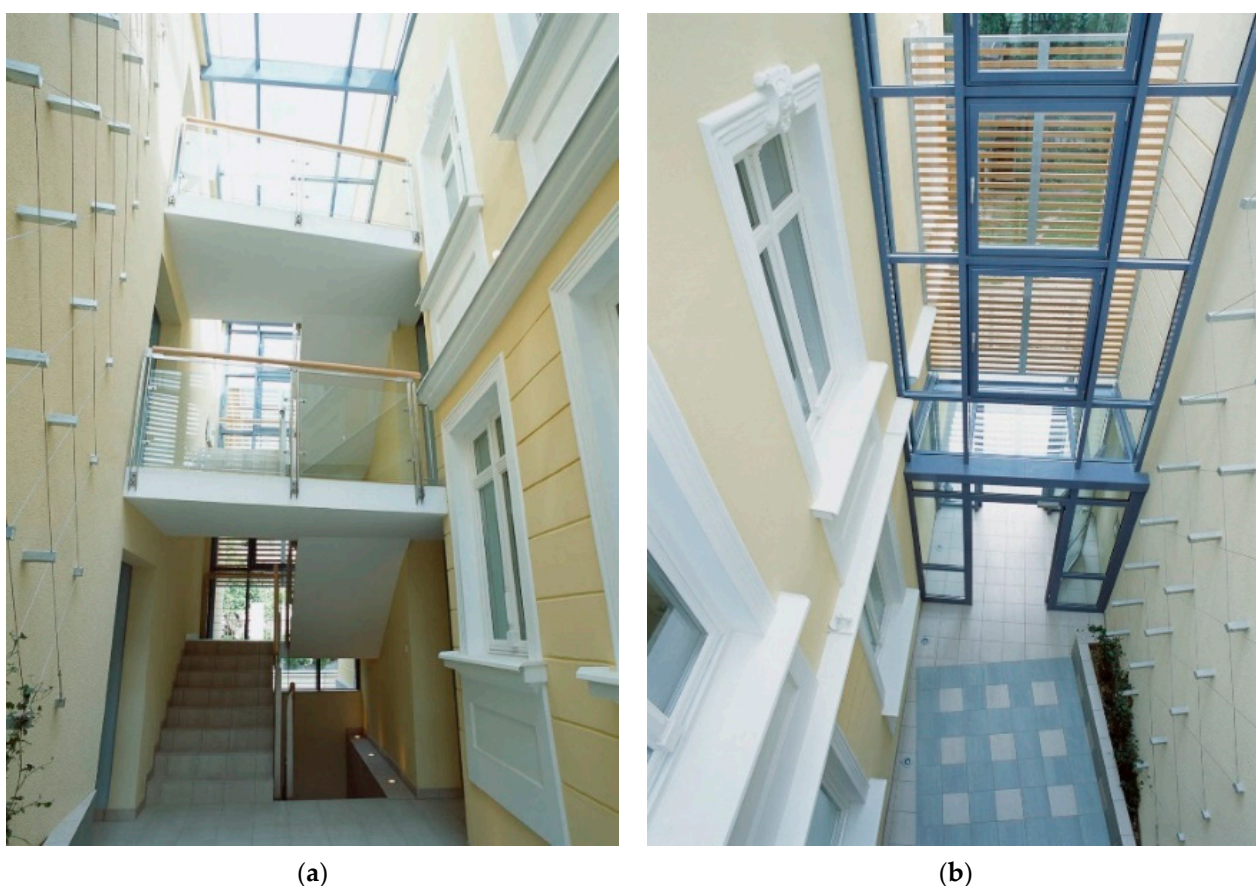
**Figure 15.** The glazed entrance hall of Willa Halina; (a) ground floor view; (b) view from the first floor. Source: FORT Taraszkiewicz Architekci.

The aforementioned glass entrance hall plays a very important role in the spatial composition of the revitalized and extended building. It connects both parts of the building and at the same time constitutes a clear boundary between what is historical and what is contemporary. This hall also allows for the exposure and daylight illumination of the western façade of Willa Halina (despite the extension). Thanks to the open staircase located in the hall, the historic façade of the villa may be viewed from many new, previously unknown perspectives, showing its undoubted beauty (Figure 15).

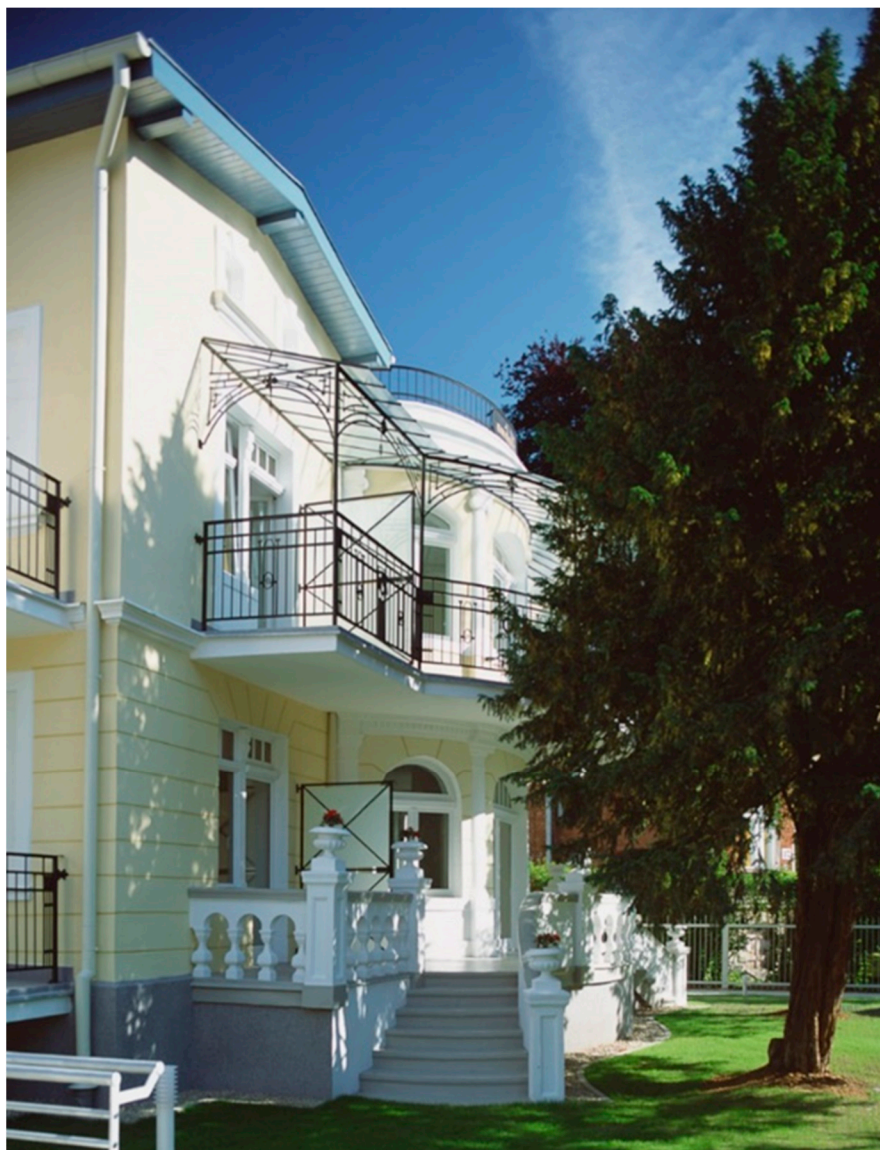
**Figure 16.** The historical part of Willa Halina. Front elevation after revitalization. Source: FORT Taraszkiewicz Architekci.

An element complementing the revitalization design of Willa Halina was the arrangement of its surroundings. There is a pedestrian access to the main entrance of the building paved with stone slabs; a modern-form exit ramp from the underground garage has been designed and the rest of the area has been planned as a vast lawn, serving as a kind of rain garden for rainwater retention. An important part of the revitalization of the villa's surroundings was saving the two magnificent, heavily damaged and neglected yew trees flanking the main façade of the building which had been planted here in 1896 by the first owner according to a design by Walter Schulz. Although these yews have now reached a size that makes it difficult to see the front elevation of the villa, they are an important element of its urban composition and at the same time a living testimony to the urban and architectural ideas of the late nineteenth century, as well as an embodiment of the contemporary ideas of sustainable development, in which nature conservation is one of the basic elements [52,53] (Figure 16).
