# Intervention Strategies for the Seismic Improvement of Masonry Buildings Based on FME Validation: The Case of a Terraced Building Struck by the 2016 Central Italy Earthquake

**Keywords:** masonry; terraced buildings; seismic behaviour; frame by macro element; intervention; performance ratio; FRM

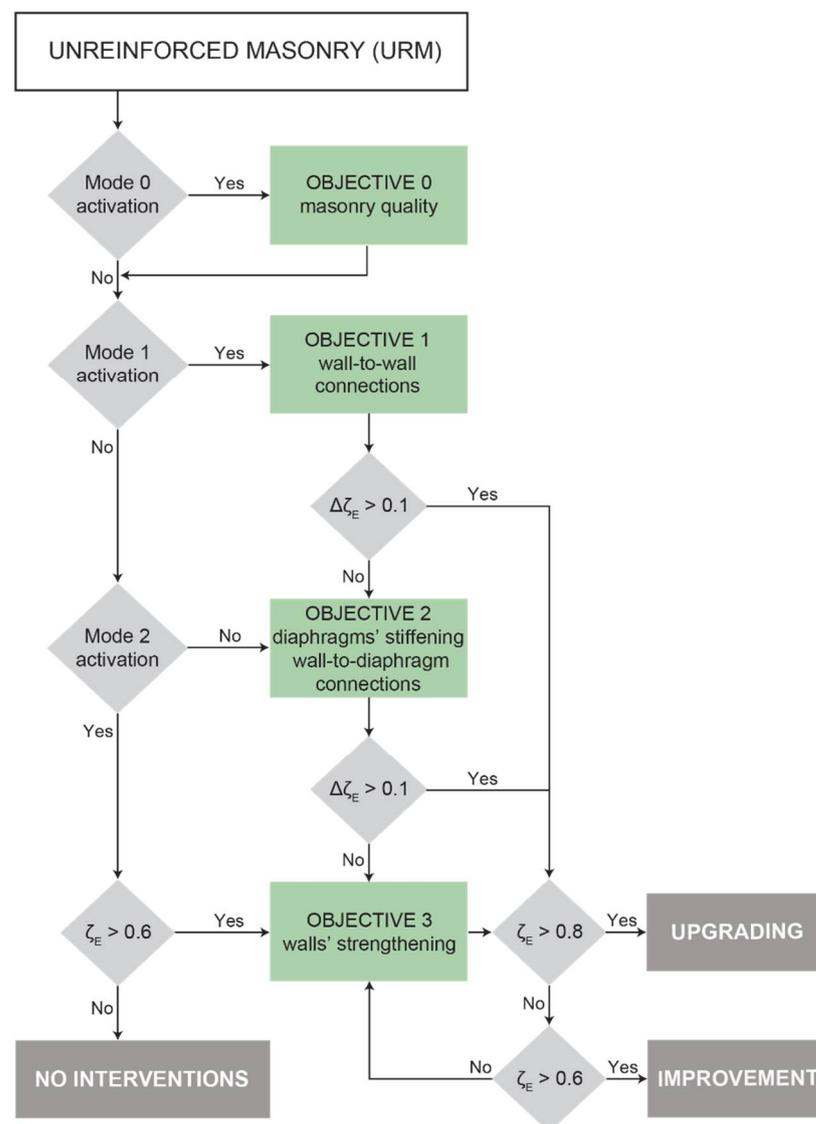
**Figure 1.** Incremental procedure for selection and evaluation of interventions on masonry buildings according to expected seismic performances.

Figure 1 shows an incremental procedure which guides the choice of intervention types as a function of the vulnerabilities commonly recognized in URM buildings and in the framework of those seismic performance targets (i.e., the 'objectives') required by the seismic code. Mode 0 stands for crumbling of inadequate-quality masonry (no macroblocks can be identified); mode 1 refers to OOP failure of macroblocks (no box-

like behaviour can be identified). Mode 2 involves the IP resistance of walls: for the best performance, shear damage should occur preferably in spandrels than piers (i.e., keeping the bearing walls extended for the whole height of the structure as undamaged as possible) [29–31]. As modes 0 and 1 describe negative conditions (i.e., those which imply the potential loss of a building), the chart proposes specific countermeasures to contrast their activation (objectives 0 and 1, respectively); conversely, mode 2 is the preferred structural behaviour; therefore, the interventions are applied when it is not reached (e.g., interventions on diaphragms, objective 2). It is worth noting that the strengthening of walls is proposed only following mode 2 interventions (objective 3), when minimum performance levels are not met, in spite of the box-like behaviour. The progressive application of interventions minimizes the risk of their potential unfavourable contribution, as each stage is propaedeutic to the following one. Moreover, the impact of interventions can be adjusted depending on the final level of expected seismic performance, i.e., either improvement (lighter interventions) or upgrading (massive and/or widespread interventions).

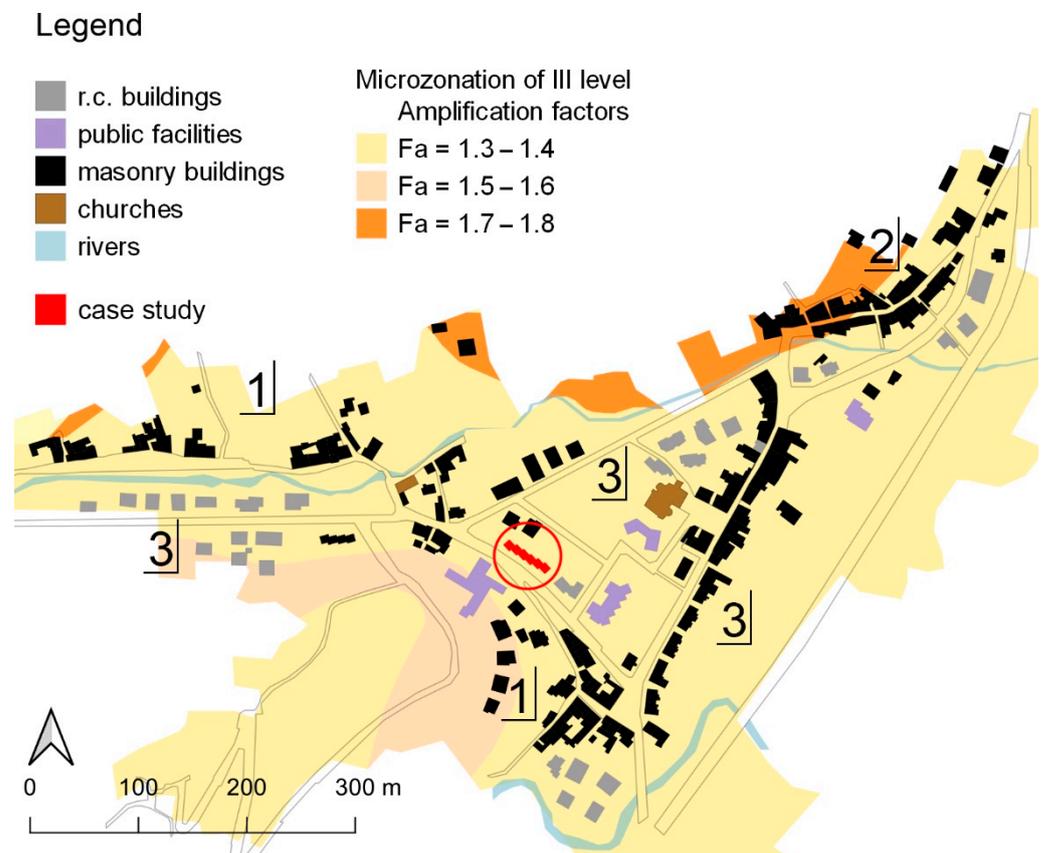
**Figure 2.** Pieve Torina: overview with village plan, soil amplification factors, structural and functional types of buildings, and location of case study. Key to numbers: (1) oldest nuclei; (2) 18th century building aggregates; (3) 20th century and recent buildings.

The case study is located in Pieve Torina, a village in the Marche region, Central Italy. Pieve Torina has pre-Roman origins and stands at 470 m above sea level on a foothill area at the left side of the Chienti Valley. In the 18th century, new agglomerates of terraced houses and masonry building aggregates around the medieval nucleus were built [32]. During the 20th century, Pieve Torina was supplied with public facilities (middle school, town hall) and housing promoted by the IACP (Italian acronym for Local Public Housing Authority), which connected the old building nuclei. The case study presented herein is part of this last expansion of the village (Figure 2).

Figure 2 shows the urban plan of Pieve Torina and its microzonation analysis.

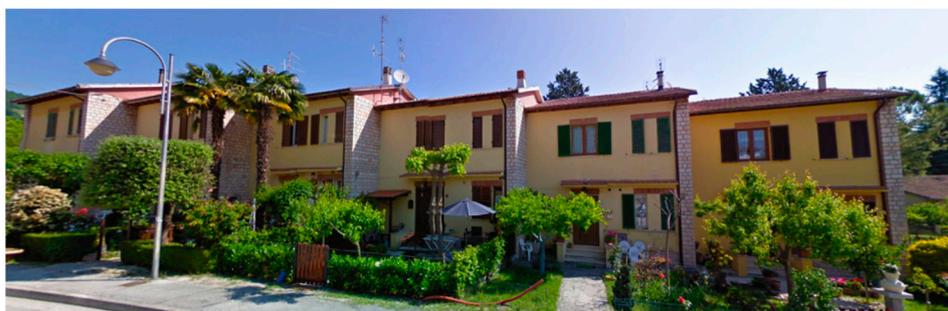
**Figure 3.** External view of IACP building before earthquake (adapted from Google Earth).

The case study, henceforth referred to as IACP building, is a terraced building built in the mid-1960s, i.e., earlier than any seismic regulation applied to Pieve Torina [38]. It is composed of six units stretching along the NW–SE axis for a length of 43.17 m and a depth of 6.85 m towards north. Each unit has a compact and regular shape (plan of  $7.57 \times 6.85$  m) with vertically aligned openings on the south and north facades only (Figure 3). The building has two storeys (gross area of  $50 \text{ m}^2$  per level and unit) and a basement, emerging for 0.70 m from the ground level, for a total elevation of 6.90 m in the north and the south facades from the ground to the eave line. Units are shifted for about 1.5 m. The gable walls on the east and west sides are completely blind; the ridge stands at 9.07 m above the ground. The walkable area of each floor is  $34 \text{ m}^2$ , while the staircase has a footprint of about  $4 \text{ m}^2$ . A loadbearing wall divides the raised ground floor, whilst, in the upper storey, there are only non-structural partitions; a non-structural ceiling also completes the first storey. The gross volume above ground is about  $2094 \text{ m}^3$ .

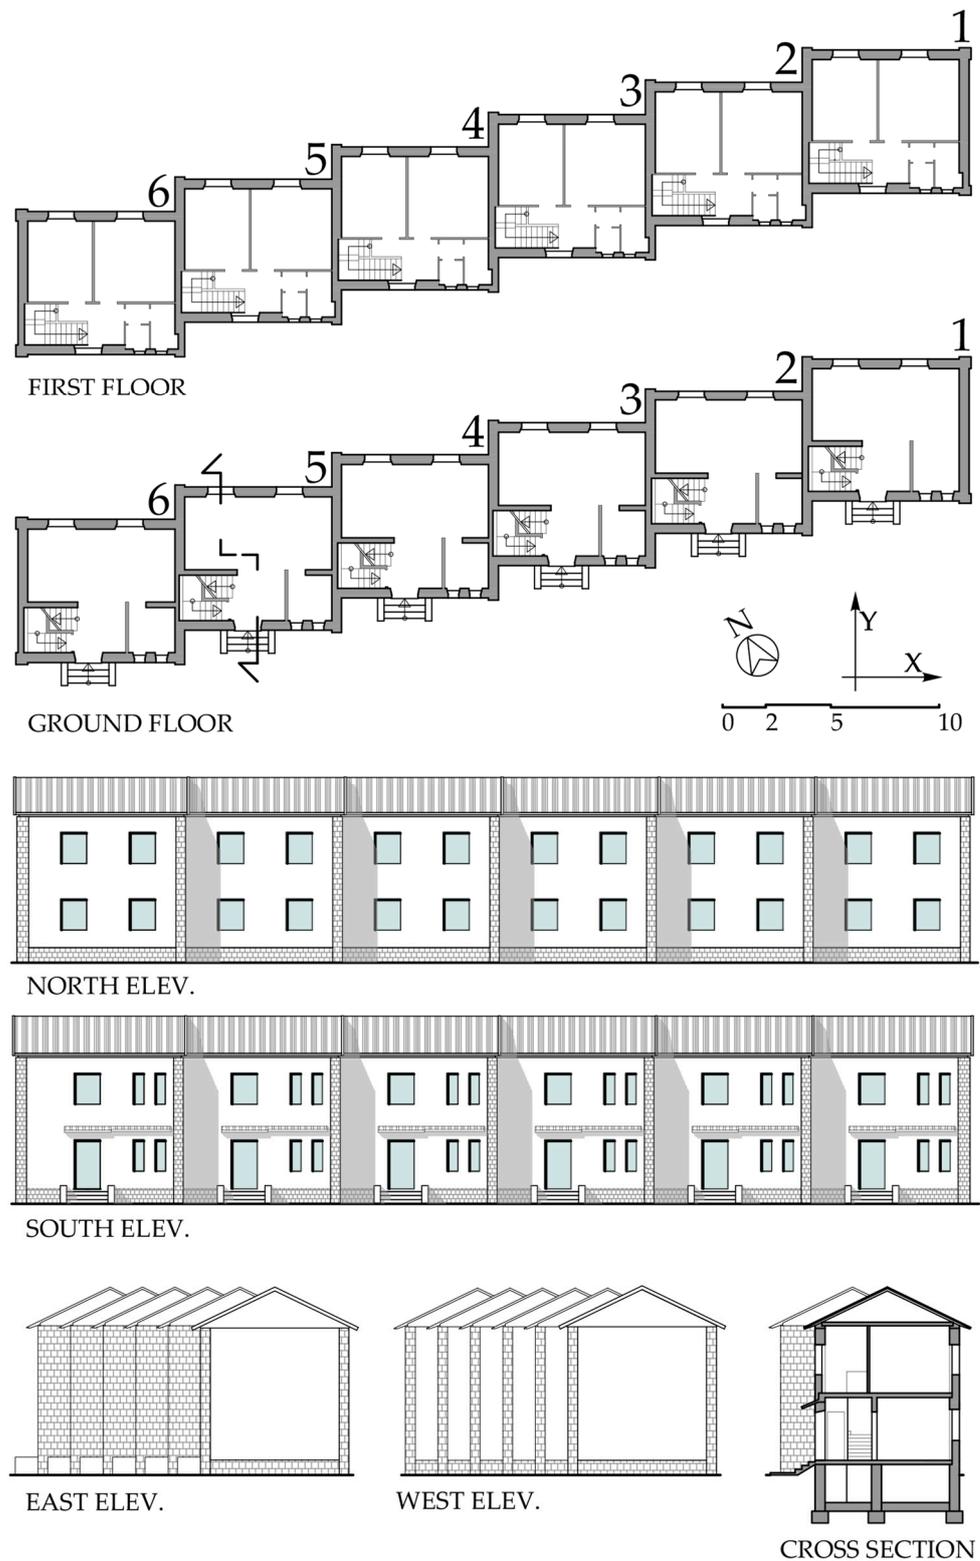
**Figure 4.** Geometrical survey of IACP building.

In this study, the dwelling units are identified by a progressive number from east to west, as shown in Figure 4, which also reports the geometrical characteristics of IACP building. The X and Y reference axes correspond to the longitudinal and transverse directions of the terraced building, respectively.

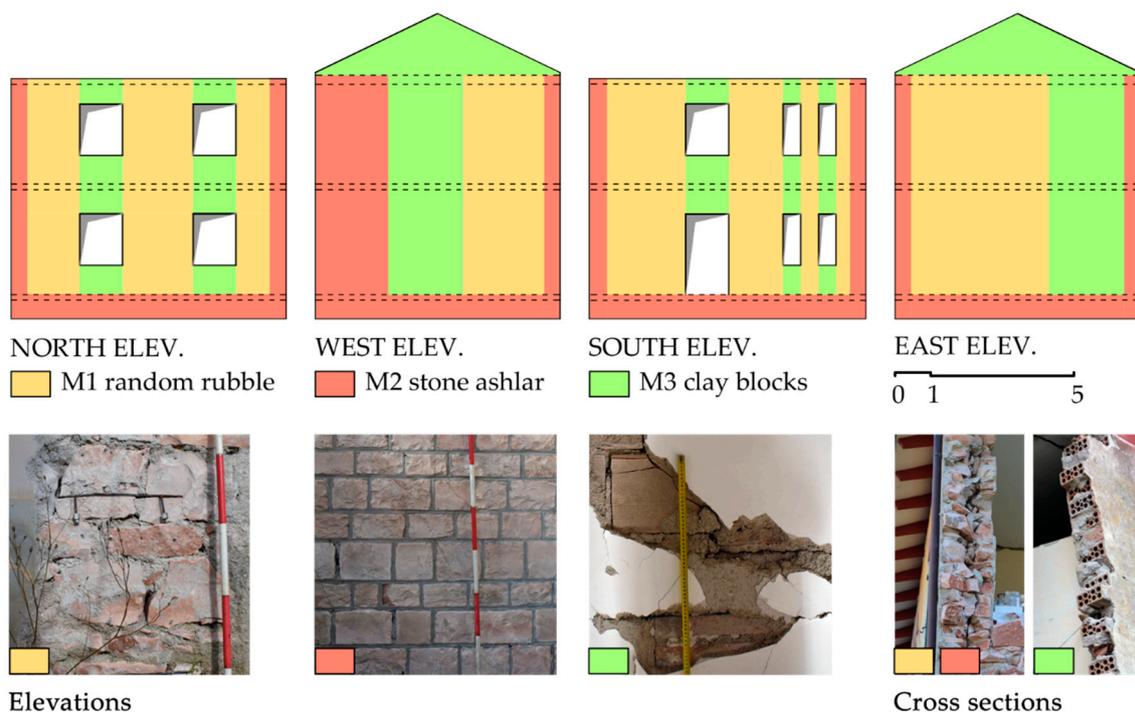
**Figure 5.** Distribution of masonry types within IACP building.

Despite the simple architectural appearance, material usage in loadbearing walls was rather patchy. Walls are made of (see Figure 5): (a) 45-cm-thick random rubble limestone masonry (M1 type, yellow colour), (b) 45-cm-thick ashlar masonry (M2 type, red colour), and (c) 25-cm-thick hollow clay block masonry (M3 type, green colour); for all the masonry types, cement mortar was used to embed units. M3 masonry is used in the east and west walls, where the staircase is, in gables, in the internal wall at the ground floor, and in the spandrels of the north and south facades; the rest is made of either M1 or M2 masonries, depending on where the ashlar finish is. However, local crumbling of ashlar masonry revealed diamond-shaped stones and the same two-leaves section of M1 type; consequently, following a conservative and simplified approach to the model, the two types were considered as one (M1, see Section 2.5).

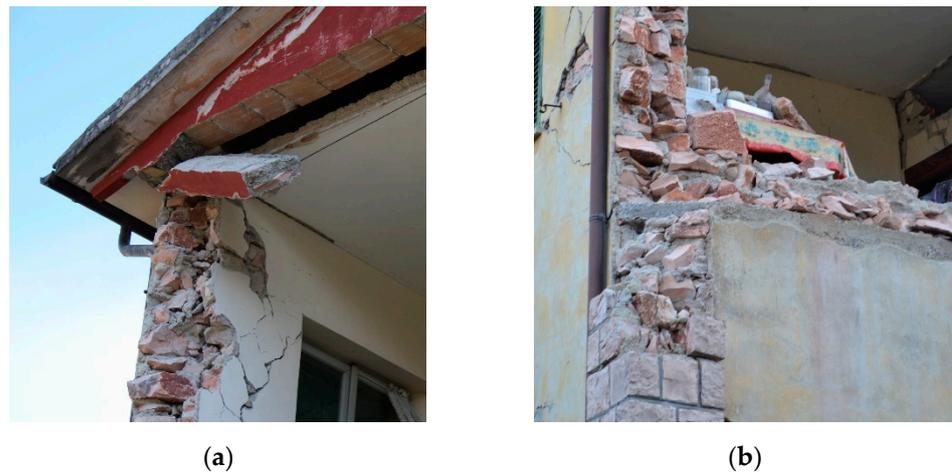
**Figure 6.** Details of unreinforced ring beams at (a) ceiling and (b) floor levels.

Floor slabs are made of a clay block ribbed system sold in those times under the SAP acronym [40]. Blocks were aligned on the work site and bound with cement mortar, including steel rebars ( $\text{Ø}4$  to  $\text{Ø}6$ ) at the bottom and top faces so that the resulting joists could be mounted without formworks and scaffolding. The structural height of the blocks could vary from 8–12 cm (lofts and ceilings) to 16–20 cm (floor slabs), and concrete was poured just to fill the spaces left between the joists, as contemporary codes [41] allowed without any overlay. These slabs were usually bordered by an unreinforced concrete ring beam, which offered the support on the walls and the anchorage of the longitudinal reinforcement of the joists; indeed, these ring beams were evident during the surveys, owing to the seismic damage (Figure 6). Finally, the roof structure is also typical of those years, that is, precast r.c. joists supporting a hollow clay tile decking. These joists are exposed to shear failure, as they do not have a specific reinforcement [17].

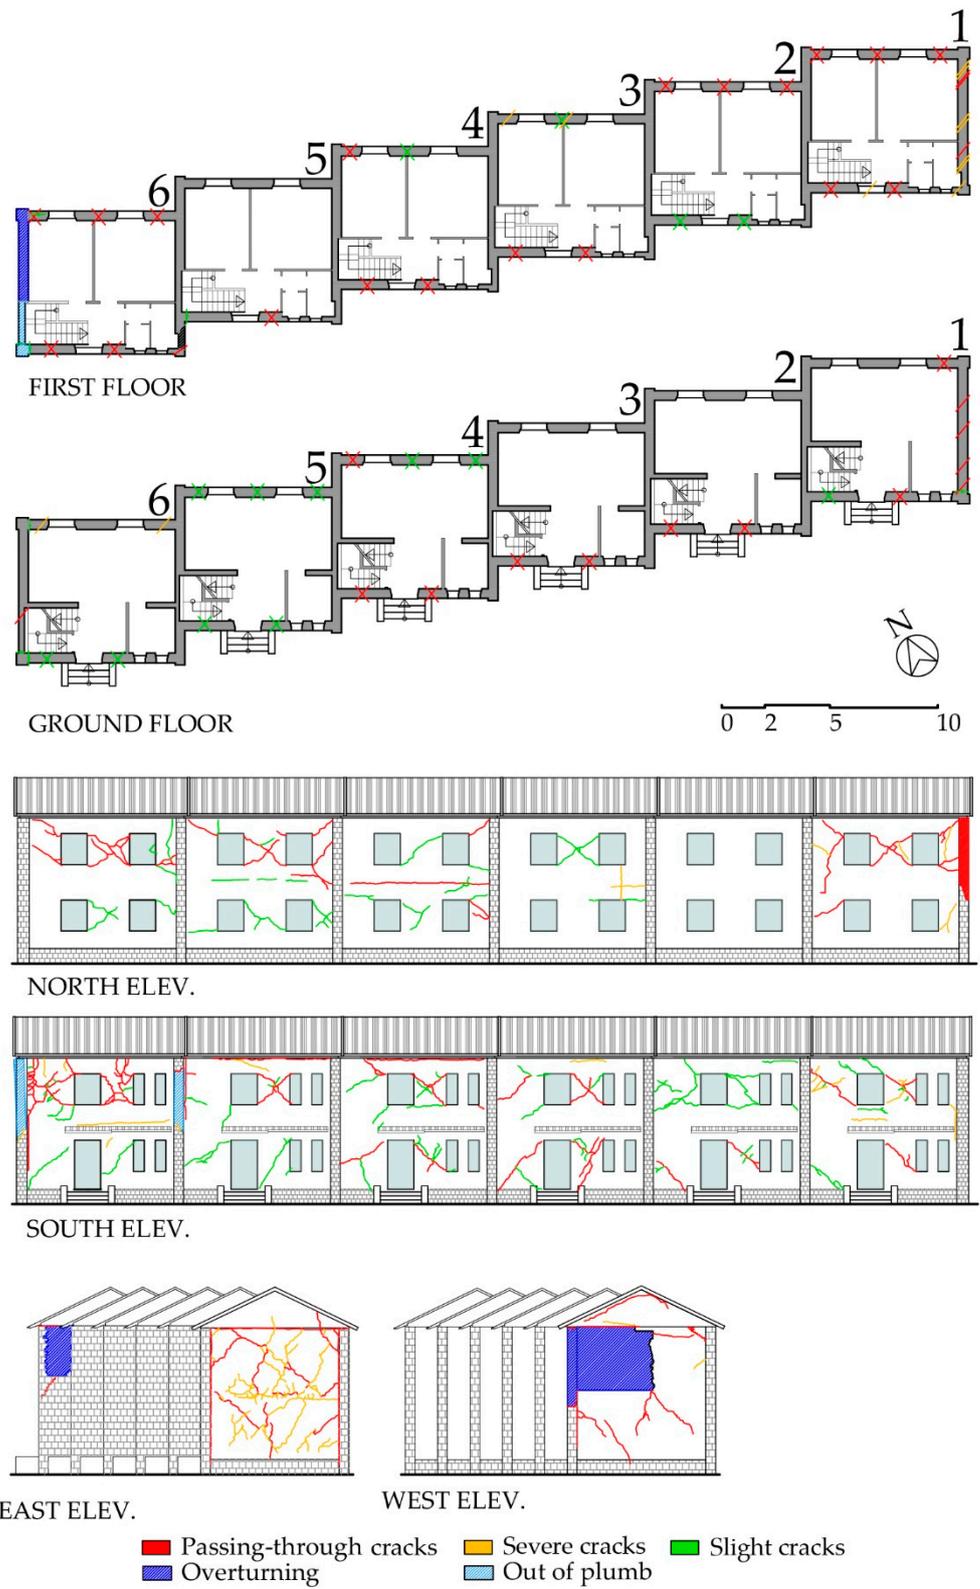
Figure 7. Overview of seismic damage of IACP building.

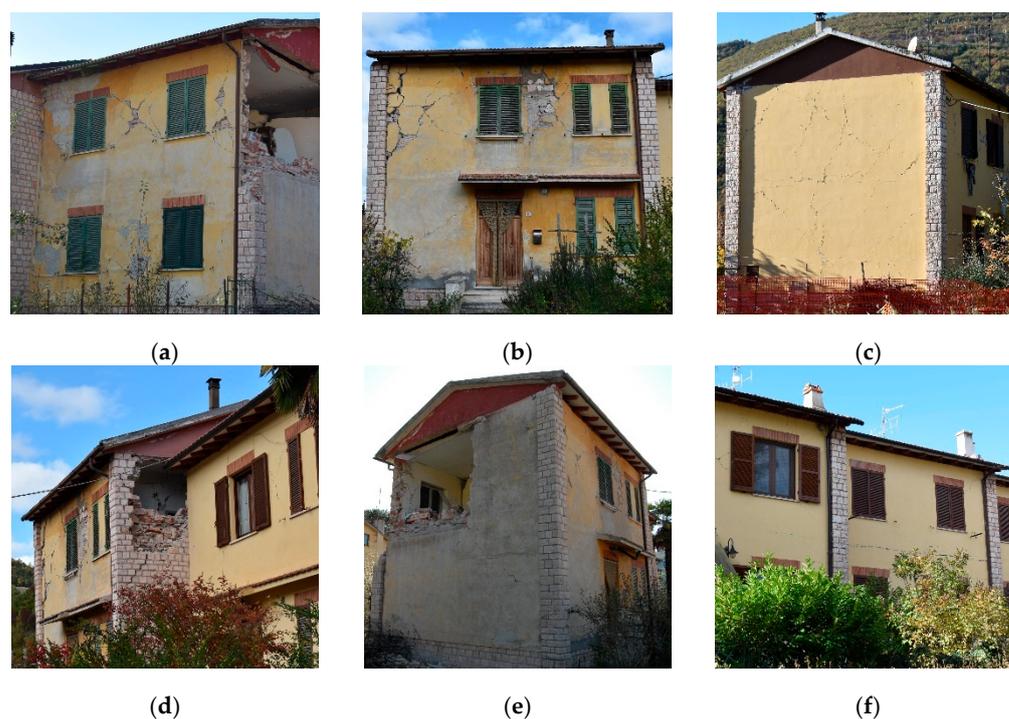
**Figure 8.** Details of damage pattern in IACP building: diagonal shear cracks of piers in (a) north and (b) south facades of unit no. 6, and activation of overturning in west facade; (c) shear cracks in east facade of unit no. 1; crumbling and overturning in (d) east and (e) west facades of unit no. 6; (f) sliding cracks at floor level in unit no. 4.

- Diagonal shear damage in piers of the north, south, and east facades, heavier in the extreme units (no. 1 and 6) and in the upper storeys (Figure 8a–c);
- Light flexural and/or crushing cracks in spandrels;
- Local crumbling and OOP collapses of panels in the west and east facades of unit no. 6 (Figure 8d–e);
- Activation of the overturning in the first storey of unit no. 6 in M3 masonry walls (Figure 8b) and shear cracks at the ground floor;
- Shear failure of non-structural partitions and slight to moderate IP damage of internal loadbearing walls (although this datum is limited to a few units);
- Sliding cracks at floor levels, mainly in internal units (Figure 8f).

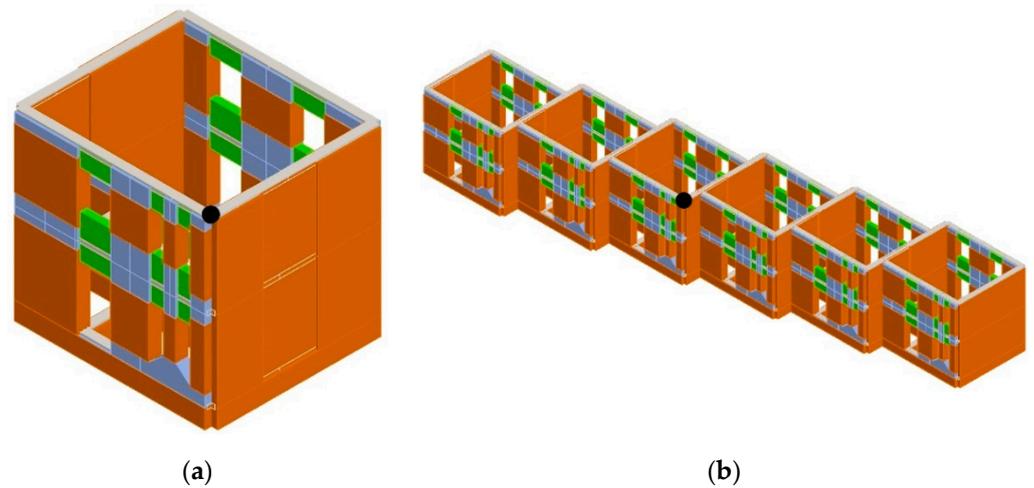
**Figure 9.** FME model, southeast 3D view: (a) single-unit model (unit no. 6); (b) whole terrace. Key to colour: piers in orange, spandrels in green, rigid nodes in blue. Black dot indicates control nodes for single-cell and whole terrace analyses, respectively (see Section 3.1.1).

The overall behaviour of both a single unit and the whole terrace was studied by means of a 3D model in the commercial version of 3Muri software [16] (Figure 9). This was justified by the predominant IP response observed after the 2016 seismic event, thanks to the presence of the strong spandrels and the semi-rigid diaphragms (see Section 2.4). In 3Muri, masonry walls with openings (i.e., doors and windows) are modelled in piers, bearing the vertical loads, and spandrels, which connect the piers through rigid nodes. Masonry panels are modelled as nonlinear beams with a piecewise relationship between the drift ratio and the horizontal force, which simulate the occurrence of flexural, shear, or mixed failure modes [43]. R.c. ring beams are modelled as nonlinear beams with elastoplastic hinges at the end sections, whose properties are determined by the criteria proposed in Italian and European codes [21,44]; diaphragms are modelled as membranes with equivalent thickness and stiffness.

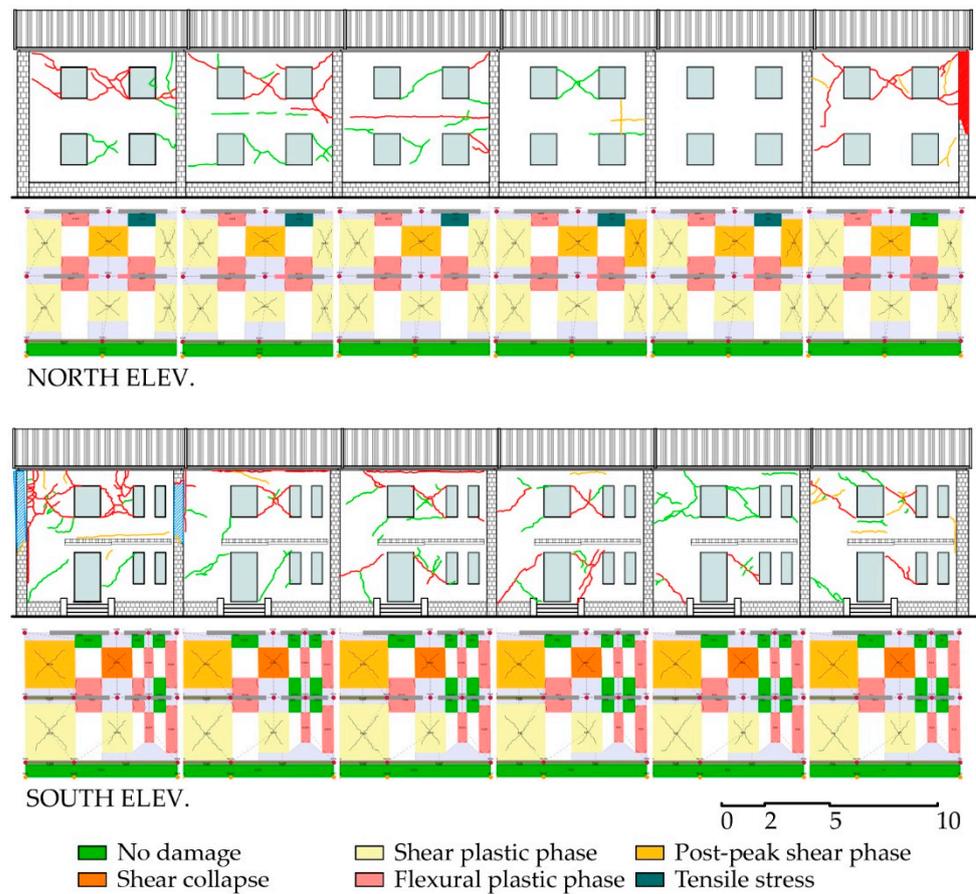
**Figure 10.** Comparison between damage state obtained from modelling and observed crack pattern.

The IACP building's real observed behaviour was considered as a reference for the calibration of the structural model (see Section 2.5) (a similar approach can also be found in [42]). The calibration procedure is summarized in the 'supplementary material' of this paper.

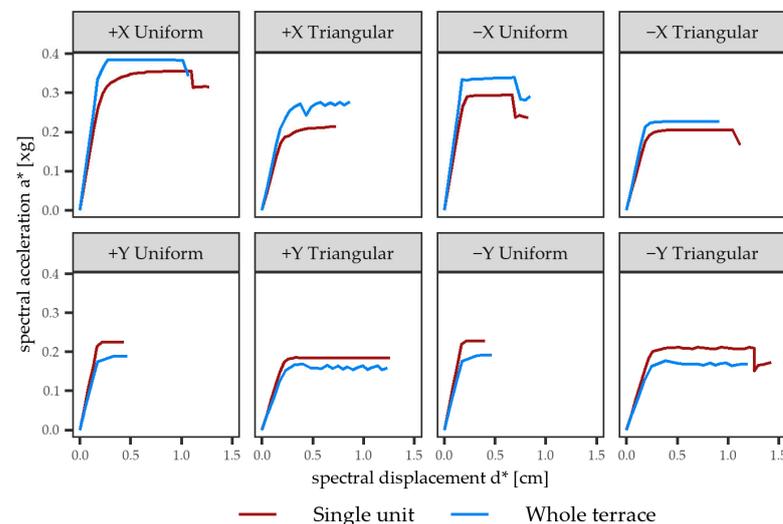
**Figure 12.** Normalized pushover analyses of as-built models (single unit and whole terrace).

Pushover analyses were carried out with either uniform or triangular distributions of horizontal loads, but without considering the accidental eccentricity between the centre of stiffness and masses as floor slabs are not completely rigid. The control node was chosen where the weakest external walls meet, in a corner of the unit (Figure 9), since slabs are not completely rigid in as-built conditions. Figure 12 shows the normalized pushover curves (spectral acceleration  $a^* = F/\Gamma m^*$ , spectral displacement  $d^* = d/\Gamma$ , where  $F$  is the total shear force at the base,  $d$  is the control node displacement,  $\Gamma$  is the modal participation factor, and  $m^*$  the participating mass) of both the single-unit and the terrace model. The overall model was stronger than the single-unit one in the X direction, and vice versa in the Y one. Indeed, there was no proportionality in the maximum shear force between the single-unit and the terrace models, and this difference was more evident in the Y direction, as the structural irregularities were amplified in that direction. The displacement capacity was almost equal between the models, with the overall model slightly more ductile.

This behaviour was also confirmed by the performance ratio  $\zeta_E$  value at the SD limit state, which was slightly higher in the single-unit model than in the overall one (0.379 and 0.283, respectively, see Section 3.2).

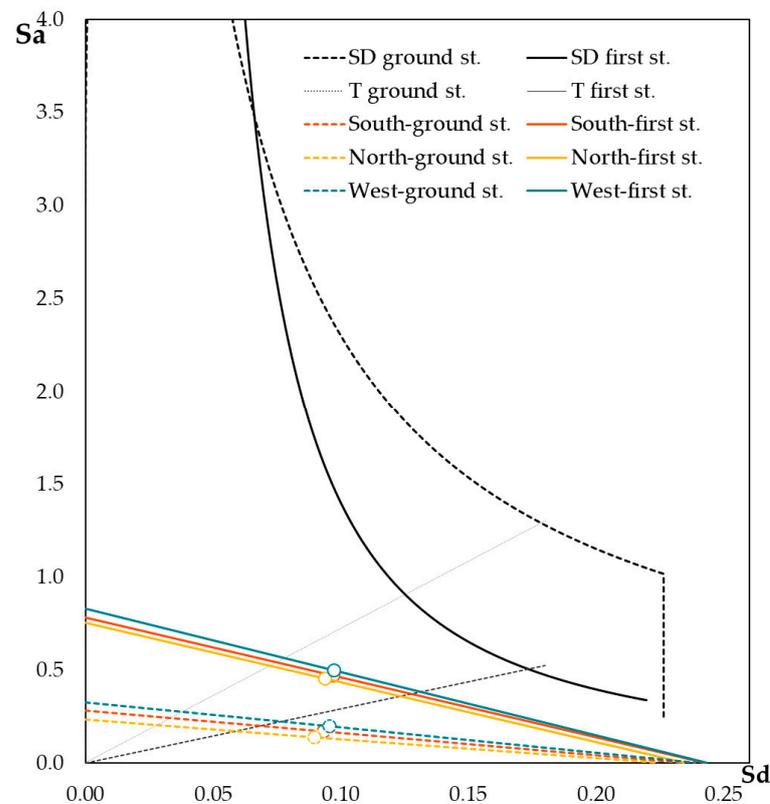
**Figure 13.** Capacity curves of local mechanisms and demand spectra at ground and first floors (empty dots represent displacement capacity at SD limit state; radial lines indicate structure’s period  $T$  at displacement capacity).

As the IACP building also showed local overturning mechanisms (see Section 2.4), the overall assessment was completed through kinematic analyses of the north, south, and west facades of the single-unit model, assuming the same loads and geometrical features considered in the numerical 3D model. Calculations were made under the hypotheses of: (i) no tensile strength; (ii) limited compressive strength (toe crushing); (iii) compactness of macroblocks during the overturning; and (iv) negligible friction between floor slabs and walls. The horizontal hinge was considered at the foot of the walls and at the first-floor level to take into account the building's dynamic filtering in the definition of the seismic demand along its height [22]. Due to the simplifying hypotheses, the overturning activation coefficients  $c$  were very conservative:  $c$  ranges between 0.025 and 0.035 at the ground floor and 0.085 and 0.095 at the first storey. Therefore, nonlinear analyses could offer a more precise understanding of the walls' behaviour through the computation of the displacement of each wall in both positions of hinges. In all walls, the limit displacement was about half their thickness, between 20 and 25 cm. Figure 13 shows the capacity curves

obtained for the IACP building at SD limit state plotted over the demand spectra in the acceleration–displacement plane ( $S_a$ – $S_d$ ).

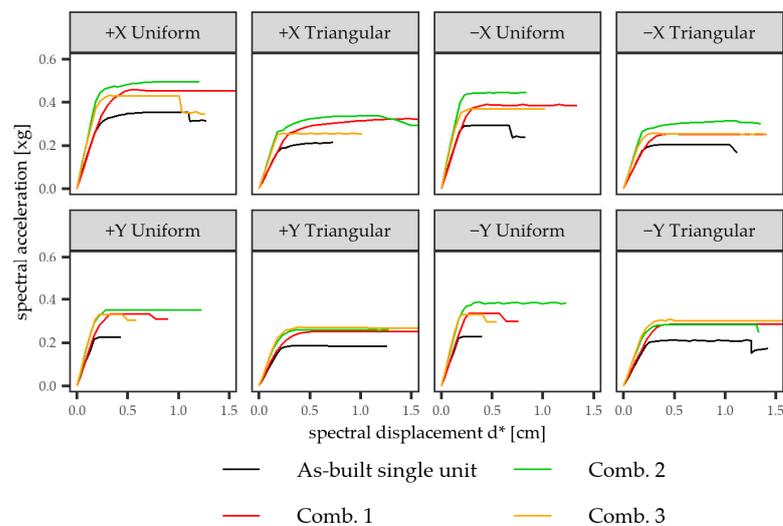
**Figure 14.** Single-unit model: normalized pushover analyses in strengthened conditions, compared to as-built.

Figures 14 and 15 show the results of pushover analyses of the single-unit and the whole-terrace models, respectively, to which the strengthening strategies proposed in Section 2.6 were applied. Each strategy determined an increase in the normalized base shear force ( $a^*$ ), up to the 40% (combination 2). This increment was more evident in the analyses carried out in the X direction of the models if compared to those in the Y direction, where blind, and therefore stronger, walls already exist in as-built conditions. The structure's ductility also increased, especially in the X direction (the maximum increase was obtained in combination 2). In the terrace model, combination 3 was more effective in the Y direction (i.e., the weakest one), owing to the increased diaphragm stiffness, which favoured the inertial redistribution among walls.

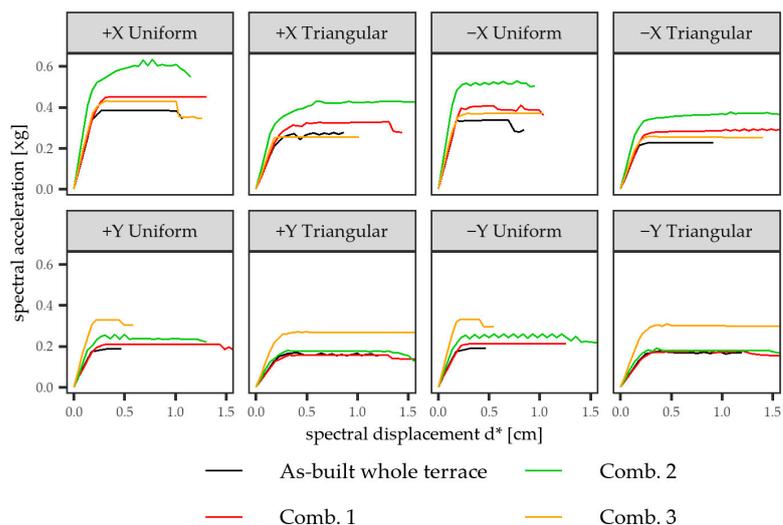
**Figure 15.** Whole-terrace model: normalized pushover analyses in strengthened conditions, compared to as-built.

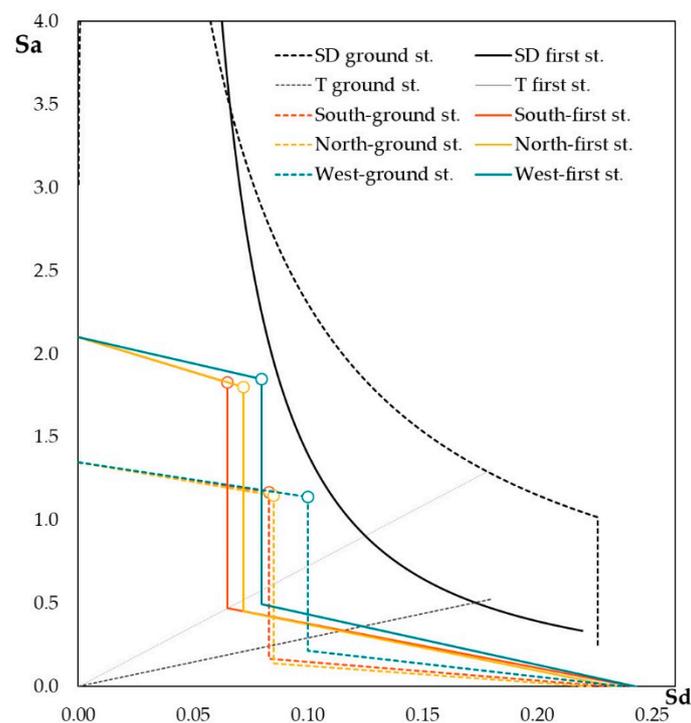
**Figure 16.** Capacity curves of local mechanisms with tie rods and demand spectra at ground and first floors (empty dots represent the displacement capacity at SD limit state; radial lines indicate the structure's period  $T$  at displacement capacity).

The same procedure was applied to OOP mechanisms, which cannot be taken into consideration by the numerical model and whose countermeasure was the application of tie rods to the loadbearing walls of IACP buildings. Ties were designed to withstand the PGA at the DL limit state and, therefore,  $\zeta_E = 1$  in strengthened conditions for both hinge positions in the overturning mechanism (see Section 3.1.2). The increase in the performance ratio  $\zeta_E$  was relevant and equal to 0.70 on average (Table 7). The capacity curve with tie rods (Figure 16) is piecewise and shows a sudden drop where tie rods reach the yield displacement (conventionally assumed at 0.1%); as north and west facades have different spans, tie rods have different ultimate displacements in the two directions, which are even closer to the unit.
