Experimental Study on Fire Resistance of Concrete Beams Made with Iron Tailings Sand

Abstract: In order to measure the effect of iron tailings sand replacing natural sand on the fire resistance of concrete beams, five full-scale iron tailings sand concrete (ITSC) beams and two natural sand concrete (NSC) beams were conducted to fire testing under dead load and rising temperature conditions. The section temperature field, mid-span displacement, failure form, and fire resistance limit of ITSC beams under fire were analyzed. The main influence factors included different ITSC strengths (C30 and C40) and constraints. The analysis results were compared with those of NSC beams. The results show that the complete replacement of natural sand with iron tailings sand had little influence on the temperature field of concrete and reinforcement in simply supported beams and continuous beams under fire. The fire endurance of the ITSC simply supported beams was similar to that of NSC simply supported beams. When exposed to fire, the higher the strength of the ITSC, the better the fire resistance of the beam. The fire endurance of continuous beams was higher than that of simply supported beams. On

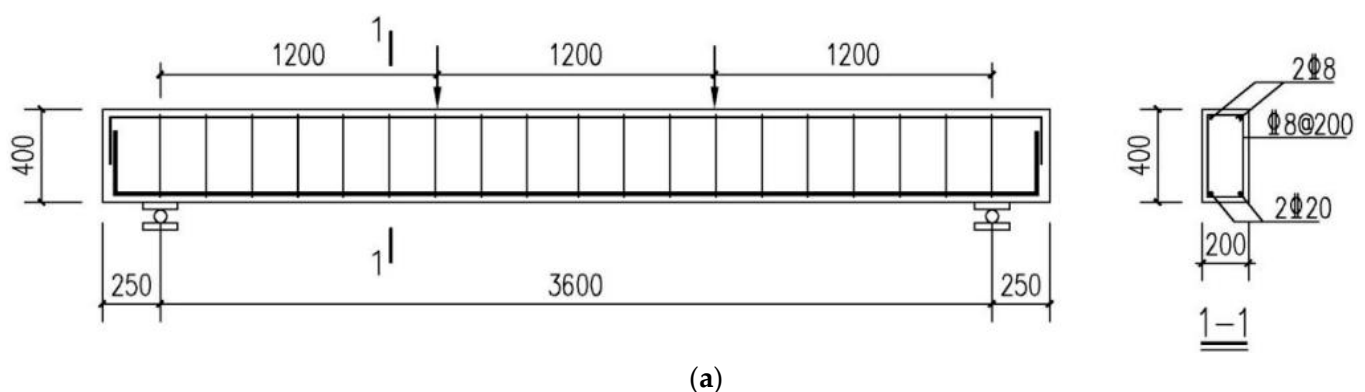
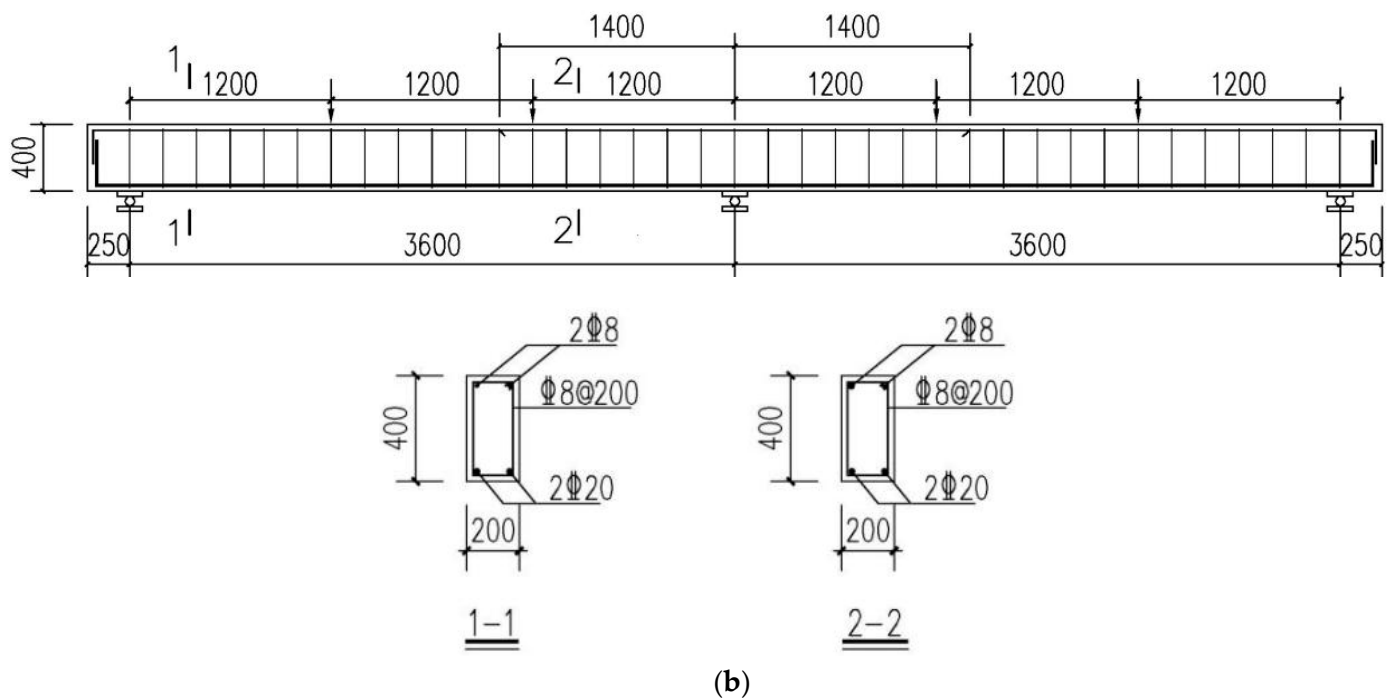
Figure 1. Arrangements of rebars for beams: (a) Simply supported beam; (b) Continuous beam.

In this experiment, the bending performance tests of five full-scale ITSC beams and two NSC beams with different concrete strengths and different constraints were carried out under fire. Three were simply supported beams and four were continuous beams. The simply supported beams and continuous beams lengths were 4100 mm and 7700 mm, respectively, and the section size was 200 mm × 400 mm. The dimensions and reinforcement

of the beam are shown in Figure 1. The serial number of the continuous beam is represented by “CB”, the number of the simply supported beam is represented by “SSB”, the iron tailings sand concrete is represented by “ITSC”, and the natural sand concrete is represented by “NSC”. To compare the fire resistance of continuous beams under different fire conditions, CB-1 is subjected to double span fire, while CB-4 is subjected to single span fire. The design parameters of specimens are shown in Table 1. On the basis of the NSC mixing ratio, the ITSC mixing ratio was kept unchanged. The dosage of admixture and concrete sand ratio were adjusted to make the mixing material workability meet the requirements. The final concrete mixing ratio is shown in Table 2. In order to reduce the influence of moisture on fire resistance of beams, test beams were placed in a dry and ventilated place for 90 days after 28 days of curing. The measured compressive strength of C30 NSC was 32.26 MPa, and the measured compressive strengths of C30 and C40 ITSC was 31.98 MPa, and 39.86 MPa, respectively.

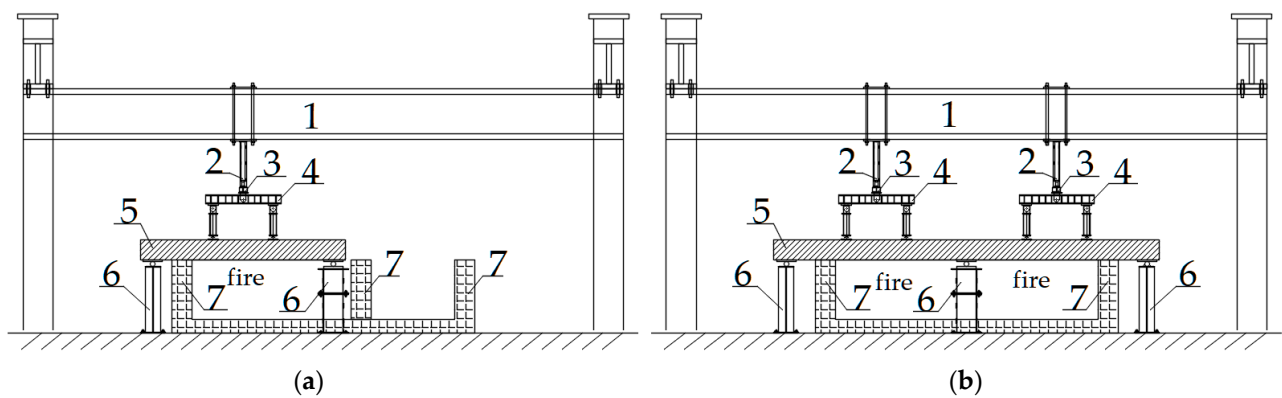
Figure 2. Test equipment: 1—longitudinal reaction steel beam; 2—hydraulic jack; 3—pressure sensor; 4—loading steel beam; 5—test beam; 6—steel bearing; 7—furnace wall; (a)—continuous beam loading device (b)—simply supported beam loading device.

The experiment was carried out in the fire laboratory of North China University of Science and Technology. All the test beams were subjected to the standard fire test under the condition of dead load-heating. In the test, the bottom surface and two sides of the beam were under fire. The beam ends were simply supported. The concentrated load was applied to the middle trisection in the beam span. The hydraulic jack equipped with a voltage regulator was used to load the test beam to the predetermined load and keep it constant. According to the European standard EC4 [29], the predetermined dead load applied by simply supported beams was 0.7 times ultimate load (considering the reduction factor of the load effect under fire), the same predetermined load was applied to continuous beams and simply supported beams with the same strength, as can be seen in Table 1. The load was measured by the pressure sensor. The furnace was heated according to the ISO834 standard heating curve. The fire resistance limit criterion was that the specimen deflection reached 1/20 of the calculated span [30]. After the specimens reached the fire resistance limit, they were unloaded and cooled naturally to room temperature. The test loading device is shown in Figures 2 and 3.

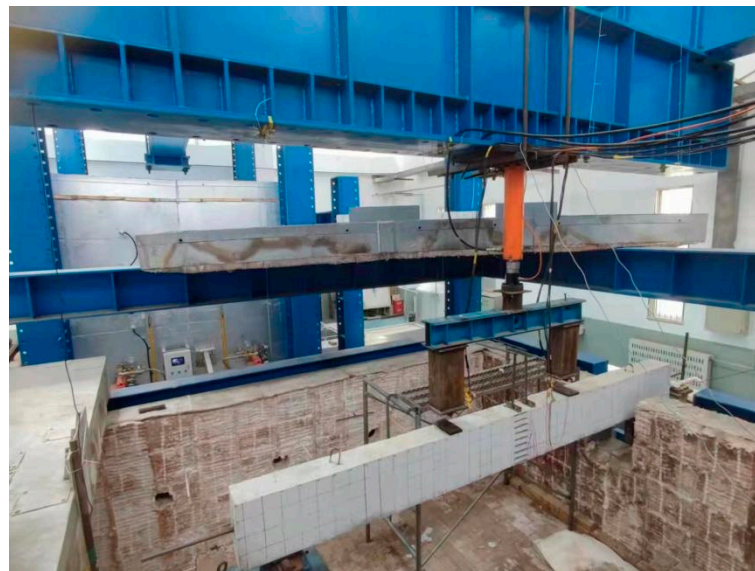
Figure 3. A full view of test equipment.

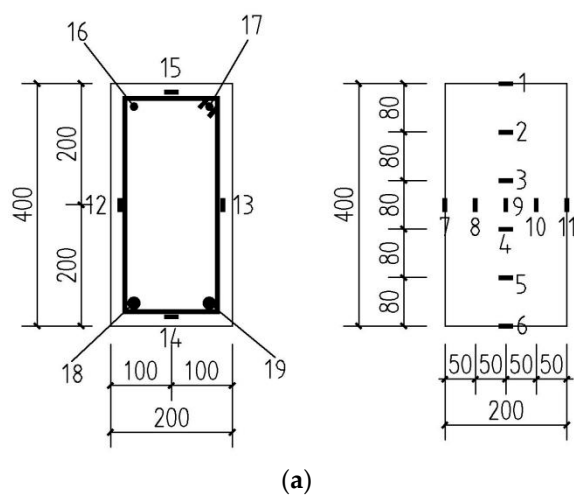
Figure 4. Arrangements of temperature measuring points: (a) Schematic diagram of measuring points; (b) real map of measuring points.

The embedded thermocouples were used to measure the temperature field of the reinforcement and concrete at different location of the beam cross section. Two sections of the mid-span and the loading point were selected to arrange the thermocouple. The 11 concrete temperature measurement points were arranged along the horizontal and vertical directions for each section. In each section, the temperature of the longitudinal bars at the both top and bottom of the beam was measured. The stirrup was arranged with a temperature measurement point along the middle of the four sides. The measuring points are shown in Figure 4. The vertical displacement of the beam was measured by a wire displacement meter arranged at the top of the beam. The displacement measuring points were correspondingly arranged at the loading points support and in the mid-span of the beam. The specific measuring points were arranged as shown in Figure 5.

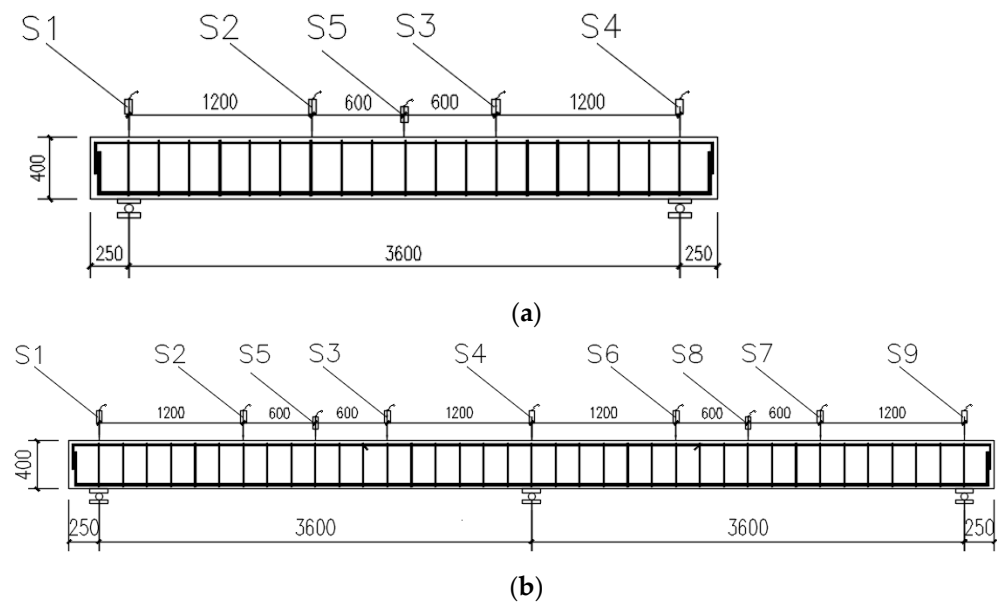
Figure 5. Arrangements of displacement transducers of beams: (a) Simply supported beam; (b) Continuous beam.

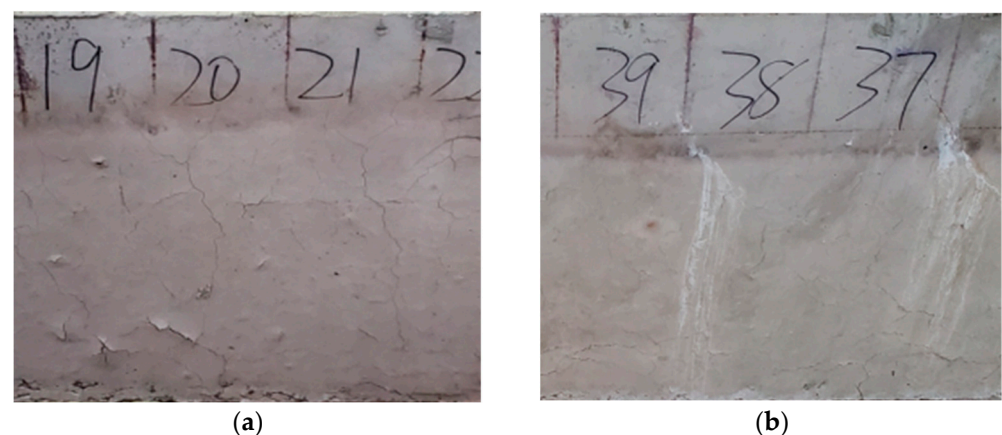
Figure 6. Water stain drawing of beam side: (a) ITSC beam; (b) NSC beam.

The test beam was loaded in stages at room temperature, and each stage was loaded with 20 kN for five minutes. After it was added to the predetermined load, the heating fire test was carried out according to the ISO834 heating curve until the test beam reached the fire resistance limit or 120 min. In the fire test process, the ITSC beam test was essentially the same as the NSC beam. After 10 min of ignition, water vapor appeared on the interface between the test beam and the furnace lid. The water vapor increased gradually with the increase in temperature. A water trace was formed on the top of the beam. With the progress of the fire test, the watermarks on the top of the beam gradually decreased and finally disappeared. To simulate the influence of the floor on the side of the beam subjected to fire, the furnace cover was used to clamp the top of the beam at the height of 100 mm to form a fire-free zone. When the furnace cover was opened after the test, it was observed that there was an apparent waterlogging line between the fire area and the non-fire area on the side of the beam. The non-fire area of the ITSC beam was dark grey, and the fire area was greyish yellow. The non-fire area of the NSC beam was grey, and the fire area was grey-white, as shown in Figure 6.

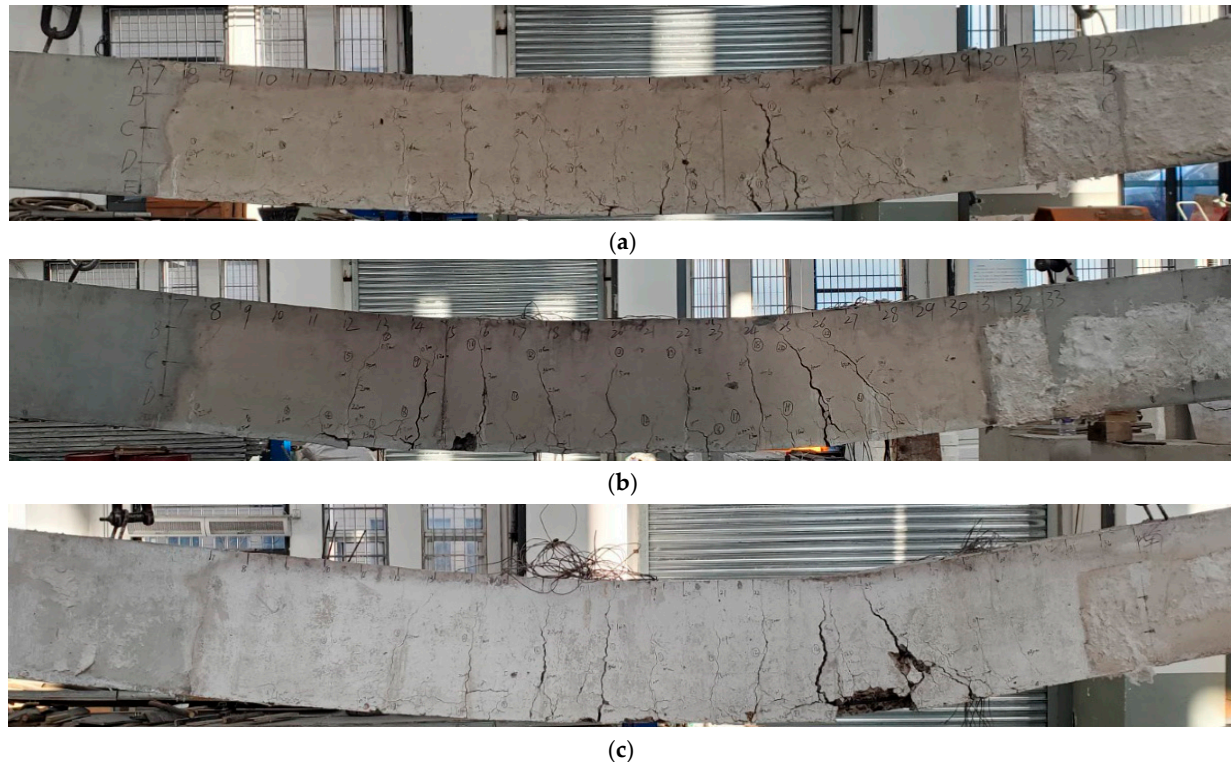
Figure 7. Failure modes of SSB under fire: (a) SSB-1; (b) SSB-2; (c) SSB-3.

The simply supported beams reached the fire resistance limit in the firing process, and the test beams were hoisted after the cease-fire. The failure mode of the simply supported beams are shown in Figure 7, and the simply supported beams had cracks on the fire surface. The cracks were distributed in a network. The surface was bulging and loosening. There was a sizeable residual flexure deformation after cooling to room temperature.

(1) Using the iron tailings sand instead of the natural sand. As it is illustrated in Figures 7–10, the test phenomena, the failure forms and the crack distribution were essentially very similar during the fire based on the comparison between NSC beams (SSB-3, CB-3) and ITSC beams (SSB-1, CB-1) with the same strength. The reason for the color change and beam cracking was the physical dehydration of cement mortar [31] and the interior change of concrete under fire [32]. The temperature rise under fire caused more cracks on the surface of the beam, and the cement mortar was seriously dehydrated [27,28]. It can be seen from Table 3 that the fire endurance (93 min) of SSB-1 beams was similar to that of SSB-3 beams (92 min). When reaching the fire endurance, the maximum crack width (13 mm) of SSB-1 beams was 7.67% lower than that of SSB-3 beams (14 mm). It can be implied from Table 4 that the residual bearing capacity (268 kN) of CB-1 beams after being exposed to fire for 120 min was similar to that of CB-2 beams (265 kN), and the maximum bending deformation and maximum crack width at failure increased by 7.14% and 6.67%, respectively, under failure. It can be seen from Figures 12 and 13 that under the standard heating condition, the temperature field distribution and temperature change of concrete and reinforcement were likely to be the same, as reported by Choi and Gao [10,11]. Although iron tailings sand replace natural sand wholly, the concrete strength does not change. The fire resistance limit, temperature field of concrete and reinforcement, residual bearing capacity after fire, and crack width of beams under fire are similar [31]. Therefore, it is possible for the iron tailings sand to replace natural sand in terms of its benefits with regard to fire resistance limit, temperature field of concrete, and reinforcement of beams.

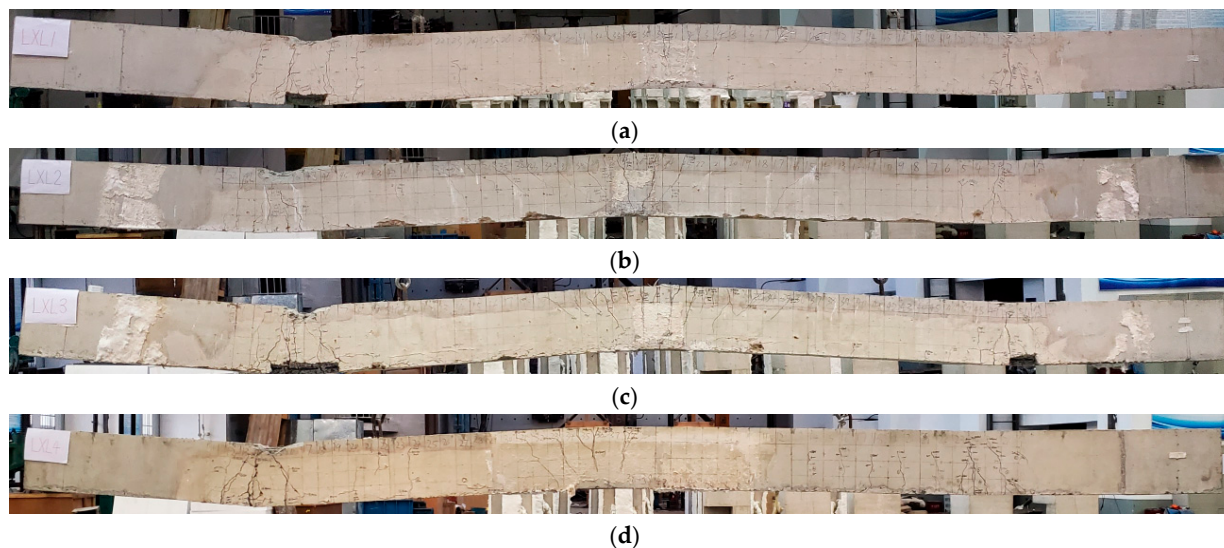
Figure 8. Failure modes of CB after fire: (a) CB-1; (b) CB-2; (c) CB-3; (d) CB-4.

The continuous beams did not reach the fire resistance limit after being exposed to fire for 120 min. After natural cooling of the continuous beams, static load tests were carried out until the continuous beams were destroyed. In the static load test, the step-load was applied at a rate of 20 kN controlled by displacement of 0.5 mm/min until the continuous beams were damaged. The failure forms of the continuous beam are shown in Figure 8. The continuous beams maintained good integrity under the fire for 120 min. There was only a slight burst occurred in the middle of the span. After cooling, there was a large recovery of bending deformation. In the static load test, there was few new main crack growing in the pure bending section. The width of the original main crack gradually increased until the failure.

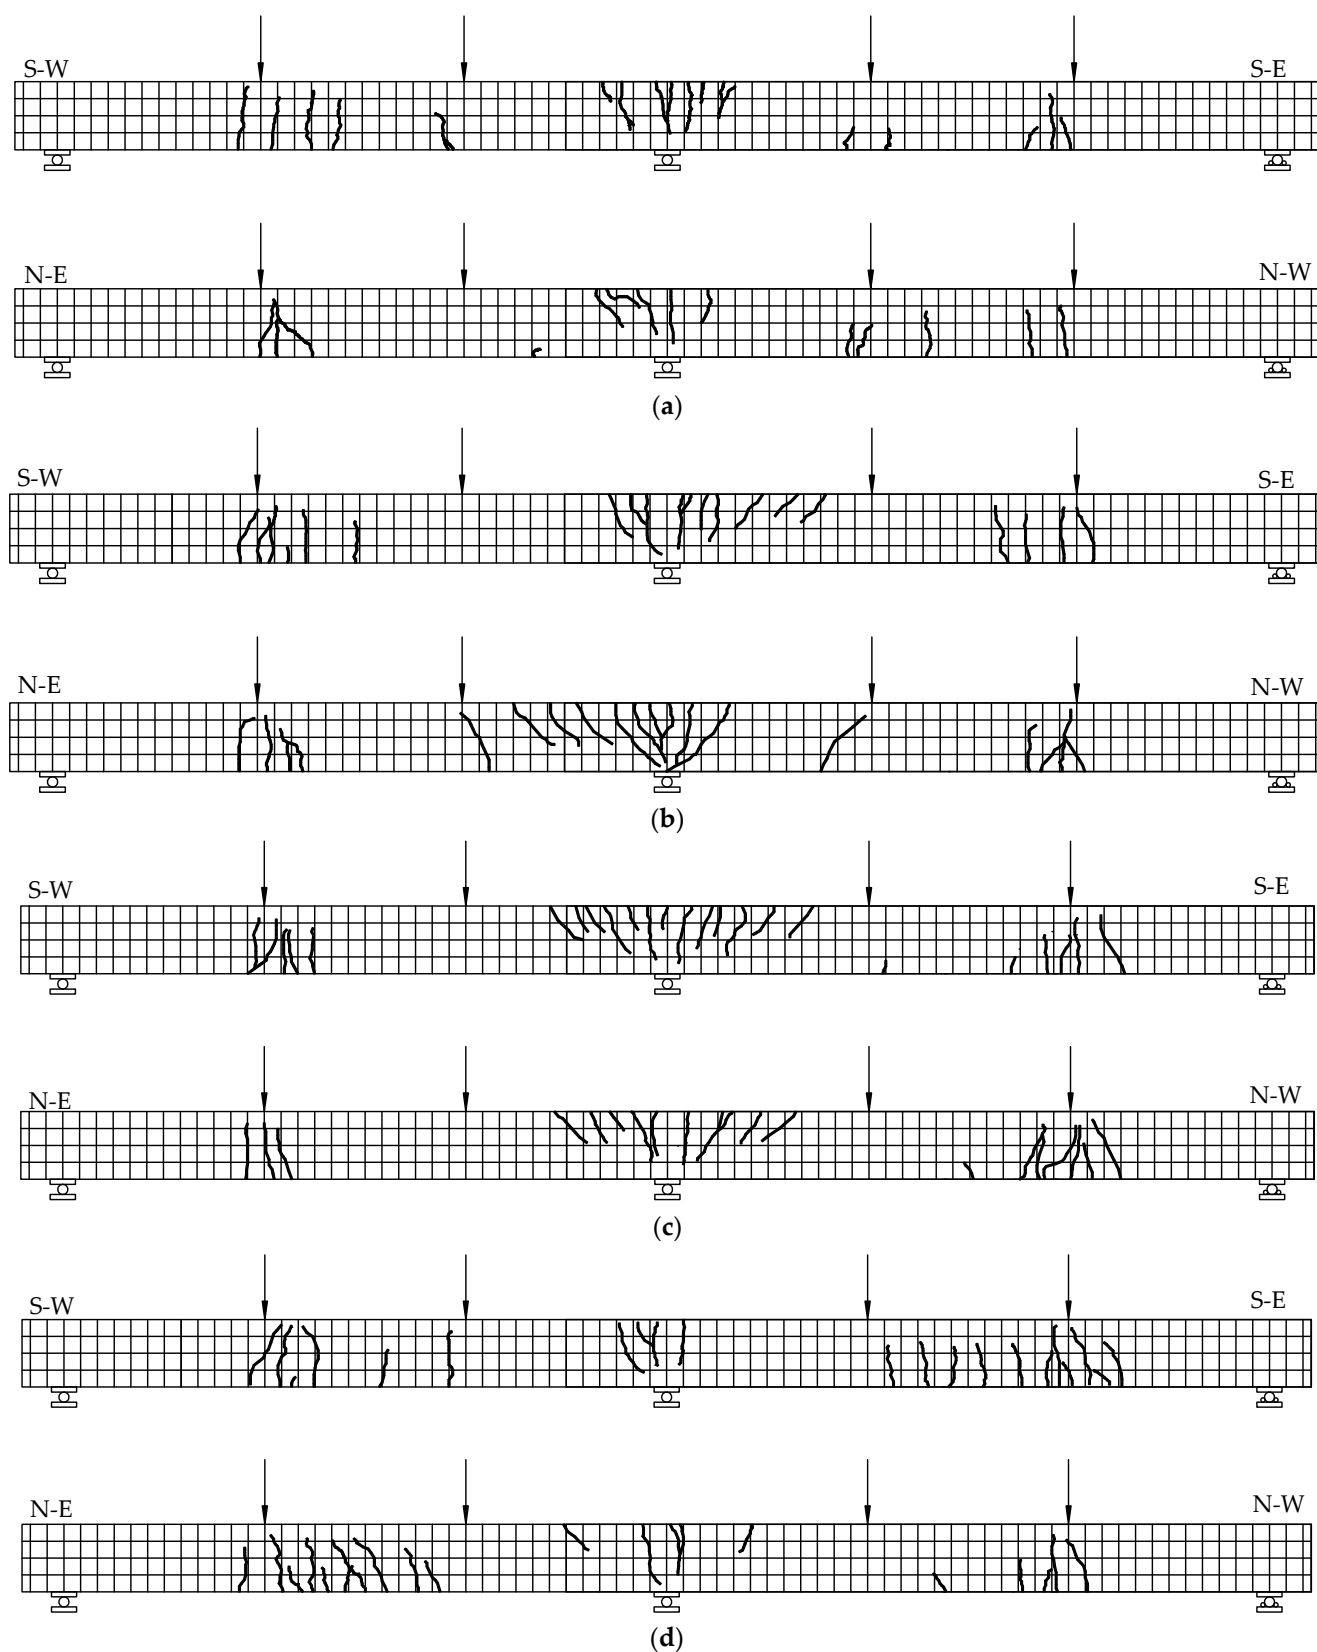
Figure 10. Crack development and failure pattern of the continuous beam under static load test failure after the fire: (a) CB-1; (b) CB-2; (c) CB-3; (d) CB-4.

Figure 10 indicates that the crack development and failure pattern of the continuous beams under static load test failure form after the fire. As can be seen from the figure, with the increasing of load, the cracks under the fire of the pure bending section gradually developed upward, and the crack width increased gradually. Then, cracks appeared in the upper part of the middle bearing and gradually developed downward. Finally, the concrete in the compression area of the pure bending section was crushed, and the continuous beams were destroyed. The maximum crack widths of the continuous beams are shown in Table 4. It can be seen that the maximum crack widths of the single-span fire CB-4 beam and CB-2 beam with high concrete strength were small at 9mm and 8mm, respectively.

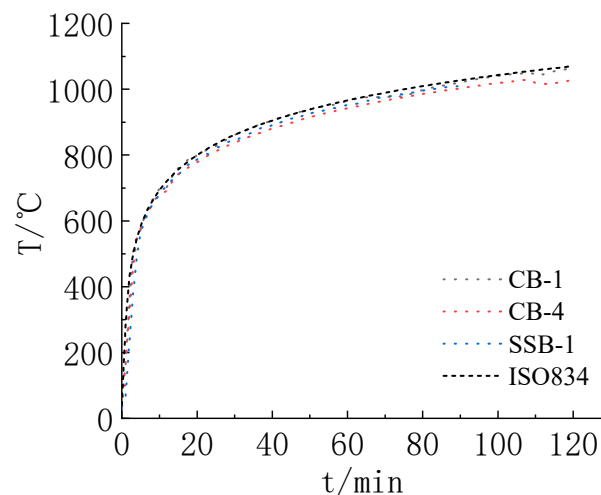
Figure 11. The time history curves of furnace temperature.

The measured furnace temperature curves of SSB-1, CB-1, and CB-4 beams were compared with the ISO834 standard heating curve shown in Figure 11. It can be seen that the fire heating curves of each test beams had the same heating trend as the standard heating curve, and the temperatures were similar.

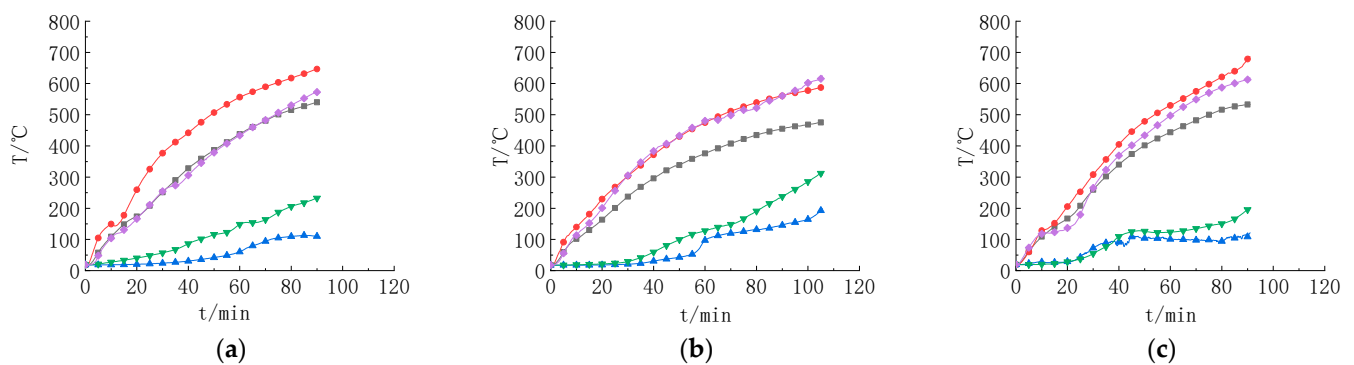
Figure 13. Time history curves of rebar temperature inside specimens: (a) SSB-1; (b) SSB-2; (c) SSB-3; (d) CB-1; (e) CB-2; (f) CB-3; (g) CB-4.

Figure 13 shows the time history curves of the temperature of stirrups and longitudinal reinforcement in the test beams under fire. According to the temperature distribution of five groups of measuring points in the figure, the temperature distribution law of reinforcement in the ITSC beams was similar to that in the NSC beams. Affected by the heat absorption by water evaporation, the longitudinal and stirrup temperature curves near the top of the beam produced a temperature lag plateau at about 100 °C. The longitudinal reinforcement near the bottom of the beam and the stirrups close to the bottom and middle of the beam increased faster as they were closer to the fire surface.

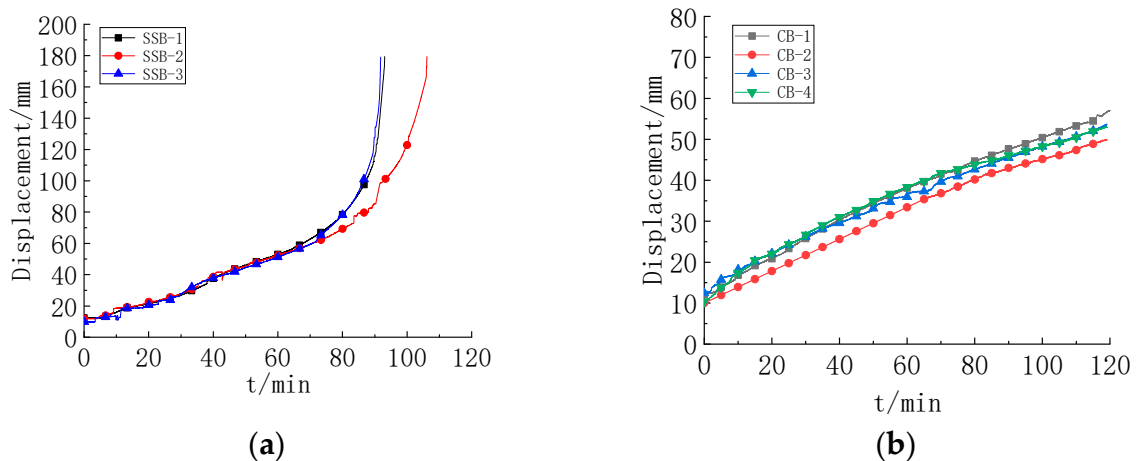
Figure 14. Increase in mid-span displacement with time for specimens exposed to fire: (a) SSB; (b) CB.

Figure 14 shows the vertical mid-span displacement of the test beam under fire as a function of time. It can be seen from the diagram that the deflection of the test beam under fire was the result of the combined action of load and temperature. The simply supported beam produced downward bending deformation under the action of high temperature. However, the bending deflection of the continuous beam was not apparent. As shown in Figure 14a, the mid-span displacement curve in the simply supported beam was divided into two segments, at rough 70 min. Before 70 min, the stiffness of the simply supported beam did not clearly deteriorate. The mid-span displacement in the span increased linearly with time. The increasing rate was slow. When the temperature exceeded 70 min, it can be seen from Figure 13 that the temperature of tensile longitudinal bars was close to 550 °C, the strength and stiffness of reinforcement are degraded. The increasing rate of the mid-span displacement increased significantly, showing a non-linear development trend. The continuous beam is a statically indeterminate structure with redundant constraints. The internal force redistribution would occur due to the decreased stiffness of the concrete in the firing process. The mid-span displacement of the continuous beam developed approximately linearly over the 120 min under fire and did not fail.
