Article

# In-Plane Seismic Behavior of Brick Masonry Walls Reinforced with Twisted Steel Bars and Conventional Steel Bars

**Citation:** Demaj, A.; Gago, A.S.; Marques, A.I.; Ferreira, J.G. In-Plane Seismic Behavior of Brick Masonry Walls Reinforced with Twisted Steel Bars and Conventional Steel Bars. *Buildings* **2022**, *12*, 421. <https://doi.org/10.3390/buildings12040421>

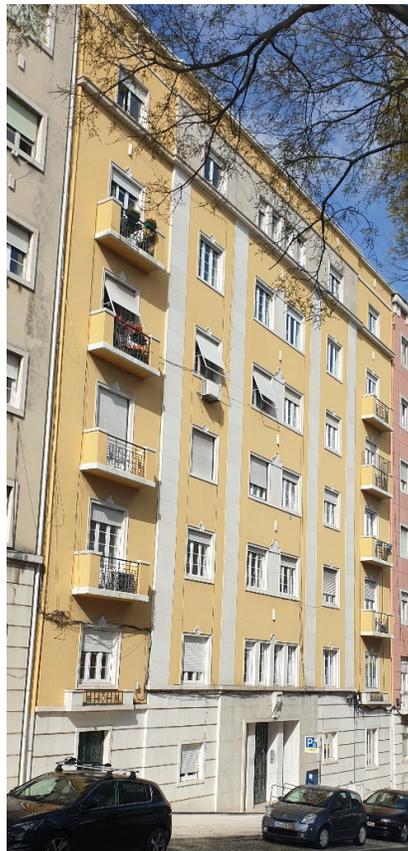
**Figure 1.** Exterior view of a “Placa” building in Lisbon, Portugal.

The overall behavior of old masonry structures is complex, since it highly depends on the masonry units, the bedding mortar, and the mortar-unit interface. Consequently, studies are required to characterize these materials and the structural behavior of the elements, and to evaluate the effectiveness of seismic strengthening solutions suitable for these buildings. In this regard, the project “RESIST-2020—Seismic Rehabilitation of Old Masonry-Concrete Buildings” focuses on the seismic behavior of solid clay brick masonry walls used in the structural arrangement of old masonry-concrete buildings. These buildings’ typology was widely used in Europe during the transition period from masonry to reinforced concrete, which took place between the 1930s and the 1950s [6,7]. In Portugal these transitional buildings (known as “placa” buildings, where “placa” means “slab”, as opposite to timber floors—Figure 1) are characterized by thin reinforced concrete slabs resting on load-bearing walls made of solid clay brick, perforated clay brick or irregular stones. These units (bricks, stones) were initially bonded together with a hydrated lime mortar, while in the latter stages of that period, mixed cement-lime-sand or simple cement-sand mortars were used. These buildings show homogeneous planned areas with non-excessive dimensions, and the number of stories rarely gets above five [8].

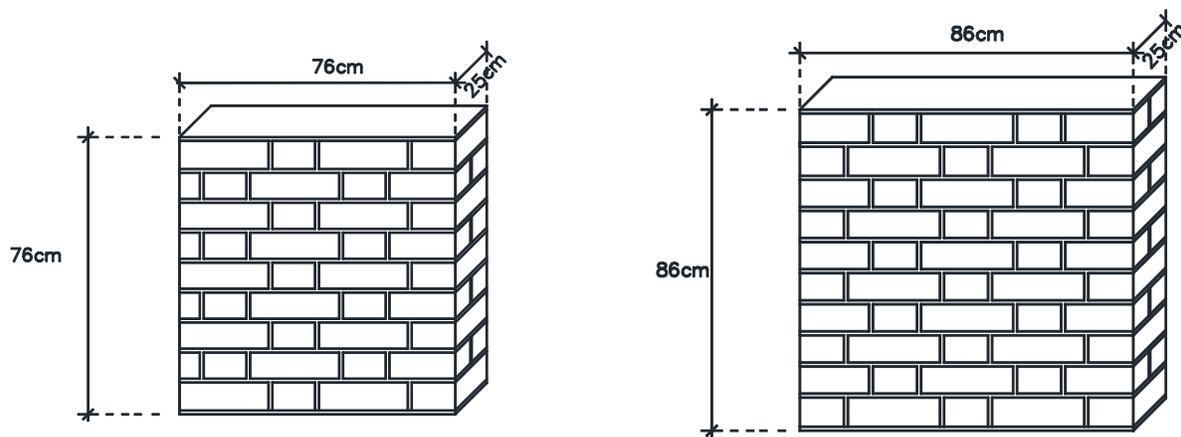
**Figure 2.** Unreinforced masonry wallette ((left) Type 1; (right) Types 2 to 4).

The experimental program involved the fabrication of masonry wallettes and their reinforcement with two different types of steel bars in diverse layouts. Three unreinforced wallettes of 76 × 76 × 25 cm (Type 1) were built for compression tests, whereas fourteen wallettes of 86 × 86 × 25 cm (Types 2, 3 and 4) were built for diagonal compression tests. Table 7 synthetizes the main characteristics of the different wallettes. A Flemish bond, similar to that used in the buildings under study (one header and one stretcher alternately), was used in the execution of the wallettes (Figure 2). The 1:5 (cement:sand) mortar mix was used as bedding mortar with a thickness of 10–15 mm. Three out of the fourteen wallettes were built with no reinforcement to be subjected to diagonal compression tests (specimens Type 2).

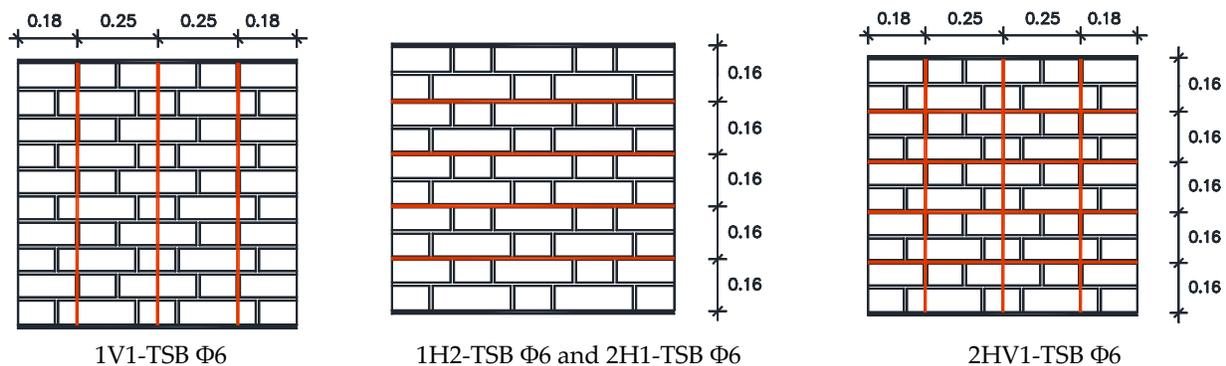
Figure 3. Specimen reinforcement layout with  $\Phi 6$  mm TSB (Type 3).

Four types of reinforcement layout were applied to the masonry walleets reinforced with  $\Phi 6$  mm TSB (specimens Type 3): vertically only with reinforcement in one face; horizontally only with reinforcement in one or in two faces; and grid type (vertical and horizontal) with reinforcement in two faces (Figure 3). Since, in certain practical application situations, it may be difficult, or even unfeasible, to reinforce both faces of the walls, the performance of reinforcement solutions applied on a single face was also needed. In particular, it was sought to know whether equivalent results could be obtained by reinforcing on only one face, by doubling the reinforcement on that face. With this objective, the “horizontal with reinforcement in only one face” layout had two bars per slot. Two specimens of each layout were built and tested.

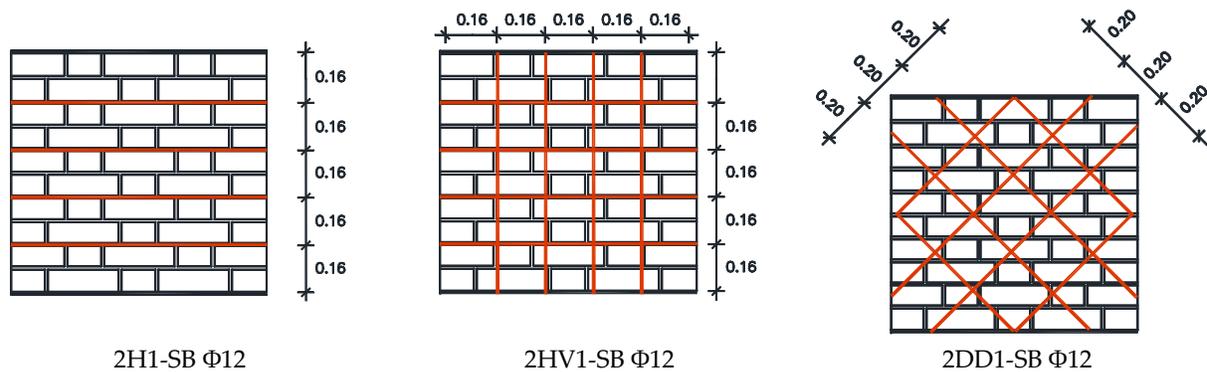
**Figure 4.** Specimen reinforcement layout with  $\Phi 12$  mm steel rebars (Type 4).

The three walleets reinforced with  $\Phi 12$  mm concrete reinforcing steel rebars (specimens Type 4) include horizontal only, grid, and ortho-diagonal reinforcement (Figure 4). Details on the reinforcement layout are provided in Table 6.

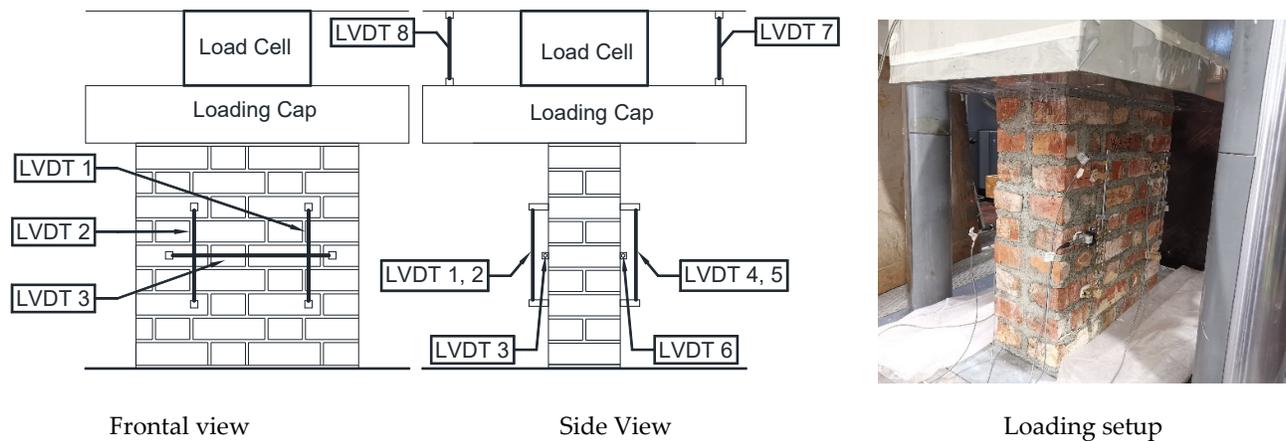
**Figure 5.** Location of the LVDTs on the masonry wallettes for Axial Compression Tests.

Axial compression tests were carried out following the provisions of the standard EN 1052-1 [27]. A vertical displacement at a rate of 0.005 mm/s was applied to the specimen through the loading cap of an MFL press with 5000 kN capacity. Eight LVDT displacement transducers were used to measure the deformation (Figure 5). Four LVDTs (LVDT 1, 2, 4, and 5), two on each side, were placed to measure the vertical shortening of the specimen, whereas two LVDTs (LVDT 3 and 6), placed horizontally on both sides of the wallette, measured the horizontal deformation of the specimen. The displacement of the loading cap, measured with the other two LVDTs, one on each side (7 and 8), allows to continue measuring overall vertical deformation after the removal of the LVDTs from the wallette to avoid damage in the final test stages.

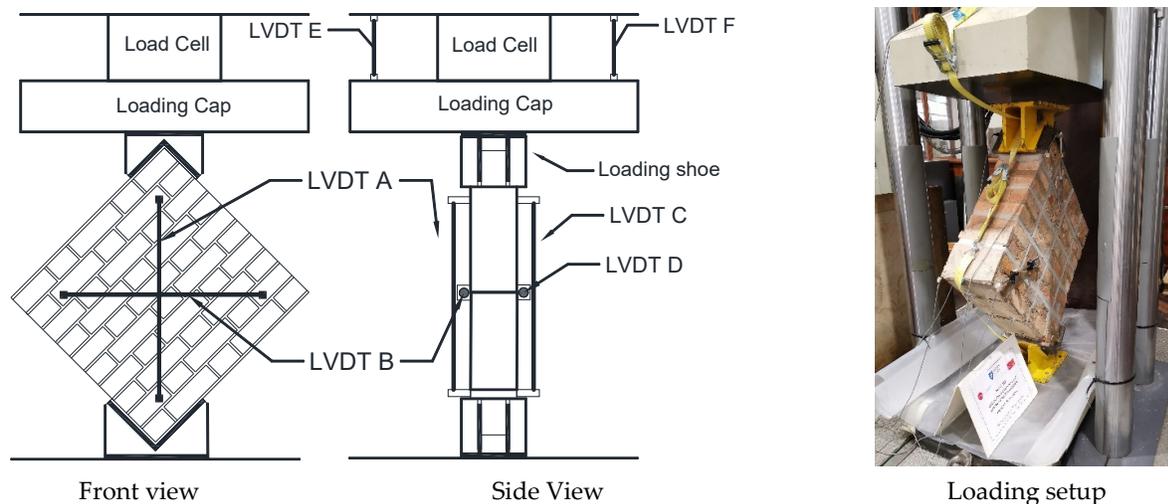
**Figure 6.** Instrumented wallette specimen for diagonal compression test.

Diagonal compression tests were carried out following the standard ASTM 519/519M-10 [28] and other experimental works alike (Table 1). The specimens prior to instrumentation were rotated by  $45^\circ$  and placed on two identical steel shoes for the vertical load application. The same load cell used in the axial compression test was used to apply a displacement-controlled force on the top vertex of the wallette at a rate of 0.005 mm/s. Six LVDTs were used to measure the deformation of wall specimens (Figure 6). Two LVDTs (LVDT A and C) were placed on each side of the wallette to measure the shortening of the specimen in a vertical direction. Another two LVDTs (LVDT B and D) were placed to measure the elongation of the specimen in horizontal direction. The load cell cap displacement was additionally logged via two LVDTs placed on each side of the load cap (LVDT E and F). Given that upon the appearance of the first cracks the LVDTs on the wallette were removed for safety reasons, the vertical displacement is ensured through the readings obtained through LVDT E and F. The loading continued until the vertical load applied at the vertex along the diagonal reached one fifth of the ultimate load.

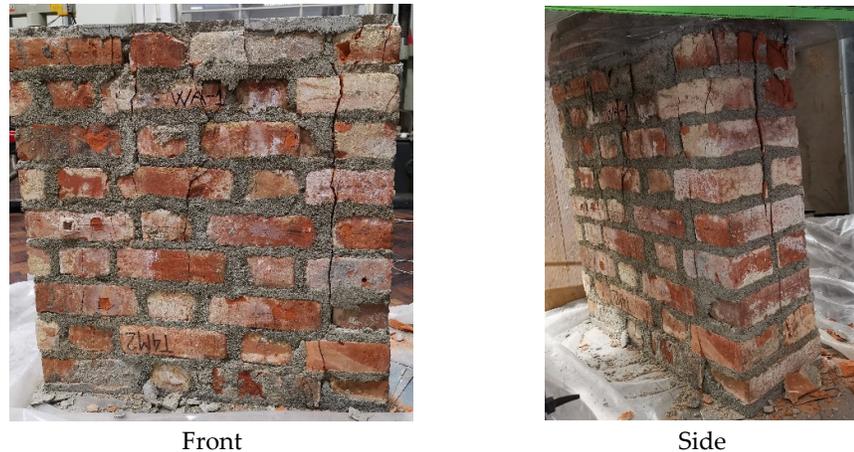
**Figure 7.** Crack patterns after the axial compression test.

The compressive strength and the modulus of elasticity were calculated according to the standard EN 1052-1 [27]. All the three unreinforced (Type 1) wassettes tested under uniaxial compression reached failure through the same mechanism: vertical cracks appeared on both faces of the wassette, which in turn were accompanied by vertical cracks on the sides due to the separation of the wythes. Figure 7 shows the crack patterns after the axial compression test.

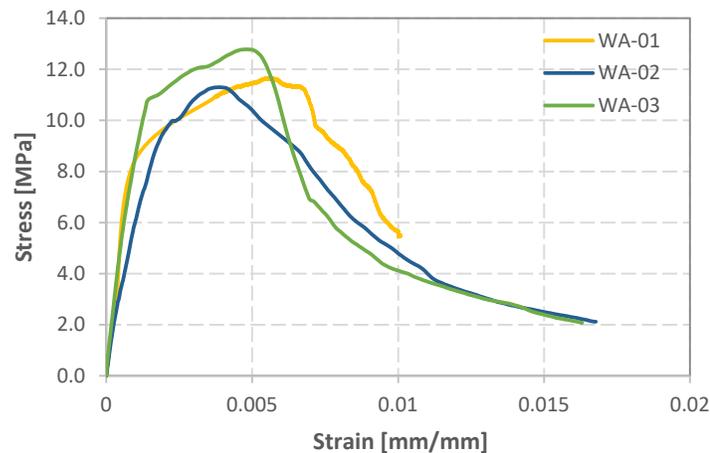
**Figure 8.** Stress-strain plots of axial compression test for each wallette.

The stress-strain relationships plotted in Figure 8 indicate that all the unreinforced wassettes behaved similarly under the axial compression load. The same is also observed in the values presented in Table 8.

As expected, the stress-strain diagram is initially linear until it reaches the yield stress. Then it is followed by a stress hardening curve until the ultimate stress, beyond which a parabolic softening curve develops with a decreasing slope.

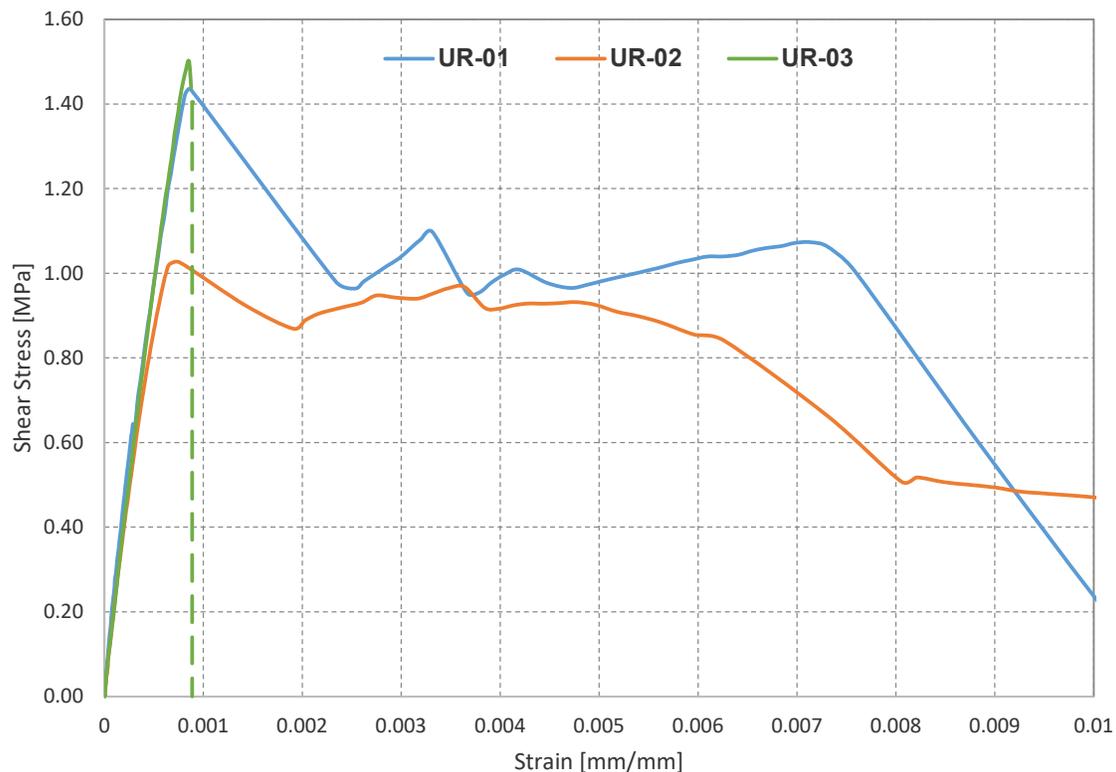
**Figure 9.** Shear stress vs. shear strain response of unreinforced wallettes under diagonal compression test (dotted line represents abrupt deformation without interim readings due to the sudden cracking and splitting apart of the two parts).

The unreinforced masonry wallettes UR-01, UR-02, and UR-03 exhibited a linear behavior until the ultimate load. Diagonal cracking failure occurred on the three specimens at relatively low strains (Figure 9).

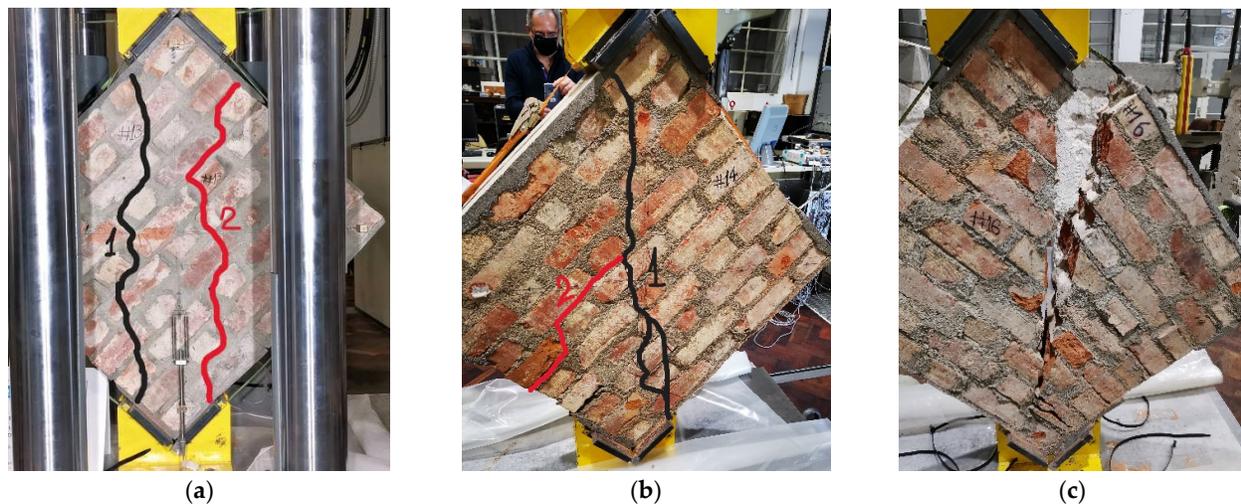
**Figure 10.** Crack patterns of the tested unreinforced wallettes. (a) UR-01; (b) UR-02; (c) UR-03.

The specimen UR-01, upon reaching the ultimate load, developed the first diagonal crack some centimeters left from the diagonal line of the specimen, followed by a second diagonal crack some centimeters right from the diagonal line of the specimen, creating as such a central strut resisting the vertical load. This phenomenon is traceable in the stress-strain plot (Figure 9), where an increase in shear stress is observed after a considerable shear strain, leading to an increase in the amount of energy absorbed. The sudden drop in the post-peak is connected to brittle failure leading to the separation of the left part (Figure 10a).

The wallette specimen UR-02 developed a diagonal crack at the ultimate load, which, after a considerable propagation to the vertices of the specimen, was followed by a second crack originating from the center of the masonry assemblage to the left through a semi-stepped cracking (Figure 10b). This specimen exhibited higher energy absorption at 20% degradation of the ultimate load, since the first crack, which occurred at the peak load, did not propagate entirely throughout the diagonal, allowing the wallette to still carry considerable load.

The specimen UR-03, at its ultimate load, underwent a sudden diagonal cracking (Figure 10c) which is the reason of the missing post-peak interim readings in the stress-strain graph, and the consequent lack of post-peak energy absorption.

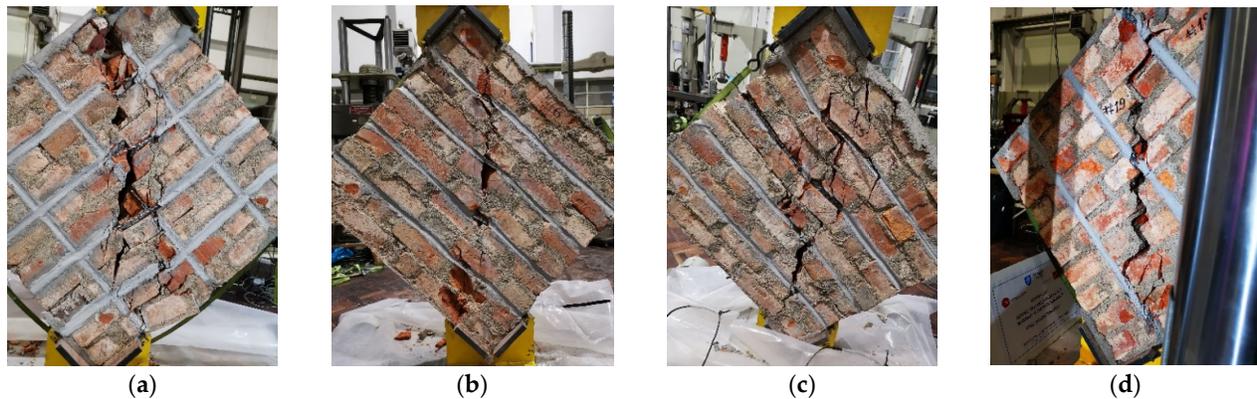
**Figure 11.** Crack patterns of the wallettes reinforced with TSB in diagonal compression test. (a) 2HV1-01; (b) 1H2-01; (c) 2H1-01; (d) 1V1-01.

The wallettes reinforced with a horizontal and vertical grid layout, 2HV1-01 and 2HV1-02 (Figure 11a), presented a linear behavior until the ultimate load. Visible cracks appeared only when the load was approaching its peak value (Figure 12). Post-peak behavior is followed by a decrease in the vertical load during the propagation of the diagonal crack. After the wall cracking, the reinforcement bars showed damage due to local bending and shear in the cracks (Figure 12). Apparently, reinforcement bars are not demanded to resist axial tension stresses, which is the mode for which they present the stronger and stiffer mechanical behavior. As a result, there is no increase in the specimen's strength when compared with the unreinforced specimen. However, the force-displacement diagram shows an increase in ductility (Figure 13). This phenomenon is due

The 1H2 wallettes, with horizontal reinforcement with two bars per slot on one face only, (Figure 11b), behaved linearly up to the ultimate load, then the load decreases due to the first diagonal crack. In terms of ultimate load and related shear strength, there was a slight increase (15%) when compared with the unreinforced specimens. Reinforcement bars showed local bending and shear damages in cracking, and as in the grid layout, they prevented the cracks from opening freely. During the loading an out-of-plane bending of the specimen was observed due to the unsymmetrical reinforcement. Moreover, when compared with the unreinforced specimens, there was no visible contribution to the energy absorption at 20% degradation of the ultimate load (Figure 14d). Similarly, 2H1 wallettes reinforced horizontally on both sides with one TSB per slot (Figure 11c) followed a linear trend until they reached the ultimate load, soon after the first visible diagonal crack appears. In this layout the energy absorption has no increase at all when compared

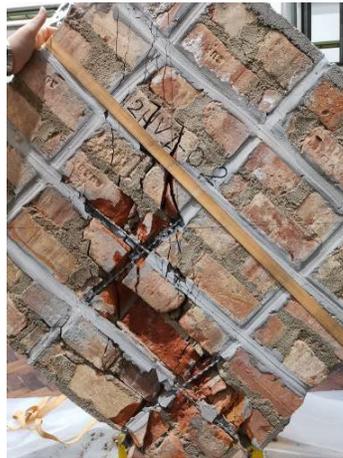
**Figure 12.** Local bending and shear damage of bars.

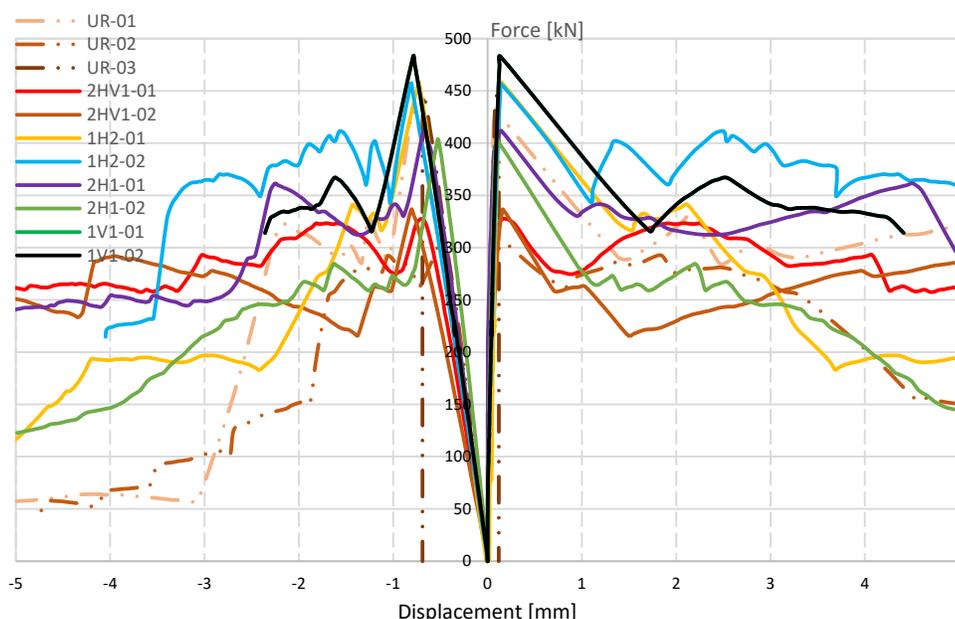
**Figure 13.** Force-displacement of TSB reinforced vs. UR wallettes.

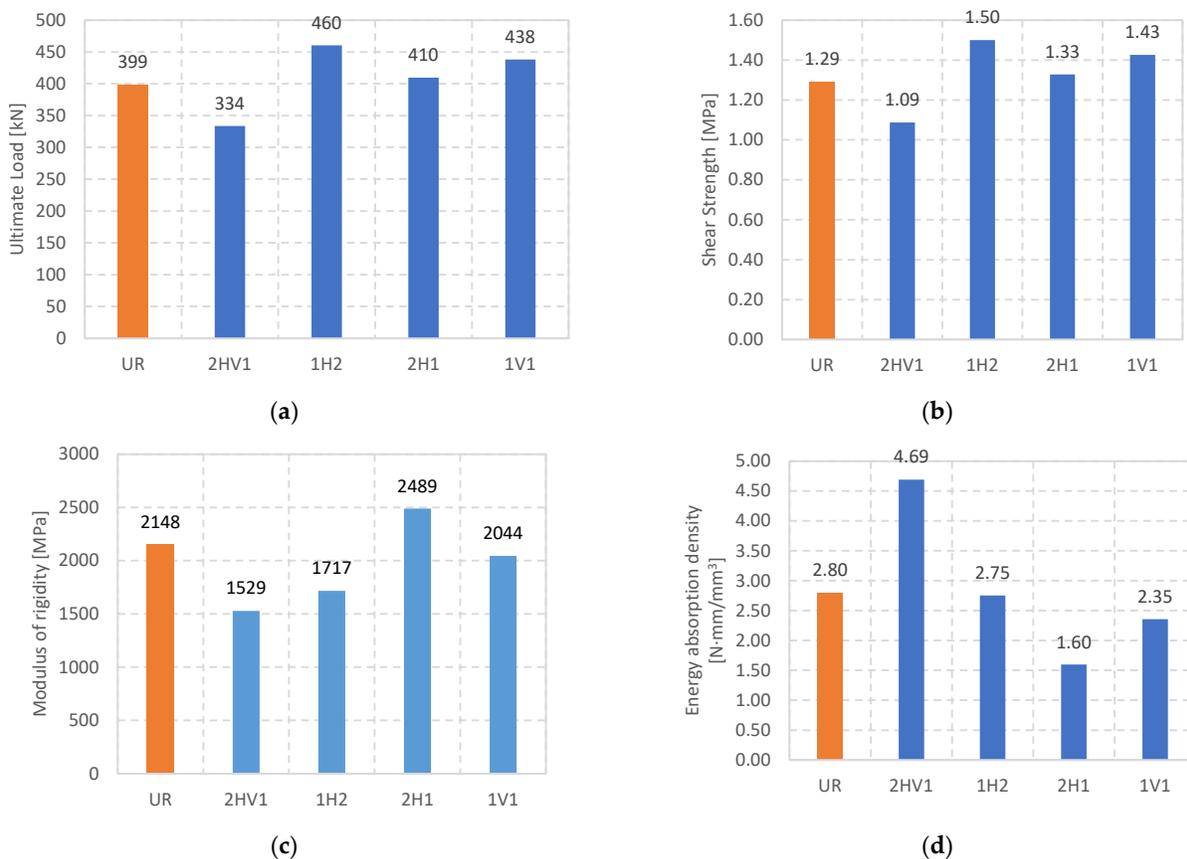
**Figure 14.** Wallettes reinforced with TSB vs. unreinforced ones in terms of ultimate load, shear strength, modulus of rigidity, and absorbed energy at 20% force degradation. (a) ultimate load; (b) shear strength; (c) modulus of rigidity; (d) absorbed energy at 20% force degradation.

to the unreinforced specimens (Figure 14d), and an irrelevant increase in ultimate load (3%) was observed (Figure 14a,b). No bar rupture was observed in these two layouts.

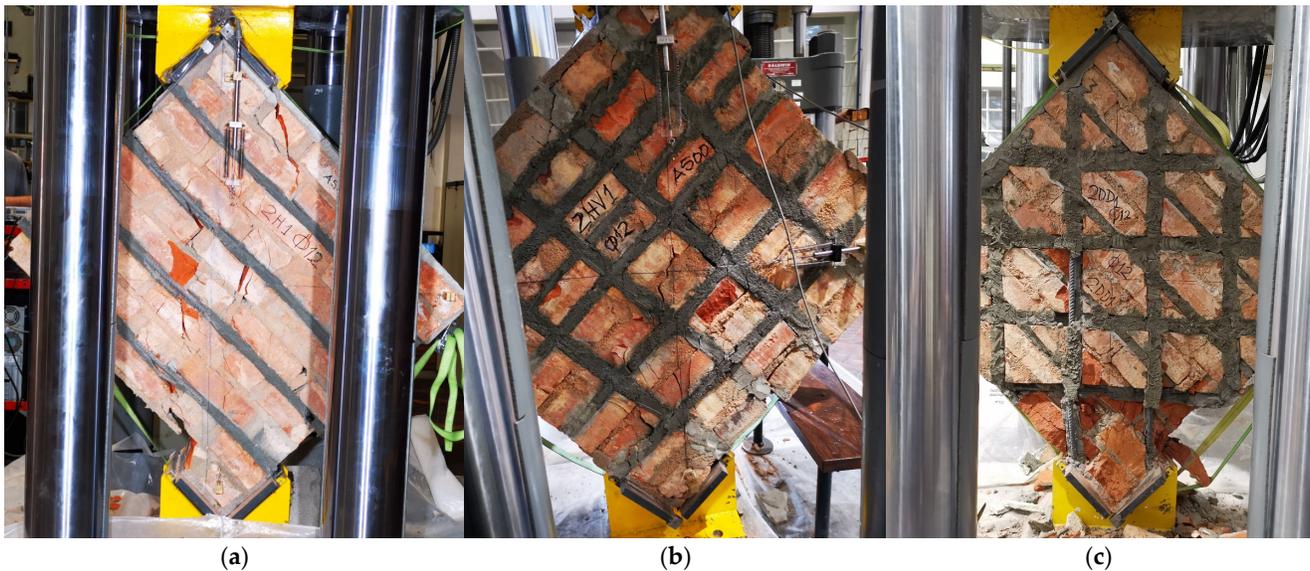
**Figure 15.** Crack patterns of the wallettes reinforced with SB in diagonal compression test. (a) 2H1; (b) 2HV1; (c) 2DD1.

The wallette specimen 2H1 (Figure 15a)—reinforced on both sides, only horizontally, in four rows, with one bar per slot—exhibits an almost linear behavior until the ultimate load (Figure 16). Two parallel diagonal cracks appeared in the central part of the specimen, the right one starting from the top and the left from the bottom vertex, creating a central “strut” which causes the load to be kept constant while the deformation increases. The failure mechanism starts with diagonal cracks opening through the masonry units and continues with sliding in the bed joints, especially in the joint of the second rebar. Upon considerable crushing of the masonry, the upper part slides down, achieving the ultimate failure. The presence of horizontal reinforcement prevents the opening of the diagonal cracks, but the lack of vertical reinforcements causes a sliding along a plane parallel to the existing reinforcement. In terms of ultimate load and shear strength there was no improvement (Figure 17a,b). However, there is a substantial increase in energy absorption at 20% degradation of the ultimate load as shown in Figure 17d.

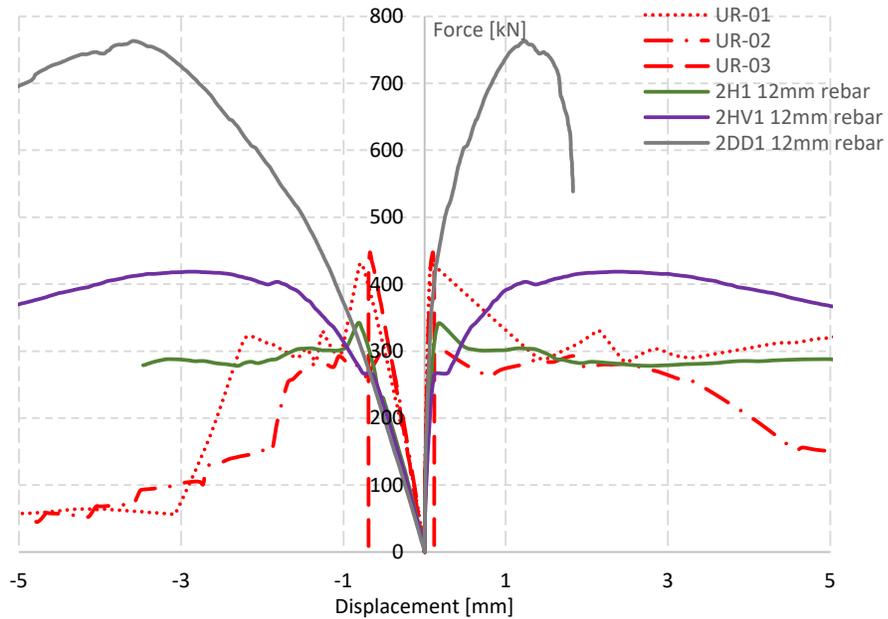
Figure 16. Force-displacement of SB reinforced vs. UR wallettes.

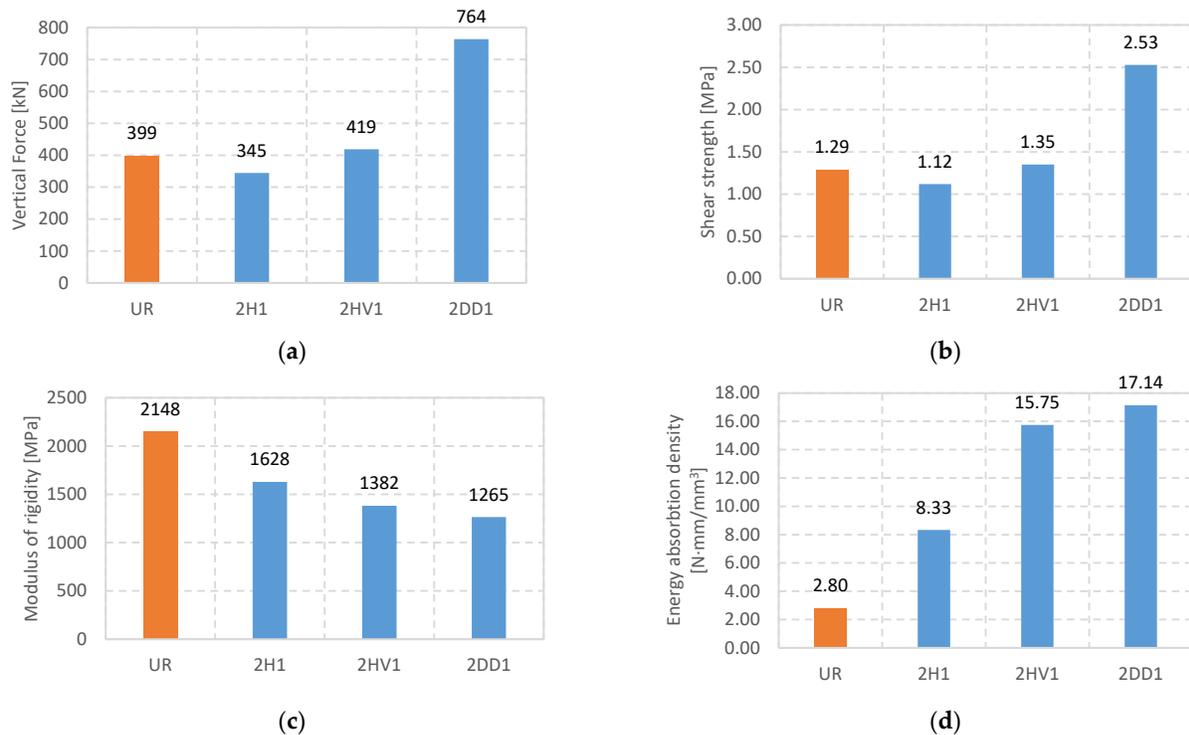
Figure 17. Wallettes reinforced with SB vs. unreinforced ones in terms of ultimate load, shear strength, modulus of rigidity, and absorbed energy at 20% force degradation. (a) ultimate load; (b) shear strength; (c) modulus of rigidity; (d) absorbed energy at 20% force degradation.

cracks from opening, although they do not contribute to the shear strength because the masonry material fails in tension. The energy absorbed at 20% degradation of the ultimate load it is higher than the specimen with horizontal-only SB reinforcement (Table 11 and Figure 17d).

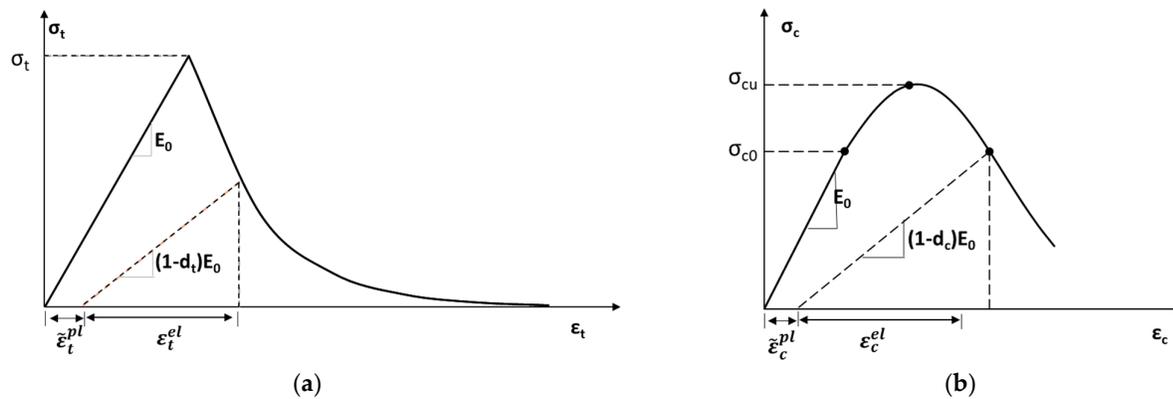
**Figure 18.** Constitutive relationship: (a) tension, (b) compression [31].

until it reaches the failure stress  $\sigma_{t0}$ , followed afterwards by a softening stress-strain response (Figure 18a). In compression, the stress-strain behavior is linear until the initial yield stress  $\sigma_{c0}$ , after which it enters the plastic regime and maintains stress hardening up to the ultimate stress  $\sigma_{cu}$ . Beyond this point stress softening occurs, following a parabolic shape (Figure 18b). The material degradation in tension and in compression is introduced using the damage parameters  $d_t$  and  $d_c$ , respectively. This damage parameter takes values from 0 to 1, where 0 corresponds to the undamaged state, and 1 represents the complete degradation of the material.

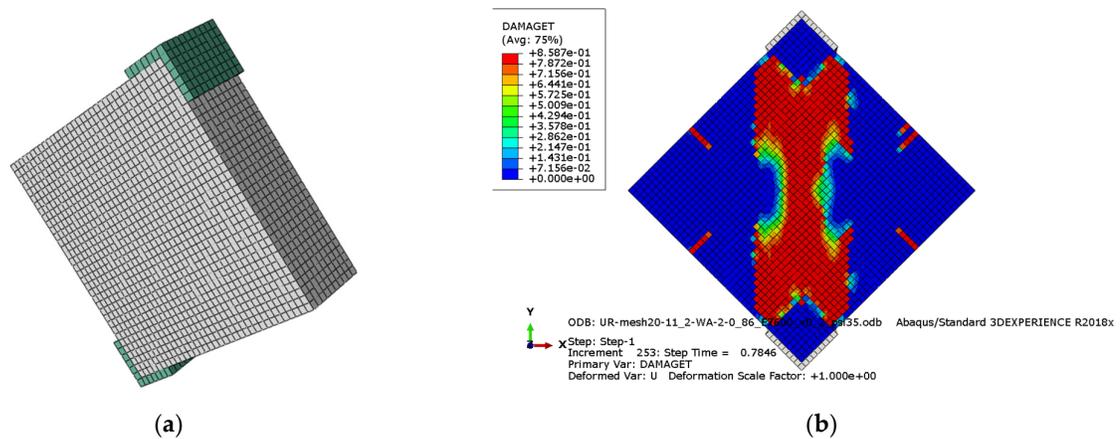
**Figure 19.** Homogeneous FE model of unreinforced wallette. (a) meshing; (b) tension damage (Abaqus output. Note then “e-01” corresponds to “ $\times 10^{-1}$ ”; “e-02” corresponds to “ $\times 10^{-2}$ ”).

The homogeneous FE model considers the brick and mortar assemblage as a continuous homogeneous material (Figure 18). The discretization of the masonry was done using an eight-node linear hexahedral solid element with reduced integration (C3D8R). The mesh was refined to 20 mm in order to provide more accurate results (Figure 19). The inelastic compressive and tension stress-strain behavior is introduced based on the experimental test performed on the wallettes. The reinforcement bars are modelled as a two-node linear 3-D truss element (T3D2), with the mechanical properties obtained from tensile strength tests (Table 4), embedded in the masonry host material.

The FE model of UR wallettes exhibits similar linear behavior, peak force, and post-peak degradation trend (Figure 21a). Also, the damaging pattern in the model (Figure 19b) is consistent with the damaging observed in the tests.

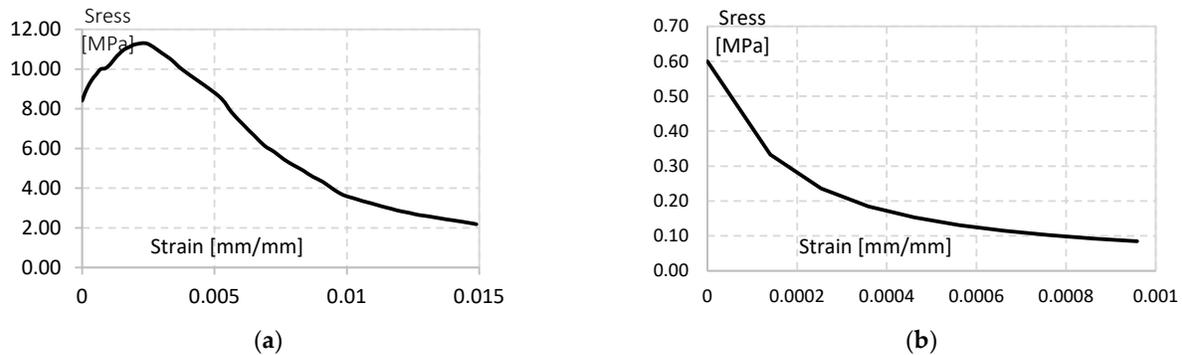
**Figure 20.** Inelastic stress-strain behavior for homogeneous FE model: (a) compression, (b) tension.

Experimental test results were used for the calibration and verification of the equivalent material properties implemented in the numerical model. Figure 20 shows the adapted inelastic stress-strain curves for the compression and tension of the homogeneous masonry material.

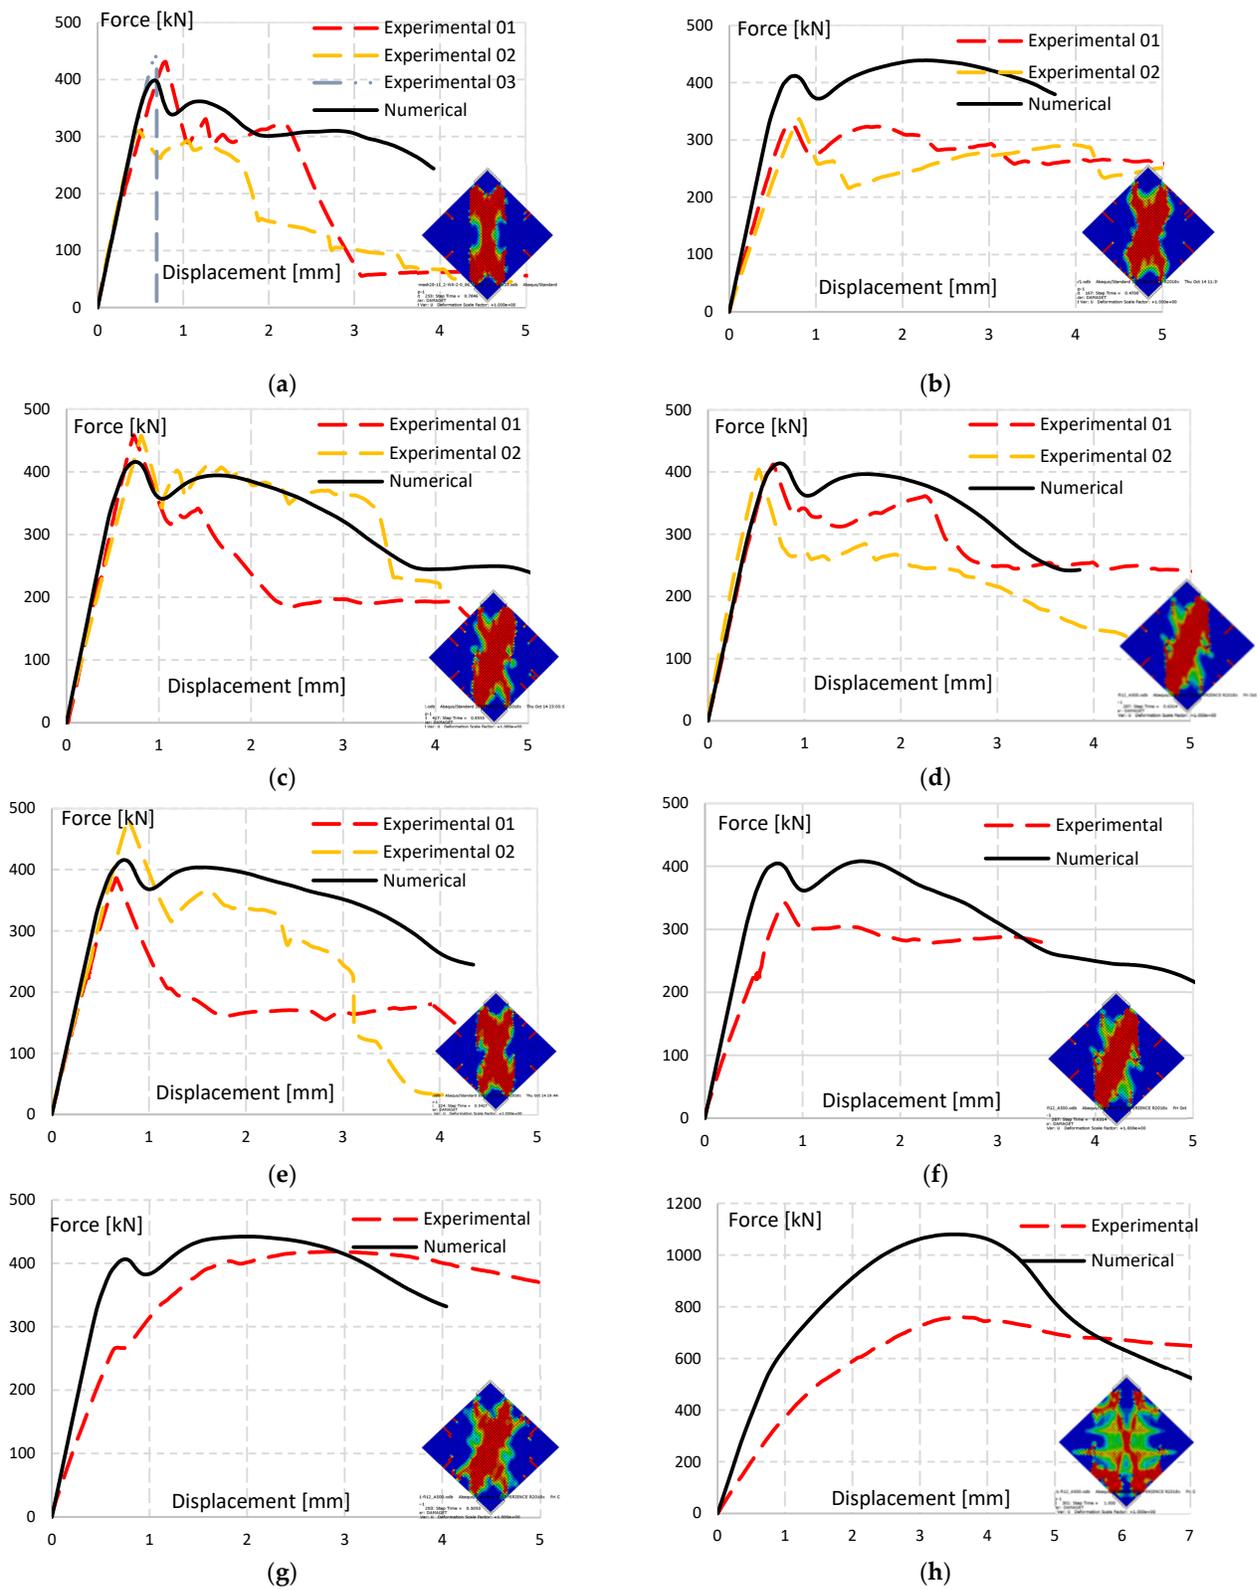
**Figure 21.** Force-displacement curves of numerical models vs. experimental results. (a) UR; (b) 2HV1; (c) 1H2; (d) 2H1; (e) 1V1; (f) 2H1-SB  $\Phi$ 12; (g) 2HV1-SB  $\Phi$ 12; (h) 2DD1-SB  $\Phi$ 12.

The homogeneous FE modelling approach was used for reproducing the experimental tests on unreinforced and reinforced specimens. The diagonal compression test was simulated for each reinforcement layout, and force-displacement curves have been derived for each type of reinforcement (Figure 21).

The FE models of the reinforced walls show damage patterns (thumbnails in Figure 21) in line with the damage obtained in the experiments, i.e., diagonal cracking and compression of the central (vertical) strut. Considering the high complexity of the wallettes' behavior, the force-displacement-curves, although not in perfect match, satisfactorily reproduce the curves obtained in the experimental tests.

The models of TSF reinforced wallettes with horizontal-only reinforcement layout (1H2 and 2H1), with one bar at each side or with two bars on one side, present similar results in terms of linear behavior, peak force, and post-peak degradation trend when compared with experimental results. The behavior of the wallette with vertical-only reinforcement layout (1V1), is also relatively well reproduced.

The model of the TSF grid reinforcement layout, 2HV1, however, shows a steeper linear behavior and a higher peak force when compared with experimental results. This is attributed to the more severe weakening effect on the wallette caused by opening horizontal and vertical slots, which is not being considered in the numerical model. This effect, however, is recognized when the 2HV1 experimental results are compared to those of the UR wallette.

In the case of SB  $\Phi 12$  reinforced specimens this phenomenon is observed also in the horizontal-only reinforcement layout, 2H1 SB  $\Phi 12$ , which similarly exhibited lower values during the diagonal compression test. In this case, a slighter difference is observed since the horizontal slots are less damaging than vertical plus horizontal slots.

Specimen 2HV1-SB  $\Phi 12$  model also exhibits a steeper linear behavior, yet with similar ultimate load and post-peak degradation trend.

The ortho-diagonal reinforcement layout FE model, 2DD1-SB  $\Phi 12$ , exhibits higher peak, since the experimental test reached failure due to the crushing of the bottom vertex. This behavior was not noted in the numerical models where the improvement effect of the rebars has been overestimated.
