# Dynamic Assessment of the Structural Behavior of a Pedestrian Bridge Aiming to Characterize and Evaluate Its Comfort Level

Reina El Dahr \*, Xenofon Lignos, Spyridon Papavieros and Ioannis Vayas

In this study, a monitoring methodology was conducted, aiming to assess the structural behavior and verify the fulfillment of the comfort criteria of the Haidari pedestrian bridge located in Greece after the completion of its construction.

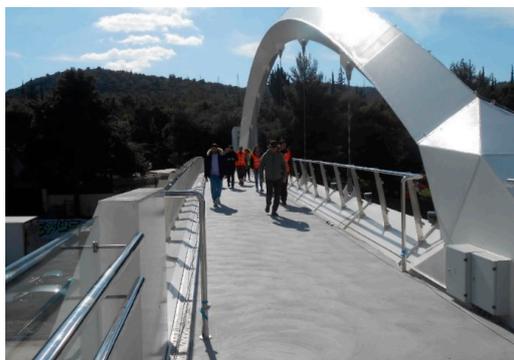
**Figure 1.** Cross-section of Haidari pedestrian bridge.

A monitoring strategy was conducted aiming to assess the structural behavior and the comfort of Haidari pedestrian bridge located in Greece after the completion of construction. The structure is an arch-and-tie bridge with a span length of 44.6 m and width of 2.74 m. Along one side, the arch stands in an eccentrical position connected to six PFEIFER type PV115 wire cables, as shown in Figure 1. The concrete deck is supported by steel girders-cantilevers of variable trapezoidal profile sections which are connected to the arch element. The bridge rests on two pedestals situated atop piles. The measured total dead weight of the bridge is 152 tons.

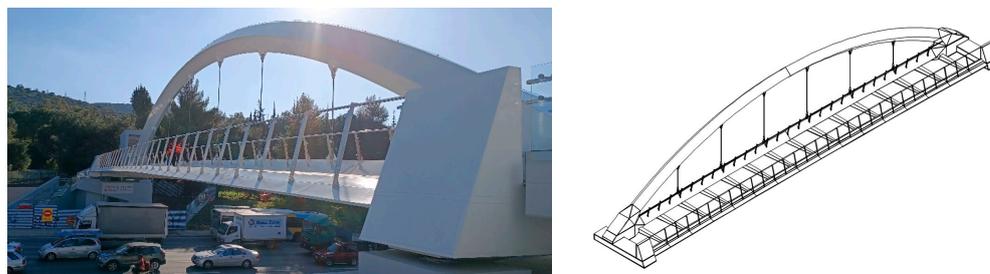
Figure 2. Side view of Haidari pedestrian bridge.

sensors were positioned at the quarter-span, near the edge of the cantilever, as illustrated in Figure 2. These sensors recorded accelerations in the vertical (z), longitudinal (x), and transversal (y) directions along the bridge deck. Subsequently, the sensor data were transmitted via wiring to a control unit located outside the bridge structure. The spatial arrangement of these sensors in a top-down view is illustrated in Figure 3. The sensor network was connected to a data acquisition system in order to process and evaluate the recorded vibrational signals collected by the accelerometers.

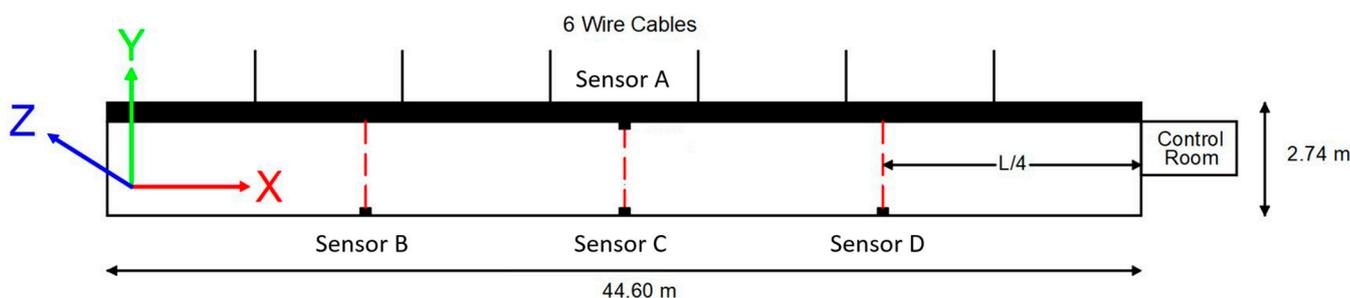
Figure 3. Sensor network mounted on Haidari pedestrian bridge.

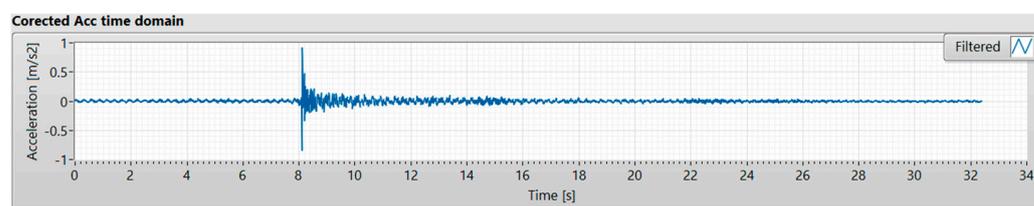
**Figure 4.** Corrected acceleration–time domain of accelerometer A for pedestrian A in vertical direction.

An evaluation of pedestrian A leaping at the bridge's midpoint is provided in the paragraphs that follow. Figure 4 shows the corrected acceleration time domain collected by accelerometer A recording the structural response toward pedestrian A disturbing the bridge with an impact jump at the mid-length of the bridge. The results are presented in the vertical direction. The mean value was determined to be  $9.8049 \text{ m/s}^2$  and was subtracted. The highest acceleration recorded was  $0.92 \text{ m/s}^2$  reported at  $8.15 \text{ s}$  when the bridge was disturbed. The acceleration is higher than the maximum allowable acceleration in the vertical direction of  $0.7 \text{ m/s}^2$  that the bridge is originally designed to experience, causing a discomfort feeling for a  $1 \text{ s}$  period of time.

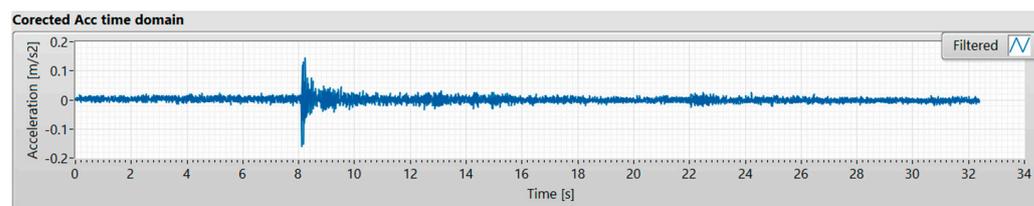
**Figure 5.** Corrected acceleration–time domain of accelerometer A for pedestrian A in lateral direction.

Figure 5 shows the corrected acceleration time domain collected by accelerometer A recording the structural response toward pedestrian A disturbing the bridge with an impact jump at the mid-length of the bridge. The results are presented in the lateral direction. The mean value was determined to be  $-0.27864 \text{ m/s}^2$  and was retrieved. The highest acceleration recorded was  $0.16 \text{ m/s}^2$ , reported at  $8.15 \text{ s}$  when the bridge was disturbed. The acceleration is lower than the maximum allowable acceleration in the lateral direction of  $0.2 \text{ m/s}^2$ , which the bridge is originally designed to experience.

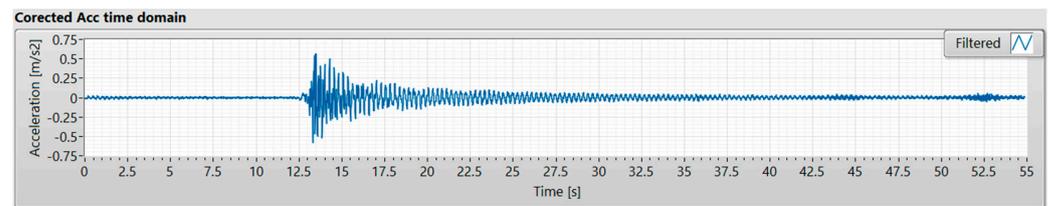
Figure 6. Corrected acceleration–time domain of accelerometer A for 6 pedestrians in vertical direction.

Figure 6 shows the corrected acceleration time domain collected by accelerometer A recording the structural response toward the six pedestrians disturbing the bridge with an impact jump at the mid-length of the bridge. The results are presented in the vertical direction. The highest acceleration recorded was  $0.6 \text{ m/s}^2$  reported at  $13.3 \text{ s}$  when the bridge was disturbed. The acceleration is lower than the maximum allowable acceleration in the vertical direction of  $0.7 \text{ m/s}^2$ , which the bridge is originally designed to experience.

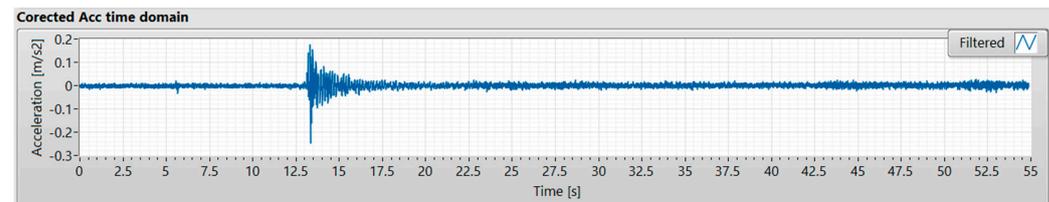
Figure 7. Corrected acceleration–time domain of accelerometer A for 6 pedestrians in lateral direction.

Figure 7 shows the corrected acceleration time domain collected by accelerometer A recording the structural response toward the six pedestrians disturbing the bridge with an impact jump at the mid-length of the bridge. The results are presented in the lateral direction. The highest acceleration recorded was  $0.25 \text{ m/s}^2$  reported at  $13.3 \text{ s}$  when the bridge was disturbed. The acceleration is higher than the maximum allowable acceleration in the lateral direction of  $0.2 \text{ m/s}^2$ , which the bridge is originally designed to experience, causing a discomfort feeling for a  $1 \text{ s}$  period of time.

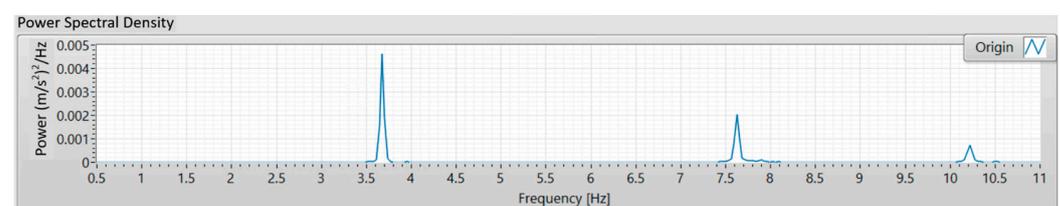
Figure 8. Power spectral density of the system eigenfrequency in vertical direction.

The frequency domain is obtained after performing power spectral density (PSD) function on the corrected acceleration time domain of accelerometer A in the vertical direction. The signal from PSD is evaluated to find the peaks in terms of natural frequencies in (Hz) and their respective power in  $\left[\frac{(\text{m/s}^2)^2}{\text{Hz}}\right]$  (Figure 8). It reports three eigenfrequencies, respectively, at 3.67 Hz, 7.62 Hz, and 10.22 Hz (Figure 9).

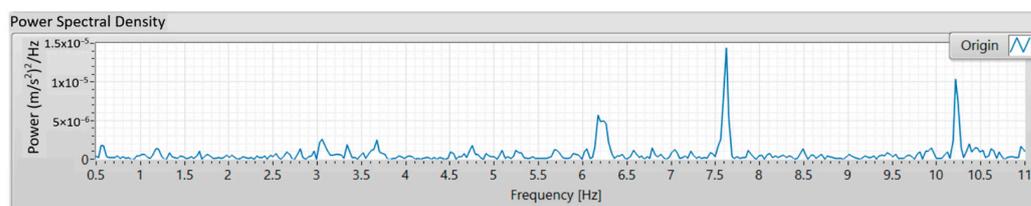
**Figure 10.** Power spectral density of the system eigenfrequency in lateral direction.

The frequency domain is obtained after performing the power spectral density (PSD) function on the corrected acceleration time domain of accelerometer A in the lateral direction. The signal from PSD is evaluated in Figure 10 and reports three eigenfrequencies, respectively, at 3.67 Hz, 6.24 Hz, and 7.62 Hz (Figure 11).

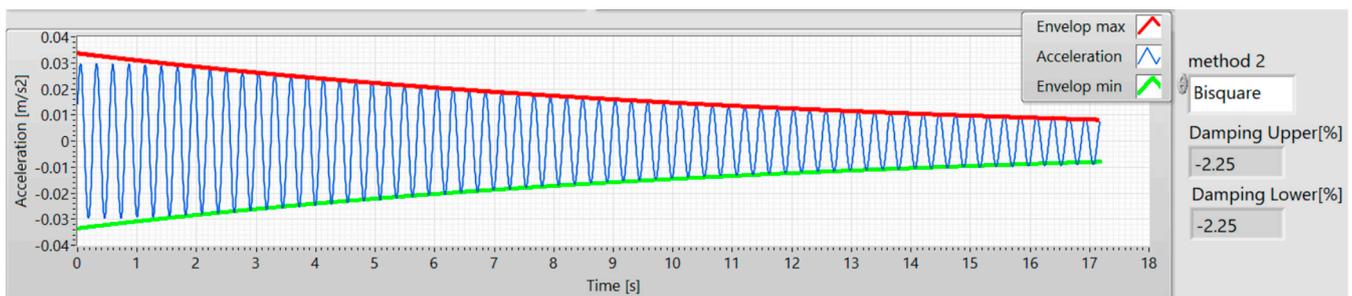
**Figure 12.** LabVIEW graph showing the acceleration–time domain of accelerometer A with envelopes for the first eigenfrequency in the vertical direction calculated by Hilbert transform.

For the first eigenfrequency, a second-order Butterworth bandpass filter was applied on the corrected acceleration–time domain data of accelerometer A in the vertical direction, with cutoff frequencies between 3.61 and 3.73 Hz. According to the Hilbert transform, the damping ratio is 2.25% (Figure 12).

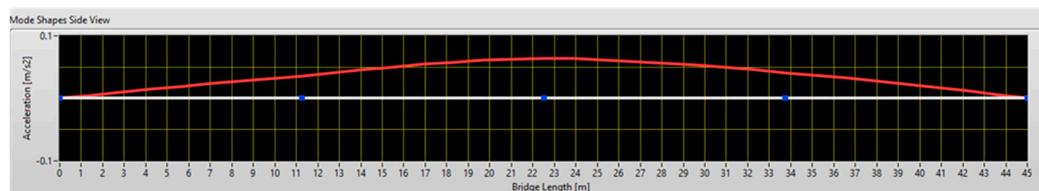
**Figure 13.** Bridge mode shapes in vertical direction for the first eigenfrequency.

For the first eigenfrequency, in the vertical direction the three accelerations delineated in blue dots along the bridge length (outlined in white) synchronize, having the same phase at a specific moment with a different altitude. From the reported data of the second eigenfrequency, both accelerometers installed on the quarter edges of the bridge share the same phase, yet the accelerometer mounted on the mid-length of the bridge is shifted by  $\pi/2$ . The amplitude of the accelerometers indicates the displacement aspect at each sensor location, revealing the two consecutive mode shapes of the bridge (represented in red) in Figures 13 and 14.

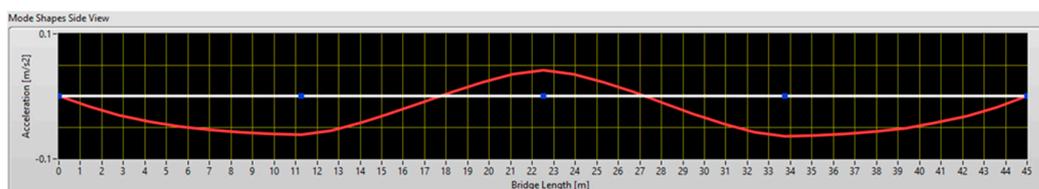
**Figure 14.** Bridge mode shapes in vertical direction for the second eigenfrequency.

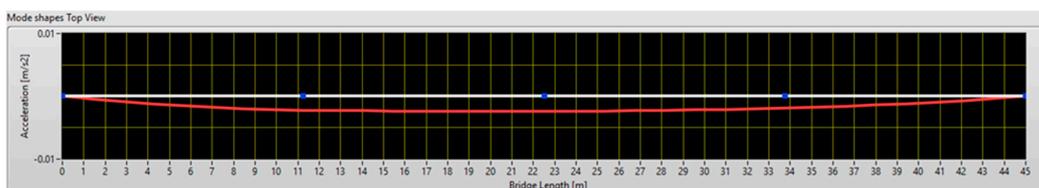
**Figure 15.** Bridge mode shapes in lateral direction for the first eigenfrequency.

Likewise, for the first eigenfrequency in the lateral direction, the three accelerations delineated in blue dots along the bridge length (outlined in white) synchronize, having the same phase at a specific moment with a different altitude. From the reported data of the second eigenfrequency, both accelerometers installed on the quarter edges of the bridge share the same phase, yet the accelerometer mounted on the mid-length of the bridge is shifted by  $\pi/2$ . The amplitude of the accelerometers indicates the displacement aspect at each sensor location, revealing the two consecutive mode shapes of the bridge (represented in red) in Figures 15 and 16.

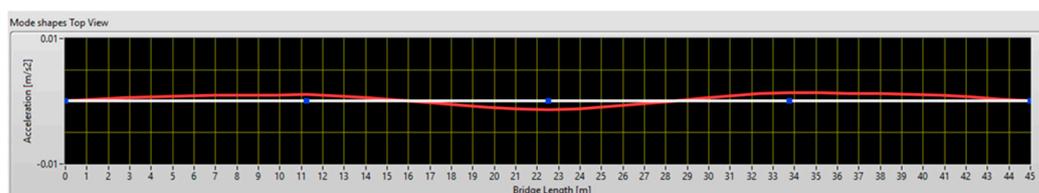
**Figure 16.** Bridge mode shapes in lateral direction for the second eigenfrequency.

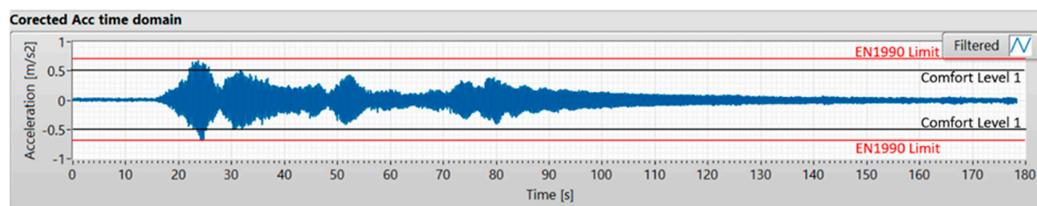
Figure 17. Comfort level for pedestrian A running at 3.67 Hz frequency in vertical direction.

2 Hz walk and a 3.67 Hz run and a random walk in both lateral and vertical directions. The comfort feeling was observed in pedestrians for all activities in the lateral and vertical directions. When crossing the bridge at 3.67 Hz, for the activity of one pedestrian, the comfort limits were touching the limit in the vertical direction, as is shown in Figure 17, but they were not surpassed. However, for the lateral direction, the pedestrian did not feel any structural movement causing their discomfort, as shown in Figure 18. Same for the activity of a group of pedestrians, the comfort limits were touching the limit in the vertical direction, as is shown in Figure 19, but they were not surpassed. However, for the lateral direction, the pedestrian did not feel any structural movement causing their discomfort, as shown in Figure 20.

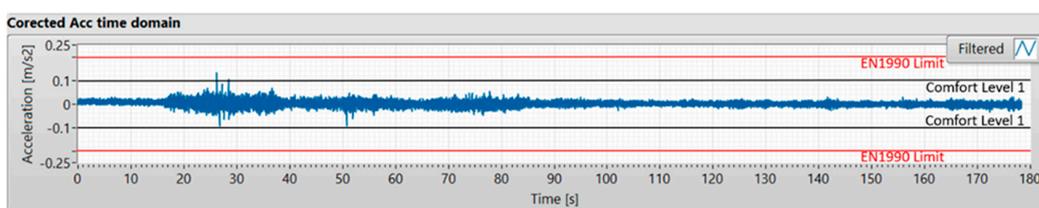
Figure 18. Comfort level for pedestrian A running at 3.67 Hz frequency in lateral direction.

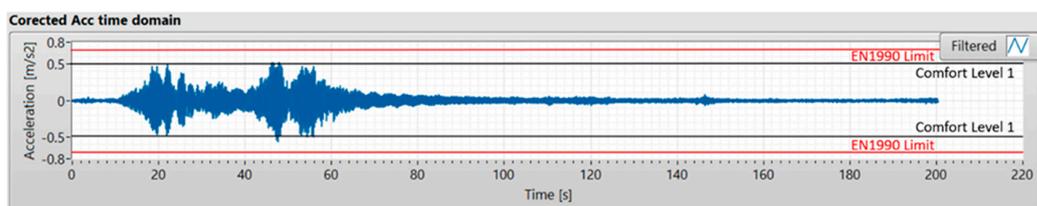
Figure 19. Comfort level of a 9-pedestrian group running at 3.67 Hz frequency in vertical direction.

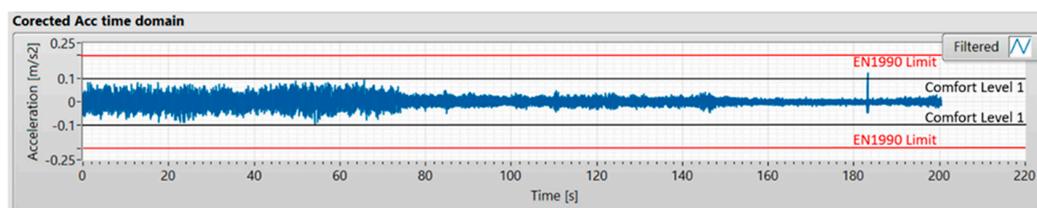
Figure 20. Comfort level of a 9-pedestrian group running at 3.67 Hz frequency in lateral direction.

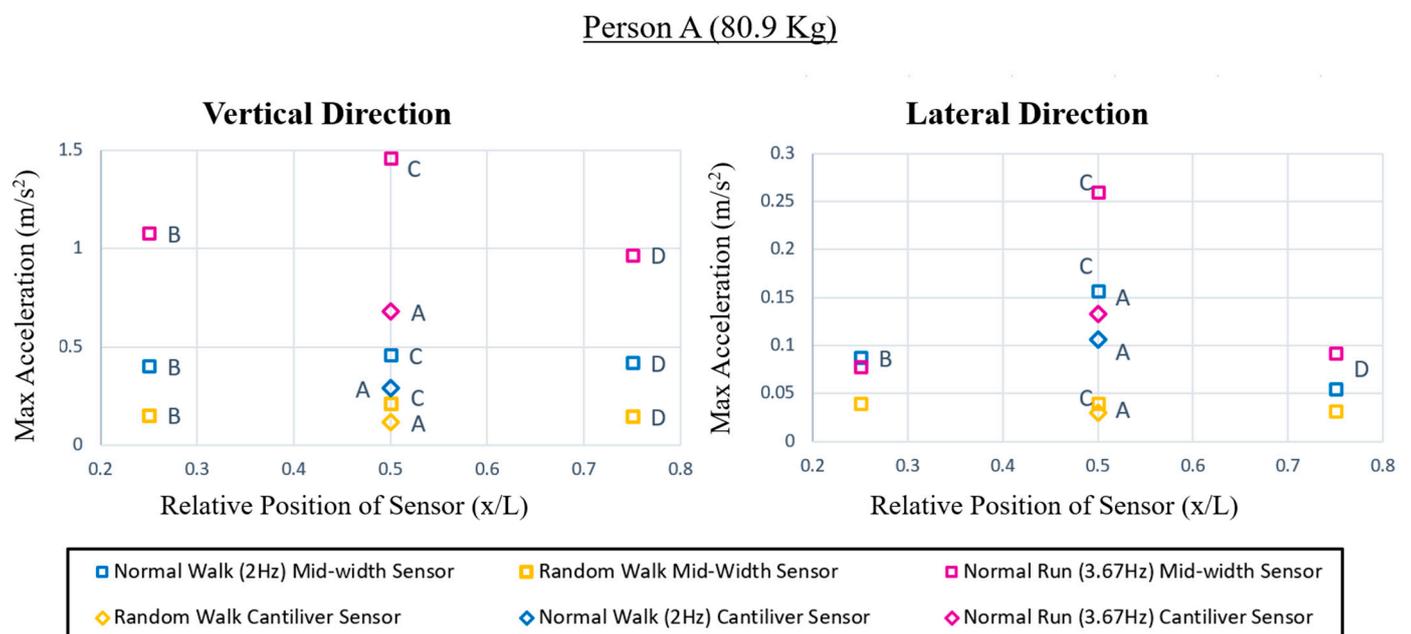
**Figure 21.** Spatial distribution of maximum accelerations as pedestrian A crosses along the bridge length.

A comprehensive investigation of the spatial distribution of peak accelerations along the longitudinal and lateral dimensions of the bridge can be ascertained from the depictions in Figures 21 and 22. These figures illustrate the maximum recorded acceleration values obtained from each sensor (accelerometers A and C at  $L/2$ , B at  $L/4$ , and D at  $3L/4$ , where B, C, and D are located at mid-width, and A is located at the cantilever side) during the three different crossings (normal walk at 2 Hz, random walk, and normal run at 3.67 Hz) exerted by pedestrian A and a group consisting of nine pedestrians. It is shown that for the case of pedestrian A, accelerometer C was recording the most intensified response while disturbing the bridge with the three different frequencies in both directions, revealing a symmetric response for sensors at quarter-edges with respect to the sensors at mid-length. Conversely, for the case of the nine pedestrians, it is shown that accelerometers B and D record higher acceleration than accelerometer C, as shown in the results of a random run scenario in the vertical direction. Moreover, the results of only one of the quarter-edge sensors can exceed that of the mid-length, addressing an asymmetric response, as is shown in the result of a random walk scenario in the lateral direction. This is due to unsynchronized footsteps of numerous pedestrians taking more time to adjust their movement with their neighbors while crossing the bridge. Then, the whole crowd readjust their pace to harmonize with the that of the bridge. For both cases of one and nine pedestrians and at any disturbance frequency, accelerometer C always records a higher acceleration intensity than accelerometer A. It is noteworthy that, in the vertical direction, a maximum acceleration of  $1.5 \text{ m/s}^2$  was reported for both cases of one pedestrian and a crowd.

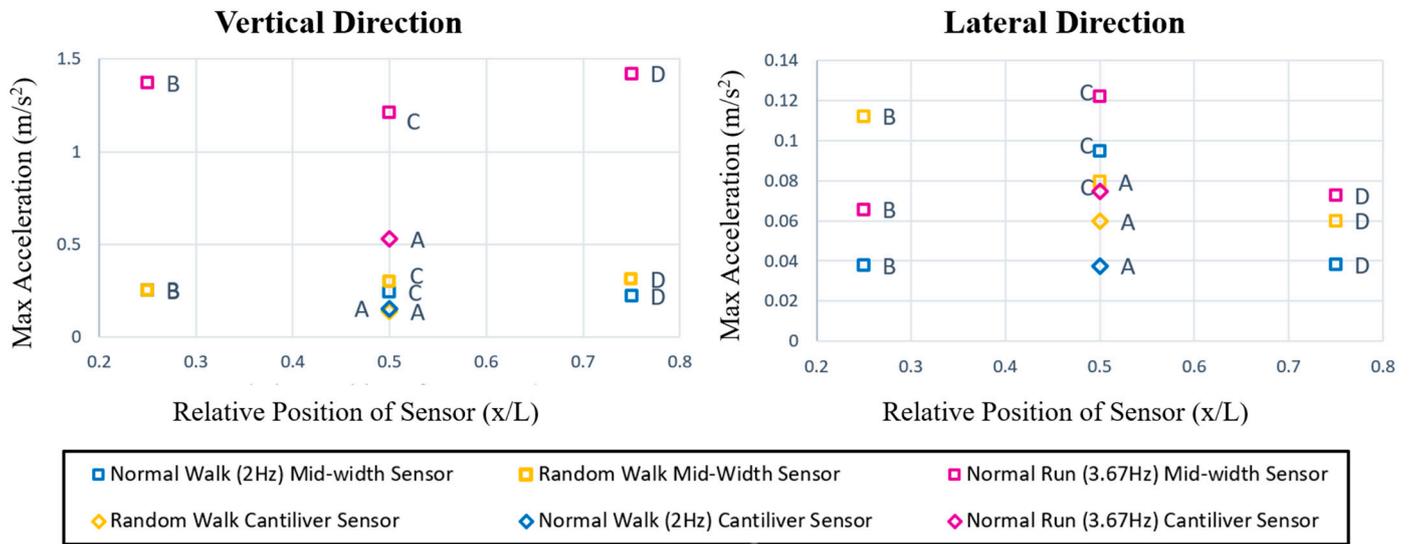
Figure 22. Spatial distribution of maximum accelerations as the 9-pedestrian group crosses along the bridge length.

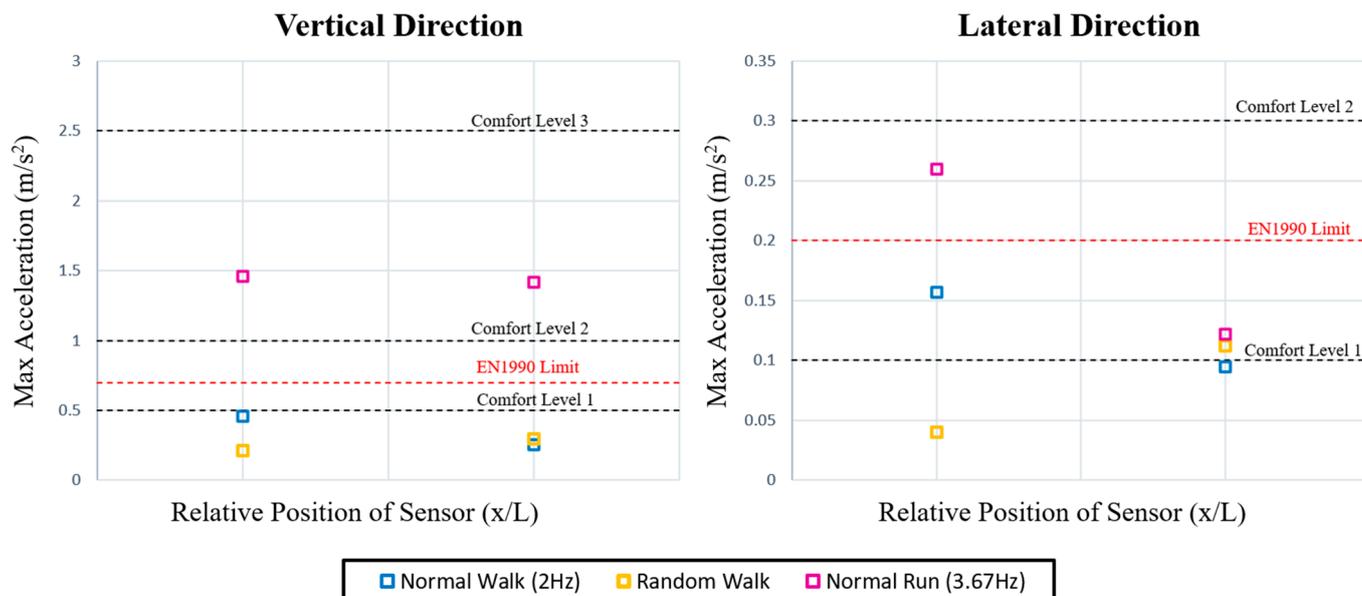
**Figure 23.** Maximum vertical and horizontal accelerations for each type of walking from individual pedestrian and group of 9 pedestrians.

Figure 23 compares the maximum accelerations recorded by one individual and group pedestrian crossings for each type of walk. The differences in accelerations between people for almost all crossings are evident in both directions. However, there is no apparent ratio between pedestrian weight and deployed acceleration, leading to the conclusion that the amount of acceleration recorded when pedestrians cross depend on other biometric characteristics.

The limit values for accelerations, as defined in the specifications, are also indicated in the same figure. It should be noted that for all passages, the developing accelerations are classified at the maximum comfort level on the basis of specifications in both vertical and lateral directions. The exceptions are the crossings of pedestrian A and the group of nine pedestrians running with a frequency equal to the first vertical frequency of the 3.67 Hz bridge where vertical accelerations are at medium comfort levels.
