Article

Understanding and Predicting Localised Variations in the Degradation Rate of Architectural, Organically Coated, Steel Cladding

Citation: Savill, T.; Jewell, E. Understanding and Predicting Localised Variations in the Degradation Rate of Architectural, Organically Coated, Steel Cladding. *Buildings* **2023**, *13*, 270. <https://doi.org/10.3390/buildings13020270>

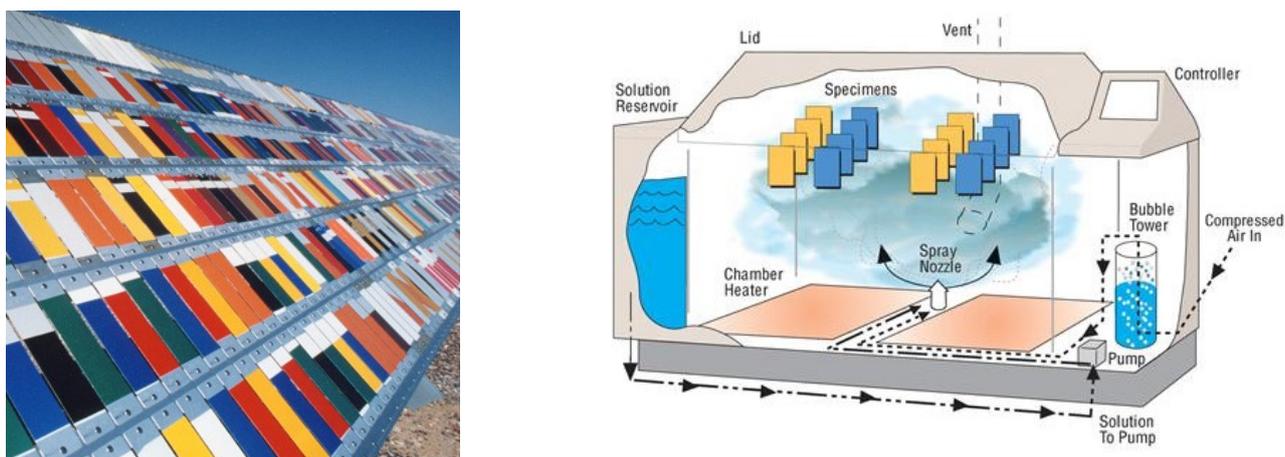
Figure 1. Outdoor weathering rack (left) and a salt-spray tester (right) [17,18].

Natural weathering testing is carried out by placing samples outside on racks and monitoring degradation during a period of up to 10 years (e.g., ISO 2810:2020 or BS EN 13523-19) whereas accelerated testing is usually a laboratory-based technique where the samples respond to aggressive environments such as salt-spray testing (e.g., ASTM B117 or BS EN 13523-8) or UV/condensation cycling (e.g., ISO 11507:2007 or BS EN 13523-10) [12–14]. It is important to note that the accelerated tests do not replicate atmospheric conditions and are typically used as a comparative tool to assess resistance between different products. Even though natural weathering sites are usually situated in harsh environments, such as marine or high UV and humidity, results can take years to gather due to the panel system technology. These extended test periods become a barrier to coating innovation and, subsequently, building design. Additionally, it is possible that the conditions at the test sites may differ from the proposed building site. Accelerated testing, such as salt spray or UV allows much quicker analysis of performance; however, the resulting analysis has to be viewed as an extrapolated result due to the artificial nature of the test, and it is often reported that accelerated results show poor correlation with field results [15,16]. Examples of a weathering rack and salt-spray tester are shown in Figure 1.

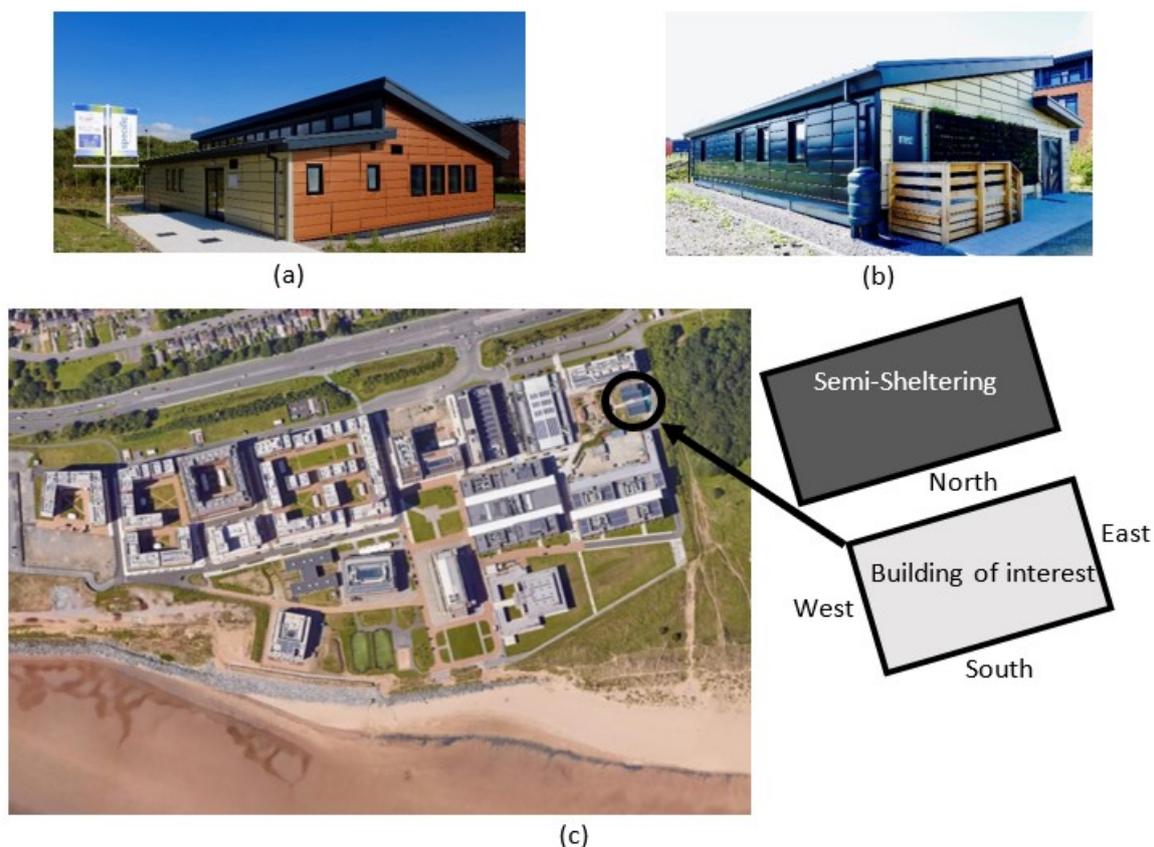
Figure 2. Building viewed from the (a) northwest, (b) southeast, and (c) location of the building and the façade names used for reference.

The building used in this study is located on the Swansea University Bay Campus, Swansea, UK, as shown in Figure 2a,b, and is a one-story multipurpose teaching and office space that is mostly clad with polyvinylidene fluoride (PVDF)-coated steel panels. The building has a rectangular floor plan of 18 m × 12 m. The structural elements of the building are constructed from SIPS panels manufactured by Matrix structures and incorporate a transpired solar collector for thermal energy capture on the southern aspect and building-integrated PV on the roof for electrical energy capture, Figure 2a. The building was built in 2016 and the OCS is well within modern coated steel cladding lifetime warranties. The material characteristics are given in Table 1.

The building is orientated slightly askew of cardinal points; however, can be said to have a north, west, east, and south aspect, as shown in Figure 2c. The location of the building is determined to be extremely corrosive with a classification of C4/5 according to ISO 9223. The key features of this location that make it a highly corrosive environment are the proximity to the sea (approximately 300 m due south), the M4 motorway (approximately 2 km due north), and various heavy industries (approximately 1–7 km southeast). It is also important to note that a building site exists directly adjacent to the west and south of the building and as a result the west side of the building was inaccessible during this work. There is also a small two-story building directly north of the building of interest that somewhat shelters the north face, which is important to note for later analysis in this work.

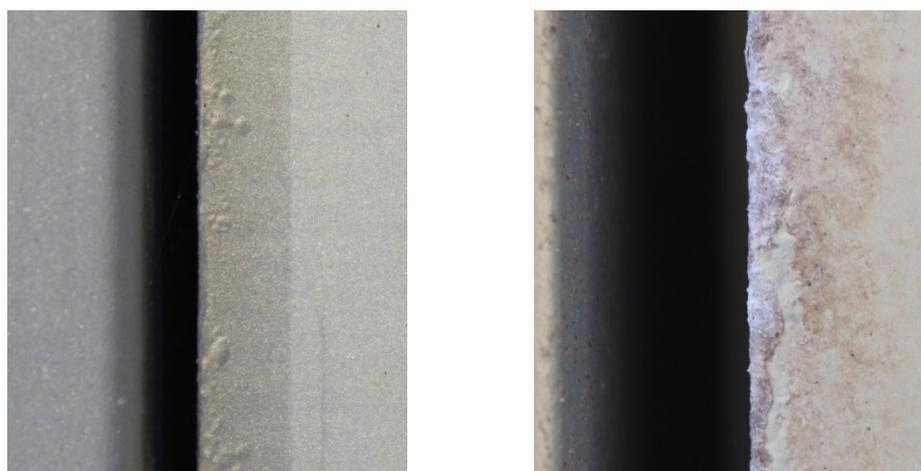
Figure 3. Examples of the two main types of cut edge degradation observed: blistering (**left**) and white rust (**right**).

In order to measure the quantity of degradation across the classroom, a number of steps were involved with the first being a close visual inspection of the building. From this it was determined that generally the coated cladding was performing well and, in fact, the only sign of degradation was at the cut edge. This was to be expected as modern organic coatings are unlikely to experience thorough coating failure within 6 years following the building's construction, and cut edge corrosion is one of the most common routes of degradation for organically coated cladding [27]. Hence, the parameter measured to ascertain the degree of degradation was simply the distance from the cut edge that degradation had occurred. Measurement was carried out using digital callipers across a number of panels on each accessible façade of the building at different heights and locations, such as an alcove. The type of cut edge degradation was also noted with both blisters and white rust observed (both shown in Figure 3). Blisters are considered an early stage of cut edge coating degradation, whereas white rust is indicative of more severe metal substrate deterioration. At paint blister locations, water had penetrated the organic coating/metal interface and had reacted with the galvanised zinc surface causing a delamination separation of the metal and organic paint. This can ultimately lead to white rust formation when the zinc on the underlying galvanised metal surface is oxidised to zinc oxide.

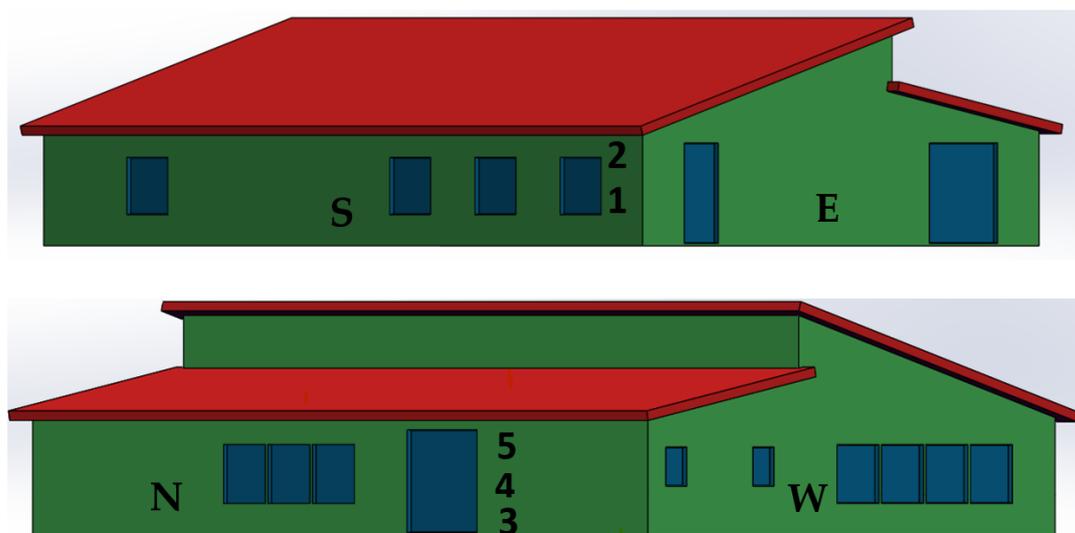
Figure 4. Location of the five sensing boxes on the building. The building is coloured according to materials with green indicating PVDF cladding, red indicating integrated PV roofing, blue indicating windows and doors, and dark purple indicating the soffit region composed of PVC cladding material.

Five of these multifunctional sensing boxes were used in this work and these were deployed to observe if significant variations in conditions exist between low, middle, and high locations on a façade and for different façades. To this aim, three boxes were placed on the north face of the building at ground level, mid-way up the façade, and in the eaves; two boxes were placed on the south face at mid-way up the façade and in the eaves. These locations are given in Table 4 and shown schematically in Figure 4. Data were collected from September 2020 to September 2021 at a rate of four measurements per hour.

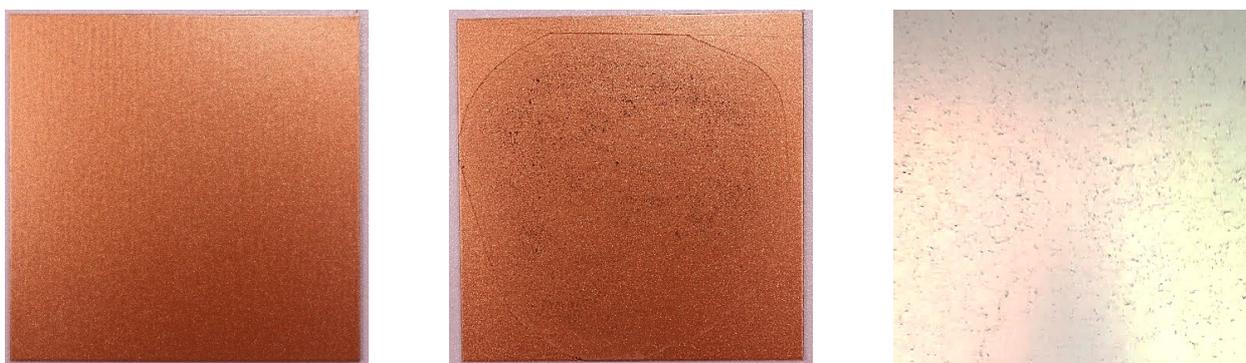
Figure 5. Initially clean PVDF sample (left), PVDF sample with wet-applied 4000 mgm⁻² of deposit (middle), and observed natural deposit on the building (right).

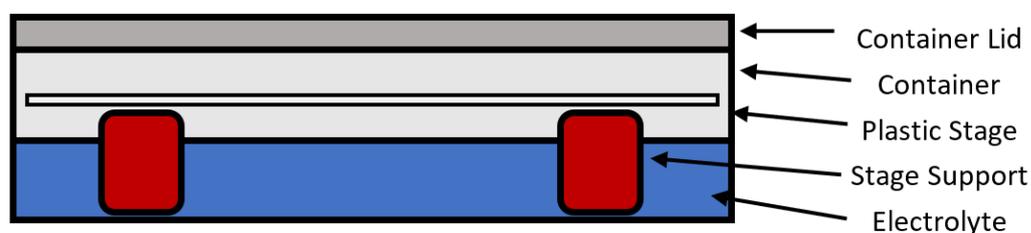
Figure 6. Experimental setup of the humidity testing chamber.

The moisture retention of the fouling deposit from localised microclimates was considered to be a possible contributory factor in the degradation of the OCS. An experimental method was developed that allowed for this to be investigated in the laboratory by placing fouled samples in a controlled humid environment, Figure 6. This was composed of a sealed tub partially filled with a 5 wt.% NaCl electrolyte to maintain a humidity of 95%. The samples were placed on a plastic stage that was supported and held out of the electrolyte by using plastic supports. The three samples of each coating system with deposits representing 0, 2000, 4000 mg m⁻² were first weighed and then placed in the chamber. They were then removed and reweighed periodically to measure weight change as a result of moisture absorption onto the surface. After the final weight was recorded, the samples were also photographed to allow visual observation of any changes.

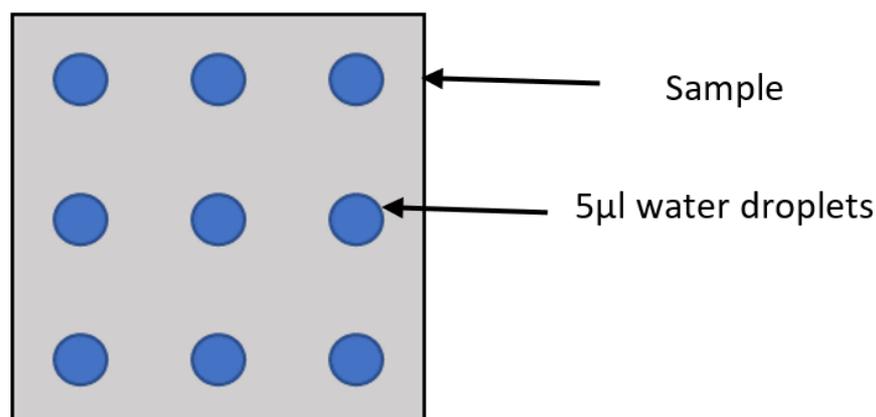
Figure 7. Droplet test used to measure drying/water retention.

In order to measure the effect of deposit presence on the retention of water and the drying rate of the laboratory-fouled samples, each sample was weighed and then nine 5 μ L drops of deionised water were placed on the sample, as shown in Figure 7. The samples were left at room temperature and reweighed every 10 min until the weight of the sample returned to that of the original state. The weight of water present on the samples was then calculated for each time step.

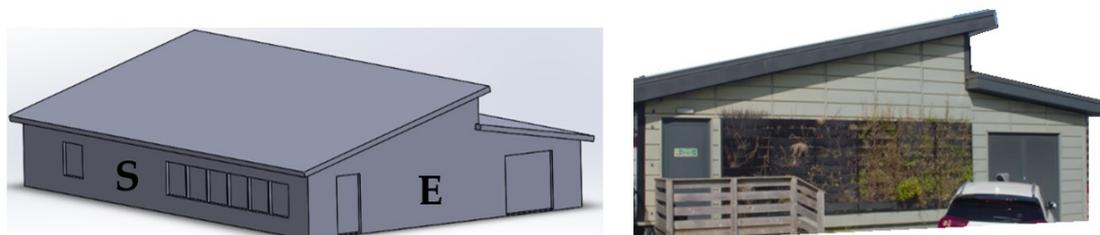
Figure 8. Building model (left) and actual building (right).

The building was created as a scale 1:1, 3D object in Solidworks 2022 using both the original architectural plans and physical measurements to ensure accurate building dimensions were used. To reduce the computational demand, small details such as the joints between panel sections, guttering, and other such features were not included in the model; however, larger features such as doorway and window surrounds were included. The building model is shown in Figure 8.

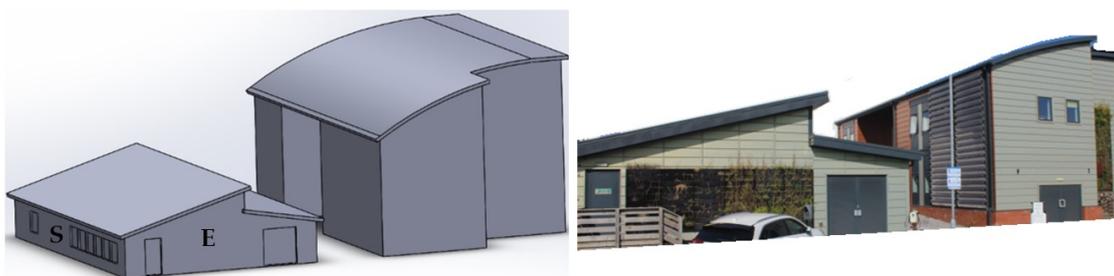
Figure 9. Dual building model (left) and actual buildings (right).

The nearby building providing sheltering was similarly modelled but, to reduce computational demand, less detail was used as it was only included to show the effect of a nearby sheltering building. This simple model was then, when required, placed as measured in relation to the building model, as shown in Figure 9.

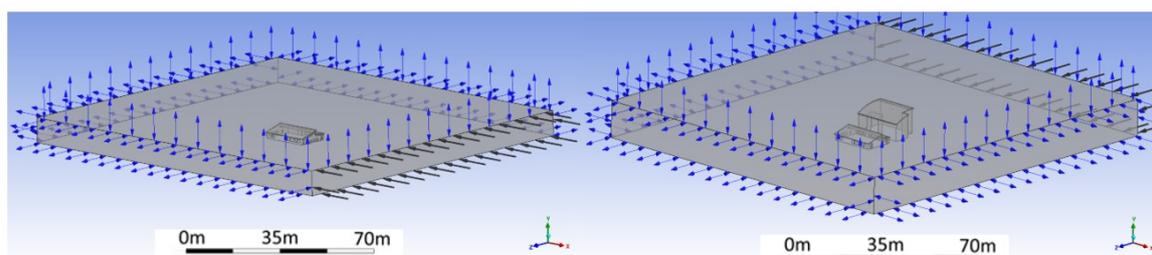
Figure 10. The computation domain for the single (left) and dual building (right) models. The black arrows signify an inlet boundary condition whereas the blue arrows show an open boundary condition.

The computational domain is shown in Figure 10 and had the following boundary conditions set: the upper face 'sky' boundary was set as an opening with 0 Pa relative pressure with random injection of water particles from approximately 600,000 injection regions. The inlet location varied depending on the desired wind direction for each test; however, each inlet was defined to have a normal air velocity varying from 2 to 12 ms^{-1} , representing a range of local wind conditions (Table 2). All other boundaries were set as smooth walls with a restitution and parallel coefficient of 0 to draw attention to the areas that rain impacted the building, i.e., when droplets hit the surface, they stick, and their path is considered ended. No consideration was given to the droplet's formation on the surface or the subsequent dripping through the action of gravity. The droplet flow rate was such that total droplet volume represented the annual rainfall. All other boundaries were set as smooth walls with a restitution and parallel coefficient of 0 to draw attention to the areas that rain impacted the building.

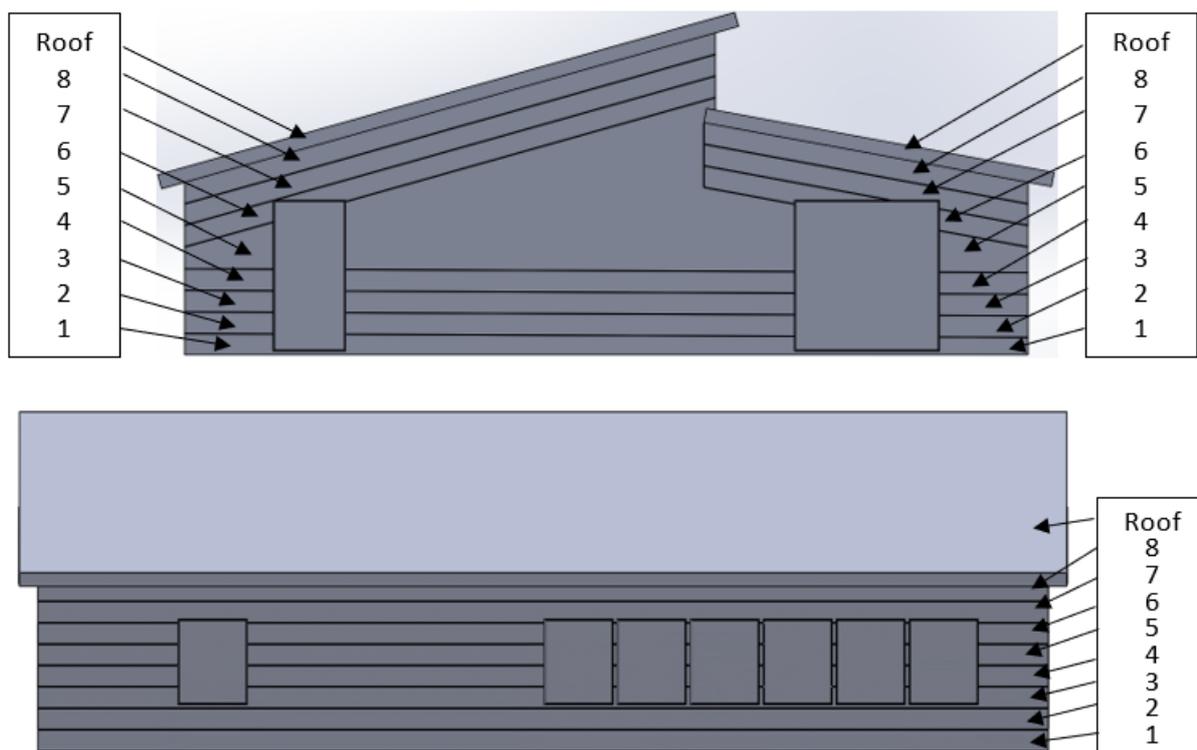
**Figure 11.** Example of façade sectioning for the east (**top**) and south (**bottom**) façades.

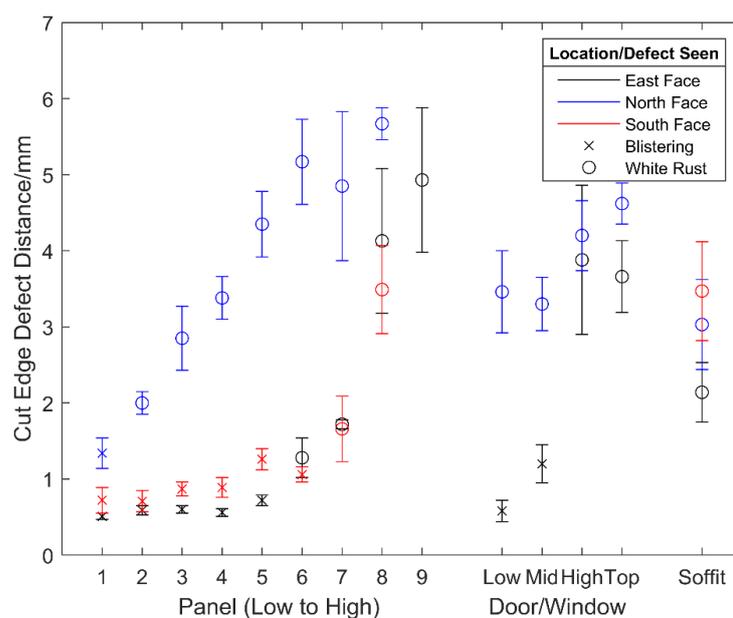
Figure 12. Variation in cut edge defect size and type across the building.

The observed cut edge defect distance across various locations on the building is shown in Figure 12. Generally, the east and south façades showed similar levels of performance; however, far greater degradation was observed on the north face. Equally, it was observed that distance and severity of cut edge corrosion increased with the height of the panel with far more significant cut edge degradation occurring in the panels mounted high in the eaves of the building than those at ground level for all observed façades. Initially, degradation is observed as blistering, which initiates corrosion and formation of white rust, which is in line with the literature [6]. This trend was also observed in door and window regions. The soffit region displayed moderate defect size, although this region was composed of more durable PVC-based coated material; hence, this may explain why it was perceived to be performing better than the highest PVDF panels that are in close proximity to the soffit region.

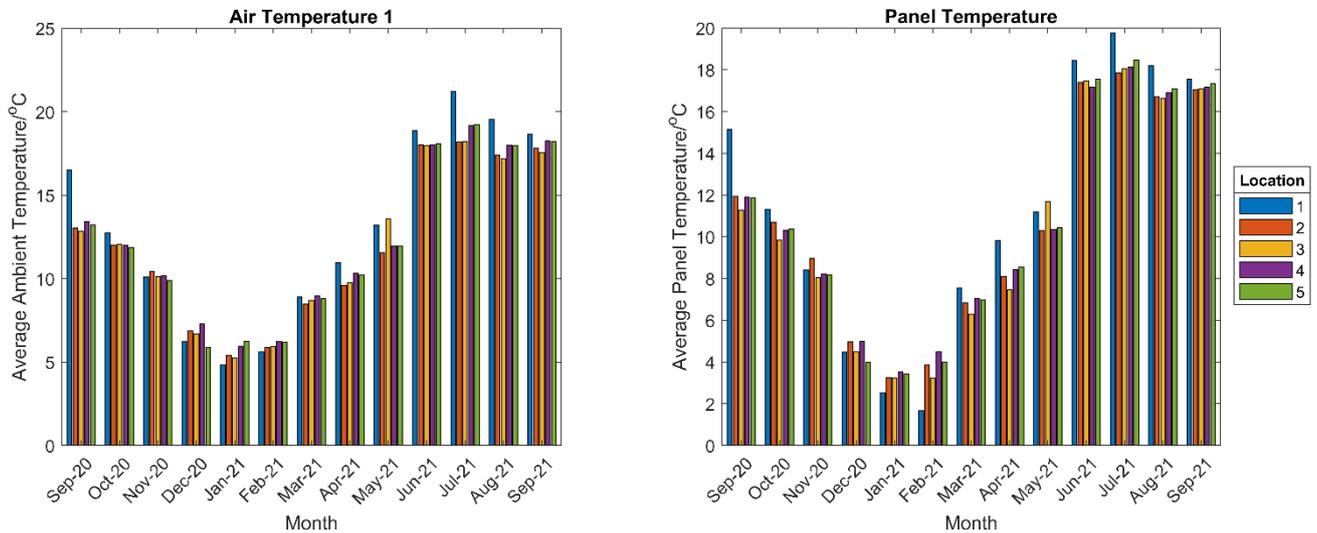
Figure 13. Comparison of air (left) and panel (right) temperatures recorded at each location.

experienced some of the lower temperatures in the winter months. The panel temperatures follow a similar trend to the ambient temperature but are on average approximately 3 °C lower. This is attributed to radiative heat losses experienced during the measurement process of the IR thermopile sensor.

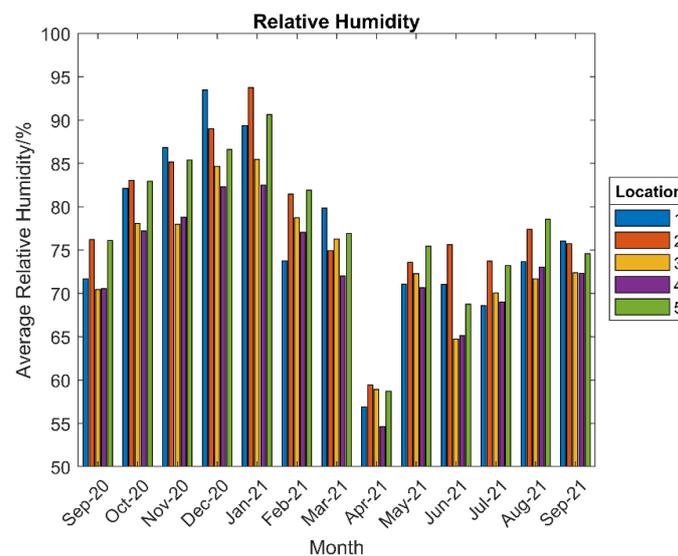
Figure 14. Comparison of the relative humidity recorded at each location.

The measured humidity at each site, shown in Figure 14, shows much more variation among locations. Of particular interest is the difference between those locations that are high up in the eaves and are considered sheltered locations (2,5) and those lower down, which are far more exposed to the elements (1,3,4). Although there was some variation, on average these high locations recorded 4–5% increased relative humidity during the test period.

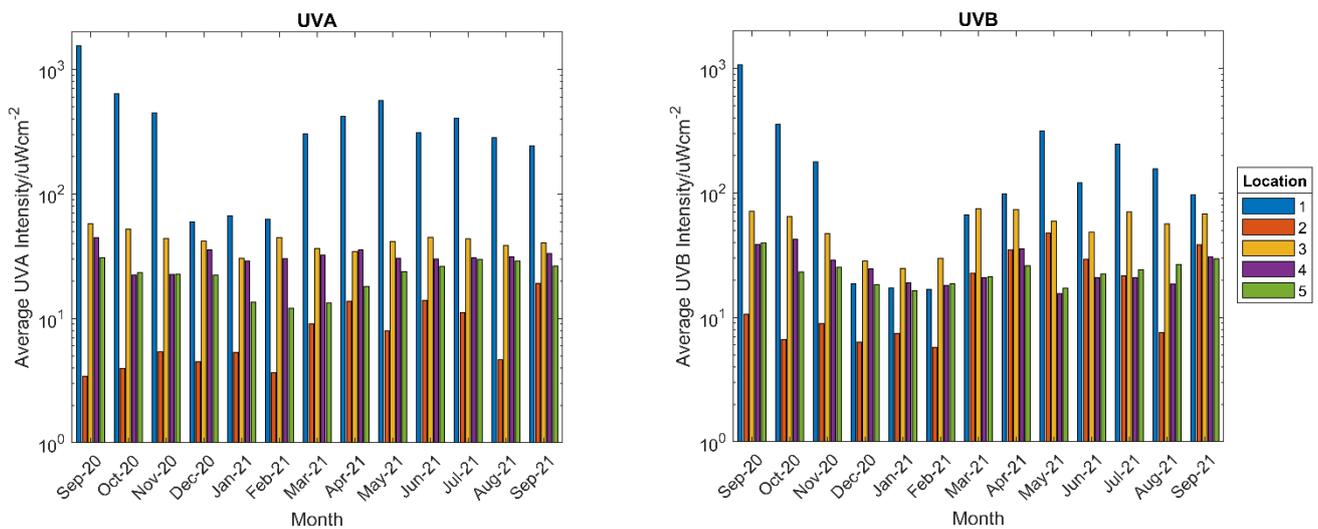
Figure 15. Comparison of UVA (left) and UVB (right) intensity recorded at each location.

location (1) received the highest UV exposure, which is consistent with sun movements for the northern hemisphere.

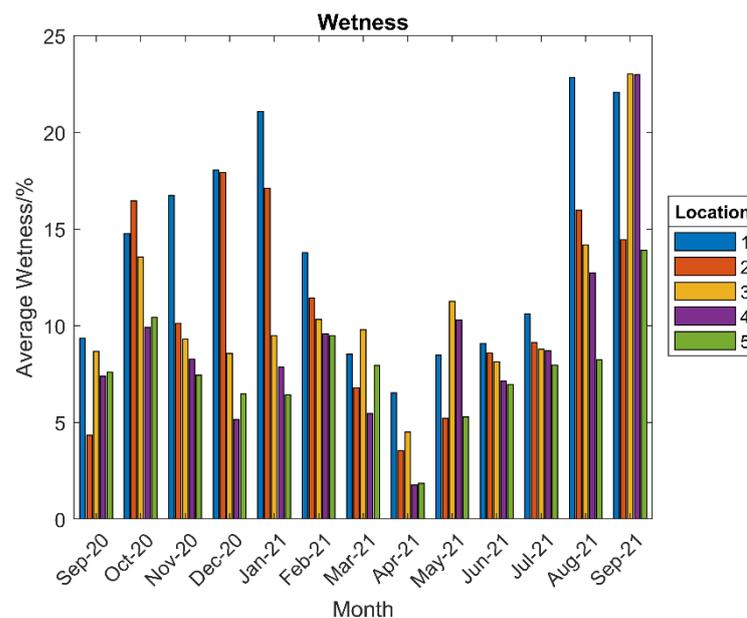
Figure 16. Comparison of % wetness recorded at each location.

The measured time of wetness at each location was calculated by comparing the number of readings captured suggesting probe wetness over 10% to those suggesting probe wetness under 10%. In Figure 16, it is observed that generally sites 1 and 2 showed greater wetness than the other sites. It is thought this is because sites 1 and 2 are more exposed to wind-driven rain than the north sites due to the semi-sheltered nature of the north face due to the building closely situated adjacent to the north. As expected, owing to increased rain exposure, comparing the mid and low sites to the counterpart high sites, the more exposed lower sites showed greater wetness. However, the high time of wetness of site 2 shows that just because a site is high and sheltered by the roof of a building does not necessarily preclude it from moisture build-up related to factors such as humidity.

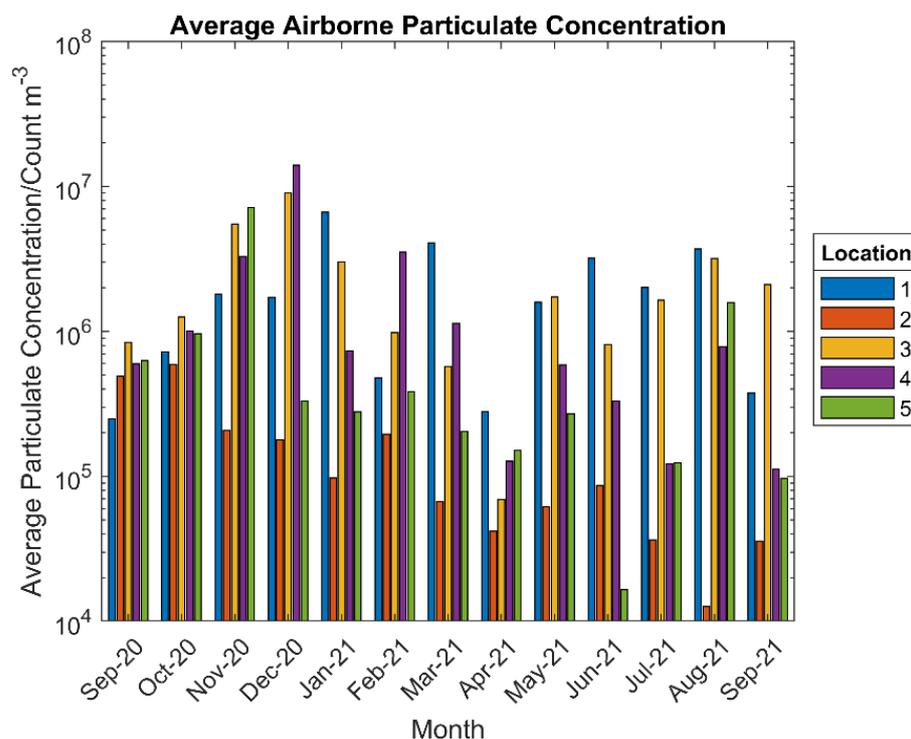
Figure 17. Comparison of particulate concentration recorded at each location.

Figure 17 shows the measured particulate concentration at each location from which it is observed that there appear to be few obvious trends, although it can be said that higher average concentrations were observed on the lower, more exposed regions. It is thought this is because these locations experience the greatest exposure to wind, and hence more particles are wind-driven towards these areas. However, it is important to note that the number of particles arriving at a location does not always correlate with the amount of deposit building-up due to variations in natural washing across the building.

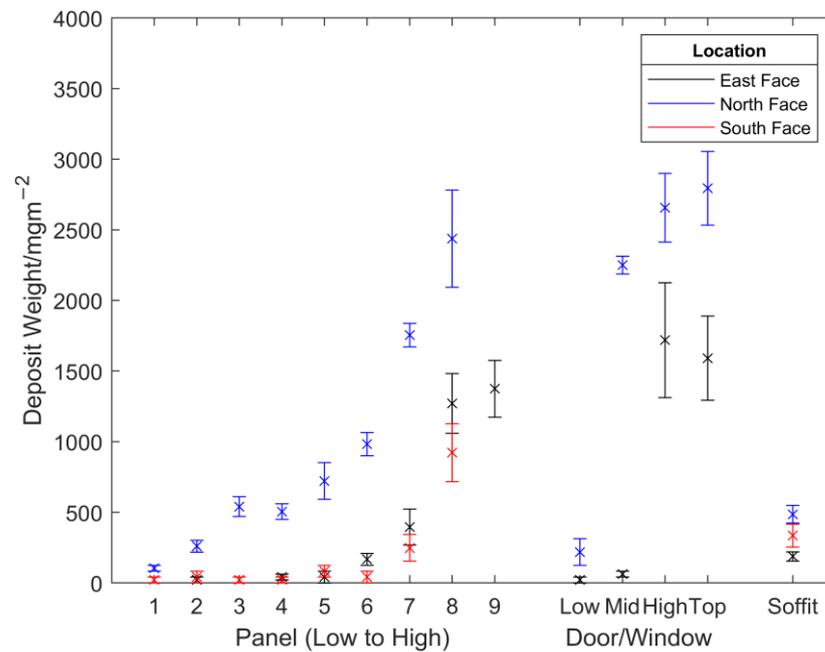
Figure 18. Variation in the amount of deposit present across the building.

The calculated weight of natural deposit built-up at each building location is shown in Figure 18. Generally, the north façade shows greater deposit build-up than the east and south, which show similar levels. Furthermore, the amount of deposit present increases from low at ground-level panels to the highest at the panel in the eaves of the roof and similarly increases in the door and window surrounds. The soffit regions showed relatively low levels of deposit build-up. Comparing the data presented in Figure 18 to that of the cut edge defect data shown in Figure 12, it is evident that increased natural deposits correspond to increased cut edge defects and white rust.

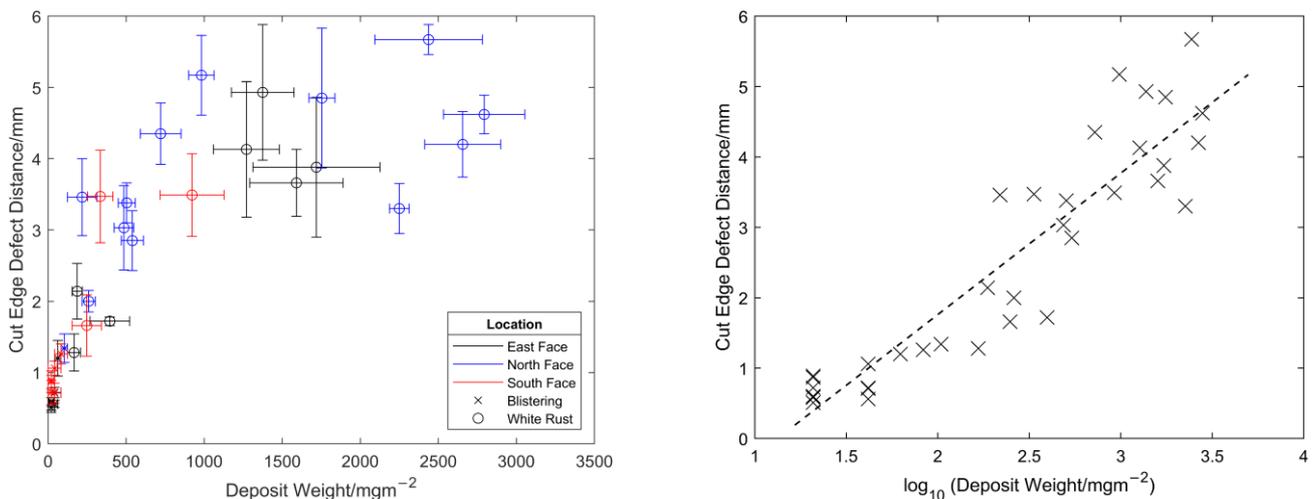
Figure 19. Comparison of the cut edge defect distance to the measured deposit weight in each location (left) and a demonstration of the logarithmic trend between the two factors (right).

To compare the correlation visually, the deposit weight was plotted against the cut edge defect distance, Figure 19, and a positive, nonlinear trend was observed. It was also observed that blistering only occurred in locations where the deposit weight was lower than approximately 250 mgm^{-2} , with white rust observed at all locations with larger deposit weights. Figure 19 also displays that the trend can be approximated to logarithmic with a calculated Pearson correlation coefficient of 0.92. The strength of the correlation led to discarding the idea that the performance variation could only be down to an additional factor such as poorer workmanship and installation in these regions.

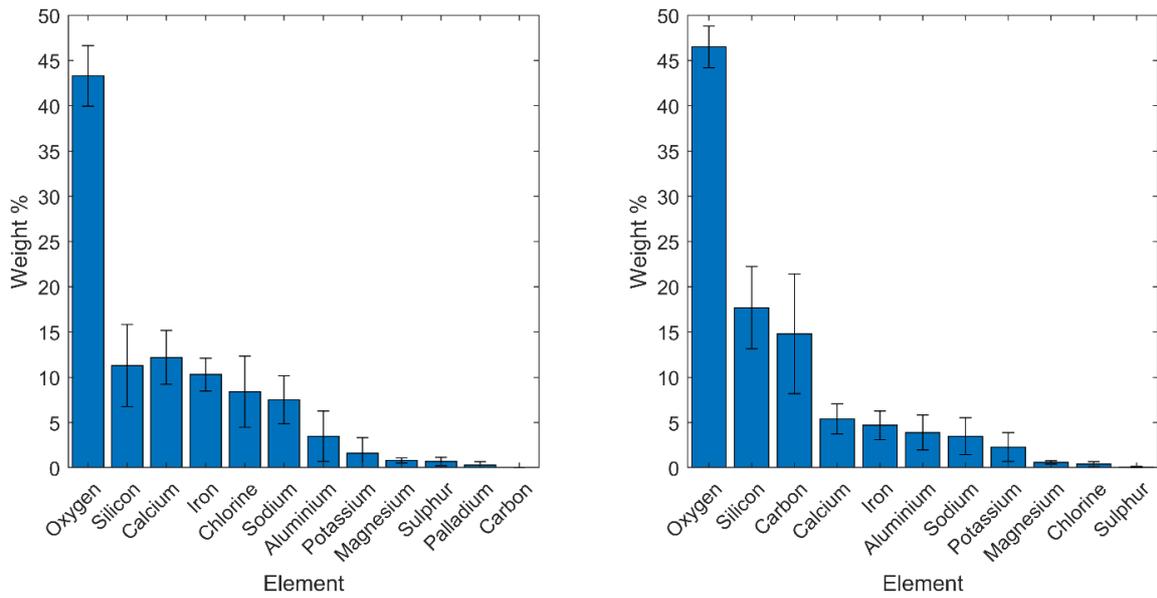
Figure 20. EDS analysis of the SP sample (left) and the P sample (right).

Figure 20 shows the results of the EDS analysis of the natural deposit samples SP and P. A variety of elements are present in both samples and the weight % of those often expected to be present in soluble compounds decreases in the P sample, where dissolution would have likely occurred. Of particular interest is the presence of chlorine, which appears to be soluble, presumably as Cl^- , which contributes to accelerated corrosion.

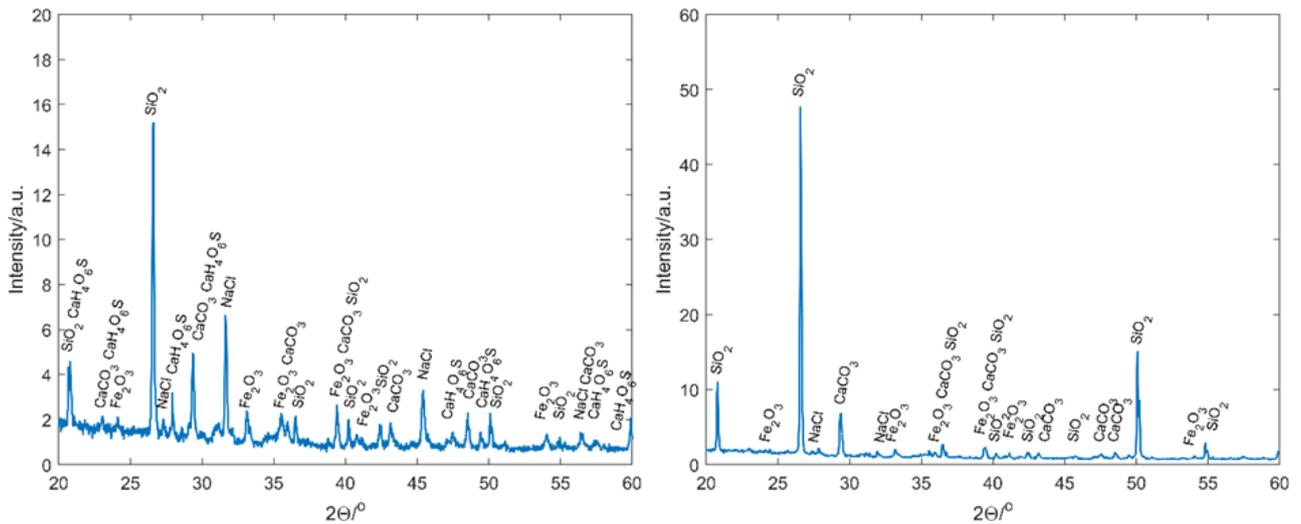
Figure 21. XRD analysis of the SP sample (left) and the P sample (right).

The EDS% weight data were used in combination with the likely compounds present, matched with the XRD results, Figure 21, to identify the compounds and the likely percentage distribution of these compounds in the two samples. The resulting data are displayed in Figure 22. Again, it was observed that water-soluble compounds are less prevalent in the P sample, as would be expected. It is worth noting that not all elements identified in the EDS work formed part of a compound in the XRD analysis, suggesting other compounds composed of the unmatched elements may also be present.

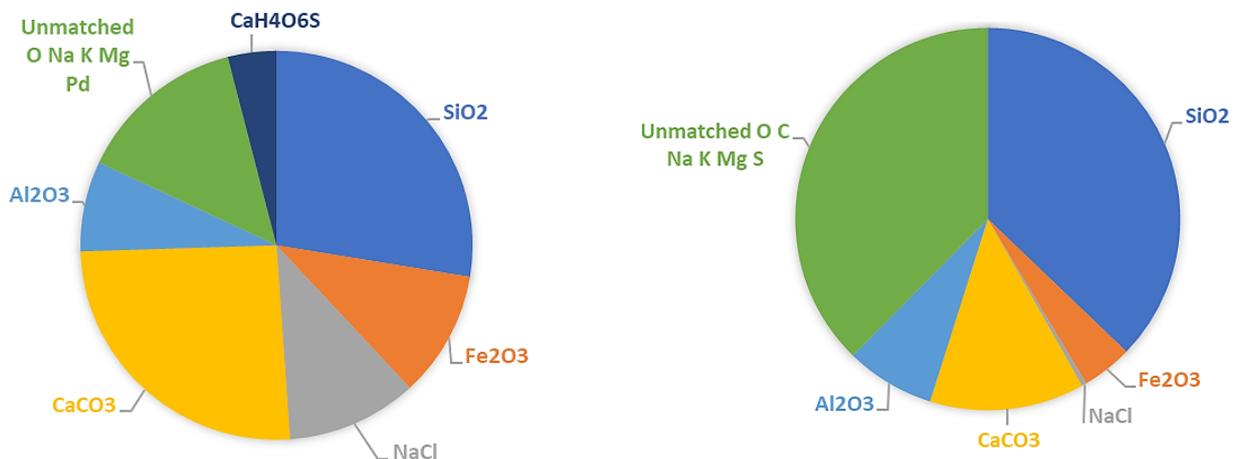
Figure 22. Likely constituents of the analysis of the SP sample (left) and the P sample (right).

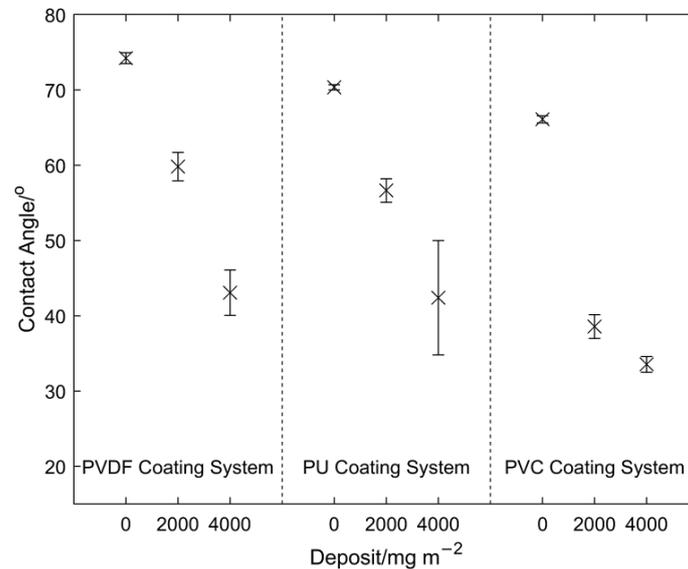
Figure 23. The effect of increased deposit build-up on the wetting angle measurements for the three different coating systems.

rapidly. This clearly demonstrates that deposit built-up results in the surface becoming more hydrophilic. In practice, this would lead to less water runoff, greater spreading of the water droplets, and longer exposure times of the paint to the conductive water.

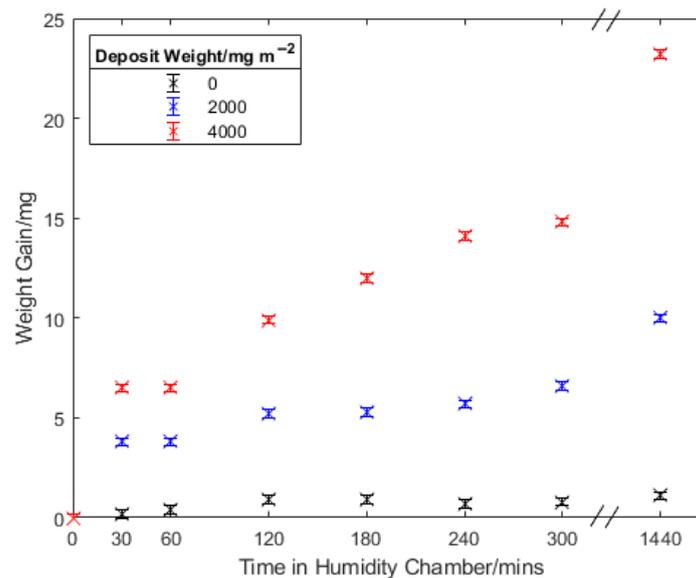
Figure 24. Water adsorption as a result of deposit weight and time in a humidity chamber for the PVDF-coated samples.

The results of the humidity chamber test for the PVDF coating system are shown in Figure 24. It can be observed that the samples with applied deposit increased in mass through time in the humidity chamber, and that the greater the deposit weight applied, the greater this increase. The control sample gained a small amount of weight after approximately 2 h and levelled, representing some condensation due to initial sample temperature. The mean increase in mass per $\text{mg/m}^2/\text{day}$ at 95% humidity was determined to be $5 \pm 0.5 \mu\text{g}$. Thus, any surface fouling plays a key role in maintaining moisture on the paint surface, increasing water diffusion through coating to the substrate below.

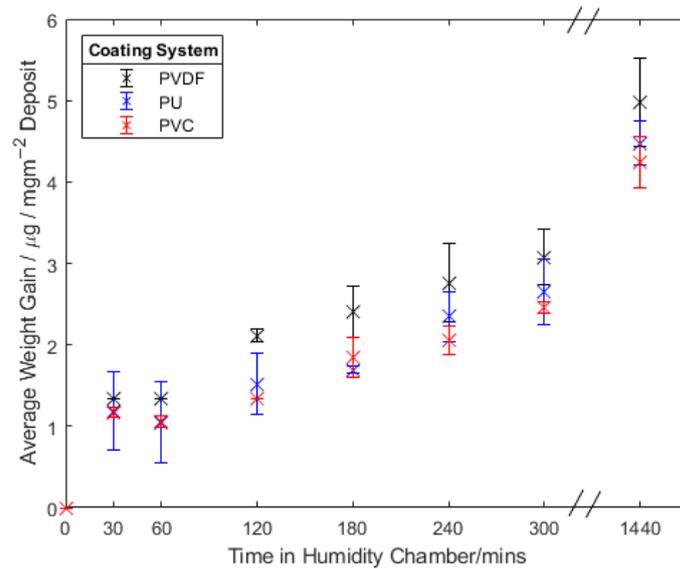
Figure 25. Water adsorption per mgm^{-2} of deposit weight as a result of time in the humidity chamber for each coating system.

These trends were also observed with the other coating systems. For all coating systems, the weight gain with time, per mgm^{-2} of deposit vs. the clean samples, is given in Figure 25. It is displayed that all the three coating systems perform similarly, suggesting that independent of the coating system used the sample will gain approximately $4\text{--}5.5 \mu\text{g}$ of H_2O per mgm^{-2} of deposit present, per day, in a 95% humidity environment.

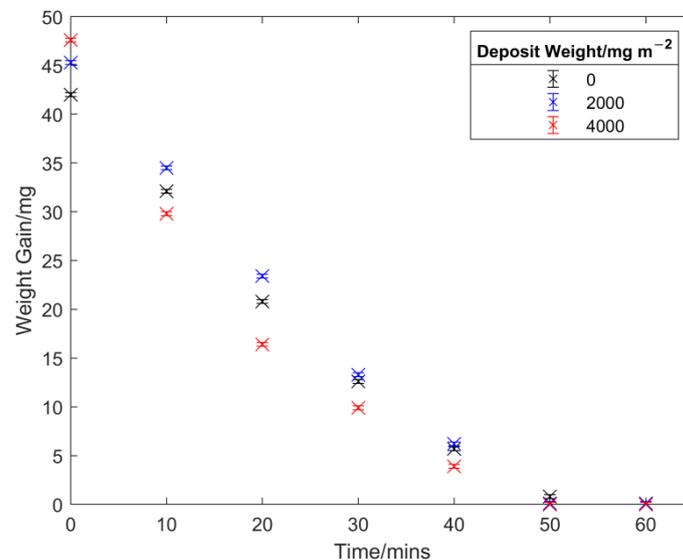
Figure 26. Effect of deposit weight on the drying of applied water droplets for the PVDF-coated samples.

When subjected to a lower relative humidity, moisture leaves the surface, Figure 26. The consistency of the mass loss suggests that the deposit build-up has little effect on the ability of the sample to dry. However, it has to be considered that the deposit-applied samples do have a reduced contact angle and hence the droplets covered a larger area. Therefore, it would be expected that the droplets on the lower contact angle samples would evaporate faster due to increased surface area to volume ratio. Hence, the fact that all the samples showed similar drying rates suggests that there is an element of the deposit retaining the water, somewhat. It is difficult, however, to conclude that amount of deposit has a significant effect on the drying rate for this sample.

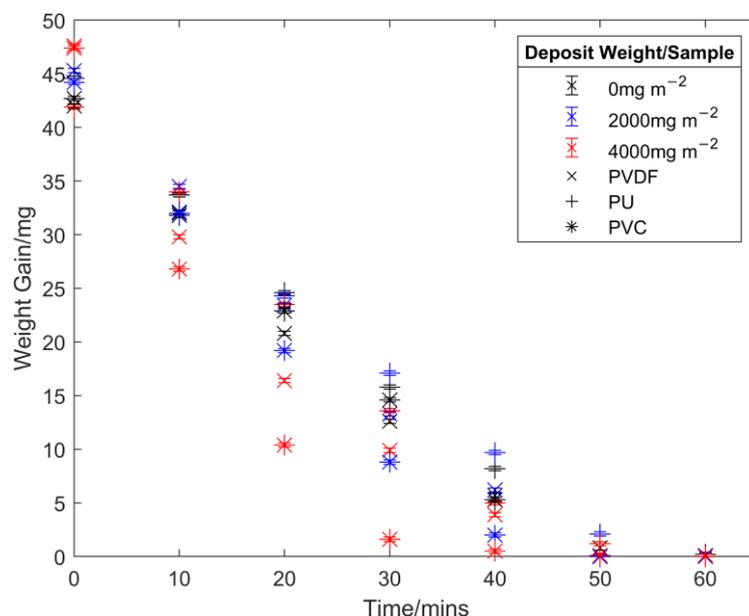
Figure 27. Effect of deposit weight on the drying of applied water droplets for all coating systems.

Similar results were observed for the other coating systems, as shown in Figure 27. There appears to be little trend in terms of drying rate, again suggesting that the competing factors of contact angle and water retention by the deposit mean there is little difference in the drying rate observed using this testing method.

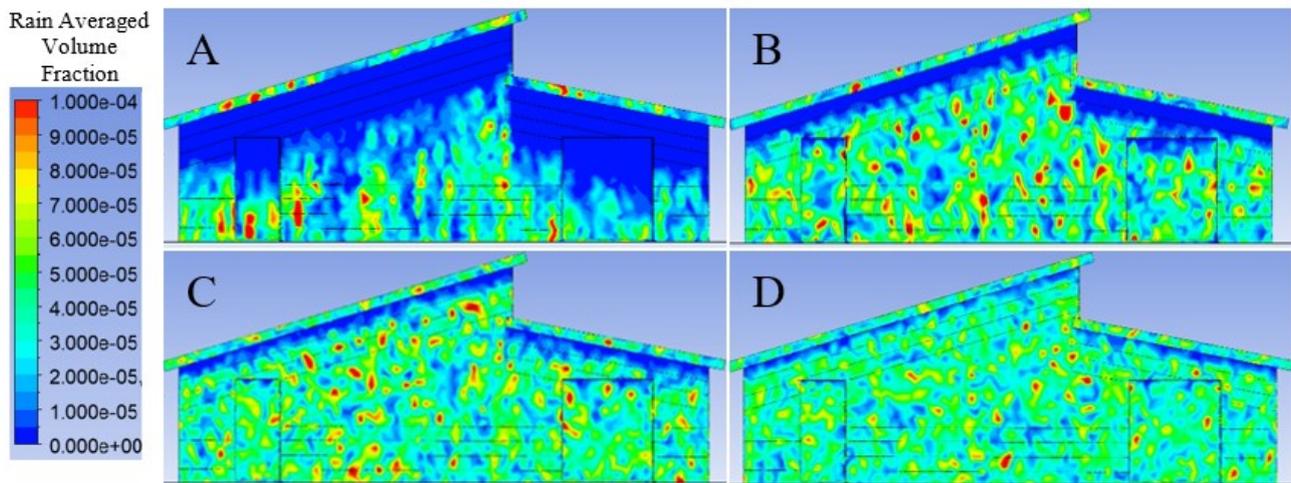
Figure 28. Predicted rain impact density for the east elevation under 2 (A), 4 (B), 6 (C), and 8 (D) ms⁻¹ wind speed applied normal to the east elevation.

Firstly, it is observed that the greatest barrier preventing natural washing of the façade via rain impact is the roof soffit overlap. This creates a shielded region which is protected to an extent from the wind-driven rain particles. The extent to which this occurs is a function of the wind speed; when the wind speed is low, then the sheltered area is large, but as the wind speed increases, the particle trajectory is increased in the horizontal direction reducing the sheltering effect of the roof overlap. However, even at high wind speeds of 10–12 ms^{-1} , the roof soffit still maintains a sheltering effect to some extent. At lower speeds (4–6 ms^{-1}), it is also possible to see that the doorway and window inset surrounds also produce a sheltering effect to some extent with greater sheltering observed in the higher regions of the surrounding area.

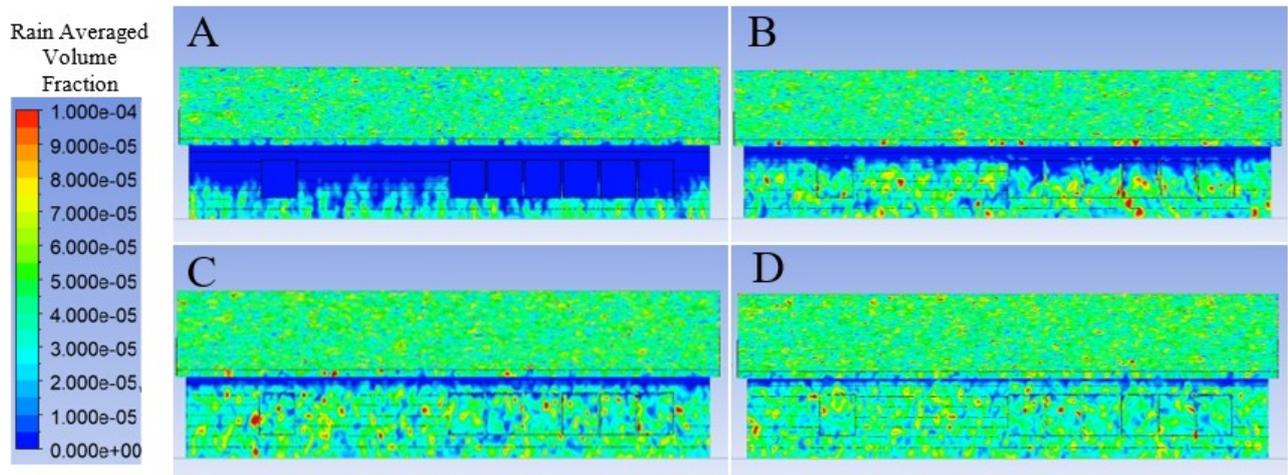
Figure 29. Predicted rain impact density for the south elevation under 2 (A), 4 (B), 6 (C), and 8 (D) ms⁻¹ wind speed applied normal to the south elevation.

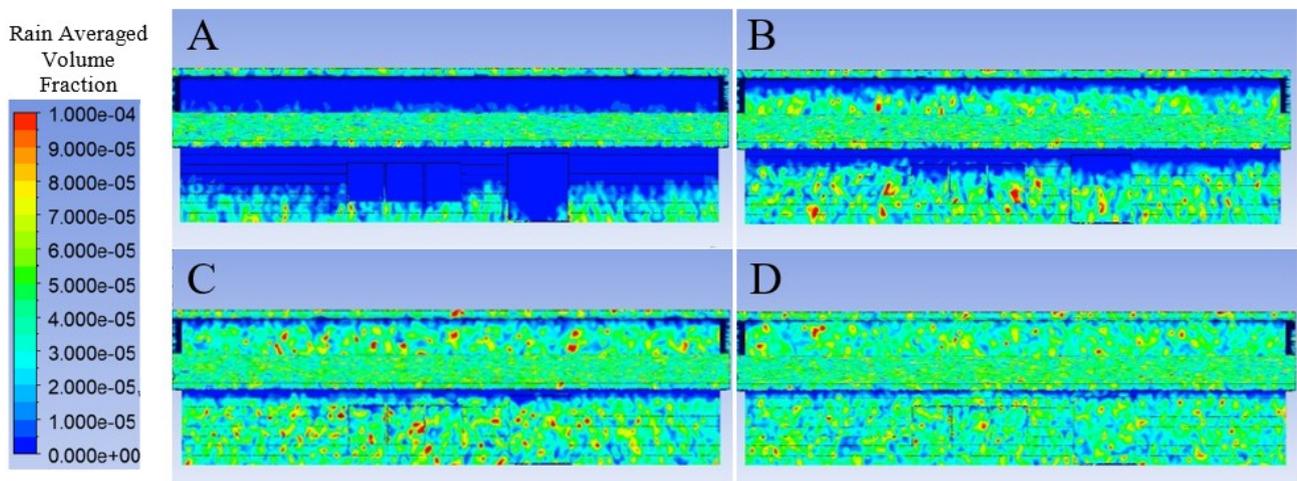
Figure 30. Predicted rain impact density for the north elevation under 2 (A), 4 (B), 6 (C), and 8 (D) ms⁻¹ wind speed applied normal to the north elevation.

It is worth noting that the regions that are shown to have a low probability of natural washing are well correlated to those that have a high quantity of natural deposits. This provided some confidence that the model may be able to predict regions likely to be subjected to fouling and therefore higher degradation rates. The exception to this is the north face where this model predicts that similar rain impact occurs on the south and north faces, suggesting that similar deposit levels should be seen on the actual building. However, this is thought to be due to the lack of the second sheltering building in this model.
