Article

Understanding and Predicting Localised Variations in the Degradation Rate of Architectural, Organically Coated, Steel Cladding

Citation: Savill, T.; Jewell, E. Understanding and Predicting Localised Variations in the Degradation Rate of Architectural, Organically Coated, Steel Cladding. *Buildings* **2023**, *13*, 270. <https://doi.org/10.3390/buildings13020270>

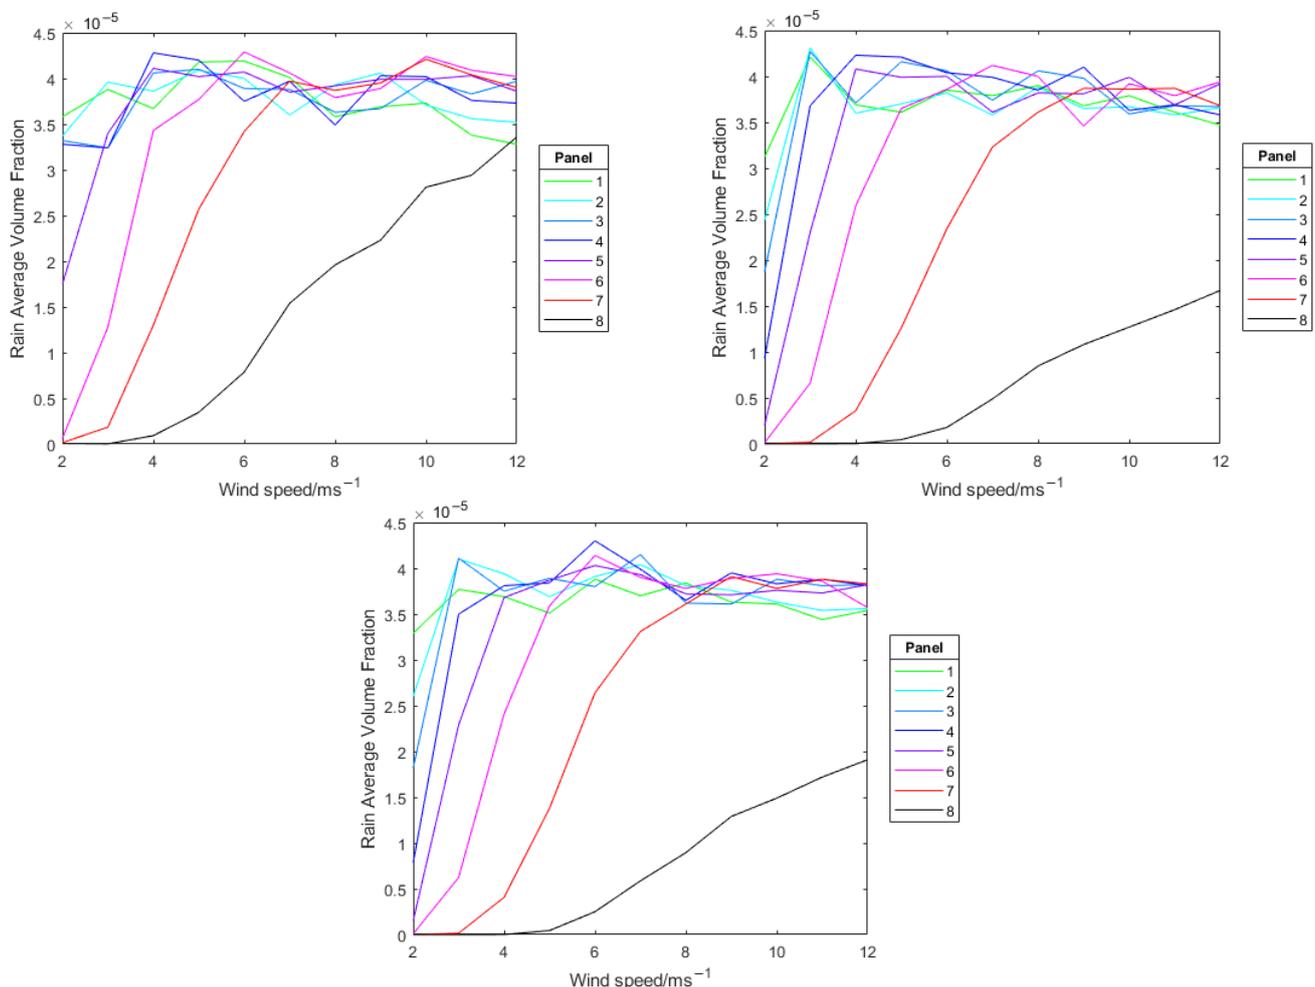
Figure 31. Measured average rain volume fraction at each location for the east (top left), south (top right), and north (bottom) façade.

The measured average rain volume fraction for each location identified in Figure 11 can be seen in Figure 31. This provides further evidence to corroborate the visual observation that the roof soffit provides a sheltering effect that decreases with increased wind speed. It is also apparent just how significant that sheltering effect is on the higher panels (6–8), suggesting a very low probability of direct rainfall contacting these panels unless a high normal wind speed is present.

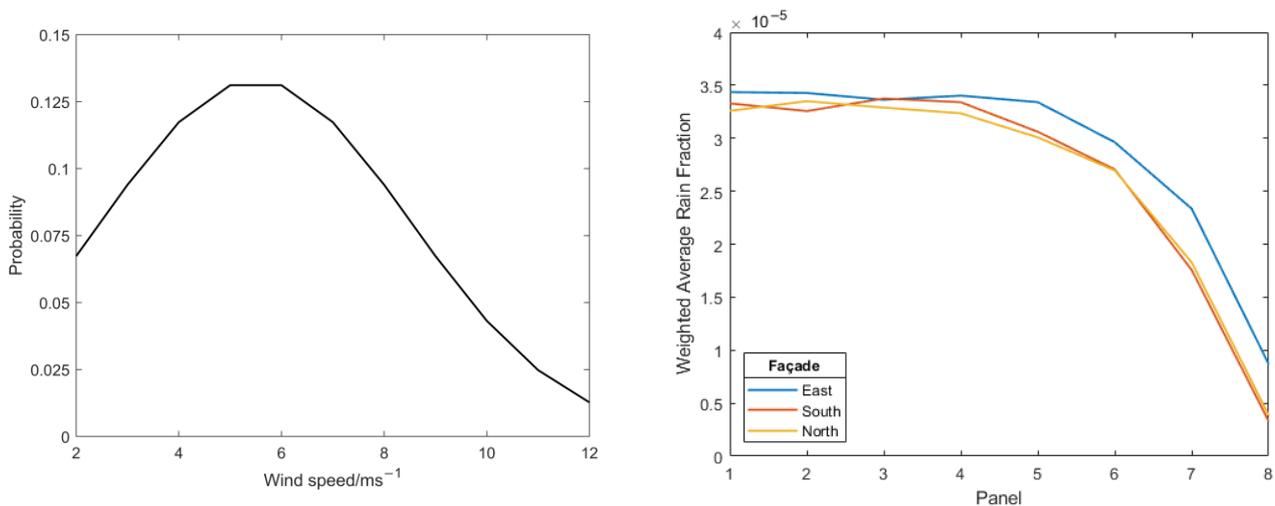
Figure 32. Wind-speed probability distribution used (left) to calculate wind-speed weighted averaged rain fraction for each panel on each façade (right).

In order to compare these results to the measured fouling, for each panel the values of rain average volume fraction for each wind speed were converted into a single value using a weighted average corresponding to the likely wind-speed probability shown in Figure 32. It was thought that the wind-speed probability was suitable for the location tested given the previously mentioned average weather conditions.

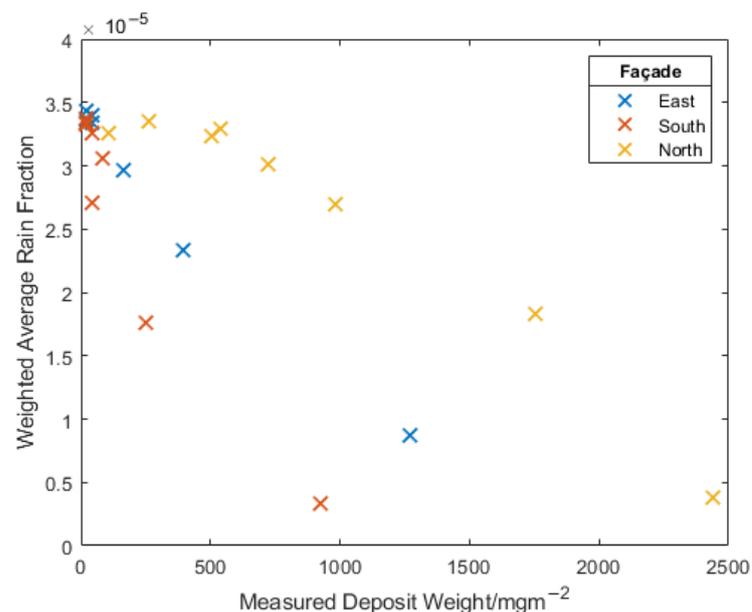
Figure 33. Comparison between measured deposit fouling intensity and model predicted rain impact density.

When this value was plotted against the measured deposit fouling, Figure 33, the results show that, as expected, the extent of fouling increases as the quantity of model-predicted rain impact decreases. While the east and south faces generally show similar behaviour, the north face, however, is observed to show far greater fouling for a similar weighted average rain fraction. It is thought this is due to the importance of considering other nearby buildings on the effect of natural building washing and not solely the geometry of the building of interest.

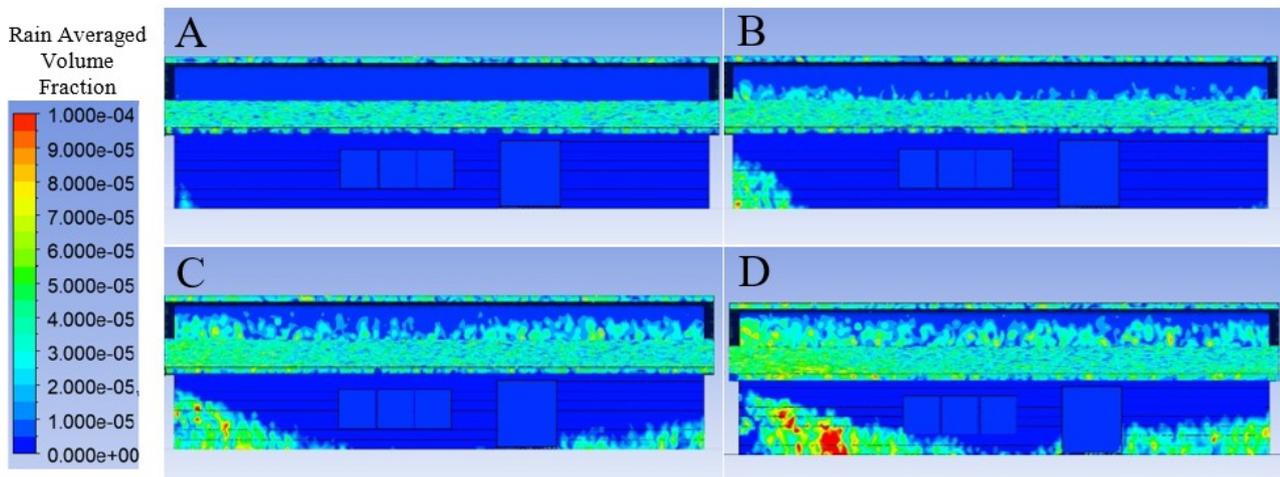
Figure 34. Effect of the semi-shielding building on the predicted rain impact density for the north elevation under 2 (A), 4 (B), 6 (C), and 8 (D) ms^{-1} wind speed applied normal to the north elevation.

displays this effect. It is clear that, when compared to the single building model, the dual building model predicts far less natural rain impact on the north face. This correlates far better to the measured deposit build-up shown previously with high levels of deposit observed on the lower panels.

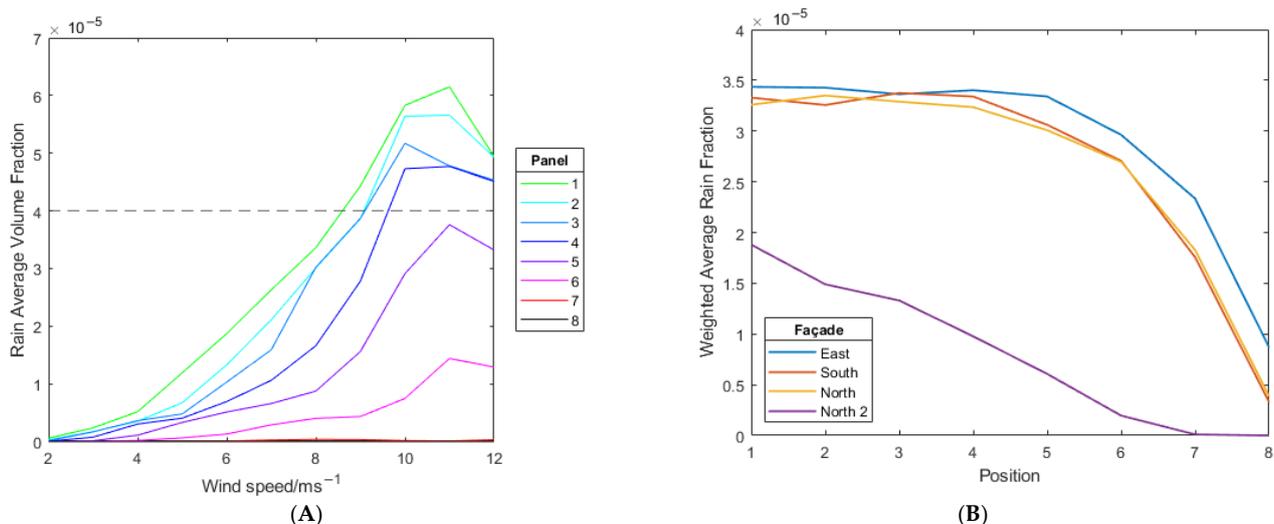
Figure 35. (A) Measured average rain volume fraction at each location for the north façade in the dual building model. The dashed line represents the maximum volume fraction achieved in the single building model. (B) Comparison between the wind-speed-weighted rain impact density for the two models used.

It is observed in Figure 35 that with the adjacent building included in the model all the panels on the north façade record far lower averaged volume fractions of rain at the lower wind speeds ($2\text{--}8 \text{ ms}^{-1}$). In fact, it is observed that a wind speed of 8 ms^{-1} is required just for panel 1 to receive a similar rain average volume fraction to panel 1 in the single building model at just $2\text{--}4 \text{ ms}^{-1}$. While panels 1–4 do experience slightly higher volume fractions at high wind speeds $8\text{--}12 \text{ ms}^{-1}$, it should be noted that panels 5–8 never record similar volume fractions to those in the single building model, even at high wind speeds. This difference in the predicted north façade rain impact density in the two models is further shown by the wind-speed-weighted average rain fraction, also shown in Figure 35.

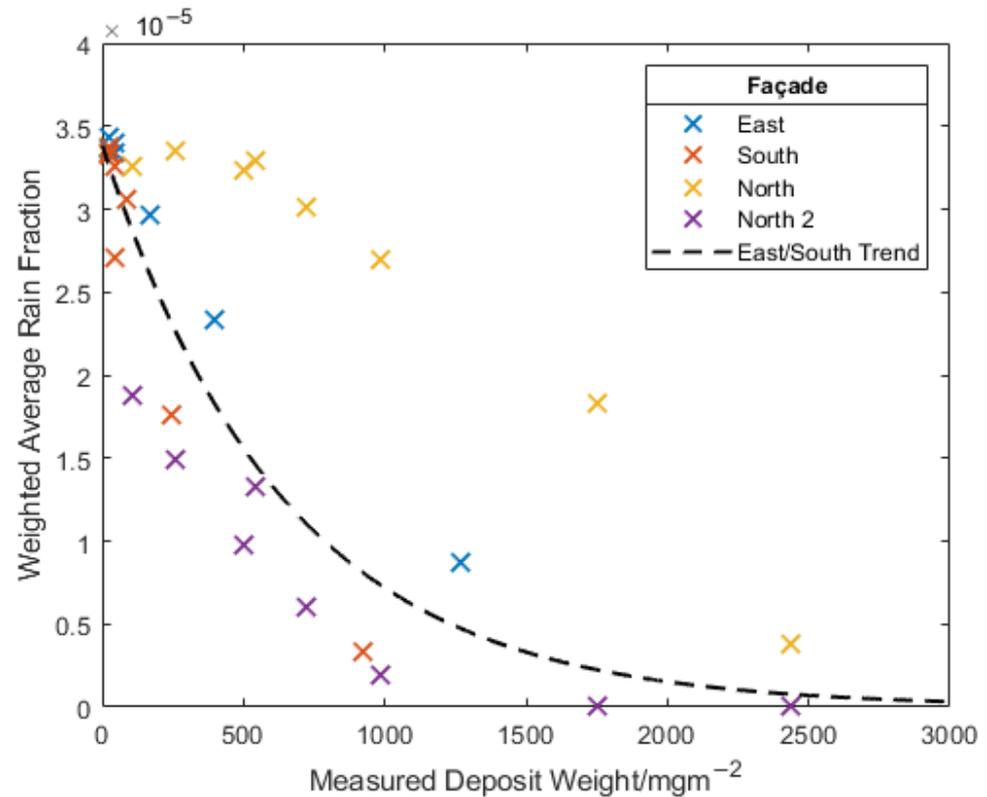
Figure 36. Comparison of the fitting of north façade data from each model to the trend given by the east and south façade data.

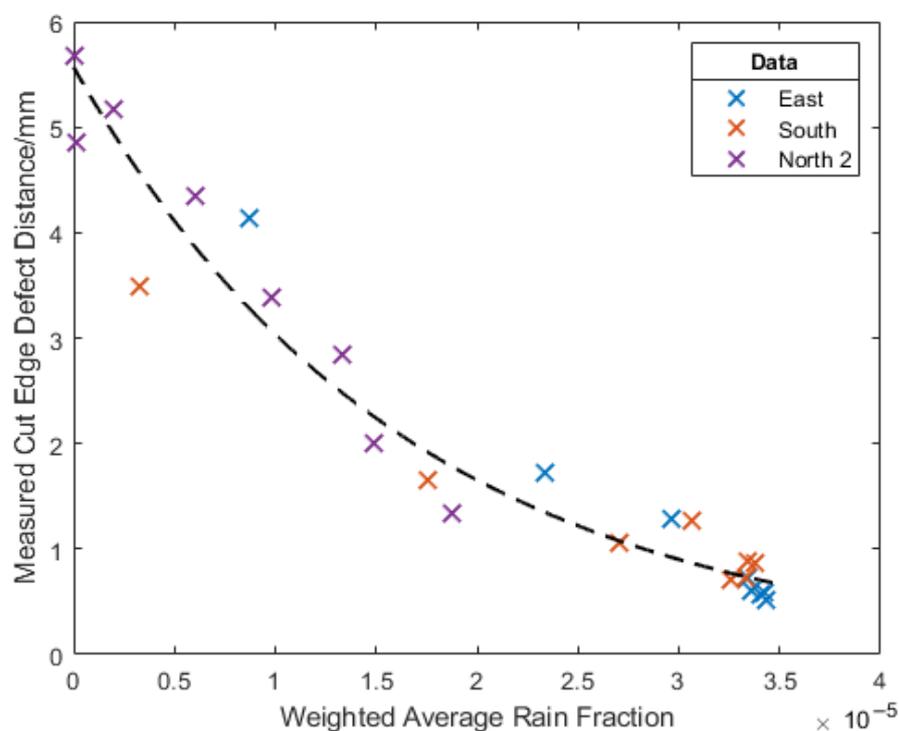
Figure 37. Comparison of measured cut edge defect distance and the model-predicted rain impact density.

While it is promising to see a clear correlation between the simulations and the deposit fouling intensity, the far more important factor is the measured distance of the cut edge corrosion defect. The result of plotting this against the wind-speed weighted average rain fraction for all façades and panels, Figure 37, is a highly correlated exponential trend between the two factors, providing an R^2 value of 0.94. The exponential decay of the cut edge defect distance with simulated rain fraction was thought to be explainable through the effect of cleaning and therefore the relative influence of deposits. As the rain impact density increases, the fouling decreases, which leads to an ever-smaller contribution of the fouling deposit to the degradation. This suggests the simulations could accurately be used to determine likely areas of concern.
