# Restoration of Tilted Buildings via Micropile Underpinning: A Case Study of a Multistory Building Supported by a Raft Foundation

**Abstract:** This paper presents a real case study of a micropiling process that was developed to stop the continuous tilting of a 9-story residential building in Dakahlia, Egypt. Shortly after the construction of the building, the surface raft foundation exhibited severe settlement problems. In order to carry out a geotechnical investigation, boreholes were drilled around the constructed building. It was discovered that in addition to a thick, soft clay layer in the soil profile, there was also a crucial eccentricity between the centroid of the total building loads and the centroid of the raft. The issue needed to be addressed immediately, and a micropiling system was proposed to satisfy the geotechnical and structural conditions associated with the case history. In addition to describing the field measurements, detailed methodology, and micropile installation process, this paper also presents three different design approaches for determining the number and location of the micropiles. Although the underpinning process itself initially induced some se

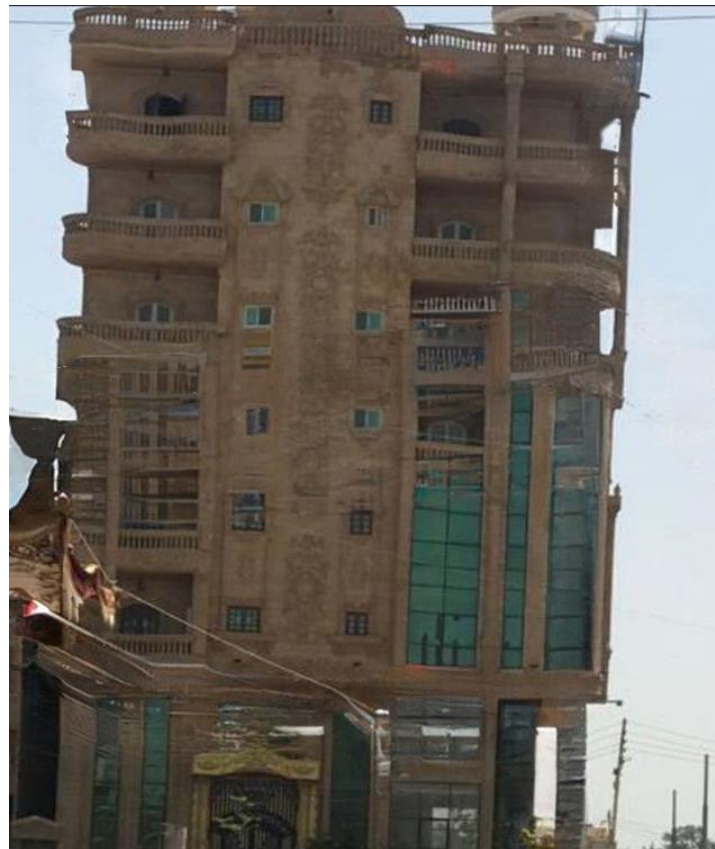
**Figure 2.** A photograph of the tilted building from the southern side.

1. The structural elements had no visible cracks; the condition of the beams, columns, and slabs was excellent.
2. With the naked eye, an increasing horizontal distance could be observed between the tower under investigation and the adjacent building to the north; however, this distance could not be accurately measured.

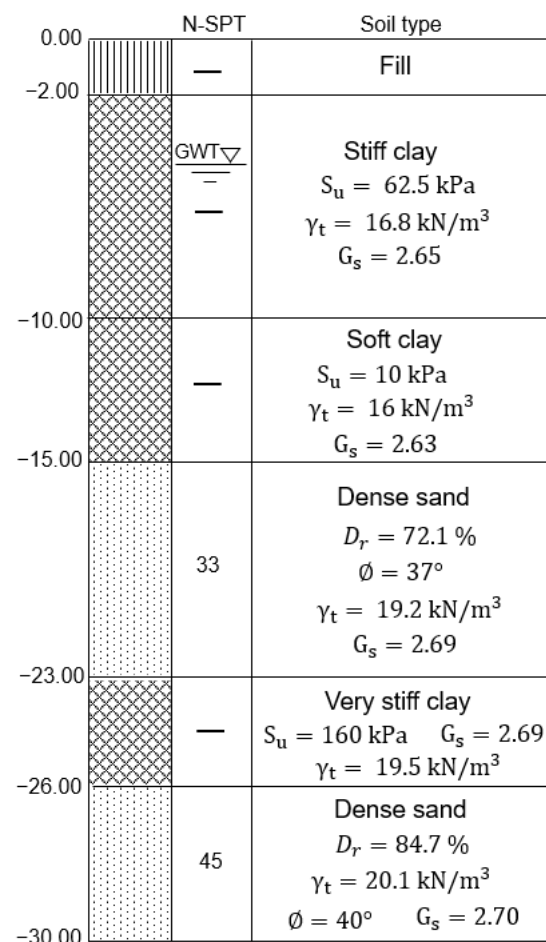
**Figure 3.** Schematic section of the soil profile around the building under investigation. Note:  $S_u$ , undrained cohesion;  $\phi$ , internal friction angle;  $\gamma_t$ , total unit weight;  $G_s$ , specific gravity;  $D_r$ , relative density.

In October 2020, a site investigation program was implemented to examine the soil stratification. The program involved drilling six boreholes around the tower, one to two meters from the tower edges at the locations depicted in Figure 1, with a spacing of not more than 15 m, one 30 m deep, two 20 m deep, and three 15 m deep. A standard penetration test was carried out whenever granular soils were encountered. The SPT N shown in Figure 3 was taken as the average of the results recorded for the 6 boreholes. For cohesive layers, a Shelby tube sampler was utilized to collect undisturbed samples, which were then tested with a pocket penetrometer and unconfined compression tests. The site soil profile, depicted schematically in Figure 3, consists primarily of: (1) fill from the ground surface to a depth of 2 m, (2) a layer of stiff clay from a depth of 2 m to 10 m, (3) a layer of soft clay from a depth of 10 m to 15 m, (4) a layer of dense sand from a depth of 15 m to 23 m, (5) a layer of very stiff clay from a depth of 23 m to 26 m, and (6) a layer of dense sand from a depth of 26 m to 30 m. The groundwater table was recorded at about 3.5 m below the ground surface, 24 h after drilling the boreholes. The total depth of the soft clay layer was observed to increase by up to 6 m toward the southeast corner of the site. In accordance with the soil conditions beneath the bottom of the raft (located 2.6 m below the ground surface), the soil was expected to have an allowable bearing capacity of 70 kPa. It is important to note that in early 2019, as per the recommendations of a geotechnical consultant, the plan was to construct the building on a piled raft. Despite this, the building was eventually built on a surface raft, and the consultant's recommendations were disregarded.

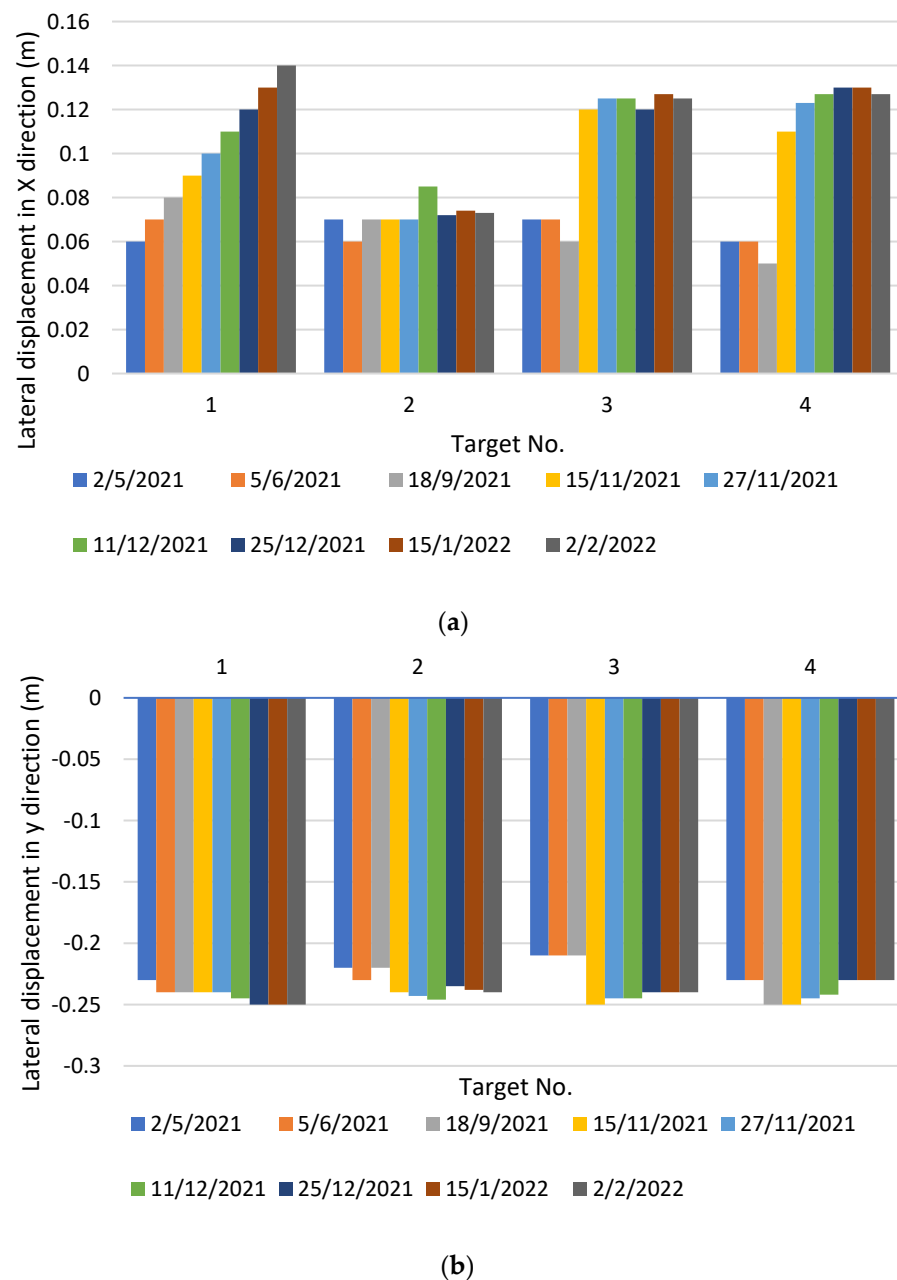
**Figure 4.** Target points movements with respect to time: (a) in x direction and (b) in y direction.

As shown in Figure 4, immediately prior to the micropiling process, on 27 November 2021, the building was tilted 24.5 cm toward the south and 12.5 cm toward the east. This corresponded to inclination ratios of around 1H:113V toward the south and 1H:222V toward the east. Moreover, rotations of the east and west sides of the raft were monitored over time. These rotations, calculated by using Equations (1) and (2), are presented in Figure 5.

Thus, four monitoring targets were attached to the tower to aid observations. As shown in Figure 1, targets 1, 2, 3, and 4 were positioned at the top of the tower 27.8 m above the foundation level, at the southwest, northwest, southeast, and northeast corners, respectively. The monitoring survey observation results are presented in Figure 4, where positive values of  $x$  indicate displacement toward the east, and negative values of  $y$  indicate displacement toward the south (see Figure 1). In Figure 4, it can be seen that the building was tilting farther toward the southeast corner until the installation of the repair system was implemented from 7 December 2021 to 1 February 2022. The monitoring survey indicated that the underpinning process itself initially induced some settlement. This could be attributable primarily to the micropile installation technique, which involved soil excavation, leading to stress relief. A similar observation was reported by Lopes et al. [22].

Beginning on 25 December 2021, a noticeable reduction in the rate of displacement was observed, demonstrating the success of the repair system.

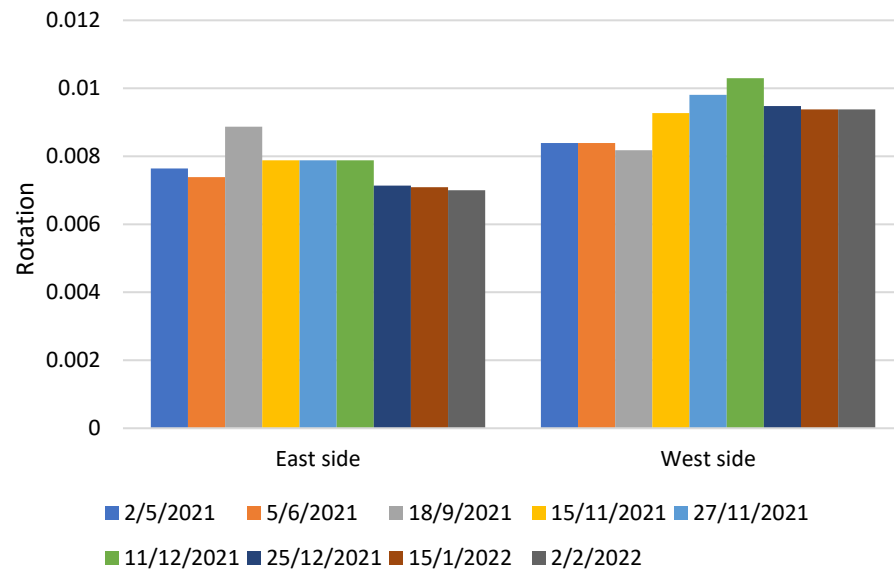
**Figure 5.** Rotation of east and west sides with respect to time.

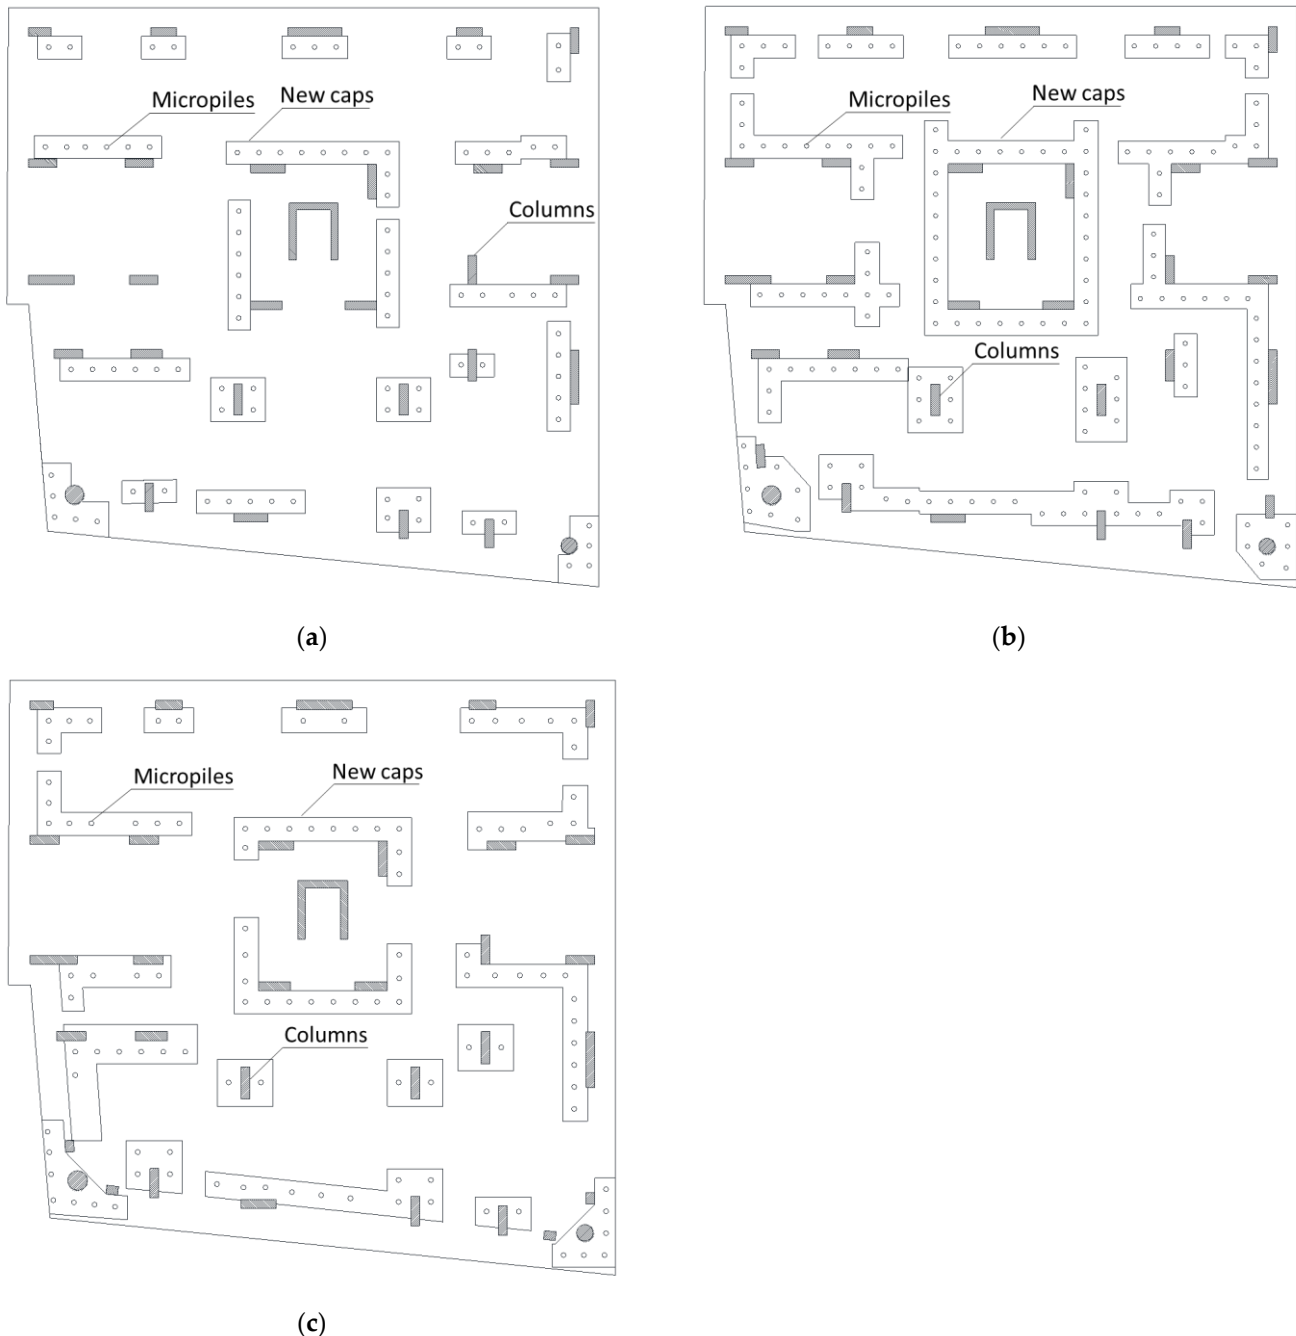
**Figure 6.** Layouts of the three proposed micropile configurations: (a) first approach, (b) second approach, and (c) third approach.

The total number of micropiles determined by this approach was 91, as illustrated in Figure 6a. Of the three configurations proposed, this approach estimated the lowest number of micropiles.

The total number of micropiles determined by this approach was 164, as illustrated in Figure 6b. Of the three configurations proposed, this approach estimated the greatest number of micropiles.

The total number of micropiles determined by this approach was 111, as illustrated in Figure 6c. Of the three configurations proposed, this was the one selected for the rehabili-

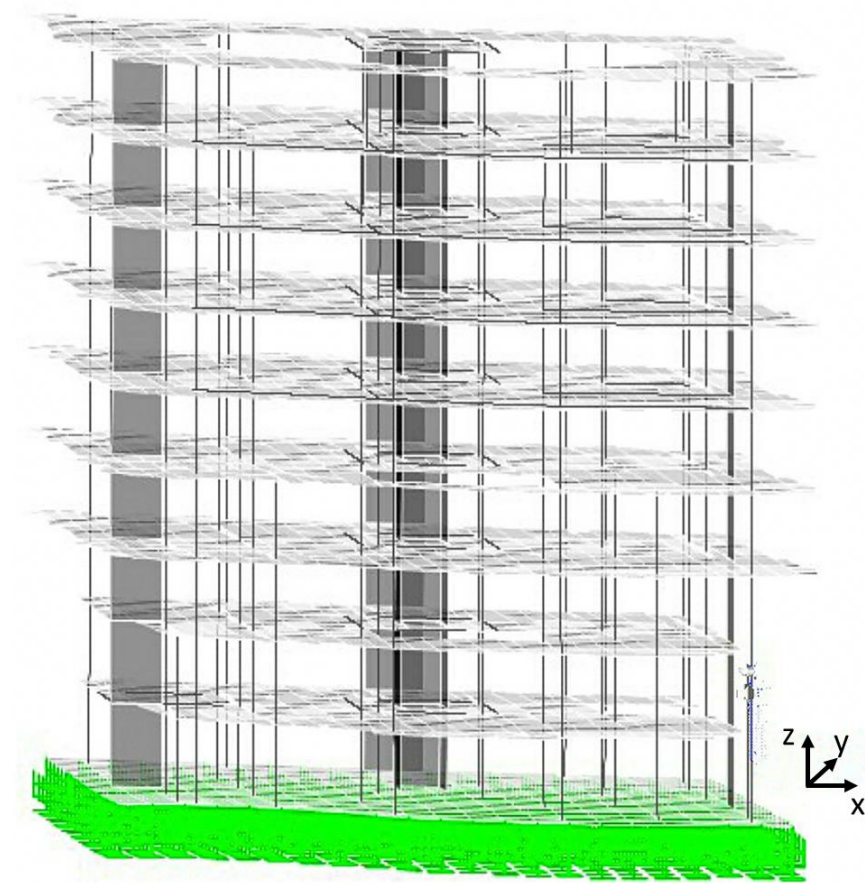
**Figure 7.** 3D finite element model of the tilted building developed by using ETABS.

3. In the model, the soil modulus of subgrade reaction was assigned. Moreover, a ground movement was input to represent the actual tilting of the building, as illustrated in Figure 7.

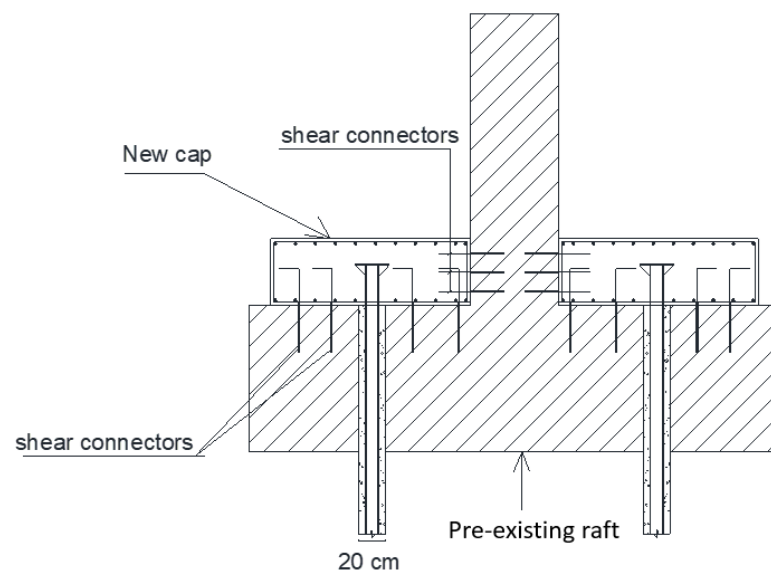
**Figure 9.** Sample cross-section of the micropiled raft.

Following completion of the installation of micropiles around a particular column, a reinforced concrete cap with a thickness of 400 mm was used to join the micropiles to the column and to the pre-existing raft. Vertical and horizontal shear connectors were utilized for this purpose. Figure 9 illustrates a sample cross-section of the micropiled raft, showing the pre-existing raft, a column, two micropiles 20 cm in diameter, a new reinforced concrete cap, and shear connectors.

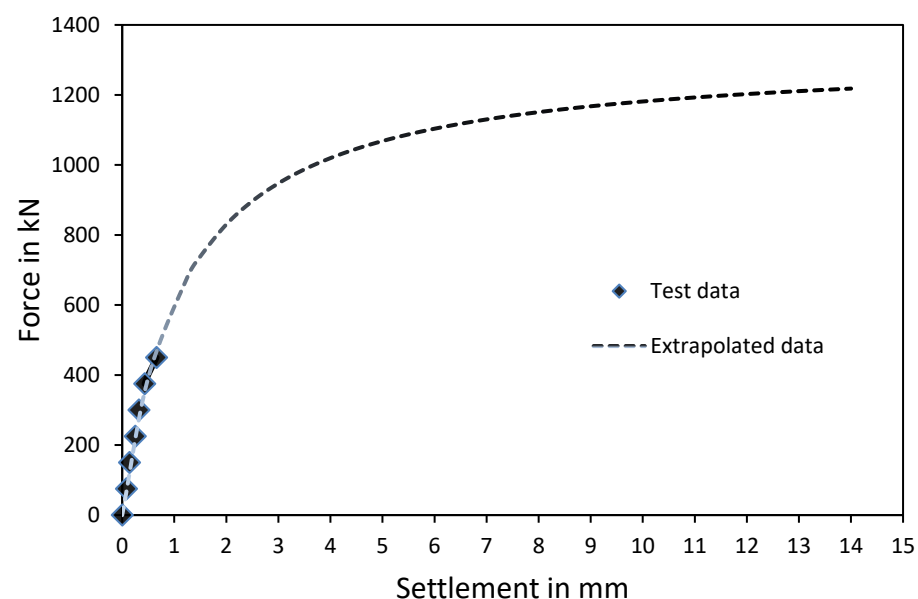
Figure 10. Load-settlement curve obtained from the micropile load test.

In order to confirm the actual micropile geotechnical capacity, a vertical static load test was conducted on one of the bearing micropiles. A test load of 450 kN was used, which caused a maximum settlement of 0.66 mm, as shown in Figure 10. Based on the authors' knowledge of micropile load tests, the behavior of the tested micropile was determined to be excellent. This could be attributed primarily to the grouting technique used for Type B micropiles, where grout is injected under high pressure, resulting in associated ground improvement. It should also be noted that the micropile used for testing was located in the northern half of the building, where the soil profile may be better than that observed in the initial investigation of the soil around the building. An analysis of the test results confirmed this advantageous micropile behavior and estimated the allowable static load to be 562 kN. This represented the average value obtained from the modified Chin and Brinch Hansen methods that are usually used to analyze pile load tests [27].
