# Seismic Retrofitting of Mid-Rise Unreinforced Masonry Residential Buildings after the 2010 Kraljevo, Serbia Earthquake: A Case Study

**Abstract:** There is a significant building stock of post-WWII low- and mid-rise unreinforced masonry (URM) buildings in Serbia and the region (former Yugoslavia). Numerous buildings of this typology collapsed due to the devastating 1963 Skopje, Yugoslavia earthquake, causing fatalities, injuries, and property losses, as well as experienced damage in a few recent earthquakes in the region, including the 2010 Kraljevo, Serbia earthquake ( $M_W$  5.5) and the 2020 Petrinja, Croatia earthquake (M 6.4). These buildings are three- to five-stories high, have clay brick masonry walls, and rigid floor slabs, usually with an RC ring beam at each floor level. This paper presents a case study of a URM building which was damaged due to the 2010 Kraljevo earthquake and subsequently retrofitted. A comparison of seismic analysis results, including the capacity/demand ratio and displacement/drift values, for the original and retrofitted building according to the seismic design and retrofit codes which were followed in Serbia as well as some of the neighboring co

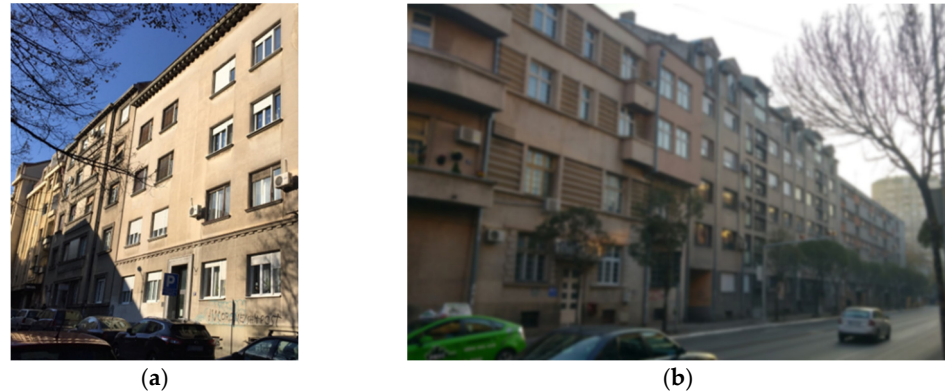
semi-prefabricated RC floor systems. Buildings of this type constitute a significant fraction of the building stock in urban areas of Serbia and neighboring countries and are the focus of this study. A few examples of typical urban URM multi-family residential buildings from Serbian cities Belgrade and Niš are shown in Figure 1a and Figure 1b respectively.

**Figure 1.** Examples of URM multi-family residential buildings in Serbian cities: (a) Belgrade and (b) Niš.

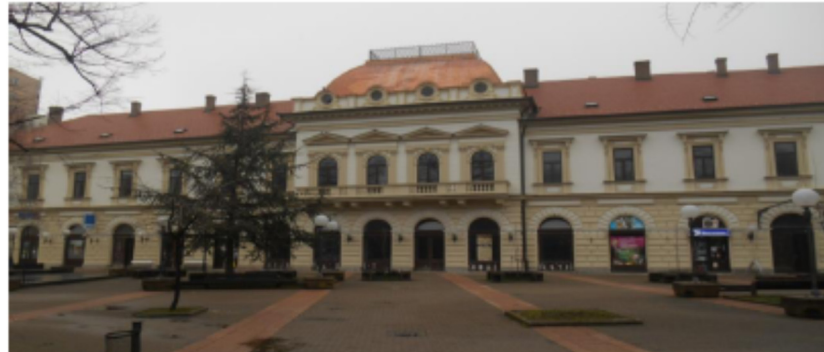
This approach was used to increase the seismic resistance of the Diocese in Pančevo, Serbia, an existing URM building of cultural and historical importance which was constructed in 1832 (Figure 9) [63]. Loadbearing URM walls were 62 cm thick and were constructed in lime mortar. Due to earlier interventions, significant portions of load-bearing walls were removed and openings were formed in transverse walls (shown in solid red

**Figure 9.** The Diocese in Pančevo, Serbia—a view of the front façade.

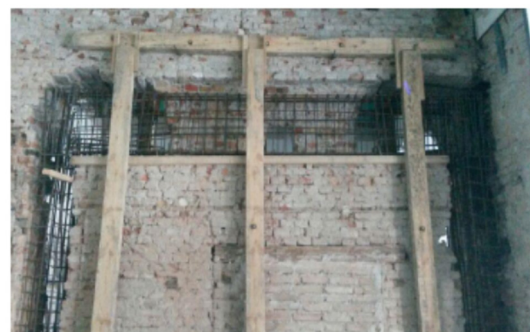
**Figure 11.** New RC frames were constructed as a part of the seismic retrofitting of the Diocese in Pančevo: (a) formwork and scaffolding arrangement and (b) frame reinforcement detailing.

In order to restore the lateral load-resisting capacity of the structure in the transverse direction, the width of new RC frames constructed at the locations of original walls was the same as wall thickness (Figure 10). RC beams were 72 cm high, while column dimension in the plane of the frame was 50 cm. Seismic analysis and design of new frames in the transverse direction at the ground floor level were carried out according to the PTN-S and PTN-R codes (and applicable codes for the design of RC structures). Figure 11a shows a scaffolding arrangement for transferring gravity loads from the upper floors to the ground, as well as reinforcement for the RC frame. Reinforcement detailing for a typical RC frame is shown in Figure 11b.
