# Seismic Assessment of the Archangeloi (Başmelekler) Church in Kumyaka, Türkiye

**Abstract:** This study describes the seismic assessment of the Archangeloi (Başmelekler) Church in Kumyaka (Sige), Türkiye. The Archangeloi Church is an important religious monument that has survived to the present day from the eighth century. Through field surveys, the structural system, damages and masonry texture were determined. Pushover analysis was performed with OpenSees software, which has an advanced nonlinear analysis capability. The Damage TC3D material damage model with advanced features was used, allowing a more stable and effective application of mixed implicit–explicit analyses. Displacement-based pushover analyses were performed with different control points, and the damage patterns, ultimate strength and strength reductions were obtained effectively. The pushover analysis reflected the structure’s expected behavior, especially its post-ultimate strength and failure patterns, owing to the material damage model’s advanced mixed implicit–explicit capacity. Kinematic analyses were performed to determine the overturning mechanisms. Due to the analysis assumptions and pre-assigned failure

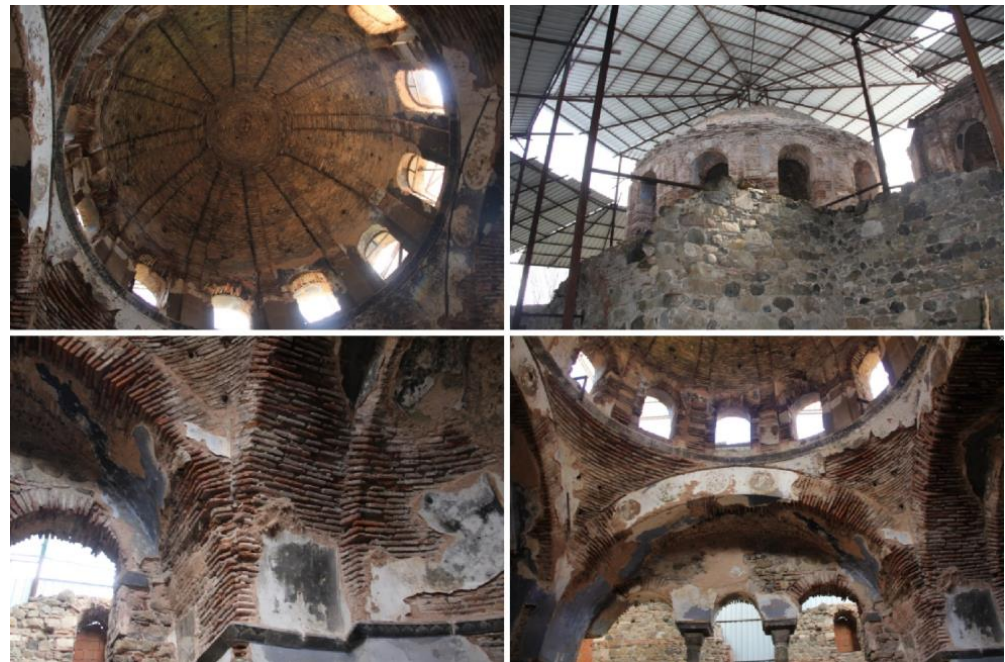
**Figure 5.** Views of domes, arches and pendentives at naos.

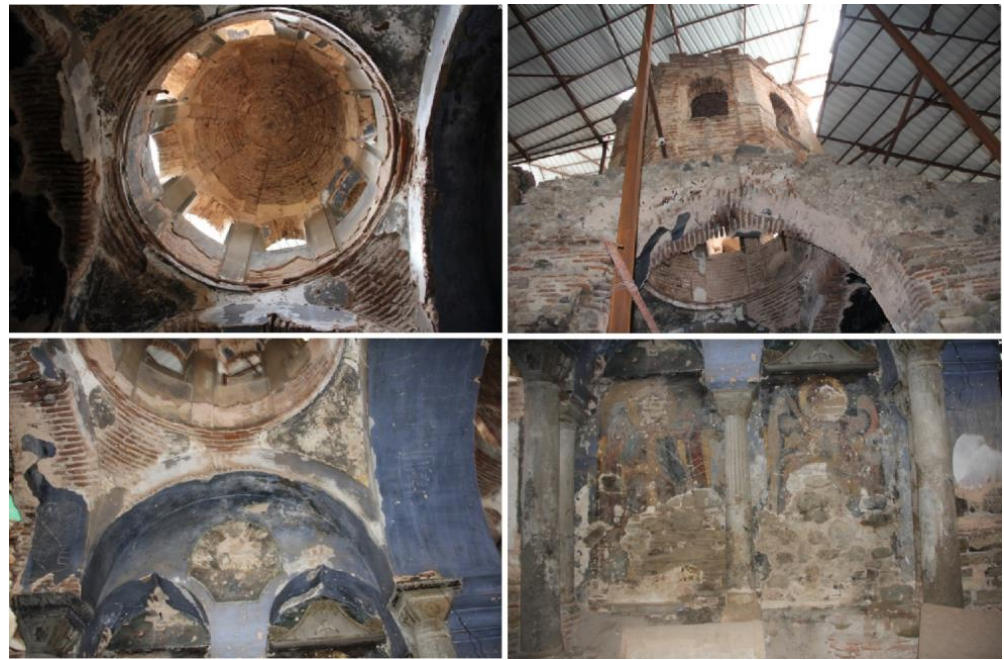
**Figure 6.** Views of domes, arches and pendentives at narthex.

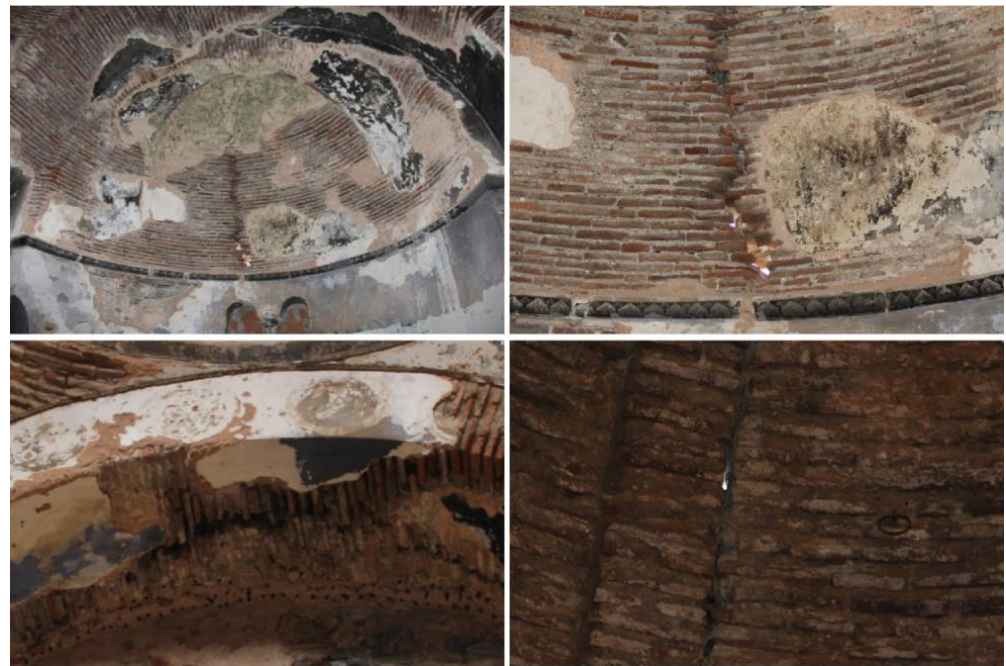
**Figure 7.** Cracks in the domes and arches.

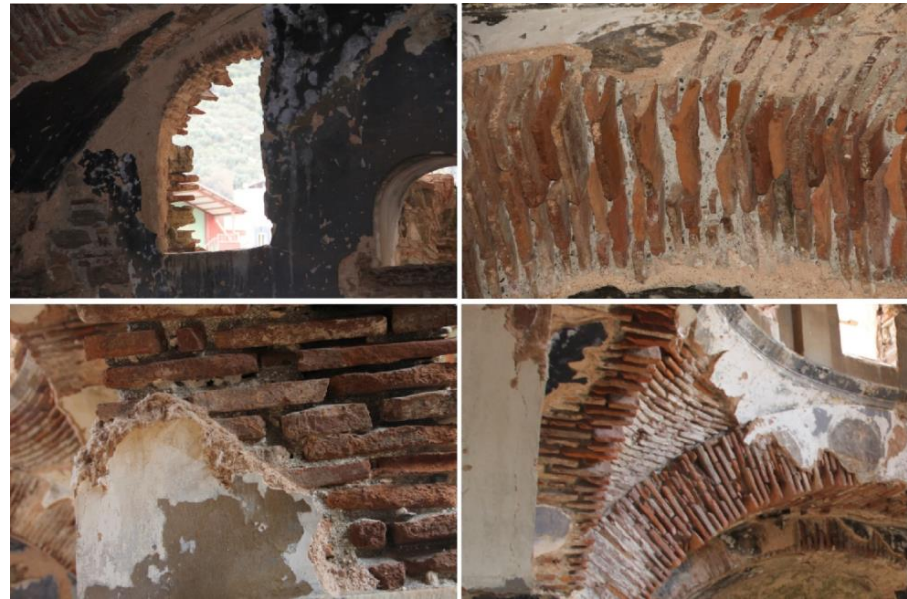
**Figure 8.** Damages and mortar losses in brick elements.

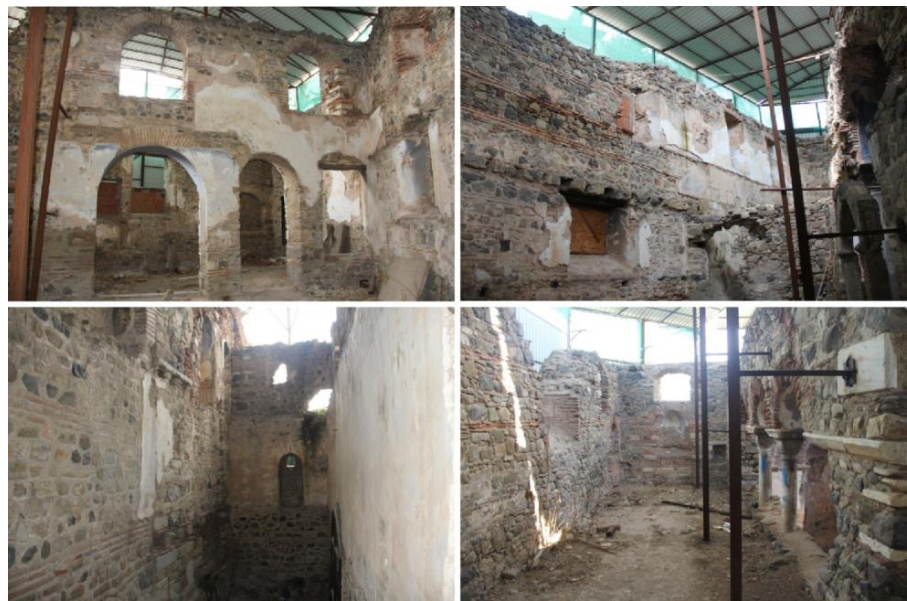
**Figure 9.** Views of West-South Narthex, St. Nikolaos Chapel and Haralambos Chapel.

Views from the St. Nikolaos Chapel, West Narthex, South Narthex, St. Haralambos Chapel and Healing Room locations are presented in Figure 9. In the current state, only the walls of these structures are left. The ruins of these walls have stone masonry. Losses in the cross-section area and joint mortars, severe cracks and excessive deterioration were found in these walls. It was observed that some of the timber bond beams on window openings have gone missing in time due to decay, and there is severe damage on those left. In some parts, the masonry pieces above the windows are also destroyed. Similarly, the wall parts behind the niches are damaged and opened. Some window and door openings were filled with dissimilar materials. The wooden beams inside the walls have been damaged due to

decay, and some of the beams have been lost. Partial interventions were made on some of the walls using different materials.
