Structural Assessment and Strengthening of a Historic Masonry Orthodox Church

Abstract: This study provides insight into the structural assessment, diagnosis, and strengthening of the medieval church of Tazlău Monastery in Piatra Neamț, Romania. The first part of the paper briefly presents the wider context of strengthening and preserving heritage churches and monastic buildings and describes the architectural setting and the structural features of the traditional Romanian Orthodox churches. The second part of the paper is a case study related to the rehabilitation of a medieval heritage church, which is the paramount building of a larger monastic complex. Erected in 1496, the church of the Nativity of the Blessed Virgin Mary closely follows the medieval traditional Orthodox patterns from both architectural and structural points of view. Structural assessment and diagnosis revealed that degradations were induced and developed throughout the life of the structure due to approximately 24 earthquakes (estimated at over 6.0 magnitude) having endangered the structural safety of the building and the mural iconography. After the structural diagnosis, a combined and complex method of stre

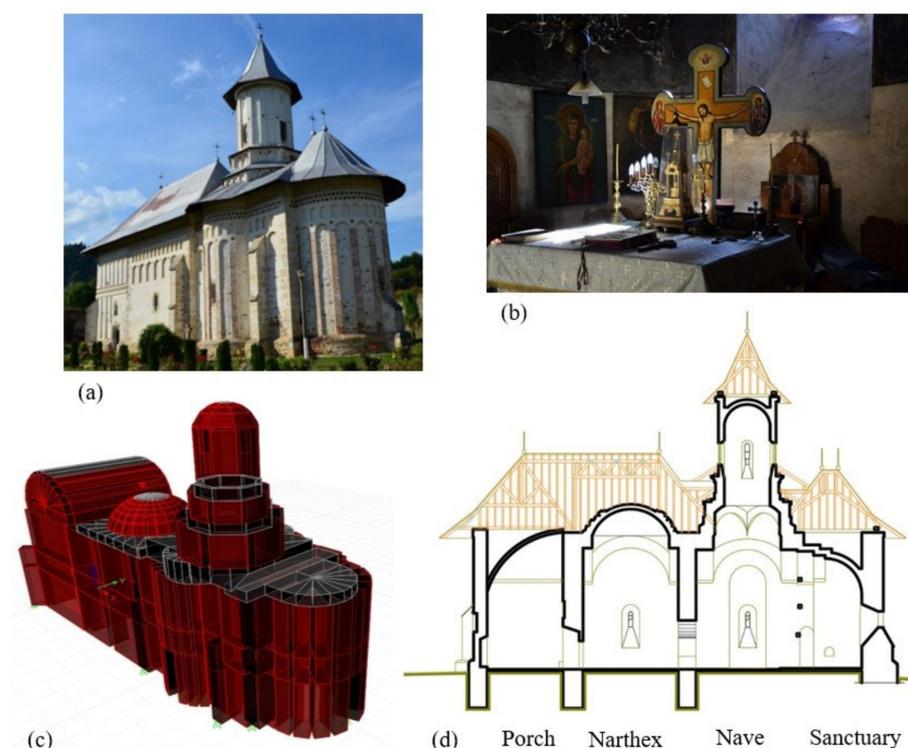
Figure 1. Tazlău monastery: (a) The church of the Nativity of the Blessed Virgin Mary of Tazlău monastery, (b) Sanctuary and altar table, (c) 3D model—*isometric view*, (d) *Longitudinal section and arrangement of spaces*.

An Orthodox Church building consists of three interconnected spaces: the narthex (and porch in some cases), nave, and Sanctuary, which, as a whole, represent the architectural setting for the Liturgy (Figure 1) [22,23]. These spaces are arranged along an axis that is aligned from west (the narthex and porch) to east (the Sanctuary). The narthex and the porch are usually separated from the nave through an internal wall. The nave is separated from the altar by a screen called iconostasis. Thus, from an architectural point of view, an Orthodox Church building is centered around the Sanctuary and, in particular, the altar table. The latter, from the religious point of view, symbolizes the mystical and eternal presence of the heavenly throne of God [24]. In Romania, the traditional monastery churches follow a unique pattern of being long and narrow, with only one apse that spans the entire width of the church and one roof characterized by a large overhang (Figure 1).

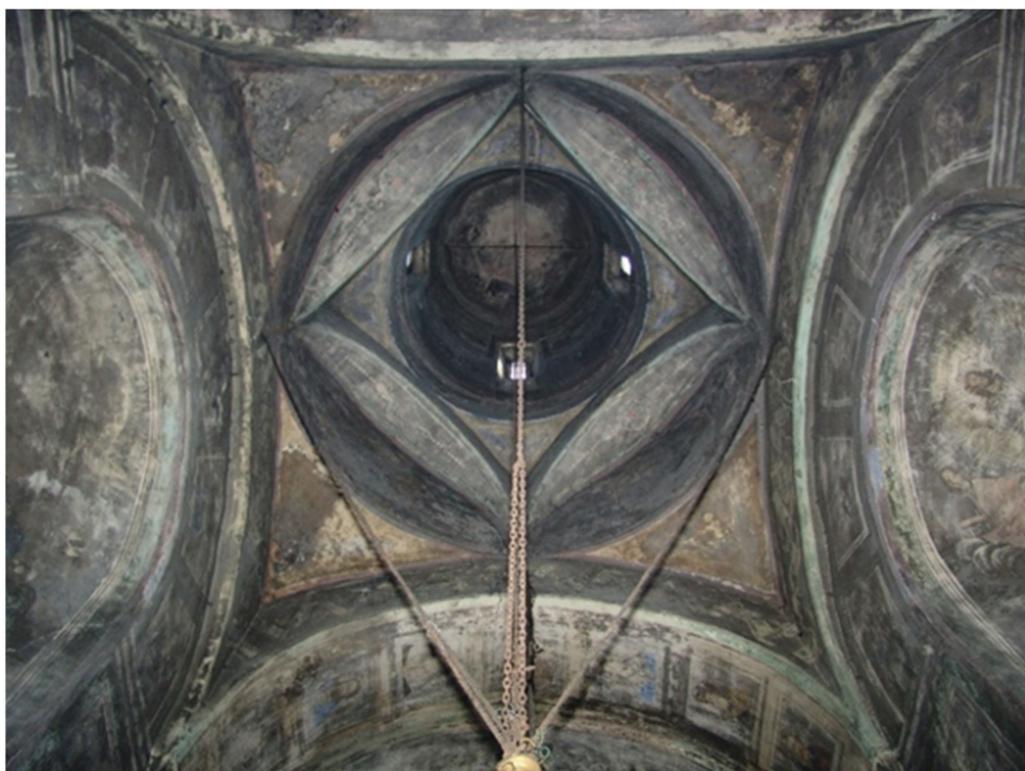
Figure 2. The interior of the tower, perspective at the square-shaped and star-shaped bases.

The structural system of the church of the Nativity of the Blessed Virgin Mary, erected between 1496 and 1497, consists of single-leaf, river stone masonry walls varying in thickness between 1.65 and 1.05 m [25]. The vaults are made of brick masonry in the form of a dome, which rests on stone pediments and arches. The church tower, which starts at the level of the nave dome, is made of brick masonry. This configuration proves that medieval craftsmen were aware of the seismic activity of the site, and they empirically designed a gradual transition between the rigid elements (stone walls) and the more flexible elements (brick masonry tower and vaults). The same gradual transition approach was adopted for the tower and the walls of the nave. Two consecutive horizontal bases were constructed, the first in a square-shaped pattern and the second in a star-shaped pattern (Figure 2).

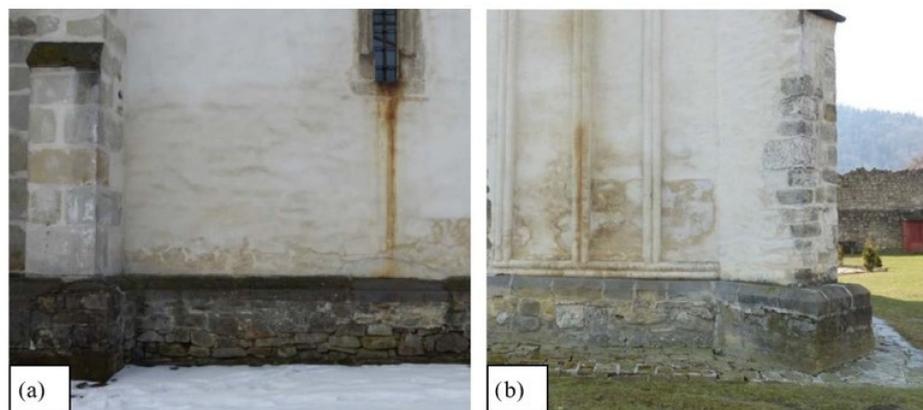
Figure 5. Examples of degradation patterns in the church of the Nativity of the Blessed Virgin Mary: (a) darkening due to rising damp in the façade, (b) salt efflorescence.

As a general rule, the uncontrolled presence of water is considered one of the most important factors that threaten heritage assets throughout the entire history of architecture [37,38]. In the case of the church of the Nativity of the Blessed Virgin Mary, it was observed that water had been absorbed from the ground through the phenomenon of capillarity due to the specific porous nature of stones and mortar (Figure 5) [39]. It is well

known that this process (referred to as rising damp) is harmful to all porous materials as it may favor the occurrence of frost-induced damage, making them vulnerable to additional degradation mechanisms, such as biological growth or wind erosion [40]. By visual observation, the church is deeply affected by rising damp, and at least two common degradation patterns occurred on the external surface of the walls, color change (darkening) (Figure 5a) and efflorescence (Figure 5b).
