# Resistance of Gable Structure of Nuclear Island to Progressive Collapse in Conventional Island Shield Building of Nuclear Power Plants

**Abstract:** The gable wall of the conventional island of a nuclear power plant carries various pipeline loads connecting the nuclear island and the conventional island. If the gable wall collapses and is damaged due to the progressive collapse of the main plant structure of the conventional island, it will directly threaten the safety of the nuclear island. Therefore, it is of great significance to systematically study the resistance of the gable structure of the nuclear island to progressive collapse for the safe operation of nuclear power plants. Based on the SAP2000 finite element analysis platform, this paper established a model of the reinforced concrete frame structure of the first span of the shield building on the conventional island of a nuclear power plant, including the gable. According to the alternate path method, the node displacement and bearing capacity responses were used to determine the critical components in the gable, and single column failures of the top four in importance were selected as different analysis conditions. No

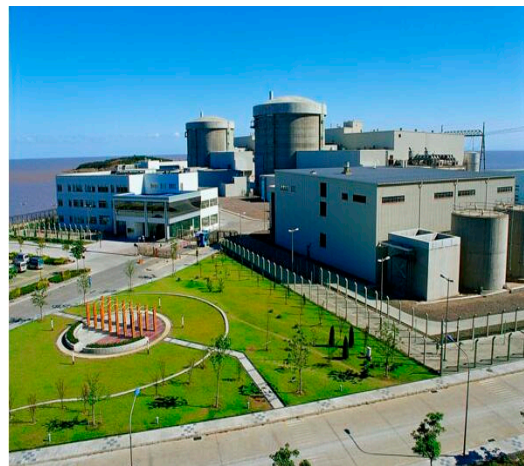
**Figure 3.** General layout of nuclear power plant.

Most of the above studies on progressive collapse resistance are based on common building structures, while those on nuclear power plants are rare. The nuclear island on the main plant side of the conventional island is closely linked to the gable (as shown in Figure 3), and there is an electrical plant near the gable. If the shield building of the conventional island progressively collapses, then the gable near the location is also very likely to collapse, directly causing damage to the nuclear island. Therefore, the collapse resistance of the gable near the nuclear island should be improved as much as possible, so as to ensure that the safety margin of the nuclear island can be relatively guaranteed even if the shield building of the conventional island collapses and is progressively destroyed under accidental action [29]. Based on this, this paper takes the gable structure of the nuclear island side of the shield building of the conventional island of a nuclear power plant as the research object for progressive collapse simulation. The study analyzes the nonlinear static and dynamic anti-progressive collapse abilities of the gable wall under four different working conditions, as well as the sequence of the hinge and internal force distribution, etc., providing a reference for the anti-progressive collapse design of the gable structure of the nuclear island side of the shield building of the conventional island of nuclear power plants.
