# Study on Impact Resistance of All-Lightweight Concrete Columns Based on Steel Fiber Reinforced and Various Axial Compression Ratio

**Keywords:** non-sintered fly ash haydites; all-lightweight concrete columns; axial compression ratio; steel fibers; mechanical properties for impact resistance

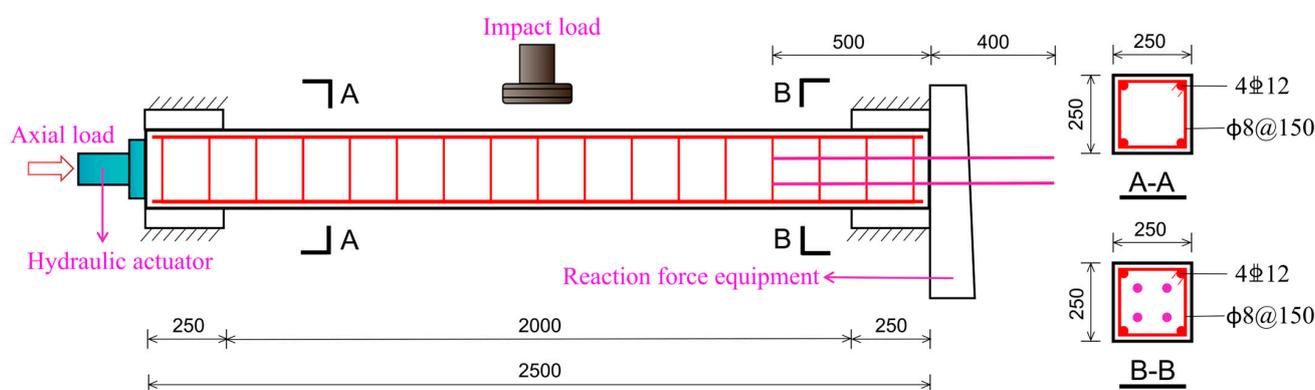
Figure 1. Reinforcement construction and dimensioning schematic for ALWC columns.

The design of the ALWC column's reinforcement structure and size follows the guidelines outlined in Code for Design of Concrete Structures [24]. Figure 1 illustrates the design of the ALWC column, while Table 1 presents the design parameters of the specimen. The specimen has a size of  $250 \times 250 \times 2500$  mm, is fixed at both ends, and has a net span of 2000 mm. Longitudinal reinforcement, symmetrically arranged on both sides, consists of 12 mm diameter bars. Hoop reinforcement, with an 8 mm diameter and spaced at intervals of 150 mm, is also included. The concrete has a protective layer thickness of 20 mm. Additionally, four anchoring bolts are embedded at one end of the specimen, with a depth of 500 mm.

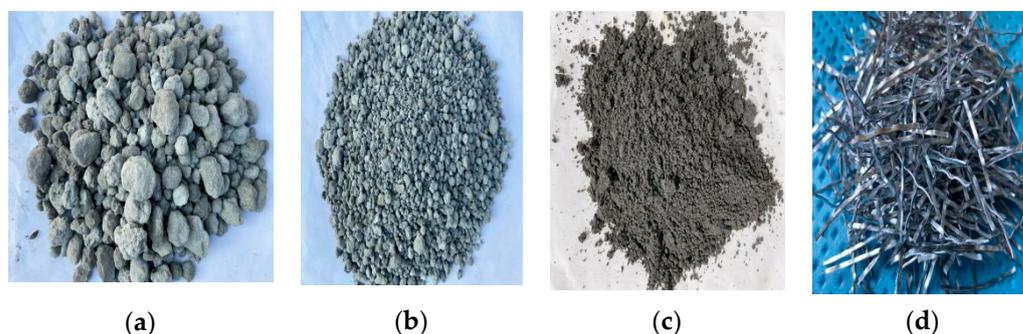
**Figure 2.** ALWC's main constituent materials are: (a) non-sintered fly ash ceramic granules; (b) non-sintered fly ash ceramic sand; (c) fly ash; and (d) shear wave steel fibers.

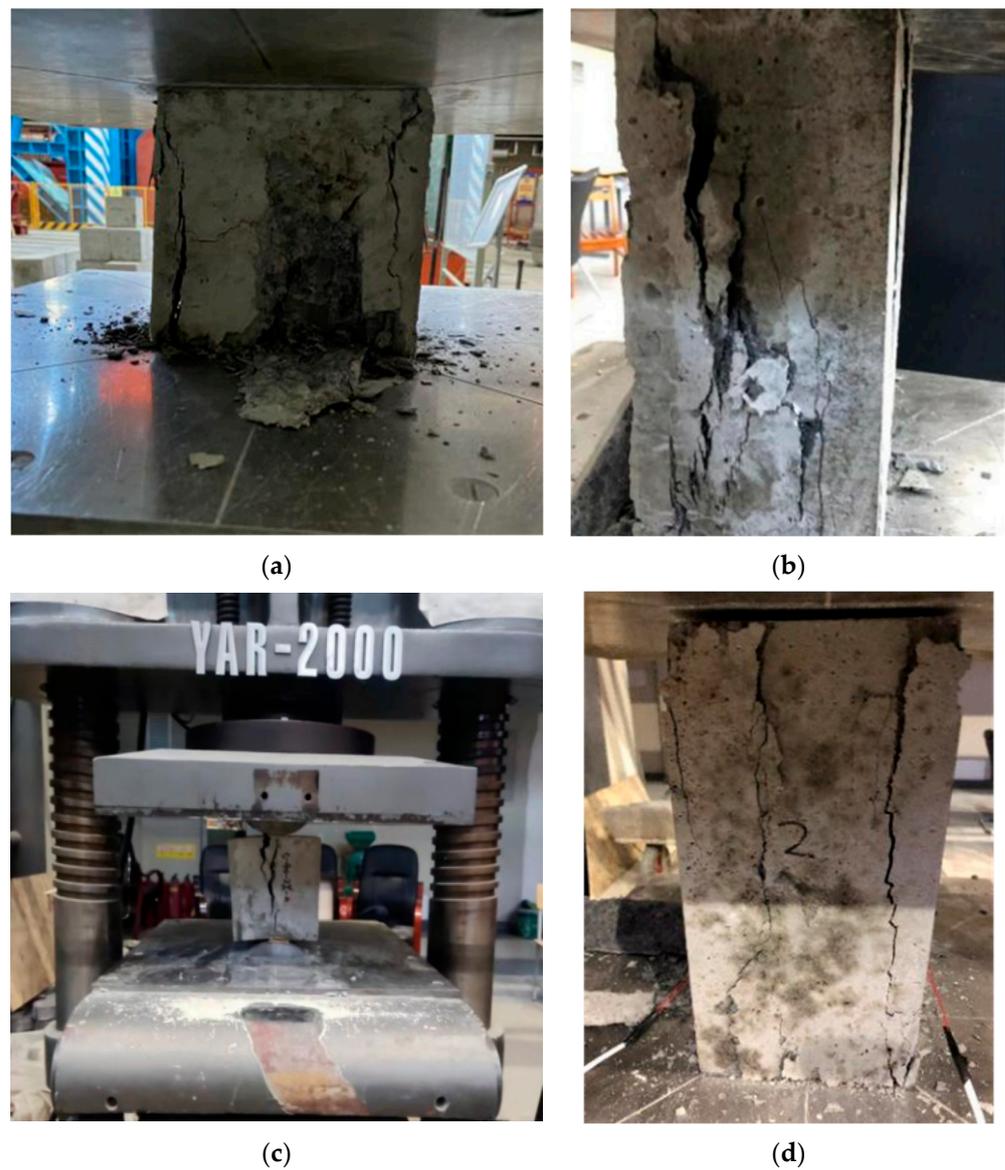
**Figure 3.** ALWC mechanical properties destruction phenomena: (a) cubic compressive strength test; (b) axial compressive strength Test; (c) split tensile strength test; (d) modulus of elasticity test.

A batch of cube specimens with a 150 mm side length and prism specimens with  $150 \text{ mm} \times 150 \text{ mm} \times 300 \text{ mm}$  size were poured while making ALWC column specimens. These specimens were cured under standard conditions for 28 days to determine their cubic compressive strength, axial compressive strength, splitting tensile strength, and modulus of elasticity. The test blocks were loaded using a 200 T electro-hydraulic servo universal testing machine with the loading rate set at 0.5 Mpa/s. Three experiments were conducted for each strength test, and the results were averaged. The damage phenomena of test blocks during loading are shown in Figure 3, and the strength test results of different test block types of ALWC are detailed in Table 5.

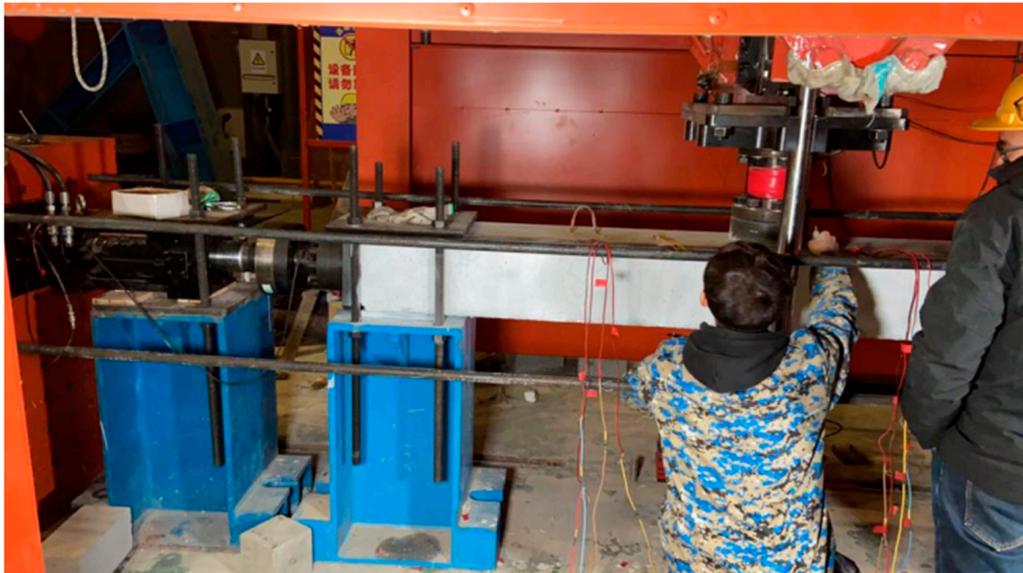
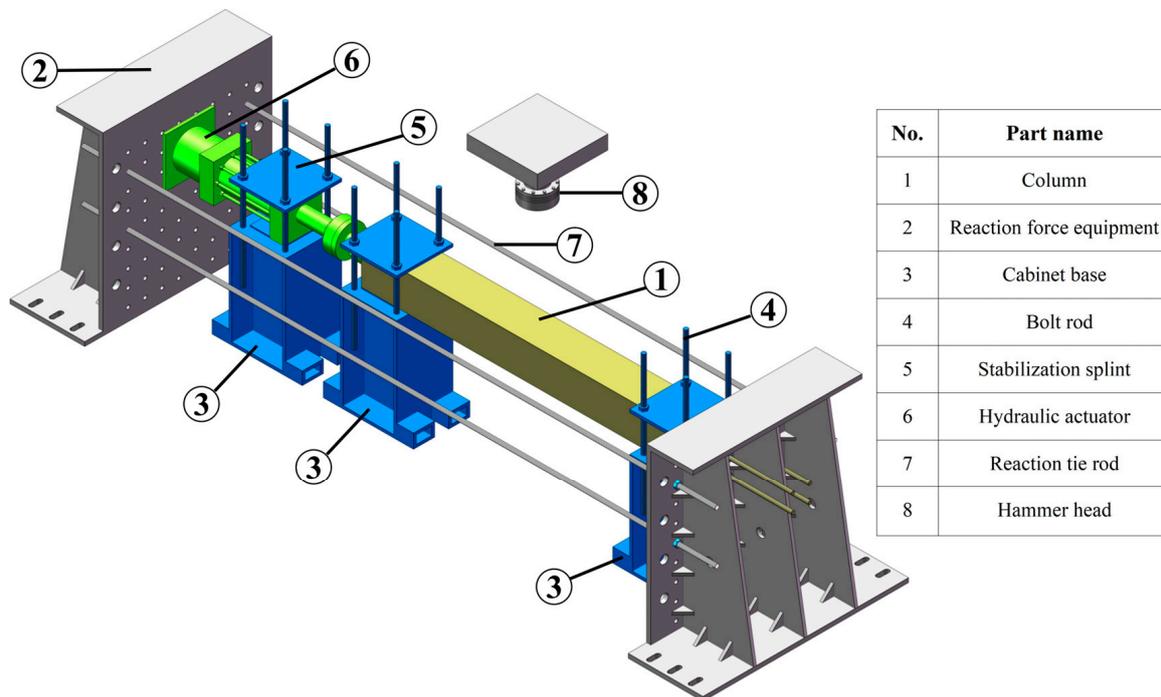
**Figure 4.** Schematic diagram of the impact test device: (a) arrangement of the device at the test site; (b) model diagram of the test device.

The experiment was conducted at the Structural Laboratory of Jilin Jianzhu University. The impact testing apparatus comprised four components: a drop hammer testing machine, a hydraulic actuator, a fixing device, and reaction force equipment, as depicted in Figure 4. The base of the hydraulic actuator was tightly integrated with the left-side reaction force equipment, applying an axial load to the left end of the specimen through the loading head. The bolt rod for anchoring the specimen penetrated the hole on the right side of the reaction force equipment and was secured at the back of the reaction force equipment with a nut. The specimen and hydraulic actuator were fixed and supported using a combination

of clamping plates and pedestals. The reaction force equipment was constrained by the ground anchor, and its upward displacement was restricted by four reaction tie rods, ensuring accurate application of the axial load and rebound of the specimen after impact.

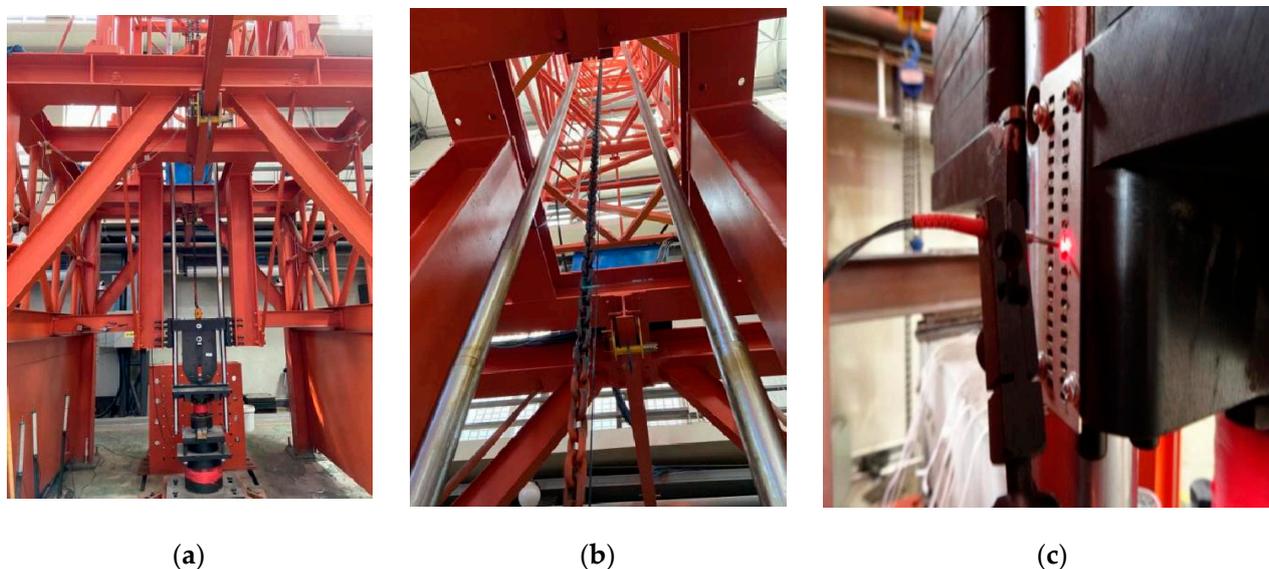
**Figure 5.** Drop hammer tester device: (a) hammer head; (b) guide rail; (c) infrared laser probe.

The falling hammer tester is shown in Figure 5. After the test begins, the grating reflector above the hammer head causes a change in the reflected signal when the infrared probe is routed, triggering the data acquisition system to record the strain signal generated by the impact. After the hammerhead makes contact with the column, the impact force is measured by the force sensor above the hammerhead. The data acquisition system is the NIPXI e-1006Q from NI, which is acquired by LabView Signal Express 2015 software with a sampling rate of 1 MHz.

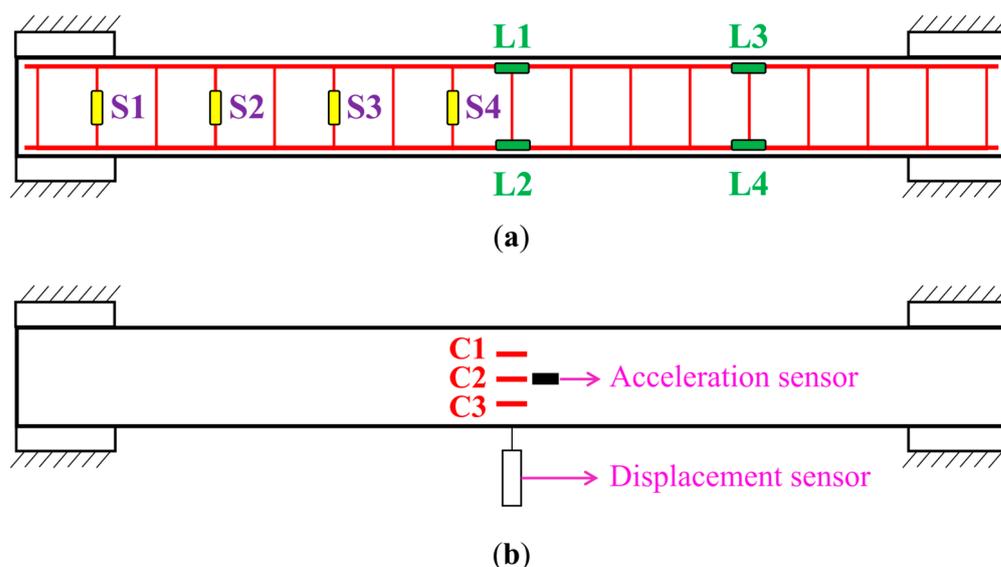
**Figure 6.** Layout of test points: (a) Layout of strain measurement points of reinforcement; (b) Layout of measurement points on the outer surface of concrete, acceleration transducer, and tie-bar displacement transducer.

The steel and concrete strain gauges, as well as the acceleration and displacement sensors, are arranged as shown in Figure 6. Among them, strain gauges S1~S4 are used to measure the hoop strain, strain gauges L1~L4 are used to measure the longitudinal reinforcement strain, and strain gauges C1~C3 are used to measure the concrete strain in the span. Acceleration sensors are arranged to the right of strain gauge C2 to measure acceleration changes. A pull rod displacement sensor is arranged at the bottom of the mid-span to measure the mid-span displacement.

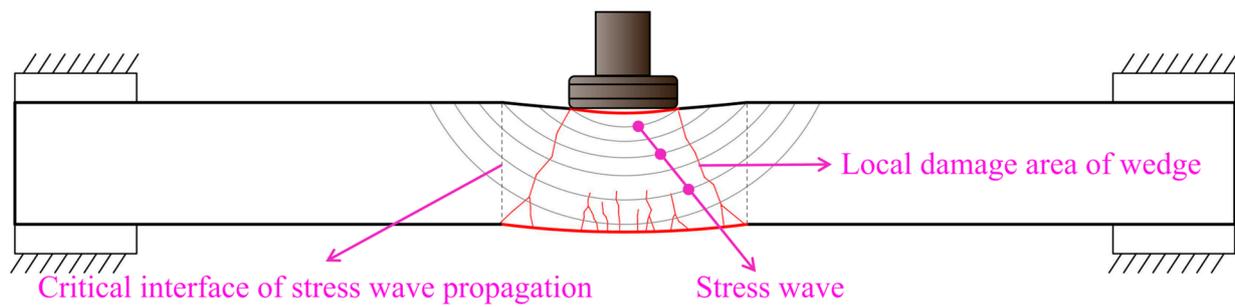
**Figure 8.** Diagram of stress wave diffusion morphology.

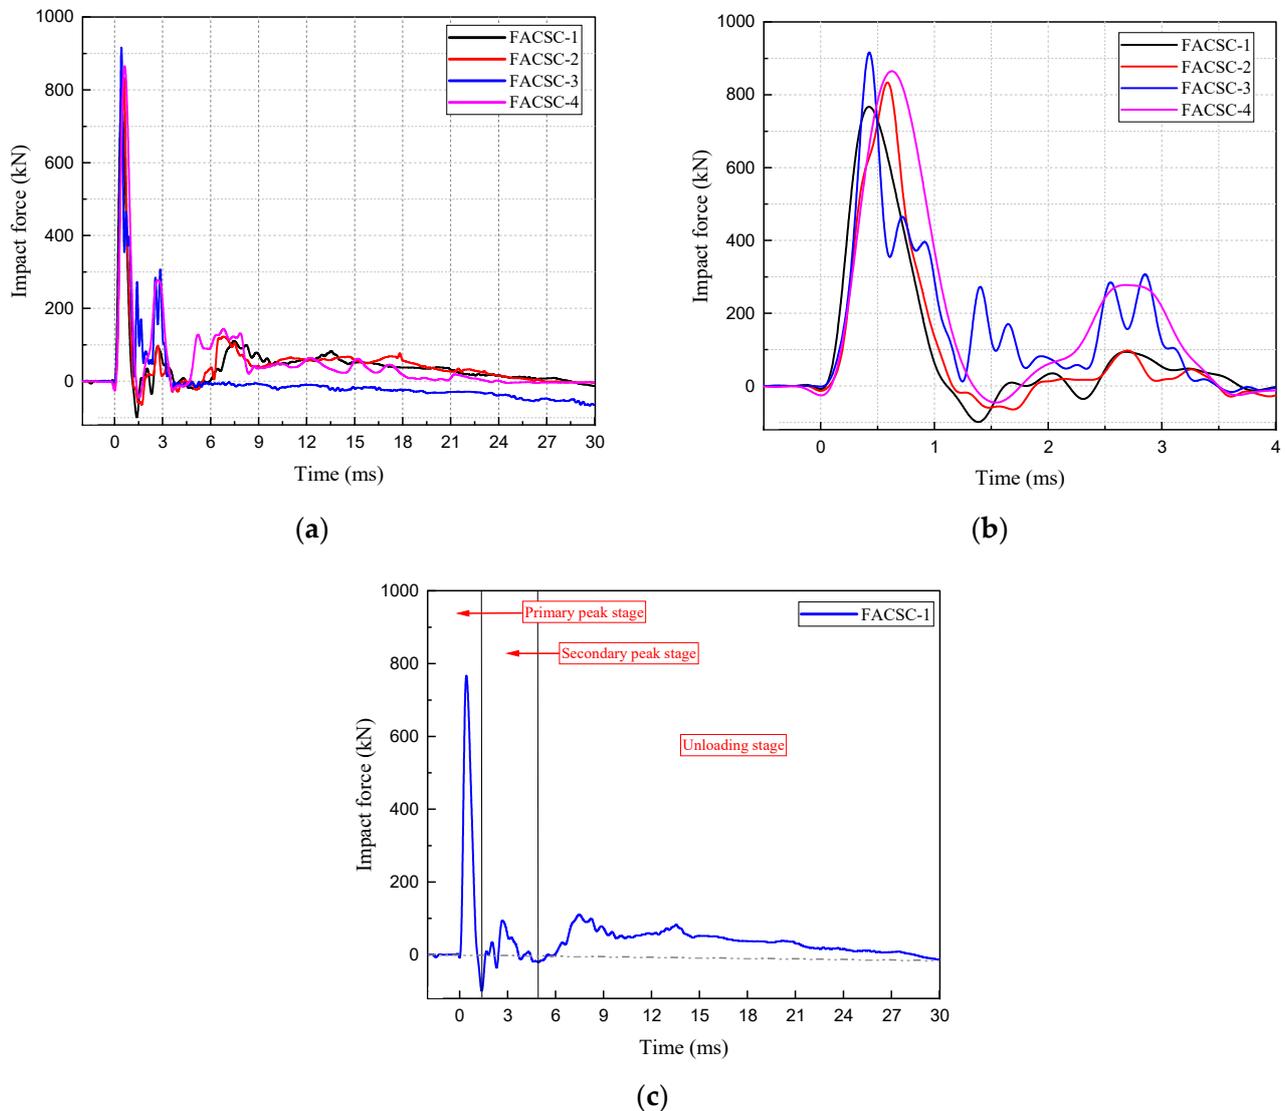
**Figure 9.** Impact time-course curves: (a) Impact time-course curves for all specimens; (b) localized magnification of the impact time-course curves from 0–4 ms; (c) impact time-course curves for specimen FACSC-1.

The time history curve of impact force can accurately reflect the specimen's response under impact load. Information on the strength, stiffness, and failure stage of the specimen can be obtained through this curve. Figure 9a shows the time history curve of the impact force of each specimen under impact obtained from the test, and Figure 9b is a partially enlarged view of Figure 9a from 0 to 4 ms. The specimen FACSC-1 was selected as a typical specimen, and it was observed that the curve development process was roughly divided into the primary peak stage, secondary peak stage, and unloading stage, as shown in Figure 9c. First, when the hammer touches the specimen for the first time, the impact can be released quickly, the impact force instantly climbs to its maximum, and the hammer and the cylinder accelerate downward together. Affected by inertial resistance, the contact between the hammer and the specimen will weaken rapidly and bounce up, and the impact force will drop sharply from the peak to 0, which is the primary peak section. Subsequently, a secondary peak section occurs, and the hammer falls again to contact the cylinder, resulting in a secondary peak. Finally, the hammerhead keeps contact with the cylinder and oscillates up and down, and the impact force gradually decreases and enters the unloading section.

The peak impact force reflects the stiffness of the local contact area between the hammer and the specimen. In general, the greater the stiffness of the specimen, the higher the stress level in the contact area, increasing the peak impact force. It can be observed from Figure 9 that under impact load, the specimens show a main wave pattern with a duration of about 1.5 ms and a secondary wave pattern with a duration of about 2.5 ms. It should be noted that the curve of the FACSC-3 specimen basically stops fluctuating at 3.6 ms and then develops in a horizontal straight-line state. The rest of the specimens stopped fluctuating in about 10 ms and descended in the form of a slow inclined straight line and dropped to 0 scales in about 30 ms, forming an unloading section of impact force. The specimen FACSC-3 stopped fluctuating at 3.6 ms, then decreased slowly and stabilized at a negative value. The main reason is that after the FACSC-3 specimen is impacted twice, the mid-span damage is serious, the contact position of the hammerhead is obviously bent, the center area of the round hammerhead is separated from the concrete, and only the edge of the hammer head is in contact with the length direction of the specimen, which forms a reaction force supporting both ends of the hammerhead, resulting in a negative value, which shows that the size and shape of the hammerhead will have an impact on the test results.

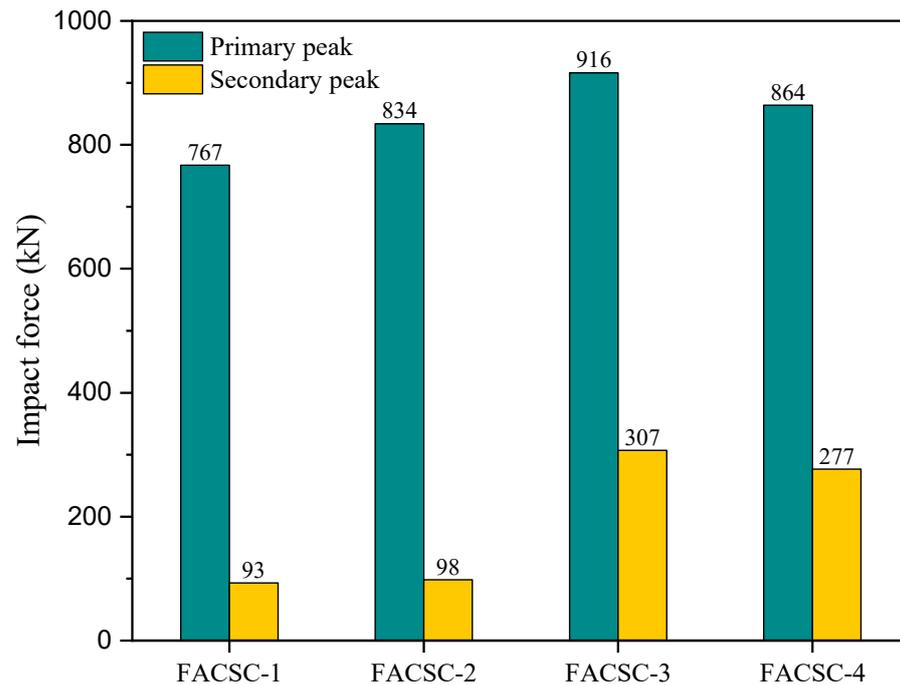
Figure 10. Comparison of primary and secondary peaks of ALWC columns.

The magnitude of the primary peak and the secondary peak of the four columns and their changing trends are presented in Figure 10, from which it can be seen that with the increase in the axial pressure ratio, the local stiffness of the contact area gradually increases, leading to a gradual increase in the primary peak of the impact force and showing a linear growth trend. When the axial pressure ratio is raised from 0.1 to 0.2, the primary peak of impact force is raised by 8.7%, and the secondary peak is raised by 3.2%; when the axial pressure ratio is raised from 0.2 to 0.3, the primary peak of impact force is raised by about 9.8%, and the rebound occurs in the decreasing section of the primary peak, where the impact force drops to the position of 354 kN, which is due to the large deformation of the specimen when it is subjected to the impact load. This deformation is stored in elastic or

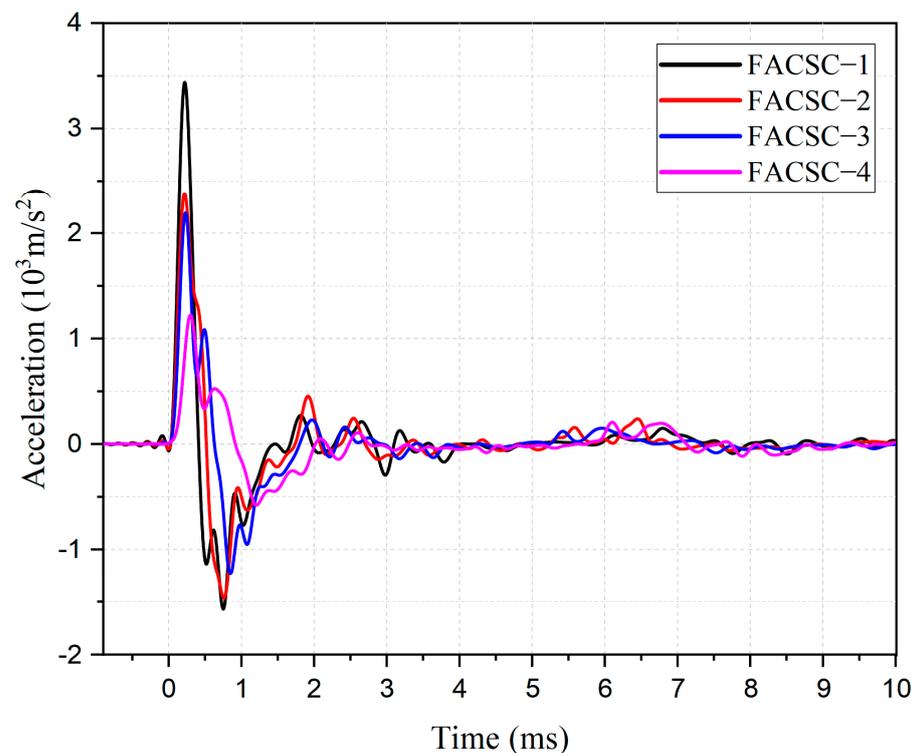
Figure 11. Acceleration time course curve.

Figure 11 shows the time-course curve of acceleration across the specimen collected by the accelerometer. The acceleration of the specimen rises rapidly from 0 scales and reaches its peak at 0.22 ms. After that, the specimen acceleration drops below the 0 scale and forms a negative peak with a long duration. During the negative peak time, the acceleration undergoes several oscillations and finally rises back toward the 0 scale.

Figure 11 shows that the specimens exhibit a nonlinear change in impact toughness at different axial pressure ratios. When the axial pressure ratio was increased from 0.1 to 0.2, the peak acceleration of the specimen decreased by 30.81%, indicating that increasing the axial pressure ratio could effectively improve the impact toughness of the specimen. However, when the axial pressure ratio was increased from 0.2 to 0.3, the peak acceleration of the specimens decreased by 8.4%, which was significantly smaller, indicating that increasing the axial pressure ratio could improve the impact toughness of the specimens within a certain range. However, when a certain threshold was exceeded, the effect of increasing the axial pressure ratio on the peak acceleration of the specimens became less significant. It should be noted that this conclusion is only based on the data given, and more experimental data are needed to more accurately assess the magnitude of the effect of different axial pressure ratios on the impact toughness of the specimens.

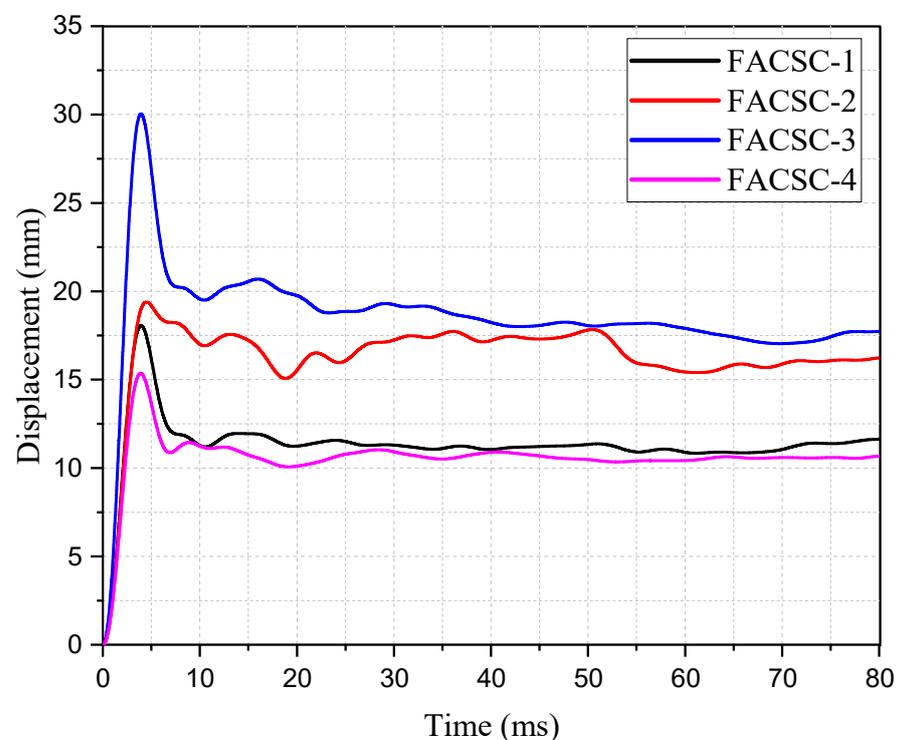
Figure 12. Mid-span displacement time course curve.

The curve of the spanwise displacement of the specimen obtained from the impact test with time is shown in Figure 12. The curve has the characteristics of sinusoidal development, which contains two parts: the peak displacement phase and the plastic deformation phase. The peak displacement phase reflects the specimen's maximum deformation amplitude when subjected to impact loading. The plastic deformation stage reflects the process of free vibration of the specimen after eliminating the external force relying on inertia.

According to the information in Figures 9 and 12, the peak displacement stage can be further divided into two stages: the elastic deformation stage and the transitional deformation stage. The specimen shows a local response mode in the primary peak stage

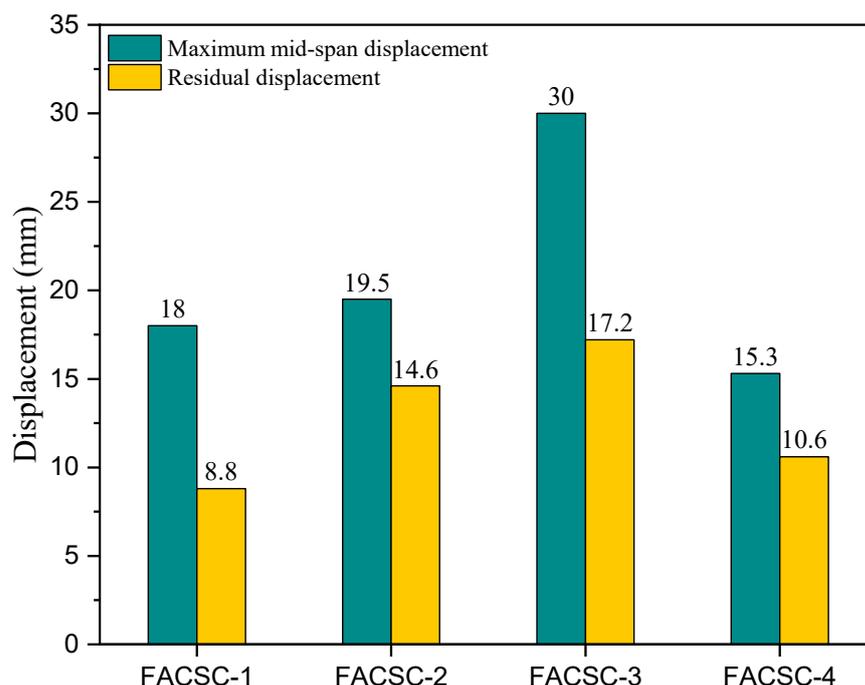
**Figure 13.** Comparison of maximum and residual displacements in the mid-span.

The data in Figure 13 shows that when the axial pressure ratio increases from 0.1 to 0.2, the maximum displacement in the span increases by 8.3% and the residual displacement increases by 65.9%; when the axial pressure ratio increases from 0.2 to 0.3, the maximum displacement in the span increases by 53.8% and the residual displacement increases by 17.8%. The results show that the maximum displacement in the span increases nonlinearly with the increase of the axial compression ratio. From the damage morphology of the specimens, the overall damage in the net span range of FACSC-2 is serious. In contrast, the damage of FACSC-1 and FACSC-3 is biased toward the local damage in the span. This may be the main reason for the large amplitude of curve oscillation of specimen FACSC-2 and the difficulty in recovering toward the pre-deformation.

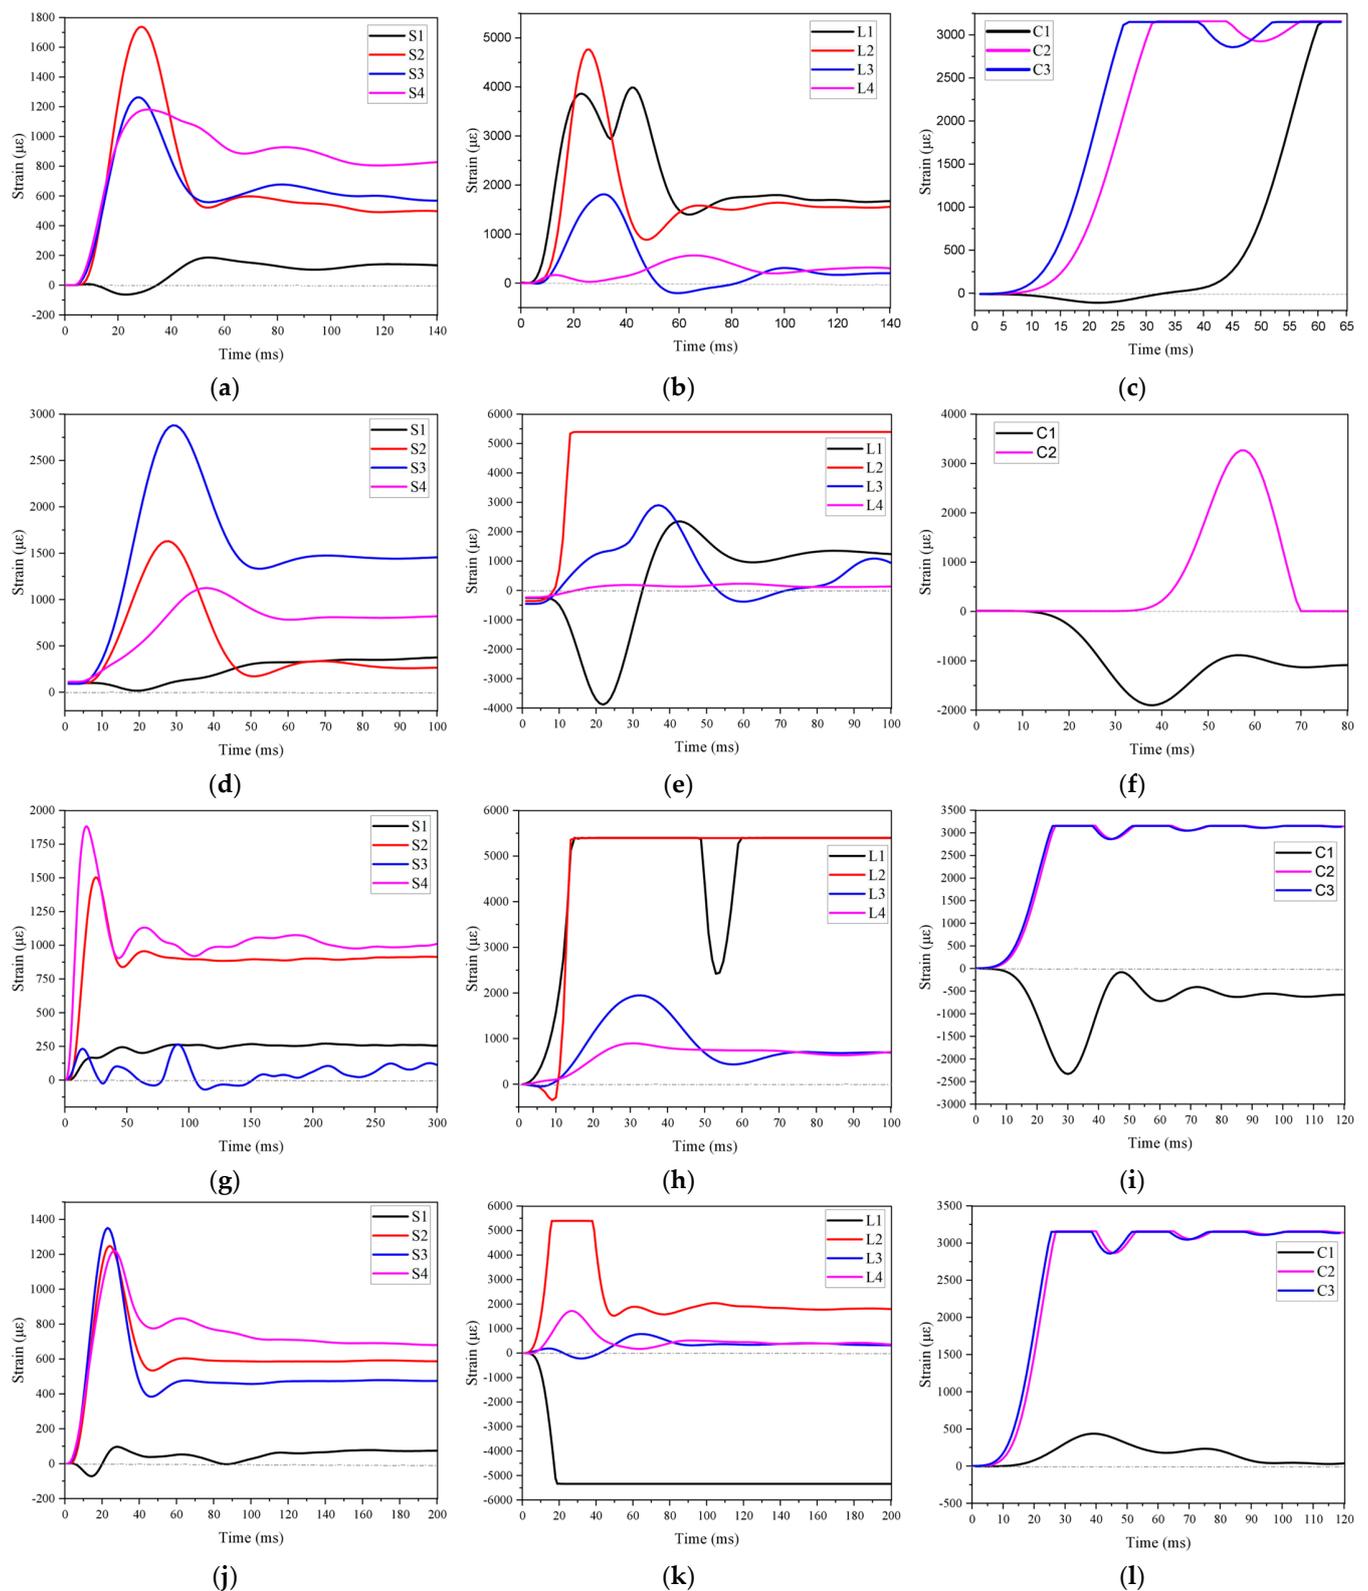
**Figure 14.** The strain curve of steel bar and concrete: (a–c) is the dynamic strain time history of specimen FACSC-1; (d–f) is the dynamic strain time history of specimen FACSC-2; (g–i) is the dynamic strain time history of specimen FACSC-3; (j–l) is the dynamic strain time history of specimen FACSC-4.

The steel and concrete strain curves are shown in Figure 14. Positive values indicate tension and negative values indicate compression. Because the drop hammer impact test is a rapid loading test method, a large amount of energy will be released in a very short time, causing a large impact load on the specimen, and the strain at the location of the strain gauge will increase sharply, which may lead to the failure or failure of some strain gauges.

By observing Figure 14, it can be found that when subjected to impact, the stirrup bears transverse shear stress, and the longitudinal steel bar shares the overall bending formed by the impact load through tension and compression. The strain value of the longitudinal steel bar is much higher than that of the stirrup. In addition, due to the greater compression and shear stress on the concrete at the mid-span, the strain of the longitudinal reinforcement in this area is more significant. By comparing the changes in the stirrup strain of the specimen, it is found that with the increase of the axial compression ratio, the stress distribution of the concrete inside the specimen will gradually shift to the mid-span position, resulting in the strain value of the stirrup on the cross-section of the specimen gradually increasing to the mid-span.

Observations from Figure 14 indicate the occurrence of a significant stress surge in the longitudinal strain gauges L1 and L2 during the initial loading phase of the experiment. Even at the conclusion of the impact force, both L1 and L2 exhibit considerable residual strain, signifying substantial yielding and plastic deformation in the longitudinal reinforcement at these respective locations. Conversely, the residual strain in strain gauges L3 and L4 is exceedingly small, even approaching zero.

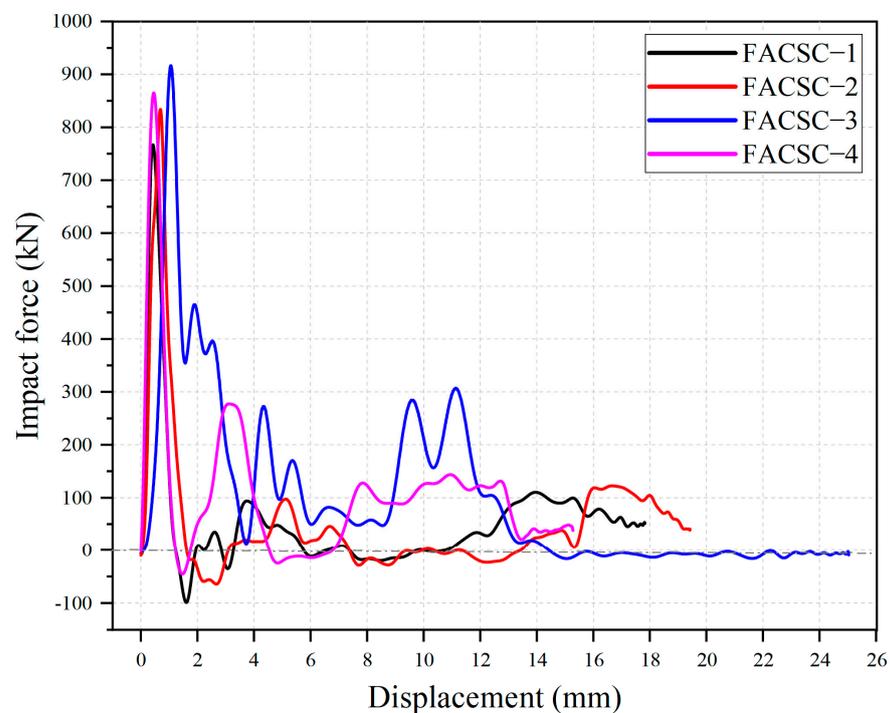
**Figure 15.** Displacement-impact force curve of ALWC columns.

Figure 15 illustrates the displacement-impact force curve of the specimen under impact load. Among them, the horizontal coordinate indicates the specimen displacement, and the vertical coordinate indicates the impact load applied. The envelope area of the impact force-displacement curve is the work performed by the impact load, i.e., the energy  $E_p$  absorbed by the deformation of the specimen during the whole impact process. By integrating the displacement-impact force curve through Equation (2), the specimen's deformation energy dissipation characteristic curve can be obtained, referred to as the energy dissipation curve in the following, as shown in Figure 16. Equation (2) in  $F(y)$  indicates the impact force at displacement  $y$ , and  $y$  is the displacement of the specimen. Figure 17 shows the magnitude of energy absorbed by the specimen.

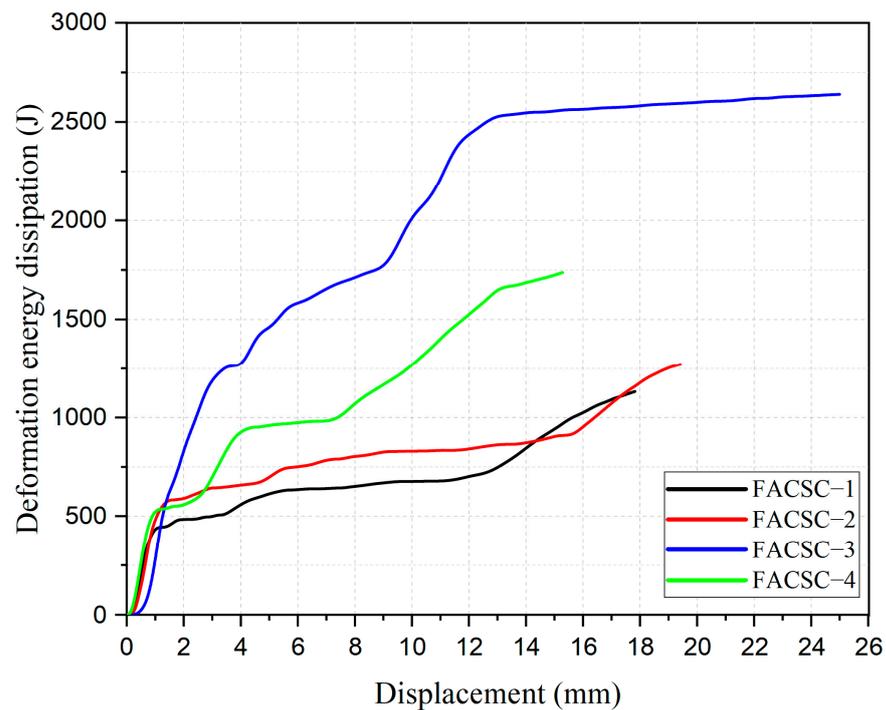
Figure 16. Deformation energy dissipation characteristic curve.

Based on the energy dissipation curves shown in Figure 16, the deformation energy dissipation curves for axial compression ratios of 0.1 and 0.2 show similar trends and develop in a parallel fashion. Specimens FACSC-1 and FACSC-2 show a higher slope of the energy dissipation curve at the early stage of deformation (elastic deformation stage) when the specimen's stiffness is higher and can consume more energy. At the deformation of specimens FACSC-1 and FACSC-2 to 1.08 mm and 1.45 mm, respectively, the slope of the energy dissipation curve decreased significantly due to the accumulation of damage and the reduction of stiffness of the specimens. At this time, the deformation energy dissipation of specimen FACSC-1 is 439 J, while that of specimen FACSC-2 is 577 J. The difference between them is 138 J. When the specimen reaches the maximum deformation, the deformation energy dissipation of specimens FACSC-1 and FACSC-2 are 1132 J and 1272 J, respectively, and the difference is 140 J. Thus, it can be seen that the increase of axial compression ratio from 0.1 to 0.2 The deformation energy of specimen FACSC-1 and FACSC-2 is 1132 J and 1272 J, respectively, with a difference of 140 J. Thus, the increase of the axial compression ratio from 0.1 to 0.2 only significantly improves the initial deformation energy.

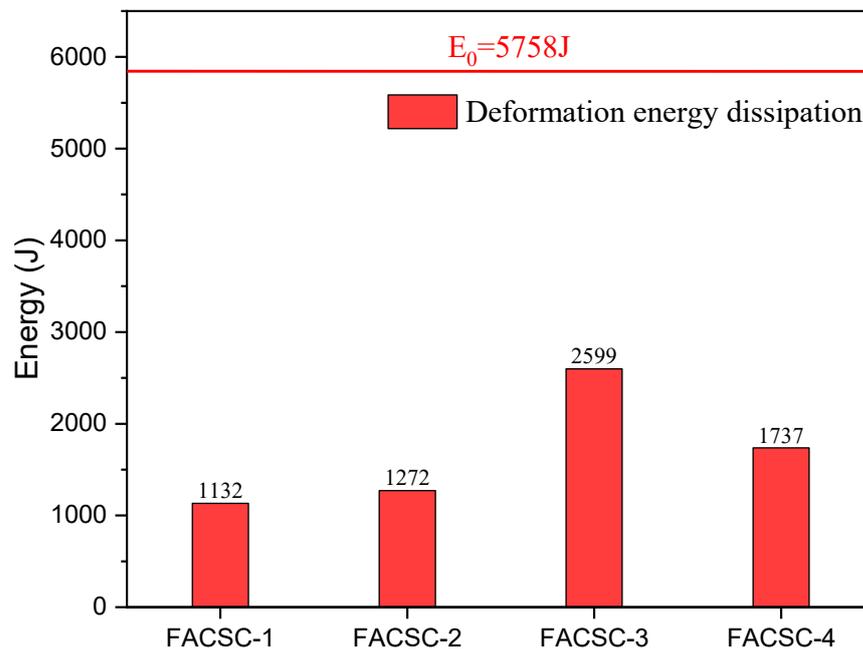
Figure 17. Characteristic value of deformation energy dissipation of ALWC columns.

When the axial compression ratio is 0.3, the energy consumption curve keeps a high slope trend in the 0–13 mm deformation range. As shown in Figure 17, the deformation energy consumption of specimens FACSC-1, FACSC-2 and FACSC-3 is 19.66%, 22.09% and 39.23% of the initial impact energy  $E_0$ , respectively. Among them, the deformation energy consumption of FACSC-2 was increased by 12.37% compared with FACSC-1, and the deformation energy consumption of FACSC-3 was increased by 104.32% compared with FACSC-2. The experimental results indicate that by increasing the axial compression ratio, the column relies more on deformation to consume the impact energy.
