# Experimental Analysis of Watertightness Performance of Interfaces between Masonry and Steel Structures Subjected to Accelerated Aging

**Abstract:** Steel buildings often experience failure at the interfaces between their vertical exterior enclosure systems (VEESs) and structural elements. This phenomenon generates various pathological manifestations in steel buildings, resulting in the precocious decay of the structure and the diminishment of its service life. The treatment of these interfaces is essential for ensuring their proper performance and watertightness, and to protect the durability of the steel structure. This paper proposes a method for treating common interface joints between masonry and steel structures with the application of an EPDM (ethylene propylene diene monomer) elastomer membrane. The main goal of this building technique is to ensure the durability and watertightness of the interface's joints when they are subjected to aging triggered by heat exposure and thermal shock. The experimental models tested consisted of a steel frame and a conventional masonry vertical enclosure system with ceramic blocks plastered with cement mortar. The models were subjected to

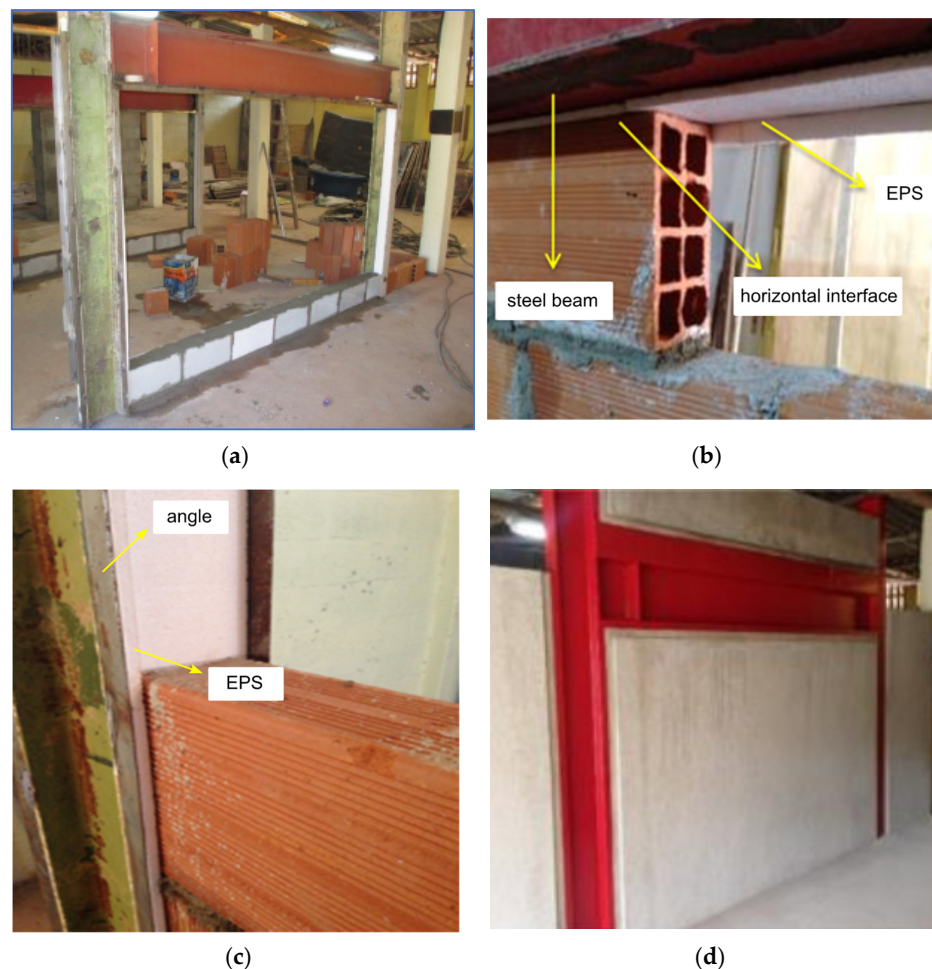
Ceramic blocks with dimensions of  $9 \times 19 \times 29$  cm (Figure 10) were employed in the construction of the experimental model.

**Figure 10.** Constructing the experimental model: (a) steel frame overview; (b) masonry placement in relation to the horizontal joint; (c) masonry placement in relation to the vertical joint; (d) appearance of the model before treating the joints between the masonry and the steel beam.

On the steel frame's columns and beams, steel angles and EPS were placed such as to allow the wall to move apart from the steel frame (Figure 10b,c).

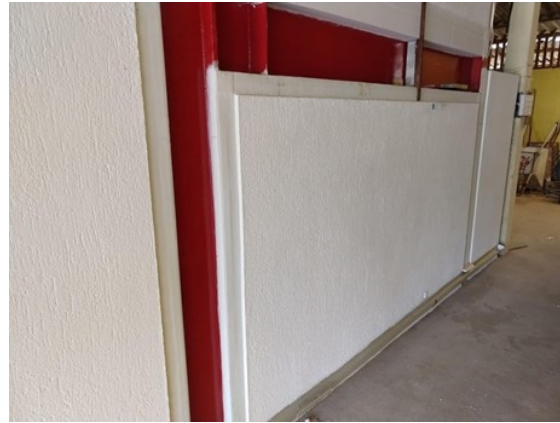
The outer wall of the experimental model received two coats of white acrylic paint. The region where the wall interfaced with the joint treated with the EPDM elastomer membrane was not painted, in order to preserve its characteristics without alteration after the heat exposure and thermal shock test. Figure 13 displays the general appearance of the model after its external surface was painted.

**Figure 13.** General appearance of the wall after its external surface was painted.

The purpose of this procedure was to seal any cracks that might exist in the masonry's mortar coating, preventing potential water leaks through the surface of the wall that would interfere in the evaluation of the interfaces' watertightness performance.

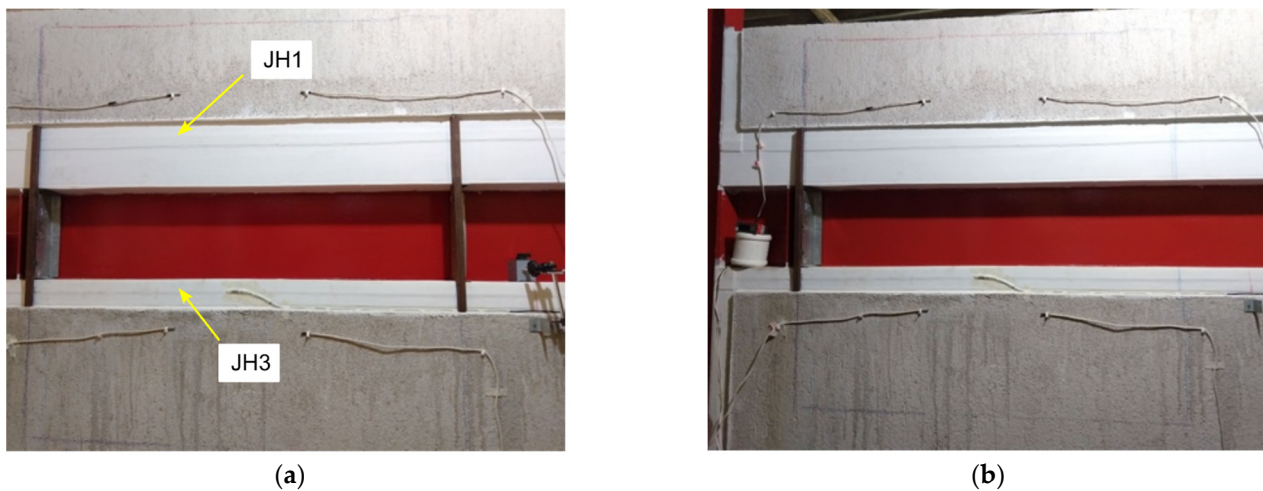
In Figure 19, the appearance of interface INT2 of specimen E2 can be observed before and after the heat exposure and thermal shock test. No damage was detected in the outer

face of the region around interface INT2 in either specimen. In the region of the joints treated with the EPDM membrane, no alterations could be detected with the naked eye.

**Figure 19.** Appearance of interface INT2 in specimen E2: (a) before the heat exposure and thermal shock test; (b) after the test.

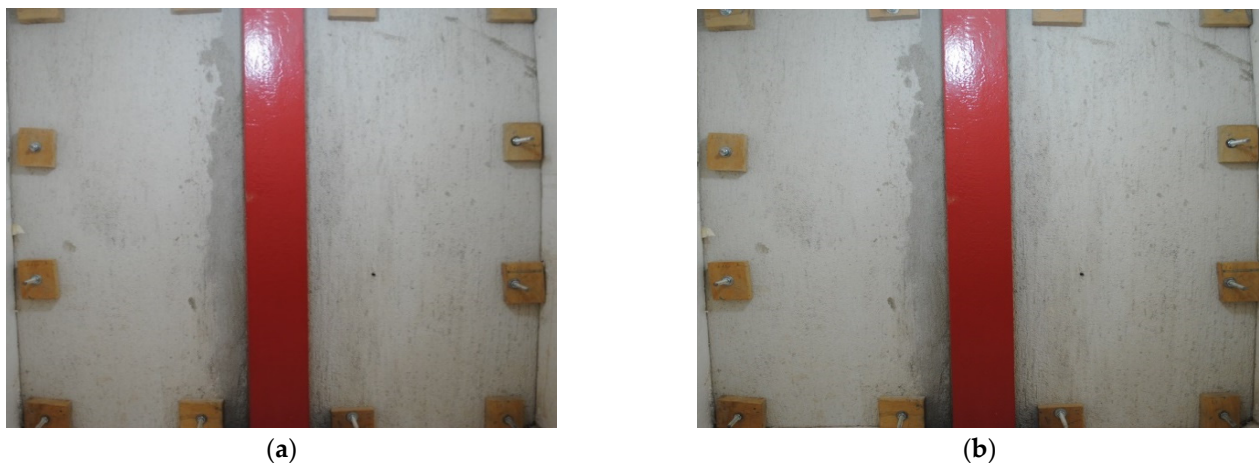
The results obtained in the watertightness test conducted using the three common types of interface showed that no humidity stains could be found on the inner face of any of the specimens, even after the continuous application of a pneumatic pressure of 400 Pa for eight hours. Figures 25–27 display the specimens' inner faces at the beginning and end of the watertightness test.

**Figure 25.** Appearance of the INT1 specimen's inner face before and after the watertightness test: (a) before; (b) after.

Moreover, no evidence of water leaks was found on the specimen's inner face after a visual evaluation of the tested areas. This result suggests that painting the specimens with acrylic paint prevented water from penetrating through possible existing cracks in the mortar coating, and that no water passed through the joints that had been treated with an EPDM elastomer membrane.

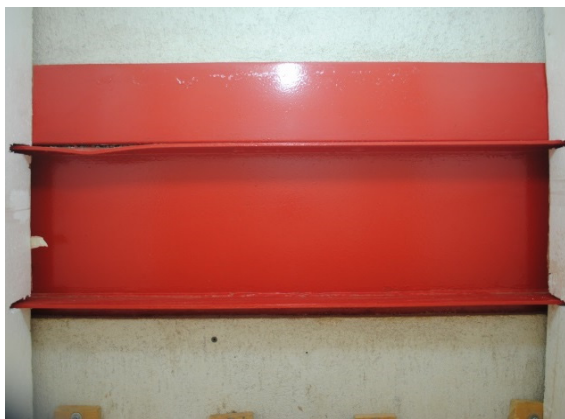
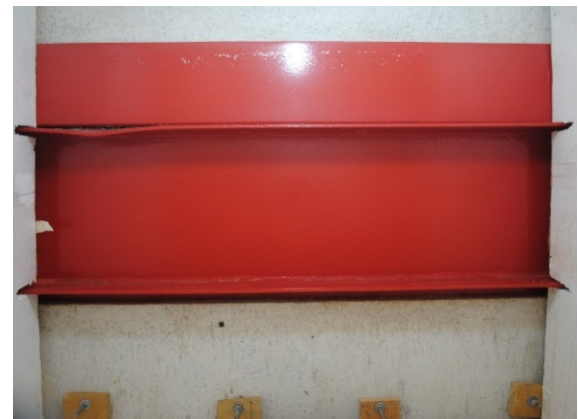
**Figure 26.** Appearance of the INT2 specimen's inner face before and after the watertightness test: (a) before; (b) after.

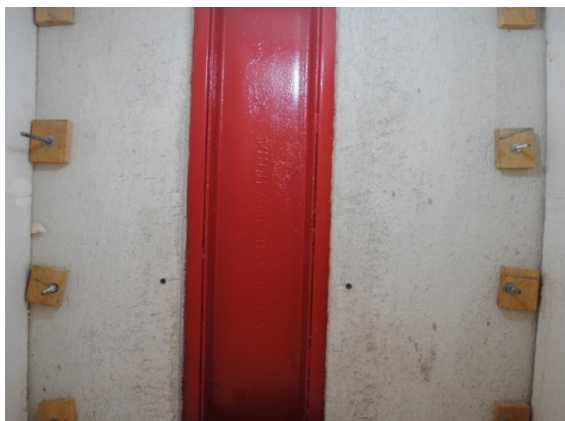
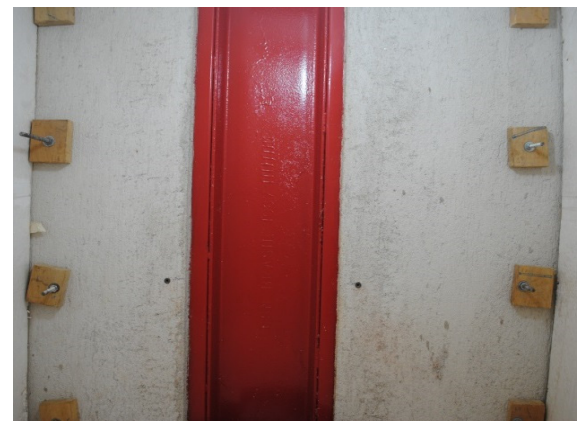
**Figure 27.** Appearance of the INT3 specimen's inner face before and after the watertightness test: (a) before; (b) after.
