Characteristics and Mechanism of Large Deformation of Tunnels in Tertiary Soft Rock: A Case Study

Abstract: During the excavation of a water-conveyance tunnel in Tertiary soft rocks in China, significant deformation of the surrounding rocks and damage to the support were observed. Substantial horizontal deformation, reaching magnitudes of meters, was observed in the right side wall after a certain period of tunnel excavation. Extensive investigations, including field surveys, monitoring data analysis, laboratory tests, and numerical simulations, were conducted to understand the underlying mechanisms of this large deformation. The section of the tunnel with large deformation consisted of Tertiary sandy mudstone, mudstone interbedded with marl, and glutenite. Laboratory tests and mineral composition analysis revealed that the sandy mudstone and mudstone interbedded with marl exhibited low strength, which was closely related to the water content of the rock specimens. The compressive strength gradually decreased with increasing water content, and when the water content of mudstone interbedded with marl reached 26.96%, the uniaxial compressive strength decreased to only 0.24 MPa. Addi

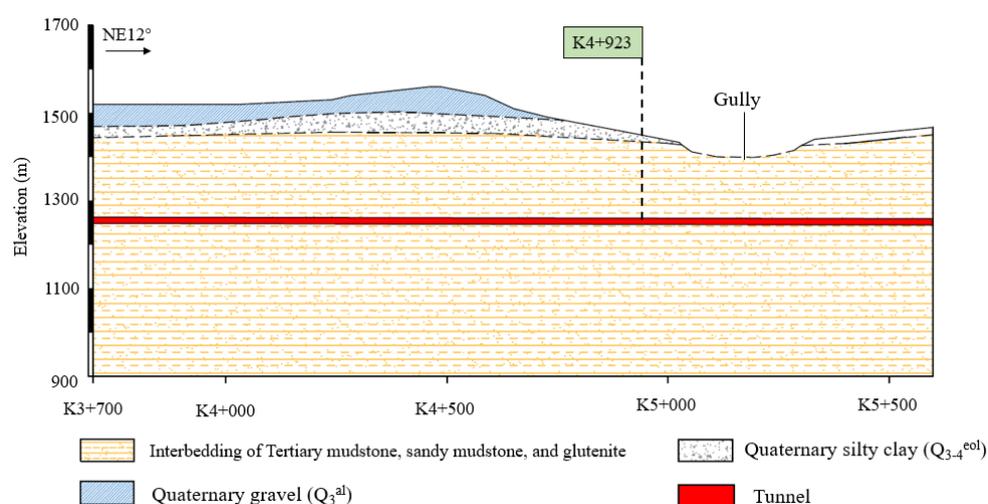
Figure 1. Geological profile of the water-conveyance tunnel (A part of the water conveyance tunnel section from K3 + 700 to K5 + 500).

The water-conveyance tunnel has a total length of 41.823 km, maximum burial depth of 2268 m, design flow $70 \text{ m}^3/\text{s}$, and diameter of 6.9 m [28]. It is designed as a free-flow tunnel and constructed using a drill and blast-heading method. The tunnel section studied here is in the chainage range of K3 + 700 to K5 + 500, beneath a hilly area where the ground elevation is 1420 to 1560 m. The tunnel section is buried at the depth of 140 to 300 m. The mountains in the area are relatively flat, with a natural slope angle of 25° to 35° . The tunnel section traverses beneath a gully with a width of 150 to 200 m. The topography in the area of the tunnel section is shown in Figure 1.

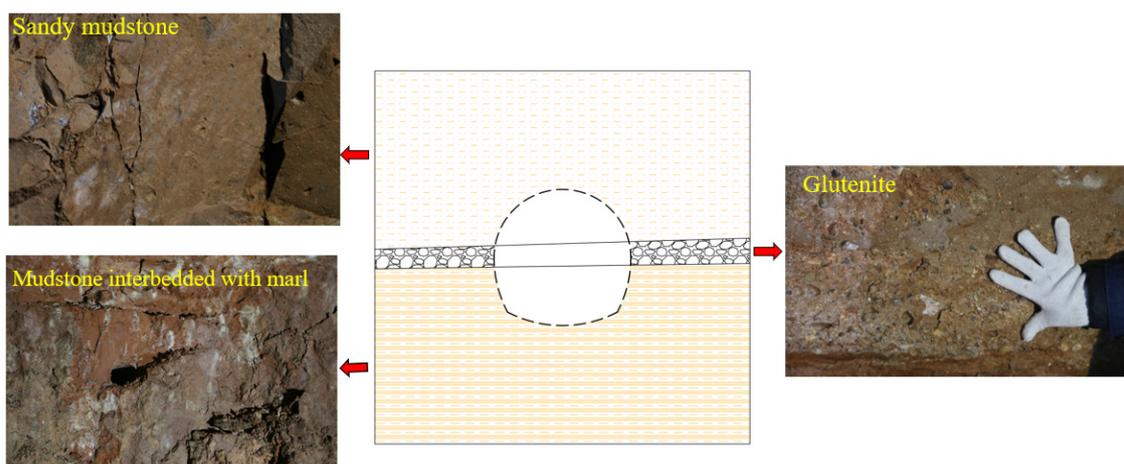
Figure 2 illustrates the lithological distribution revealed at the tunnel face (K4 + 923) after excavation of the tunnel. Three types of rocks are found on the cross-section: namely, mudstone interbedded with marl, glutenite, and sandy mudstone. The upper portion of the cross-section predominantly consists of a reddish-brown, thick to ultra-thick sandy mudstone. This particular rock type exhibits weak to medium argillaceous and calcareous cementation. It has a natural moisture content of 18.03%. Situated in the middle of the cross-section is a medium-thick bedded, gravelly glutenite. This glutenite also displays a

reddish–brown hue, which is accompanied by weak cementation and inadequate sorting of gravels. It exhibits a relatively moist condition and contains approximately 15% to 20% gravel, with grain sizes ranging from 5 to 10 mm and a maximum grain size of 30 mm. The particle sizes within the glutenite are unevenly distributed. The lower portion of the cross-section is occupied by mudstone interbedded with marl. This rock type primarily exhibits a reddish–brown color interspersed with off-white marl layers. The mudstone interbedded with marl displays weak argillaceous and calcareous cementation. Its natural moisture content is 15.48%.

Figure 2. Lithology revealed by excavation at the K4 + 923 cross-section.

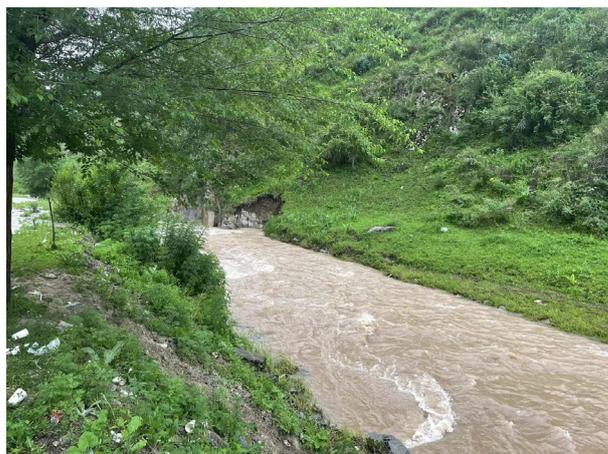
Figure 3. Real picture of gully.

The tunnel section studied in the research traverses beneath a gully that has a width of 150 to 200 m at a vertical distance of 138 m from the tunnel. There are ice and snow meltwater from nearby mountains and atmospheric precipitation flow throughout the year in the gully. The design flood flows for the twenty-year and fifty-year return periods are 142 and 164 m^3/s , respectively. The real scene of the gully is shown in Figure 3. The annual precipitation over the area is 350.2 mm, and the precipitation mainly occurs from April to September every year. During the tunnel excavation process, certain surrounding rocks within the tunnel section were observed to undergo water seepage, which was identified by the on-site geological engineer as being associated with the water source originating from the nearby gully.

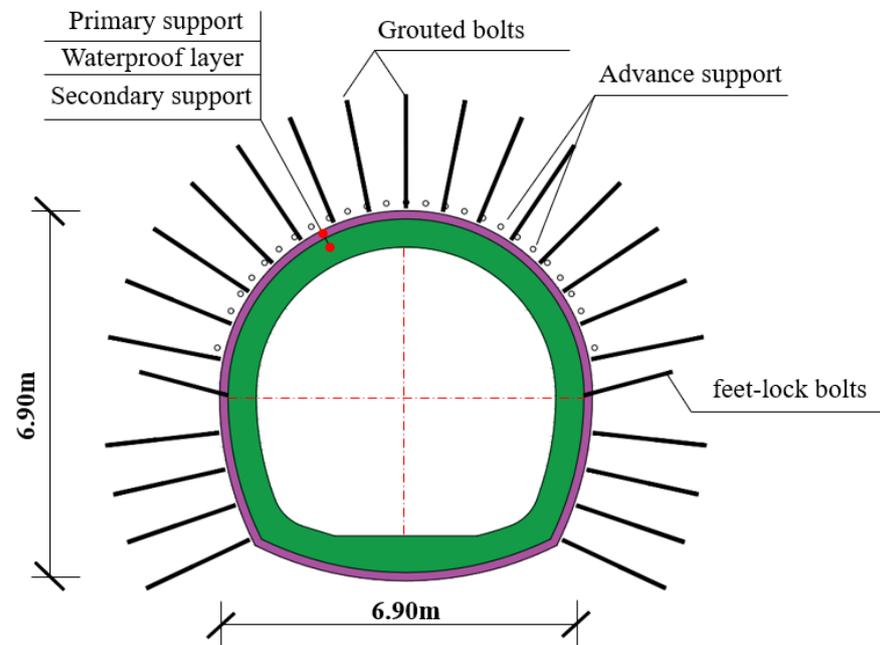
Figure 4. Tunnel cross-sectional dimensions.

The tunnel was constructed using the new Austrian tunneling method [29] with the implementation of effective drainage measures throughout the tunnel construction process. It was excavated in two benches, and the footage of each cyclic excavation is no longer than 250 mm. Based on the empirical evidence obtained from field construction, the average daily advance rate was observed to range from 1 to 1.5 m, which corresponds to a total of four to six cycles of simultaneous excavation of the upper and lower benches. The primary support system employed for the tunnel encompassed a composite approach involving the implementation of hollow grouting anchor bolts, steel arches, mesh reinforcement, and shotcrete. Subsequently, a reinforced concrete structure was utilized for the secondary lining. The detailed support parameters of the tunnel section are summarized in Table 1, and the excavation section size is shown in Figure 4.

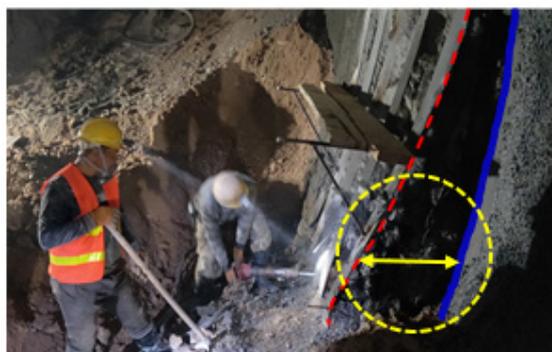
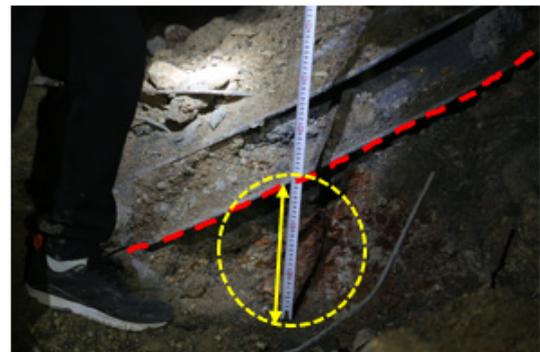
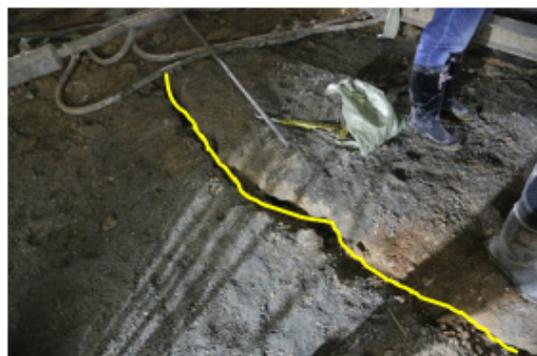
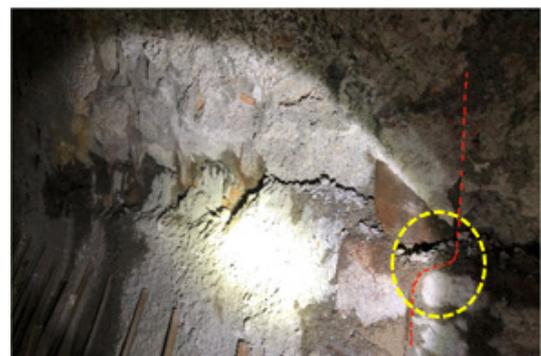
In mid to late September 2019, large deformation occurred in the surrounding rocks during the excavation of the tunnel section K4 + 904 to K4 + 924. Monitoring data show that the maximum horizontal deformation at the deformation monitoring point on the right-hand wall on the cross-section at K4 + 923 was 990.6 mm, invading the construction space of the secondary lining. Then, the bottom of the tunnel section was also subject to severe heave. On 23 October 2019, longitudinal cracks were found on the lining in the tunnel section (K4 + 904.3 to K4 + 913.3) where a lining had been applied to the inverted arch; on 3 November 2019, the inverted arch was cracked and lifted upwards in the unlined tunnel section (K4 + 913.3 to K4 + 924). Meanwhile, support in the tunnel section with large deformation of surrounding rocks also suffered from a series of damaging events such as cracking of the shotcrete and yielding of its steel arch supports, posing a threat to the stabil-

ity and long-term safety of the surrounding rock-support system in the construction and operating periods of the tunnel. Figure 5 shows the consequences of the large deformation and damage to the primary support in the tunnel section.

Figure 5. Large deformation of surrounding rock and support failure during tunnel excavation. (a) Large deformation in the horizontal direction; (b) Tunnel bottom lifting; (c) Cracking at the bottom of tunnel; (d) Steel arch bending.

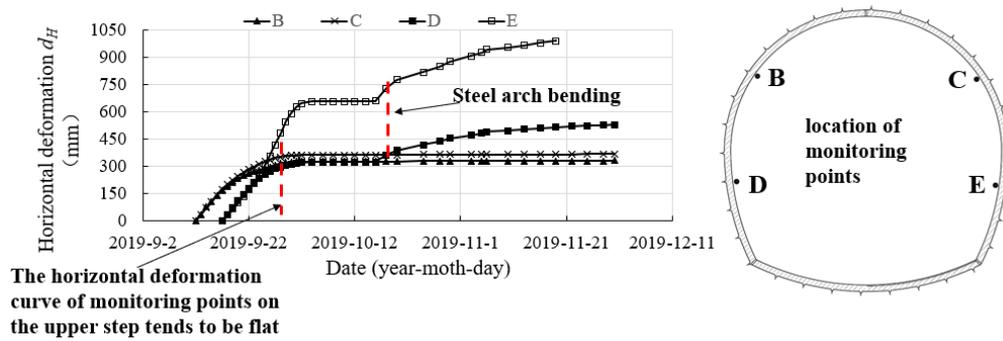
The cross section K4 + 923 under monitoring is within the tunnel section K4 + 904 to K4 + 924 where large deformation occurred. The monitoring results of the cross-section include those at points B and C in the upper bench and points D and E in the lower bench. The points in the upper bench of the cross-section were monitored from 12 September 2019. Figure 6 shows the horizontal deformation curves of surrounding rocks on the cross-section at K4 + 923. Figure 7 shows the horizontal deformation rate curves of surrounding rocks on the cross-section at K4 + 923.

The deformation curves at monitoring points in the upper bench of the cross-section basically change in a consistent trend. The deformation rate always peaked on the second day of monitoring, which was followed by a gradual decrease. The deformation of surrounding rocks tended to gradually converge by 18 September 2019 (the 16th day of monitoring). By 30 November 2019 (the last time the monitoring points were used to collect data in the upper bench), the cumulative horizontal deformation at point B on the left spandrel was 332.2 mm, and the horizontal deformation rate was 0.2 mm/d; the cumulative horizontal deformation at point C on the right spandrel was 368.4 mm, and the horizontal deformation rate was 0.1 mm/d.

Figure 6. Horizontal deformation curves of surrounding rocks at monitoring points on the cross-section at K4 + 923.

According to the above analysis, the deformation curves at different positions in the upper bench of the cross-section K4 + 923 follow similar trends: the deformation rates both reached the peak on the second day of monitoring and then gradually declined, tending to converge on the 16th day of monitoring. In addition, the deformations on the left and right-hand sides in the upper bench are similar. After the first convergence of deformations at two points on the left and right-hand walls in the lower bench of the cross-section, the deformation rates increased significantly on 18 October 2019. According to the distortion of steel arches observed in the field during this time period, it is speculated that because the steel arches were under too much load and therefore locally yielded, the primary support failed to bear the pressure of surrounding rocks. This finally led to the large increase in deformation rates after the first convergence of deformations at points on left and right-hand walls in the lower bench. In addition, the horizontal deformation of the right-hand wall in the lower bench was significantly larger than that of the left-hand wall.

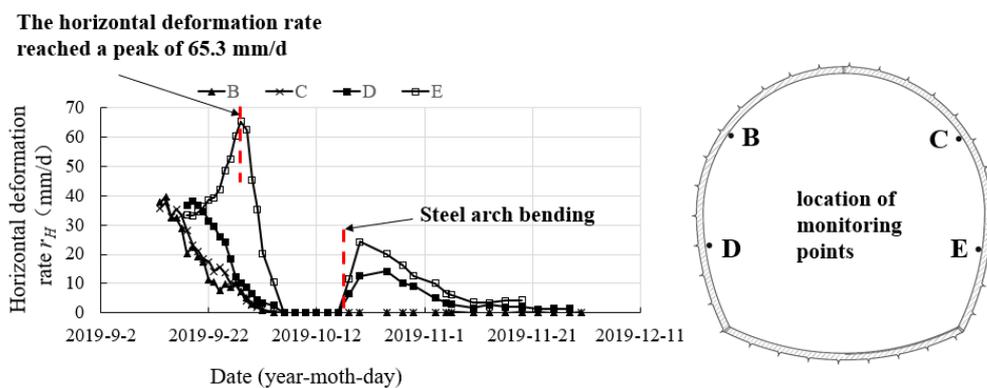
Points in the lower bench on the cross-section at K4 + 923 were monitored from 17 September 2019. The deformation rate at point D on the left-hand wall reached the peak on the second day of monitoring, with a horizontal deformation rate of 38.1 mm/d, which then gradually declined. By 2 October 2019 (the 15th day of monitoring), the deformation of surrounding rocks tended to converge. After starting to monitor the deformation at point E on the right-hand wall, the horizontal deformation inward to the tunnel increased constantly and reached a peak of 65.3 mm/d on 27 September 2019 (the 10th day of monitoring). Then, the rate of deformation gradually declined, and the deformation of surrounding rocks tended to convergence by 4 October 2019 (the 17th day of monitoring). On 18 October 2019, the deformation rates at points D and E in the lower bench tended to increase. The horizontal deformation rate at point D on the left-hand wall was 10.1 mm/d while that at point E on the right-hand wall was 16.2 mm/d on 26 October 2019. Thereafter, the deformation rates at the two points gradually decreased. By 30 November 2019, the cumulative horizontal deformation at point D on the left-hand wall was 530.7 mm with the horizontal deformation rate 1.4 mm/d. The cumulative horizontal deformation at point E on the right-hand wall was 990.6 mm by 19 November 2019, and the horizontal deformation rate was 4.4 mm/d.

Figure 7. Horizontal deformation rate curves of surrounding rocks at monitoring points on the cross-section at K4 + 923.

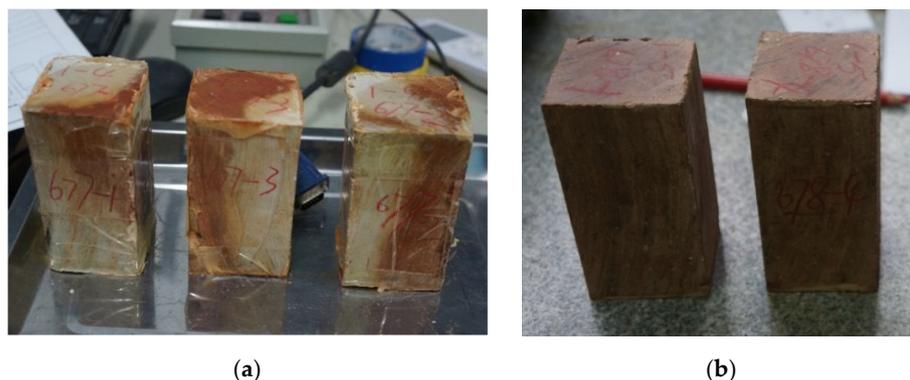
The mudstone interbedded with marl and sandy mudstone exposed in the tunnel section with large deformation were sampled in the field, allowing measurement of the physico-mechanical properties of the rocks. The glutenite was not successfully sampled because it was too loose to allow intact specimen recovery. After being sampled in situ, the rock surfaces were sealed with paraffin immediately, and then the samples were wrapped using multiple layers of transparent tape and plastic film to ensure the intactness of samples and decrease water loss during transportation. The rock samples taken from the field were machined into cuboidal specimens measuring 50 mm × 50 mm × 100 mm (Figure 8a,b) and then immersed in water and air-dried to obtain specimens of different water contents. An RMT-301 (RMT-401) rigid servo-motor testing system for rocks was used to test the UCS of rock specimens, and the test results are listed in Table 2. According to the test results, except for some of the two types of rock specimens that have a UCS value between 5 and 15 MPa, the UCS of others is less than 5 MPa, so they are classified as soft to extremely soft rocks. The water content significantly affects the strength of the two types of rocks. To be specific, the UCSs of mudstone interbedded with marl and sandy mudstone decrease to different extents with the increasing water content; at a given water content, mudstone interbedded with marl has a lower UCS than sandy mudstone.

Figure 8. Specimens of standard size: (a) Mudstone interbedded with marl and (b) Sandy mudstone.

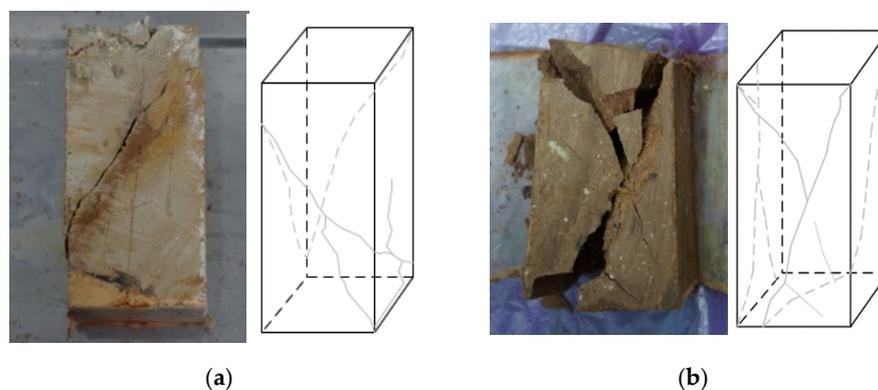
In the natural state, the morphology of the two samples subjected to failure under uniaxial compression is shown in Figure 9. From the observations of the failure states of the two rock samples under uniaxial loading, the two rock samples are shear failures under uniaxial stress. The fracture surface crosses the entire specimen diagonally, creating a complete fracture crack. Additionally, there are localized micro-cracks present on the end faces of the specimen.

Figure 9. Uniaxial compression failure form of rock samples in the natural state: (a) Mudstone interbedded with marl with UCS of 0.84 MPa and (b) Sandy mudstone with UCS of 3.72 MPa.

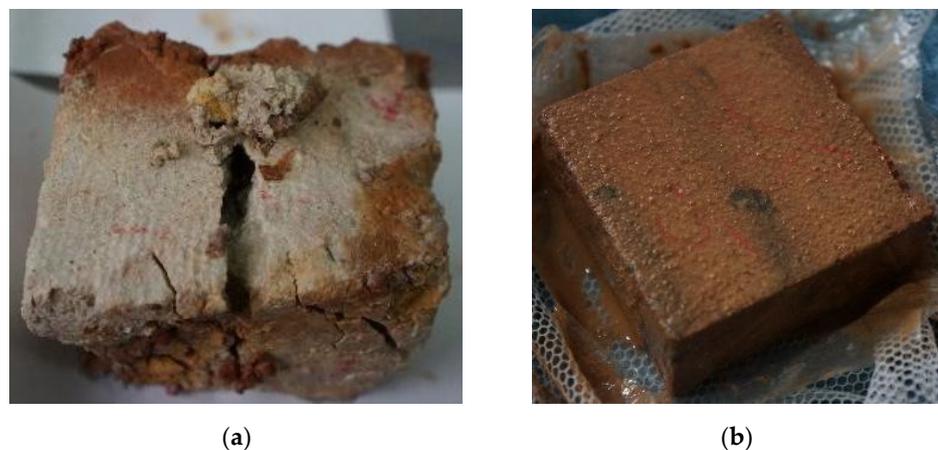
Meanwhile, a cubic specimen of mudstone interbedded with marl and that of sandy mudstone were selected and immersed in water to investigate their hydrophilicity and observe the changes in their appearance after immersion for 24 h. As shown in Figure 10, mudstone interbedded with marl absorbed water and rapidly swelled after being exposed to water, showing argillation and softening characteristics. When exposed to water, mudstone interbedded with marl underwent physical and chemical reactions, which resulted in the swelling, breakage, and decomposition of the rock block. This was also mainly because mudstone interbedded with marl contains some clay minerals that have high hydrophilicity. After being immersed in water for 24 h, the rock block changed obviously in the shape and was argillated, losing almost all load-bearing capacity. As for sandy mudstone, only a thin muddy layer was formed on the surface of the specimen after being exposed to water, while the specimen did not change greatly in the appearance and retained its original shape. Some fragments spalled upon pinching the specimen manually.

Figure 10. Appearances of the two types of rocks after being immersed in water for 24 h: (a) Mudstone interbedded with marl and (b) Sandy mudstone.

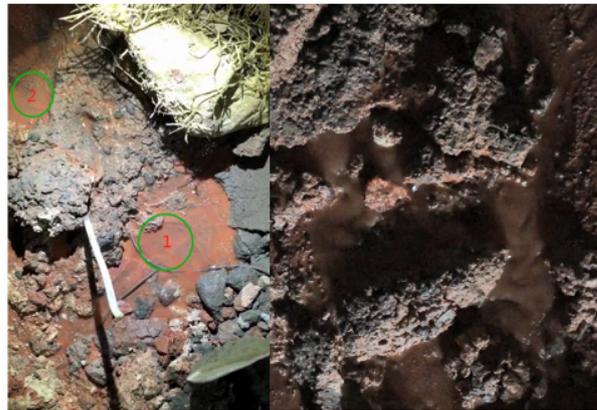
The large deformation of tunnels is closely related to activities of groundwater. The tunnel face was basically dry in the initial stage of excavation, and local areas of the glutenite layer were moist. After 7 to 10 days, the glutenite layer had become saturated, which was accompanied by water seepage. After one month, groundwater began to seep from the tensile fractures occurring due to the uplift of the inverted arch at K4 + 914 (Figure 11). It was speculated that water in the tunnel was from the gully, although mudstone can be regarded as impermeable, whose permeability coefficient is generally $10^{-9} \sim 10^{-7}$ cm/s [32]. The strata exposed in the middle of the tunnel face were a glutenite layer (NW275°SW∠15°~25°) of high water permeability at an angle of 83° with the tunnel axis (NE12°). According to the direction of the tunnel axis and the occurrence of the glutenite layer exposed during excavation, the end of the glutenite layer is located just beneath the gully, thus forming a channel allowing the migration of groundwater. The formation of plastic zones in the excavation process caused changes in the seepage field, which guided groundwater to flow to the tunnel [33]. Based on the strength tests of the two types of rock samples and the water immersion test, it can be observed that the presence of groundwater has a significant softening effect on the mudstone interbedded with marl beneath the glutenite layer. This softening effect results in a considerable reduction in the strength of the rock mass. Furthermore, the presence of groundwater induces seepage forces within the rock mass. As the water flows through the rock mass, it exerts pressure on the rock grains, causing them to displace and facilitating the deformation of the rock mass. This seepage force acts as an additional mechanism for weakening the rock mass and reducing its strength. Overall, the combined effects of groundwater softening and seepage forces contribute to the significant reduction in the strength of the mudstone interbedded with marl beneath the glutenite layer. These findings highlight the importance of considering groundwater conditions in the stability analysis and design of engineering projects involving such rock masses.

Figure 11. Seepage of groundwater from the inverted arch near K4 + 914.

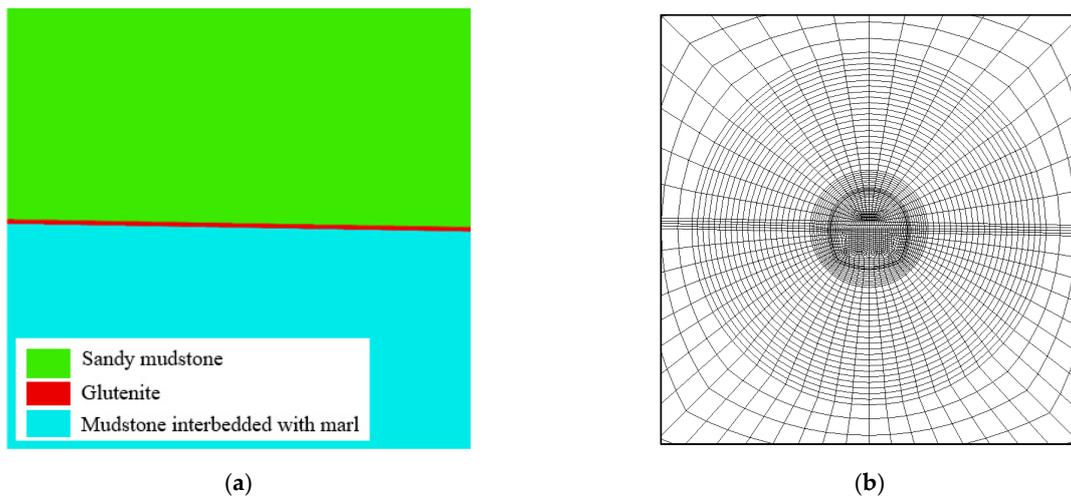
The commercial software $FLAC^{3D}$ was used to conduct numerical simulation. Figure 12a shows the numerical model established based on the geological conditions revealed by excavation of the cross-section at K4 + 923, and Figure 12b displays the mesh generated around the tunnel. Hexahedral meshing was applied to the whole simulation model, forming 3548 elements and 7156 nodes. The model was in a range with the horizontal and vertical lengths both of 150 m. It is worth noting that the burial depth of the cross-section at K4 + 923 of the tunnel is 190 m, while the thickness of the overburden above the tunnel in the model is 75 m. Therefore, geostatic stress of overlying strata with a thickness of 115 m was also applied to the model in the simulation process. The boundary conditions for the numerical model are as follows: the left and right vertical sides are subject to horizontal restrictions only, while the bottom boundary is subject to both horizontal and vertical restrictions.

Figure 12. Numerical simulation model and the mesh: (a) Numerical simulation model and (b) The mesh around the tunnel.

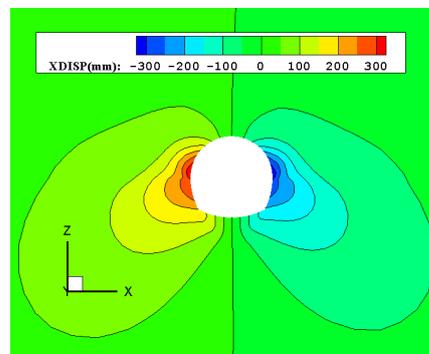
Figure 13 shows the horizontal deformation of rocks after excavation of the tunnel based on rock parameters in Table 1. The maximum horizontal deformation of the tunnel is found in the middle–upper part of the left and right-hand walls, and the horizontal deformation at this position in the right-hand wall is 366.5 mm. Figure 14 illustrates the distribution of plastic zones. The depths of plastic zones in the vault and side walls of the tunnel are 5.7 and 8.6 m, respectively. Plastic zones are dominated by shear plastic zones, with a small area of shear-tension plastic zones distributed in shallow surrounding rocks of the tunnel. The deformation of surrounding rocks obtained by numerical simulations was compared with

Figure 13. Horizontal deformation of surrounding rocks of the tunnel when not considering the softening effect of groundwater.

that measured during excavation of the tunnel, which indicated that the two are consistent in the upper bench. However, the measured deformation of surrounding rocks in the lower bench is much greater than that attained by numerical simulation. This is because the softening effect of groundwater on the lower mudstone interbedded with marl was not considered in the numerical simulation. As mentioned in Section 4.3, the formation of plastic zones during the excavation induces changes in the seepage field, guiding groundwater to flow toward the tunnel, which thus significantly decreases the strength of mudstone interbedded with marl below the glutenite layer. This is also the cause for the significant increase in the deformation of surrounding rocks in the lower bench. Therefore, the rock mass parameters of mudstone interbedded with marl after encountering groundwater shall be obtained through back-analysis based on the monitoring data from the lower bench of the tunnel.

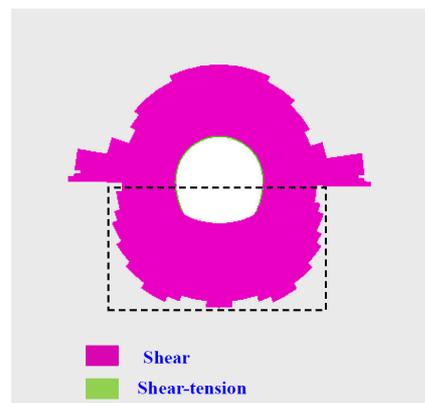
Figure 14. Plastic zones after excavation of the tunnel.

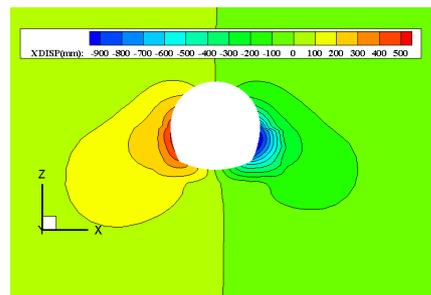
For simplicity, only the weakening effect of groundwater on the elastic modulus of rock mass is considered in the back-analysis process. The range of the surrounding rock involved in the back-analysis is the plastic zone of mudstone intercalated with marl, as shown by the black box line in Figure 14. According to results of back-analysis, the elastic modulus of softened mudstone interbedded with marl in the left-hand wall is 0.012 GPa, while that of the softened mudstone interbedded with marl in the right-hand wall is 0.007 GPa. Figure 15 shows the horizontal deformation of surrounding rocks after excavation of the tunnel when considering the softening effect of groundwater on mudstone interbedded with marl. The maximum horizontal deformation of the left-hand wall in the lower bench is 518.5 mm, while that of the right-hand wall is 992.2 mm, which is consistent with the measured deformation. Differential deformations are observed in the lower bench's side walls, which are attributed to varying degrees of groundwater-induced softening effects on the mudstone interbedded with marl. Field surveys further reveal a relatively higher moisture content in the right-hand wall compared to the left, providing corroborative evidence for the aforementioned explanation.

Figure 15. Horizontal deformation of surrounding rocks of the tunnel when considering the softening effect of groundwater.

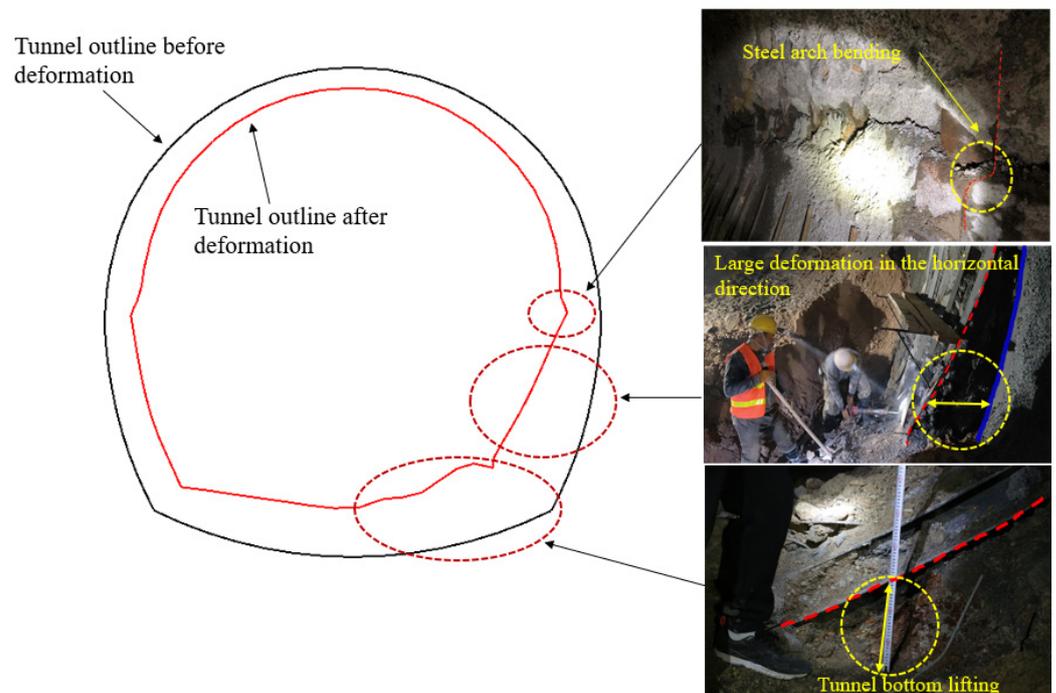
According to the deformation value of surrounding rock obtained by numerical simulation, the tunnel outline after deformation is fitted, as shown in Figure 16. By comparing the tunnel outlines before and after the deformation of the surrounding rock, it can be seen that the results of the numerical simulation can well reproduce the large deformation and the damage of the supporting structure during the tunnel excavation.

Figure 16. Tunnel outlines before and after the deformation of the surrounding rock.

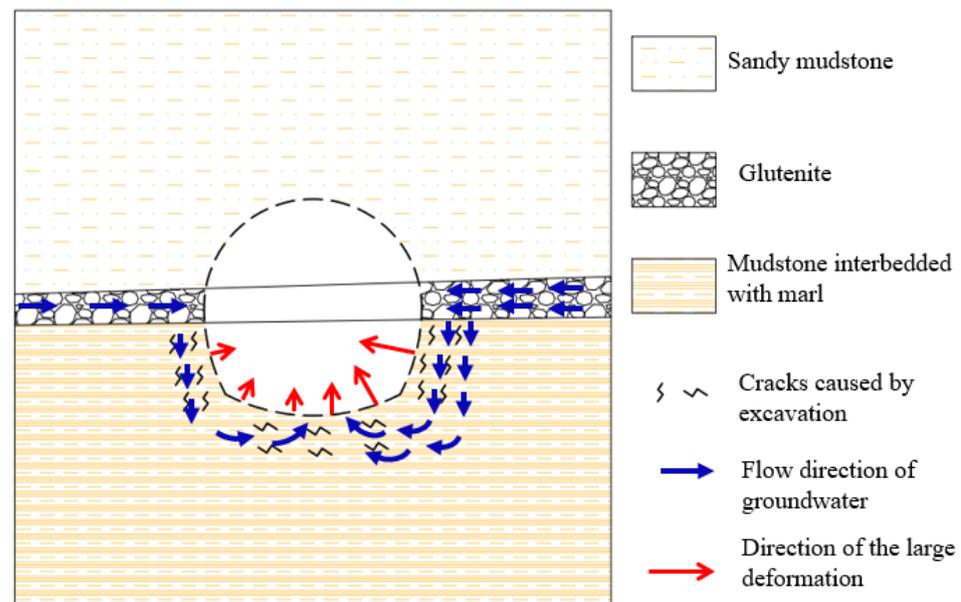
Figure 17 depicts the mechanism through which the groundwater's softening effect facilitates significant deformation of the tunnel's surrounding rocks. The process is explained as follows: the tunnel section from K4 + 904 to K4 + 924 is close to the gully and the excavation of the tunnel changes the seepage path of the groundwater. The glutenite layer, with its high water permeability in the middle of the tunnel, becomes the preferential pathway for the migration of groundwater, so that the water content or permeability of surrounding rocks in the middle and lower parts of the tunnel increases significantly. Meanwhile, the surrounding rocks are unloaded and relaxed due to excavation of the tunnel, resulting in the initiation, propagation, and coalescence of fractures (Figure 9). This further increases the permeability of the rocks and significantly changes the moisture conditions therein. Surrounding rocks are argillated and softened when exposed to water, show significantly decreased strength, and swell to some extent, leading to large plastic deformation. In particular, the mudstone interbedded with marl in the middle and lower parts of the tunnel undergoes greater plastic deformation under the influences of the glutenite aquifer. Therefore, the mechanism of occurrence of the large deformation of the rock surrounding the tunnel section from K4 + 904 to K4 + 924 is closely related to the strata structure and lithological distribution of the section as well as water recharging from the gully.

In the tunnel section where the large deformation occurred, the mechanical performance of mudstone interbedded with marl below the glutenite layer is more significantly deteriorated compared with that of the sandy mudstone above the glutenite layer under the combined influences of the lithological difference and groundwater. The difference in the mechanical performance of surrounding rocks below and above the glutenite layer generates an uneven load on the primary support (as evinced by the larger deformation in the lower side walls than in the upper part). This also induces local buckling of the steel arch at the glutenite layer.

Figure 17. Diagrammatic sketch for the mechanism of large deformation in the tunnel.
