Proposal of a Protocol for the Safe Removal of Post-Earthquake Provisional Shorings

Abstract: The recent seismic events in Italy, including the earthquakes in L'Aquila in 2009 and central Italy in 2016, have significantly impacted the historical centers of small and medium-sized cities. These events directly affected their ancient masonry building heritage, resulting in severe damage. In order to minimize the risk of collapses and prevent further harm to people and structures until restoration efforts can be carried out, provisional post-seismic shorings have been extensively employed. These occurrences motivated several studies focused on the selection and assembly of post-seismic shorings, considering the various rigid failure mechanisms that may occur in a wall or section of an ancient masonry building. Yet, thus far, the critical considerations concerning the disassembly of these shorings, which significantly influence the repair process of a compromised structure from safety, organizational, and economic perspectives, have been overlooked. This research endeavors to establish a protocol for the dismantling of provisional shorings. To this end, a preliminary risk assessment to

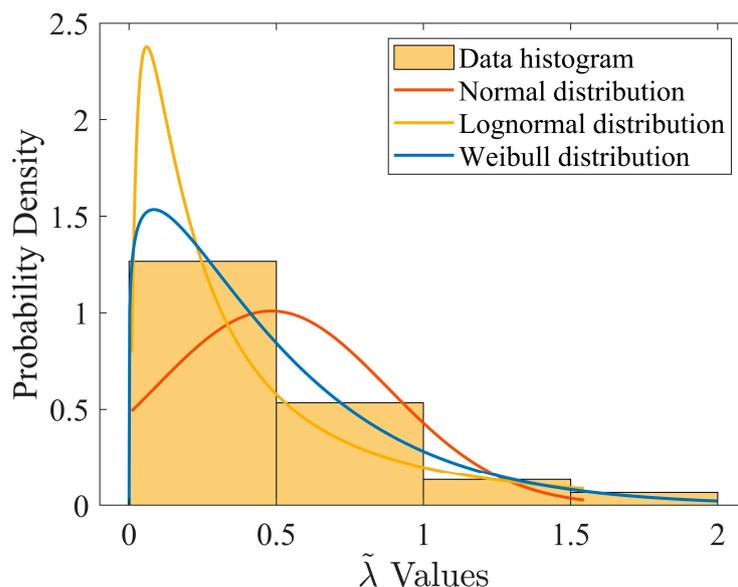
Figure 3. Normalized histogram of normalized safety index for the test cases.

This fitting is based on the assumption that the considered cases are representative of the masonry building inventory in the analyzed area. For comparison purposes, the fitted distribution is overlaid on the chosen intervals. As hinted above, the value a_{ref} considered herein is the expected maximum acceleration provided by the technical standard [14], $a_{ref} = 0.25$ g.

When compared to the normalized histogram of the data, the fitted Weibull distribution (blue curve in Figures 3 and 4) seems to provide a better fit for the data. Figure 4 presents the fitted probability density function for this distribution along with the suggested safety intervals and the normalized safety factors for the sample cases. These cases are categorized based on the presence or absence of provisional shorings, represented by purple and green dots, respectively. Assuming that the sample selection accurately represents the masonry building inventory in the analyzed area, the fitted Weibull distribution quantifies the probability of a masonry building in the area having a specific $\tilde{\lambda}$. Furthermore, the region beneath the probability density functions, bounded by two successive threshold values ($\tilde{\lambda}_i$), signifies the proportion of masonry buildings expected to fall within the safety interval defined by those two $\tilde{\lambda}_i$.

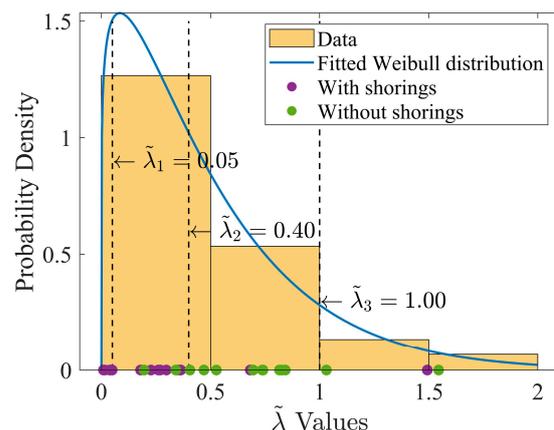
Figure 4. Comparison between test cases and chosen safety intervals.

Figure 4 shows that, according to the chosen safety intervals, the majority of the cases with provisional shoring (purple dots) are included in the first two safety intervals; while the majority of the cases without provisional shorings (green dots) are classified in the third and fourth intervals. In both cases, there are two exceptions. Additionally, it can be seen that the first interval, although relatively narrow, includes a significant number of cases, all of which involved shorings. Comparing the fitted distribution with the interval thresholds—given that the median value of the fitted distribution is approximately 0.37—slightly more than

50% of the masonry structures would be categorized in the first two safety intervals, and the first interval would contain about 7% of the masonry structures.

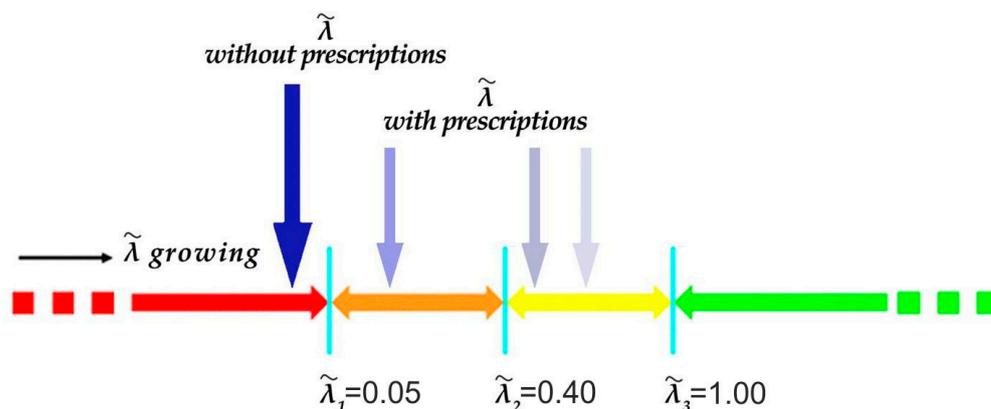
Figure 5. Effect of mandatory and optional prescriptions on the safety index $\tilde{\lambda}$.

- **Step 3. Evaluation of the safety index with the mandatory preliminary interventions:** The damaged wall is subject only to the horizontal static action of the pushing roof. As a preliminary mandatory intervention, the disassembly of the roof is then required (see Figure 9). The consequent value of the safety index is $\tilde{\lambda} = \lambda_a/a_{ref} = 0.33$. This value still falls inside the orange safety interval (see Figure 5).

- **Step 4. Evaluation of the safety index with the optional preliminary interventions:** As in the restoration design, the disassembly of the last floor, just below the roof, is required as a preliminary operation before the removal of the provisional shorings (see Figure 10). The consequent final value of the safety index is $\tilde{\lambda} = \lambda_{final}/a_{ref} = 0.42$. The required optional intervention allows the safety index to fall inside the yellow safety interval (see Figure 5).

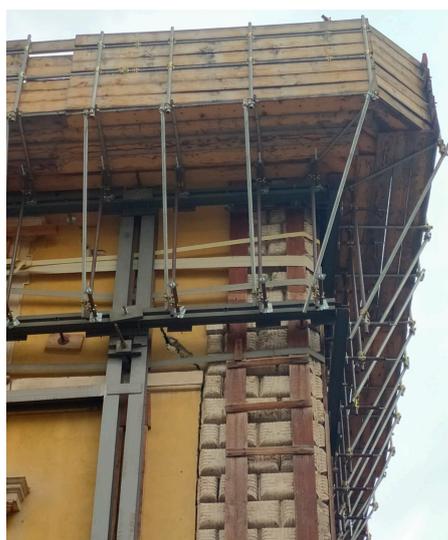
Figure 6. Palazzo Carli, double failure rigid mechanism: (a) cantonal rollover mechanism; (b) composed tilting mechanism.

- Cantonal rollover mechanism (see no. 5 in Figure 1, Figure 6a, green line in Figure 7). Composed tilting mechanism of the façade on Via Roma (see no. 6 in Figure 1, Figure 6b, red line in Figure 7).

To contrast these mechanisms, three types of shoring systems have been inserted: hoops, jackets, and anti-fall propping of the roof (see pictures in Figure 6). In this paper, only the composed tilting mechanism of the façade is considered for this case study. To illustrate the proposed methodology and tool, a building information modeling (BIM) model of Palazzo Carli was constructed. Figure 7 displays a rendered image of Palazzo Carli alongside the identified provisional shoring system, which was employed to secure the investigated failure mechanisms affecting the façade.

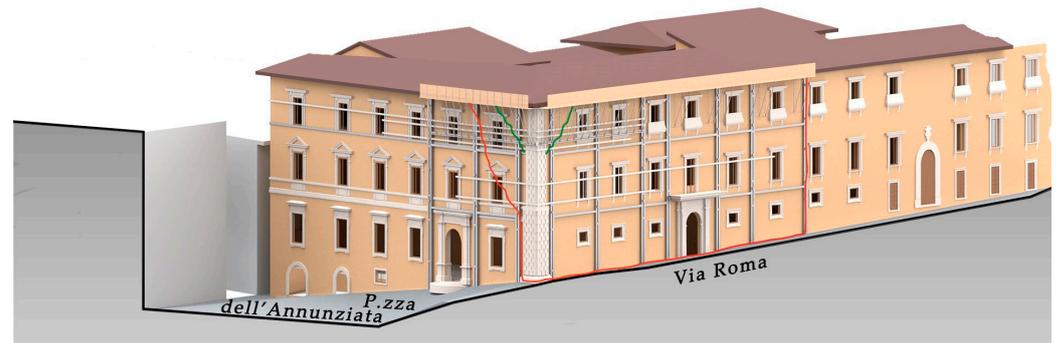
Figure 7. Palazzo Carli, with the detected provisional shoring system and the main crack lines (green line: cantonal rollover mechanism; red line: composed tilting mechanism of the façade).

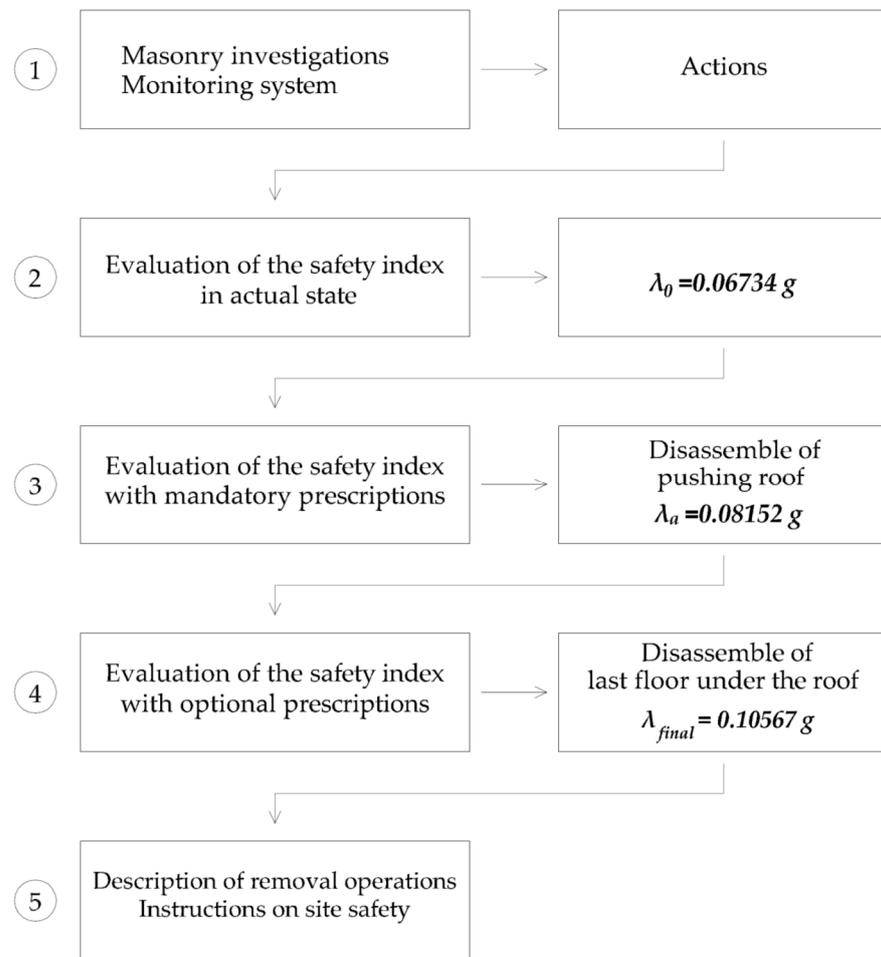
Figure 8. Flow chart of the methodology on the case of study, where numbers indicate the order of execution of each step.

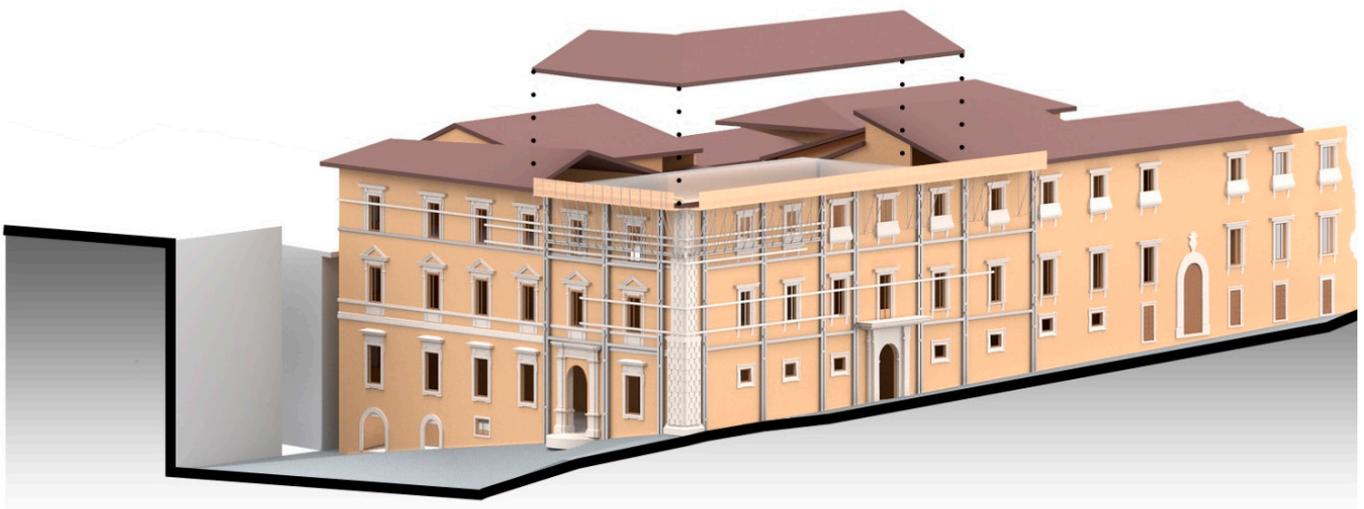
Figure 9. Mandatory prescriptions: disassemble the pushing roof.

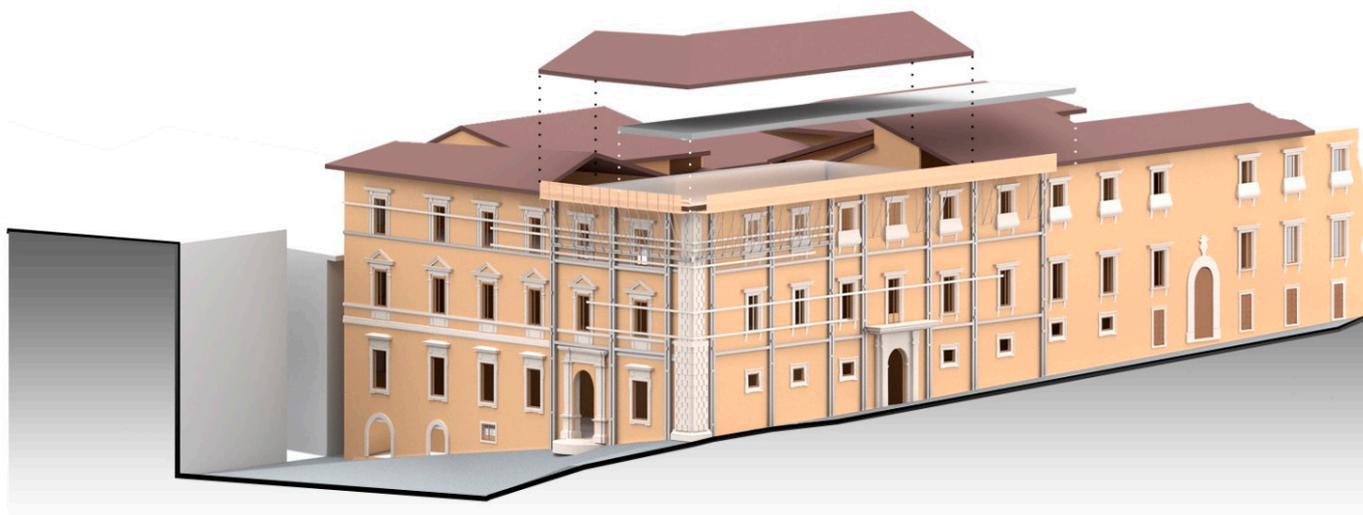
Figure 10. Optional prescriptions: disassemble the floor just below the roof.
