# Conservation of Defensive Military Structures Built with Rammed Earth

**Abstract:** Earth is a complex material with mechanical and physical behaviors that differ from modern building materials. The conservation of rammed-earth (RE) constructions presents specific difficulties that are challenging to overcome. A lack of knowledge about RE due to its abandonment for decades and interventions adopting materials and repair methodologies designed for conventional constructions have led to inadequate interventions. In the case of historic defensive constructions, the doubts and technical difficulties are even greater due to the nature of so-called military RE (with physical and mechanical characteristics which differ significantly from those of civil, more common RE) and, not least, due to the historical and cultural heritage value of these constructions. Some important interventions have been carried out recently, while others are underway or in the planning stage, and there is a constant lack of information and technical data regarding the best ways to intervene. To fill this gap, the state of conservation of defensive RE structures and the results of interventions carried out thro

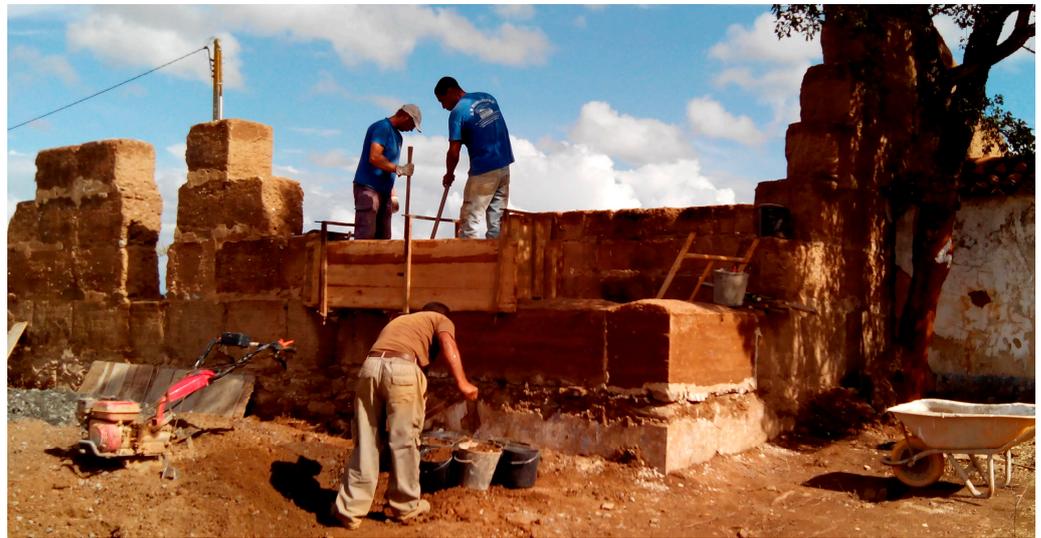
**Figure 1.** Example of civil rammed earth being produced in Santiago do Cacém, Portugal. Author: M. Rocha, 2014.

in situ, sequentially and in rows, constituting monolithic walls. The resulting product is called “common” or “civil” rammed earth (Figure 1).

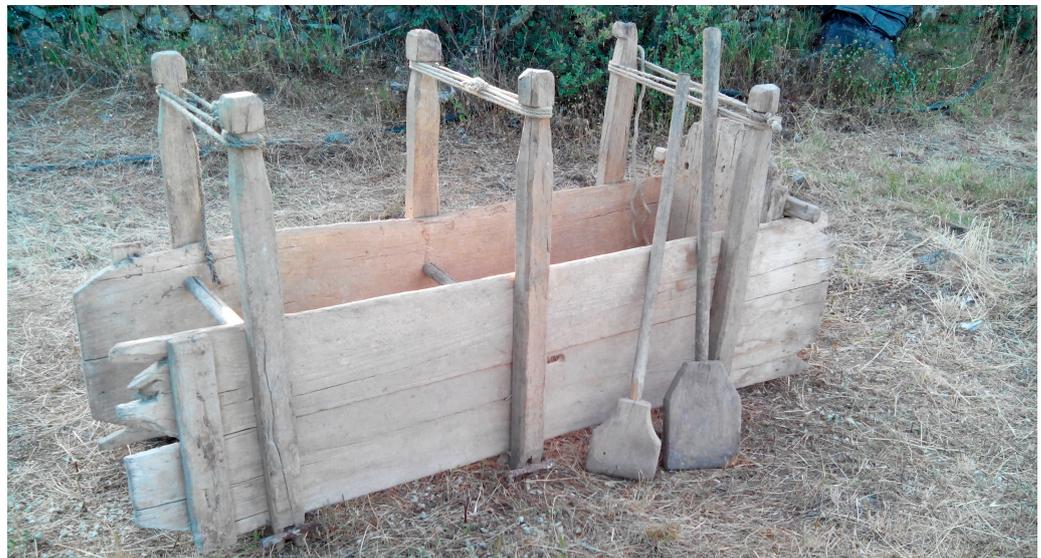
**Figure 2.** Example of a vernacular Portuguese formwork for civil rammed earth. Author: M. Rocha, 2016.

Figure 2 shows a traditional formwork set for the production of civil rammed earth in the south of Portugal. Several other examples of rammed-earth formworks used in the Mediterranean region and in China were collected by Qi et al. [12].

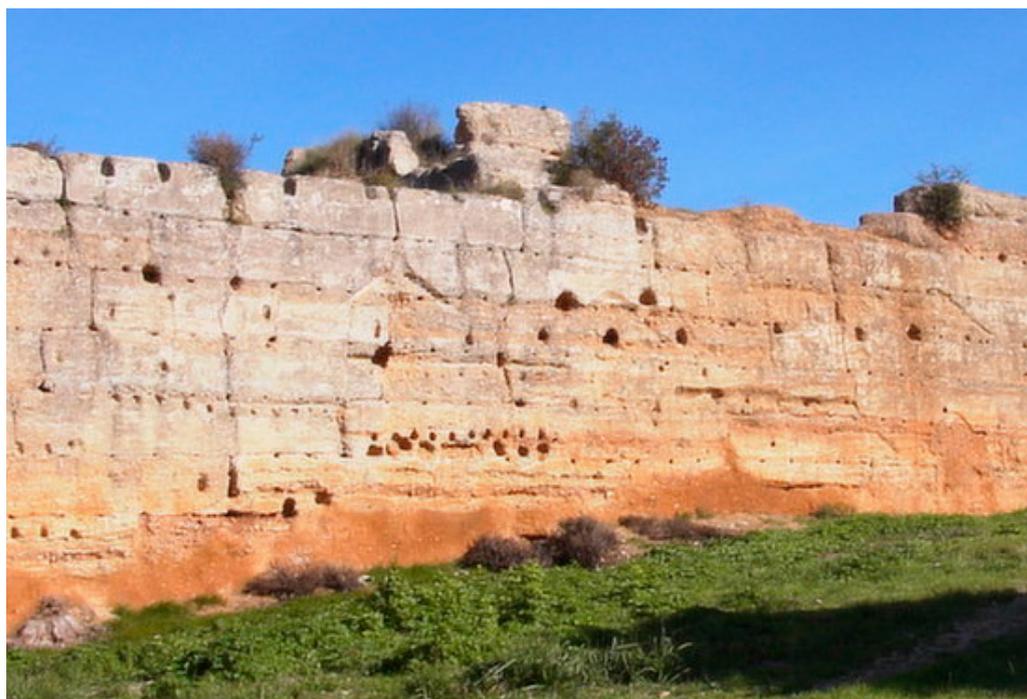
**Figure 3.** Example of a military rammed-earth defensive fortress in Paderne Castle, Portugal; some of the visible holes are from the original formworks used. Author: M. Rocha, 2003.

In the case of constructions with defensive military purposes, air lime and sometimes other additions were added to the earth. This mixture with the earth was made before placing it inside the formwork in layers for compaction, taking on the designation of “military” rammed earth (Figure 3).

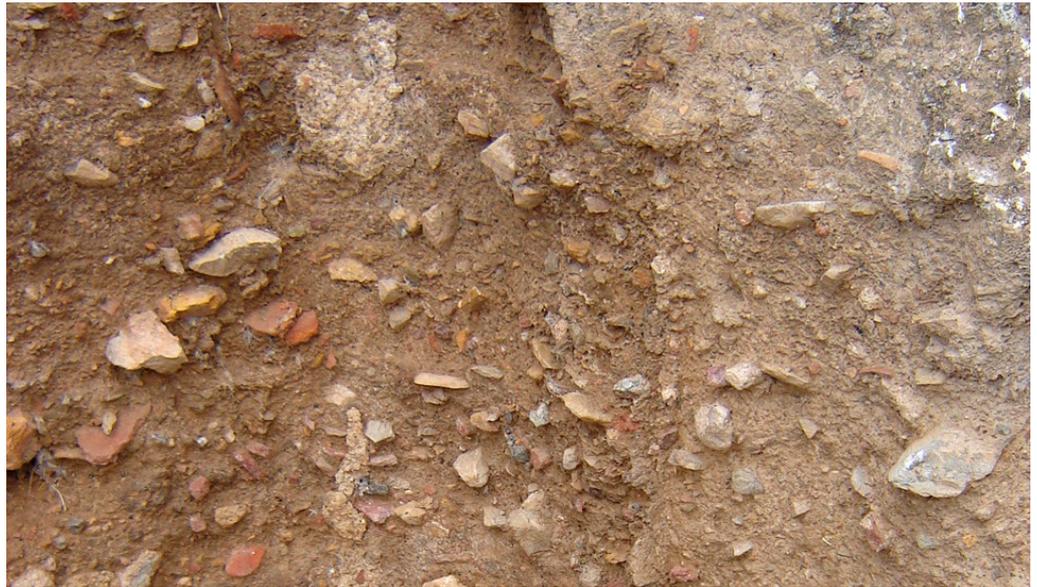
**Figure 5.** Detail of crushed red ceramic and medium-sized stones added to the earth in the rammed-earth Juromenha fortification. Author: M. Rocha, 2022.

Concerning the production of the military rammed earth, in addition to quick lime, other additions to the earth were carried out where it was made, such as the addition of crushed red ceramic waste (from bricks and tiles) and medium-sized stones (Figure 5). Nevertheless, the intentionality of adding these materials is uncertain. Because they were military defensive structures, these buildings required fast construction and fast reconstruction. For that purpose, the collection of building materials was always conducted nearby, and the available supplies could easily include debris from former constructions destroyed by war.

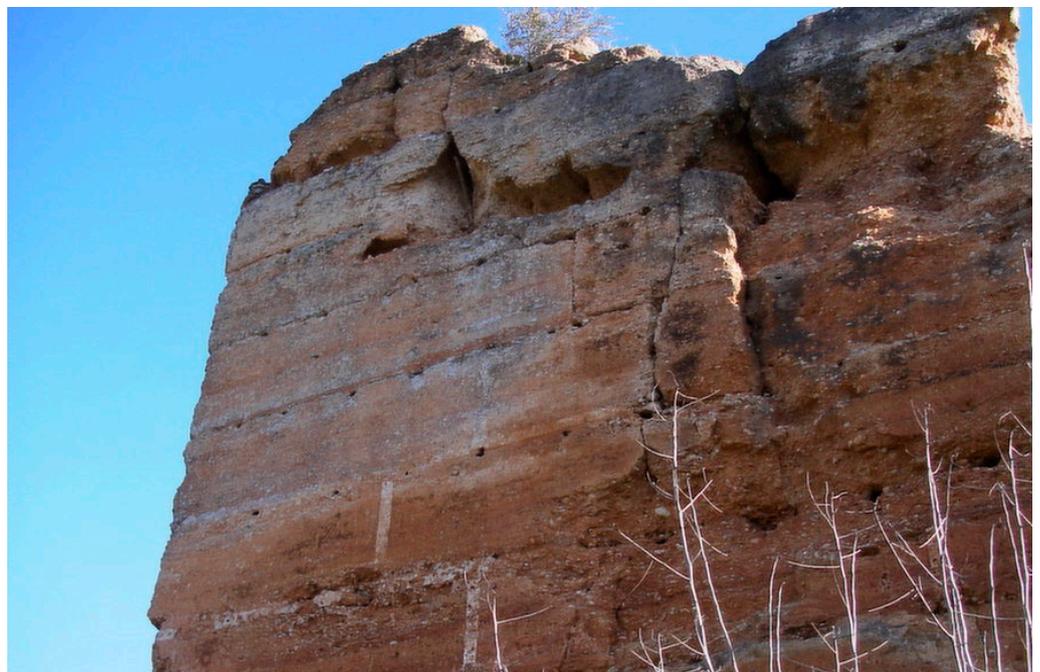
**Figure 6.** Detail of simulated ashlar stone masonry in the rammed-earth Paderne fortification. Author: M. Rocha, 2003.

Defensive military rammed-earth walls were most likely rendered whenever possible. The renders were applied in such a way as to simulate that the wall was built with large ashlar stone masonry, probably causing a greater impact on enemies. So, at least one of the reasons was aesthetic related to military issues. The renders are frequently no longer present; only trace elements show how they were in the past (Figure 6).

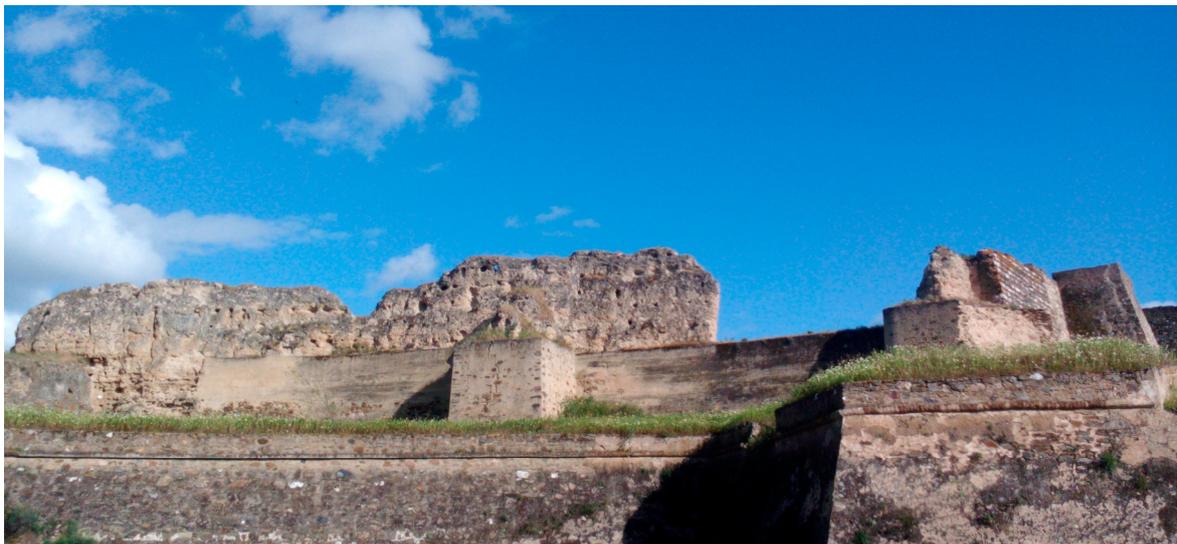
**Figure 8.** Example of a military rammed-earth structure built and rebuilt in different historical phases (Juromenha, Portugal). Author: M. Rocha, 2019.

The *Reconquista* (re-conquest of the territory by the Iberian Christian kingdoms) was much slower than the Muslim invasion (Figure 7), and during this period, damage, repairs and adaptations to military buildings occurred; later, during the Christian period, there were various interventions and modifications. Many of these fortifications, such as Juromenha, were later modified during the Iberian Wars of the 17th century (Figure 8).

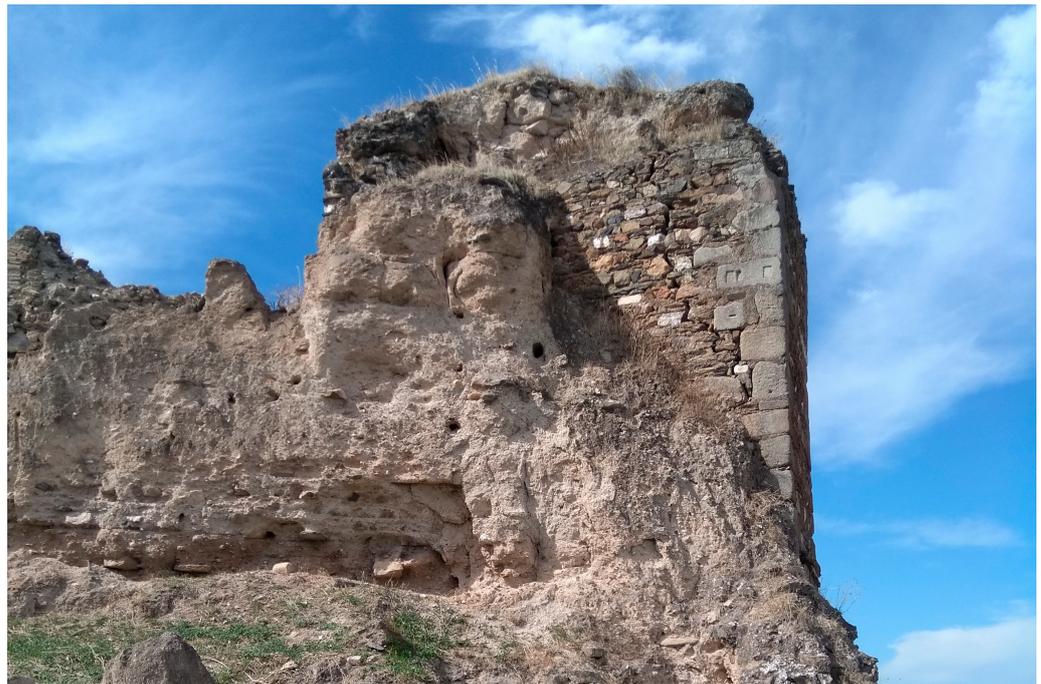
**Figure 10.** Action of water and structural failure in a military rammed-earth structure (Juromenha, Portugal). Author: M. Rocha, 2021.

One of the specificities of the technical diagnosis of military rammed earth consists of understanding the balance between the presence of water and the structural stability of each building element in question [17] since these are the two main causes of deterioration: the action of water and structural failure. Moreover, generally, one enhances the other (Figure 10).

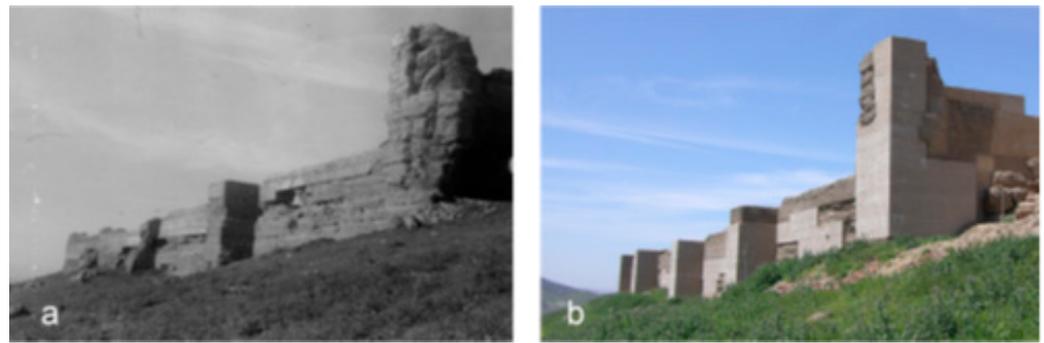
**Figure 11.** Recovery of volumes in a military rammed-earth fortress to avoid collapse (Reina Castle, Spain): (a) before intervention (unknown author, 1960's); (b) after intervention (Author: M. Rocha, 2007).

- (3) The recovery of volumes in the sense of recovering the profile and the mass of the construction through the reconstruction of some missing parts, which allows for a reading of the original construction before its deterioration and simultaneously decreases the degradation path (Figure 11).

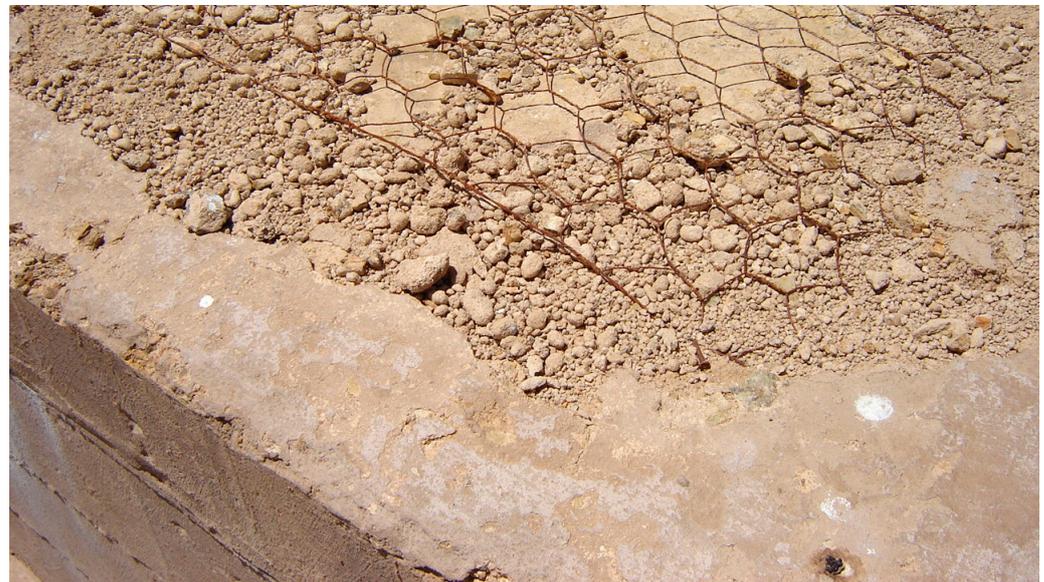
**Figure 12.** Detail of the incompatibility of materials in an intervention for the conservation of a rammed-earth Reina fortification, causing damage to the structure (Author: M. Rocha, 2007).

The analyses and evaluation of a number of recent actions of repair and conservation of military rammed-earth structures reveal that foreign techniques and/or materials were applied in conservation actions, and they frequently caused incompatibilities (Figures 12–14) with the pre-existing environment and often distorted the constructive concept or the original architectural or cultural language.

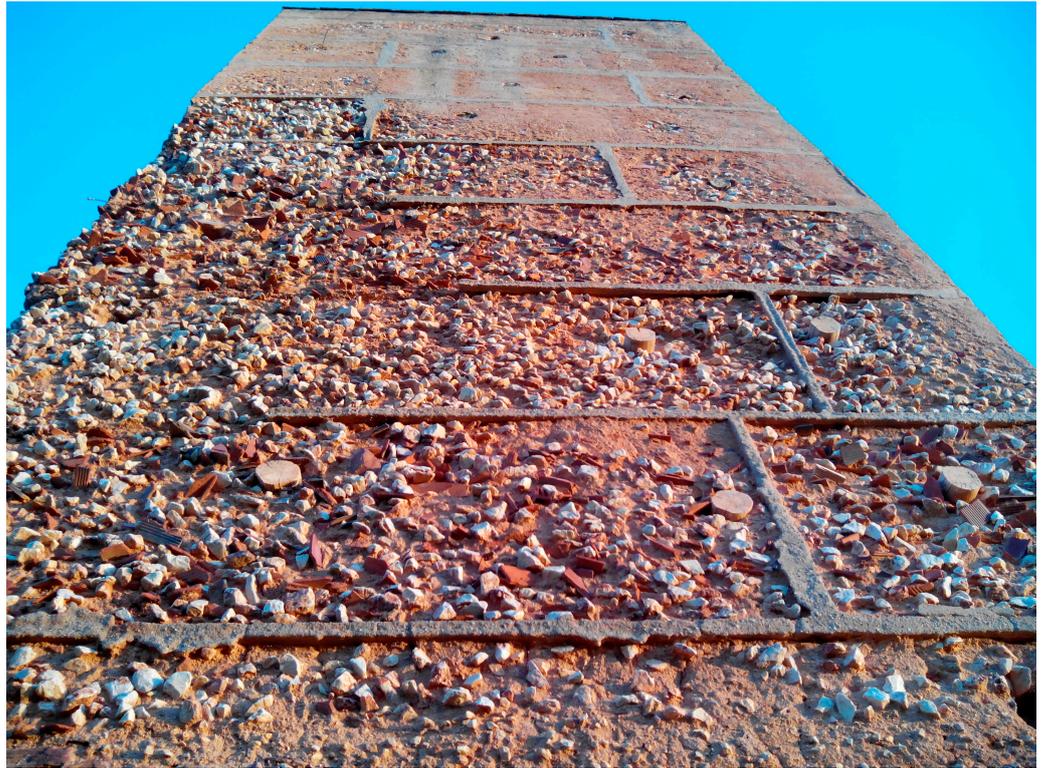
**Figure 13.** Detail of an ineffective intervention for the recovery of volumes in the fortification of Silves, Portugal, simulating rammed earth but distorting the original architectural and constructive concept (Author: M. Rocha, 2016).

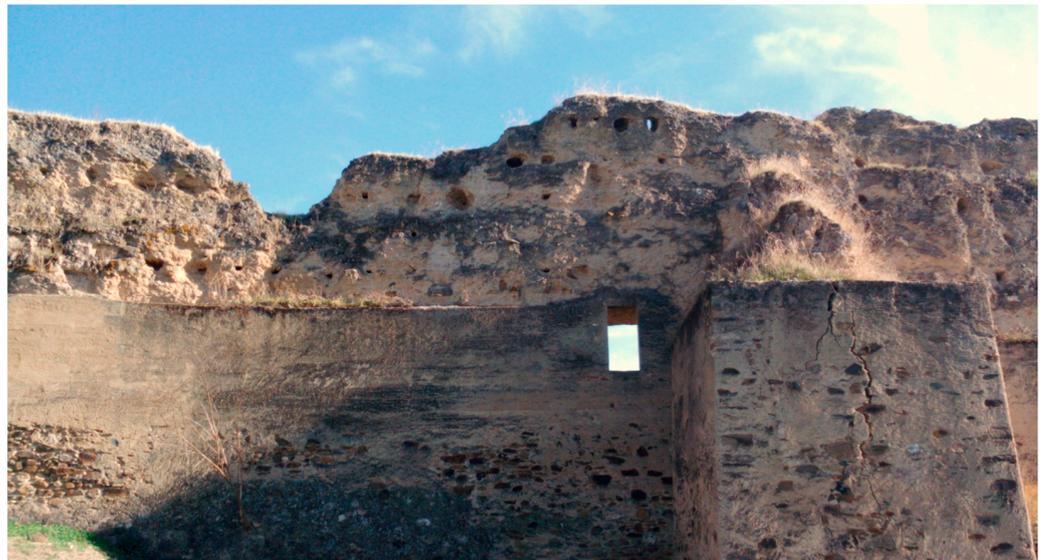
**Figure 14.** Detail of inadequate past intervention for surface repair, with mortar placed inside formworks to simulate rammed earth in the Juromenha fortress, Portugal. Although keeping its integrity for decades, this intervention has a very low visual compatibility (Author: M. Rocha, 2021).
