Article

Experimental Analysis of Mechanical Behavior of Timber-Concrete Composite Beams with Different Connecting Systems

Citation: Cvetković, R.; Ranković, S.; Mišulić, T.K.; Kukaras, D. Experimental Analysis of Mechanical Behavior of Timber-Concrete Composite Beams with Different Connecting Systems. *Buildings* **2024**, *14*, 79. <https://doi.org/10.3390/buildings14010079>

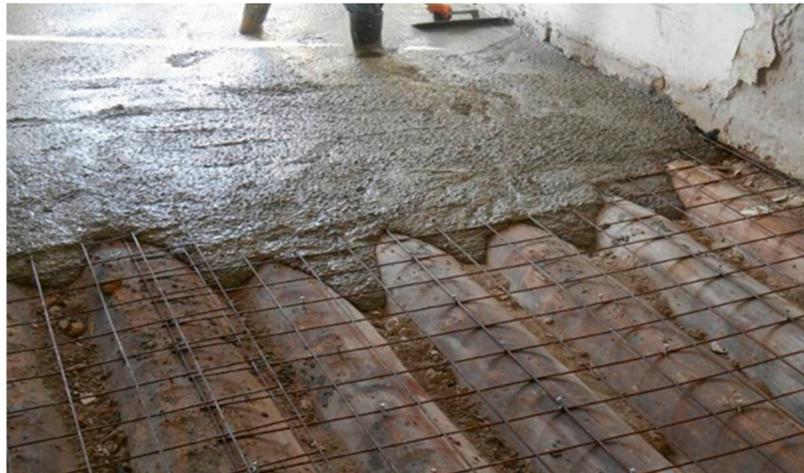
Figure 1. Strengthening of the existing timber floor structures of a building with cultural monument status, using the method of coupling with concrete [3].

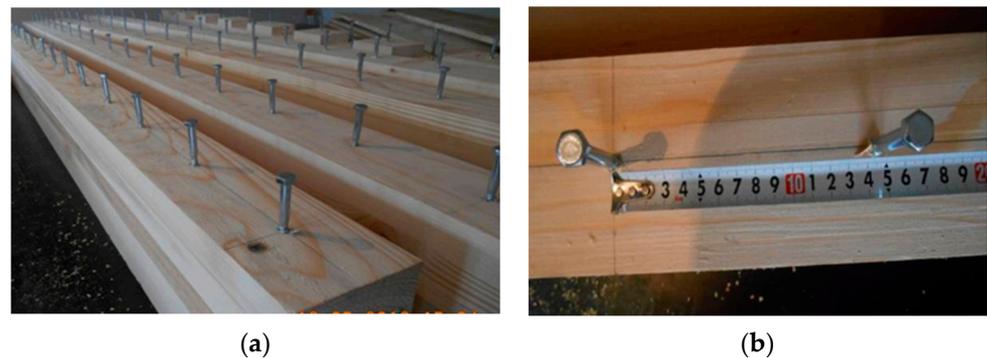
The first series of beams (BF) was made in the traditional manner, using mechanical fastener-coach screws (inner/outer diameter 8/5.8 mm, total length $l = 150$ mm, S355) [45]. Coach screws are installed at the spacing of 15 cm along the whole length of the timber-concrete contact surface. Screws were driven into the timber part up to 100 mm deep, Figure 2, while the remaining 50 mm was in the concrete part of the cross-section.

Figure 2. (a) Coupling system for BF-beams; (b) Coach screws positioned at spacing of 150 mm.

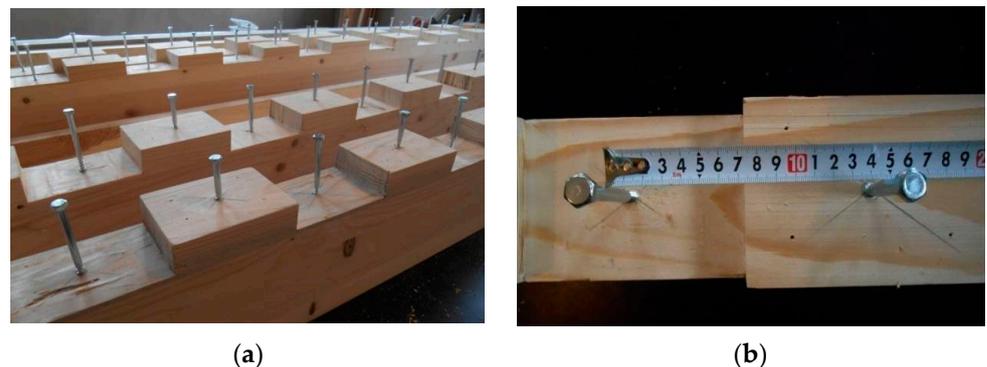
The second series of beams (BN) was created by coupling of timber and concrete with a more complex connecting system that consisted of combination of parallelepiped notches and additional screws. Parallelepiped notches were cut at distance of 30 cm along the beam taking up the whole width, with dimensions depth/length/width= 35/150/100 mm. In the middle of each notch, coach screws with the outer diameter of 8 mm and length $l = 180$ mm were used, while in between notches, shorter coach screws $d/l = 8/150$ were applied. Using a connecting system made of two screws of different lengths screwed in the notches and on top of the timber beams, the screws were at a distance of 150 mm like in the BF-series, but participating in shear force resistance alternately-directly in timber/concrete interlayer or together with the notch filled with concrete, Figure 3.

Figure 3. (a) System of coupling for BN-beams; (b) Screw + notch reinforced by a screw.

The screws are screwed into previously drilled holes with 10% smaller diameter than the screw itself. The attempt to install screws without previously drilled holes led to screw failure due to high timber quality (GL24h) and low moisture content of the timber. The formwork for casting the concrete slab was positioned on a previously prepared elevated stable steel frame platform, Figure 4.

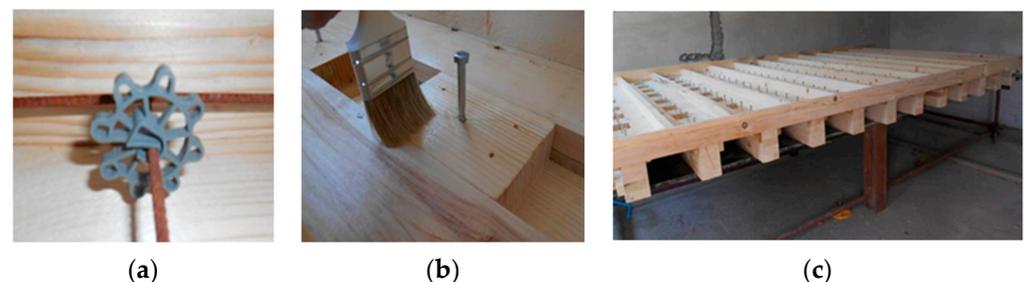
Figure 4. (a) Spacer for steel mesh; (b) Moisture protection of specimens; (c) Working platform with formwork for TCC beams of series BF and BN.

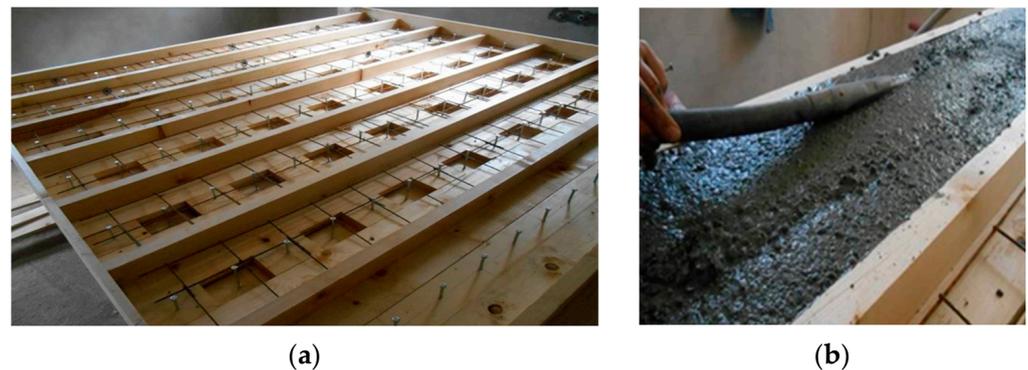
The formwork was made at the same time for all 12 beams, Figure 5. Before casting concrete into the formwork over timber beams, the screws were installed and notches were cut according to the previously described pattern. In order to prevent water transfer from concrete into timber, a transparent polish is applied over the upper parts of timber beams and the bottom and sides of the formwork. In this way, the adhesion between timber and concrete parts is reduced to a minimum, that is, the friction coefficient in the adherent surface of timber and concrete composite cross-section is reduced. The result of the reduced friction was that the biggest part of shear force in the adherent surface was being taken over by the connecting systems.

Figure 5. (a) Formwork of TCC beams before casting concrete; (b) Per-vibrator usage.

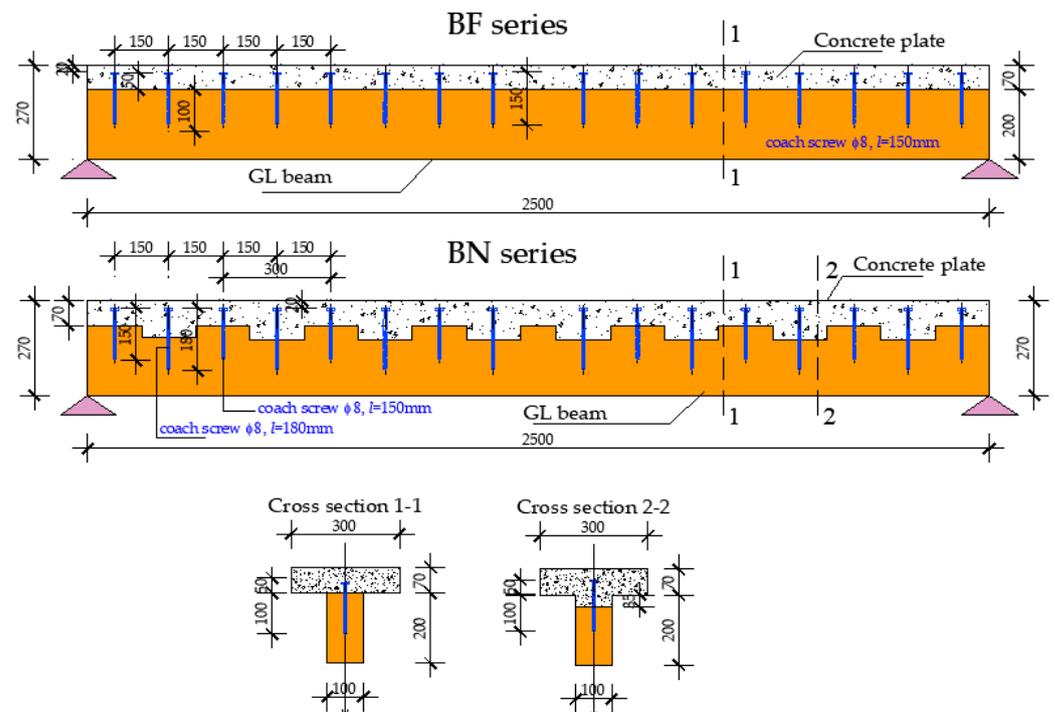
Figure 6. Geometric characteristics with positions of fasteners and notches of TCC beams BF and BN-series.

The final geometry of the tested beams of BF and BN-series is given in Figure 6.

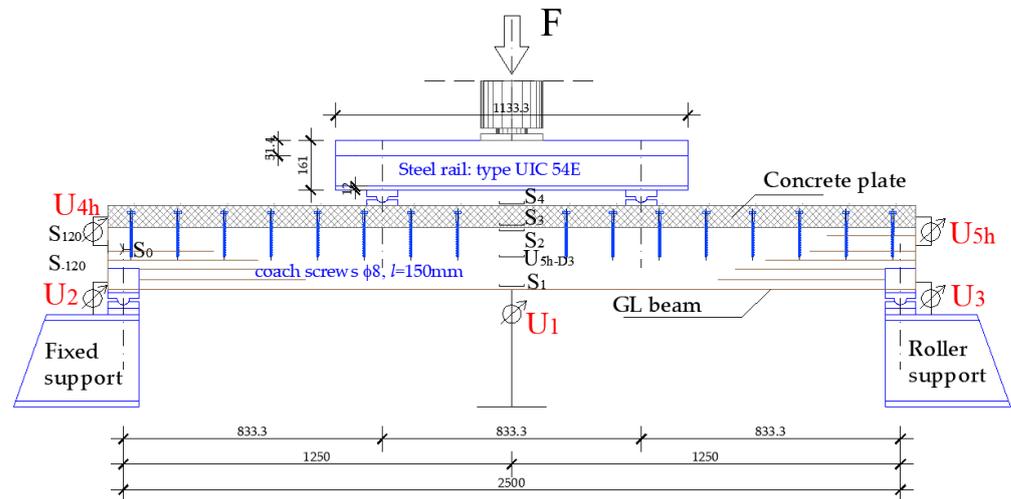
The details about the test setup as well as about the position and description of instruments and measurement points used in experimental study of the TCC beams of BF-series are given on Figure 7 and Table 1, while for beams of BN-series on Figure 8 and Table 2.

Figure 7. Model of TCC beams BF-series. Load disposition and measuring points.

The development and change of stress states during the load application were monitored by strain measuring according to the detailed description given in Figure 7 and Table 1, as well as in Figure 8 and Table 2. Strains were monitored up to final steps of maximum loading for both series.

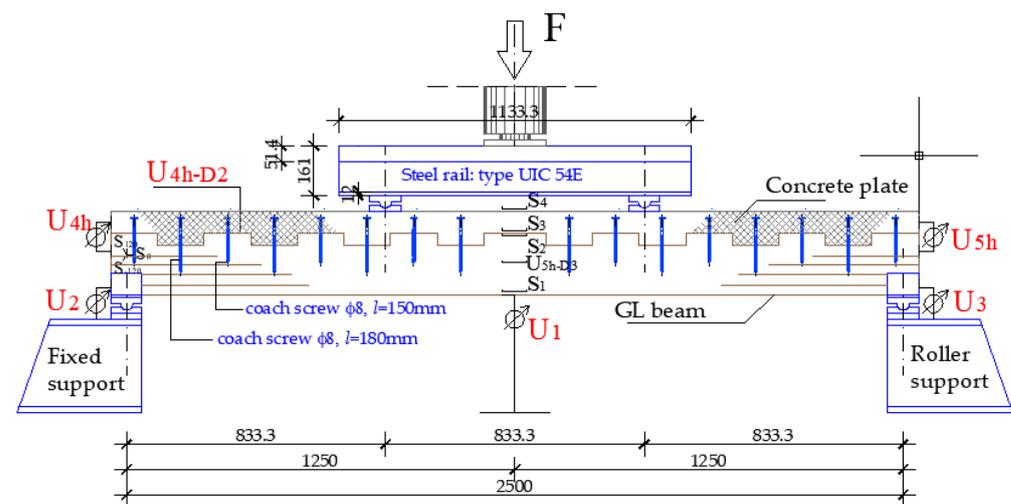
Figure 8. Model of TCC beam BN-series. Load disposition and measuring points.

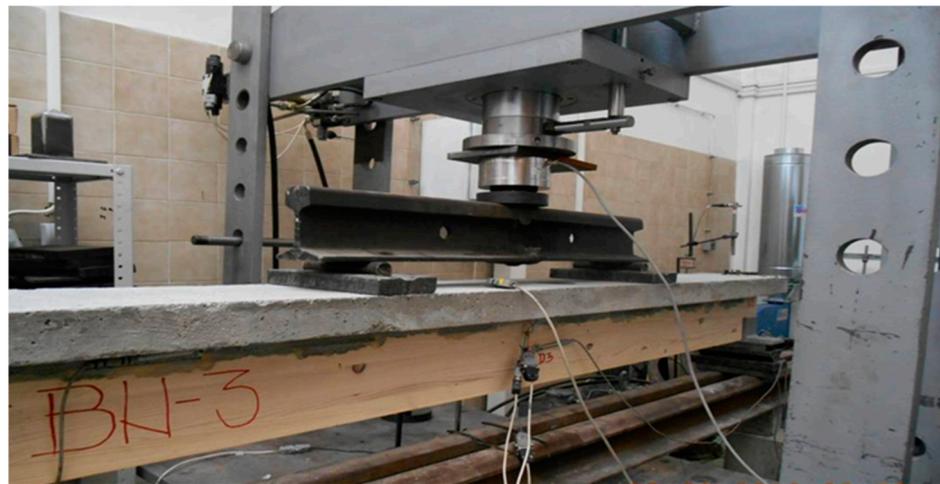
The interesting details about test setup, measuring points and instruments during the experiments are illustrated through Figures 9–11.

Figure 9. Test setup of composite beams BN-series.

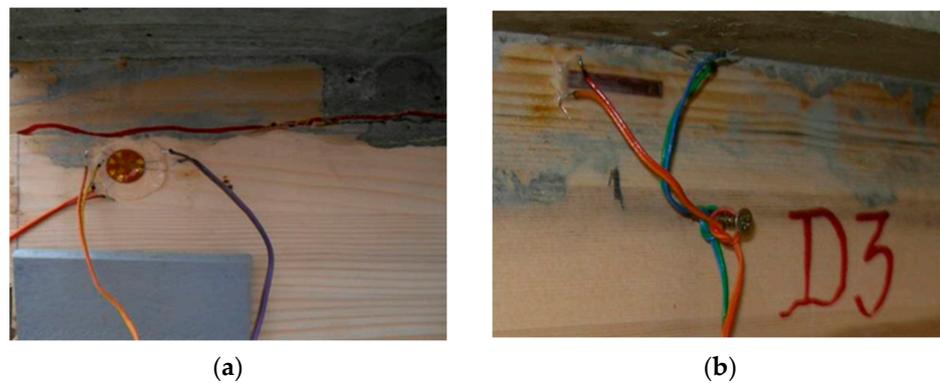
Figure 10. (a) Position of rosettes and strain gauges in the zone of support; (b) Position of strain gauges in the middle beam zone in the top side of a timber and bottom side of concrete parts.

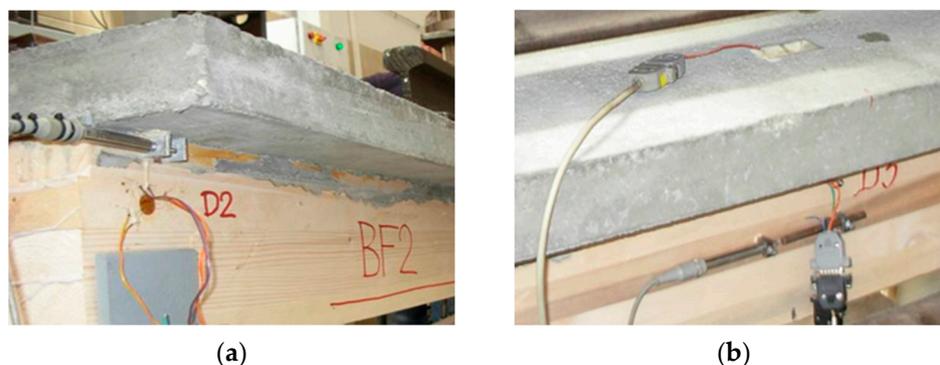
Figure 11. (a) Dilatometer in the support zone; (b) Dilatometer in the middle of the beam.

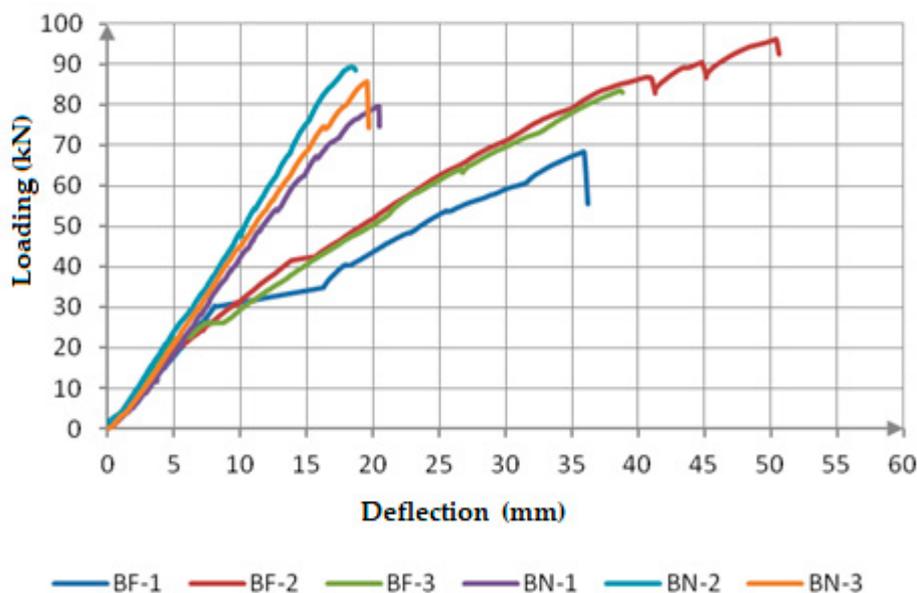
In Figure 12, the load–mid-span deflection diagrams of all TCC beams are shown. In the case of BF-series, the first tested specimen BF-1, showed an obvious discontinuation at the beginning of the test, but later regularly continued up to the explicit failure. This result influenced the average value of the max load for BF-series, as well as the average deflection in middle span. The max load for BF-series was in the range of 68.19–90.33 kN, Figure 13, while deflections were in the range of 35.73–44.74 mm (i.e., $L/70$ – $L/55.87$, expressed in relation to span L), Figure 14. Despite an observed irregularity in first specimen’s behavior, the exhibited load-deflection relation could be considered as approximately linear up to the failure point, which indicates linear-elastic behavior of TCC beams of BF-series.

Figure 12. Load-deflection diagrams in mid-spans for all tested specimens (BF and BN-series).

In the case of BN-series, Figure 12, all tested specimens showed a very steady performance related to mechanical and deformity parameters. Max load for BN-series was in the range of 79.67–89.43 kN, Figure 13, while deflections were in the range of 18.36–20.42 mm

BN-series: Composite beams of the BN-series (BN-1, BN-2 and BN-3), showed linear-elastic behavior up to failure with a high level of similarity between specimen behaviors, which can be seen from the load-deflection diagrams, Figure 12.

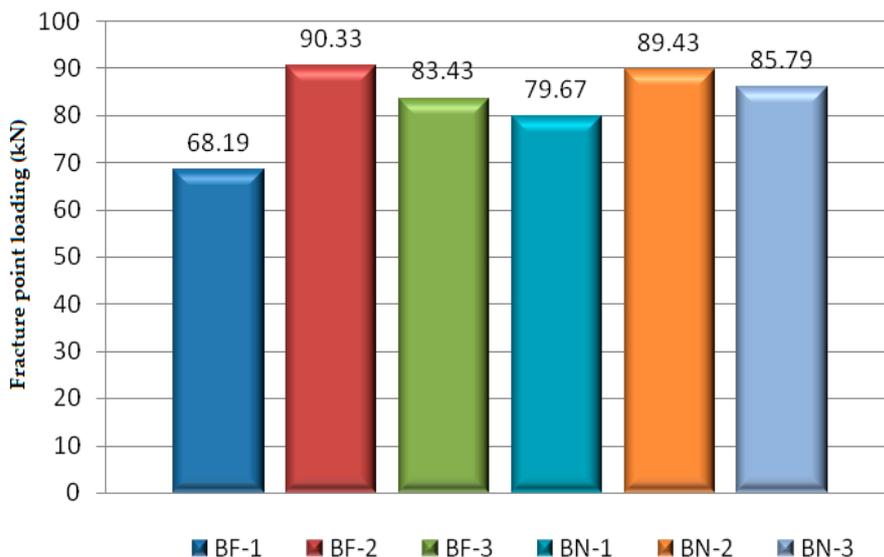
Figure 13. Comparative presentation of max load values for all tested beams (BF and BN-series).

Comparison of loading intensity which caused failure (max load values F_{\max}) for both series, Figure 13, expressed over average values in Table 3, show that mean $F_{\max} = 80.65$ kN for BF specimens is only about 5% lower than for BN specimens where mean $F_{\max} = 84.96$ kN.

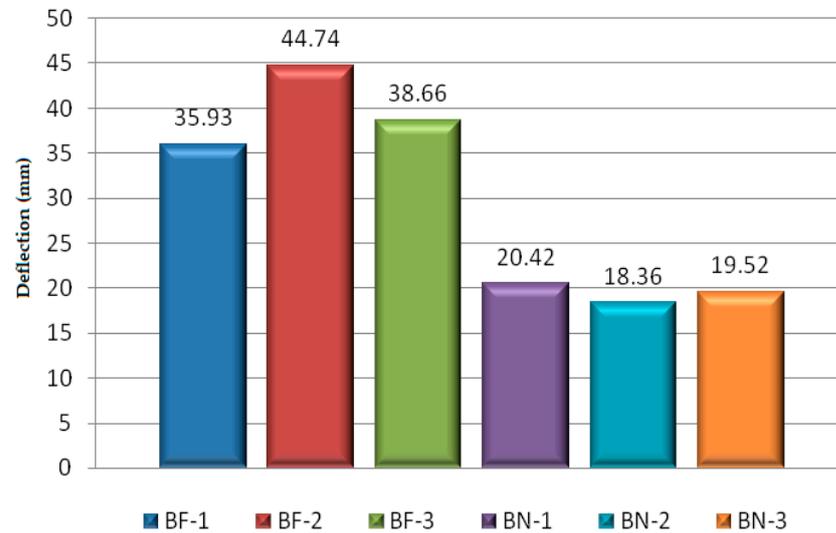
(i.e., $L/136-L/122.42$, expressed in relation to span L), Figure 14. This series of TCC beams exhibited an almost perfectly linear load-deflection relation so the BN-series could be considered to have ideal linear-elastic behavior up to failure. The reasons for such a phenomenon lie in the choice of the connecting systems used in TCC coupling, the high value of achieved stiffness and the fact that beams of a short span were used in the experiment.

Figure 14. Comparative presentation of max deflection values for all tested beams (BF and BN-series).

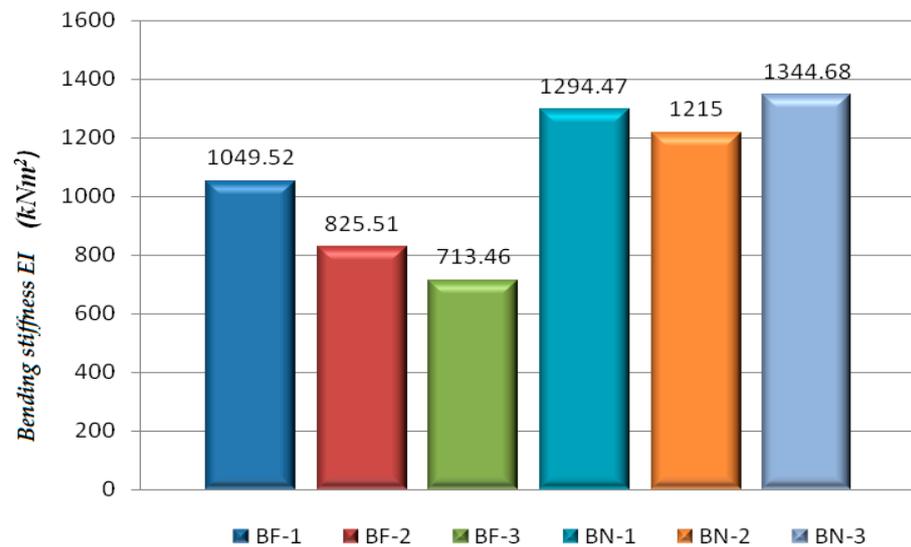
The calculated values of bending stiffness for all test specimens (BF and BN-series) are presented in Figure 15 and summarized with other relevant data in Table 3.

Figure 15. Comparative presentation of bending stiffness (EI) for all tested beams (BF and BN-series).

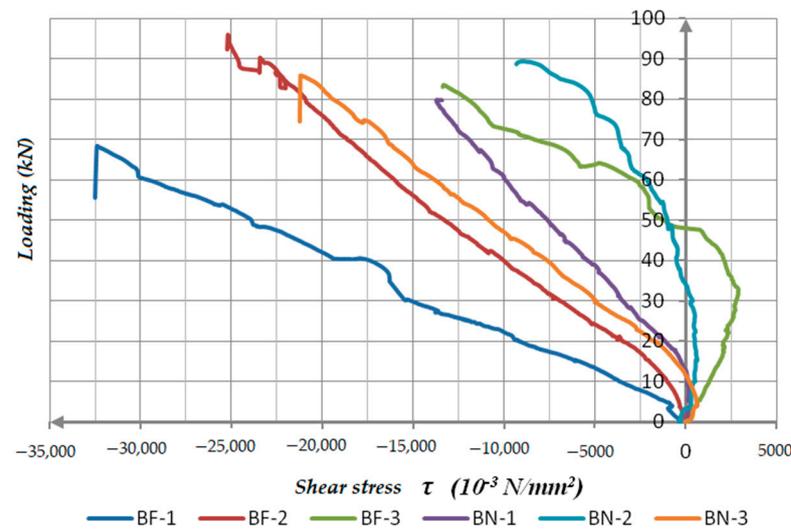
Shear stress states in the support zones of simple beams are important because they are loaded with transversal intensity. This primarily defines the load bearing capacity of the timber part of the cross-section and then defines the shear force transfer through the connecting system. As important factors for mechanical analysis, the measurement and calculation of shear stress through the rosette of strain gauges (Tables 1 and 2) at a fixed support are given through a comparative presentation of the shear stress-load increase relation at the support zones for each tested beam separately in Figure 16. The values of shear stress in the BN-series beams ranges from 10–20 N/mm² and in the BF-series beams, from 15–35 N/mm².

Figure 16. Comparative presentation of F- τ relation of the tested beams.

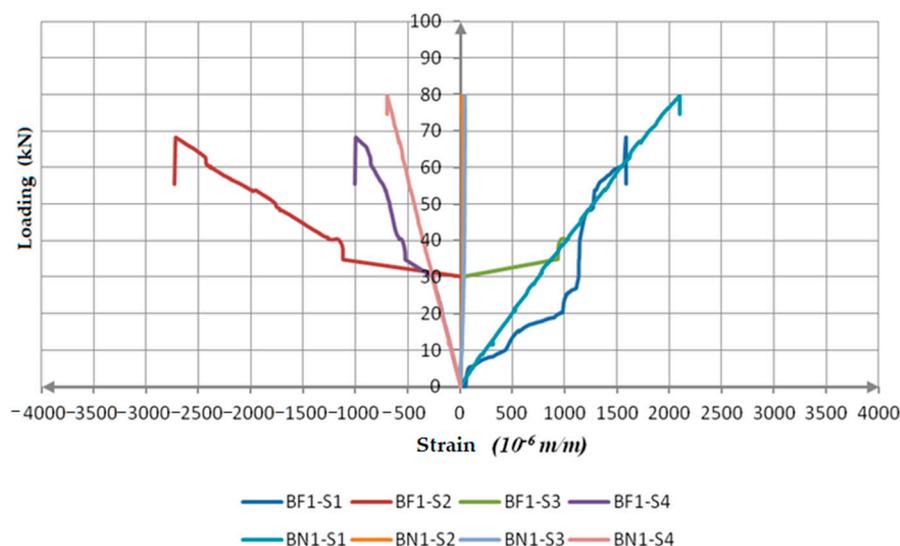
The development of strains in the bottom and top sides of the mid-span cross-section is presented in Figure 17 for both series BF and BN. These diagrams show strain in pressure and in tension as negative and positive values. Acquired data through measuring points S1, S2, S3, S4 in the time interval of 1 s, make it possible to present strain distribution per height of the coupled cross-section for any level of loading.

Figure 17. Comparative presentation of measured strains of BF-1 and BN-1 beams.

BF-series: The distribution of strains across the height of the cross-section is expressed as elastic, i.e., the strain development is approximately linear. The strain values in adjacent fibers, bottom side of concrete and top side of a timber cross-section (measuring points S2 and S3) have almost the same absolute values which indicate the co-acting of the elements of a composite beam and the existence of the real effect of coupling achieved by built-in fasteners. Such a development of strains in the bottom and top sides of timber and concrete is present up to a level of 20–30% of F_{max} , and after that, due to excessive tension strength in concrete (crack development) there is a failure of the measuring point S3. All three tested beams of the BF-series are characterized by such a development of strain in the bottom, tensioned concrete zone and it indicates a low level of crack initiation which begins with the development of micro-cracks in concrete. The fact is that beams have a stable performance up until the failure for which an additional 70–80% of load application is needed.

BN-series: The development of strain in the bottom and top sides of timber-concrete parts of BN beams has an approximately linear form up to the failure. The measured strains at the top side of the timber (S2) and the bottom side of the concrete parts (S3) have approximately the same absolute values. This indicates the co-acting of elements and the existence of a high degree of coupling realized by applied connecting systems. The measured strain values are almost equal to zero and have a steady development during the load application up to the point of failure. These results lead to the conclusion that BN-series beams act as homogeneous sections and could be described as rigid coupling representatives.

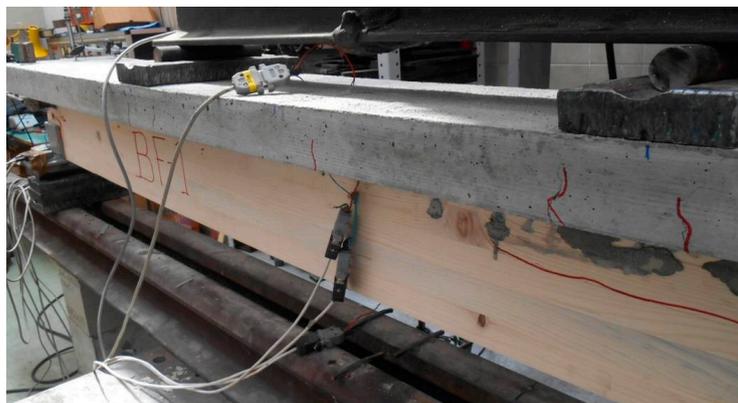
The failure of beam BF-1, which occurred in the support zone due to a horizontal shear in the middle of the timber height and outside the glued lines (10 mm long), is an explicit example of shear failure. Before the failure in the timber part, the cracks occurred in bottom side of the concrete part in the zone of load points, Figure 18. The development of the cracks is obvious, but with openings smaller than the permitted crack width ($a < 0.3$ mm). None of the tested beams showed signs of plasticization in the compressed zone of the concrete part of the cross-section. There was no failure in the concrete part of the cross-section during loading, and the first cracks were observed just before the timber failure i.e., prior to reaching the maximum deflection of the beam.

Figure 18. Failure of BF-1 beam, cracks development in concrete and timber parts.

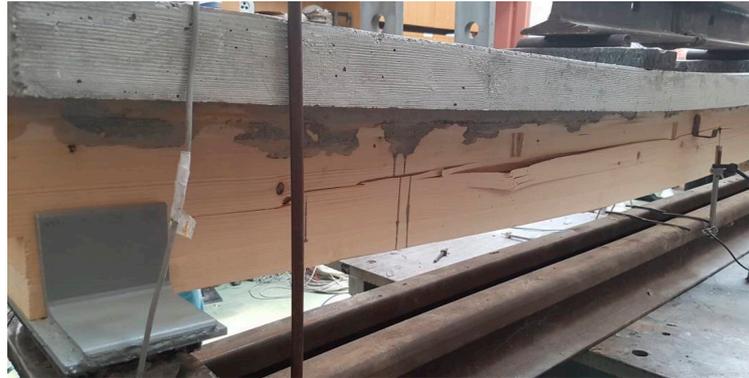
In Figure 19, the beam BF-2 is shown after the failure. The failure mechanisms imply failure was due to reached tension and shear strength limits in timber, with a pronounced splitting in the mid-span of the timber beam and cracking close to a neutral plane along the whole length of the beam. Also, there were indications of cracks in the bottom side of the concrete part. The beam BF-3, Figure 20, had a failure mechanism very similar to BF-2.

Figure 19. Failure of BF-2 beam, crack development in concrete and timber parts.

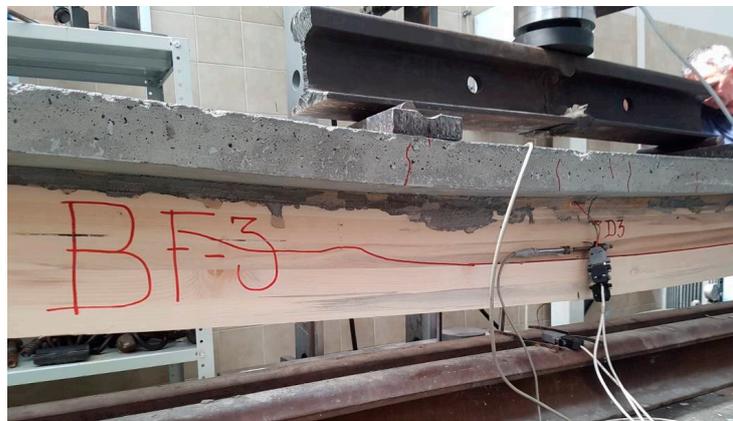
Figure 20. Failure of BF-3 beam, crack development in concrete and timber parts.

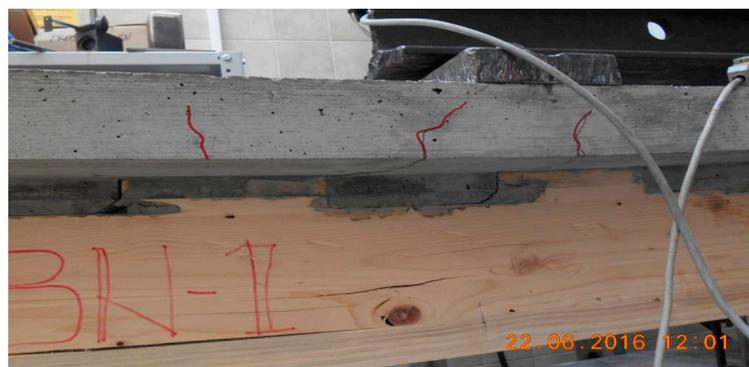
In the tested BN-1 and BN-3 beams, the failure occurred due to the initial failure in the tensioned part of the laminated timber in the middle third of the beam span. It happened suddenly, followed by a loud and abrupt failure of timber, which is a sign of tension failure in timber. The initial failure occurred in the timber part in zones of defects (knots, the glued lamellas with grains inclined along longitudinal direction), Figure 21.

Figure 21. Failure of BN-1 beam, crack development in concrete and timber.

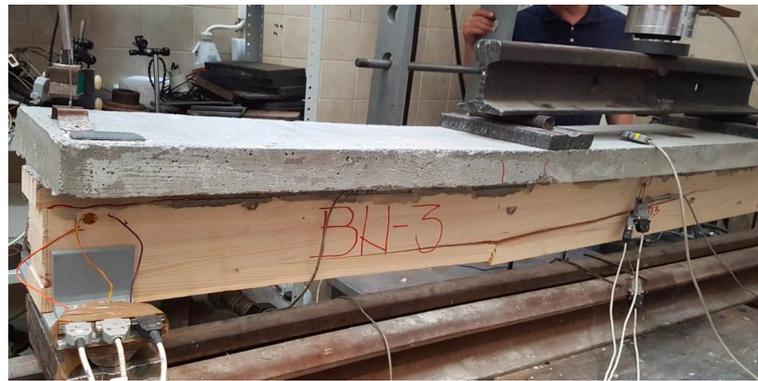
With increasing load and taking into consideration the beam span, further failure development occurs in the form of horizontal or inclined crack lines which go towards the supports, but do not reach them, Figure 22. Due to exceeded tension strength in mid-span of the beam there was pronounced development of cracks in the concrete slab strengthened by the concrete notches reinforced by screws. From that zone to the right and left, there is failure in the notch joint of timber and concrete which grows bigger as it approaches the support.

Figure 22. Failure of BN-3 beam, crack development in concrete and timber.

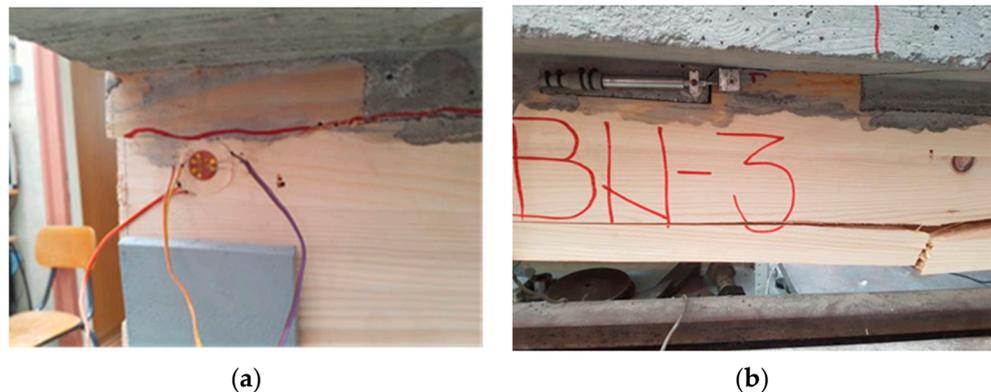
In the left support of the BN-3 specimen, there was a total destruction of the end notch and surrounding timber caused by shear and the horizontal displacement of 12 mm, Figure 23a,b. Compared to BF-series, beams of BN-series have a higher stiffness level. Failure due to excessive tension strength parallel to the grains occurs in the mid-span, but in the lower third of timber cross-section height. With increasing load, the neutral line goes upwards, stresses are transferred to the timber-concrete joint zone and horizontal displacement of the elements of the connecting system was observed. Simultaneous failure occurs due to excessive timber tension strength in the middle third of the span, timber shear strength in the support notches and concrete tension strength in the notch zone.

Figure 23. (a) Failure of the timber part of the support notch of BN-3 beam; (b) Crack development in concrete and timber in the middle third of the span.

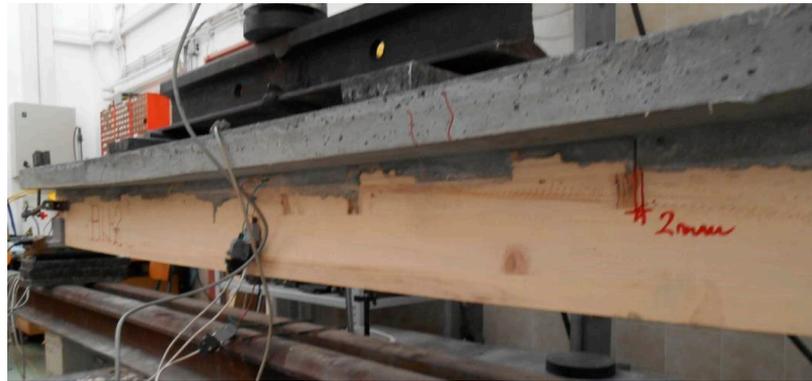
BN-2 beam, with an approximately equal level of applied max loading and reached deflection, shows completely different behavior, i.e., shows behavior similar to the BF specimens. The failure occurred in the right support zone due to an excess of shear stresses and the cracks develop horizontally towards the left support. There is a noticeable

Prior to the failure in the timber part of the beam, concrete cracks in the zone of load points were detected in the thirds of the beam span. The crack development was obvious, going up to the half of the height of the concrete slab, Figure 24. In the notch zone they have perpendicular direction in regard to longitudinal direction of the composite beam. None of the tested beams had any signs of plasticization in the compressed zone of the concrete part or in the compressed zone of the glued laminated timber, except in the support zone due to excessive compression strength perpendicular to the grains in timber (plasticization of 3–5 mm noticed in final steps of loading). No significant plasticization was noticed between the concrete notches and the timber notches due to specific local stresses because of the previously caused timber shear failure parallel to the grains.

Figure 24. Failure of BN-2 beam, crack development in concrete and timber.
