# Effect of Corrosion on Fatigue Failure of Composite Girders with Corrugated Web on Steel Bottom Plate

**Abstract:** Corrosive environments can adversely affect the fatigue performance of bridges and other building structures. In order to determine the influence of corrosion on the fatigue failure of concrete composite girders with a corrugated web on a steel bottom plate (hereinafter referred to as CGCWSB), a scaled model test was conducted on a CGCWSB with a span of 30 m, which served as the structural prototype. Through the model test, theoretical analysis, and numerical simulation, the influence of uniform corrosion and pitting corrosion on the fatigue failure of the CGCWSB was determined, and the propagation law of pitting fatigue crack was determined. The results show that (1) the uniform corrosion caused the stress of the CGCWSB to become larger and the performance of the CGCWSB was reduced, the stress growth of the test girder after corrosion was about 10%, the corrosion rate was 9%, the pitting unevenness coefficient was 1.25, and the relative corrosion life was 26.34 years; (2) the fatigue failure of the non-corroded girder belongs to the weld fatigue failure, and the f

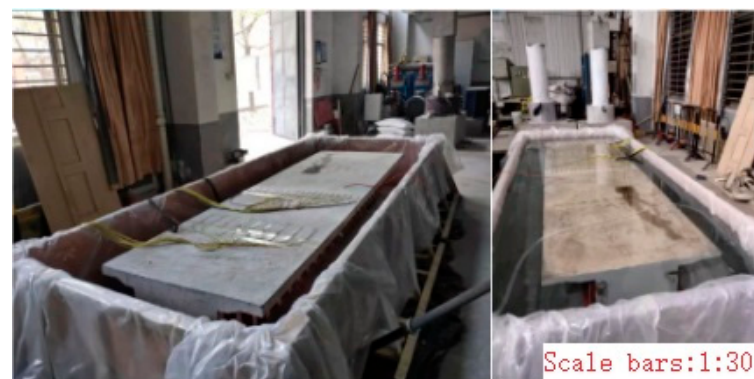
**Figure 4.** Girder corrosion test.

The salt corrosion test adopts long-term immersion method, according to the relevant requirements in the full immersion test method for metallic materials [16]. The general NaCl solution concentration for a steel corrosion test is taken as 2%, 3.5%, and 5%, while the NaCl solution concentration for chloride salt erosion test for concrete structure is higher, such as the NaCl solution concentration of concrete in salt erosion tests in the literature [17] is 5%, 10%, and 16%, respectively. Given that the composite girder material comprises two distinct materials, namely steel and concrete, the NaCl solution concentration for the salt erosion test of the two materials was selected as 6%. One piece of the test girder was immersed in the NaCl solution, which was designated as 2# girders as illustrated in Figure 4. The remaining unimmersed test girders were designated as 1# girders. The chloride salt erosion cycle of reinforced concrete is lengthy, extending throughout the service life of the structure. Considering the chloride salt concentration and the findings of previous chloride salt erosion tests, the immersion period for this corrosion test was 18 months.

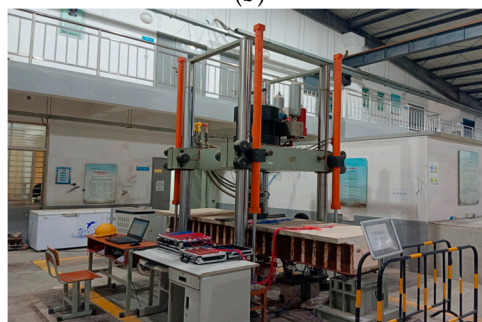
**Figure 5.** Girder fatigue test. (a) Stress–strain sampling system. (b) Fatigue loading system. (c) Test girder loading.

Both test girders underwent fatigue and static tests for the same load rating. There are two types of fatigue loading tests: the fatigue characteristic test and the fatigue failure test. The fatigue load utilizes sinusoidal loads, and the load frequency is determined to be 3 Hz. Specification [18]'s fatigue load calculation model I was used to calculate the fatigue loads of the original bridge. Using the constant load stress value as the lower limit for loading the composite girder model, we assumed the stress value when working with constant load and live load on the girder model as the upper limit value. For 2 million cycles, the fatigue test load was subjected to loads with upper and lower limits of 53.5 kN and 16.5 kN, respectively. The fatigue failure test exhibited an increase in load amplitude and a graded result. Table 1 shows the loading conditions, and Figure 5 displays the fatigue test. Static loading was followed by each level of fatigue loading cycle, which had a maximum load of 80 kN. Test data were collected every 10 kN after static loading.

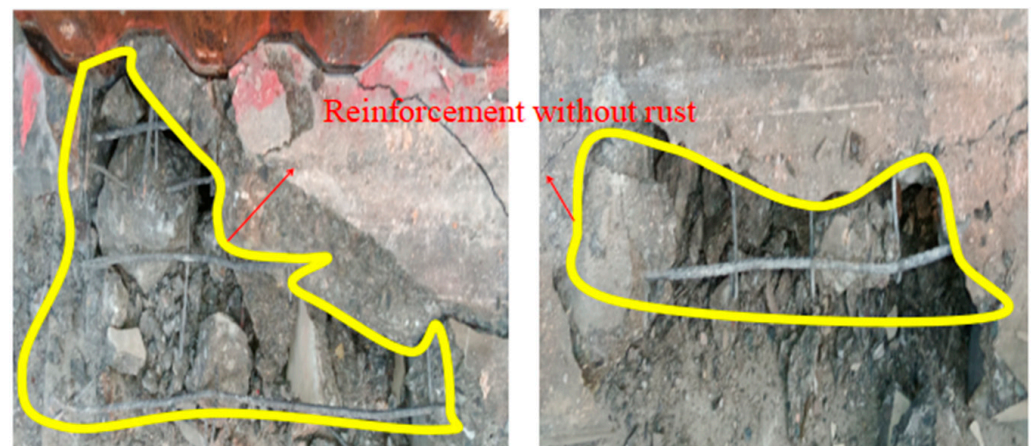
**Figure 8.** Corrosion of reinforcement.

The concrete top slab was smashed after the fatigue test to determine the corrosion results of the reinforcing bars in the top slab of the 2# test girders, as shown in Figure 8. It can be seen that there was no obvious corrosion phenomenon of the test girder reinforcement, i.e., the effective bearing area of the reinforcement was not reduced. As the corrosion ion was chloride ion, the influence of chloride salt on concrete could be ignored, so it can be considered that the effective bearing area of the top plate of the test girder after corrosion was not reduced. Combined with the appearance of the corrosion test girder, it can be considered that the corrosion of chloride salt on the steel bottom plate wave web concrete combination girder was mainly the corrosion of the steel bottom plate. In the process of calculation and analysis, the reduction in the effective bearing area of the test girder was mainly the reduction in the effective bearing area of the bottom plate.

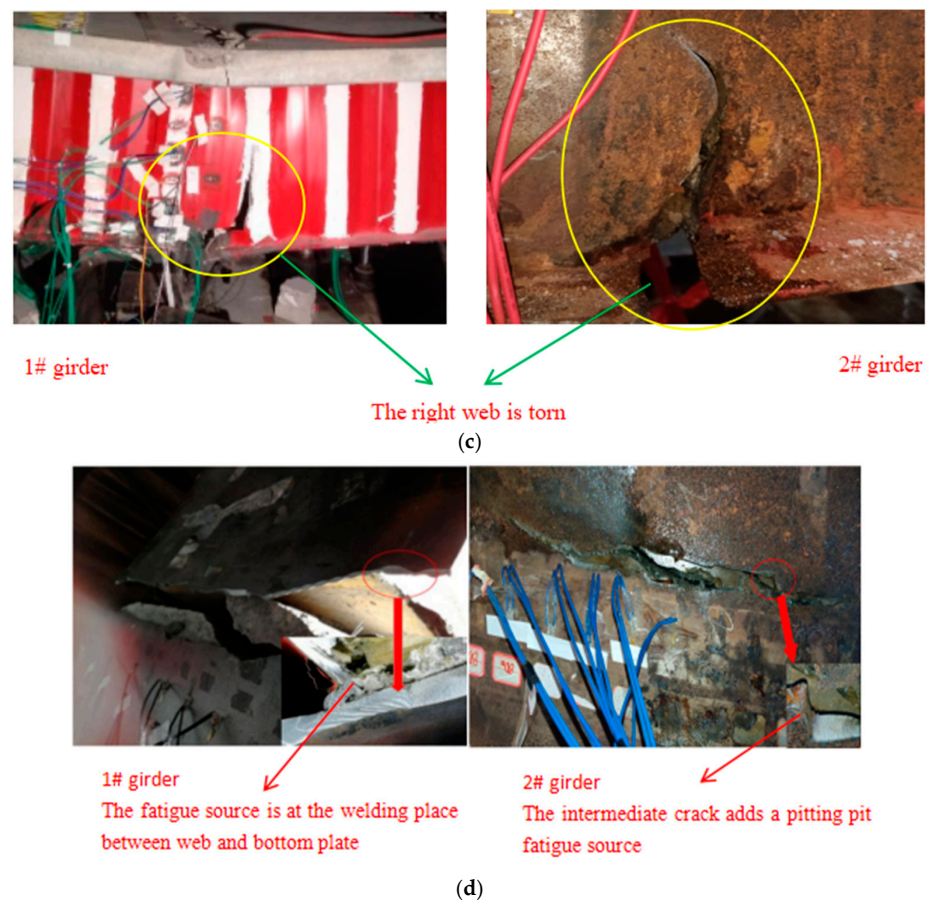
**Figure 10.** Test girder failure pattern and fatigue source. (a) Cracks at the bottom of the girder. (b) Cracks in the left web. (c) Right web crack. (d) Fatigue source.

The final failure of the test girder is shown in Figure 10.

As can be seen from Figure 10, the final failure of the 1# test girder had only one through crack at the bottom of the girder, and the left and right side webs were torn at the moment of the failure of the test girder, forming an upward-developing crack; from the position of the fatigue cracks, the fatigue source of the 1# test girder was located at the welded joints at the interface of the bottom plate and the web, which indicated that the fatigue failure of the test girder was a welded joint fatigue failure and its failure process conformed to the general rule of welded joint fatigue failure. The final failure of the 2# test girder produced three cracks at the bottom of the girder, and in comparison with the failure result of the test girder of 1#, the test girder of 2# also showed the phenomenon that the web plates on both sides were torn at the moment of the failure of the test girder, and tearing cracks upward along the cross-section of the girder were formed, and the form of its failure was still that the fatigue source was located in the welded joints at the interface of the bottom plate and the web plate. The failure was still in the form of fatigue failure of the welded joints located at the interface between the bottom plate and the web plate; the end of the middle crack was far away from the web plate and was not through, which indicated that a pitting pit was formed after salt corrosion and became the fatigue source of fatigue failure, and combined with the position of the "fatigue source" at the corrosion fatigue fracture, it also explained that this fatigue crack formation was due to the fact that the pitting pit had become the fatigue source of fatigue failure. The location of the corrosion fatigue fracture is also shown. Comparing the failure forms of the two test girders, it can be seen that the fatigue failure form of the non-corroded CGCWSB was the weld fatigue failure at the interface between the bottom plate and the web, while the fatigue failure form of the corroded CGCWSB was the coexistence of weld fatigue failure and the pitting fatigue failure phenomenon. From the above analysis, it can be concluded that uniform

corrosion does not affect the weld joints at the interface to become the fatigue source of fatigue failure, while pitting corrosion will form a new fatigue source.
