# Holistic Assessment for Social Housing Retrofitting: Integrating Seismic, Energy, and Social Aspects in the REHOUSE Project

## 2. The Case Study Building

The Italian demo site building (IDSB), also named “Building A”, is part of a residential complex of reinforced concrete social housing units designed in the early 1980s, located in the municipality of Margherita di Savoia, (province of BT, Apulia Region, Figure 1a), being in the “Capitanata” area, which is considered to be one of the most socially vulnerable areas in Italy [19].

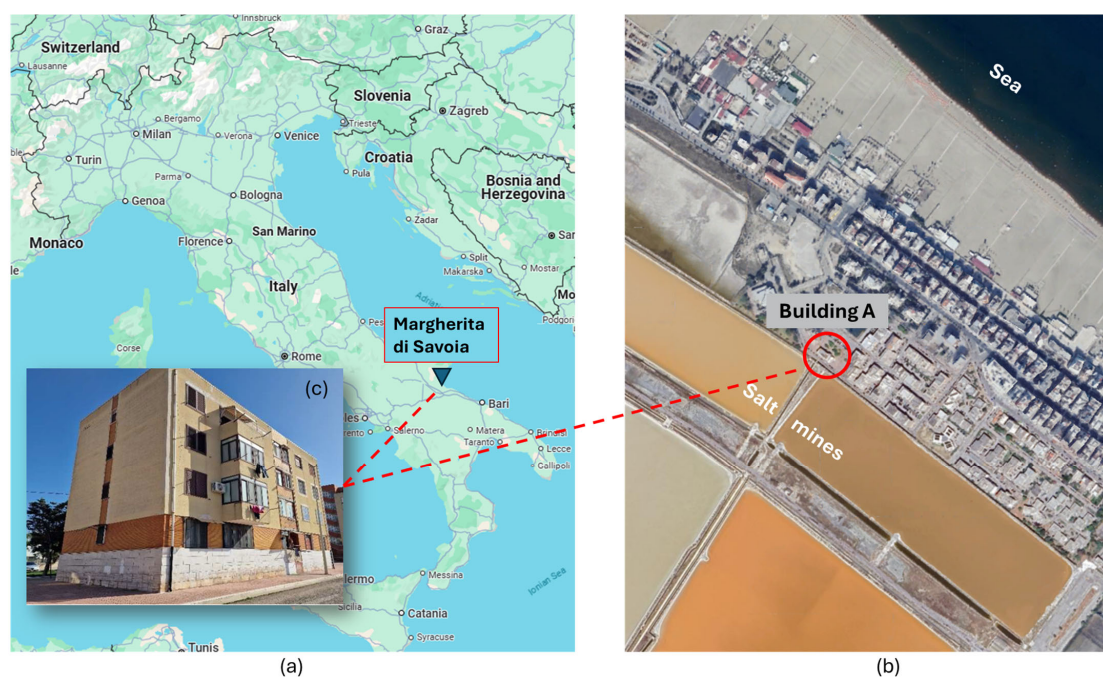
**Figure 1.** (a) Geographical location of Margherita di Savoia; (b) location of building A; (c) building view from the northwest corner.

The building (Figure 1c) is located in a sub-urban context between the salt mines on the southwest side and the sea on the northeast side (Figure 1b). The knowledge about the structural entity from a geometric standpoint, material properties, and reinforcement amount and layout is based on the information gathered from the design documentation made available by ARCA Capitanata, which is the building's owner.

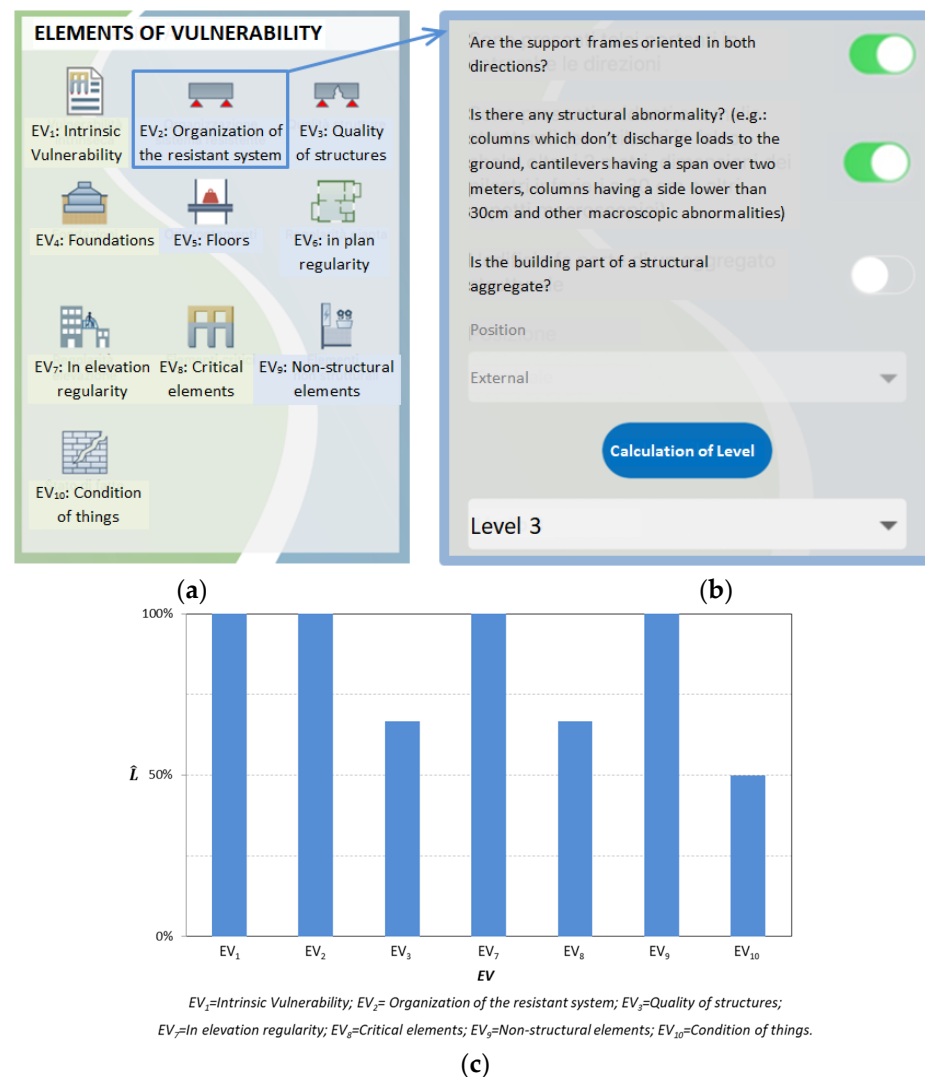
**Figure 5.** (a) List of  $EV_i$  investigated through the app; (b) example of calculation of the level of intervention concerning the organization of the resistant system; (c) synthetic representation of  $EV_i$  with  $\hat{L}_i \geq 50\%$  (extracted from ENEA app “Condomini+ 4.0”).

A preliminary structural assessment of the building was performed through the ENEA app “Condomini+ 4.0” [22]. This evaluation, which can be defined as expeditious and qualitative, is not based on instrumental tests and numerical simulations and therefore does not return a vulnerability analysis. However, resting on well-known structural deficiencies and seismic effects, it enables revealing the structural criticalities inferable from a thorough study of the technical documentation and a visual inspection of the building. A wizard guides the specialist through the investigation of the most representative elements of vulnerability ( $EV_{is}$ ), listed in Figure 5a, up to obtaining an estimation of the level of intervention ( $L_i$ ) expected for each of them. Each  $L_i$  can take a value between 1 and  $L_{i\_max}$ , and it increases with the relevant issues. If  $\hat{L}_i = L_i / L_{i\_max} = 100\%$ , it means that  $L_i$  reached its threshold value and the corresponding  $EV_i$  is highly critical. For the case study, the calculation of the level of intervention concerning the organization of the resistant system is reported, by way of example, in Figure 5b, and all the  $EV_{is}$  with  $\hat{L}_i \geq 50\%$  are synthetically represented in Figure 5c. The corresponding criticalities are briefly described below.

Finally, by weighing all the  $L_{is}$ , the app provides an overall level of intervention ( $L$ ). This parameter is a synthetic index of the structural deficiencies revealed by the investigation and increases on a scale from 1 to 6. For the case study, a value  $L = 4$  was obtained, which means that, overall, the building has a medium–high criticality level, which suggests performing a detailed structural/seismic assessment, as reported in the following.

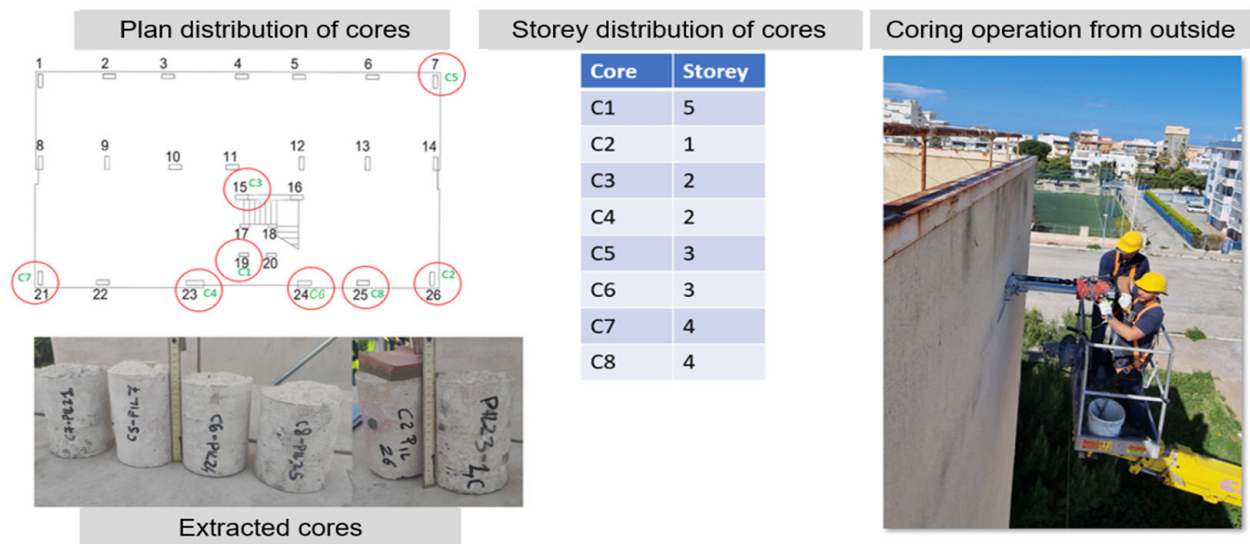
Figure 10. Concrete core drilling (for column and storey numbers, see Figures 2 and 3 respectively).

The building has a floor area of approximately 220 m<sup>2</sup>. To achieve the knowledge level KL2, a total of eight cores were extracted (two per storey). Considering the difficulty of extracting samples from wide beams, the coring activities focused only on the columns. Each core has a diameter of 10 cm and a length of approximately 13 cm (Figure 10). The extraction procedure followed the standards of UNI EN 13791:2019 [9].

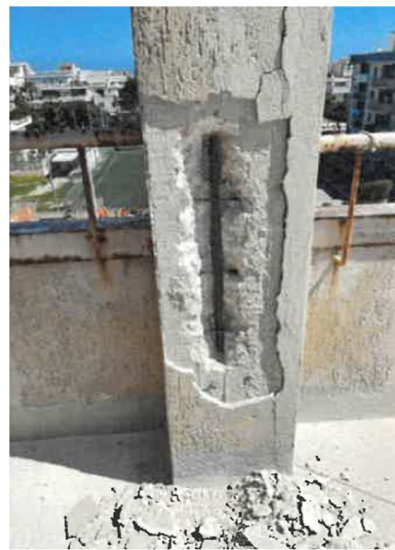
**Figure 11.** A column rebar before the extraction.

The reinforcement-extracted specimens, with a length of approximately 60 cm (Figure 11), underwent tensile failure testing in accordance with standard UNI EN ISO 6892-1:2020 [29].

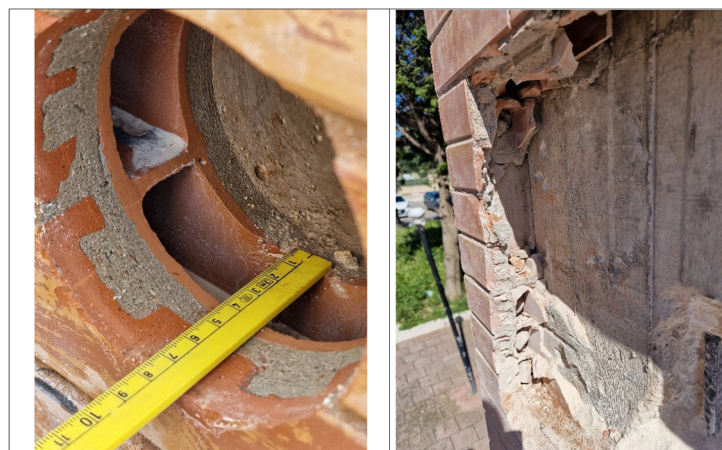
**Figure 18.** Results of the coring tests and visual inspections.

The transmittance, used in the simulation software, was calculated from the results of the coring tests performed on the wall package. In Figure 18, two wall packages are evidenced.
