# Development of Eco-Friendly Soil Improvement Agent for Enhanced Slope Stability and Erosion Control in Urban Areas

**Abstract:** Due to the impact of climate change, extreme rainfall events are becoming more frequent, resulting in shallow slope collapse and erosion that trigger debris flows. While traditional reinforcement methods like anchoring and nailing are effective, they can be costly and environmentally unfriendly. To address this issue, researchers have investigated using in situ soil reinforcement with vegetation, which is a more sustainable and economical option. In this study, a soil improvement agent was developed using leaf mold and herbal medicine to promote vegetation growth. Adding microcement and gypsum hemihydrate increased the shear strength of the soil, preventing surface erosion. A laboratory test confirmed that the combination of these ingredients effectively increased the soil's resistance to erosion caused by rainfall. The soil improvement agent proposed in this study was applied to the case of the slope failure in the Gwangju area, South Korea, to confirm the slope stability for 10 days of rainfall. The results of numerical analysis confirmed that the re

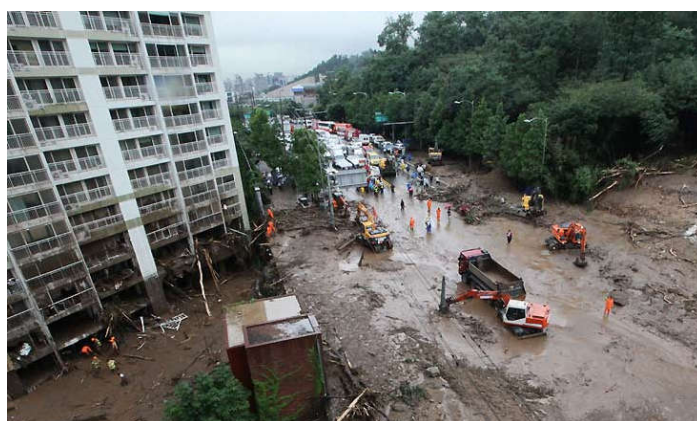
**Figure 1.** Inundation of apartments caused by debris flow on surrounding slopes due to heavy rain (Umyeonsan Mt. in Seoul, Korea, 2011).

On July 27, 2011, many landslides and debris flows occurred simultaneously in the study area. A total of 151 landslides and 33 debris flows expanded from one or more landslides were reported (Figure 1) [1]. While traditional reinforcement methods such as outwardly rugged and threatening anchoring and nailing have been widely used, slopes in urban areas require eco-friendly reinforcement methods to reduce property and human damage. Figure 2 also shows that the slope around the building structure is subject to dangerous conditions due to the weathering and scouring of soil slopes.

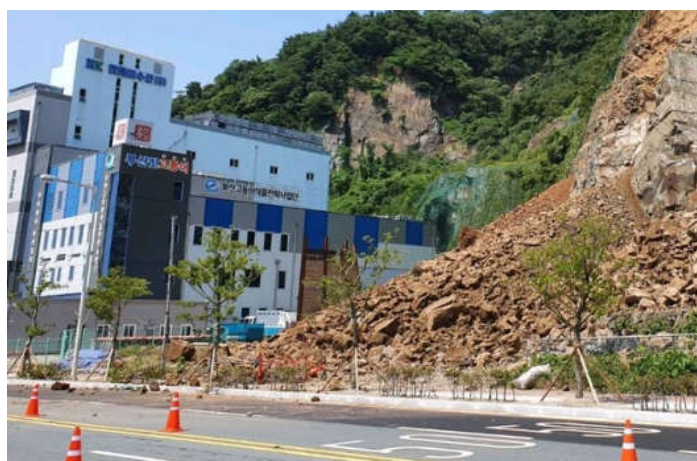
**Figure 2.** Building damage caused by weathering and scouring of soil slope in urban areas (Busan, Korea, 2021).

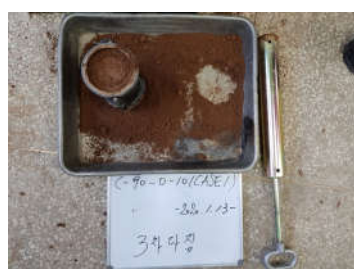
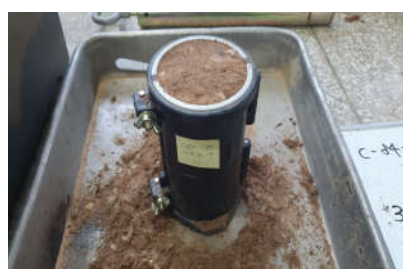
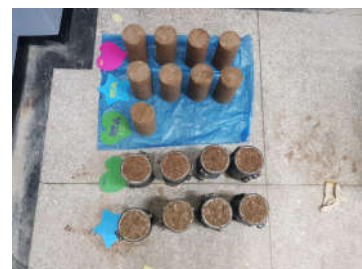
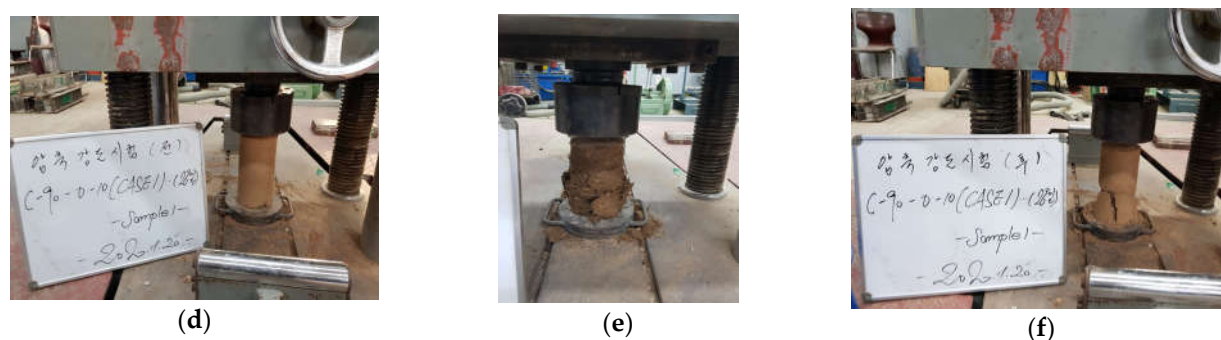
**Figure 3.** Sample preparation and uniaxial compression test. (a) Mixture preparation; (b) compaction of soil mixture; (c) soil mixture with curing time; (d) uniaxial compression test; (e) failure of uniaxial test; (f) measurement by type.

Figure 3 and Table 3 present the results of the uniaxial compression test conducted on cylindrical specimens ( $\varnothing 10 \times 20$  cm) prepared from five soil samples, including the original soil and four soil improvement agents. The test aimed to compare the uniaxial compressive strength of the samples according to the content of the soil improvement agents. The specimens containing cement-based additives, except for the original soil sample, were tested for strength improvement at different curing times (3, 7, and 28 days).

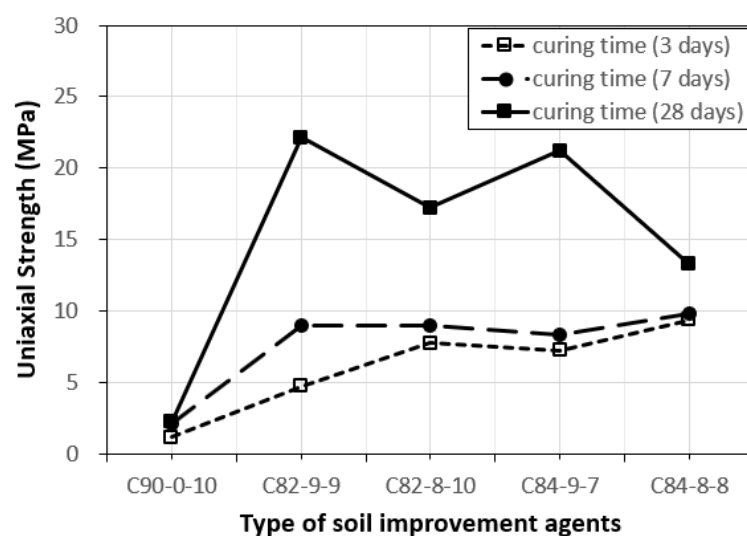
Figure 4. Uniaxial compressive strength of mixed soils.

Figure 4 illustrates the uniaxial compressive strengths of soils mixed with four soil improvement agents, including the original soil (C-90-0-10) sample, at curing times of 3, 7, and 28 days. Among the samples mixed with soil improvement agents, C-84-8-8 showed the highest initial uniaxial compressive strength, but its strength at 28 days was the lowest. On the other hand, C-82-9-9 exhibited the highest uniaxial compressive strength at 28 days, but its initial strength was the lowest. This could be due to the low weight content of the original soil and the significant improvement in strength with increasing curing time, thanks to the high content of the microcement and hardener.

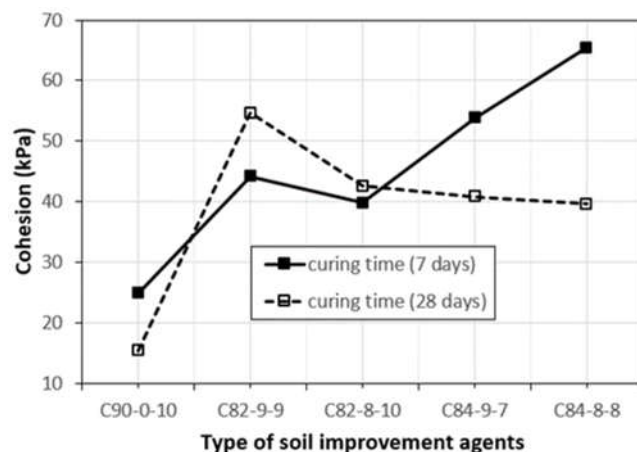
Figure 5. Cohesion variation of mixture.

Figures 5 and 6 present a graphical comparison of the cohesion and internal friction angle results reported in Table 4. The data suggest that the C-82-9-9 soil improvement agent consistently improved the strength of the soil, showing a steady increase in cohesion and the internal friction angle at both 7 and 28 days of age.

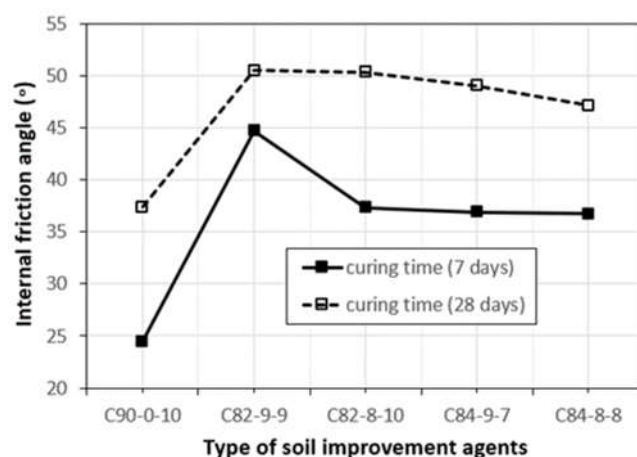
Figure 6. Friction angle variation of mixture.

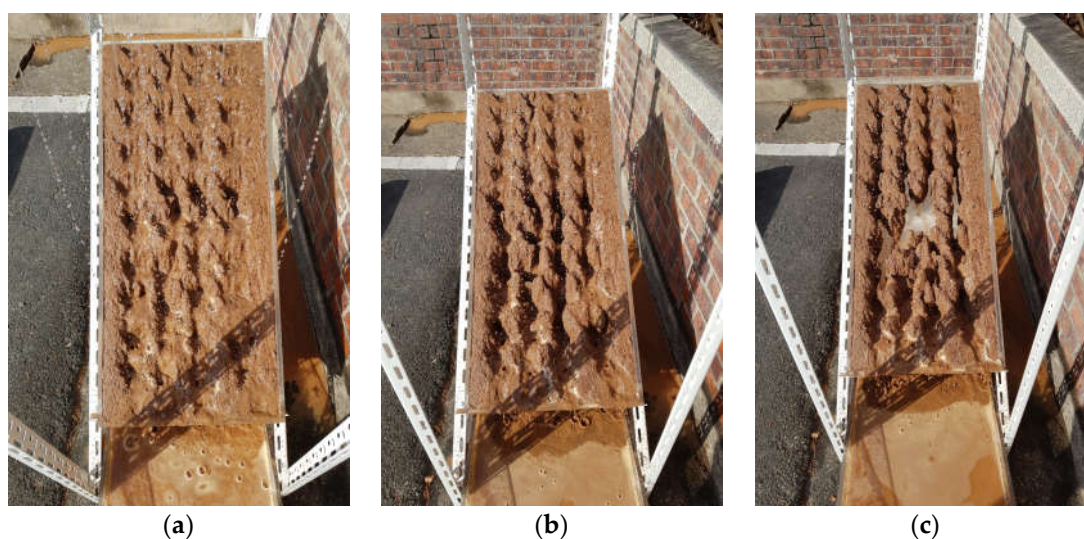
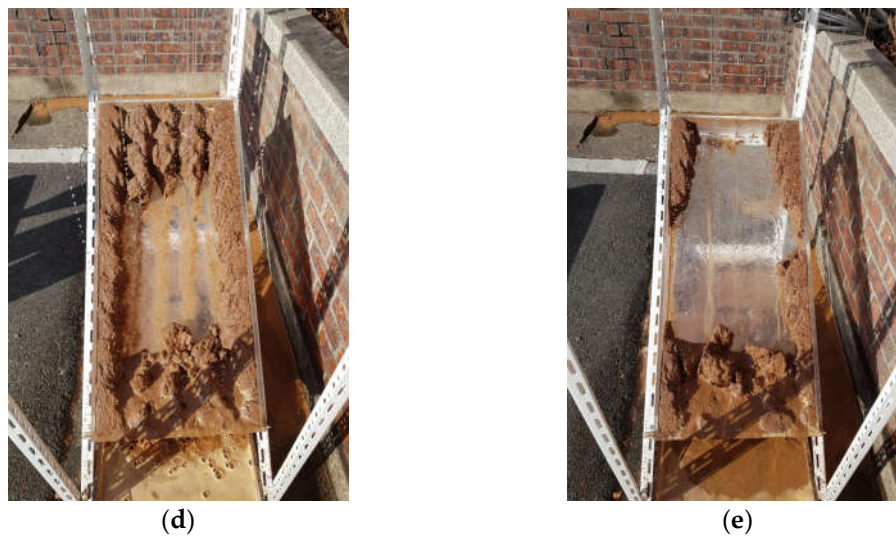
**Figure 8.** Erosion test due to rainfall with various times (original soil: C-90-0-10). (a) 5 min after rainfall; (b) 10 min after rainfall; (c) 15 min after rainfall; (d) 20 min after rainfall; (e) 30 min after rainfall.

To observe and analyze the effects of rainfall on soil erosion and scour, a model test was conducted using a rainfall simulator, wooden frame, and soil box, as depicted in Figures 8 and 9. The test included five samples, including in situ soil, but only photographs of the in situ soil slope and C-82-9-9, which showed the largest difference in the loss rate, were presented as rainfall test results over time, as shown in Figures 8 and 9. The results of the in situ soil (C-90-0-10) rainfall test showed a clear soil loss in the form of scour immediately after the start of rainfall. Over time, the degree of scour became increasingly severe, and after 15 min, rainwater infiltrated the soil and caused the surface to slide, resulting in failure [2,13].

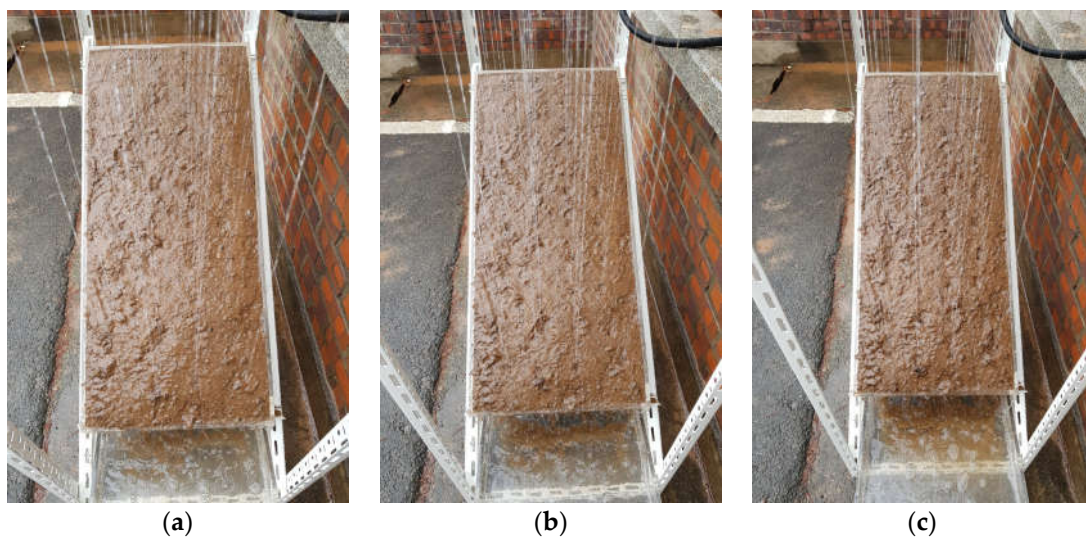
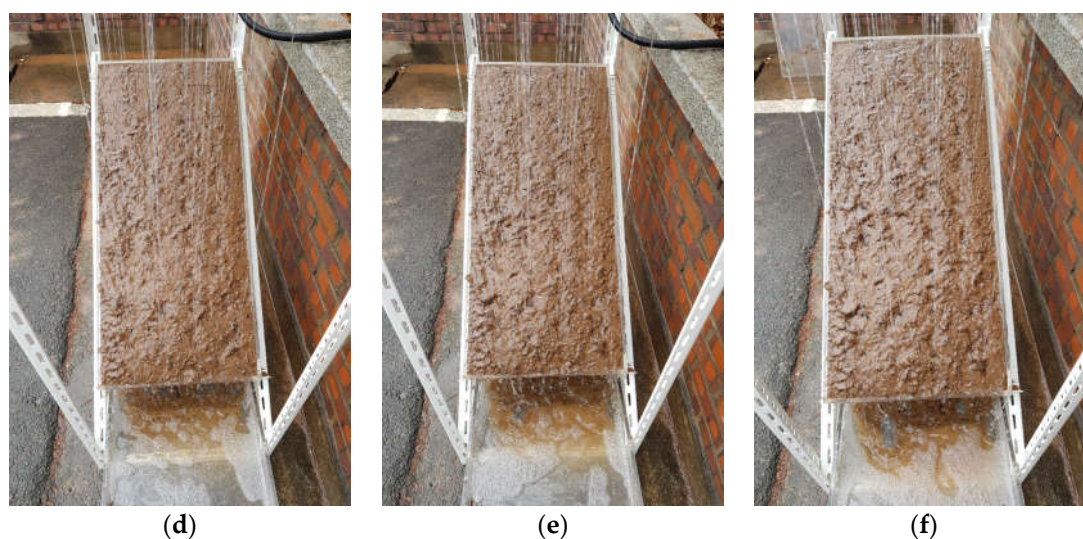
**Figure 9.** Erosion test due to rainfall with various times (mixed soil: C-82-9-9). (a) 5 min after rainfall; (b) 10 min after rainfall; (c) 20 min after rainfall; (d) 30 min after rainfall; (e) 40 min after rainfall; (f) 60 min after rainfall.

As shown in Figure 9, the rainfall test results of C-82-9-9 demonstrate that the surface soil loss was significantly reduced, and the properties of the surface were maintained immediately after rainfall, unlike in situ soil (C-90-0-10). In the rainfall test results of C-82-8-10, the soil loss was reduced compared to in situ soil (C-90-0-10), and scour loss caused by a fall did not occur. In the rainfall test results of C-84-9-7, scour caused by a fall occurred, but almost no soil loss occurred compared to in situ soil. In the rainfall test results of C-84-8-8, the soil loss was significantly reduced compared to in situ soil (C-90-0-10). However, scouring began to occur on the surface due to the fall of rainwater after 30 min, even though there was almost no surface loss until 20 min.

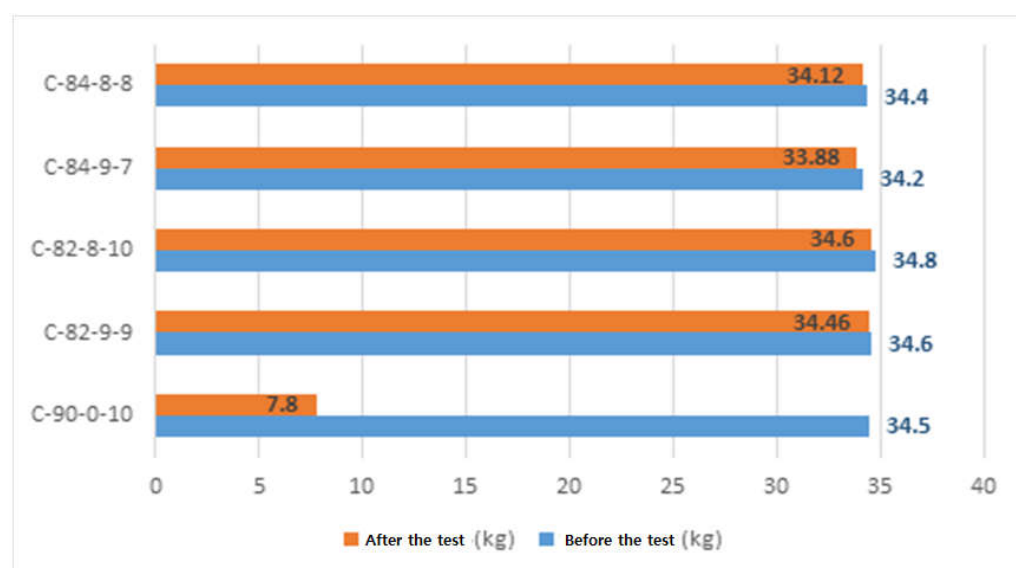
**Figure 10.** Erosion test due to rainfall over time (mixed soil: C-82-9-9).

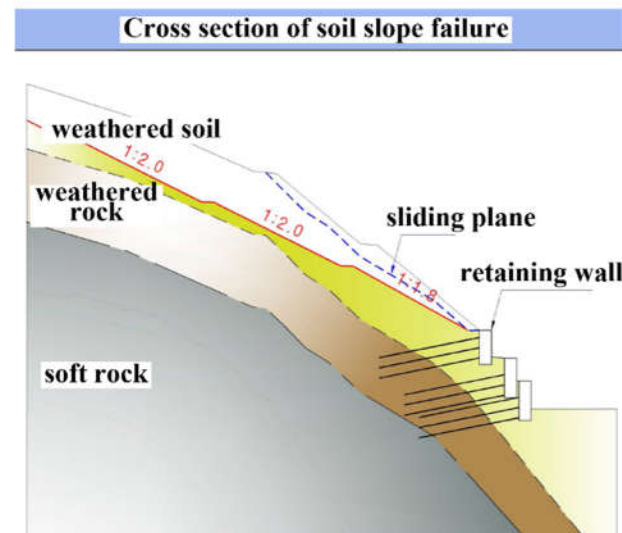
Figure 11. Cross-section of collapsed slope.

Figure 11 shows a cross-section of the slope reinforcement design. The site slope was gentler (1:1.7 to 1.4) than a standard slope (1:1.2 to 1.5); however, many traces of scouring in the form of shallow failures owing to heavy rainfall were found. Figure 12 shows the location of the collapse of the retaining wall's slope behind the high school building. The site covered by blue tarpaulin is the area where the collapse occurred. The failure occurred in the soil layer; however, there was no damage to the retaining wall structure.

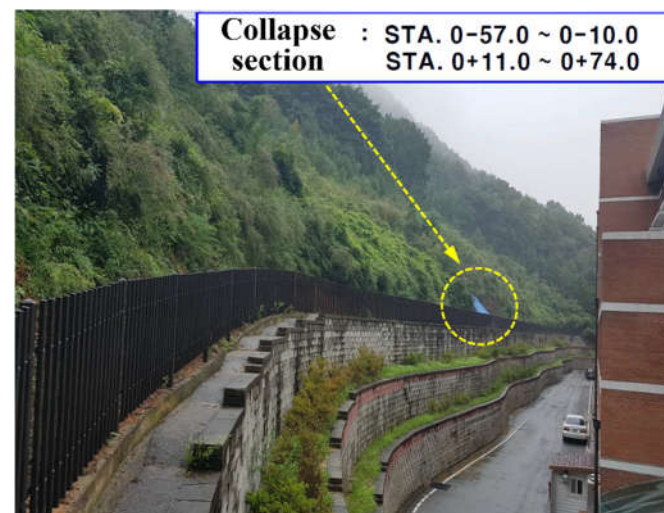
Figure 12. Slope failure site behind the high school building.

The slope behind the high school collapsed on 31 August 2018, due to heavy rainfall. The slope section where the surface layer collapsed has already been repaired and reinforced by the soil nailing method, but numerical analysis was performed to compare

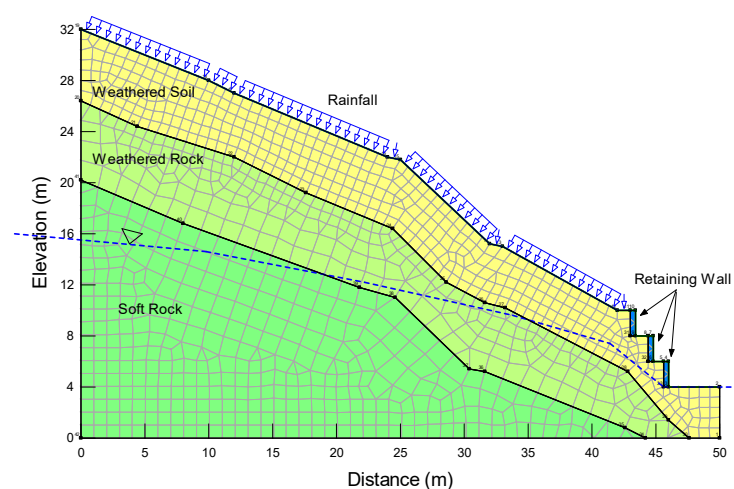
**Figure 14.** Initial condition for seepage and stability analysis, in situ [15].

The boundary conditions were set according to the retaining wall's design conditions, as shown in Figures 14 and 15, and the slope stability was examined in

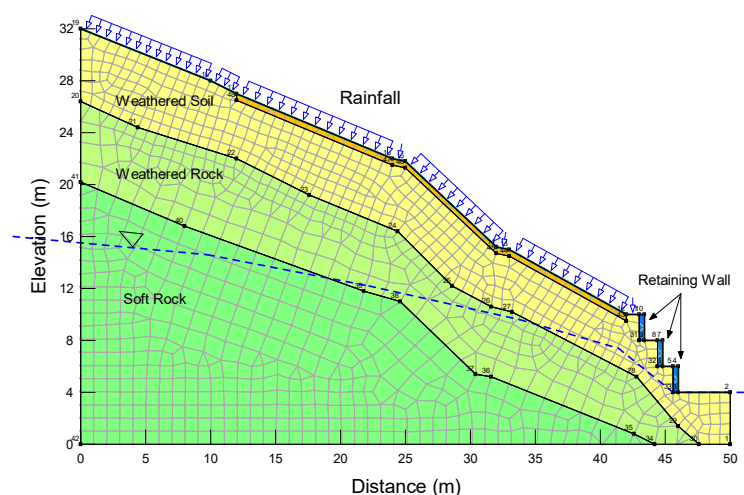
**Figure 15.** Initial condition for seepage and stability analysis with soil improvement agent [15].

connection with seepage analysis for ten days. Figure 15 shows the geometry mesh for comparing the safety factor by reinforcing the surface layer of the slope with a thickness of 50 cm with a soil improvement agent (orange color).

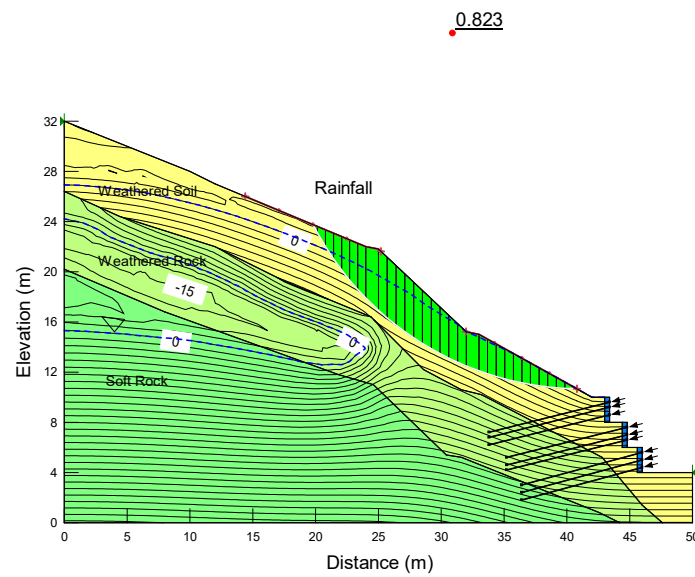
**Figure 18.** Erosion and scour due to rainfall (after 10 days,  $F_s = 0.823$ ).

Figures 16–19 show the results of the safety factor of slopes on the second and last 10 days after rainfall. The second day is the initial period of rain, and the safety factor of the slope rose from 1.175 to 1.352 after reinforcement with soil improvement agent. After 10 days of rainfall, the slope collapsed, but it was analyzed that soil slope by reinforcement did not cause collapse due to an increase in the safety factor. The arrows indicate that the anchor's tensile force is acting on the retaining wall.

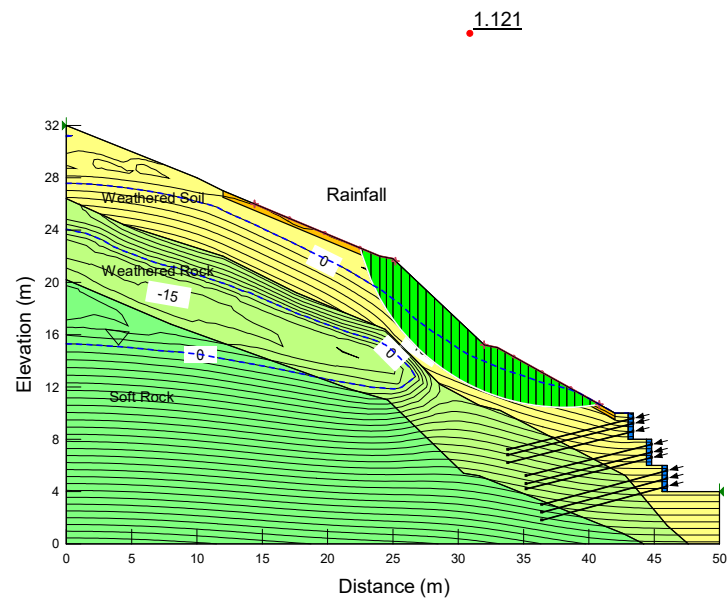
**Figure 19.** Reinforcement by soil improvement agent (after 10 days,  $F_s = 1.121$ ).

Figure 19 shows the change in which the safety factor of the slope increases due to the reinforcement of the soil improvement agent. In situ, rainfall continued for 10 days, causing collapse as the instability of the slope increased, but it was confirmed that the stability of the slope was maintained by the application of the soil improvement agent developed in this study.

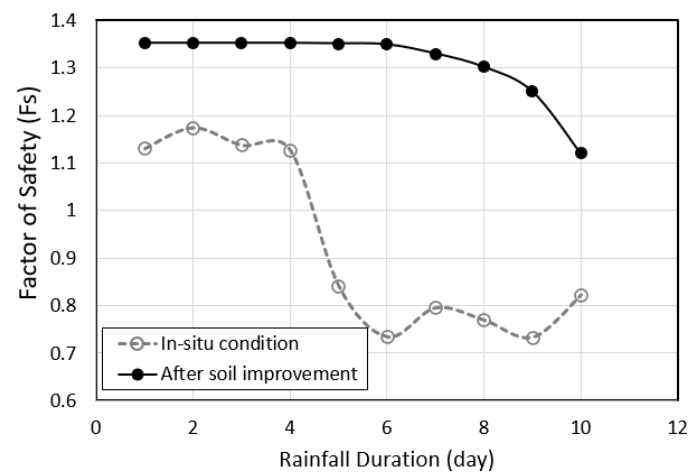
**Figure 20.** Change in safety factor before and after reinforcement with soil improvement agent.

Figure 20 shows a result comparing the safety factors of the slope composed of the original soil and the slope reinforced with the soil improvement agent. As rainfall continues, the difference in safety factors increases, and it can be seen that at this site, as the rainfall duration elapses by 5 days, a risk of slope failure occurs.
