# Development of Eco-Friendly Soil Improvement Agent for Enhanced Slope Stability and Erosion Control in Urban Areas

Dae-Hung Kang

and Jaehong Kim \*

Department of Civil and Environmental Engineering, Dongshin University, Naju 58245, Republic of Korea; tycoon@dsu.ac.kr

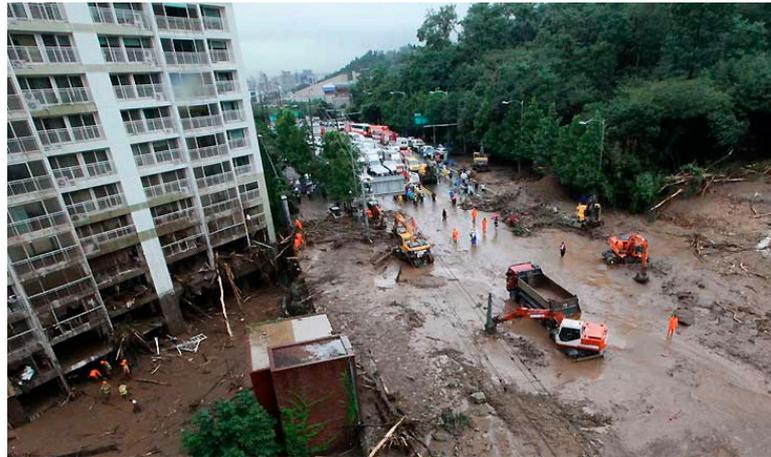
**Figure 1.** Inundation of apartments caused by debris flow on surrounding slopes due to heavy rain (Umyeonsan Mt. in Seoul, Korea, 2011).

On 27 July 2011, many landslides and debris flows occurred simultaneously in the study area. A total of 151 landslides and 33 debris flows expanded from one or more landslides were reported (Figure 1) [1]. While traditional reinforcement methods such as outwardly rugged and threatening anchoring and nailing have been widely used, slopes in urban areas require eco-friendly reinforcement methods to reduce property and human damage. Figure 2 also shows that the slope around the building structure is subject to dangerous conditions due to the weathering and scouring of soil slopes.

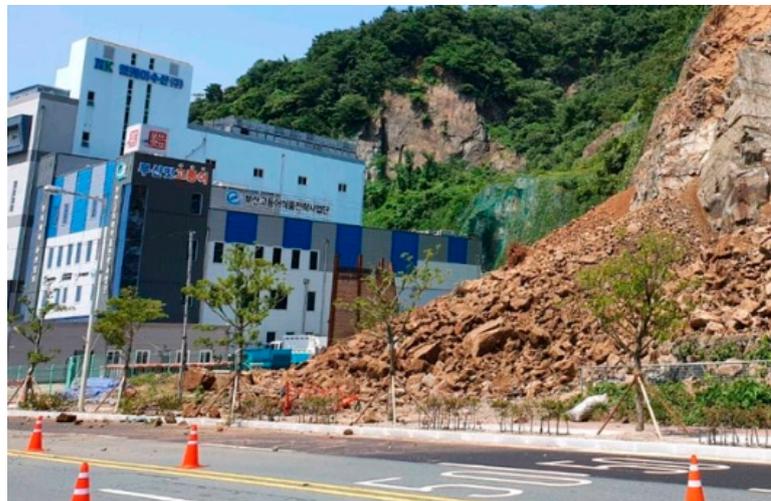
**Figure 2.** Building damage caused by weathering and scouring of soil slope in urban areas (Busan, Korea, 2021).

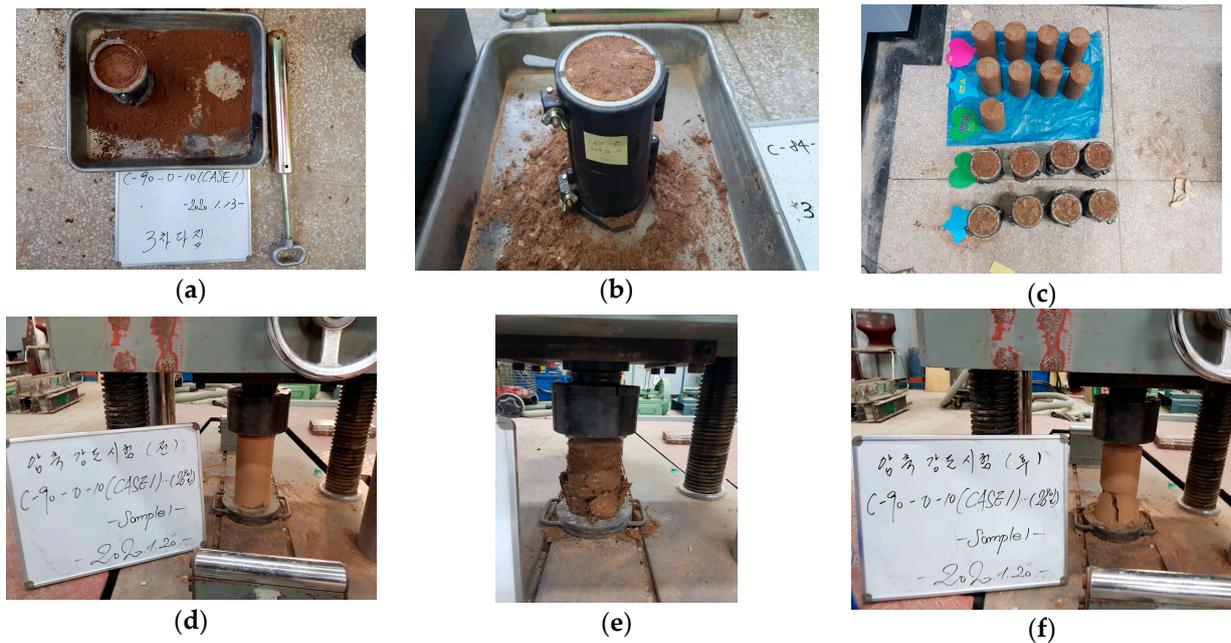
**Figure 3.** Sample preparation and uniaxial compression test. (a) Mixture preparation; (b) compaction of soil mixture; (c) soil mixture with curing time; (d) uniaxial compression test; (e) failure of uniaxial test; (f) measurement by type.

Figure 3 and Table 3 present the results of the uniaxial compression test conducted on cylindrical specimens ( $\varnothing 10 \times 20$  cm) prepared from five soil samples, including the original soil and four soil improvement agents. The test aimed to compare the uniaxial compressive strength of the samples according to the content of the soil improvement agents. The specimens containing cement-based additives, except for the original soil sample, were tested for strength improvement at different curing times (3, 7, and 28 days).

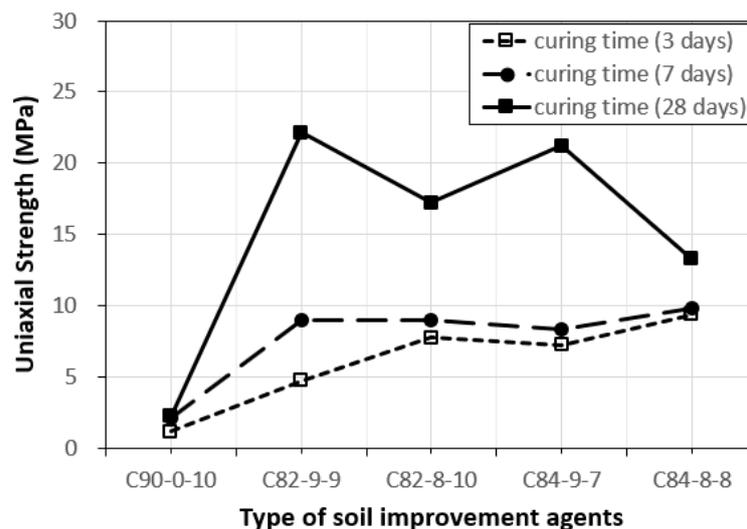
**Figure 4.** Uniaxial compressive strength of mixed soils.

Figure 4 illustrates the uniaxial compressive strengths of soils mixed with four soil improvement agents, including the original soil (C-90-0-10) sample, at curing times of 3, 7, and 28 days. Among the samples mixed with soil improvement agents, C-84-8-8 showed the highest initial uniaxial compressive strength, but its strength at 28 days was the lowest. On the other hand, C-82-9-9 exhibited the highest uniaxial compressive strength at 28 days, but its initial strength was the lowest. This could be due to the low weight content of the original soil and the significant improvement in strength with increasing curing time, thanks to the high content of the microcement and hardener.

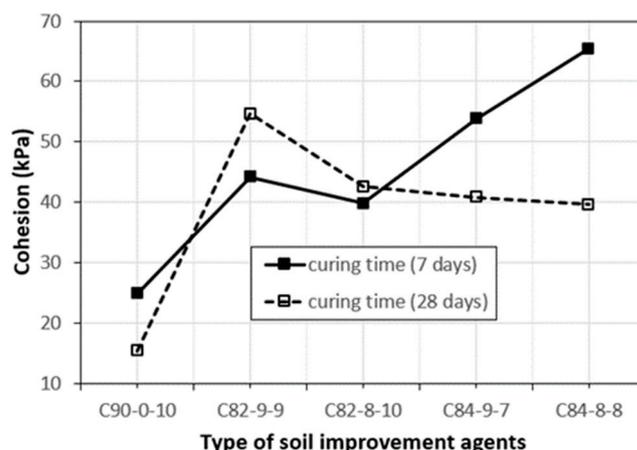
**Figure 5.** Cohesion variation of mixture.

Figures 5 and 6 present a graphical comparison of the cohesion and internal friction angle results reported in Table 4. The data suggest that the C-82-9-9 soil improvement agent consistently improved the strength of the soil, showing a steady increase in cohesion and the internal friction angle at both 7 and 28 days of age.

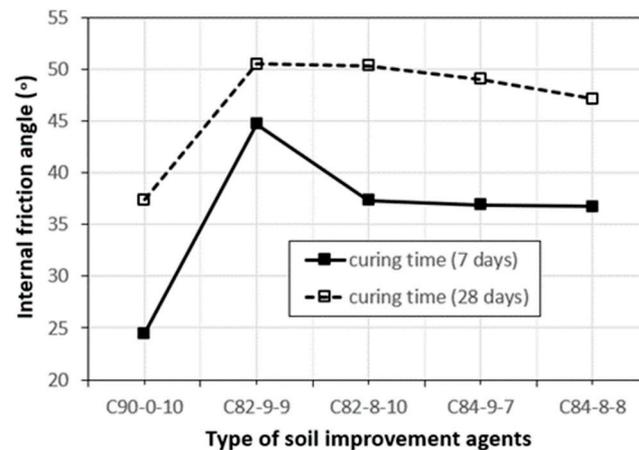
Figure 6. Friction angle variation of mixture.

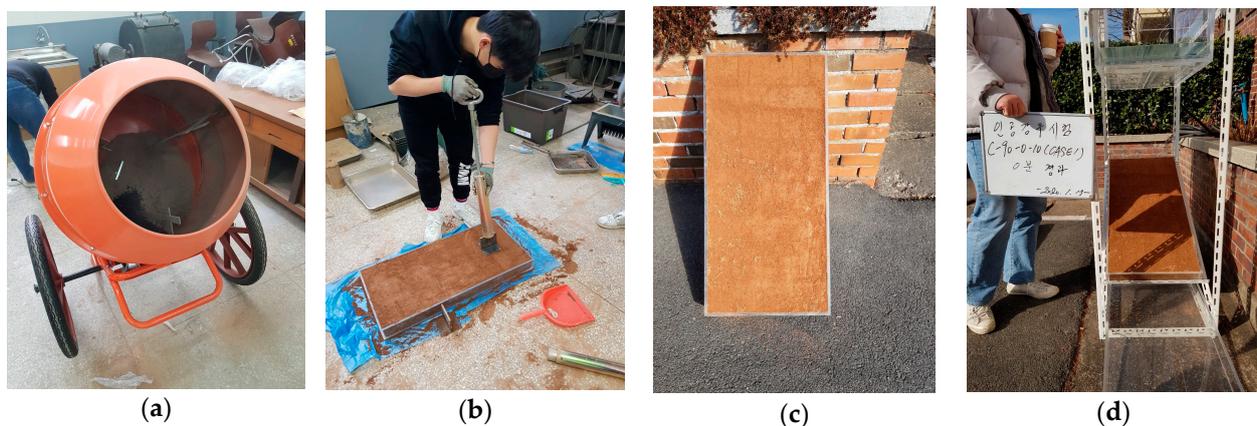
Figure 7. Experimental procedure for soil slope erosion test by rainfall. (a) mixing process of samples; (b) compaction of soil mixture; (c) curing time by type; (d) slope frame set for rainfall test.

An experimental setup was created in the laboratory to investigate the effectiveness of materials in reinforcing the ground surface against heavy rainfall. To analyze the surface failure types and scour in response to soil improvement agents, soil slope plates were prepared, and an experimental setup was constructed as shown in Figure 7. The original soil was mixed with additives and compacted to create soil slope models. The test was then conducted by simulating rainfall conditions artificially. Rectangular soil slope plates ( $40 \times 84 \times 7$  cm) were fabricated as specimens to resemble the slope conditions, and they were supported by an angle frame, as shown in Figure 7d. Four specimens were prepared for each test case with a compaction rate of over 90%, and the slope of the model test slope was set to 1:1.5 (vertical–horizontal), based on the design standards of the Ministry of Land, Infrastructure, and Transport [3] for slopes ranging from 0 to 6 m in height and 5 m or higher in cutting earth slope. An acrylic box was also created to function as a rainfall simulator capable of storing water. The rainfall model test for erosion in the soil slope applied a rainfall intensity of 30 mm/hr, which is the average value of showers most common during the rainy season in South Korea. The experimental setup allowed for the examination of the surface failure types and scour, taking into account the effects of various soil improvement agents on the slope.

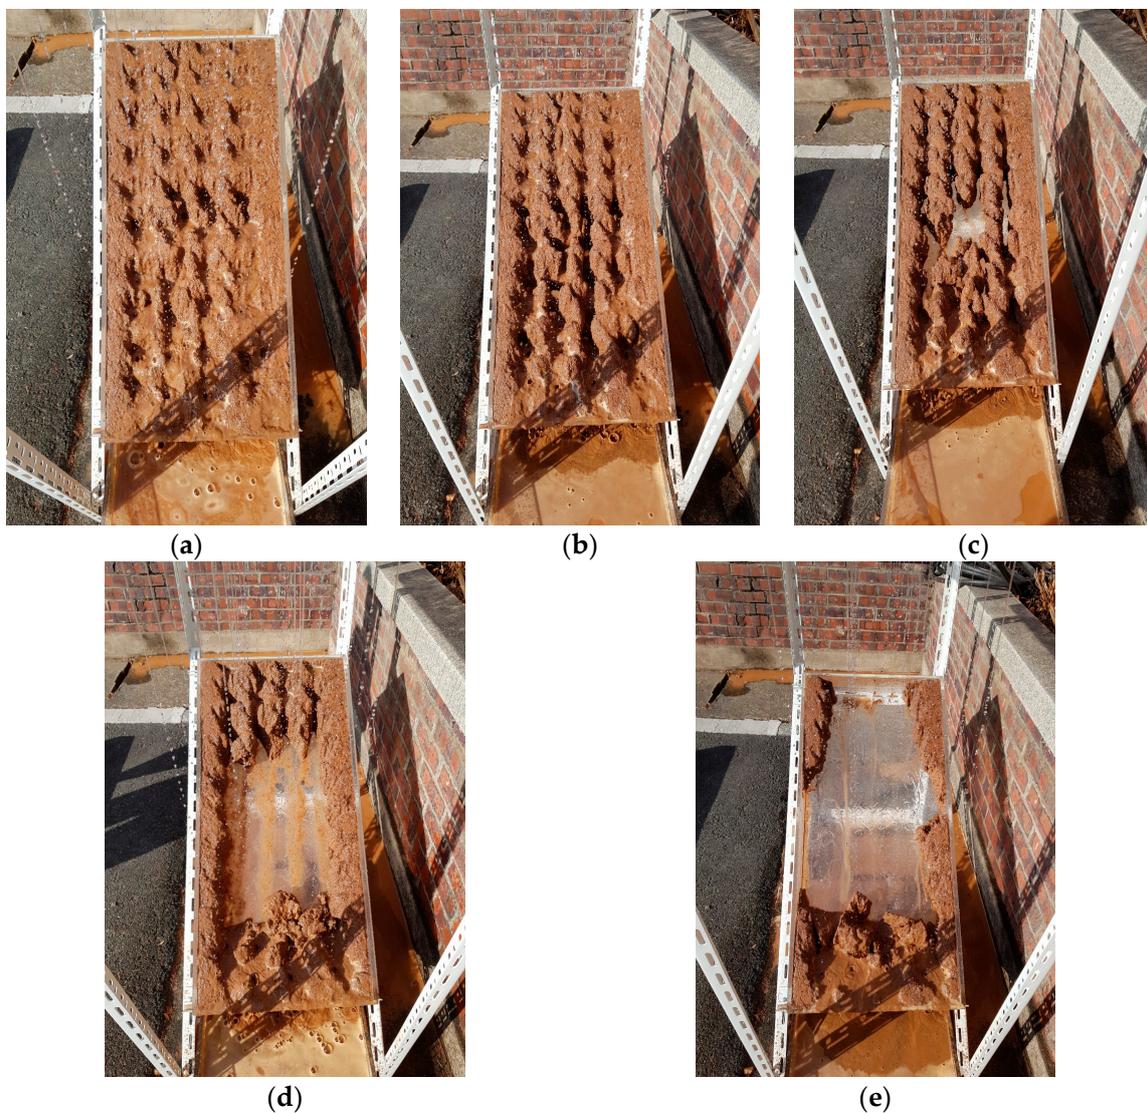
**Figure 8.** Erosion test due to rainfall with various times (original soil: C-90-0-10). (a) 5 min after rainfall; (b) 10 min after rainfall; (c) 15 min after rainfall; (d) 20 min after rainfall; (e) 30 min after rainfall.

Figures 8 and 9. The test included five samples, including in situ soil, but only photographs of the in situ soil slope and C-82-9-9, which showed the largest difference in the loss rate, were presented as rainfall test results over time, as shown in Figures 8 and 9. The results of the in situ soil (C-90-0-10) rainfall test showed a clear soil loss in the form of scour immediately after the start of rainfall. Over time, the degree of scour became increasingly severe, and after 15 min, rainwater infiltrated the soil and caused the surface to slide, resulting in failure [2,13].

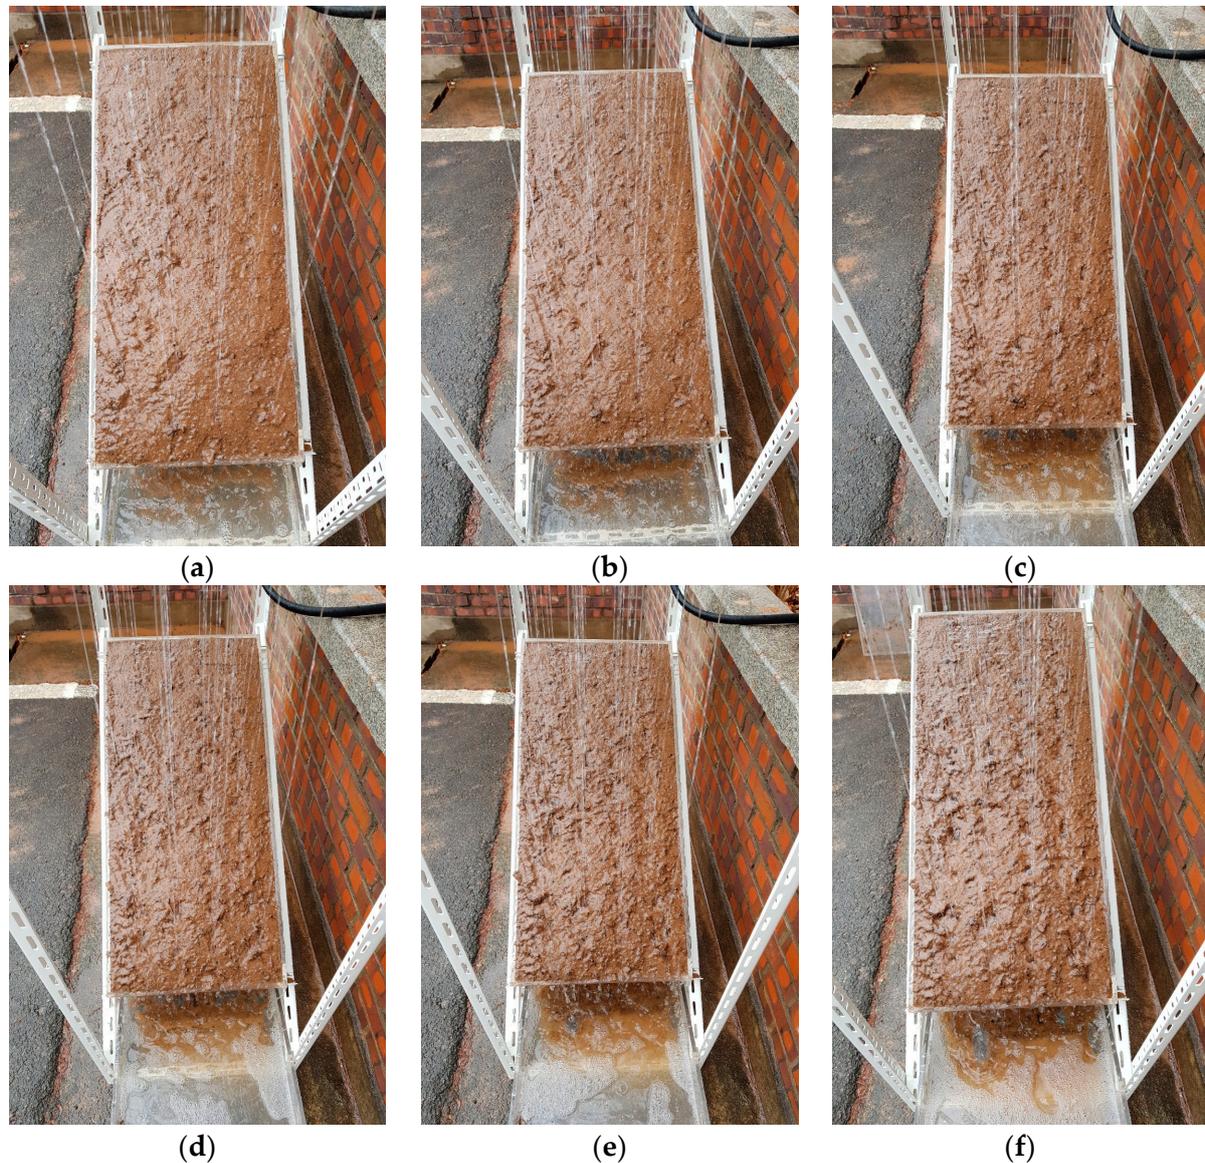
**Figure 9.** Erosion test due to rainfall with various times (mixed soil: C-82-9-9). (a) 5 min after rainfall; (b) 10 min after rainfall; (c) 20 min after rainfall; (d) 30 min after rainfall; (e) 40 min after rainfall; (f) 60 min after rainfall.

As shown in Figure 9, the rainfall test results of C-82-9-9 demonstrate that the surface soil loss was significantly reduced, and the properties of the surface were maintained immediately after rainfall, unlike in situ soil (C-90-0-10). In the rainfall test results of C-82-8-10, the soil loss was reduced compared to in situ soil (C-90-0-10), and scour loss caused by a fall did not occur. In the rainfall test results of C-84-9-7, scour caused by a fall occurred, but almost no soil loss occurred compared to in situ soil. In the rainfall test results of C-84-8-8, the soil loss was significantly reduced compared to in situ soil (C-90-0-10). However, scouring began to occur on the surface due to the fall of rainwater after 30 min, even though there was almost no surface loss until 20 min.

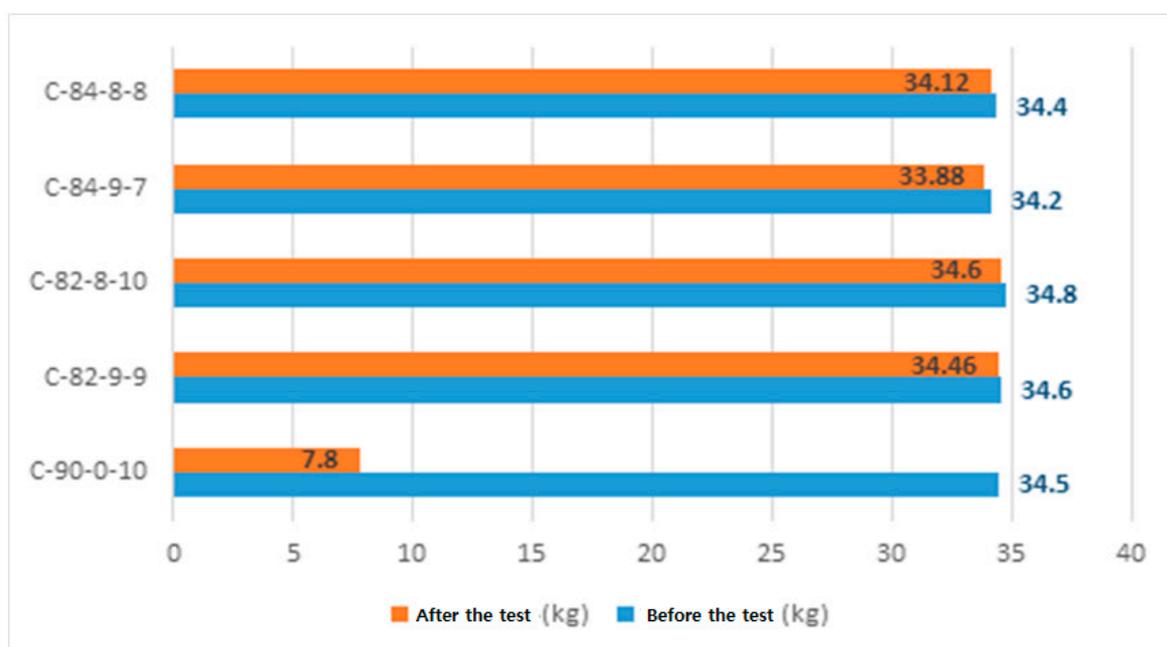
**Figure 10.** Erosion test due to rainfall over time (mixed soil: C-82-9-9).

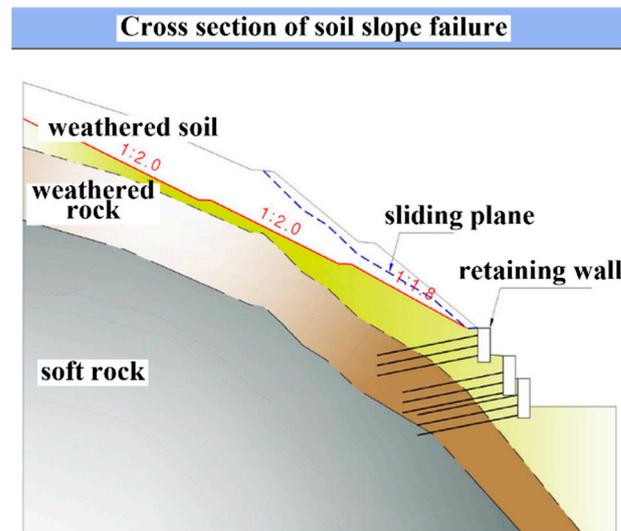
Figure 11. Cross-section of collapsed slope.

Figure 11 shows a cross-section of the slope reinforcement design. The site slope was gentler (1:1.7 to 1.4) than a standard slope (1:1.2 to 1.5); however, many traces of scouring in the form of shallow failures owing to heavy rainfall were found. Figure 12 shows the location of the collapse of the retaining wall's slope behind the high school building. The site covered by blue tarpaulin is the area where the collapse occurred. The failure occurred in the soil layer; however, there was no damage to the retaining wall structure.

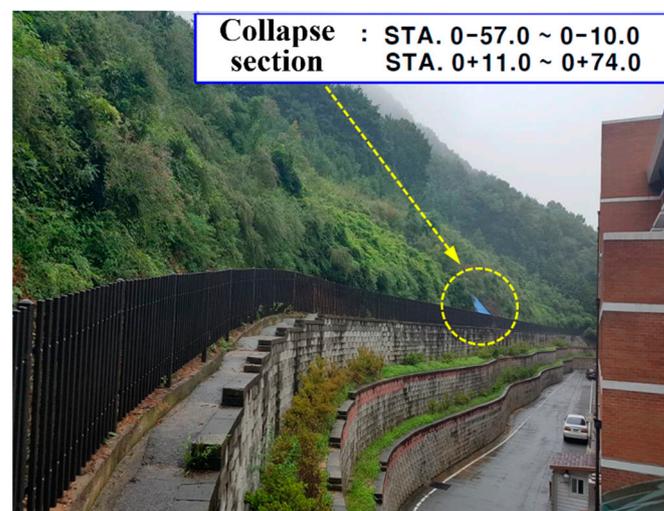
Figure 12. Slope failure site behind the high school building.

The slope behind the high school collapsed on 31 August 2018, due to heavy rainfall. The slope section where the surface layer collapsed has already been repaired and reinforced by the soil nailing method, but numerical analysis was performed to compare the slope

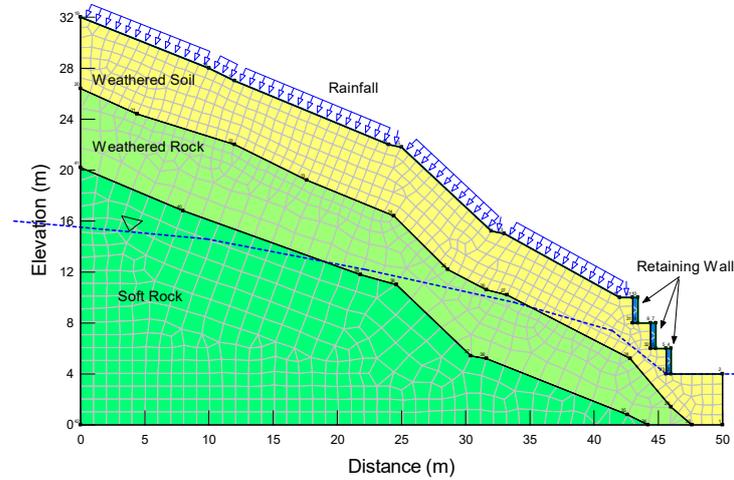
**Figure 14.** Initial condition for seepage and stability analysis, in situ [15].

The boundary conditions were set according to the retaining wall's design conditions, as shown in Figures 14 and 15, and the slope stability was examined in connection with

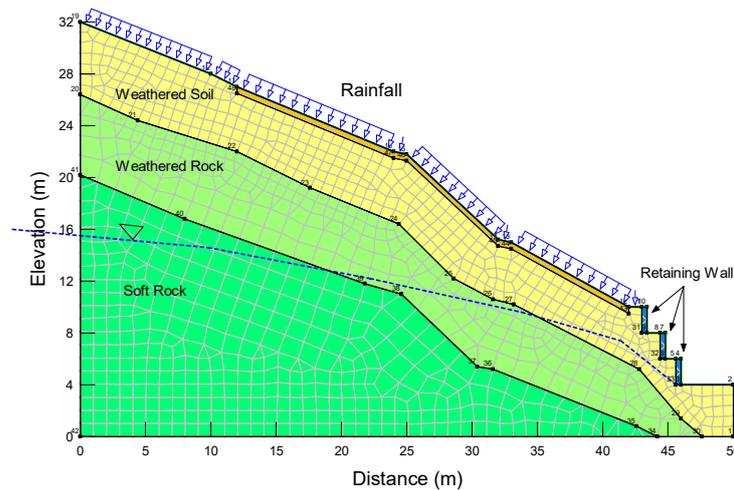
**Figure 15.** Initial condition for seepage and stability analysis with soil improvement agent [15].

seepage analysis for ten days. Figure 15 shows the geometry mesh for comparing the safety factor by reinforcing the surface layer of the slope with a thickness of 50 cm with a soil improvement agent (orange color).

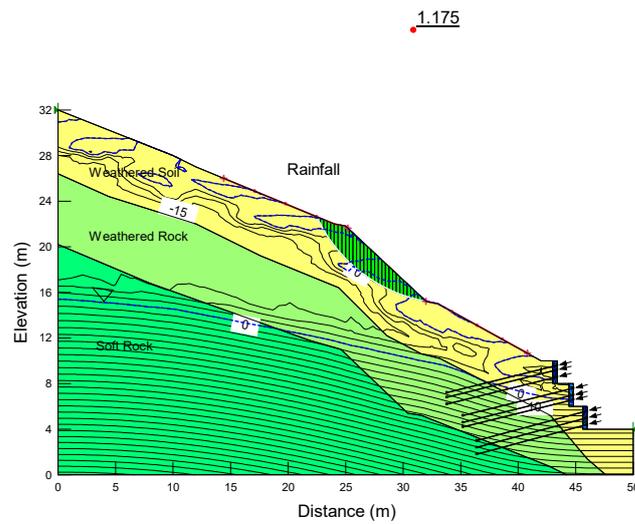
Figure 16. Erosion and scour due to rainfall (after 2 days,  $F_s = 1.175$ ).

Figures 16–19 show the results of the safety factor of slopes on the second and last 10 days after rainfall. The second day is the initial period of rain, and the safety factor of the slope rose from 1.175 to 1.352 after reinforcement with soil improvement agent. After 10 days of rainfall, the slope collapsed, but it was analyzed that soil slope by reinforcement did not cause collapse due to an increase in the safety factor. The arrows indicate that the anchor's tensile force is acting on the retaining wall.

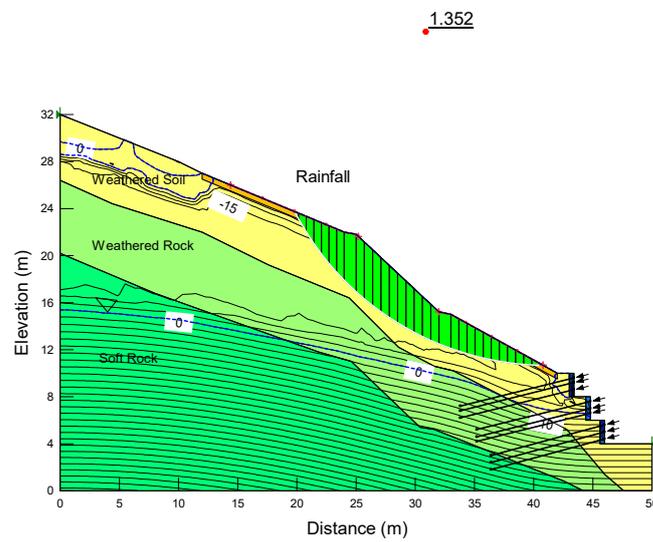
Figure 17. Reinforcement by soil improvement agent (after 2 days,  $F_s = 1.352$ ).

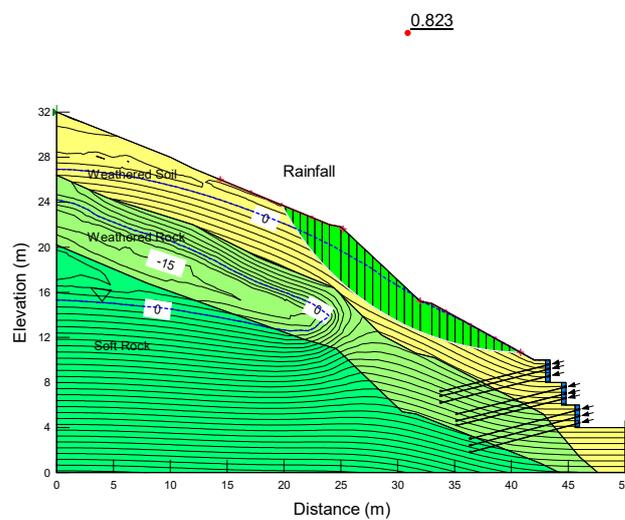
Figure 18. Erosion and scour due to rainfall (after 10 days,  $F_s = 0.823$ ).

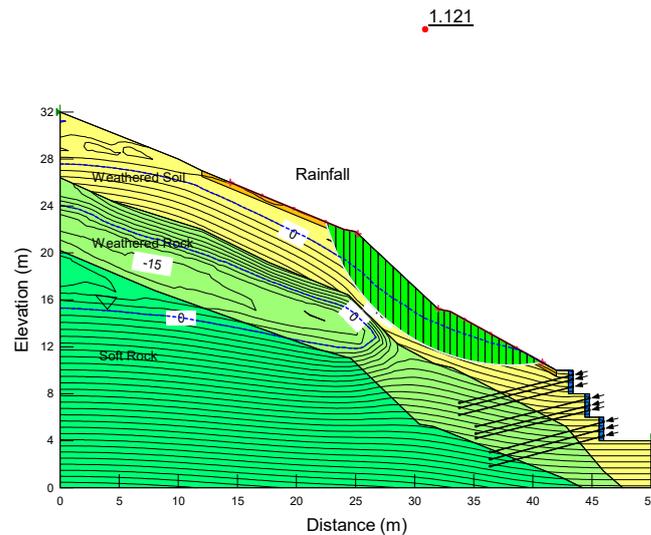
Figure 19. Reinforcement by soil improvement agent (after 10 days,  $F_s = 1.121$ ).

Figure 19 shows the change in which the safety factor of the slope increases due to the reinforcement of the soil improvement agent. In situ, rainfall continued for 10 days, causing collapse as the instability of the slope increased, but it was confirmed that the stability of the slope was maintained by the application of the soil improvement agent developed in this study.

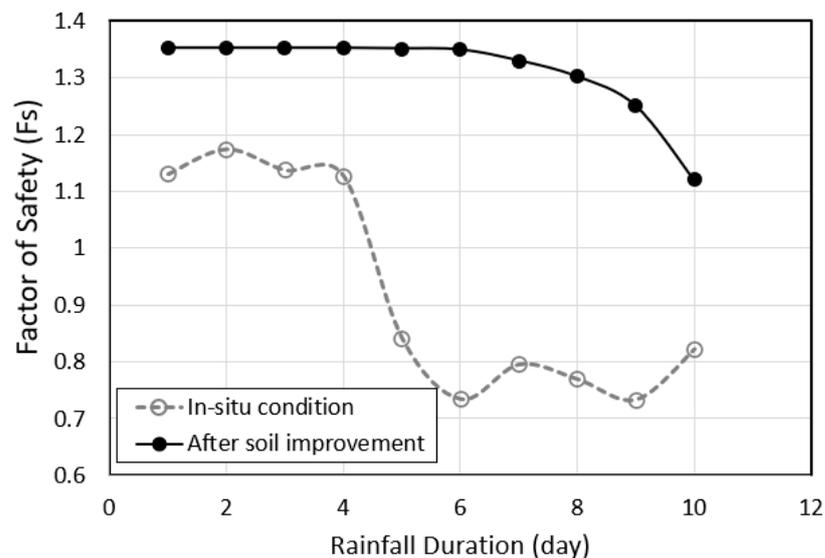
Figure 20. Change in safety factor before and after reinforcement with soil improvement agent.

Figure 20 shows a result comparing the safety factors of the slope composed of the original soil and the slope reinforced with the soil improvement agent. As rainfall continues, the difference in safety factors increases, and it can be seen that at this site, as the rainfall duration elapses by 5 days, a risk of slope failure occurs.
