Experimental Investigation of the Explosion Effects on Reinforced Concrete Slabs with Fibers

Abstract: In today’s world, concrete structures are exposed to various influences, including explosive actions. With the increasing use of fiber-reinforced concrete (FRC), it is essential to investigate its response to blast effects. As there are few studies on this topic worldwide, this research is dedicated to the question of how blast effects affect the damage and properties of six different types of reinforced concrete (RC) slabs. These samples differ in concrete classes (C30/37 and C50/60) and in the type of fibers added (steel and polypropylene). Visual inspections and non-destructive measurements are carried out before and after blasting. The damaged area of the concrete surface is determined by visual inspection, while non-destructive measurements evaluate parameters such as the rebound value of the Schmidt hammer, the electrical resistivity of the concrete, the velocity of the ultrasonic wave, and the dynamic modulus of elasticity. Equal amounts of explosives are applied to five of the RC slabs to enable a comparative analysis of the resulting damage. Based on the comparison of th

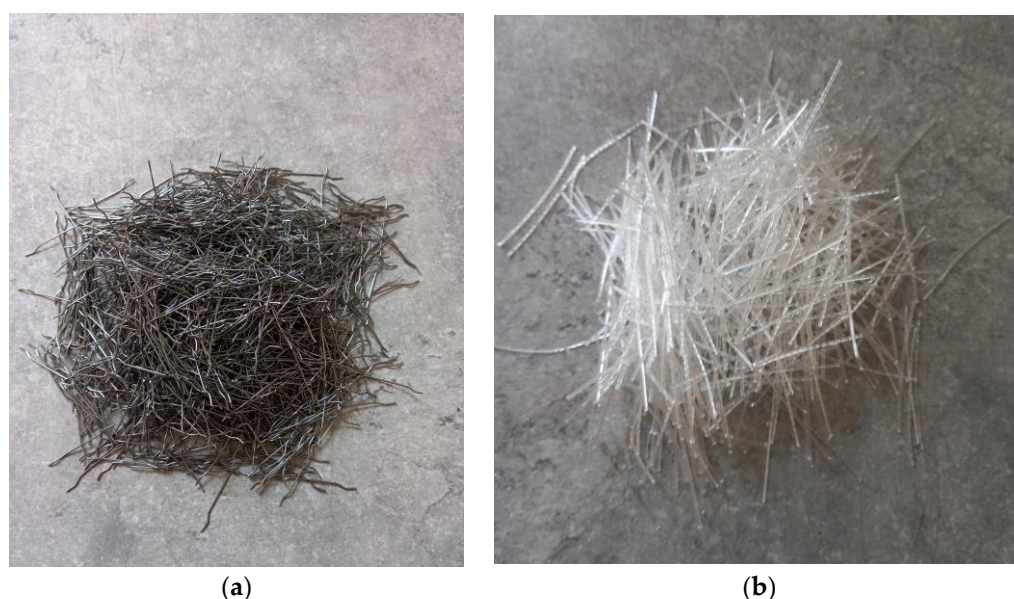
Figure 2. Fibers used in reinforced concrete slab specimens: (a) steel fibers and (b) polypropylene fibers.

Two concrete classes are provided for the test specimens: C30/37 as normal-strength concrete and C50/60 as higher-strength concrete. However, for some specimens with normal strength, slightly higher values of concrete strength according to European standards EN 206 and EN 12390-3 [36,37] are achieved after 28 days (Tables 1 and 2). The experiments are carried out on test specimens without fibers, with steel fibers, and with polypropylene fibers. Steel fibers are 25 mm long and have tensile strength of 400 MPa, while polypropylene fibers are 54 mm long with tensile strength of 600–800 MPa (Figure 2). The type and quantity of fibers as well as the planned and achieved compressive strength class of the concrete strength for each test specimen are listed in Table 1. The RC slab specimens are cast at a certified concrete manufacturer, where laboratory tests are also conducted to determine the compressive strength of the concrete after 28 days for each of the six RC slabs (Table 2). Detailed data on the concrete mixture used for making the samples are presented in Table 3.

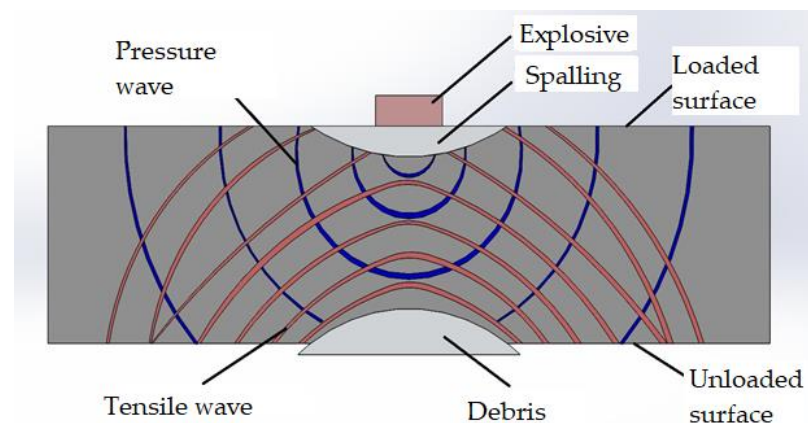
Figure 3. Scheme of contact detonation.

The explosive charge is placed directly on the surface of the samples to achieve contact detonation. Loads activated during the contact detonation cause high compressive stress and shear stress, which are often very destructive to the structure. As shown in Figure 3, a strong pressure wave is initially generated in the vicinity of the explosive charge [28]. This wave exceeds the compressive strength of the concrete and causes its crushing. The pressure wave continues to propagate through the concrete structure and finally reaches the lower unloaded surface. From there, it is reflected as a tensile stress wave, which poses a greater risk to concrete structures due to the significantly lower tensile strength of concrete compared to its compressive strength.

When the amplitude of the tensile stress wave exceeds the concrete's tensile strength, the concrete structure starts to crush, expelling fragments as flying debris from its lower or unloaded side. This flying debris poses a serious threat to people and equipment in the vicinity of the structure [28,41].

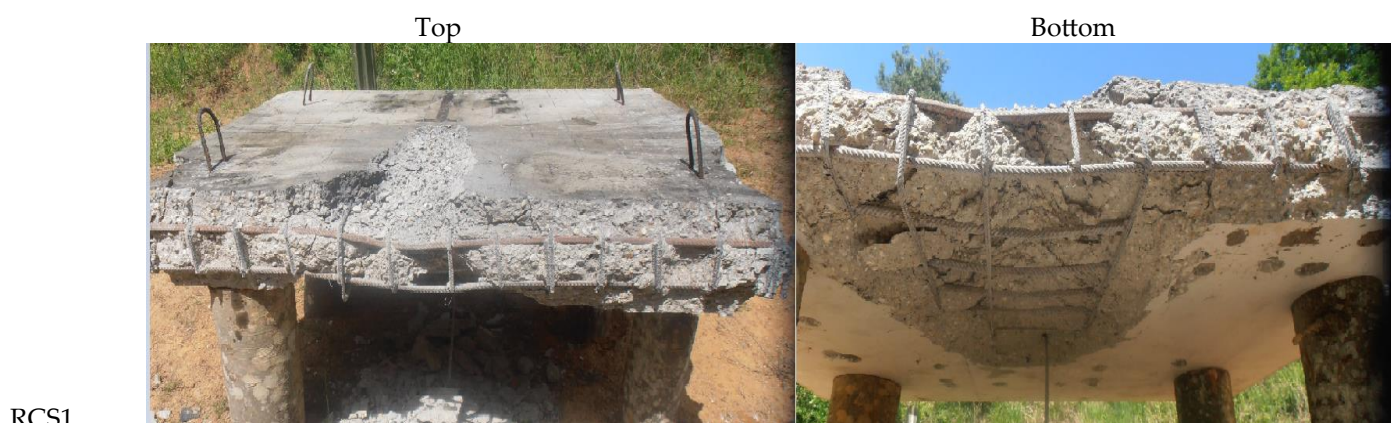
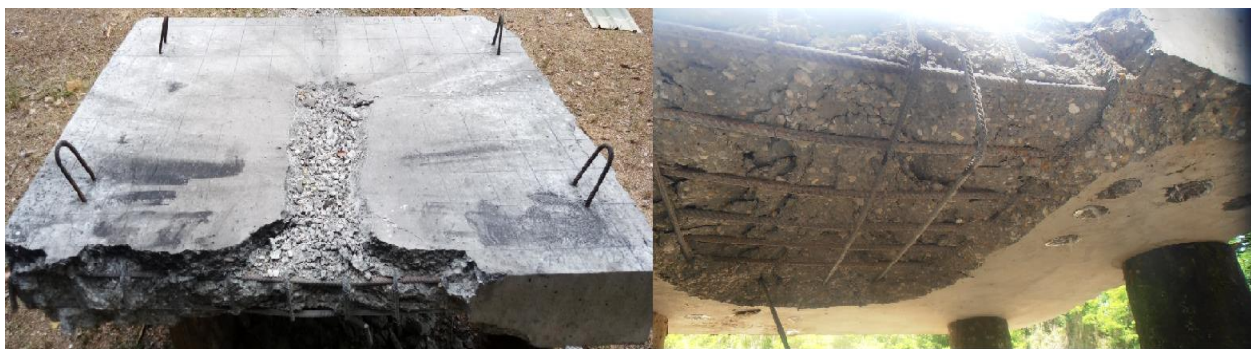
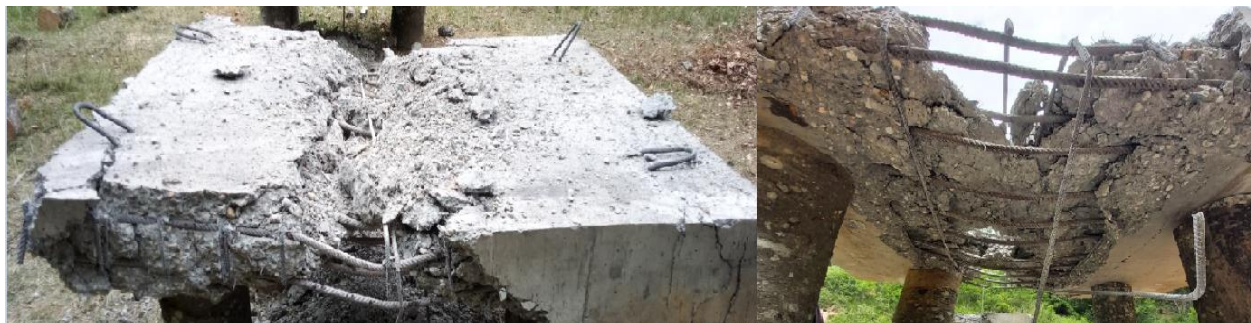
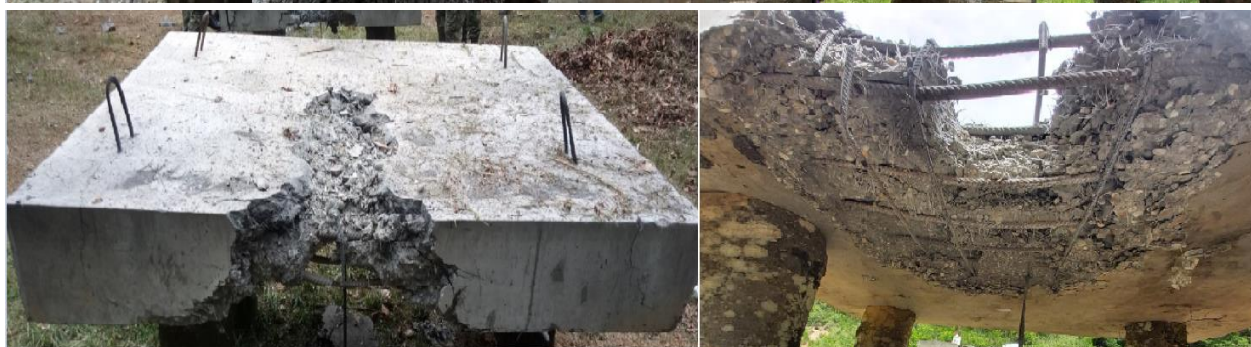
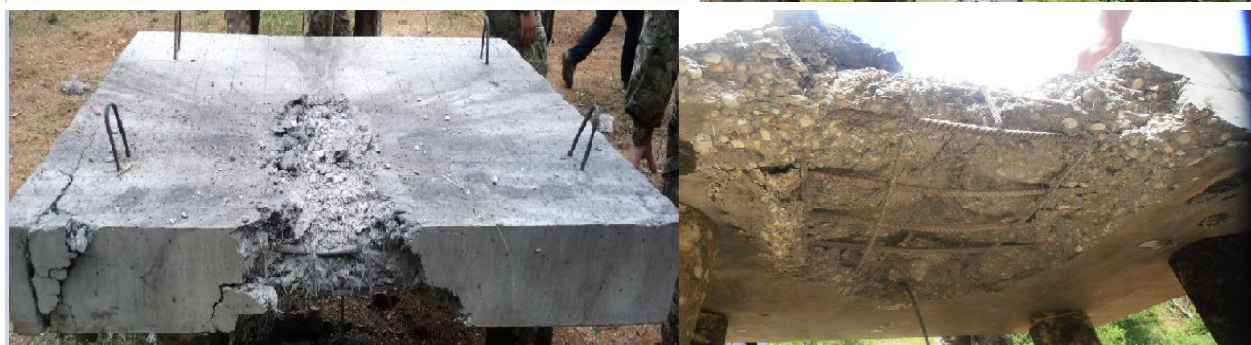
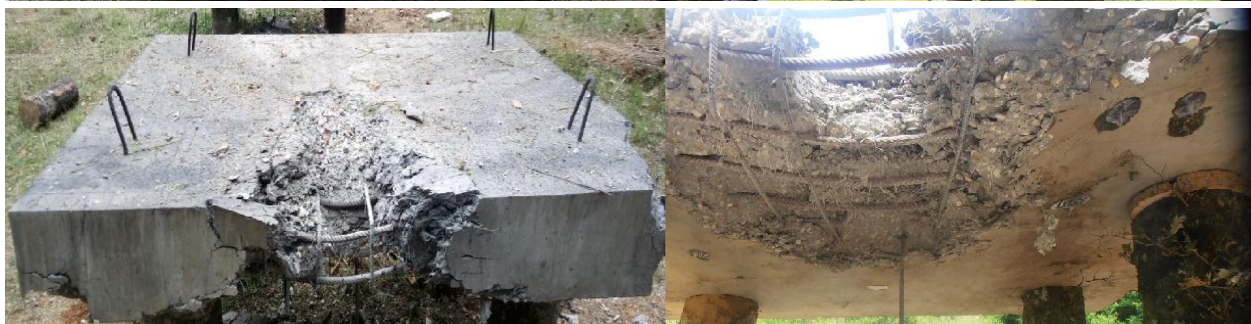
Figure 4. RC slab samples (RCS1-6) after explosive action: upper (left) and lower (right) surfaces.

The damaged surface of the concrete, that is, the surface of the spalled and punctured concrete, is evaluated by visual inspection and measurement (Figures 4 and 5; Table 5). These methods applied to the RC slab specimens demonstrate high accuracy and reliability for the following reasons: before the explosion, a reinforcing mesh was drawn on the top and bottom of the slab at 15 × 15 cm intervals, which facilitated the accuracy of the measurement of surface damage, while the size of the slab specimens and their placement at a height of 1 m above the ground enabled precise measurements from above and below.

When analyzing the results of the RC slab samples, it is found that all the RC slab samples show major surface damage on the bottom side due to the explosion. This is a consequence of the lower tensile strength of the concrete compared to its compressive strength and the principle of the impact of contact detonation (Table 5; Figures 3–5).

In the first part of the analysis, samples RCS1, RCS2, RCS4, RCS5, and RCS6 are considered because they contain a similar amount of explosive. The impacts of the compressive strength, presence, and type of fibers on the damage caused by the blasting effect are investigated. The analysis of the results of these samples shows that the highest surface damage occurs in samples RCS1 and RCS2, namely in slabs without fibers. It is obvious that the area of punctured concrete (8–10%) is significantly larger in these samples compared to the samples with fibers (2–4%). The surface area of the spalled concrete on the top side of all five samples is approximately the same. However, when comparing the surface area of the spalled concrete on the bottom side, it is noticeable that the results are similar for the samples without fibers and the samples with steel fibers (22–29% of spalled surface), and that they are larger compared to the samples with polypropylene fibers (18% of spalled surface). The FRC slabs (RCS4, RCS5, and RCS6) show significantly less surface damage. For the slab with steel fibers, the area of the punctured concrete is significantly smaller compared to the slabs with polypropylene fibers. However, the area of spalled concrete on the lower surface of the sample with steel fibers is significantly larger (Table 5; Figures 4 and 5).

After analyzing the results, it is found that the samples without fibers (RCS1 and RCS2) show the most severe concrete puncture on the side surfaces as a result of the explosive effect. The samples with polypropylene fibers (RCS5 and RCS6) have a lesser extent of concrete puncture on the side faces. Notably, in the case of the sample with steel fibers (RCS4), there is no puncture of the concrete at the edge of the slab (Figure 5).

In the second part of the analysis, samples with steel fibers but with different amounts of explosives used, RCS3 and RCS4, are compared. As expected, the greatest destruction occurs in the sample with a larger amount of explosive (RCS3). A comparison between the damaged areas of RCS3 and RCS4 reveals that, for RCS3, the area of destruction is 167% larger on the top surface, while it is 110% larger on the bottom surface. For sample RCS3, the spalled area is 60% larger on both the top and bottom surfaces than for sample RCS4. The surface area of the punctured concrete in sample RCS3 is approximately 807% larger. It is crucial to emphasize that significant puncture of concrete occurs on the lateral sides (edge of slabs) of sample RCS3, while no such puncture is observed on the lateral sides in sample RCS4 (Table 5; Figures 4 and 5).

In view of the fact that RCS3 uses about three times the amount of explosives compared to RCS4, the ratio of the damaged surfaces of the two plates is analyzed. It is found that the damaged surface on the upper side of RCS3 is about three times as large as that of RCS4 ($r = \text{ARCS3, damaged} / \text{ARCS4, damaged} = 2.7$) and the damaged surface on the bottom side is about twice as large ($r = \text{ARCS3, damaged} / \text{ARCS4, damaged} = 2.1$). In other words, the damaged top surface of sample RCS3 is about three times as large as the amount of explosive activated on it (Table 5; Figures 4 and 5).

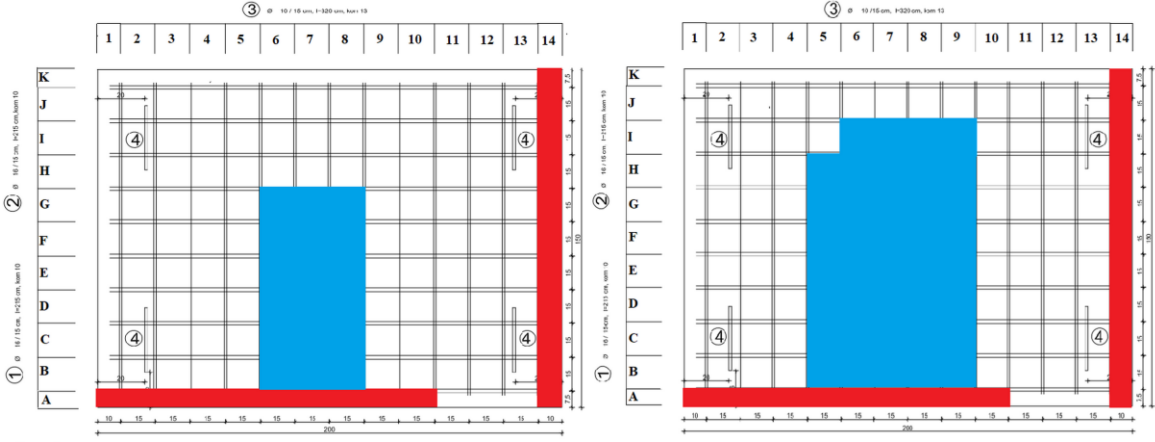
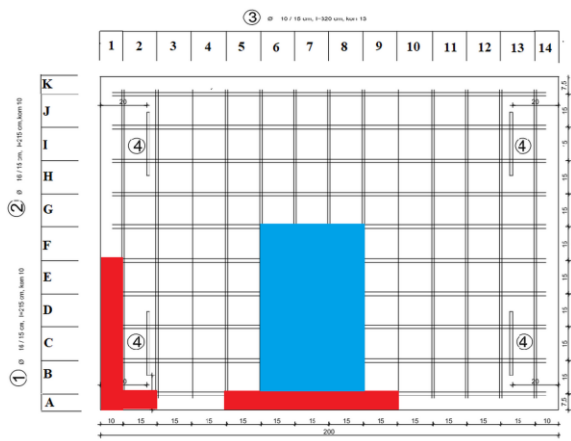
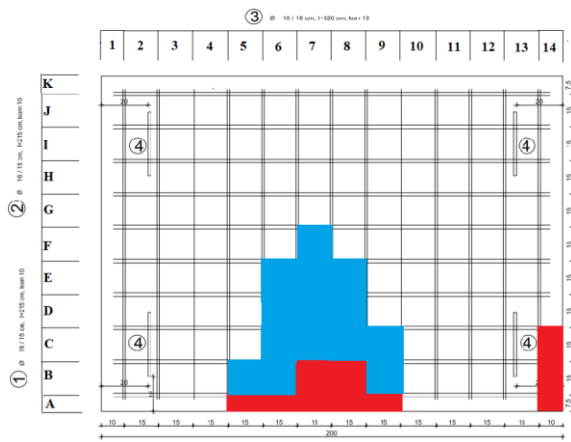
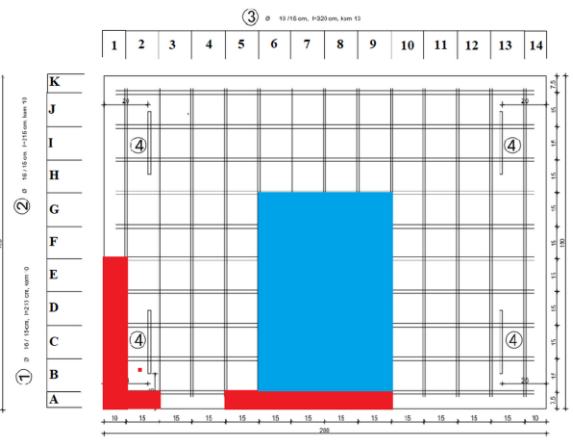
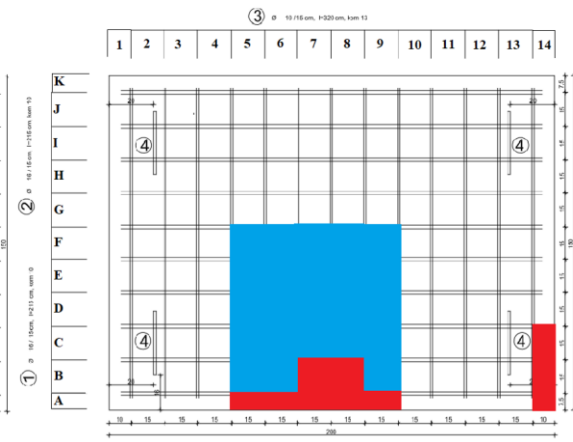
Legend:
■ punctured
■ spalled

Figure 5. Punctured and spalled surfaces on specimens of RC slabs on the upper (left) and lower (right) surfaces after explosive action.

A spalled surface implies the destruction of the concrete cover up to the reinforcement level or in some places even a few centimeters deeper than the reinforcement. A punctured surface is the destruction of concrete over the entire thickness of the RC slab, usually on the slab edges.

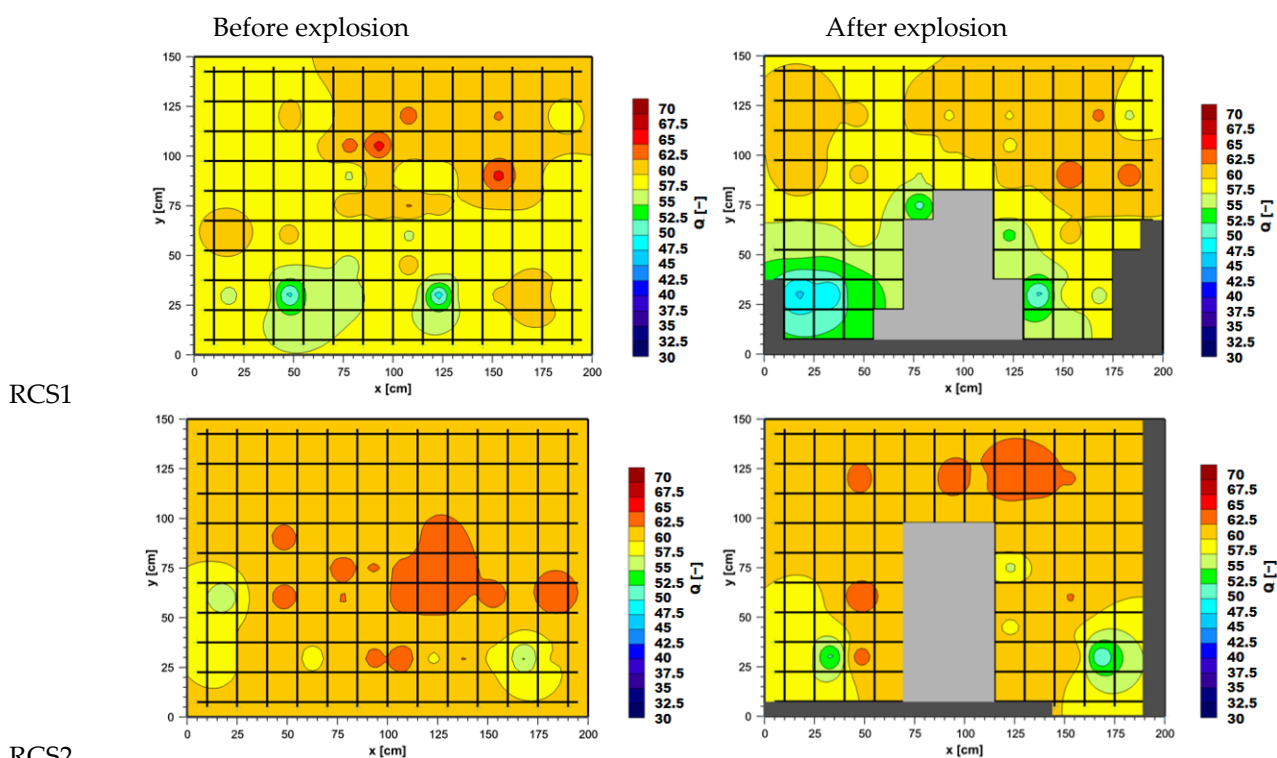
Figure 6. The rebound values Q measured before (left) and after (right) the explosion on the top of each RC slab specimen.

The rebound value, Q , is measured before and after the explosion on the top of each RC slab specimen. Q is measured before and after the explosion at the same predefined 52 measurement spots with ten impacts per spot for each RC slab specimen. At the place where the explosives are placed, six measurements are additionally carried out before the explosion to confirm the uniformity of quality. After the explosion, this part is damaged, so the tests could not be repeated at these spots. The results of testing the Q value before and after the explosion for each RC slab specimen are shown graphically in Figure 6. The mean Q value and the standard deviation of the Q value before and after the explosion are calculated for each RC slab specimen (Table 6). In addition, the ratio of the mean Q value after and before the explosion (r_Q) and the ratio of the standard deviations of the Q value after and before the explosion ($r_{\delta Q}$) are calculated according to the following expression:

By analyzing the RC slab specimens exposed to a conventional amount of explosives (RCS1, RCS2, RCS4, RCS5, and RCS6), it is clear that the most significant reduction in Q value due to explosives exposure is observed in specimen RCS6, with an r_Q value of 0.95. Conversely, the strongest Q value increase occurs in RCS5, where the calculated r_Q value reaches 1.05. The highest r_{6Q} value is measured for specimen RCS6 at 2.75. This means that the explosion effect on this specimen led to the greatest development of cracks and damage to the concrete, resulting in uneven strength and quality. In contrast, the lowest r_{6Q} value is 0.63 and is observed in the RCS5 specimen. This result indicates that, as a result of the explosive action on sample RCS5, there is a uniformization of the strength and quality of the concrete, which deviates from the expectations and the results of measurements on other samples. Therefore, it can be concluded that a gross error occurred. However, when looking at the values of Q before and after the explosion, there is not a significant difference in the values (Figure 6; Table 6).

When examining the area where the explosion affected the Q value, it is found that this zone is relatively uniform in size for all specimens. The sharpest drop in Q value is primarily concentrated along the entire abscissa axis (the longer side of a slab) and extends up to approximately 110 cm along the ordinate axis (the shorter side of the board). Beyond this point along the ordinate axis, the Q value remains mostly unchanged, apart from occasional local increases in the observed value (Figure 6).

For samples RCS3 and RCS4, the r_Q ratios are 0.89 and 1.01, while the r_{6Q} ratios are 2.86 and 1.22, respectively. Through a comparison of the measurement outcomes between the RCS3 and RCS4 slabs, it is determined that the value of r_Q in RCS4 is approximately 12% higher. The value of r_{6Q} in specimen RCS3 is about 134% higher than the value of r_{6Q} observed in specimen RCS4. The reason for this is greater local damage in RC slab specimen RCS3 due to the triple amount of explosives.

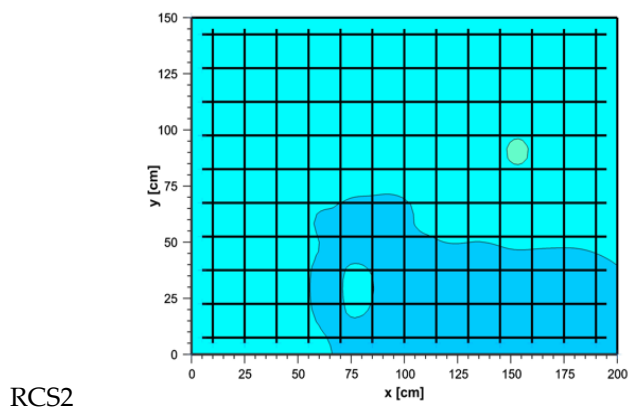
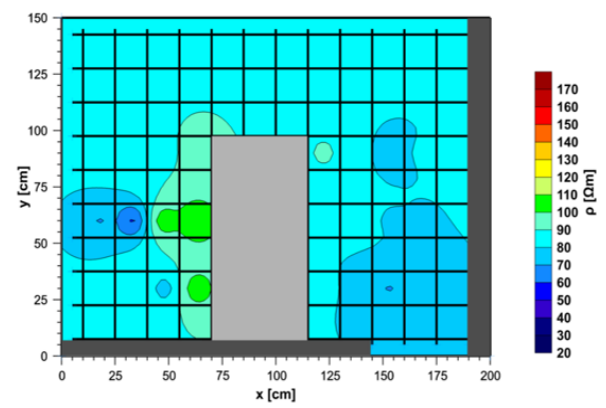
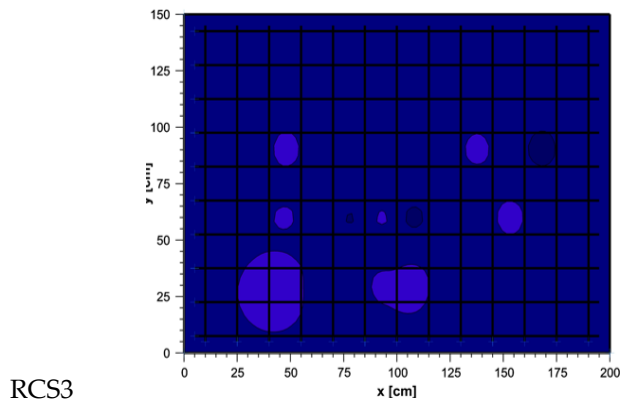
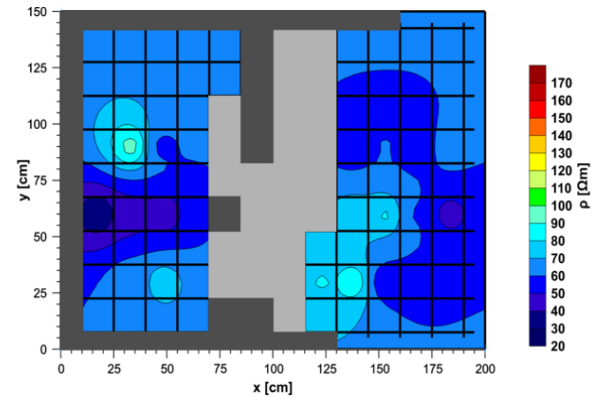
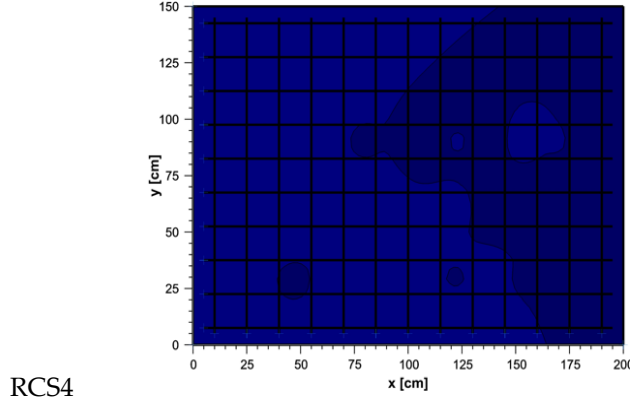
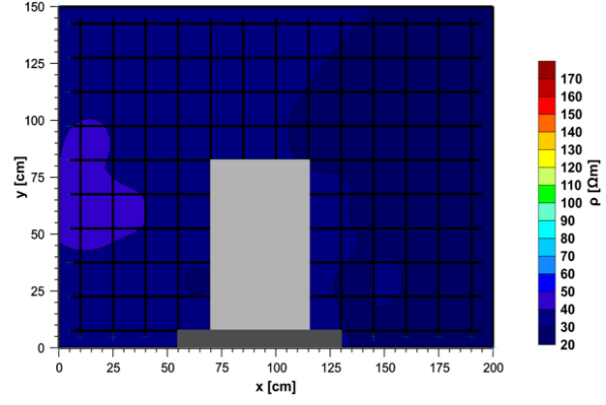
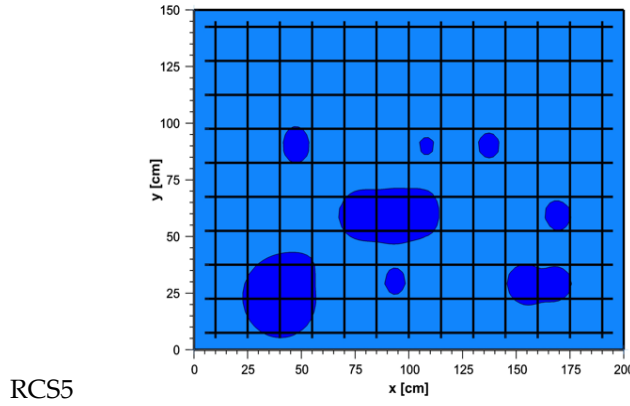
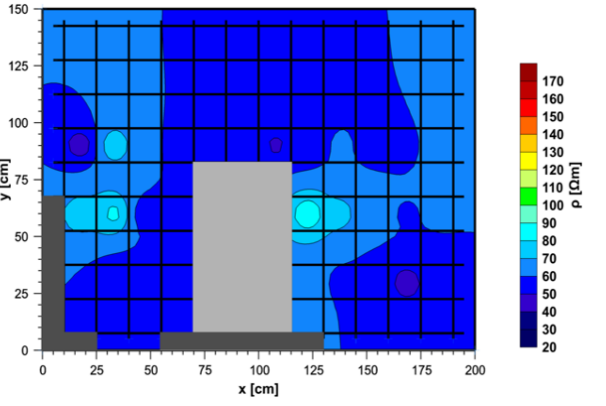
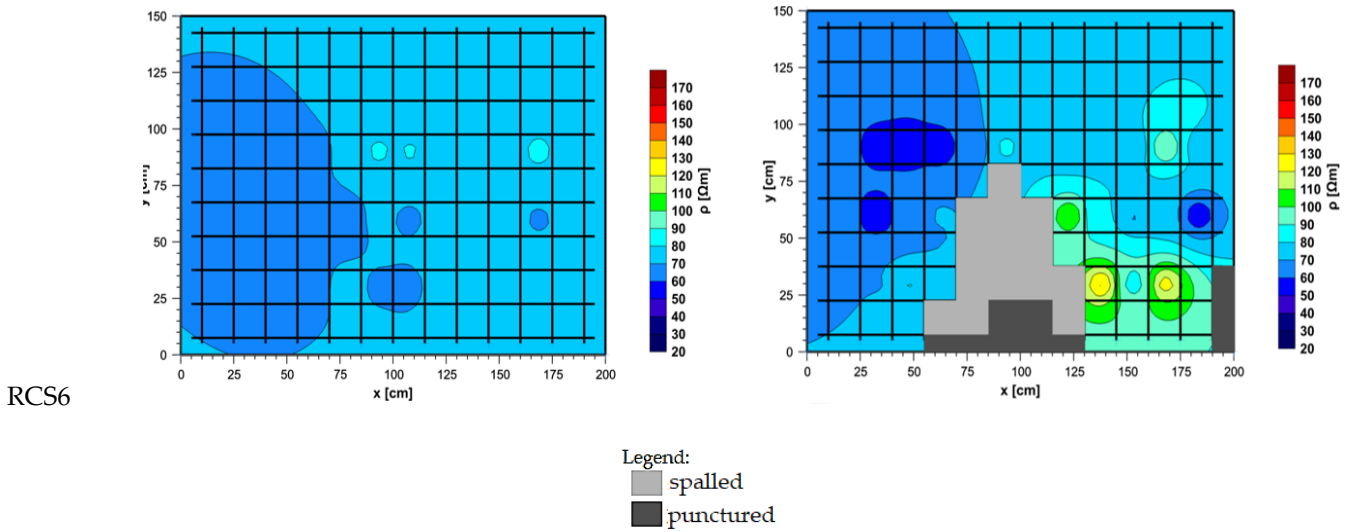
Figure 7. Electrical resistivity of the reinforced concrete slabs before (left) and after (right) explosive action.

The electrical resistivity, ρ , is measured before and after the explosion on the top of each RC slab specimen. The electrical resistivity is measured at 48 predefined measurement spots with three tests per spot for each RC slab specimen. At the place where the explosive is placed, an additional four measurements are conducted before the explosion to confirm the uniformity of quality. As expected, this part was damaged after the explosion, so the tests could not be repeated at these four spots.

From the analyzed data, it can be deduced that, when using conventional amounts of explosives (RCS1, RCS2, RCS4, RCS5, and RCS6), the most significant reduction in the mean value of ρ occurs in specimen RCS1, with a recorded r_ρ value of 0.94. Conversely, the greatest increase in ρ is observed in specimen RCS6, where the r_ρ value reaches 1.05.

Test specimen RCS5 exhibits the highest $r_{6\rho}$ value of 4.48, signifying considerable internal damage and the formation of numerous cracks resulting from explosive action. Consequently, this leads to a reduction in the compactness of the concrete structure. In contrast, the lowest $r_{6\rho}$ value of 1.69 is recorded for RCS4 (Figure 7; Table 6).

Upon comparing the zones affected by explosive action on RC slab specimens, it is observed that the most extensive zone is identified in specimens RCS5 and RCS6. The zones of influence are slightly smaller in other specimens (RCS1, RCS2, and RCS4). Beyond approximately 120.00 cm along the ordinate axis, notable fluctuations in the ρ value are absent (Figure 7; Table 6).

For sample RCS3, the r_ρ ratio is 1.70, while the $r_{6\rho}$ ratio is 2.85. By analyzing and comparing the ρ values in specimens RCS3 and RCS4, it is determined that the r_ρ ratio in RCS3 is nearly 63% higher. The $r_{6\rho}$ value in test specimen RCS3 exceeds that of RCS4 by almost 69% (Figure 7; Table 6). An increase in the electrical resistivity of concrete in the sample with the highest mass of explosive (RCS3) may indicate that more energy as well as more heat were released during the explosion, which reduced the water content in the concrete and thus contributed to the increase in the electrical resistivity of the concrete after the explosion.

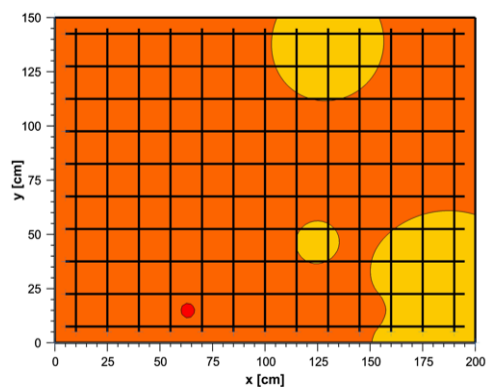
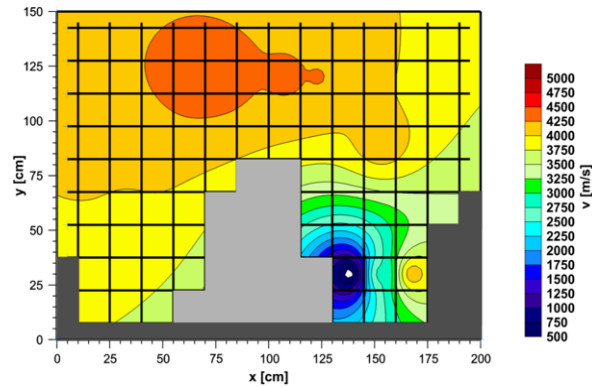
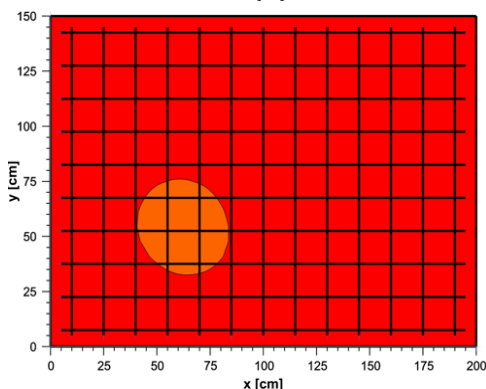
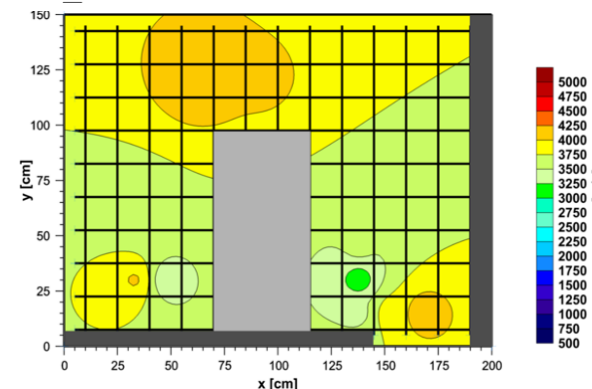
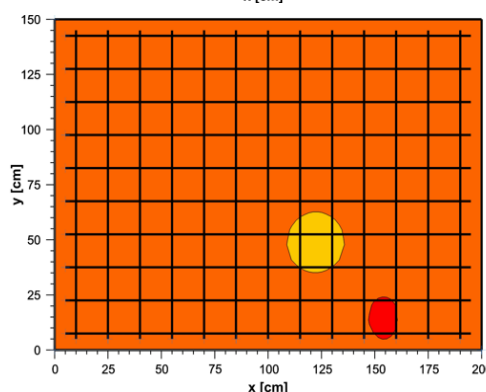
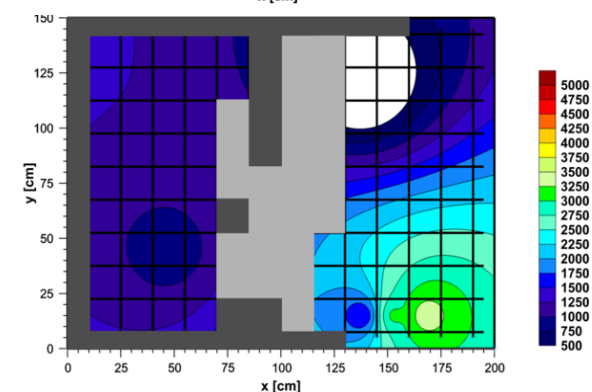
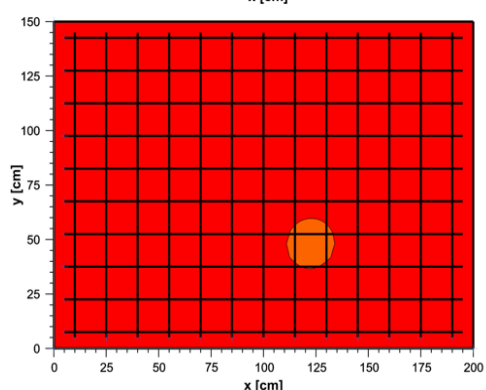
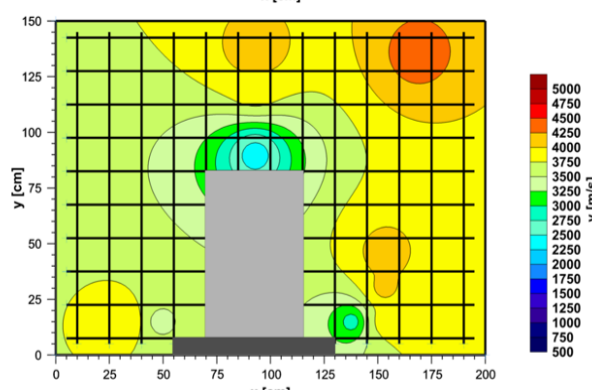
Figure 8. Velocity of the ultrasonic wave through the concrete in specimens of reinforced concrete slabs before (left) and after (right) explosive action.

The velocity of the ultrasonic wave, v , is measured before and after the explosion through the RC slab thickness of 25 cm. The velocity of the ultrasonic wave is measured at 44 predefined measurement spots with three tests per spot for each RC slab specimen. At the place where the explosive is placed, an additional six measurements are conducted before the explosion to confirm the uniformity of quality. As expected, the upper or lower surfaces of this part were damaged after the explosion, so the tests could not be repeated at these six spots.

When analyzing the data, it is found that the quality of the concrete deteriorated from good to poor quality for all the RC slab specimens (RCS1, RCS2, RCS4, RCS5, and RCS6) during the demolition of the elements with a conventional amount of explosive. The most significant reduction in the v value is observed in the RCS6 specimen, with a corresponding r_v ratio of 0.70. In contrast, the smallest reduction in the v value is found in the RCS1 specimen, which has an r_v ratio of 0.86 (Figure 8; Table 6). The highest r_{6v} ratio, 21.11, is found in RCS6. The lowest r_{6v} ratio of 7.48 is found in the RCS2 sample.

According to the criteria listed in Table 4, the most significant deterioration in concrete quality, which transitioned from good to poor, is observed in the RCS5 specimen. Approximately 1.16 m² (39%) of the surface shows poor concrete quality. In contrast, the RCS2 specimen shows no areas where the concrete quality decreased from good to poor (Figure 8; Table 6).

The most extensive area of deterioration in concrete quality from good to medium is found in the RCS4 specimen. More specifically, approximately 2.11 m² (70%) of the surface has a medium concrete quality after the explosive impact. In contrast, the smallest area showing a medium level of deterioration due to the impact of the explosives is found in the RCS1 sample. Here, the concrete of medium quality covers around 0.97 m² (32%) after the explosion (Figure 8).

In addition, RCS1 has the widest zone in which the concrete quality remains good due to the influence of the explosion. After the explosion, approximately 1.14 m² (38%) of the RCS1 specimen surface had good concrete quality. In contrast, the smallest zones with the least impact of the explosive are found in the RCS5 and RCS6 specimens. These specimens exhibit good concrete quality over approximately 0.10 m² (3%) of the surface (Figure 8).

The most significant reduction in the v value is observed in the RCS6 specimen with a corresponding r_v ratio of 0.70. In contrast, the smallest reduction in the v value is found in the RCS1 specimen, which has an r_v ratio of 0.86. The highest r_{6v} ratio of 21.11 is found in RCS6, while the lowest r_{6v} ratio of 7.48 is found in sample RCS2.

For sample RCS3, the r_v ratio is 0.41, while the r_{6v} ratio is 11.08. By comparing the analyzed data from specimens RCS3 and RCS4, it is observed that the value of r_v in RCS3 is 50% lower compared to RCS4. It is essential to highlight that, following the explosive event in RCS3, the quality of the concrete is deemed poor, and there are no instances of good concrete quality recorded at any measurement point (Figure 8). In contrast, in RCS4, the concrete quality is rated as medium. The value of r_{6v} in RCS4 exceeded that in RCS3 by 69%.
