# Preserving the Past: Investigating Zanzibar's Ancient Construction Materials for Sustainable Heritage Conservation

**Citation:** Ali, B.S.; Castro, J.J.; Omi, S.; Nazimi, K. Preserving the Past: Investigating Zanzibar's Ancient Construction Materials for Sustainable Heritage Conservation. *Buildings* **2024**, *14*, 2129. <https://doi.org/10.3390/buildings14072129>

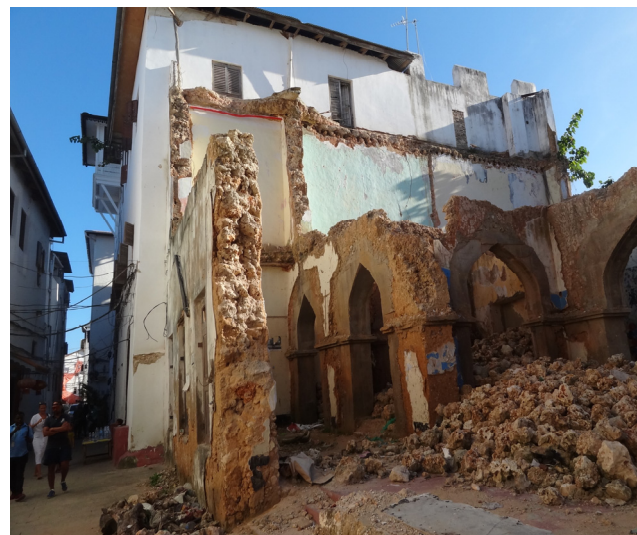
**Figure 4.** Example of the collapsed building (photos by author).

The sampling strategy for investigating construction materials in Zanzibar Stone Town focused on selecting diverse locations representing various stages of degradation and architectural significance. These locations were chosen to capture and explore the range of materials used in construction, aiding in the comprehensive analysis of physical, mechanical, and chemical characteristics. Cumulatively, samples were obtained from each location and meticulously prepared to meet standardized dimensions, which included cutting, reshaping, and smoothing according to the required testing guidelines. Each experiment was conducted on at least three specimens, and the average of the obtained values was recorded. Controlled conditions were maintained for the specimens to standardize moisture levels and minimize variability in the results.

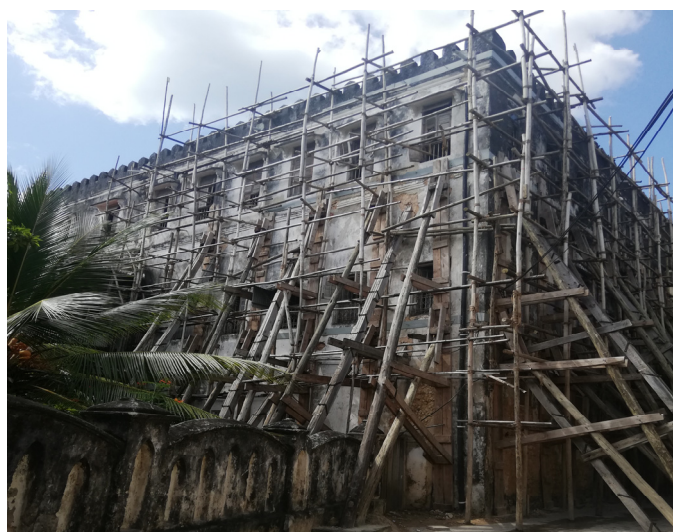
**Figure 5.** Example building renovation (photos by author).

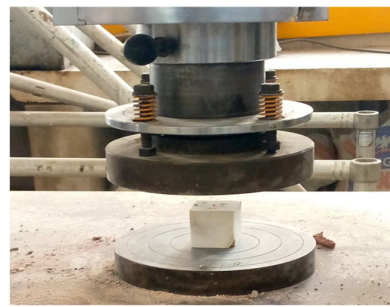
(a) Compressive strength test of coral stone

However, the compressive strength (CS) test was conducted under the ASTM C170/C170M standard [40]. The process entailed placing the specimen on the compression plate and applying a uniformly distributed load, continuously increasing until the specimen broke (Figure 7a,c). A total of twenty cubic specimens ( $70\text{ mm} \times 70\text{ mm} \times 70\text{ mm}$ ) were tested, with ten specimens having the load applied parallel to the anisotropy plane (X-axis) and the other ten specimens having the load applied perpendicular to the anisotropy plane (Z-axis). The testing apparatus utilized was an Instron 5582 Universal Testing Machine (UTM) (Instron Corporation, Norwood, MA, USA) with a capacity press with a maximum load capacity of 3000 kN, equipped with a microprocessor control.

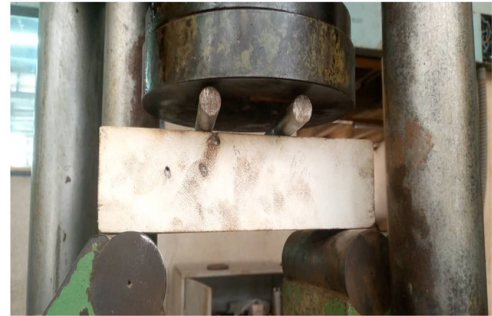
(b) Flexural strength test of coral stone

The material's flexural strength was assessed based on the ASTM C880/C880M-15 standard [34,35]. The test involved placing the specimen between two rollers and applying a load to the center point until the specimen broke. The direction of the force application was taken into account, and ten specimens (each measuring  $30\text{ mm} \times 100\text{ mm} \times 350\text{ mm}$ ) were tested for each direction: perpendicular to the edge of the anisotropy planes (X-axis), parallel (Y-axis), and perpendicular (Z-axis). The testing machine was an Instron 5582 Universal Testing Machine (UTM) with a capacity press with a maximum load capacity of 3000 kN (Figure 7b).

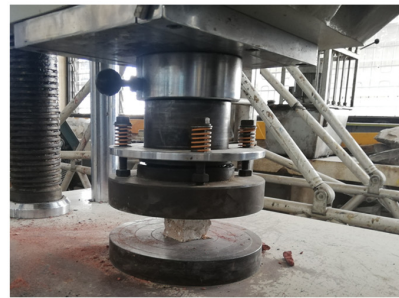
(c) Compressive strength test of mortar

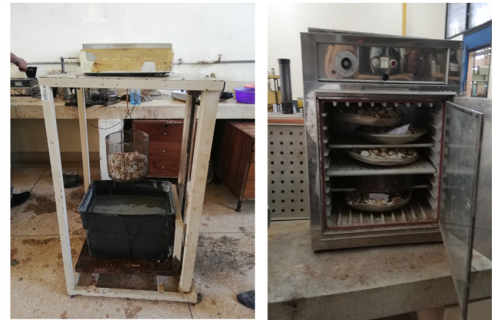
(d) Physical properties test of coral stone

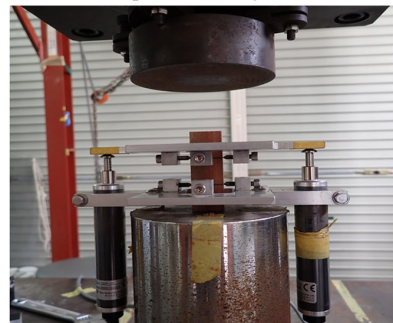
(g) Compression test of wood

Moreover, compression tests of wood samples were conducted on small clear specimens according to JIS Z 2101 [38,39], using an Instron 5582 Universal Testing Machine (UTM) with a capacity of  $\pm 100$  kN. The UTM measured load with an accuracy of 0.5% and deflection with an accuracy of  $0.25\ \mu\text{m}$ . Specimens were loaded at a controlled rate of  $0.6\ \text{mm/min}$  using flat platens, as shown in Figure 7g. Tests were performed on specimens measuring  $25\ \text{mm} \times 25\ \text{mm} \times 75\ \text{mm}$ , applying a compressive load parallel to the fibers until failure. The compressive modulus of elasticity ( $E_c$ ) was calculated from the stress-strain curve over the elastic portion, based on stress and strain at 40% and 10% of the ultimate compressive [38,39].

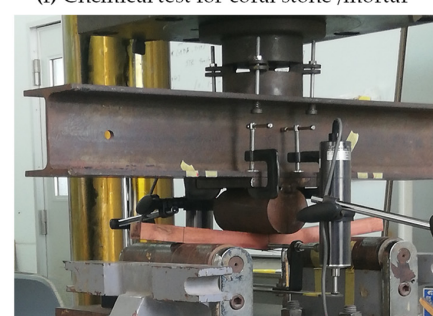
(h) Bending test of wood
