# Globalization and Architecture: Urban Homogenization and Challenges for Unprotected Heritage. The Case of Postmodern Buildings with Complex Geometric Shapes in the Ensanche of San Sebastián <sup>†</sup>

Department of Architecture, Universidad del País Vasco/Euskal Herriko Unibertsitatea, 48940 Leioa, Biscay, Spain; maria.senderos@ehu.eus (M.S.); juanpedro.otaduy@ehu.eus (J.P.O.); fernando.mora@ehu.eus (F.M.)

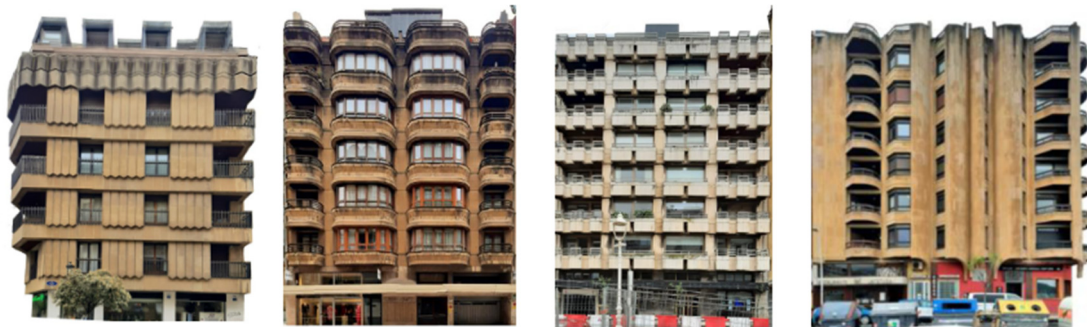
**Figure 2.** Buildings in the Ensanche of San Sebastián classified as stone sculptural.

These structures feature facades with stone coverings that create a rich interplay of shadows and an intricate arrangement of planes that project and recede. In Figure 2, the facades of some of these buildings are displayed.

These buildings are notable for their volumetric facade solutions, in which stone plays a significant role due to its distinctive texture and greater material thickness. These innovative architectural designs are part of an international trend that, in the case of the Ensanche, has been contextualized by employing traditional materials. This adaptation achieves a coherent integration in terms of materiality and color, despite its radically contrasting and disruptive forms.

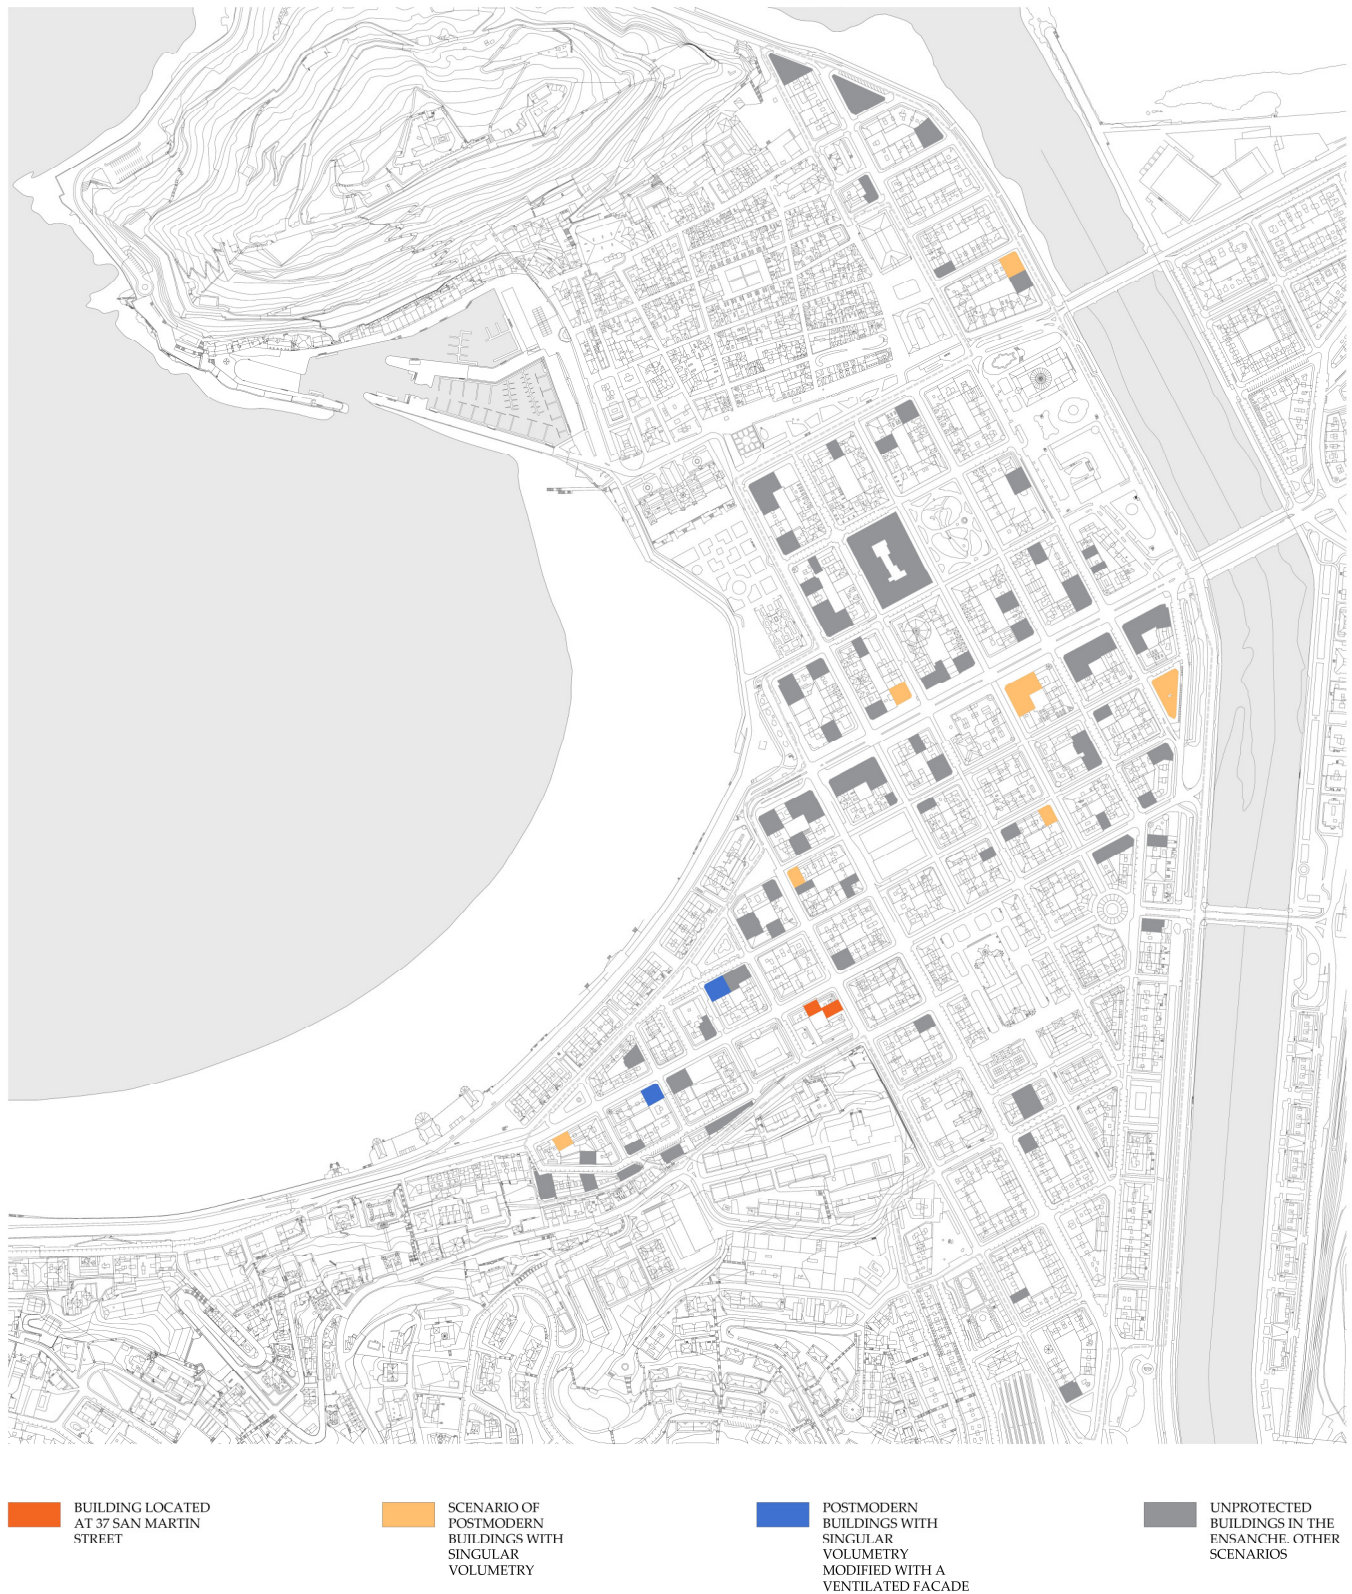
**Figure 3.** Site plan with the unprotected buildings of the Ensanche, the postmodern buildings with unique volumetry, and the San Martín 37 building.

In recent years, two of these buildings have been modified through the installation of ventilated facades, representing 20% of the total in this category (Figure 3). These alterations have affected the facade composition, materiality, and color, leading to a simplification of their design and changes to their architectural characteristics. Such modifications undermine the cultural and architectural heritage value by transforming the buildings and

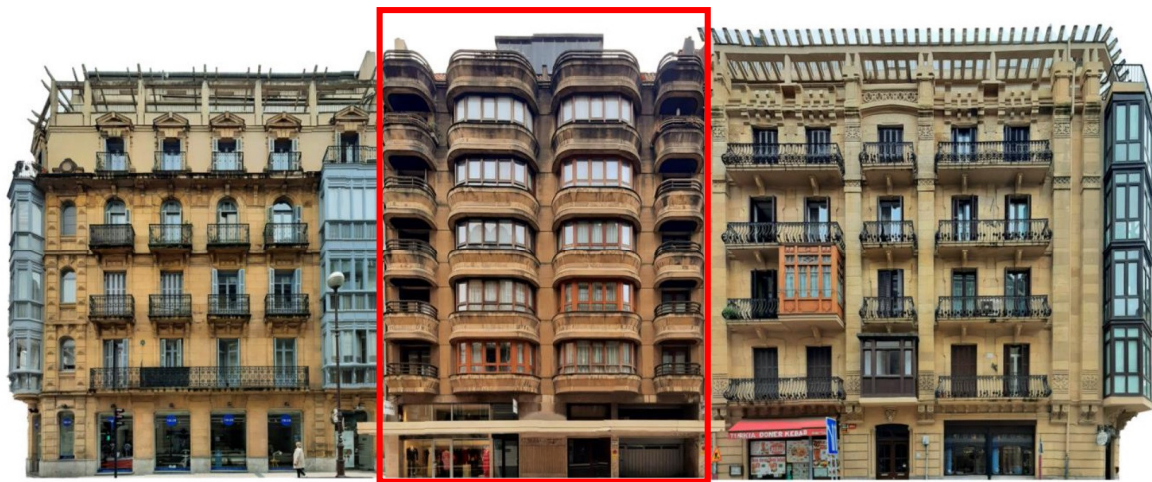
**Figure 5.** Building front of the odd numbers of C/San Martín. Case study building located at number 37, framed in a red rectangle. Restitution obtained with the free software Hugin (Hugin 2022.0.0).

This article outlines the application of a methodological framework to the building located at 37 San Martín Street in the Ensanche of San Sebastián. This building, constructed in 1976, is situated between two party walls. Its facade is symmetrical and features small balconies that project outward from the facade alignment, along with two viewpoints that harmonize aesthetically with the balconies. The building has been categorized among stone sculptural buildings due to the variety of planes on the balconies and viewpoints, which are inclined at various angles (upward, downward, and vertically along the parapets). The facade is covered with a sandstone veneer, which, despite its modern composition, enables the building to blend into the visual context of the surrounding street complex. Figure 5 illustrates the facade alignment of the building under study.

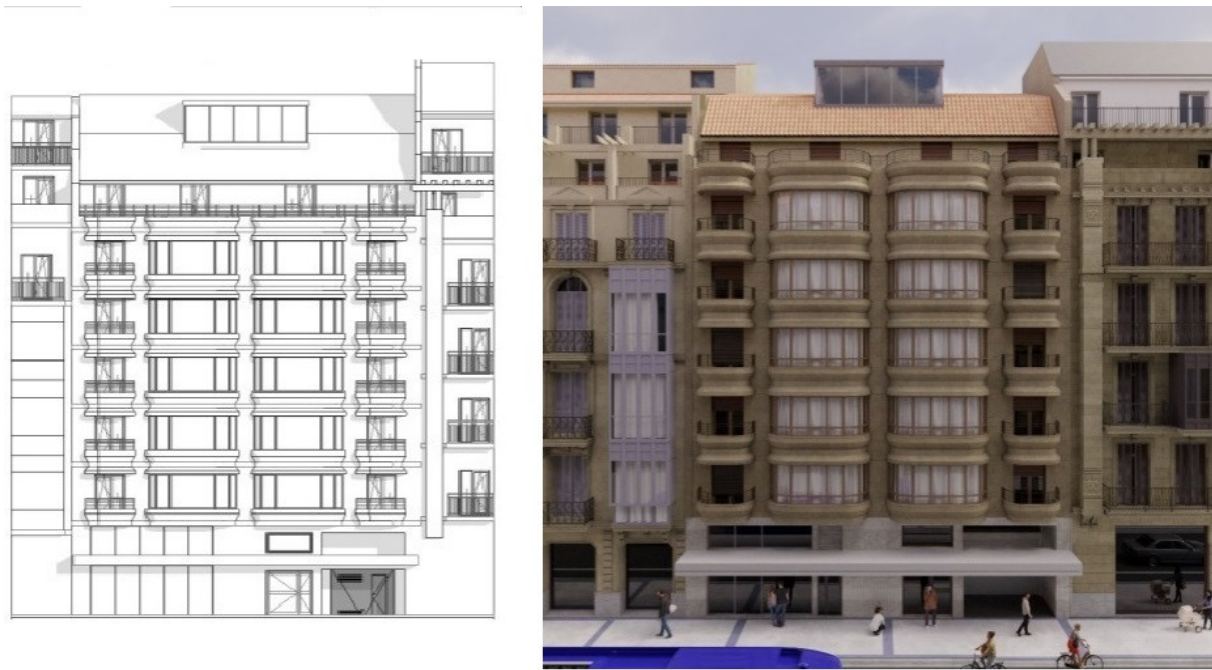
**Figure 9.** Model of the current state of the facade of the case study in Revit software and rendered image with finishes and textures.

The model was rendered to provide realistic colors and textures. Figure 9 illustrates the elevation of the facade extracted from the 3D model created in Revit, alongside the corresponding rendered facade [39,40].

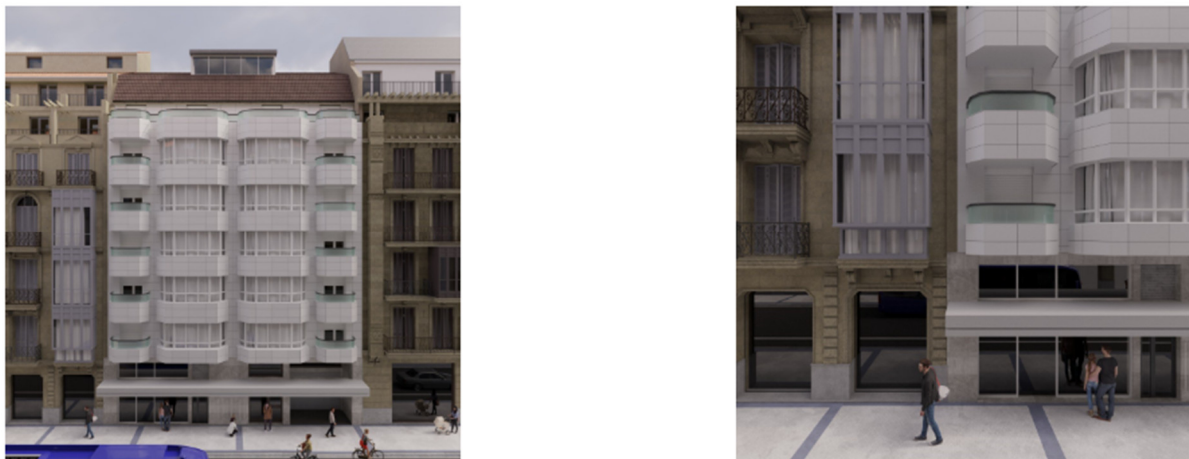
**Figure 10.** Simulation of a possible intervention of the envelope with the substitution of material and color and simplification of the geometry; cladding detail on the front of the curved balcony and replacement of metal railings with translucent glass.

The ventilated facade systems used in the simulations mimic the materials most commonly utilized in contemporary interventions, aiming to standardize and economize their use. These materials typically have a uniform appearance and a smooth texture, which starkly contrasts with the materials originally used in the facades. Additionally, current trends in facade materials and carpentry favor pure white and a range of greys, moving away from the sand and raw colors that defined the original buildings.

However, the standardization of materials limits the complexity of the original facade designs. In the case study, the diversity of inclined planes, curved volumes, and other sculptural elements of the facade has been significantly simplified in the proposed intervention. For instance, the upwardly inclined planes and downwardly inclined planes of the balcony parapets have disappeared, and the original curved volumes have reverted to flat, chamfered planes. Furthermore, metal railings with horizontal bars that once offered views into the facade have been replaced with translucent glass railings, introducing a new plane and altering the facade's volume.

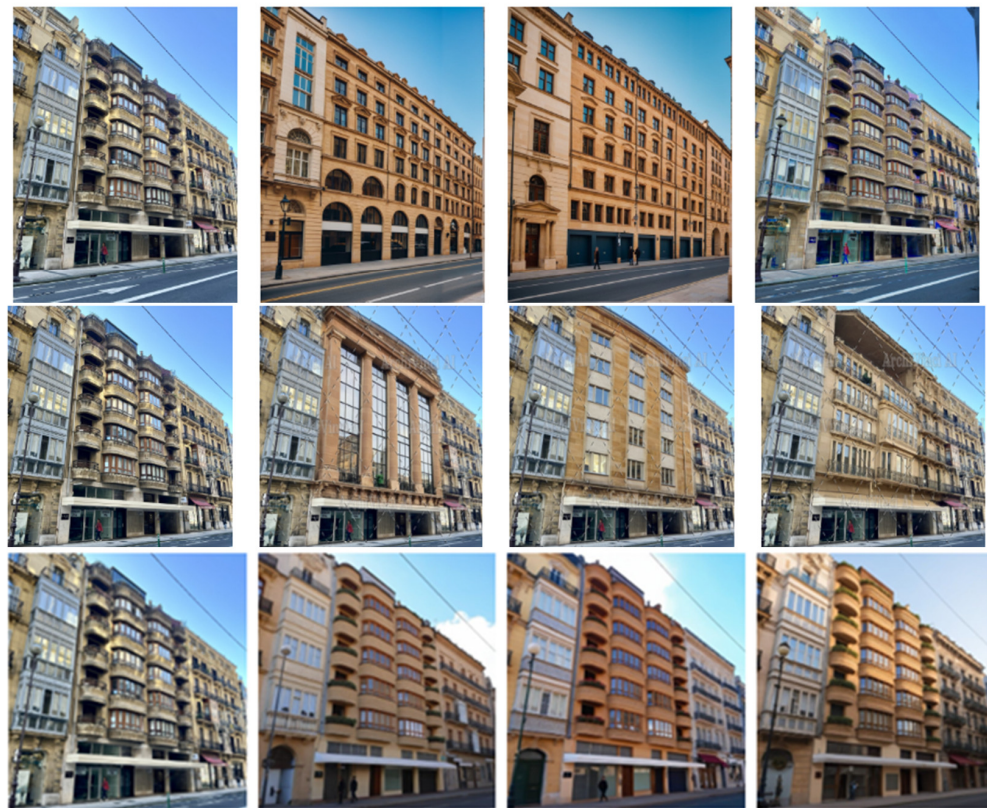
**Figure 11.** Simulations performed from the image on the left in different AI software (top Archivinci (Cigraph, Milan, Italy), middle Copilot (Microsoft 365 Copilot, 2025), and bottom PromeAI (PromeAI, 2025)).

The following section presents examples generated with different platforms, allowing for a comparison of the results and a discussion of the implications of these tools in the practice of architectural conservation (Figure 11). This analysis highlights the need to adjust AI algorithms to ensure that proposed interventions respect heritage values, thereby promoting a more responsible approach to the use of these technologies.
