# Experimental Study on the Mechanical Performance of Cast-in-Place Base Joints for X-Shaped Columns in Cooling Towers

**Keywords:** super-large cooling tower; X-shaped reinforced concrete column; ultimate load; cast-in-place base joint; mechanical performance; experimental study

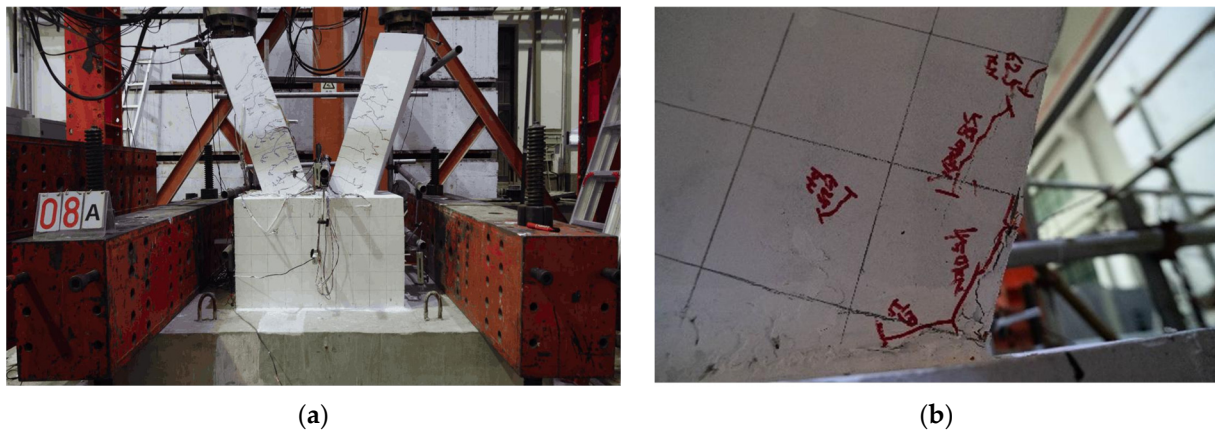
**Figure 7.** Failure morphology diagram of specimen JD-1 in phase 4. (a) Phase 4 integral structure. (b) Phase 4 partial view.

Phase 4: Concrete crushing occurred at the bottom of the north side of the columns. A pronounced, elongated crack developed on the pedestal's top surface, accompanied by the appearance of fine cracks on the south face, as depicted in Figure 7.

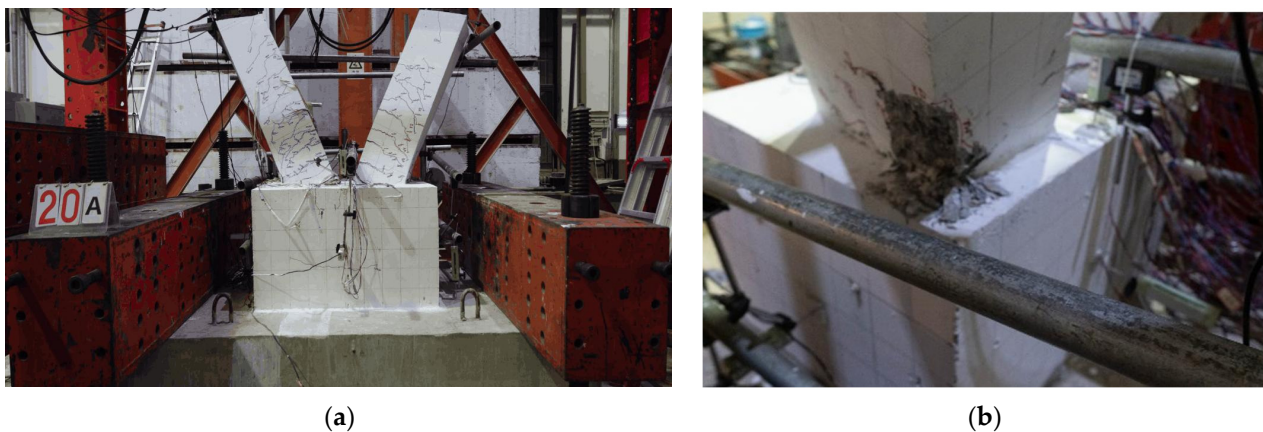
**Figure 8.** Failure morphology diagram of specimen JD-1 in phase 6. (a) Phase 6 integral structure. (b) Phase 6 partial view.

Phase 6: The crack patterns in the columns fully developed. Extensive concrete spalling occurred at the bottom of the north side of the columns, with a visible separation gap appearing between the column bases and the pedestal top surface. The pedestal top surface showed slight upward bulging, while the cracks on the east and west sides remained relatively narrow, as shown in Figure 8.
