# Effects of Transverse Reinforcement Detailing on the Damage Mechanisms of RC Elements: Lessons from the 2023 Kahramanmaraş Earthquakes

## Abstract

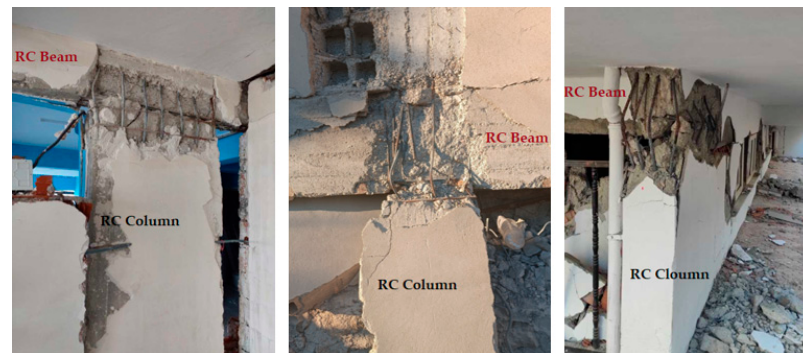
**Figure 5.** Illustrations of structural failure modes, characterized by the simultaneous crushing of the concrete matrix and lateral buckling of longitudinal bars due to inadequate stirrup configurations in beam-column joints.

severely earthquake-affected provinces of Hatay, Kahramanmaraş, and Adıyaman, were predominantly constructed before the year 2000. Most of the inspected buildings fell under the category of heavy damage, while the remainder experienced complete collapse. Systematic field evaluations revealed critical common structural and material deficiencies among these buildings: the measured transverse reinforcement (stirrup) spacing was significantly wider than the limits prescribed by seismic design codes, the hook details were overwhelmingly configured at  $90^\circ$ , and the concrete compressive strengths were critically below standard design requirements. In RC systems, columns and beams constitute the primary load-bearing elements of the structural system. The beam–column connections play a critical role in transferring loads between horizontal and vertical members. Within RC frame structures, these joint regions are subjected to significant shear demands under seismic loading, which can have a decisive influence on overall earthquake resistance. Earthquake-induced forces generate concentrated shear stresses at these connections, often leading to localized deterioration of concrete. This problem can be alleviated through the provision of adequate transverse reinforcement in the beam-column joint regions. Nevertheless, Figure 5 illustrates cases of concrete crushing and buckling of longitudinal reinforcement resulting from insufficient transverse reinforcement at these connections.

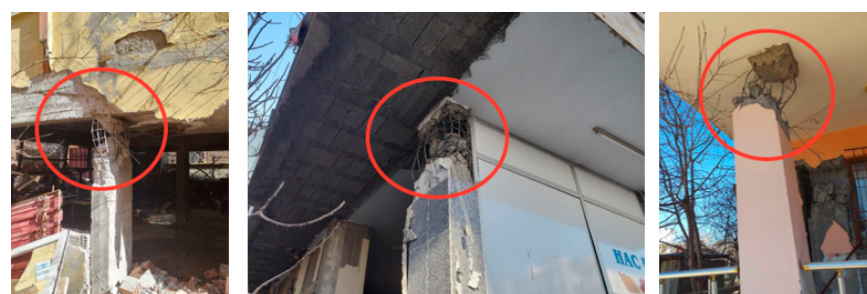
**Figure 6.** Representative failure modes observed at the upper confinement zone consequent to substandard transverse reinforcement detailing.

After load transfer through the beam-column joints, bending moments increase at the top of the columns, especially during earthquakes. This may cause damage in the plastic hinge regions. Figure 6 shows the plastic hinges formed at the column ends due to inadequate transverse reinforcement and the resulting damage. In these regions, insufficient confinement provided by transverse reinforcement relative to seismic code requirements results in buckling of longitudinal reinforcement and consequently induces brittle failure of the surrounding concrete.

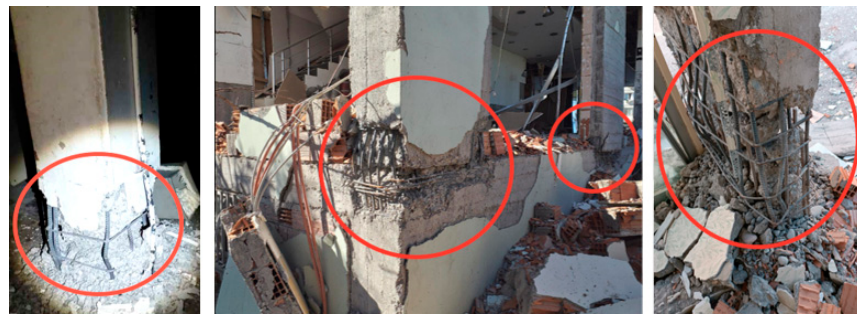
**Figure 7.** Examples of failures in the lower end of the column.

The damage examples resulting from insufficient and inadequate transverse reinforcement at the lower end region of the RC columns during the earthquake are shown in Figure 7.

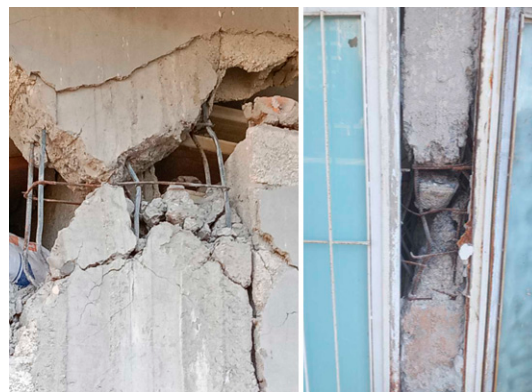
**Figure 8.** Failures in the middle region of the column.

Figure 8 illustrates representative failure modes in the mid-height region of the columns, triggered by the combination of deficient lateral confinement and low-grade concrete.

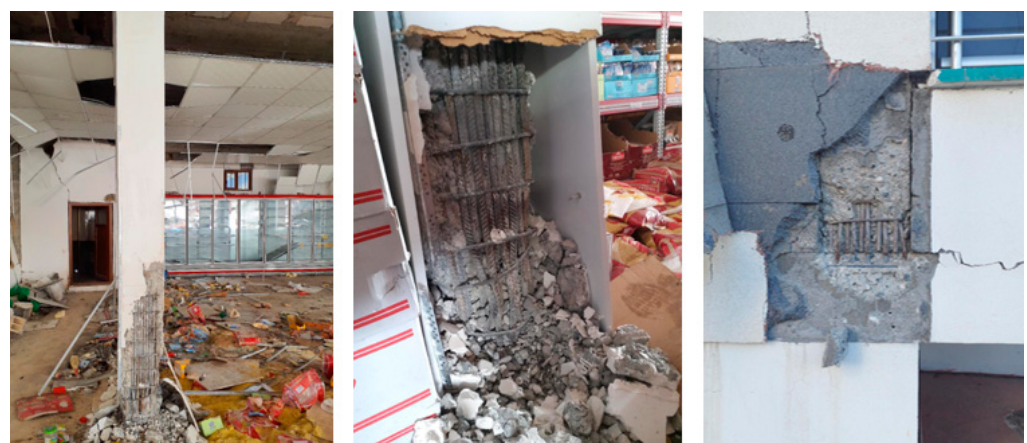
**Figure 9.** Examples of failures resulting from the failure of transverse reinforcements to perform their expected functions due to excessive use of longitudinal reinforcement.

Considering these damages, the codes used in Türkiye recommend increasing the transverse reinforcement in the lower and upper regions of columns. This aims to enhance the strength and ductility of these areas. However, excessive use of longitudinal reinforcement in these regions has caused issues with the expected contribution of transverse reinforcements to increasing the brittleness of the concrete. Examples of damage occurring in the column end sections are shown in Figure 9.

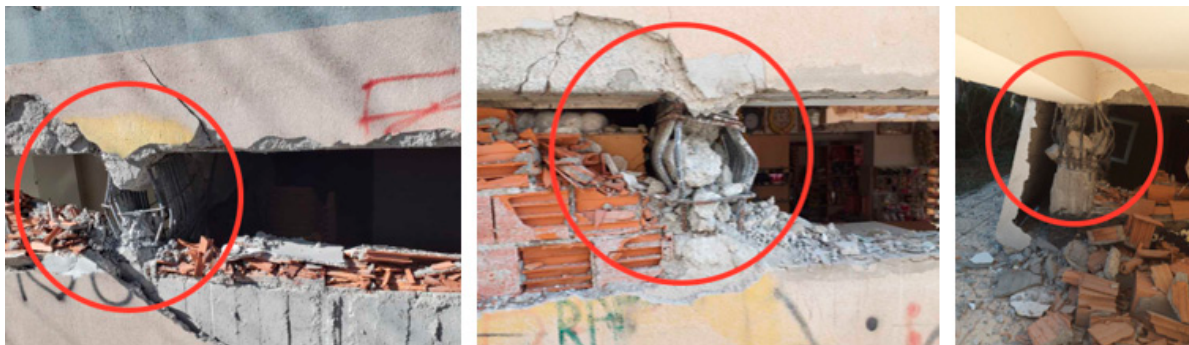
**Figure 10.** Buckling of longitudinal reinforcement due to insufficient transverse reinforcement in short columns.

Insufficient transverse reinforcement in short columns, which can form due to various reasons, increases the extent of damage in these structures. Examples of failure resulting from inadequate transverse reinforcement in short columns are shown in Figure 10.

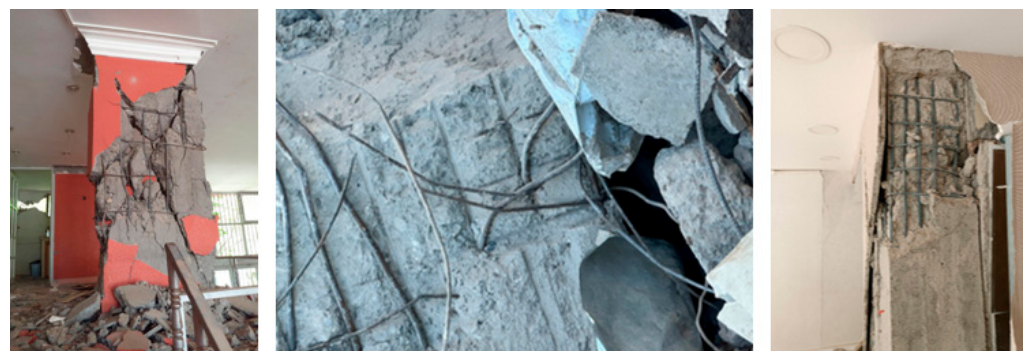
**Figure 11.** Insufficient concrete-reinforcement interlock resulting from the use of plain reinforcement.

In damaged RC structures in earthquake-prone areas, the use of plain reinforcement has not been commonly observed. While previous regulations allowed the use of plain reinforcement until 2007, the regulations after 2007 permitted this type of reinforcement only in transverse and stirrups. Since plain reinforcement lacks any ribs, there is no mechanical bond formed between the concrete and the reinforcement. As a result, the concrete can easily slip off the reinforcement, preventing the concrete and reinforcement from working together, which contradicts the fundamental principle of reinforced concrete. During earthquake loading, the weak bond between plain reinforcement and concrete leads to early reinforcement slip and rapid bond deterioration. This behavior reduces the composite action between concrete and steel, resulting in concrete spalling and local damage. In contrast, the ribs present in deformed reinforcement significantly enhance the interlock between the concrete and the reinforcement. Examples of failure resulting from insufficient interlock between concrete and reinforcement due to the use of plain reinforcement are shown in Figure 11.

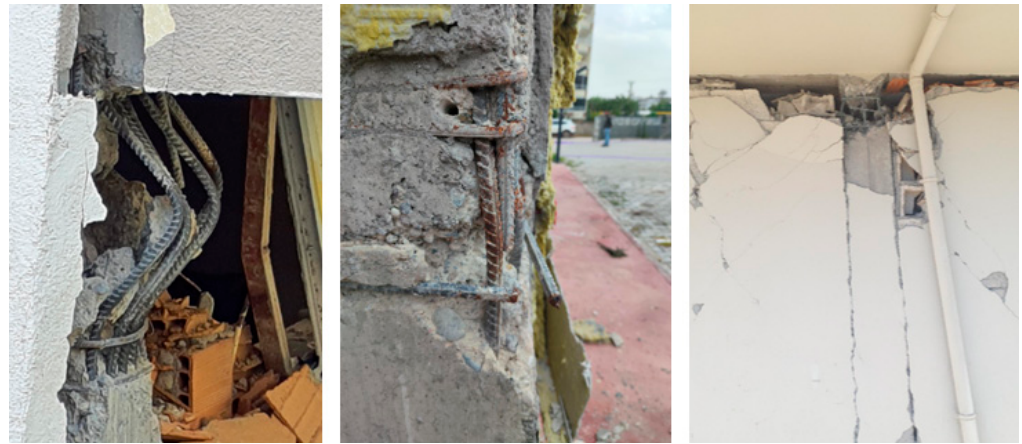
**Figure 12.** Buckling samples in longitudinal reinforcement.

A commonly observed type of failure resulting from insufficient transverse reinforcement is the buckling of longitudinal reinforcement. Buckled longitudinal reinforcement can lead to the crushing and spalling of concrete. Additionally, failures have been observed in transverse reinforcement when the shear force capacity is exceeded. Examples of buckling in longitudinal reinforcement and fractures in transverse reinforcement are shown in Figure 12. In cases where the transverse reinforcement in columns is insufficient, the transverse reinforcements may not prevent the buckling of longitudinal reinforcement, leading to fractures in the transverse reinforcements.

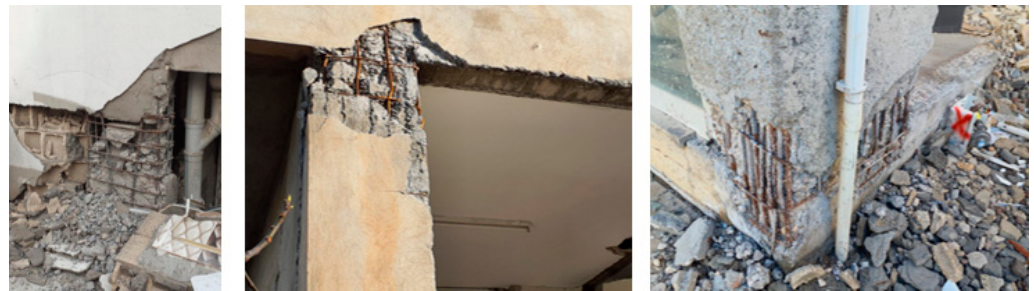
**Figure 13.** Corroded reinforcement and insufficient interlock resulting from inadequate concrete cover thickness.

One of the key parameters influencing the load-bearing capacity of RC structural elements is insufficient concrete cover thickness. Inadequate cover may lead to the corrosion of reinforcement over time, which reduces the effective cross-sectional area of steel and consequently diminishes the load-carrying capacity of the member. Examples of columns that experienced corrosion-induced damage because of insufficient concrete cover are presented in Figure 13.

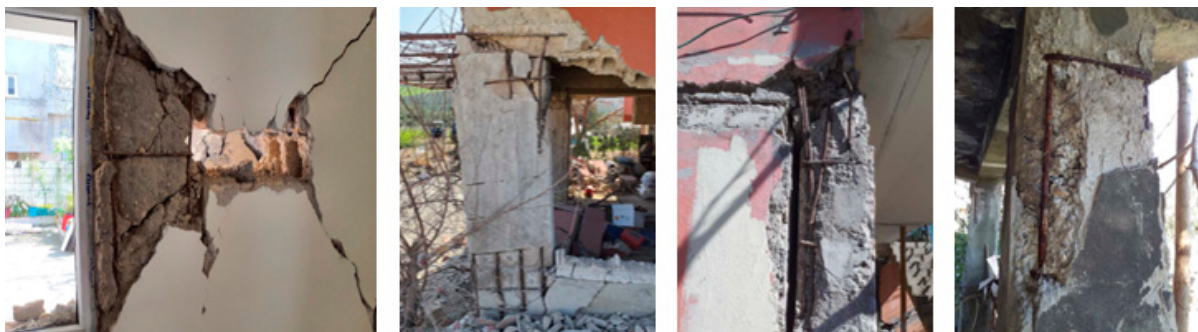
**Figure 14.** Examples of failure from insufficient transverse reinforcement and concrete cover.

In addition to inadequate concrete cover thickness, insufficient transverse reinforcement also increases the level of damage. Examples of failure resulting from insufficient transverse reinforcement and clear concrete cover depth are shown in Figure 14.

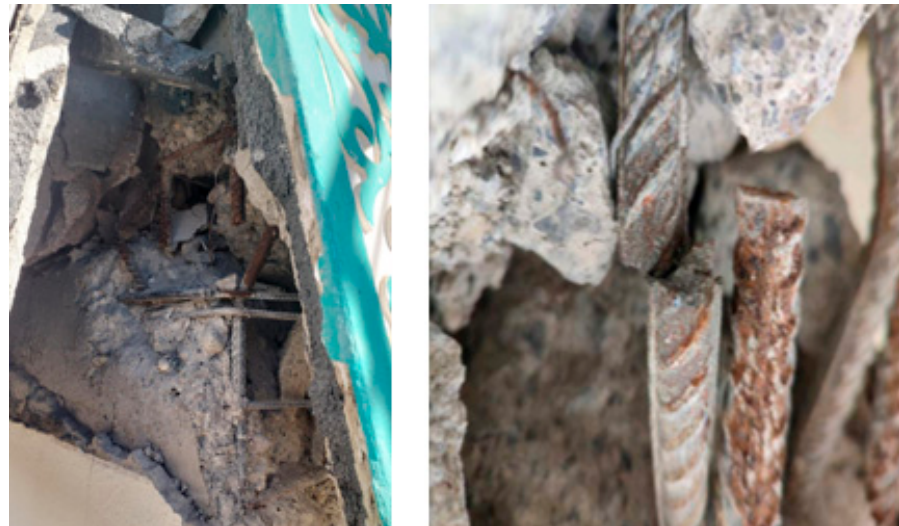
**Figure 15.** Fracture in the longitudinal reinforcement.

Due to insufficient transverse reinforcement, the load-bearing capacities of longitudinal reinforcements have been exceeded, resulting in fractures in the longitudinal reinforcements. The characteristics associated with this type of damage are clearly presented in Figure 15.

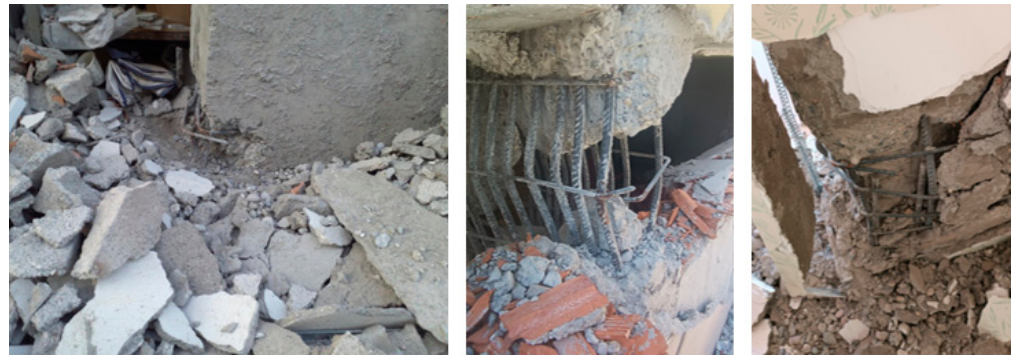
**Figure 17.** Examples of slips of transverse reinforcement caused by insufficient anchorage of  $90^\circ$  hooks during earthquake loading.

Although seismic design provisions recommend that transverse reinforcement in columns be detailed with  $135^\circ$  hooks around longitudinal reinforcement, in practice  $90^\circ$  hook configurations are sometimes used, which may result in inadequate anchorage of the transverse reinforcement. This detailing deficiency can facilitate the premature slip or pull-out of transverse reinforcement from the longitudinal bars. Examples of the resulting damage are presented in Figure 17.

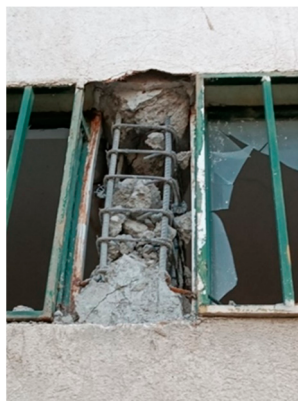
**Figure 18.** An example of a transverse reinforcement applied with a  $135^\circ$  angle.

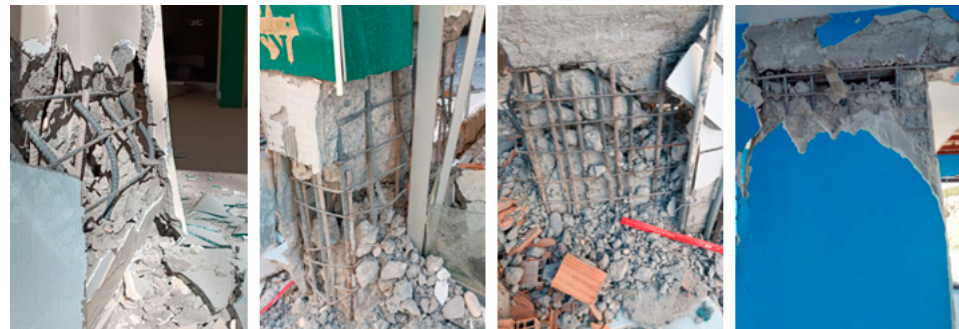
**Figure 20.** Configuration of distinct reinforcement types in transverse and longitudinal directions.

The combined structural performance of longitudinal and transverse reinforcement in reinforced concrete (RC) columns is adversely influenced when ribbed bars are used as longitudinal reinforcement together with plain bars as transverse reinforcement. This reinforcement configuration results in inadequate anchorage, thereby limiting the intended contribution of the reinforcement system under loading conditions. Typical failure mechanisms associated with RC columns incorporating ribbed longitudinal reinforcement and plain transverse reinforcement are illustrated in Figure 20.

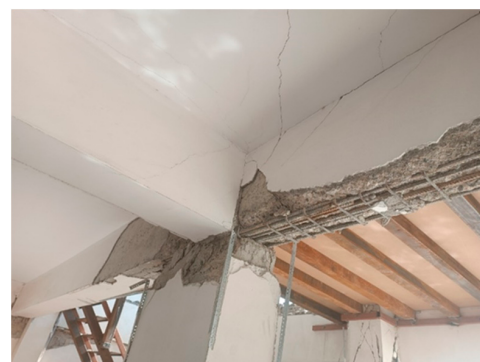
**Figure 22.** Insufficient concrete cover thickness in the RC beam.

In RC beams, excessive use of longitudinal reinforcement negatively affects the bond between the concrete and the reinforcement. Excessive longitudinal reinforcement limits the spacing between bars, making concrete placement and compaction difficult. This often creates voids and a weak bond, which reduces the overall capacity of the member. Additionally, as with columns, insufficient concrete cover thickness impacts the load-carrying capacity of the reinforcements. An example of damage observed in a beam due to excessive longitudinal reinforcement and insufficient concrete cover thickness is shown in Figure 22.

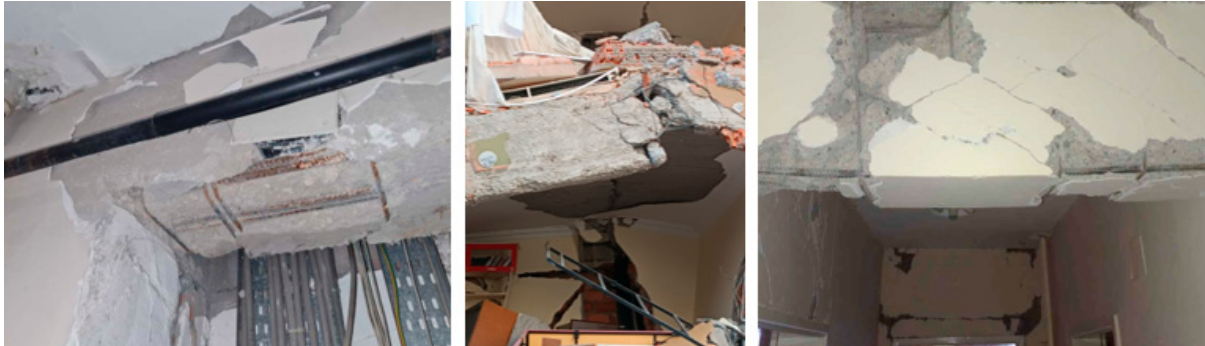
**Figure 23.** Examples of failure caused by insufficient transverse reinforcement in beams.

A lack of transverse reinforcement caused diagonal shear cracks to develop rapidly. As seismic demand grew, these cracks widened, reducing the beam's shear capacity and leading to brittle failure in some members. Examples of failure caused by insufficient transverse reinforcement in beams are shown in Figure 23.

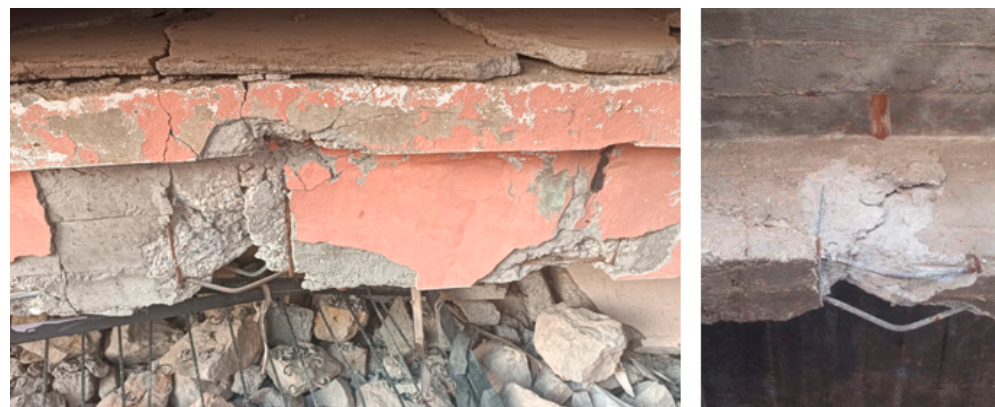
**Figure 24.** Lateral buckling failure in RC beams.

The most significant damage caused by insufficient transverse reinforcement, similar to that in columns, is the buckling of longitudinal reinforcement. Examples of lateral buckling damage occurring in longitudinal reinforcement in beams are shown in Figure 24.

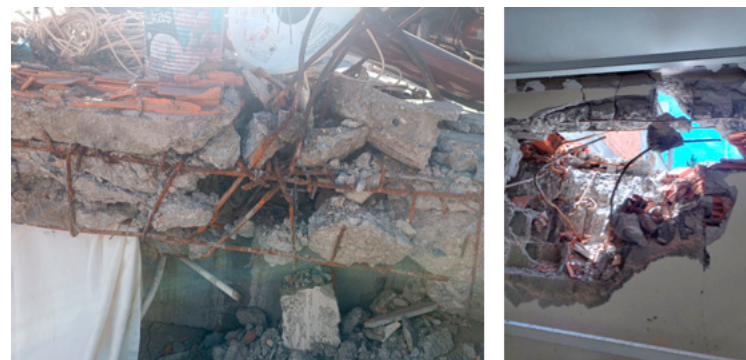
**Figure 25.** Examples of failure caused by corroded plain reinforcement.

Corrosion reduces the steel's effective area and weakens its bond with concrete. In plain-bar members, this is highly critical; since there is already little mechanical interlock, cracking occurs earlier and load capacity drops. Examples of failure caused by the use of plain reinforcement and the corrosion of reinforcement in beams are shown in Figure 25.

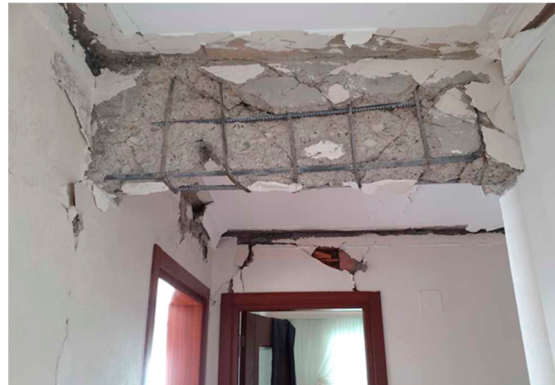
**Figure 26.** The use of different types of reinforcement in longitudinal and transverse bars.

The use of different types of reinforcement in transverse and longitudinal bars in beams, similar to columns, has caused anchorage problems between the reinforcements. An example of this type of damage is shown in Figure 26.
