# Study of the Seismic Response on the Infill Masonry Walls of a 15-Storey Reinforced Concrete Structure in Nepal

**Abstract:** Following the strong earthquake on April 25, 2015 in Nepal, a team from the University of Porto, in collaboration with other international institutions, made a field study on some of the most affected areas in the capital region of Kathmandu. One of the tasks was the study of a high-rise settle of buildings that were damaged following the earthquake sequence. A survey damage assessment was performed to a 15-storey infilled reinforced concrete structure, which will be detailed in the manuscript. Moreover, ambient vibration tests were carried out to determine the natural frequencies and corresponding vibration modes of the structure. The main aim of this manuscript is to present a numerical study concerning the influence of the masonry infill walls in the structure seismic response. For this, three numerical models were built discriminating the situations with and without damage and nondamaged infill walls. Validation and calibration of the numerical model was ensured by comparing the numerical frequencies with those obtained from ambient vibration tests. I

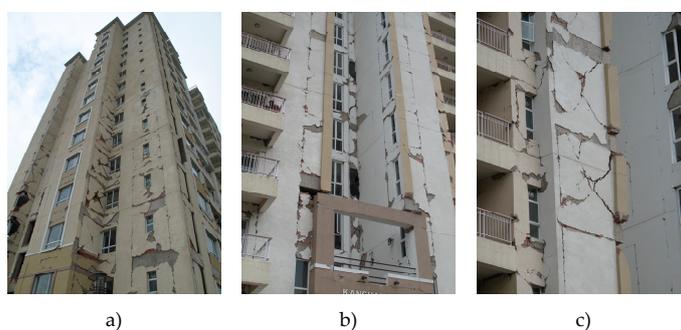
**Figure 1.** Fourteen-storey reinforced concrete structure damaged after the Gorkha earthquake: (a) distribution of the damages from the first to the seventh storey; (b) detachment of the walls from the envelope frame; (c) diagonal cracking with slight out-of-plane detachment of the wall.

Regarding the high-rise RC buildings' (with 10–18 storeys) performance from the earthquake of April 25, 2015, it was observed that most of the damage was related to the infill walls [6–8]. Figure 1 shows the structure damage of a 14-storey RC and from the observation of the vertical profile of the building, the damages are concentrated the first seven floors of the structure, as can be seen in Figure 1a. The damages are composed by detachment of the walls from the envelope frame (Figure 1b), diagonal cracking (Figure 1c) and some slight out-of-plane detachment of the wall from the frame. The reduced level of damage suits the proper seismic behaviour of these structures, which were designed as per the Indian National rules and standards. Even though, in many cases, damage was limited to the infill panels, it is worth noting that in many of these structures, the occupants had to be moved for temporary shelter (for some, more than a year) due to safety issues related to possible failure of the panels and until all repairs are complete. In some cases, the high costs associated with the repair of the buildings exceeded the structural costs of construction.

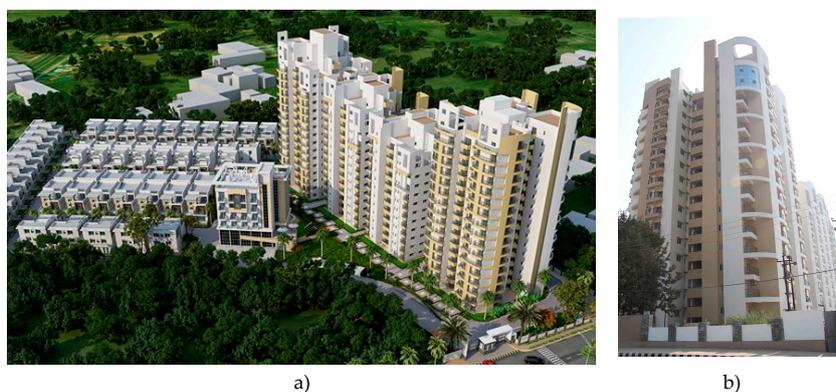
**Figure 2.** Global overview of the high-rise structure under study: (a) location of the houses and the high-rise buildings; and (b) front view.

The building is a residential structure, located in the small town of Satdobato and belongs to a large luxury development composed of small houses and four high-rise structures (Figure 2a). The building is located at the left side of those grouped together. The structure is composed of two underground floors and 15 storeys (Figure 2b). The ground-floor height is 4 m and the others are 3.2 m high—a total of 48.8 m high.

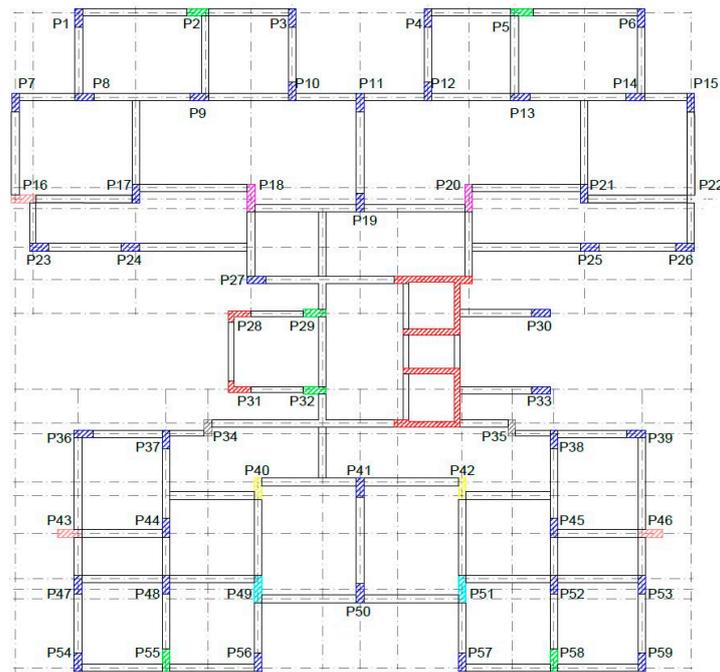
Figure 3. Case study: columns cross-section.

The tower is composed by RC frames filled with masonry infill walls made with solid clay bricks aligned according to the longitudinal and transverse direction and two stiff RC cores destined to the elevator boxes. The RC frames are composed by beam-column elements with spans relatively small. The beams are typically composed by two cross-sections, namely  $300 \times 600$  mm and  $230 \times 600$  mm. On the other hand, the columns are composed of 8 types of cross-sections, which are constant in height and very robust, as can be observed in Figure 3 and is described in Table 1. The longitudinal and transverse reinforcement is different among the different storeys. Complete detailing of all the cross-sections and reinforcements can be found in [9].

The solid RC slabs are supported by RC frame resisting system and have two different thicknesses: 125 mm and 110 mm. Two stiff RC cores destined to the elevator boxes are distributed in the middle alignment of the structure (red in Figure 3).

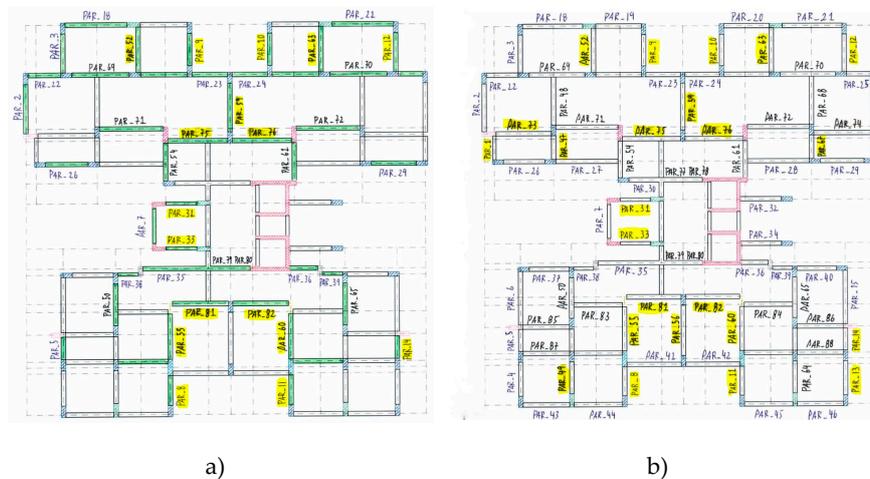
**Figure 4.** Distribution of the infill masonry walls: (a) ground floor; and (b) remaining floors. Where Par\_€ means infill panel number €.

Regarding the plan distribution of the infill panels, it was found the distribution was different between the ground floor and the remaining floors. At the ground floor, the major part of the walls did not exist to allow for the passage of people (Figure 4a). Through the observation of the plan disposition of the infill walls, some asymmetry is visible, which could introduce some torsion effect in the structure dynamic response. However, this could not be analysed without also considering the vertical structural elements, which also presents some asymmetry. Concerning the vertical disposition

of the infill walls seems to present also some asymmetry, since there is a high number of infill panels was observed in the top storeys, as can be seen in Figure 4b.

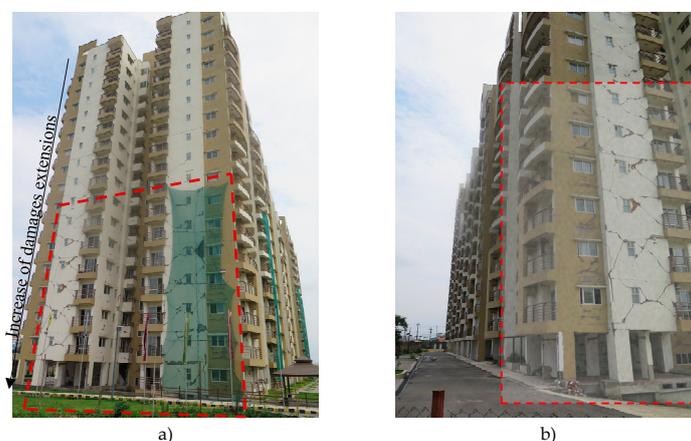
**Figure 5.** Survey damage assessment of the building: (a) north façade; (b) south-east façade.

Globally, the structural seismic performance was positive since the structural damages observed were slight to moderated. Figure 5 shows the vertical profiles of the structure from two different orientations, from which it becomes clear that the damage extension is higher in the bottom storeys (until 7th storey). Regarding the damages observed throughout the building's façades, only a few RC columns located in the ground floor suffered cracking and spalling of the concrete. It was not observed any column affected in the top storeys of the structure. Otherwise, the infill masonry walls suffered extensive damages. Diagonal cracking occurred in most of the cases followed by the detachment from the envelope frame. Out-of-plane collapse along the buildings' façade was not observed, which is justified by the robustness of the façade walls.

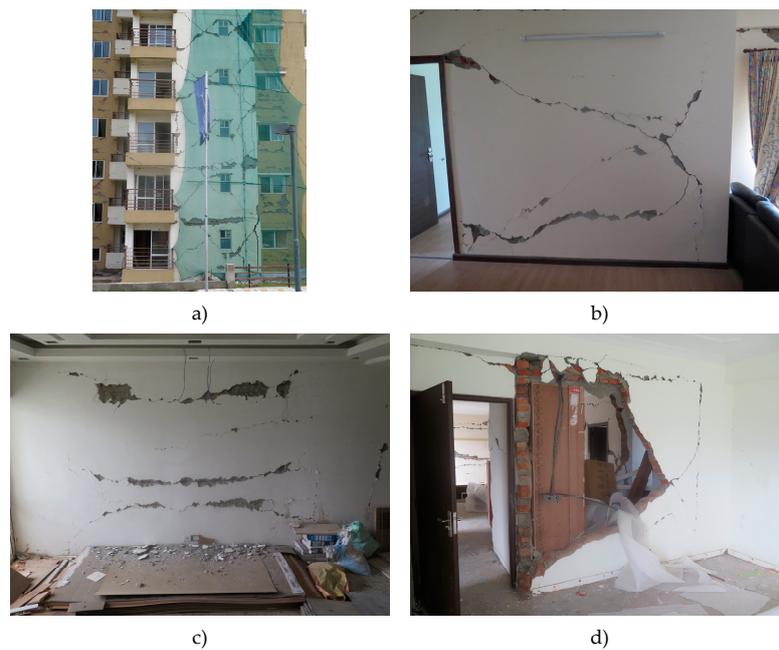
**Figure 6.** Survey damage assessment of the interior of the building: (a) diagonal cracking in façade wall; (b) diagonal cracking in interior partition wall; (c) sliding cracking in interior partition wall of storey 1; and (d) out-of-plane collapse of interior partition wall.

From the survey assessment of the interior of the building, it was observed that several panels detached from the surrounding frame and suffered diagonal cracking (Figure 6a,b). Due to the high stiffness of these infill panels, and a consequently reduced capacity to accommodate lateral distortions, shear sliding cracking was visible in some situations (Figure 6c). This damage was followed by the detachment of the panel from the surrounding envelope frame. Lastly, it was observed that some nonconfined interior partition walls suffered out-of-plane collapse (Figure 6d).

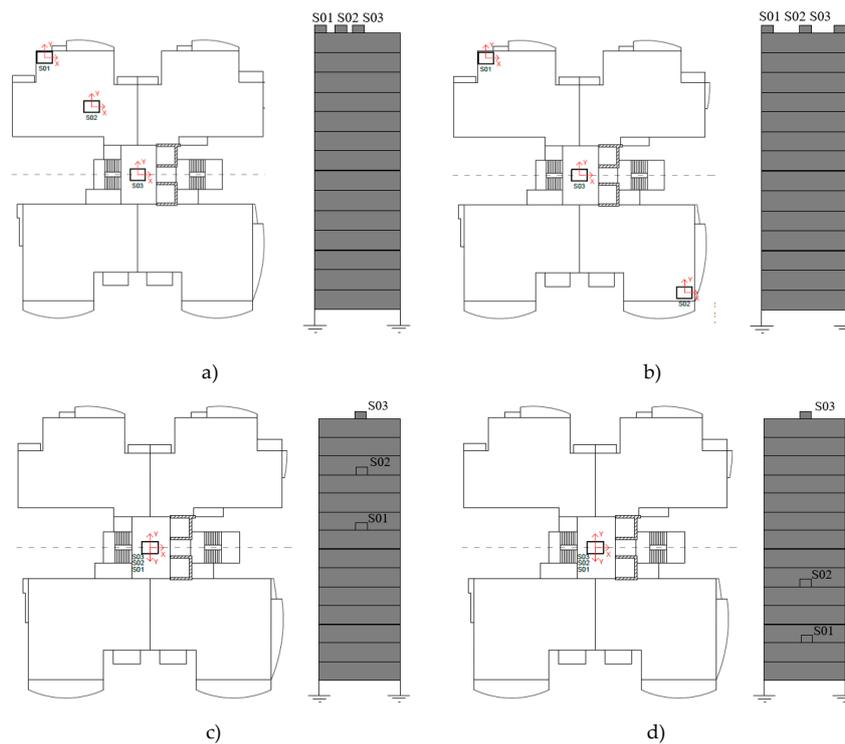
**Figure 7.** Ambient vibration tests: schematic layout of the seismometers disposition (a) Setup 1; (b) Setup 2; (c) Setup 3, and (d) Setup 4.

This was made possible by resorting to internal clock synchronization. The tests consisted in successive vibration measurements in building points, corresponding to different locations in the building plan (at the top storey) and along the building height. The vibration data was collected through four different test setups, in which the seismometer number 3 (here designated S03) was the reference. This reference seismometer was placed in the center of the building plan, close to the elevators core at the 16th storey during all setups. In the first setup, seismographs S01 and S02 were placed on floor 16 in the left block of the building to capture the local torsion mode. The second test setup was comprised by two seismometers placed at two opposite corners (16th storey) aiming to capture the global torsion mode of the structure. Finally, in the third and fourth setup all seismometers were in the same plan location of the reference seismometer. The difference among the test setups was the position of the seismometers along the vertical height of the structure, namely in the setup 3 and 4, seismograph S01 and S02 were placed at the 10th storey and 13th storey, and the 4th storey and 7th storey, respectively. Figure 7 shows the floor layout for all setups.

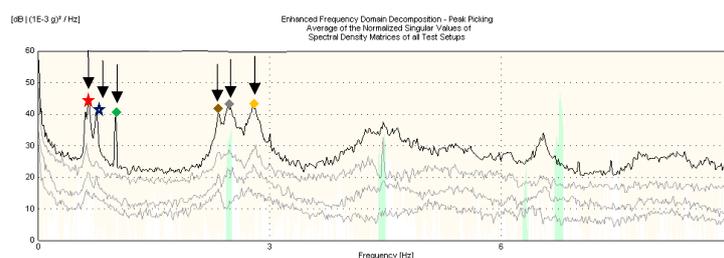
**Figure 8.** Ambient vibration test: normalized single values of spectral density matrices.

The determination of the natural frequencies and corresponding vibration mode shapes of the building is based on the acquisition of the acceleration measurements. For this purpose, the ARTeMIS [11] software for analysis and signal processing was used. The peak picking and the frequency domain decomposition (FDD) methods were used. Concerning the peak picking method, natural frequencies were identified from the peaks of the normalized average power spectra of the measured accelerations in each section, if the dynamic output in resonance is due only to one vibration mode shape. The modal identification was performed through the application of the enhanced frequency domain composition method (EFDD). The EFDD technique theory can be found in [12]. The spectral density matrices obtained from the analysis is plotted in Figure 8. From the plot 6 points are indicated which correspond to the structure natural frequencies. The 5-point red star is related to the first mode (translational mode along direction X—Figure 9a) equal to 0.61 Hz, and the blue one is related to the second mode (translational mode along direction Y—Figure 9b) equal to 0.75 Hz. Regarding the diamond scatter, it starts with the green one and it corresponds to a natural frequency equal to 1 Hz and is related to a torsional mode (Figure 9c). The gold diamond scatter corresponds to a second order vibration mode equal to 2.39 Hz (Figure 9d). Finally the gray and yellow diamond scatters correspond also to second order vibration modes equal to a natural frequency of 2.46 Hz and 2.78 Hz, respectively.

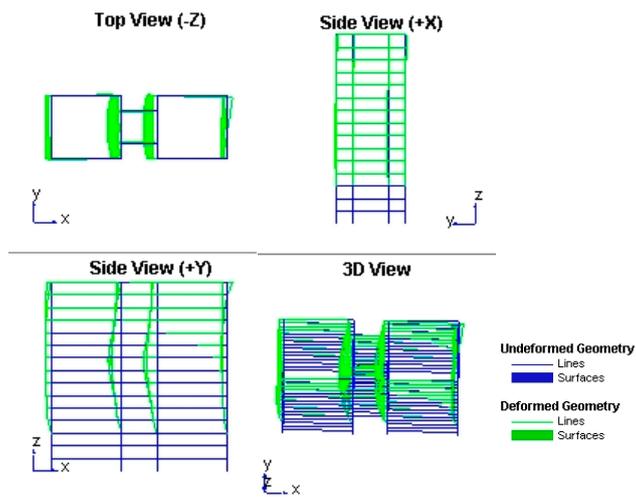
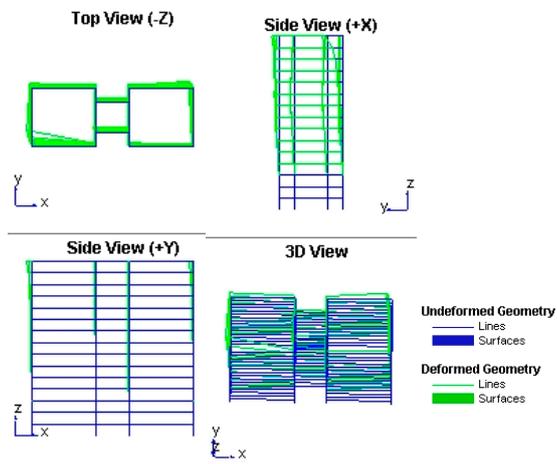
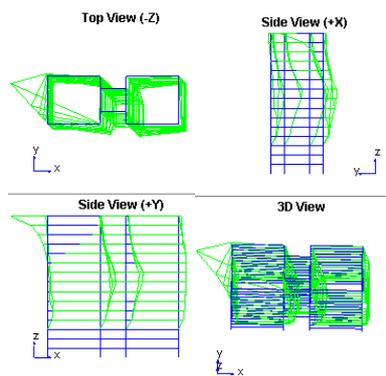
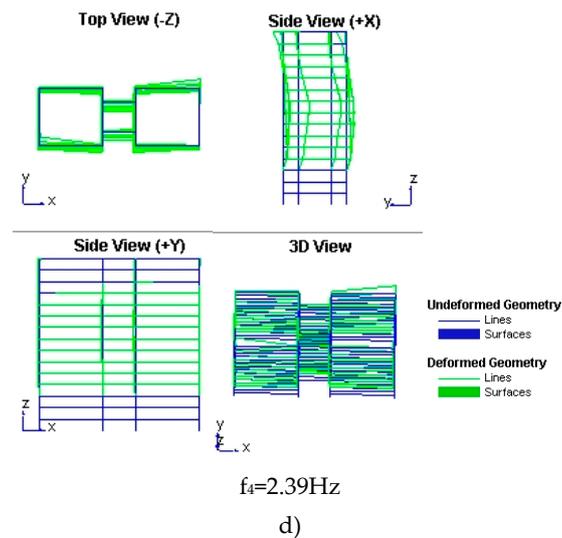
$f_1=0.61\text{Hz}$

$f_2=0.75\text{Hz}$

$f_3=1.00\text{Hz}$

**Figure 9.** Ambient vibration test results: vibration modes corresponding to (a) 1st frequency; (b) 2nd frequency, (c) 3rd frequency and (d) 4th frequency.

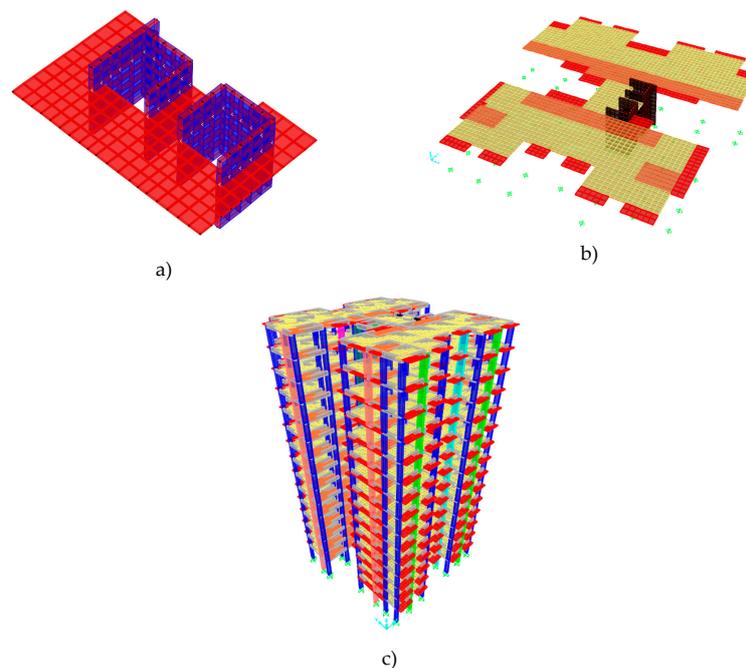
**Figure 10.** Numerical modelling of RC structure: (a) detail of the RC cores and slabs connection; (b) plan view; (c) 3D view.

The numerical modelling of the building under study started by considering the plan and vertical disposition of the structural elements according to the structural drawings. Beams and columns were modelled through bar elements. Regarding the modeling of the two central RC cores, both were modelled using finite elements (plate elements) with dimensions that correspond to each thickness (Figure 10a). The slab modelling was performed by considering the rigid diaphragm at the storey levels, meaning each one behaved as rigid body (Figure 10b). Differences between infill masonry walls and rigid diaphragm concerning the dynamic action can be found in [14]. The modelling of the staircases was neglected since their contribution in terms of stiffness was considerably lower than the RC core's stiffness. However, the staircases' mass contribution was considered. A 3D view of the bare frame numerical model is shown in Figure 10c.

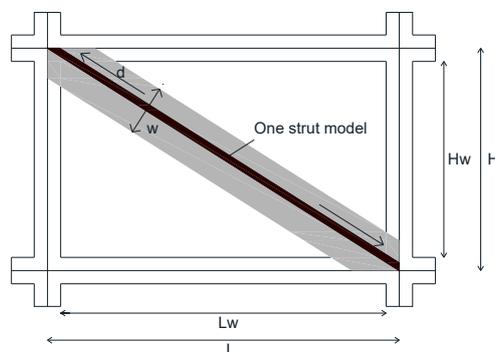
**Figure 11.** Infill masonry walls numerical modelling strategy: equivalent one strut model ( $w$ —strut width;  $L_w$ —panel length;  $H_w$ —panel height;  $H$ —inter-storey height;  $L$ —storey length).

Both simulate the infill masonry wall's in-plane behaviour through one equivalent strut (Figure 11).

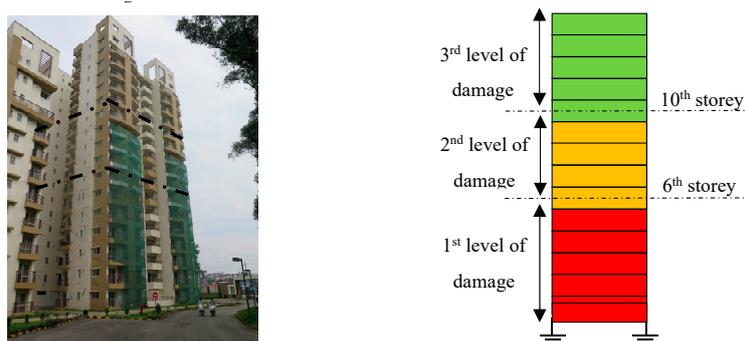
**Figure 12.** Schematic layout of the infill masonry wall level of damages assumed.

reduction factor for each panel. Thus, three different levels of damages were assumed based on the survey damage assessment (Figure 12).

For the first level of damage, a reduction factor of 0.3 was assumed between the 1st and 6th storeys. For the second level of damage, between the 6th and 10th storeys, a reduction factor of 0.5 was assumed. Finally, for the third level of damage, a coefficient of 0.7 was assumed. From the modal analysis of the model with infill masonry walls (damaged), the first four vibration modes and the corresponding natural frequencies were collected and are summarized in Table 6.

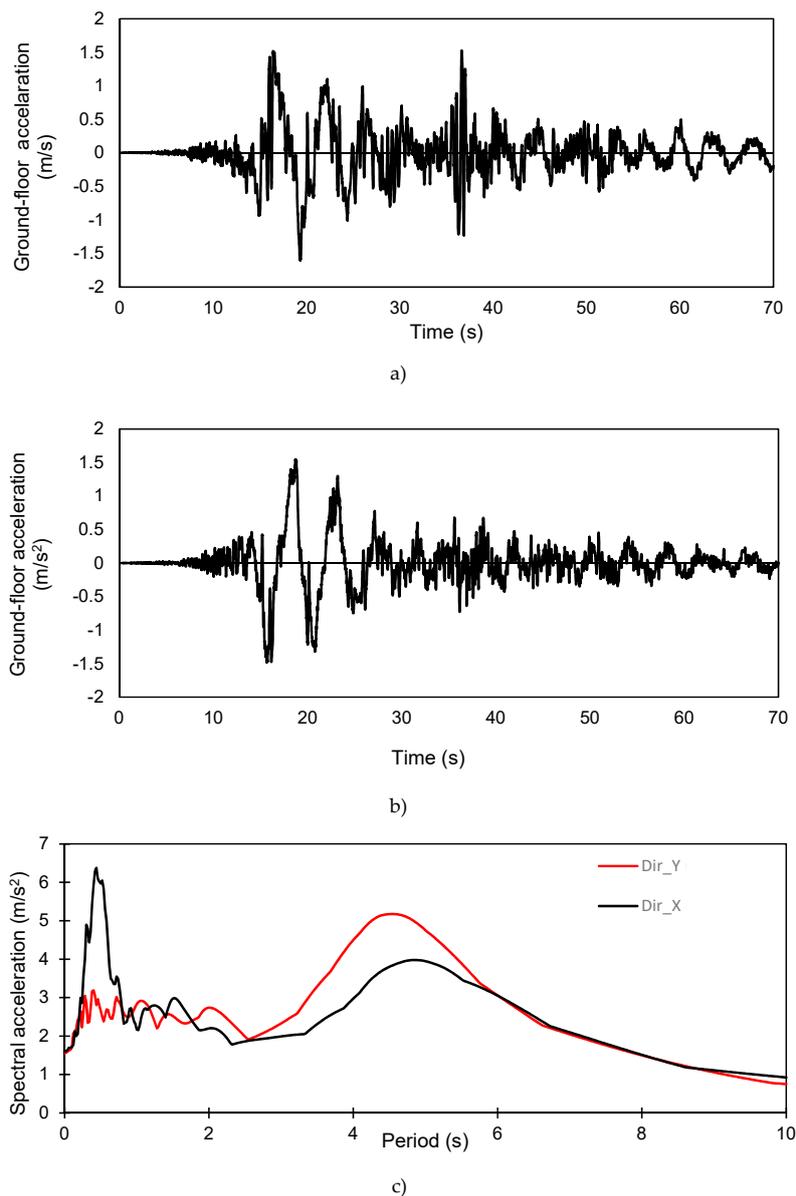
**Figure 13.** Linear elastic dynamic analysis: (a) accelerogram (direction X); (b) accelerogram (direction Y); and (c) spectral acceleration.

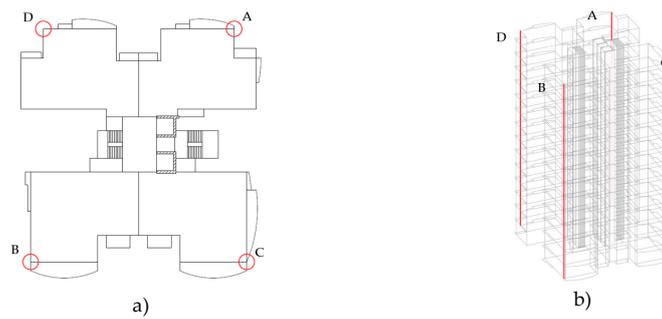
**Figure 14.** Linear elastic dynamic analysis: vertical alignments under study (a) plan view; (b) 3D view.

The analysis results will be analysed and discussed in terms of inter-storey displacements profiles, inter-storey drift ratios, inter-storey shear and inter-storey seismic loading. Four vertical alignments were analysed with the aim of accurately assessing the structural response (Figure 14).

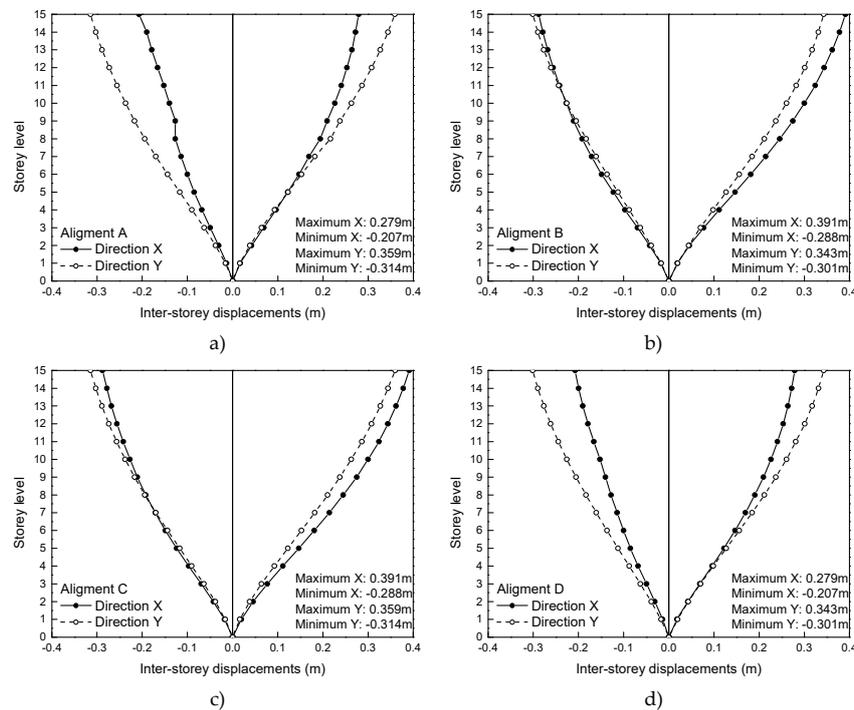
**Figure 15.** Linear elastic dynamic analysis result: maximum inter-storey displacement of Model 3 (a) alignment A; (b) alignment B; (c) alignment C and; (d) alignment D.

Figure 15 presents the maximum inter-storey displacements of Model 3 along the four vertical alignments, from which it is easy to identify similar behaviour. It can be observed that the results from alignments A and D are similar as well as the results from the alignments B and C. It is possible to find that the maximum and minimum displacements in the alignments A and D occurred along direction Y, on the other hand in the alignments B and C occurred along the direction X. This difference can be justified by the torsional effect characterized by the geometry of this structure.

Based on this maximum and minimum inter-storey displacements, it can be also concluded that the A and D alignments along the direction X are 30% lower than the results obtained by the B and C alignments. The same does not occur for the inter-storey displacements along direction Y, where the results are quite similar. Once again this can be justified by the torsion effect.

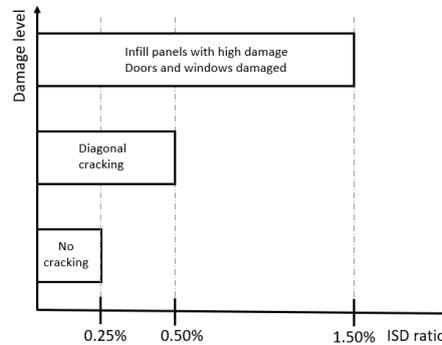
**Figure 16.** Relationship between maximum ISD ratio and infill masonry damage level proposed by FEMA-306.

axial deformation. FEMA-306 [25] and FEMA-307 [26] documents indicates also reference values of ISD ratio. The drift limit proposed for brick masonry is 1.5%, and the drift limit for the beginning of the diagonal cracking which is 0.25% can also be found in these documents, as can be observed in Figure 16.

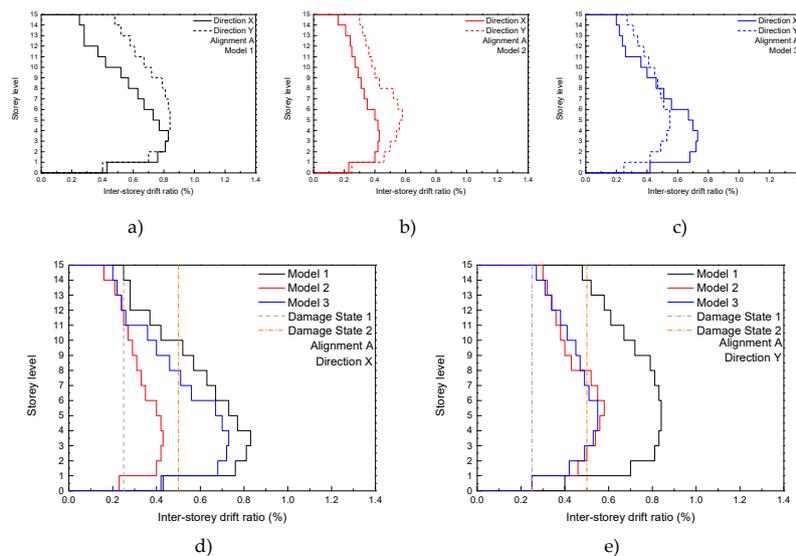
**Figure 17.** Linear elastic dynamic analysis result: maximum inter-storey drift ratio (alignment A) (a) Model 1; (b) Model 2; (c) Model 3; (d) global comparison (Direction X); and (e) global comparison (direction Y).

From the analysis of the maximum inter-storey drift (ISD) ratio profiles (Figure 17), along the alignment A, the following observations can be drawn, namely:

- (i) In all the numerical models, in both directions, the higher ISD ratio values occurred in the intermediate storeys (between storeys 3 and 7);
- (ii) Globally, it can be observed that the higher ISD ratios occurred in the direction Y, with exception of Model 3 where it is observed the opposite. This can be justified by the irregularity of the damages observed in the infill masonry walls, which reduced the global lateral stiffness and strength and increased the lateral deformation;

- (iii) From the comparison between all the numerical models, it can be observed that Model 1 reached the highest ISD ratio values along the direction X, by achieving a maximum value of 0.85%. Model 2 reached the lowest one with a maximum ISD ratio of 0.43%. Concerning the response of Model 3, the impact of the infill panel damages increased the ISD ratio to a maximum value of 0.72%, which is 15% lower than the value obtained by Model 1 (Figure 16);

- (iv) Concerning the direction Y (Figure 16), different results were found since Model 2 and Model 3 reached similar response by reaching a maximum ISD ratio around 0.57%. On the other hand, Model 1 reached again the maximum ISD with a value of 0.83%.

- (v) Regarding the drift limits, it is possible to observe that along the damages are concentrated in the storeys above the 8th; most of them had diagonal cracking as observed in situ and reported in Section 2.3. The numerical results are quite similar—from the ISD ratio envelope of Model 2 and the storeys that exceeded the drift limits, as well as in comparison with the observed post-earthquake damages.

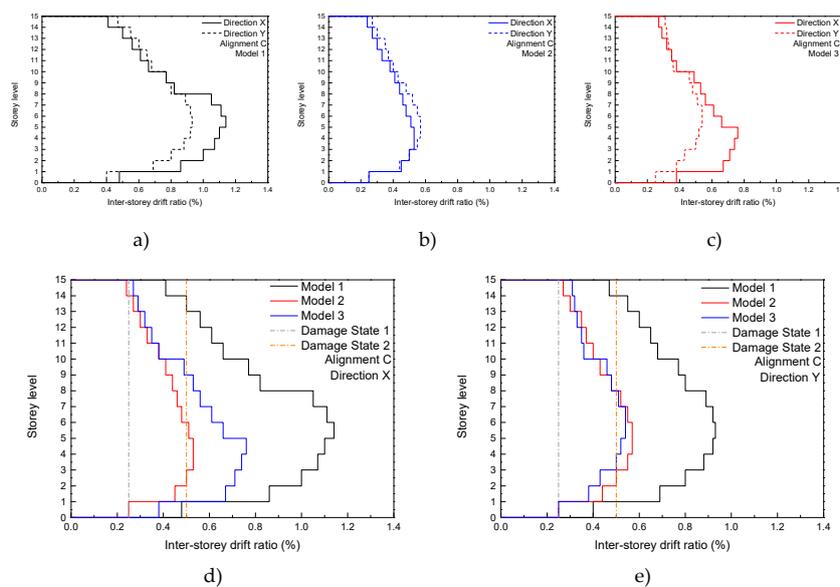
**Figure 18.** Linear elastic dynamic analysis result: maximum inter-storey drift ratio (alignment C) (a) Model 1; (b) Model 2; (c) Model 3; (d) global comparison (Direction X); and (e) global comparison (direction Y).

A similar trend was observed in the alignment C, however higher ISD ratios were achieved. Starting from the results of Model 1 (Figure 18a), the maximum ISD reached in the direction X is 26% higher than the one in direction Y. The storeys that obtained high level of ISD were the storeys between 2 and 8.

Concerning Model 2 (Figure 18b), lower differences were noticed in both directions. In fact, a small variation of around 5% is observed with the highest one along direction Y. In this case, it is not visible a special concentration of the drift demand along the building height.

Concerning direction Y, once again Model 1 reached the maximum ISD ratio followed by the Models 2 and 3, respectively. The maximum value was around 0.92%, which is 39% and 42% higher than the Models 2 and 3, respectively as observed in the alignment A results.

Finally, regarding the drift limits exceedance it is possible to draw the same observations performed for the alignment A, which basically shows that the storeys between the 2nd and 8th storeys were most affected by the earthquake motion.

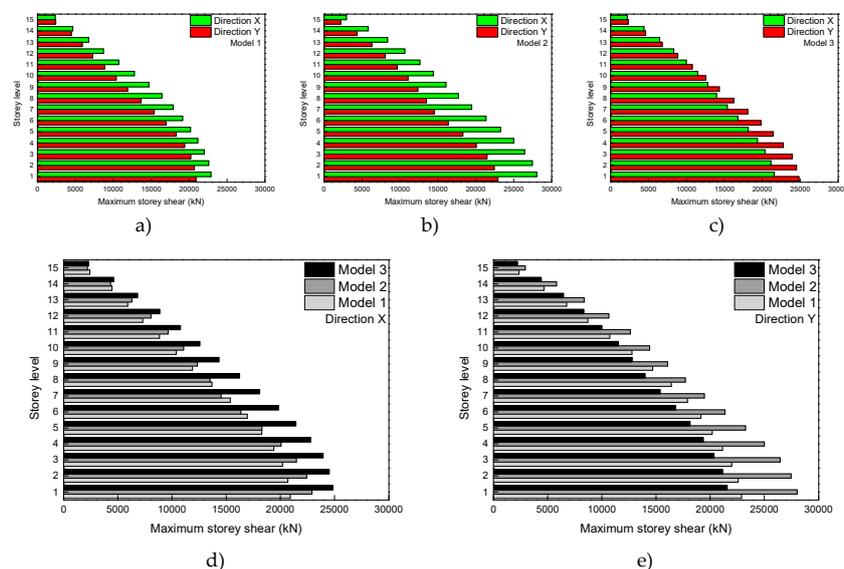
**Figure 19.** Linear elastic dynamic analysis result: maximum storey shear (a) Model 1; (b) Model 2; (c) Model 3; (d) global comparison (Direction X); and (e) global comparison (direction Y).

Concerning the analysis of the inter-storey shear, the maximum shear reached in each storey was extracted from the results, which are plotted in Figure 19. From the results it is possible to observe that the higher values were reached along the direction X (except Model 3). From the plots, it is visible that in Model 1 reached lower maximum storey shear variation along the storey height (Figure 19a). Otherwise, Model 3 was the one where a larger difference was noticed (Figure 19c). Model 2 appears to be an intermediate situation, such in direction X or Y (Figure 19b). From the global comparison along direction X (Figure 19d), it is possible to observe that Model 3 achieved results about 15% higher than Model 1 and 8% more than Model 2. The presence of the infill walls resulted in the increment of the storey shear, which could lead to significant impact on the frame columns and/or beam-column joints. Concerning direction Y (Figure 19e), it can be observed that the maximum values were reached by Model 2, followed by the Model 1 and then Model 3. Model 1 results were about 23% higher than that of Model 3, which is very similar to the model without infill walls.

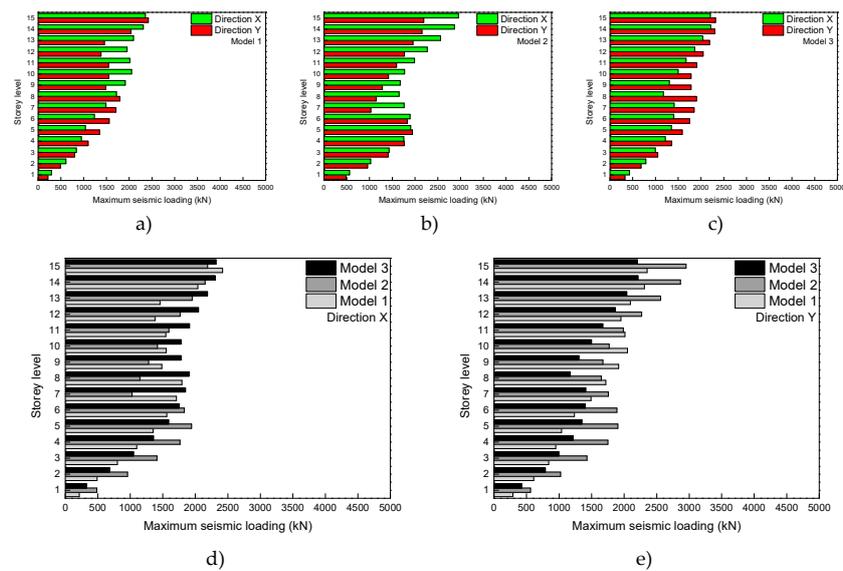
**Figure 20.** Linear elastic dynamic analysis result: maximum seismic loading envelope (a) Model 1; (b) Model 2; (c) Model 3; (d) global comparison (Direction X); and (e) global comparison (direction Y).

Finally, concerning the maximum seismic loading (Figure 20), it is visible that once again the higher values can be found along direction X in Model 1 and in Model 2. In other hand, Model 3 reached the higher maximum seismic loading along direction Y. By analysing the envelopes, it is possible to observe that in Model 1, the maximum seismic loading occurred for the storeys 8, 7 and 6 and the maximum ones in the 14th and 15th storeys (Figure 20a). Higher differences among storeys are visible in Model 2 (Figure 20b), namely the maximum values were reached along Storeys 5, 6 and 4 and finally in 14 and 15. Finally, in Model 3 (Figure 20c), the maximum seismic loadings were reached in the 8th, 7th and 9th storeys and finally in the top storeys (15 and 14).

From the global comparison between the numerical models it seems that along the direction X from the bottom until the 6th storey that Model 2 reached higher seismic loadings. From the 6th storey until 14th, Model 3 exceeded Model 2's seismic loadings. On the 15th storey, Model 1 achieved the highest value (Figure 20d). Finally, along direction Y, it seems that Model 2 always reached the highest seismic loadings when compared with the remaining ones. From the plot (Figure 20e), it is visible that the maximum seismic loadings were about 20% and 10% higher than Model 1 and 3 respectively.
