Article

Evaluation of the Performance of Unreinforced Stone Masonry Greek “Basilica” Churches When Subjected to Seismic Forces and Foundation Settlement

George C. Manos *, Lambros Kotoulas and Evangelos Kozikopoulos

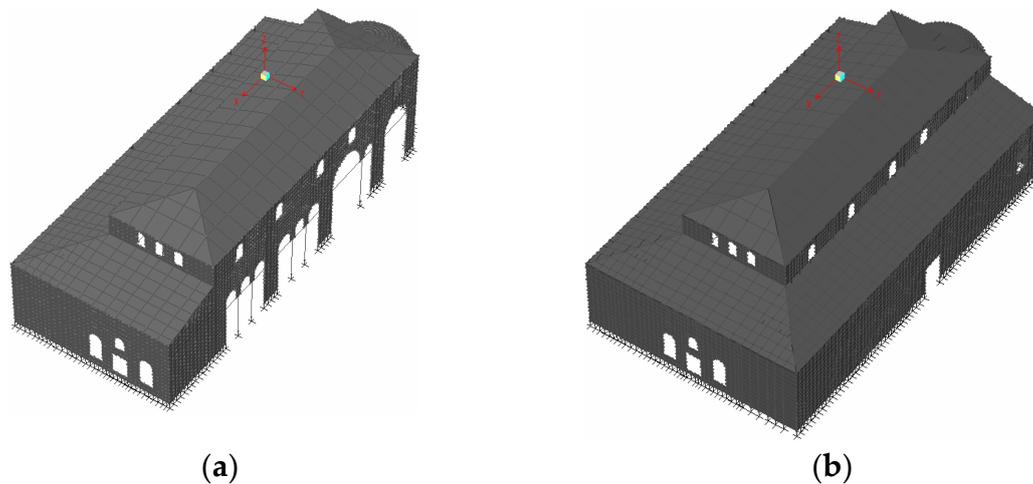
Figure 1. (a) The Basilica structural system with the interior colonnade of the central nave; (b) The Basilica structural system with the peripheral longitudinal and transverse walls.

The longitudinal and transverse walls of such structures are usually long and thick with very large in-plane stiffness. These walls are interconnected to form the main part of the total 3-D structural system, which mainly resists the horizontal earthquake forces [10,12]. Moreover, any change of shape imposed by soil-foundation settlement, because of the large in-plane wall stiffness, leads to considerable stressing of these planar structural elements and their interconnections [4]. In some cases, these planar masonry walls as well as the internal colonnades support a simple or complex relatively stiff masonry vaulting that is in turn protected by a wooden roof (Figure 2a). The soil-foundation settlement and the resulting state of stress-strain that develops on these planar masonry walls spreads also to such masonry vaulting. Therefore, the resulting structural damage develops in either the planar walls or/and the vaulting. Such relatively heavy masonry vaulting also generates large inertia forces in case of a strong earthquake ground motion, which in turn result in large tensile and shear stress demands that can be detrimental for the structural performance of the masonry planar walls and/or the masonry vaulting. Figure 2b depicts a typical damage pattern with the collapse of the central masonry dome [14].

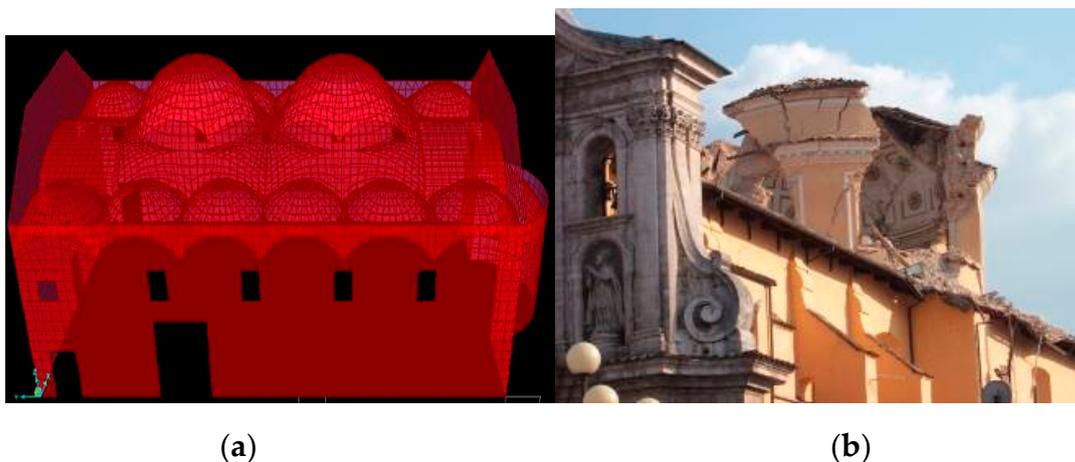
Figure 2. (a). Masonry vaulting; (b). Church of delle Anime Sante, L'Aquila earthquake 2009.

A stone masonry vaulting superstructure (Figure 2a) rests on the peripheral walls as well as on internal five-column twin colonnades. The largest portion of the South-West plan of this church is founded on relatively hard soil (weathered flysch layers) whereas the North-Eastern part, from the North-East corner up to the East part of the North wall, is founded on silty clays that were deposited over the years on top of the flysch layers prior to building the church. Soft soil layers were also added to compensate for the natural slope at this location in order to form a horizontal plane to construct the foundation of the church. A number of boreholes were made close to the East (Figure 3a) and North (Figure 3b) sides; they revealed that at the North-East corner the silty clay layers extended to a depth of 7 m.

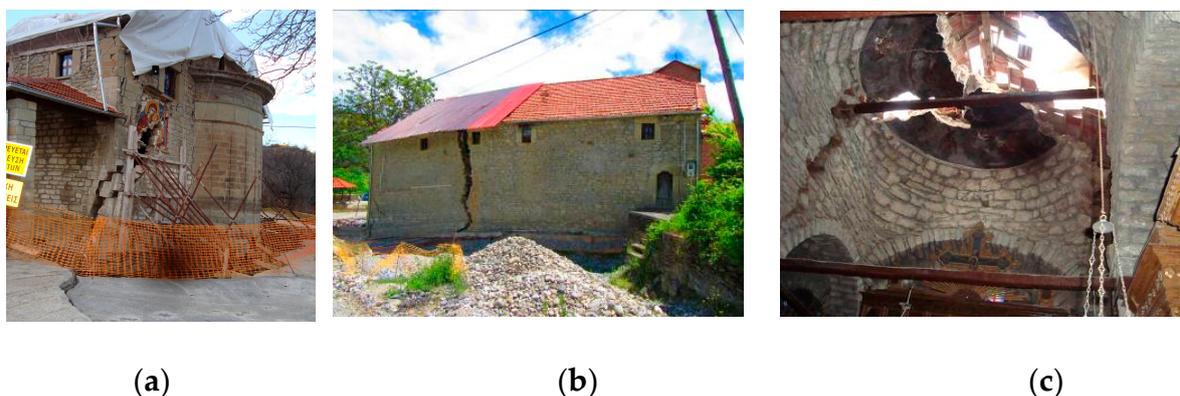
Figure 3. (a) Heavy damage of the East wall. South-East view; (b) Heavy damage of the North wall. North-West view; (c) Heavy damage of the vaulting superstructure.

The uneven settlement of the foundation of the stone masonry walls as well as of the internal columns caused considerable structural damage that progressed to the partial collapse of the whole North-East part. An external view of this church from the South-East is shown in Figure 3a. Extensive damage developed due to considerable settlement at the South-East corner. A very wide crack started off at the top of the East peripheral wall near the apse and propagated towards the bottom of this wall near the South-East corner. Furthermore, a wide crack propagates through the North peripheral wall from top to bottom as is shown in Figure 3b. It must be noted that the thickness of these masonry walls varies from 750 mm to 800 mm. From this extensive peripheral wall damage the vaulting system that is supported by these peripheral walls also suffered extensive severe cracking that eventually led to its partial collapse. The partially collapsed central dome is shown in Figure 3c.

In more detail, a comparison of the tensile stress distribution pattern at the South-East corner of the transverse wall shown in Figure 12a correlates well with the observed damage depicted in

Figure 3a for the same location (see also top of Figure 13). Similarly, the maximum in-plane tensile stress distribution at the middle of the North longitudinal wall, depicted in Figure 12b correlates well with the observed damage depicted in Figure 3b for the same location (see also middle of Figure 13). Finally, the area surrounding the supporting ring of the central dome (Figure 12a,b) also develops high in-plane tensile stress demands that exceed by far the assumed strength values which leads to a reasonably good correlation with the extensive structural damage which actually developed in this part (Figure 3c) of this “Basilica” church (see also bottom of Figure 13).

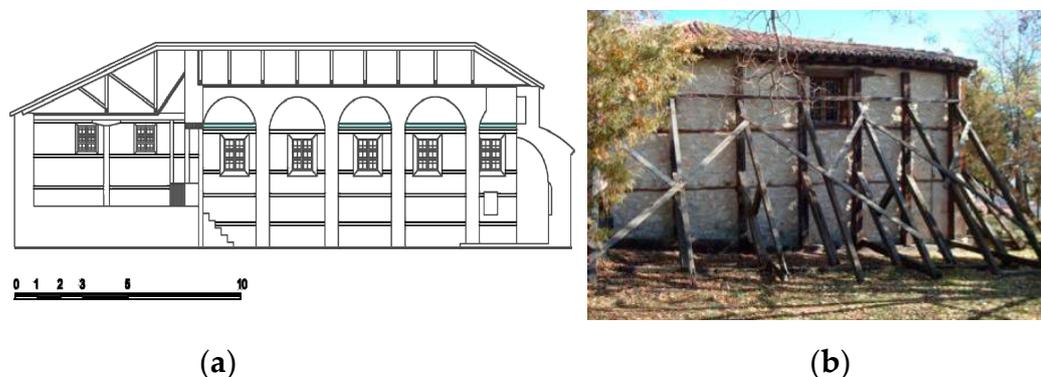
Another case of foundation settlement of a Post-Byzantine three-nave Basilica is that of the church of Profitis Ilias at Siatista–Kozani, built in 1701 A.D. on the top of a hill. This time the damage, caused by the long term foundation settlement combined with the strong earthquake motion of May 1995, is less spectacular than that shown in Figure 3a–c. This church is a three-nave “Basilica” with a wooden roof without a stone masonry vaulting system. The horizontal dimensions of this church are 23.25 m in length and 16.60 m in width. The top of the roof lies at 7.1 m from the floor level of the interior of this church. The naves are formed by four-column twin colonnades (Figure 4a) built with stone masonry. The structural damage is in the form of inclination of the South longitudinal wall outwards,

shown in Figure 4b together with its temporary wooden shoring. This is accompanied by extensive cracking at the connections of this wall with the East and West exterior masonry walls as well as with the mid-transverse wall. Cracking is also evident at the arches of the internal colonnades.

Figure 4. The “Basilica” church of Profitis Ilias at Siatista – Kozani (a) Longitudinal cross-section; (b) Wooden shoring of South longitudinal wall.

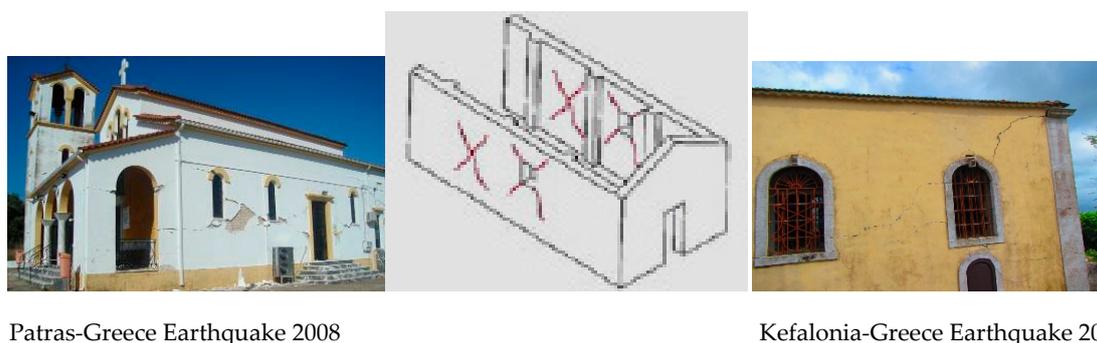
Patras-Greece Earthquake 2008

Kefalonia-Greece Earthquake 2014

Figure 5. Typical damage patterns of longitudinal walls.

Figures 5 and 6 depict the in-plane typical damage patterns of the longitudinal and transverse masonry walls for a number of stone masonry “Basilica” churches. Figures 7 and 8 depict out-of-plane typical damage patterns of the longitudinal and transverse walls for two cases of stone masonry “Basilica” churches. Initially, a simplified assumption is that the various planar and vaulting masonry structural elements are well interconnected at their intersections as well as with the wooden roof and the foundation. The simplified numerical evaluation process presented in Section 3 is based on this assumption. However, in many cases, like those depicted in Figures 7 and 8, failure of the connection between the wooden roof and the masonry wall results in loss of support for parts of the masonry walls leading to out-of-plane partial collapse. Therefore, it is realistic to consider the effect of limit stage conditions at the interconnection of the various masonry structural elements either at the corners of longitudinal and transverse planar walls or at locations where planar walls are joined with the wooden roof or the soil-foundation interface. This is studied in Section 5 utilizing the strength values listed in Table 2.

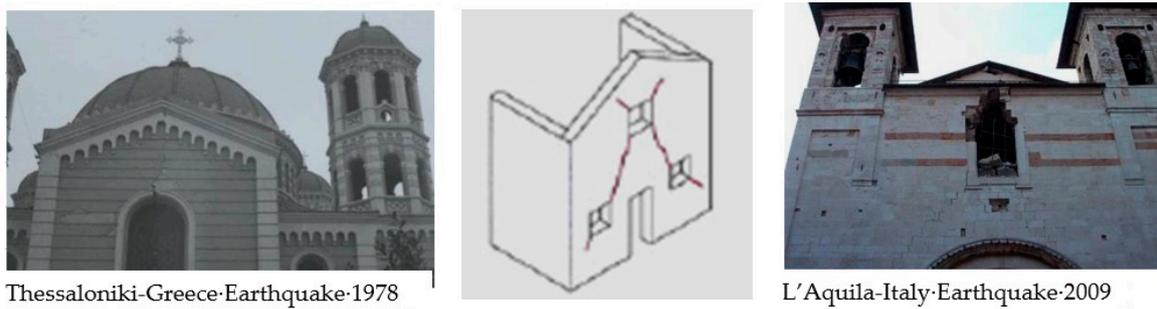
Figure 6. Typical in-plane damage of transverse wall.

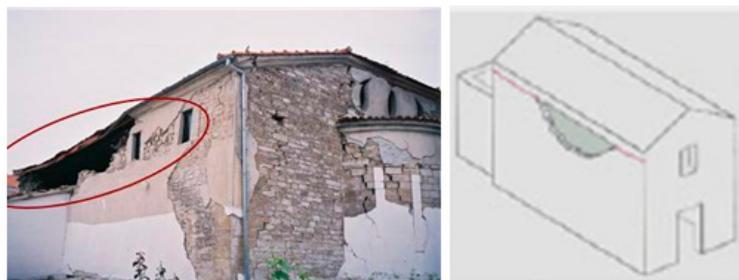
Figure 7. Typical out-of-plane damage of longitudinal wall. Kozani-Greece Earthquake 1995.

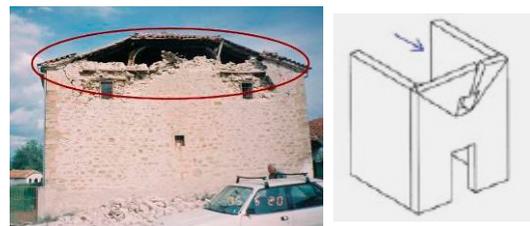
Figure 8. Typical out-of-plane damage of longitudinal wall. Kozani-Greece Earthquake 1995.

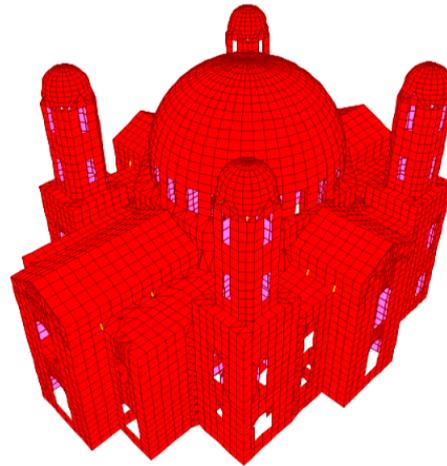
At this “*first stage*” evaluation, the performance of each particular structural element is assessed individually, assuming that these interconnections are withstanding the imposed demands without any form of damage. Assumed elastic properties are adopted for each individual masonry structural element in order to approximate its in-plane and out-of-plane stiffness characteristics. The actual main architectural features are used to form a three dimensional (3-D) numerical model of the whole structural system, as shown in Figures 2a and 9. This linear elastic numerical model is further simplified by utilizing shell elements for numerically simulating each masonry structural element thus approximating the in-plane and flexural (out-of-plane) stiffness without having to actually portray the masonry structural thickness in this numerical approximation.

Figure 9. Formation of the 3-D numerical approximation.

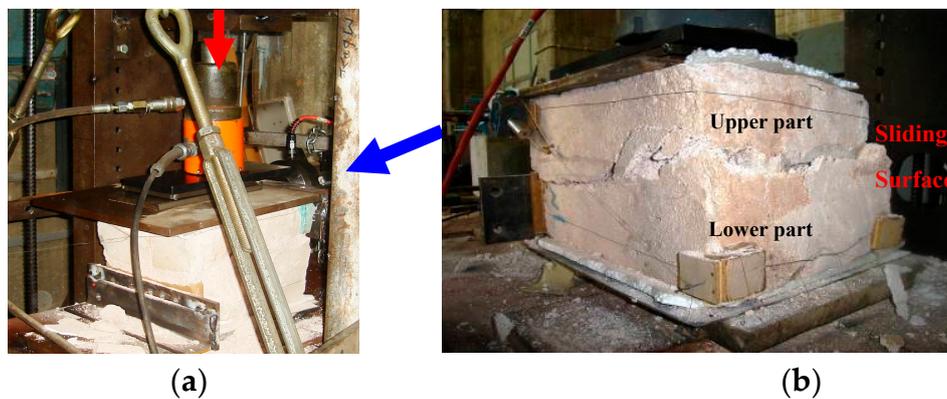
Figure 10. (a). Short stone masonry specimen subjected to sliding shear; (b) Sliding mode of failure of short stone masonry specimen.

Table 1 (column 2) lists the measured shear strength values together with the corresponding values of the compressive stress normal to the equivalent bed-joint (σ_n) applied during testing (Table 1 column 3). Employing formula 1 with values $f_{vko} = 0.12$ MPa and $\mu = 0.45$ the predicted sliding shear strength values are found, listed in Table 1 column 4. Reasonably good agreement is obtained between measured and predicted sliding shear strength, as is indicated by the relevant ratio of measured over predicted sliding shear strength with values listed in column 5 of the same Table.

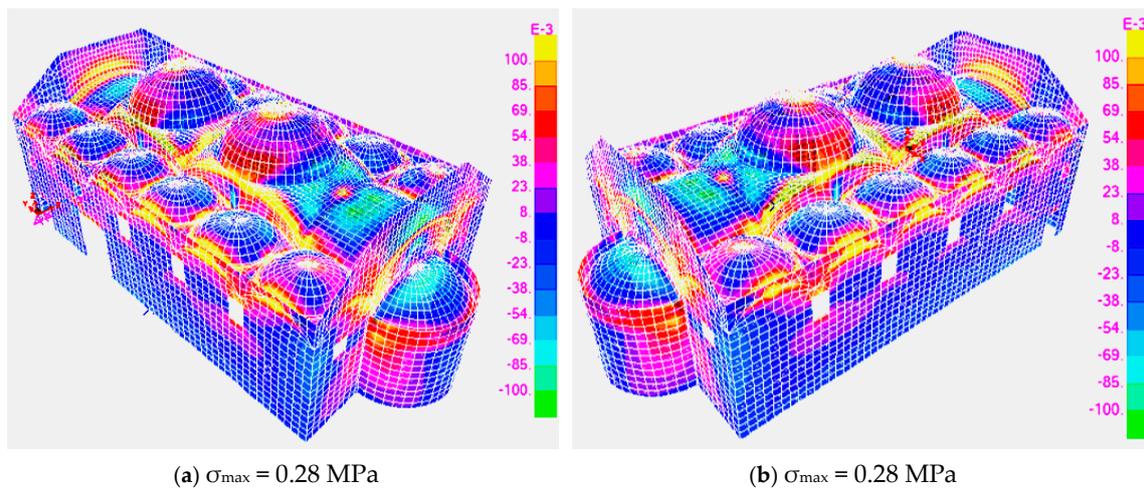
Figure 11. Non-deformable foundation (a) distribution of maximum tensile stresses South-East view (b) distribution of maximum tensile stresses North-East view. The scale at the far right of each plot indicates that the colours used to represent stress values in this numerical representation of the structure are ranging from 0.1 MPa to -0.1 MPa . Yellow colour indicates stress values exceeding 0.1MPa.

Summary results of the numerical simulation of the “Basilica” church of the Assumption of Virgin Mary at Dilofo-Voio-Kozani (Section 2, Figure 3a–c), damaged by foundation settlement are presented here. The assumptions presented in Section 3 were followed in forming this numerical model. Two different cases were simulated. In the first case the soil-foundation interface was assumed to be non-deformable (Figure 11a,b) whereas in the second case a deformable soil layer was placed under the foundation exactly at the same location as was identified from the in-situ examination (Figure 12a,b).

The in-plane maximum tensile stress distribution is shown in these figures. Figures 11a and 12a represent a South-East view of the maximum tensile stress response that can be compared to the actual structural damage shown in Figure 3a whereas Figures 11b and 12b represent a North-East view of the tensile stress response which can be similarly compared to the damage shown in Figure 3b,c. The maximum in-plane tensile stress demands appear at the regions supporting the central vertical domes and have maximum values 0.28 MPa in the case of non-deformable foundation and 0.99 MPa in the case of the deformable foundation, respectively. As can be seen, this maximum in-plane tensile stress value in the case of deformable foundation exceeds by far the tensile strength value adopted in this study and listed in column 2 of Table 2 (0.15 MPa). Therefore, in this latter case the simplified numerical process indicates that scenario c (exceeding the tensile strength) occurs in these locations, thus predicting the development of the relevant structural damage, which correlates reasonably well with observed performance.

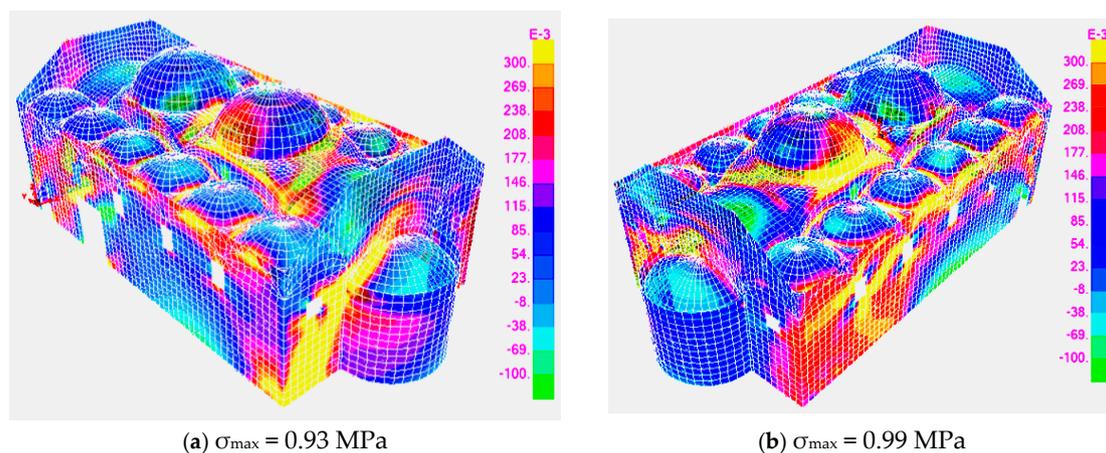
Figure 12. Deformable foundation (a) distribution of maximum tensile stresses South-East view (b) distribution of maximum tensile stresses North-East view. The scale at the far right of each plot indicates that the colours used to represent stress values in this numerical representation of the structure are ranging from 0.1 MPa to -0.1 MPa . Yellow colour indicates stress values exceeding 0.3 MPa.

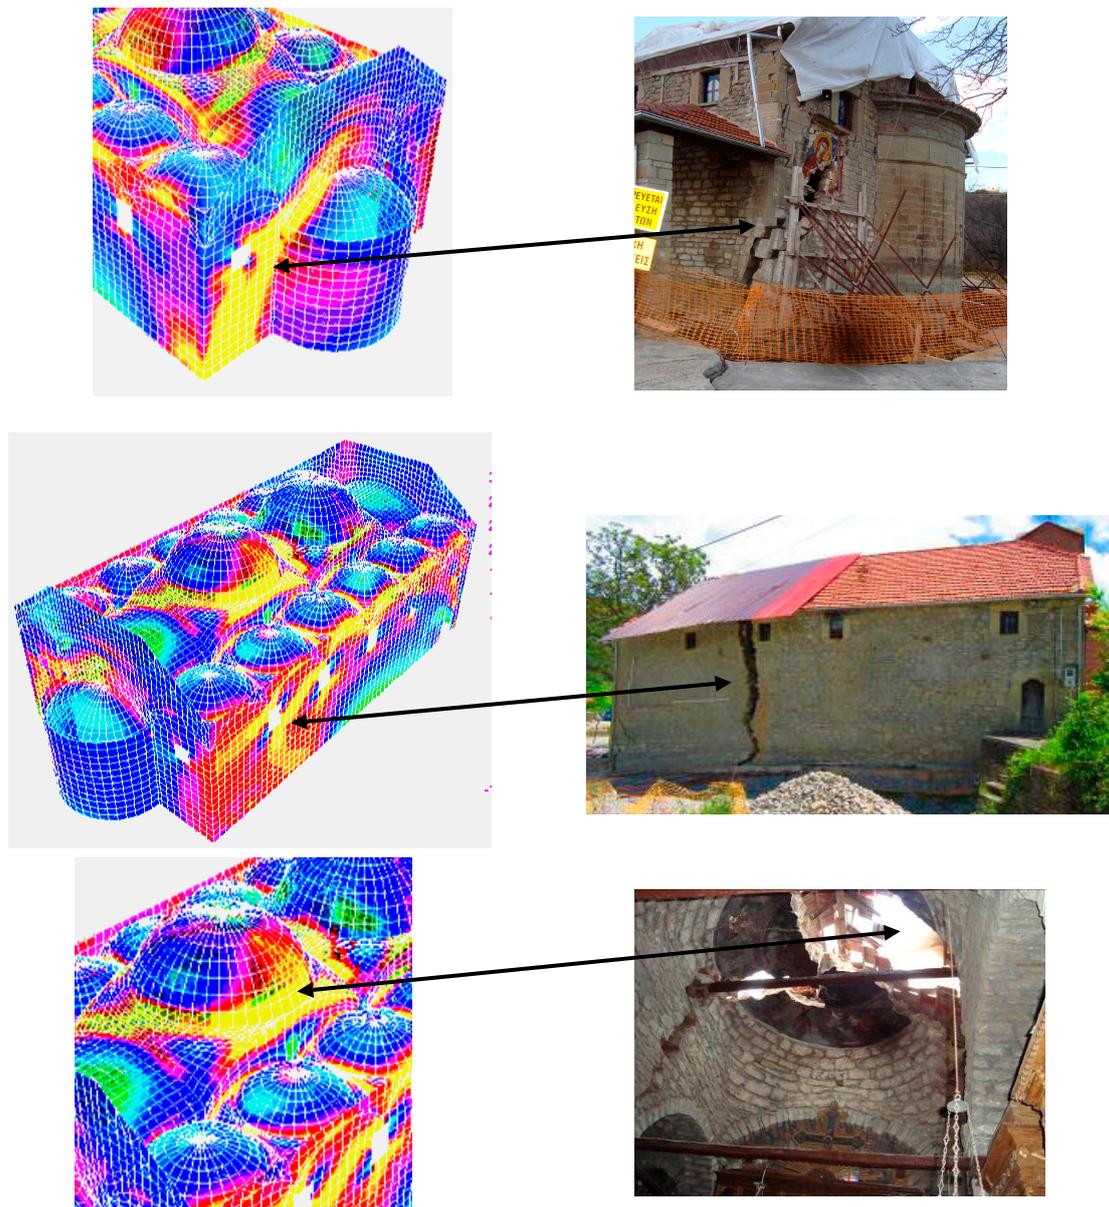
Figure 13. Correlation between predicted (deformable foundation) and observed damage.

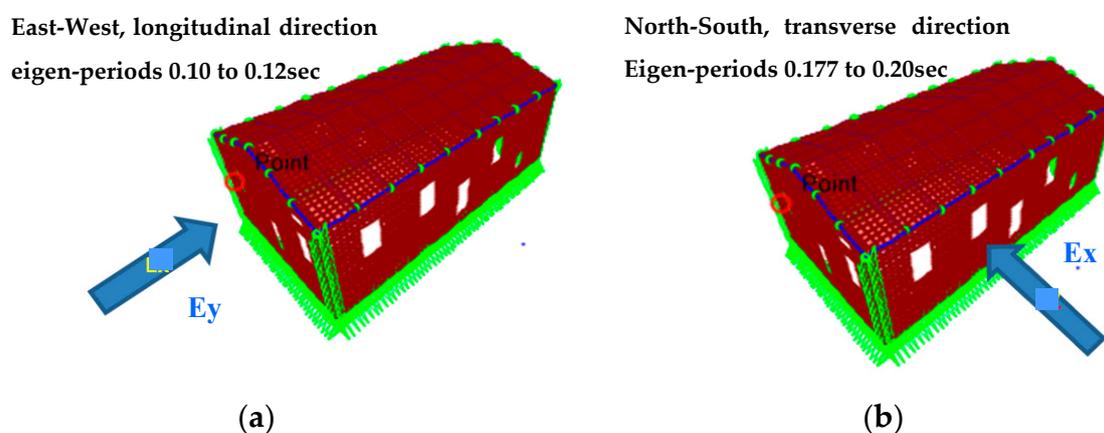
Figure 14. The numerical simulation of the “Basilica” church of St. Marina in Soullaroi in Kefalonia. (a) Longitudinal direction; (b) Transverse direction.

The dynamic and earthquake response of the 17th century “Basilica” church of St. Marina in Soullaroi, which is located in the island of Kefalonia and was heavily damaged during the 2014 earthquake sequence [11,12], is studied here. A linear elastic numerical simulation was formed as previously described. Thick shell finite elements [17] were employed to numerically simulate all the stone masonry structural elements having a thickness of 750 mm and an assumed Young’s Modulus of

1000 MPa (Table 3); 7160 finite elements were employed in total for this numerical simulation with dimensions approximately $300 \text{ mm} \times 300 \text{ mm}$. The foundation deformability was introduced with linear links [17] having axial stiffness equal to either 109 KN/mm, representing relatively hard soil conditions or 24.5 KN/mm, representing a moderately deformable foundation. Moreover, in all cases the vertical walls were connected at the corners with two-node 3-D links in an effort to control the rigidity of these connections as well as to approximate the structural behaviour when the examined structures exhibited heavy damage in these locations (see Section 5). The eigen-periods for the N-S transverse direction translational response are equal to 0.177 s and 0.20 s for the hard and medium soil deformability, respectively. Similarly, the eigen-periods for the E-W longitudinal direction translational response are equal to 0.10 s and 0.12 s for the hard and medium soil deformability, respectively (Figure 14). More information on the dynamic properties of this numerical simulation is given by Manos et al. [12]. The numerical dynamic analyses included the superposition of the gravitational forces with the seismic forces specified on the basis of the ground acceleration that was recorded at two stations during the 3rd February strongest aftershock GEER-EERI-ATC [11], Papaioannou [32]. More information on the location of these recordings in relation to the studied “Basilica” church is given in Manos et al. [12]. The corresponding response curves for the Chavriata recording which is more demanding than the Lixouri ground motion, are shown in Figure 15a,b for the North-South and East-West directions, respectively.

The results of the evaluation include all possible combinations of the gravitational forces with the seismic actions indicated in Figure 14. As can be seen in Figure 15 the R_M ratio values are well below one ($R_M < 1$) mainly for both North and South longitudinal walls indicating that these walls for this church reached a widespread out-of-plane flexural limit state.

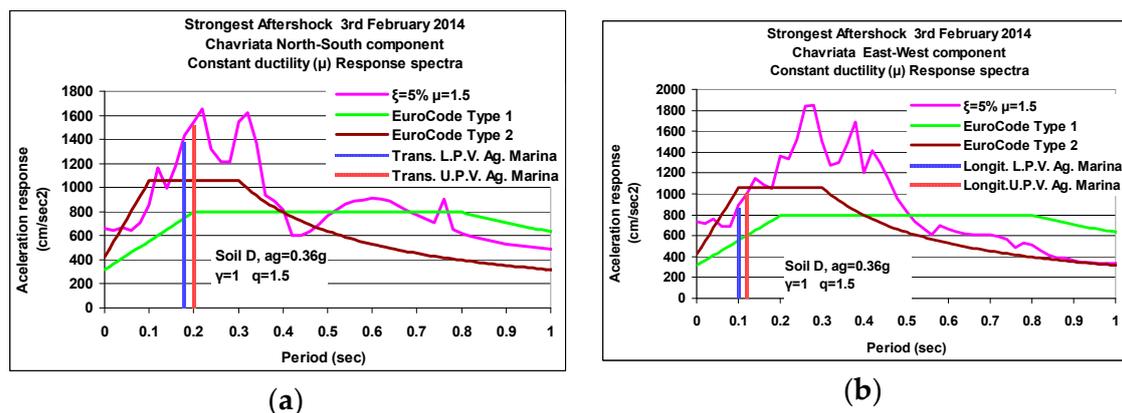
Figure 15. Constant ductility response spectral curves of the Chavriata record, Kefalonia 2014 earthquake together with the relevant Euro-Code 8 design spectral curves: (a) N-S component (b) E-W component.

In each one of these figures the relevant constant ductility spectral curves are depicted for a ductility ratio equal to 1.5, which is assumed to be valid for unreinforced masonry structures. Moreover, the Type-1 and Type-2 design spectral curves specified according to Euro-Code 8 [33–35] for design ground acceleration equal to 0.36 g (g is the acceleration of gravity), importance factor equal to $\gamma = 1$, response modification coefficient $q = 1.5$ (for unreinforced masonry) and soil category D. Finally, in each one of these figures the eigen-period values of the main translational eigen-modes in the North-South and East-West direction, as specified above, are also indicated. As can be seen from Figure 14a,b the acceleration spectral ordinates of the actual strong motion in the North-South direction are more demanding (transverse direction for the church, approximately 1.5 g) than the corresponding values in the East-West direction (longitudinal direction for the church, approximately 1.0 g).

listed in Table 3, obtained from the linear dynamic spectral analyses that employed the recorded ground motion response spectra (Chavriata record, Figure 15a,b), it can be concluded that foundation uplift cannot develop for this particular “Basilicas” church.

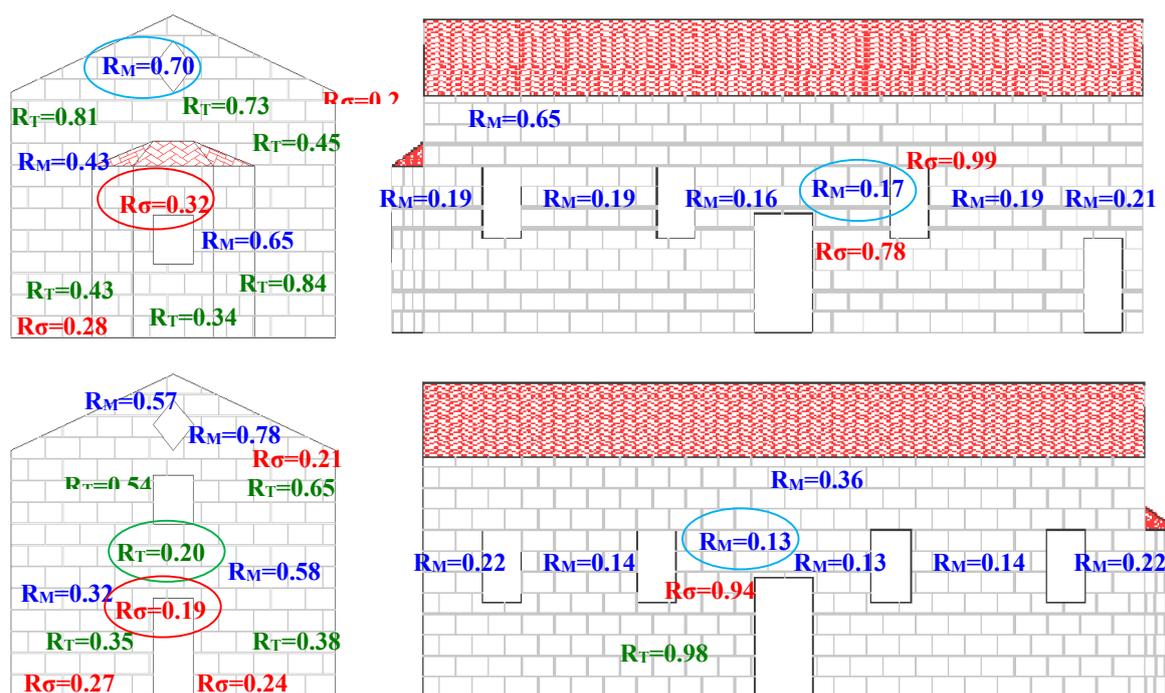
Figure 16. Summary results of the evaluation process in terms of $R\tau$, $R\sigma$, R_M ratio values, for moderately deformable foundation (axial stiffness value of supporting links equal to 24.5 KN/mm).

The following observations can be made on the basis of the $R\tau$, $R\sigma$, R_M ratio values. It can be seen that all these ratio values are smaller than one ($R\tau$, $R\sigma$, $R_M < 1$) in numerous locations, indicating that the corresponding limit state has been reached at all these locations of the structure that the relevant ratio value is linked with. For clarity the whole structure is deconstructed part by part in these figures in four walls that form its 3-D stone masonry shell. The East transverse wall is placed at the top left corner of Figure 16 whereas the West transverse wall at the bottom left corner. The South longitudinal wall is placed at the top right corner of Figure 16 whereas the North longitudinal wall at the bottom right corner.

Again, reasonably good correlation can be seen between predicted limit states, based on the simplified evaluation results of Figure 16, with the observed damage shown in Figure 17. As already discussed in Sections 2 and 3, this simplified numerical evaluation process assumes non-failing inter-connections of masonry elements. Therefore, one could neither predict the severity of the structural damage which developed near the inter-connections between the transverse and the longitudinal walls (Figure 18) nor account for the effect of this type of damage to the state of stress of each individual wall. An effort to study this effect is presented in the following Section 5.

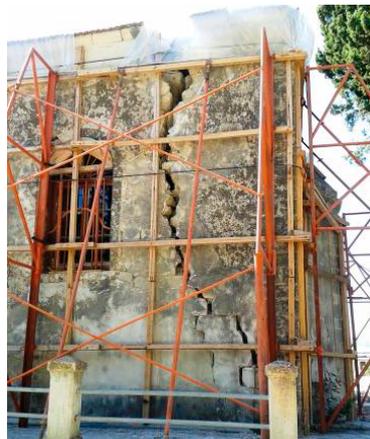
Figure 18. Damage at the N-W corner.

Next, the potential of the walls to be detached at the corners where these vertical walls are interconnected as well as at the roof level is examined. This is examined for load combinations $D + E_y$ or $D + E_x$, whereby the seismic forces E_y (East-West) or E_x (North-South) are applied in a push-over type of non-linear analyses. The obtained base shear versus horizontal displacement response from these push-over numerical analyses is depicted in Figure 21a,b for the East-West ($D + E_y$) and North-South ($D + E_x$) directions, respectively. Again, the difference between the linear response (plotted with straight lines) and the corresponding non-linear response becomes evident in these figures. As can be seen in Figure 21a, a 10 mm relative detachment displacement of the West wall occurs for a base shear value approximately 7000 kN in the East-West direction. Similarly, a 10 mm relative detachment displacement of the North wall in the North-South direction (Figure 21b) occurs for a base shear value approximately 5000 kN. In both cases, these values are smaller than the corresponding base shear values listed in Table 3, which were obtained from the dynamic spectral linear analyses that employed the Chavriata ground motion. Therefore, it can be concluded that for these force levels the detachment of these walls at the corners is predicted by combining the results of both numerical simulations. Such predicted wall detachment agrees with the observed performance (Figures 17 and 18).

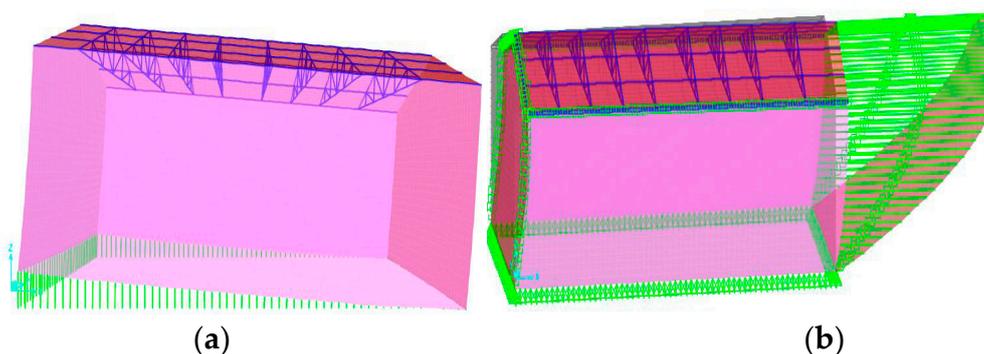
(a1) First, the two-node 3-D links at the soil-foundation interface, introduced to account for the soil-foundation deformability, are provided with a tension cut-off limit so they can sustain only compression in their axial direction and no tension (Figure 19a).

Figure 19. (a) Non-linear links to simulate uplifting of the structure at the soil-foundation interface; (b) Non-linear links to simulate detachment between the roof and the masonry walls or between vertical walls at the corners.

(b1) Similarly, two-node 3-D non-linear link elements are also utilized in connecting the vertical walls at their corners with a tension cut-off limit in such a way as to transfer compression between the intersecting walls at the corner but limited transfer of tension (Figure 19b).

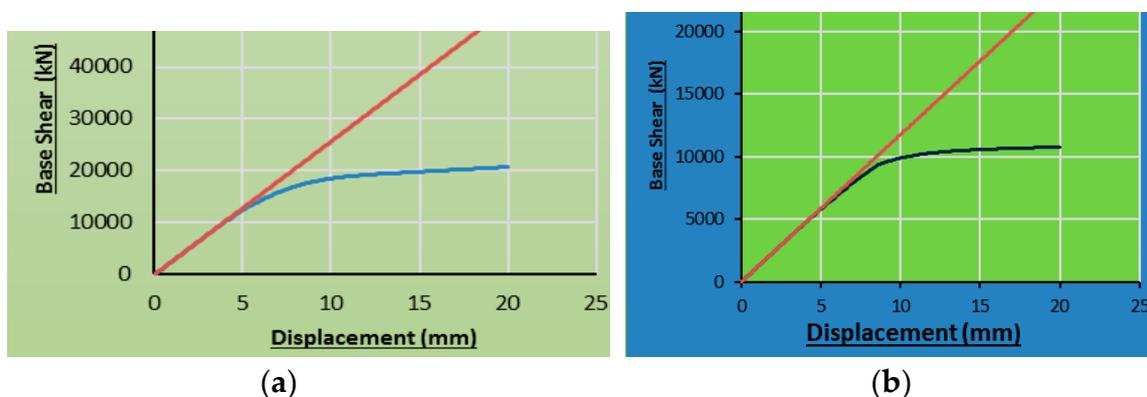
The base shear versus horizontal displacement response obtained from these push-over numerical analyses is depicted in Figure 20a,b for the East-West (D + E_y) and North-South (D + E_x) directions, respectively. The difference between the linear response (plotted with the straight lines) and the corresponding non-linear response, resulting from these push-over analyses, becomes evident in these figures. As can be seen in the uplifting of the foundation occurs when the base shear reaches approximately 20,000 KN (Figure 20a) in the East-West and 11,000 KN (Figure 20b) in the North-South direction, respectively. When these base shear values are compared with the corresponding values

Figure 20. (a) Push-over in the East-West direction (E_y), foundation uplift; (b) Push-over in the North-South direction (E_x), foundation uplift.

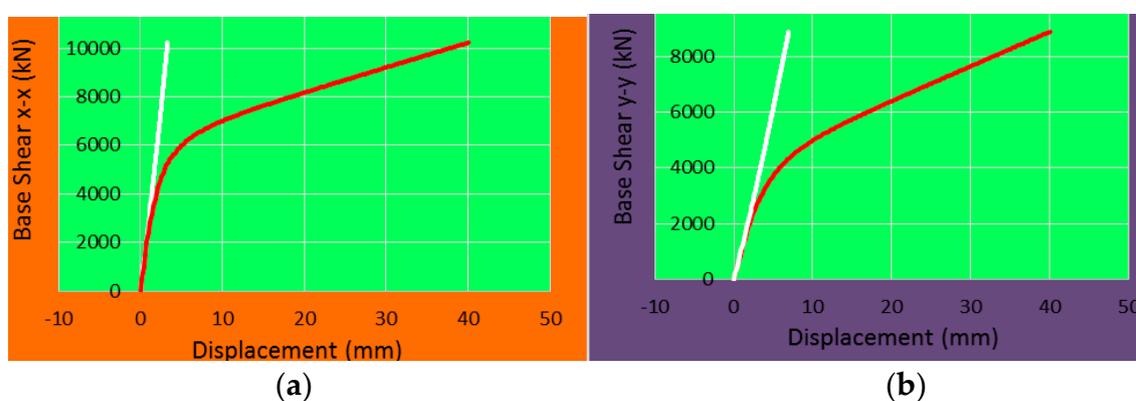
Figure 21. (a) Push-over in the East-West direction (E_y)—detachment of the West wall; (b) Push-over in the North-South direction (E_x)—detachment of the North wall.

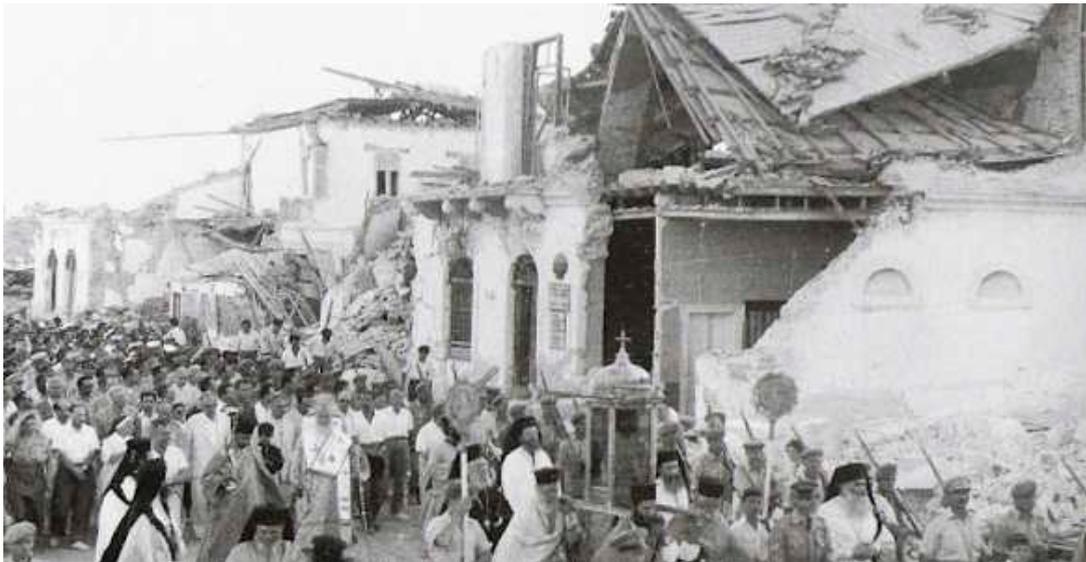
Figure 22. Images of total destruction to old masonry construction in Argostoli, Kefalonia island during the 1953 earthquake sequence.

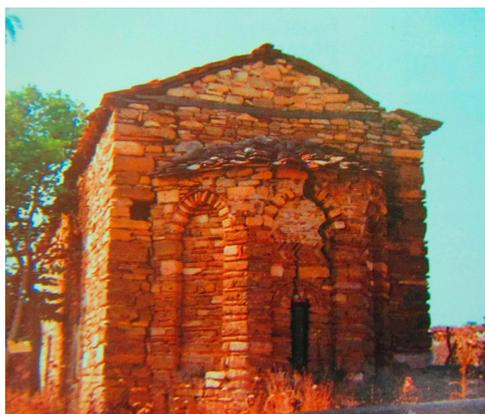
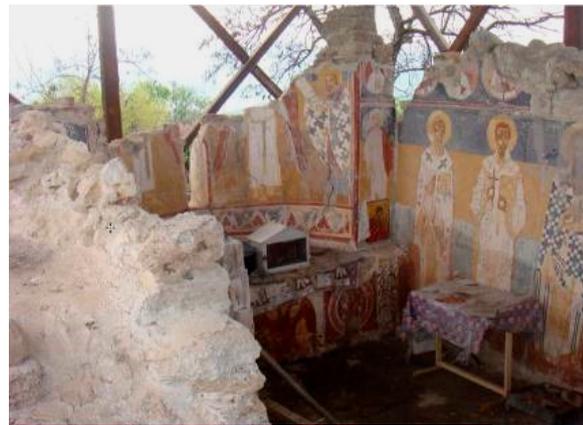
Before the 1995 earthquake sequence

Damaged by the 1995 earthquake

Figure 23. The church of Taxiarchis in Eani, Kozani prefecture.

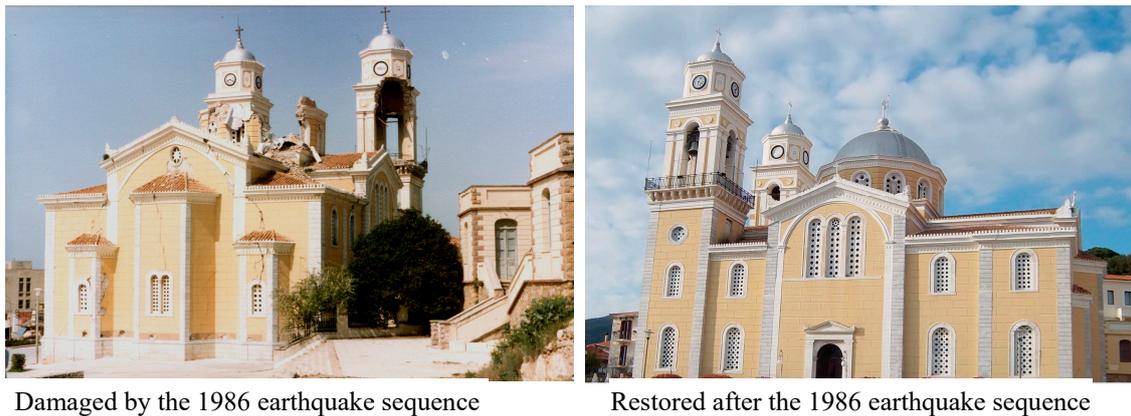
Figure 24. The church of Ipapanti in the centre of Kalamata.

A heavy task after numerous strong earthquake events during the last 50 years in many regions of Greece has been the structural rehabilitation of old masonry churches. This is also the case for masonry churches which sustained heavy structural damage in the city of Kalamata during the 1986 strong earthquake sequence. Numerous churches in this city as well as in the surrounding area were damaged. Figures 24 and 25 depict two such cases located in the centre of Kalamata. The heavy structural damage of the peripheral walls in these two churches was accompanied by the collapse of the central dome and the partial collapse of the bell towers; similar damage patterns were observed in many churches during the 2009 L'Aquila earthquake [14]. These figures also show the condition of these two churches today. It must be underlined that due to this structural rehabilitation effort for numerous cultural heritage structures in Greece over the last fifty years very valuable scientific and technical knowledge has been gained in this field.
