Article

Rehabilitation of Corrosion-Defected RC Beam-Column Members Using Patch Repair Technique

Nameer A. Alwash, Mohammed M. Kadhum and Ahmed M. Mahdi *

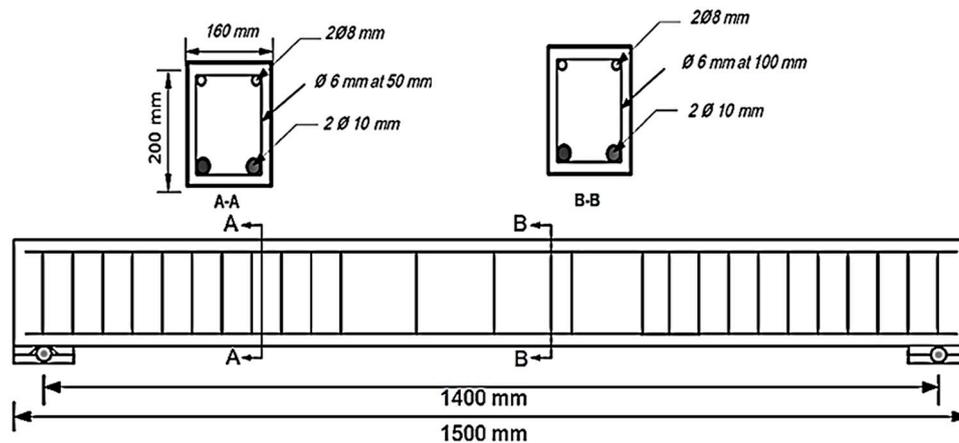
Figure 1. Concrete geometry and reinforcement details of tested specimen.

The experimental work was conducted in the structural laboratory of the civil engineering department of Al-Qadisiyah University. Ten RC beam-column members with a dimension of $160 \times 200 \times 1500$ mm were tested under constant axial force and four-point transverse load up to failure. The reinforcement details of beam-column members are shown in Figure 1. Two deformed bars with 10 mm diameters and two other bars with 8 mm diameters were used for longitudinal tension and compression reinforcement, respectively. For stirrups, a 6 mm diameter was used at a spacing of 50 mm, except the middle third span of the member, where the spacing used was 100 mm. The clear concrete cover was 20 mm on all sides of the specimen. The experimental study consisted of two test groups, as illustrated in Table 1. Group (A) included the control (undamaged) specimen, the corrosion-damaged specimens under low or high corrosion levels of 5% or 20%, respectively, and the damaged/patch-rehabilitated specimens that underwent cleaning or replacement of corroded steel bars and repaired the damaged concrete cover with new mortar. These specimens were tested under an axial force of 15 kN in addition to the transverse applied load. Group (B) included the same set of specimens but with an axial force of 30 kN.

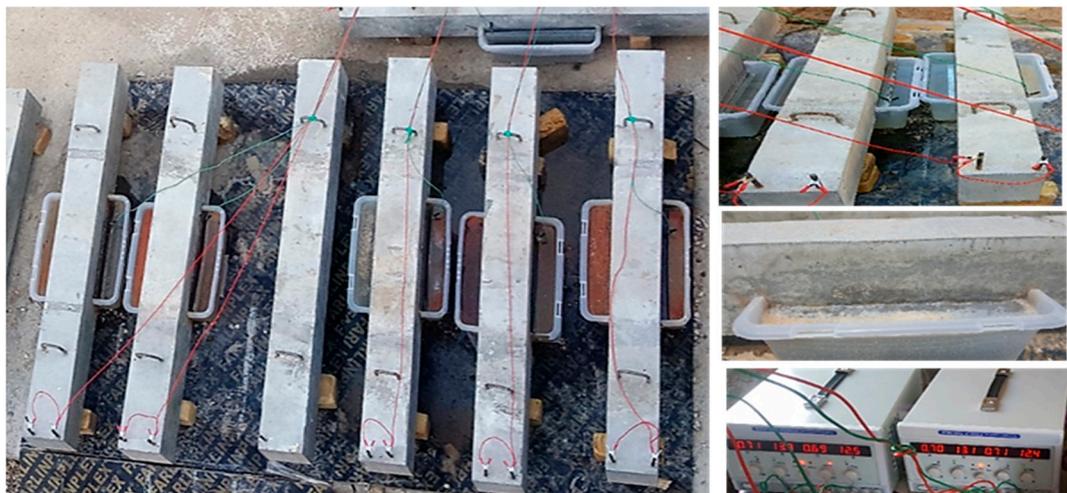
Figure 2. Acceleration corrosion process.

An electrochemical process was used in this study to accelerate the corrosion of steel reinforcement embedded inside the concrete. The corrosion was limited to critical flexural zone with a length, a width, and a height of 400 mm, 160 mm, and 40 mm, respectively. This limited region of the member was submerged in a plastic container with 5% concentrate of sodium chloride solution. Power supplies with adjustable voltage and a direct current (DC) of 700 mA were used for this process. The reinforcement cage was connected to the positive side and the stainless steel plate was connected to the negative side of the DC power supply. The desired degrees of corrosion were 5%, and 20% of the deformed bars, which could occur in a period of 8 and 32 days, respectively according to Faraday's law. The theoretical mass of rust produced per unit of surface area could be determined based on Faraday's law, as illustrated in Equation (1).

Equation (4) represents the simplified Faraday's law formula and was used for calculating the time required to get the t desired degrees of corrosion. Figure 2 shows the experimental setup of the accelerated corrosion process.

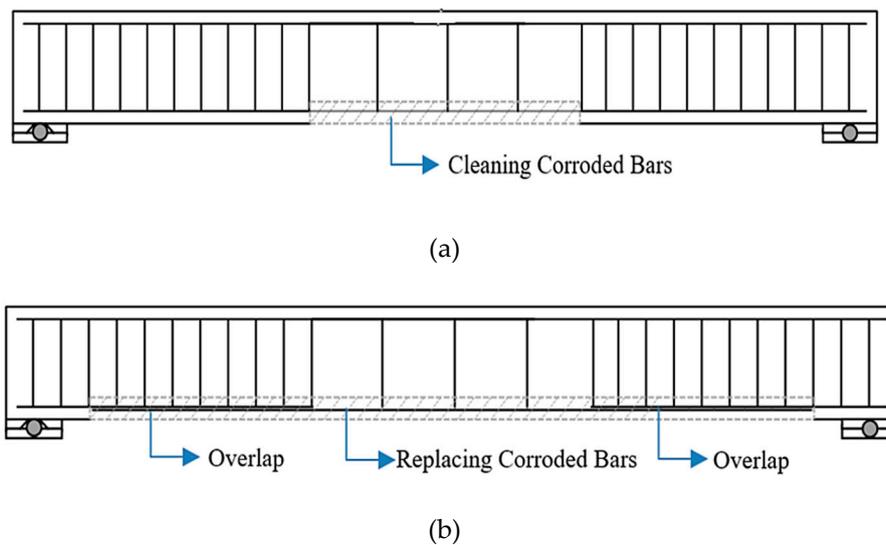
Figure 3. Detail of the patch repair technique. (a) patch repair by cleaning corroded steel bars; (b) Patch repair by replacing corroded steel bars.

The rehabilitation technique used in this study was patch repair by cleaning or replacing the corroded steel bars and repairing the damaged concrete with new mortar. Firstly, we removed the damaged concrete using manual and mechanical methods. An angle grinder, a claw hammer, and a chisel were used to remove the defective concrete. Secondly, we cleaned the remaining undamaged concrete surface by using an air blower; this stage was very important to get strong substrate. Thirdly, we evaluated the damage in steel reinforcement due to corrosion. For the low corrosion level of 5%, the steel bars were cleaned from rust by a drill motor with a brush, as illustrated in Figure 3a. For the high corrosion level of 20%, the corroded part of the steel bar was cut and removed, then replaced by a new steel bar of the same diameter with consideration to the overlap length, as illustrated in Figure 3b. Fourthly, the sikadur-32 bonding agent and the protection material from the corrosion were used to provide a bond between the existing concrete and the new mortar in addition to the bond between steel bars and the mortar. Finally, sikamonotop-614 (polymer modified repair mortar) was used to replace the damaged concrete layer. Good curing for the mortar was used to prevent shrinkage. Figure 3 shows the sketch of the patch repair technique by cleaning or replacing the corroded steel bars.

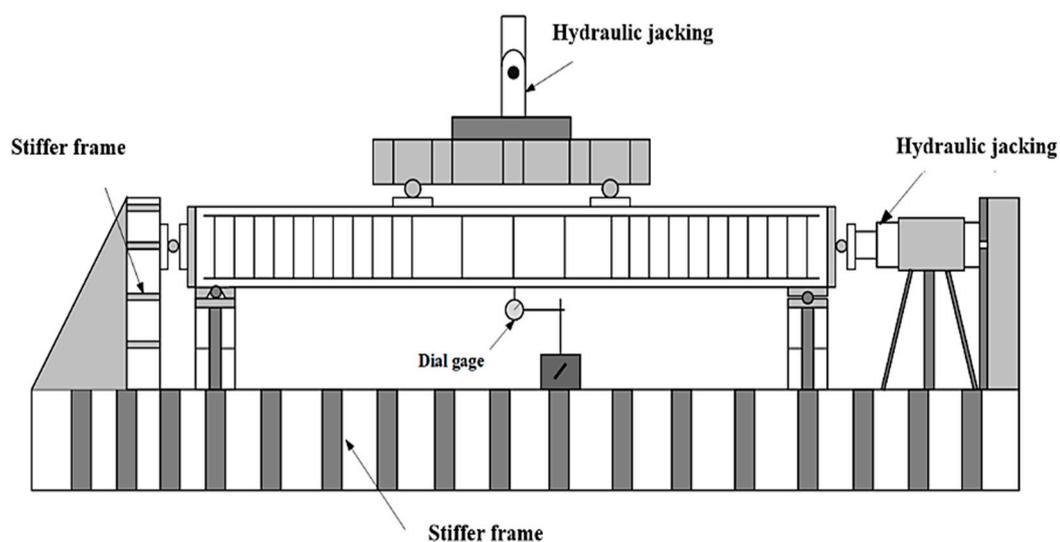
Figure 4. Sketch of modified testing machine.

A flexural test was performed for each beam-column member supported over a span of 1400 mm and under constant axial force in addition to four-point transverse load up to failure. After the accelerated corrosion process and the patch repair technique, all specimens were painted with a white color to observe the crack development and marking. A steel frame with a hydraulic jack of 60-ton capacity was used in this study. A necessary modification to this frame was made by strengthening the lower horizontal part of the frame and fixing a new supporting frame with a new hydraulic system and new hydraulic cylinder (700 bar, 500 kN maximum force) capacity, for axial force, as shown in Figure 4. During each load step the corresponding central vertical deflection, the crack patterns, and the ultimate capacity were recorded. A digital image correlation (DIC) with high quality digital camera (Nikon D7100, 24.1 Megapixel) and a computer program called GOM Correlate version 2017 were used to measure concrete strain.

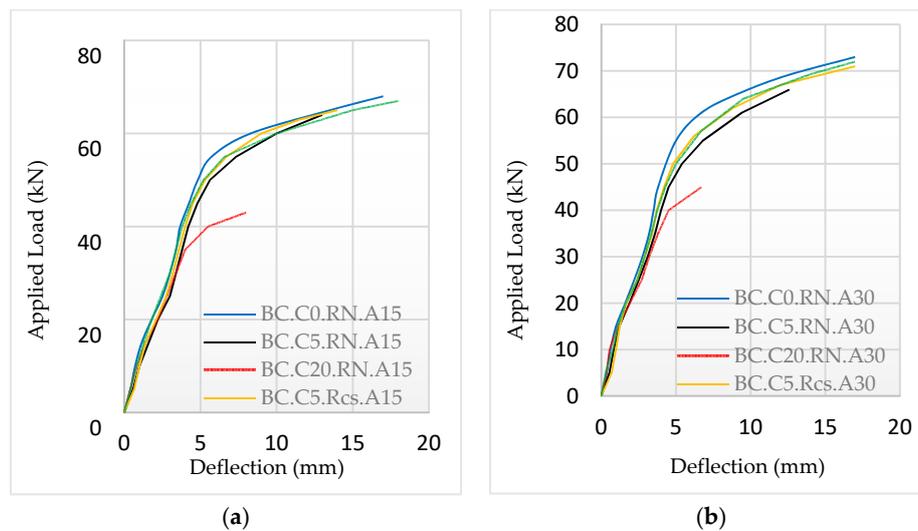
Figure 5. Comparison of load deflection response for each group. (a) Group A; (b) Group B.

At the early stages of loading, reinforced concrete beam-column specimens were free from any cracks, except the corroded specimens that contained horizontal cracks due to corrosion. The amount of displacement was very small because the stresses resulting from the applied loads were small at this stage of loading. With an increase in the transverse applied load, the cracks began to appear. The experimental results of the ultimate load and the service mid-span deflection for the tested specimens are illustrated in Table 3. A comparison of the load-deflection responses for each group is given in Figure 5.

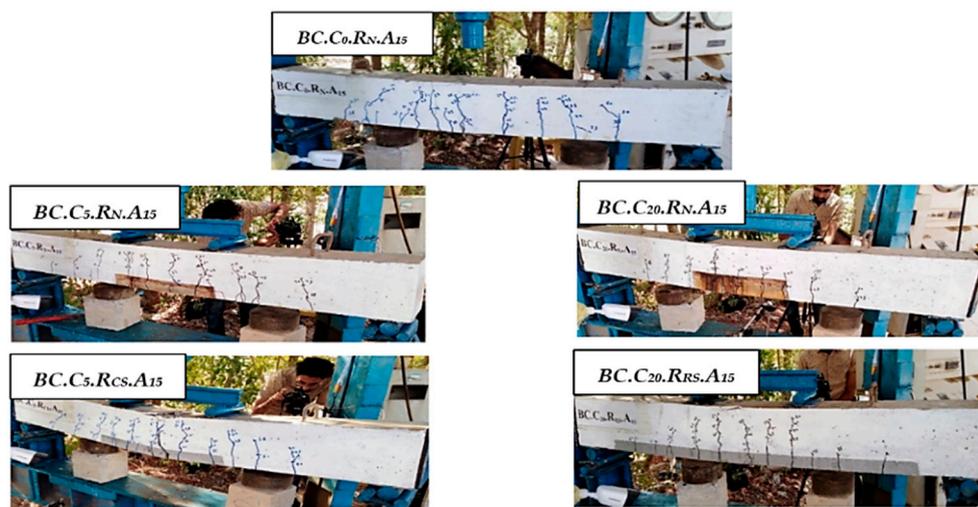
Figure 6. Cracks pattern and mode of failure of specimens in Group A.

Five specimens ($BC.C_0.R_N.A_{15}$, $BC.C_5.R_N.A_{15}$, $BC.C_{20}.R_N.A_{15}$, $BC.C_5.R_{CS}.A_{15}$, and $BC.C_{20}.R_{RS}.A_{15}$, as shown in Figure 6) were tested under a constant axial force of 15 kN, and we gradually applied transverse load up to failure. Horizontal corrosion cracks were appearing before testing due to internal pressure from the corrosion product. First, flexural cracks appeared in the middle third span of the tension face and started to propagate and widen. Then, inclined flexural shear cracks were shown. A flexural yielding followed by a concrete crushing failure occurred for all specimens in this group except one defected specimen with high corrosion level, which failed prematurely failure due to a rupture in the corroded bars. A significant reduction in the ultimate flexural strength and the serviceability was recorded with an increased level of corrosion degrees in addition to a lower stiffness in all stages of load-deflection response. The load-carrying capacity of defected/rehabilitated specimens was restored to about 95.5% after cleaning steel bars and to 98.5% after replacing steel bars with respect to the control specimen. Serviceability in terms of mid-span deflection was restored to the allowable limit of American concrete institute (ACI) code.

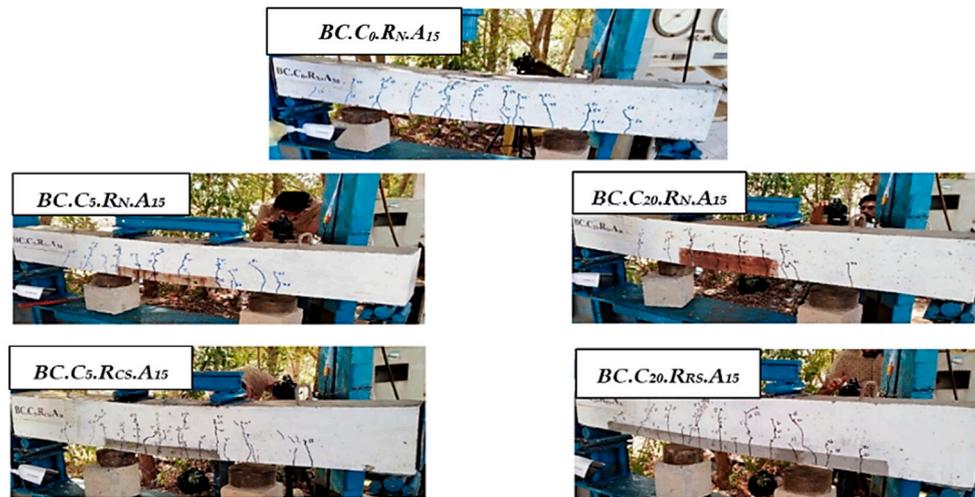
Figure 7. Cracking patterns at failure for specimens in Group B.

Five specimens (illustrated in Figure 7) were tested under a constant axial force of 30 kN, and we gradually applied transverse loading up to failure. The crack patterns were similar to those of the previous group with more propagation of flexural crack. A flexural yielding followed by concrete crushing failure occurred for all specimens in this group except one defected specimen with high corrosion level, which failed prematurely due to a rupture in the corroded bars. A significant reduction in ultimate strength and serviceability was calculated with increased corrosion degrees in addition to lower stiffness in all stages of the load-deflection response. The load-carrying capacity of deteriorated specimens was restored to about 97.3% after cleaning steel bars and to 98.6% after replacing the steel bars with respect to the control specimen. In addition, serviceability in terms of mid-span deflection was restored to the allowable limit of the ACI (American Concrete Institute) code. Compared with the specimens in Group A, the increase of the axial force was recorded to be a positive effect on the ultimate strength, the service deflection and the stiffness, and this effect was evident in the corrosion-defected specimens by decreasing the adverse effect of corrosion.

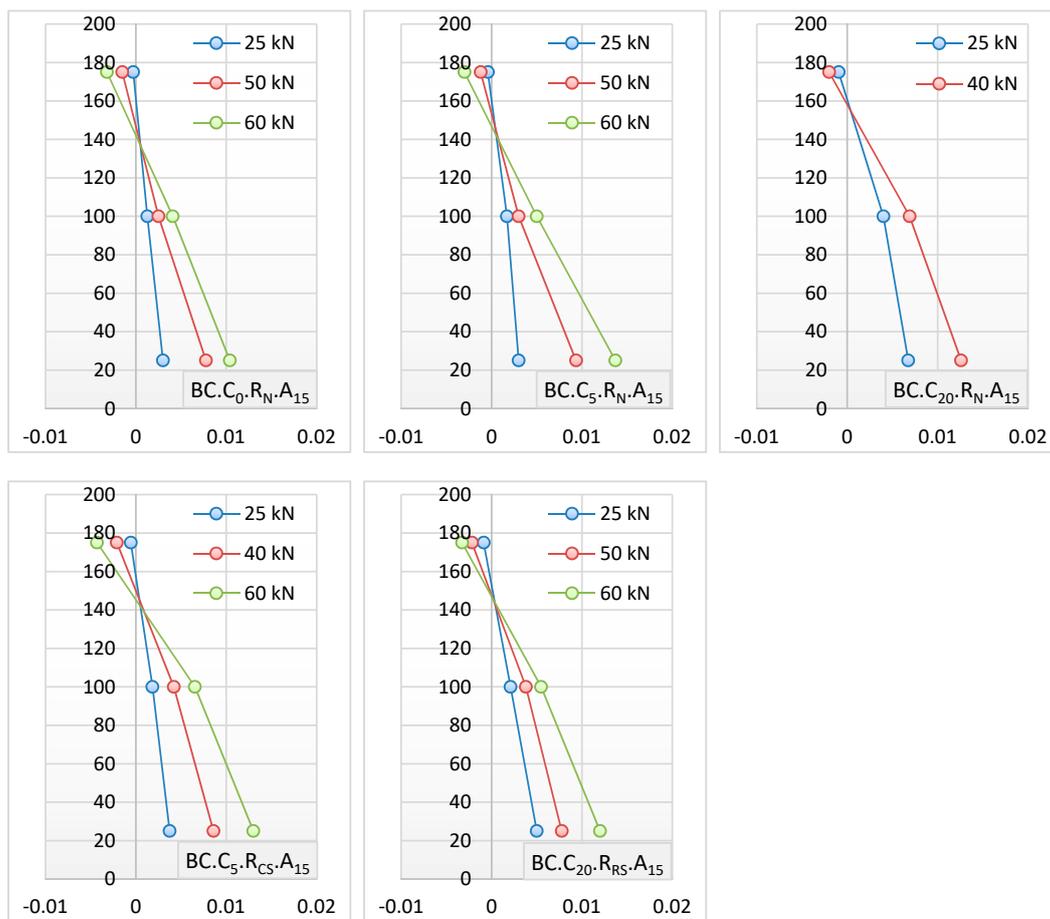
Figure 8. Concrete strain for specimens in Group A.

The concrete strain for these specimens was measured at three points through the depth of the mid span of the critical section (maximum moment). The concrete strain was recorded in different loading stages, as shown in Figure 8, where the horizontal and vertical axes represent the concrete strain and the section depth, respectively.

The results of concrete strain for the tested specimens showed that the strain distribution was approximately linear at low loads and became nonlinear at higher loads due to cracks in the concrete. The concrete strain in the tension zone for the corrosion-defected specimen increased clearly with corrosion levels compared to the control specimen due to the reduction in steel-concrete bond strength. For the defected/rehabilitated specimen with a patch repair of cleaning steel bars, the test results recorded a slightly restored concrete strain in the tension zone compared with the defected specimens due to the replacement of the damaged concrete cover with new mortar, the cleaning of the steel bars, and the use of the bonding agent material to compensate the reduction in bond strength. The defected/rehabilitated specimen with a patch repair of replacing steel bars recorded a completely restored concrete strain in the tension zone to an undamaged state. This was achieved by replacing the damaged concrete cover with new mortar, replacing the corroded steel bars and using the bonding agent material to compensate the reduction in bond strength.

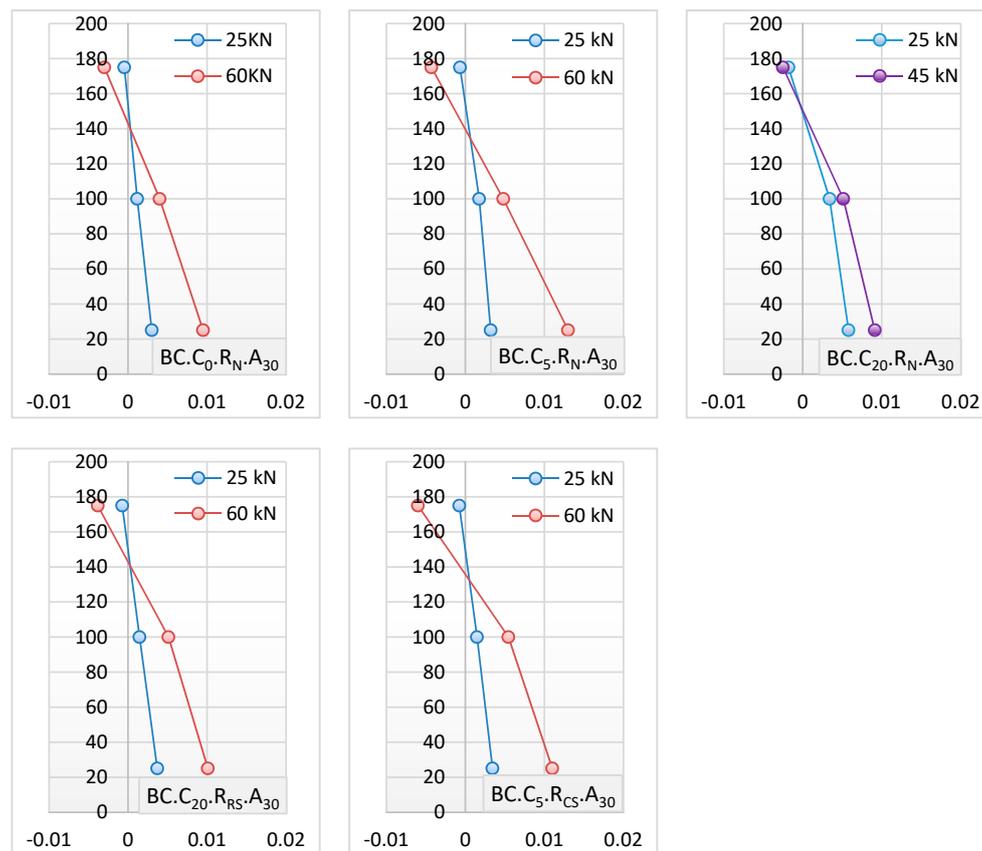
Figure 9. Concrete strain for specimens in Group B.

Furthermore, the concrete strain for these specimens was recorded through section depth with three points in the mid span of the specimens, as illustrated Figure 9.

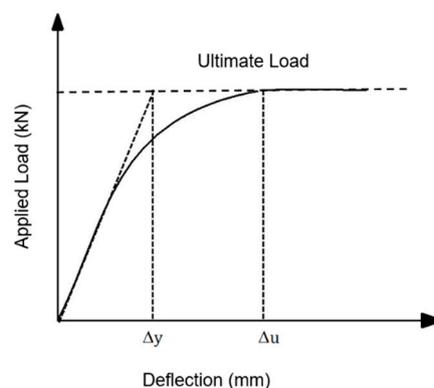
Figure 10. Determination procedure of the ductility index.

Ductility is described as the ability of a structural element to sustain inelastic deformation without significant loss in resistance [22]. Safety is the most important consideration for the design of structures. Any type of brittle failure should be avoided, since this could limit the warning time and cause lives to be endangered. If the structure possesses ductile behavior, it will be able to experience large deflections while still holding near ultimate loads. Ductility has generally been measured by a ratio called a ductility index or factor (μ_{duc}). The experimental ductility index for concrete beam-column members (control or patch repair) specimens was calculated according to the deflection at the ultimate load divided by the deflection at the equivalent yield load [23], as shown in Figure 10.
