Effects of Earthquakes on Flood Hazards: A Case Study From Christchurch, New Zealand

Mark Quigley * and Brendan Duffy

School of Earth Sciences, University of Melbourne, Parkville 3010, Australia; brendan.duffy@unimelb.edu.au

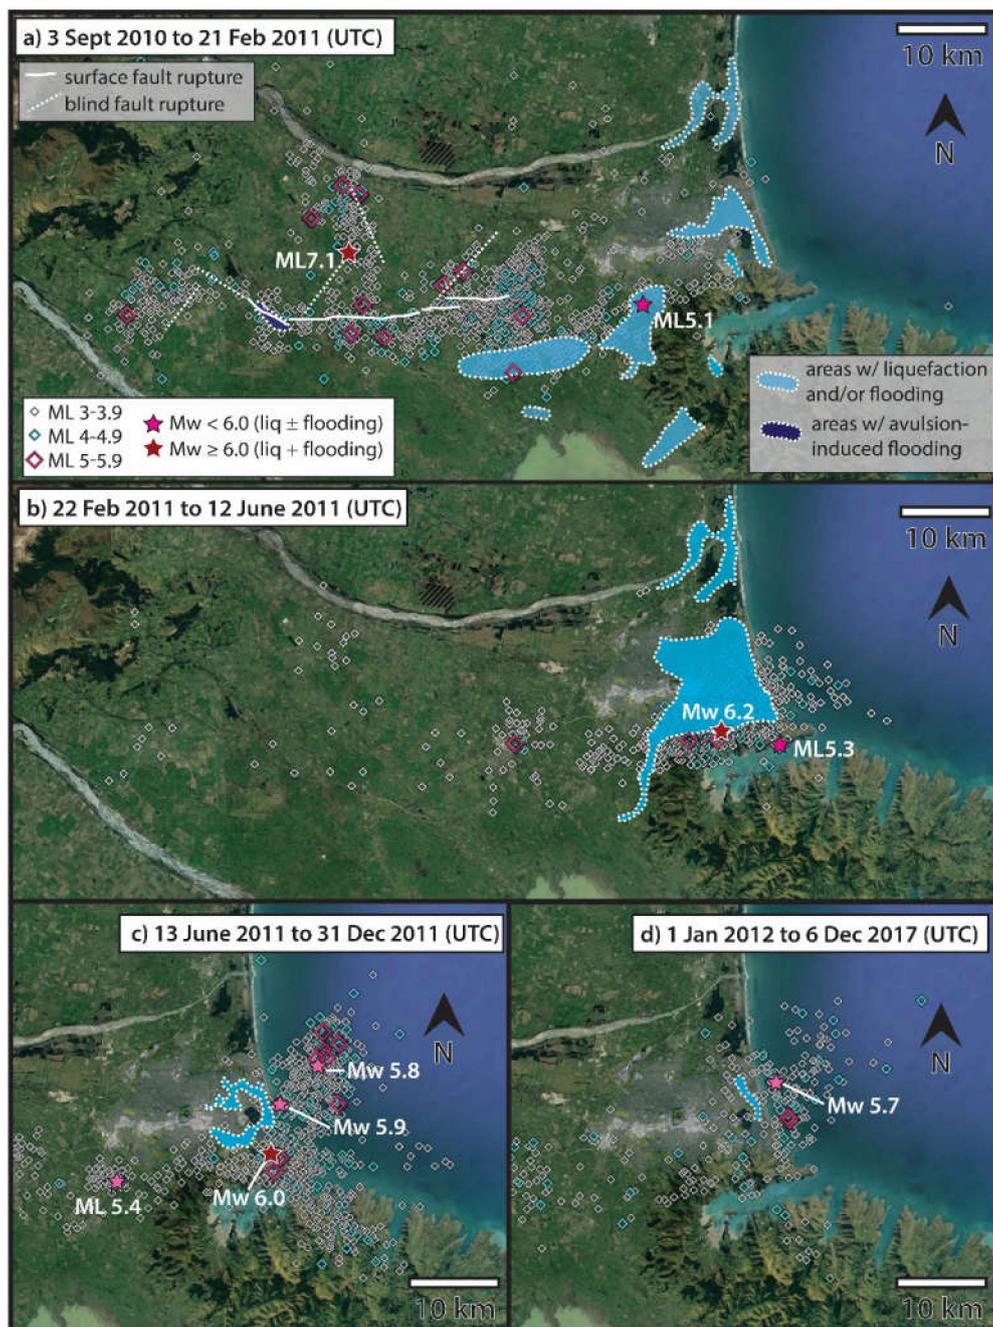
Figure 1. Canterbury earthquake sequence (CES) seismicity in the Canterbury region for time slices indicated in (a) to (d) spanning from the Darfield earthquake (3 September 2010 16:35:46 UTC) to 6 December 2017 (23:59 UTC). Locations of the earthquake epicenters and magnitude information were derived from GeoNet Quakesearch in December 2017 (<https://quakesearch.geonet.org.nz/>) for the spatial domain LAT = -43.4° to -43.7° ; LONG = 171.8° to 173° (decimal degrees). The up-dip surface projections of Darfield earthquake blind faults (dashed white lines) are from Beavan et al. [88] and the surface ruptures are from Quigley et al. [89]. The locations of liquefaction (liq) with and without flood-inducing earthquakes (see also Figure 3) are shown with stars. The areas of flooding associated with the expulsion of groundwaters (most commonly associated with liquefaction) are shown in light blue (a,b areas were simplified from Townsend et al. [102] and including the present authors' reconnaissance field observations; c,d were from reconnaissance field observations by the present authors). Areas of flooding due to partial stream avulsion were associated with fault surface rupture in the Darfield earthquake from Duffy et al. [12].

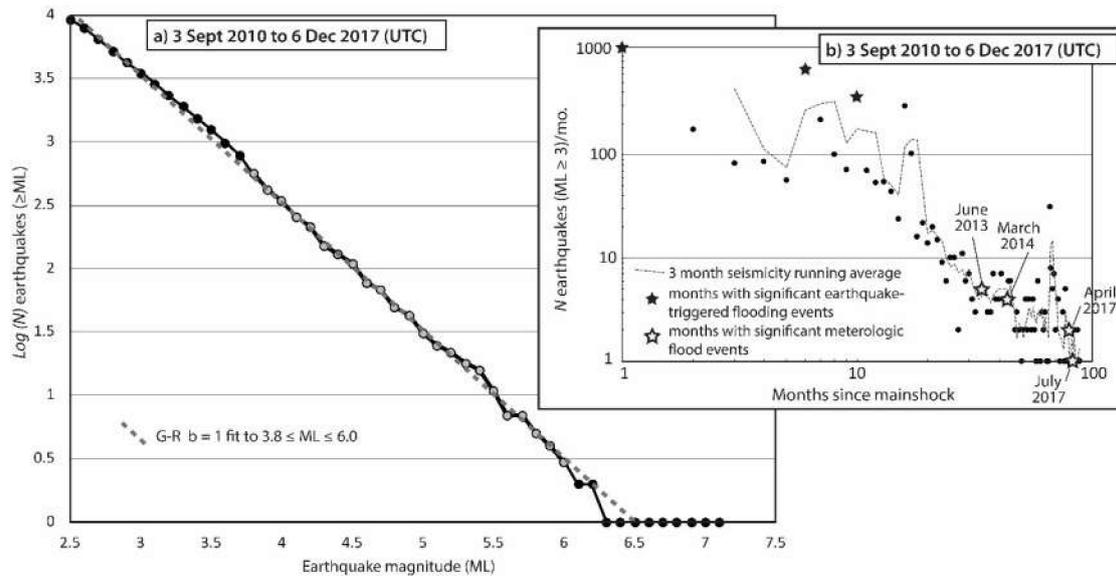
Figure 2. (a) CES seismicity for 3 September 2010 (0:00 UTC) to 6 December 2017 (23:59 UTC) derived from GeoNet Quakesearch in December 2017 (<https://quakesearch.geonet.org.nz/>) for the spatial domain $LAT = -43.4^\circ$ to -43.7° ; $LONG = 171.8^\circ$ to 173° (decimal degrees). Earthquake frequency-magnitude described by $\text{Log}(N)$ earthquakes (y-axis) with $ML \geq$ associated ML values on the x-axis. The Gutenberg–Richter (G-R) least-squares fit to earthquakes yielded $b = 1$ for the $3.8 \leq ML \leq 6.0$ range. The numbers of earthquakes in the CES region were 3492 $ML \geq 3$, 344 $ML \geq 4$, 31 $ML \geq 5$, 3 $ML \geq 6$, 1 $ML \geq 7$. (b) The number of $ML \geq 3$ earthquakes per month (y-axis) vs. months (mo.) since the Darfield earthquake (“months since mainshock”). Month 1 = Sept 4 to 30th 2010. The three-month running average of monthly earthquake rate shows a decline from the peak rate following the Darfield earthquake (>1000 earthquakes per mo.) to <10 earthquakes per mo. by July–September 2012. The 14 February 2016 M_w 5.7 earthquake was associated with a spike (>30 earthquakes per mo.) set amongst a continuing decline. Months with significant earthquake-induced flood events are shown with black stars and months with significant meteorologically-triggered flood events are shown with open stars.

The evolution of the 2010–2011 Canterbury earthquake sequence (CES) and associated ground motion and environmental effects are described by Bannister and Gledhill [86], Bradley et al. [87], and Quigley et al. [15], respectively. The CES initiated with the complex multi-fault Mw 7.1 Darfield earthquake with an epicenter \approx 38 km west of the Christchurch central business district (epicentral location from <https://quakesearch.geonet.org.nz/>) (Figure 1a). This earthquake ruptured at least seven geometrically-distinct faults [88] and generated an approximately 30 km surface rupture [89] spanning three source faults (Figure 1a). Early aftershocks (i.e., within 1 month of the Darfield earthquake) included 11 $M_L \geq 5$ earthquakes and spanned a 70 km (E–W) by 40 km (N–S) area encompassing the city of Christchurch (Figure 1a). The aftershock rate decreased following the Darfield earthquake in accordance with Omori’s Law [90] but was reinvigorated by the fatal 22 February Mw 6.2 Christchurch earthquake (Figure 1b; Figure 2) and other large aftershocks (e.g., 13 June 2011 Mw 6.0, 23 December 2011 Mw 5.9, and 14 February 2016 Mw 5.7) (Figures 1–3). The 22 February Mw 6.2 also involved a complex rupture, including two to three distinct source faults [88]. The overall spatiotemporal evolution of the CES following the Darfield earthquake involved a general eastward migration of seismicity to beneath the city and offshore, although persistent activity continues in some areas throughout the region (e.g., SW of Christchurch) (Figure 1d). The CES earthquake frequency-magnitude distributions fit Gutenberg–Richter scaling well with $b \approx 1$ (Figure 2).

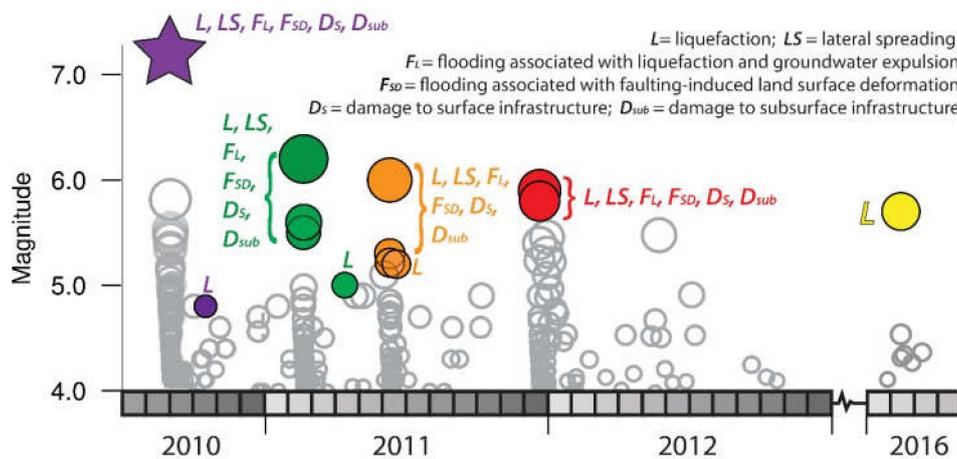
Figure 3. Earthquakes in the Christchurch region from the Darfield earthquake (2010) to 2016 that produced liquefaction, lateral spreading, flooding, and damage to infrastructure.

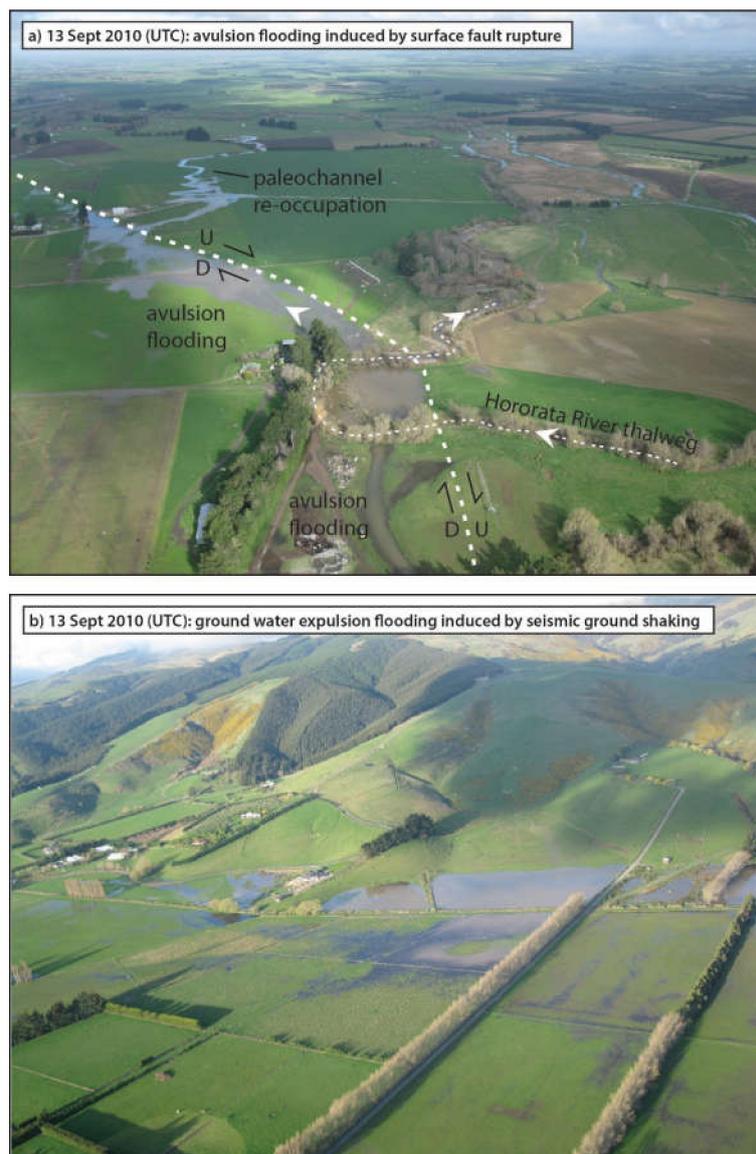
Figure 4. (a) Partial avulsion of the Hororata River resulting from a surface rupture on the Greendale Fault (dashed white line) in the Darfield earthquake. View is toward the southeast. The image location corresponds to the dark blue zone (“areas with avulsion-induced flooding”) in Figure 1a. Flooding occurred largely on the downthrown (northeast) side of the Greendale Fault and avulsion flood waters re-occupied paleochannels downstream. Image date was 13 September 2010 (9 days after the Darfield earthquake). The figure was sourced from Quigley et al. [15]. (b) Groundwater expulsion flooding along the western margin of the Port Hills due to the strong ground shaking of sediments with shallow water tables, probably accompanied by liquefaction, and probably associated with shaking amplification due to the shallowing depth of basalt bedrock toward the flanks of the Port Hills. The presence of loessic silt in sediment underlying this area may have reduced the sediment permeability and water reabsorption into the subsurface.

Flooding was observed in rural properties adjacent to the Greendale Fault (Figure 4a) and other rural areas (Figure 4b) immediately following the Darfield earthquake. Flooding was also observed in areas of liquefaction following major earthquakes (Figure 5) and in subsequent large storms (Figure 5e,f). Recurrent liquefaction (Figure 6) lowered ground surface elevations in liquefaction-affected areas by >30 cm to >1 m; the effect of flood plain lowering was observed most profoundly proximal to urban streams, where high tides locally inundated former floodplains (Figure 6d). These observations are discussed in more detail below. Earthquake-induced damage to stormwater pipelines and the consequent impacts on the connectivity and capacity levels of the pipeline stormwater network contributed to an increased flood hazard in Christchurch [110]. Taylor et al. [17] describe general processes that increased the flood vulnerability in Christchurch, including changes in overland flow paths and a reduction of surface hydraulic gradients, narrowing and shallowing of urban streams and a reduction in flood plain elevations, and land settlement that allowed tidal incursions to exert stronger influence on flood hazards.

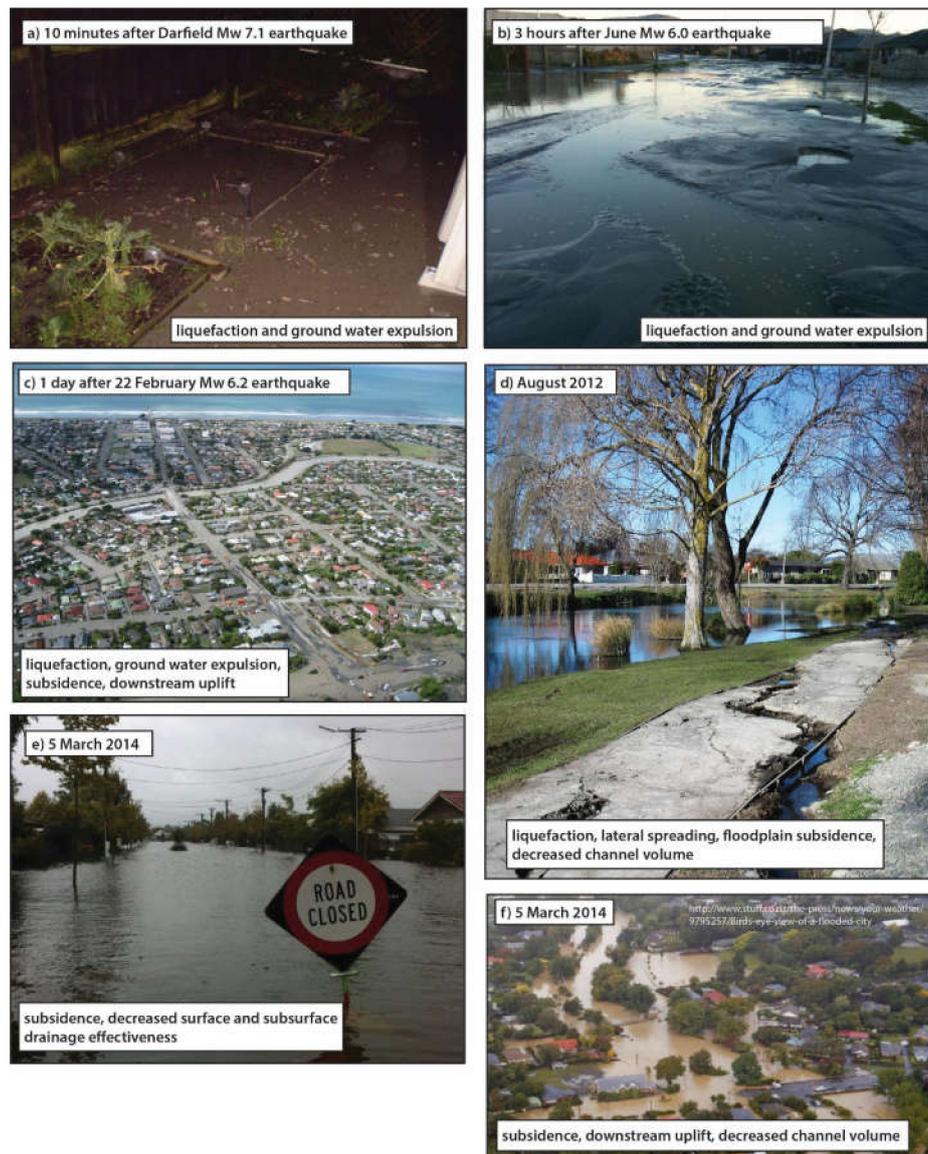
Figure 5. (a) Flooding related to the liquefaction and groundwater expulsion in eastern Christchurch after the Darfield 2010 Mw 7.1 earthquake and (b) in eastern Christchurch after the June 2011 Mw 6.0 earthquake. (c) Flooding related to liquefaction, groundwater expulsion, surface subsidence, and downstream uplift in eastern Christchurch after the February 2011 Mw 6.2 earthquake. The figure was sourced from Quigley et al. [15]. (d) Flooding related to lateral-spreading, floodplain surface subsidence, and decreased Avon River channel volumes in eastern Christchurch in 2012. The figure was sourced from Quigley et al. [15]. (e) Flooding related to the March 2014 meteorological flood event in the Flockton Basin (see Figure 7 for the location of Flockton Basin). The flooding was affected by CES-induced surface subsidence and decreased drainage infrastructure effectiveness. (f) Flooding related to the March 2014 meteorological flood event along Heathcote River. The flooding was affected by CES liquefaction, groundwater expulsion, surface subsidence, channel area changes, and downstream uplift caused by the February 2011 Mw 6.2 earthquake. Figure 5f is courtesy of The Press, Christchurch.

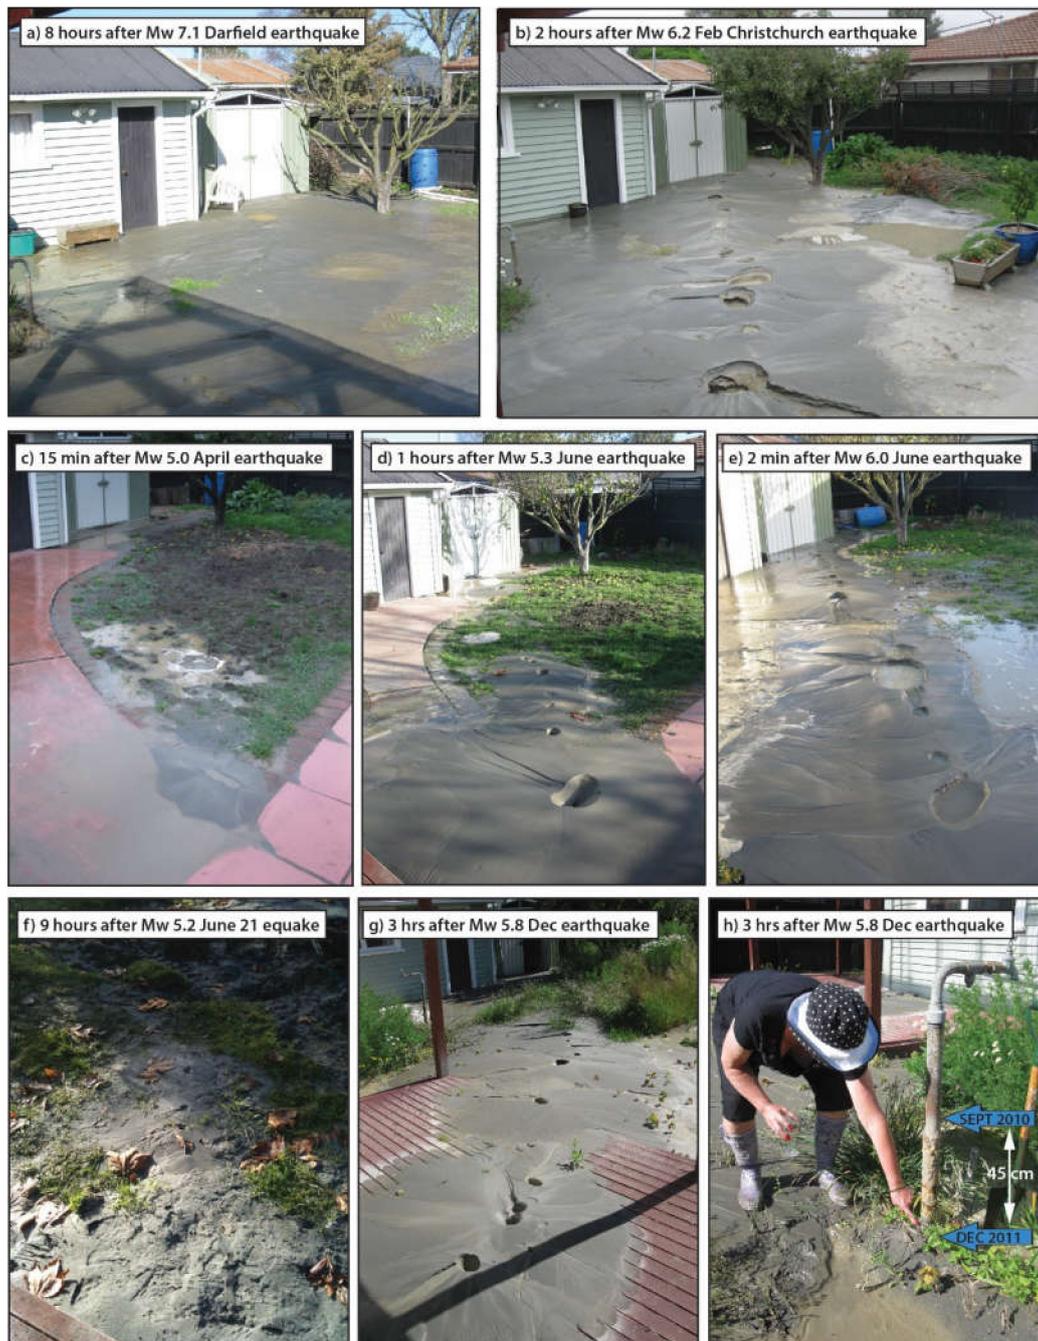
Figure 6. (a–g) Distinct episodes of recurrent liquefaction at a single site induced by CES earthquakes. The figure was sourced from Quigley et al. [33]. The timing of the photographs with respect to each earthquake is shown. (h) Cumulative land subsidence of ≈ 45 cm induced by recurrent liquefaction relative to a vertically-fixed artesian water pipe fixed into sediment below the liquefiable layer; the white stain and rust-coated pipe segment were below the ground surface prior to the 2010 Mw 7.1 Darfield earthquake.

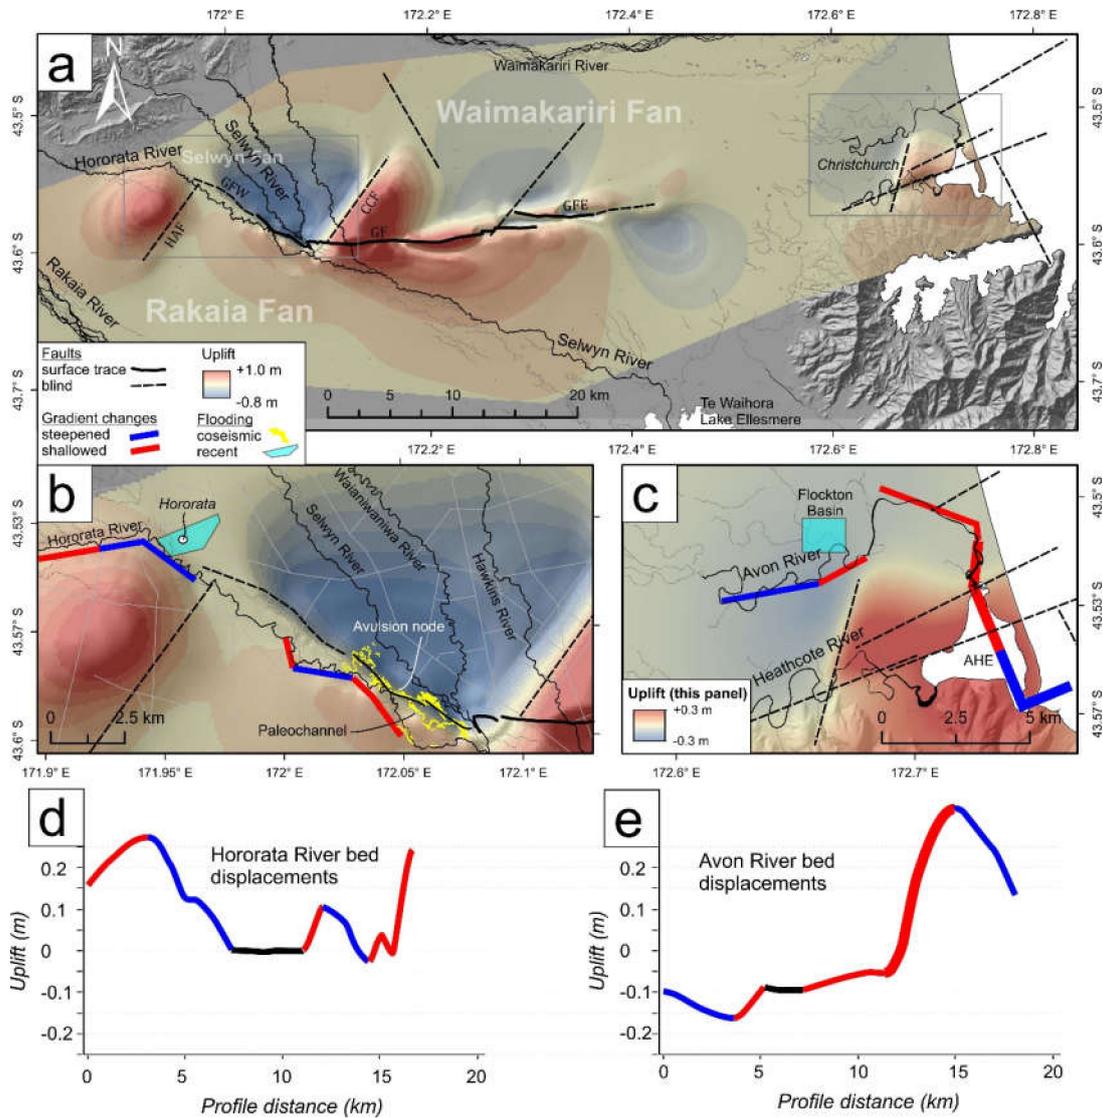
Figure 7. Vertical tectonic displacements during the Canterbury earthquake sequence and in relation to major rivers. AHE—Avon-Heathcote Estuary, CCF—Charing Cross fault, GF—Greendale fault, GFE—Greendale fault east segment, GFW—Greendale fault west segment, HAF—Hororata Anticline Fault. (a) Shaded relief map of cumulative vertical displacements during the CES summarized using data from [88] showing regions of uplift and subsidence. (b) Detail of the GFW and HAF, showing the Hororata River’s position on the proximal footwall of the GFW and the extent of coseismic flooding. The colored reaches relate to the downstream profile of elevation changes shown in panel (d). Increasing downstream uplift shallowed the gradient, and increasing downstream subsidence steepened it. (c) Detail of the Christchurch area, showing the Avon and Heathcote Rivers crossing the uplift as they flow toward the estuary. (d) Hororata River stream profile post-Darfield earthquake. (e) Avon River stream profile post CES.

Of the seven fault segments that ruptured during the Mw 7.1 Darfield earthquake, surface rupture was identified on the Greendale Fault West (GFW), Greendale Fault (GF), and Greendale Fault East (GFE) (Figure 7). The traces of these surface-rupturing faults typically consisted of a combination of discrete surface fracturing, and surface folding at broad wavelengths of 10^1 – 10^2 m. Topographic bulges

Vertical tectonic displacements of 0.8 to 1.8 m along the GFW surface rupture (Figure 7b,d) disrupted the bed of a meander bend in the strongly-flowing Hororata River, uplifting the downstream reach of the meander and forcing the river to avulse and flow along the new fault scarp [12,114]. Water flowing southeast from the avulsion node lapped onto the scarp, proving instrumental in mapping the fault in the absence of LiDAR. Floodwaters reoccupied old channels of the Selwyn River that formed low points in the scarp, eventually rejoining the Hororata River near its confluence with the Selwyn River (Figure 6b). Extensive flooding north of the avulsion node resulted from (i) the backing-up of water at the avulsion node, (ii) the expulsion of groundwater, and (iii) the tectonic damming and avulsion of ephemeral Selwyn River paleochannels that were already flowing because of underflow from the contemporary high-flood stage event in the main Selwyn River channel [15,122].

The net effect of the earthquake for post-seismic flood hazard of the southern reaches of the Hororata River is implicit in the vertical displacements shown in Figure 7. Around 2 km of riverbed was excavated over several weeks to reinstate the river in its pre-earthquake bed; that bed remains located on the footwall of a normal fault, immediately adjacent to and higher than an area of significant new accommodation space. The coseismic avulsion node is expected to be an area of major aggradation as the river (i) flows across the scarp into the bend, excavating the scarp and creating a local knickpoint, and (ii) deposits sediment as it encounters the extremely low gradient imposed by agricultural landscape change since the 1940s [122] and its post-seismic reinstatement. It is reasonable to expect that the river will re-avulse repeatedly at the avulsion node, seeking to occupy the downthrown side of the fault.

The Selwyn, Waianiwaniwa, and Hawkins Rivers all traverse the zone of subsidence on the hanging wall of the GFW and footwall of the CCF (Figure 7). The bed elevation changes along these rivers steepen their upstream profiles slightly but flatten their downstream profiles by 1/5th (from 0.5% to 0.4% [15]). As previously noted [15], this bed perturbation is likely to favor sedimentation and flooding in the reduced-gradient reaches of the river.

The Avon and Heathcote Rivers both traverse a tectonically uplifted zone before reaching the uplifted Avon-Heathcote Estuary (Figure 7c). The uplift reduces the gradient of both rivers (e.g., Figure 7e), increasing the flood hazard in parts of eastern Christchurch. The Flockton Basin, in particular, has effectively become a ponding area for floodwaters of the Avon River and its eastern tributaries, resulting in repeated flooding events since the onset of the CES.

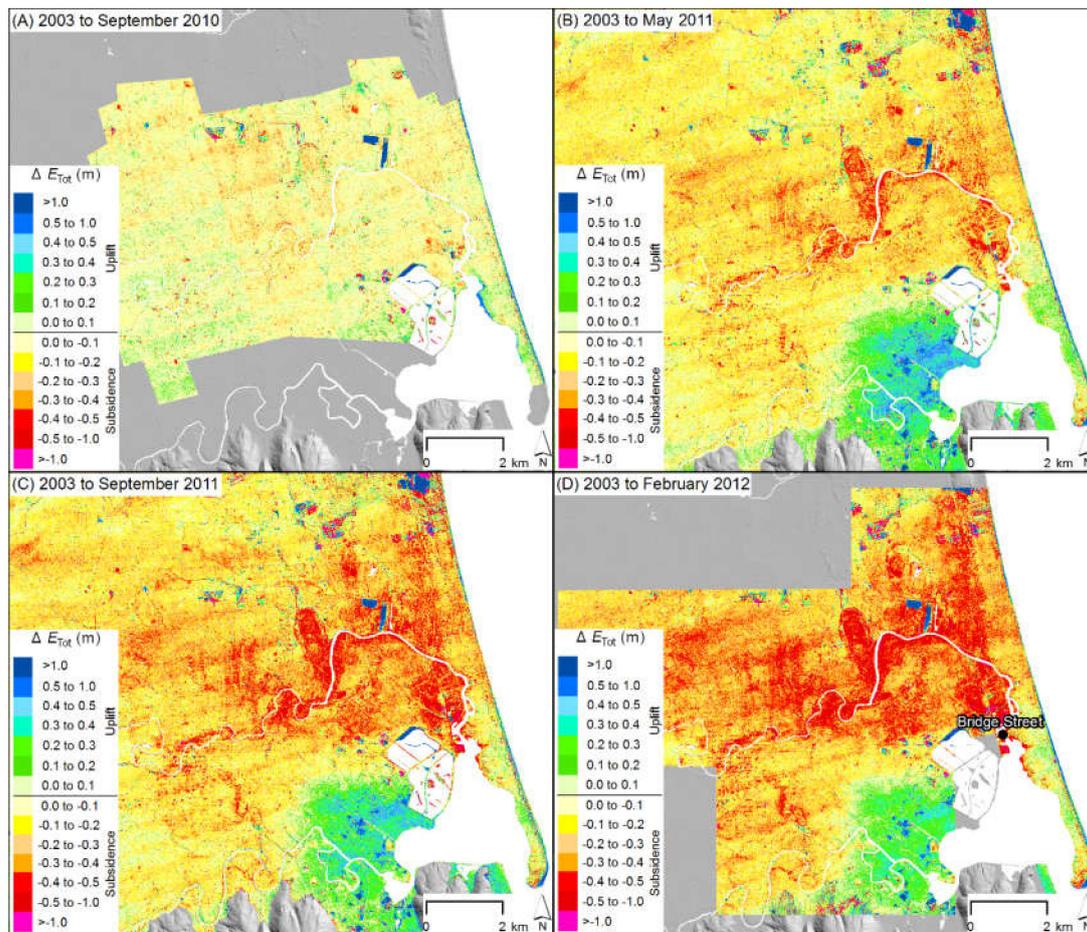
Figure 8. (a–d) Differential LiDAR models illustrating total vertical ground movements (ΔE_{Tot}) in Christchurch through the Canterbury earthquake sequence. (A) Vertical movements from 2003 to 5 September 2010, encapsulating movements from 4 September 2010. (B) Vertical movements from 2003 to May 2011, encapsulating movements from 22 February 2011. (C) Vertical movements from 2003 to September 2011, encapsulating movements from 13 June 2011. (D) Vertical movements from 2003 to February 2012, encapsulating movements from 23 December 2011. The linear artefacts evident in (a)–(d) were due to minor elevation errors along the LiDAR flight lines. The figure was sourced from Quigley et al. [15].

Extensive regional liquefaction occurred during the 4 September 2010 Darfield earthquake [15,33,102,104,106]. Liquefaction manifestation at the ground surface included sand blow formation, lateral spreading, surface subsidence, and flooding. Liquefaction-induced land damage affected $\approx 10,000$ residential properties and was generally confined to specific low-elevation (<5 m above sea level) suburbs with shallow (less than 1–2 m depth) groundwater tables [117] and thick (more than 2 m) near-surface layers of loose to medium density silt-to-fine sand sediments. Liquefaction-triggering (threshold) PGAs in areas of significant land damage were >0.15 – 0.17 g [15]. Surface subsidence ranged from less than 10 cm to more than 30 cm in areas of surface manifestations of liquefaction. Surface subsidence was caused by post-liquefaction volumetric densification, redistribution of liquefaction ejecta, including by anthropogenic removal (Figure 8) [97,118] and lateral spreading [119] (Figure 9). Liquefaction caused 74% of central and eastern Christchurch to subside; 60% of this area subsided by less than 0.2 m (Figure 8). The most severe land damage occurred proximal to urban rivers, estuaries,

The Mw 6.2 Christchurch earthquake caused the most widespread and severe liquefaction manifestation at the ground surface throughout central, southern, and eastern Christchurch, relative to all the other CES earthquakes, affecting approximately 47,000 residential properties [15]. The most severe manifestations (typically 100 to 300 mm of ejected sand and silt covering areas of more than 10 to 100 m²) were generally observed in the low-elevation suburbs adjacent to the Avon River where the groundwater was close to the ground surface [33,117] and the soils comprised thicker near-surface layers of loose- to medium-density sandy soils. The ground surface manifestations were less severe (i.e., smaller individual sand blows) in the suburbs farther away from the Avon River, where groundwater was either deeper below the ground surface or the near-surface soil layers comprised medium density to dense sandy soils. Liquefaction caused widespread and severe subsidence throughout eastern and central Christchurch due to lateral spreading, topographic re-leveling, sand and silt ejecta to the ground surface, and post-liquefaction volumetric densification. Generally, the areas where the largest volumes of water, sand, and silt ejecta occurred also experienced the greatest amount of liquefaction-related subsidence (>0.5 m). This earthquake caused 83% of eastern and central Christchurch to subside further; 78% subsided up to 0.3 m, with localized areas exceeding 1 m (Figure 8)

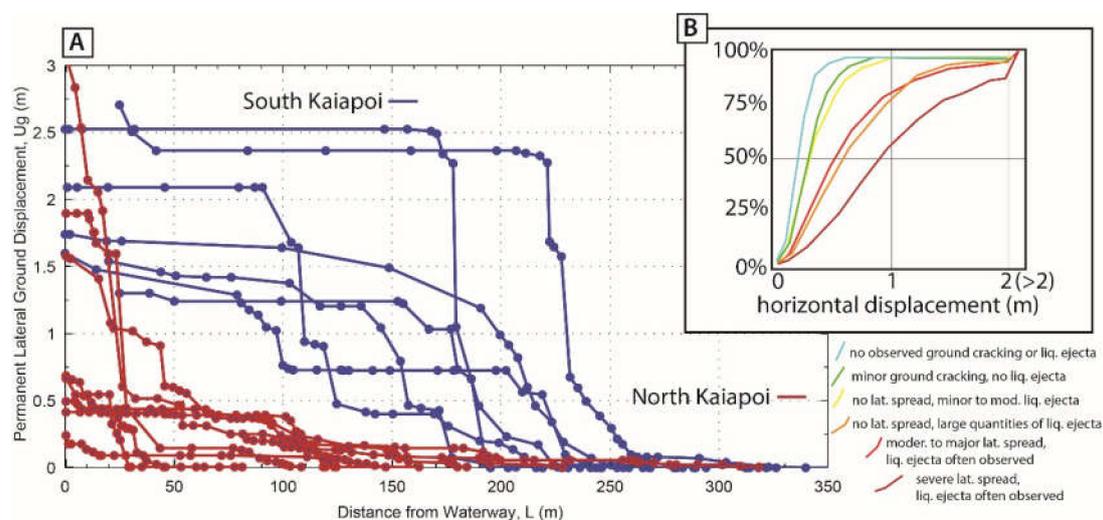
Figure 9. (A) Measured permanent lateral spreading displacements in South Kaiapoi (blue) and North Kaiapoi (red) after the 2010 Darfield earthquake. The figure was sourced from Cubrinovski et al. [121]. (B) Cumulative liquefaction-induced horizontal displacements integrated over the CES plotted for different liquefaction land damage states. The figure was sourced from Rathje et al. [109].

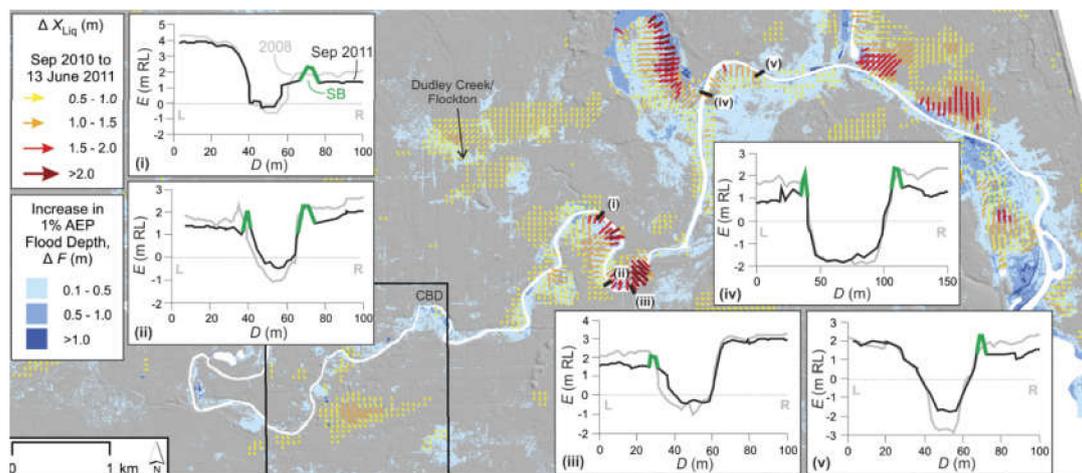
Figure 10. Main map: Cumulative horizontal movements (ΔX_{Liq}) in Christchurch in the vicinity of the Avon River from September 2010 to 13 June 2011, derived from LiDAR offset analysis [88]. Also shown: Increased 1-in-100-year storm event (1% annual exceedance probability (AEP)) flood depths (ΔF) due to subsidence caused by the Canterbury earthquake sequence using current sea level, rainfall, and urban extent. The Christchurch central business district (CBD) is shown, as is the Dudley Creek/Flockton Basin area where recent flooding of residential properties had been problematic. Inset panels: Floodplain and river cross-sections (i–v) obtained from field surveys and LiDAR analyses, with elevation (E) changes shown as the relative level in meters (m RL) from 2008 (solid gray lines) to September 2011 (black lines). Transect distance (D) is in meters (m). The locations of stopbanks (SB) constructed after the 22 February 2011 Christchurch earthquake are shown in green. The figure was sourced from Hughes et al. [14].

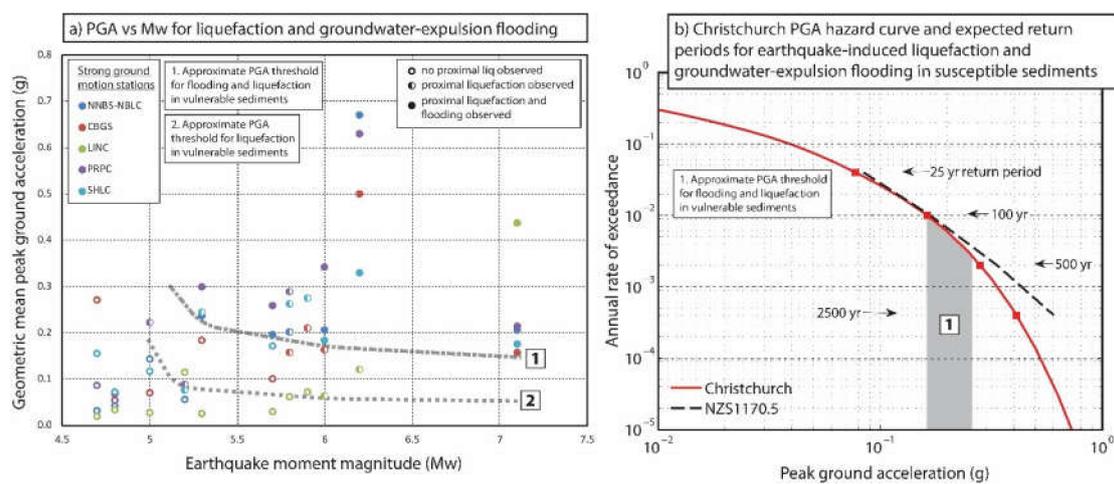
Figure 11. (a) Geometric mean peak ground acceleration (PGA) vs. Mw for CES earthquakes with the largest recorded PGAs at selected strong ground motion seismometer stations where proximal (i.e., ≤ 3 km distance) earthquake-induced liquefaction with or without groundwater-expulsion flooding was observed. Threshold boundaries for liquefaction plus flooding (1) and liquefaction only (2) were approximated from observational data points. (b) Christchurch seismic hazard curve from Bradley [92] showing the geometric mean PGA field required for liquefaction plus flooding (expanded to 0.15 to 0.3 g) intersecting the hazard curve at return periods of ≈ 100 to ≈ 475 years. NNBS—North New Brighton School, NBLC—New Brighton Library, CBGS—Christchurch Botanic Gardens, LINC—Lincoln School, PRPC—Pages Road Pumping Station, SHLC—Shirley Library.

To estimate the potential for future earthquake-induced liquefaction and associated flooding effects, we first plotted the instrumentally-recorded geometric mean PGAs at six selected strong ground motion stations (NNBS—North New Brighton School, NBLC—New Brighton Library, CBGS—Christchurch Botanic Gardens, LINC—Lincoln School, PRPC—Pages Road Pumping Station, SHLC—Shirley Library) for the 11 strongest CES earthquakes with the largest recorded PGAs. The geometric mean PGAs were sourced directly from the values presented in Bradley [92], except for the Mw 5.7 earthquake in 2016, which was computed herein from processed PGAs obtained for these stations from Geonet. The NNBS and NBLC records were merged because of data unavailability for some events; the reported NNBS-NBLC value represents the available value (if only one value was available) or the averaged value (if both records were available). Locations and geotechnical information for stations considered herein are available at (https://www.eqc.govt.nz/sites/public_files/3783-Geotech-characterisation-Chch-strong-

motion-stations.pdf) and (<https://www.geonet.org.nz/data/supplementary/nzsmdb>). PGA values were plotted against earthquake Mw and coded by symbols based on whether liquefaction with and without flooding was observed “proximal” (i.e., ≤ 3 km) to the seismometer sites in the associated earthquakes (Figure 11a). Estimated “threshold” values for liquefaction and liquefaction plus groundwater expulsion flooding in susceptible sediments were defined by linearly correlating observational data to PGA values. Minor proximal liquefaction was observed at geometric mean PGAs as low as 0.07–0.09 g and liquefaction plus groundwater expulsion surface flooding was observed in earthquakes with a geometric mean PGAs as low as 0.15 g. PGA threshold values decreased with increasing Mw because larger Mw earthquakes had longer shaking durations and thus more potentially effective liquefaction-triggering stress cycles. Using the threshold values from Figure 11a, the expected average return times of geometric mean PGAs (1/annual rate of PGA exceedance) capable of triggering future liquefaction and liquefaction plus associated groundwater expulsion flooding in Christchurch are shown in Figure 11b (using the hazard curve from Bradley [92]). The liquefaction plus groundwater expulsion flooding PGA field (#1) intersects the hazard curve at circa 100-to-475-year return times. Paleoseismic investigations of sites subjected to recurrent liquefaction during the CES revealed evidence for major pre-CES liquefaction event(s) (early historic or pre-historic “paleo-liquefaction”) in late Holocene sediments [127,128], providing additional evidence supporting the recurrence over a timescale of hundreds to thousands of years.
