Article

Displacements of Object Founded on Expansive Soils—A Case Study of Light Construction

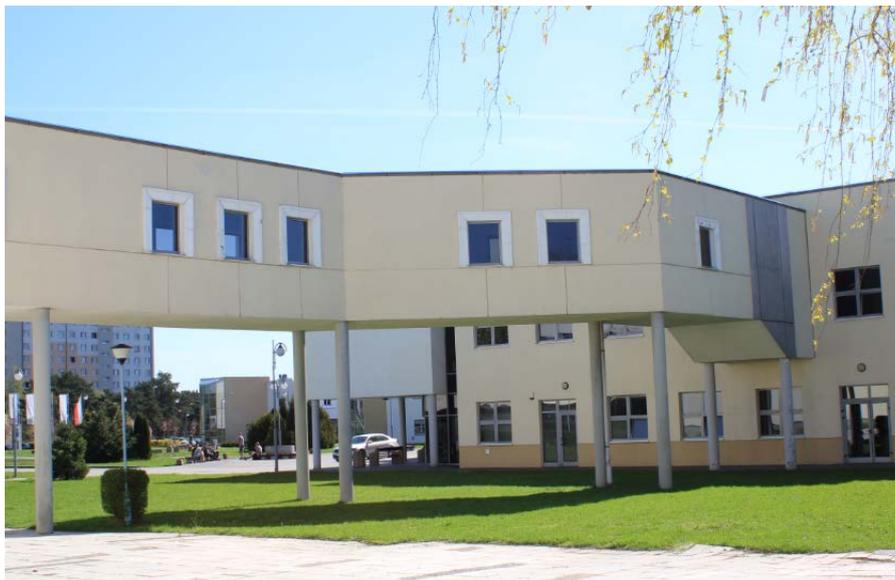
The analyzed object is an overhead passage (Figure 1). It is a relatively light structure with a low rigidity of construction due to its slenderness. The overhead part is a reinforced concrete frame structure filled with hollow brick, supported on 12 pillars with lengths from 1.0 and 3.6 at the edge to 4.7 m in the middle part. The foundation footings, one for every two neighboring pillars, are located from 1.7 m b.g.l. (below ground level) to a maximum of 4.0 m b.g.l.

Figure 1. A view of the investigated object.

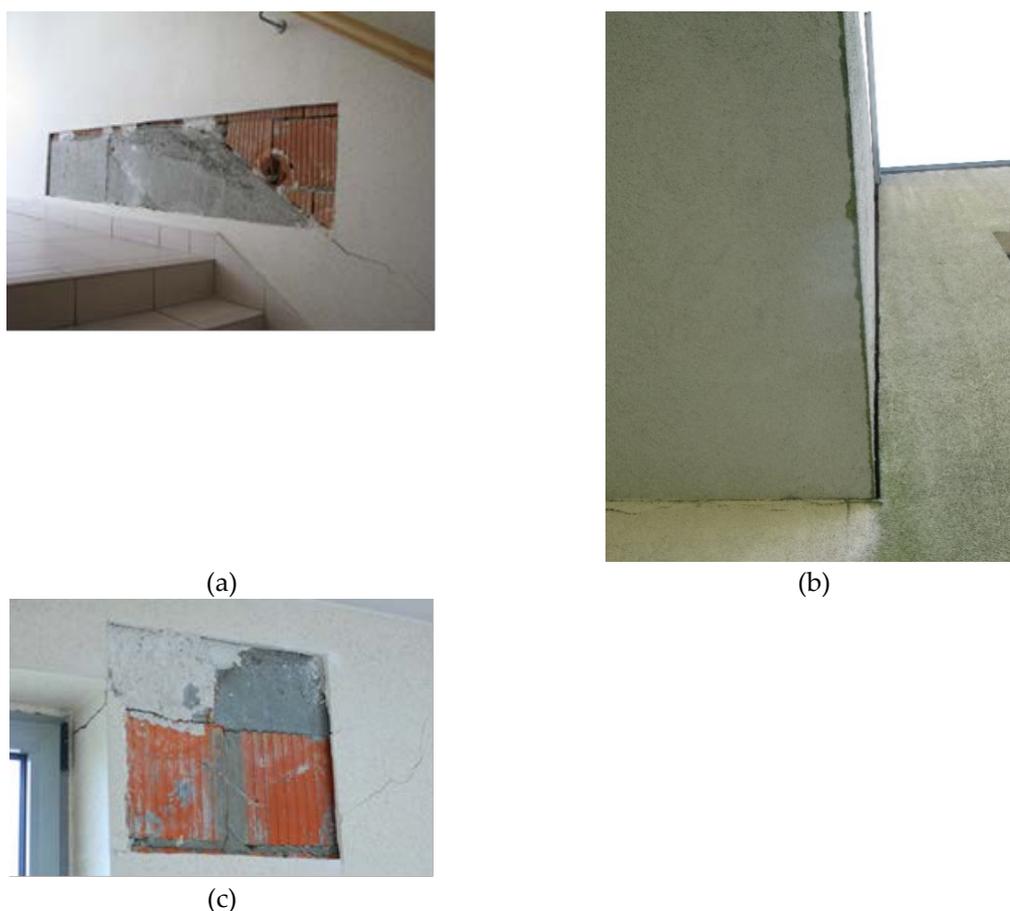
Since the completion of the construction process in 2000–2001, and despite ongoing repairs, increasing damage has occurred (Figure 2a,b). The reasons were seen in geotechnical conditions, mainly in the soil sensitive to changes in the natural water content. In particular, several dozen year-old poplars growing under the passage were able to dry the ground. The entire row of these trees was removed a few years after the construction had been completed. A detailed description of the object and the history of its failure can be found in reference [14].

After general repairs in 2016, internal cracks developed, indicating further movements to the structure. In this case, the damage was less significant, and it appeared mainly in the dilatation zone, where the passage is connected to the main building (Figure 2c).

Figure 2. Typical damage: (a) internal cracks on the contact between frame concrete construction and filling walls (b) cracks in the corner of the window (c) cracks in dilatation zone.

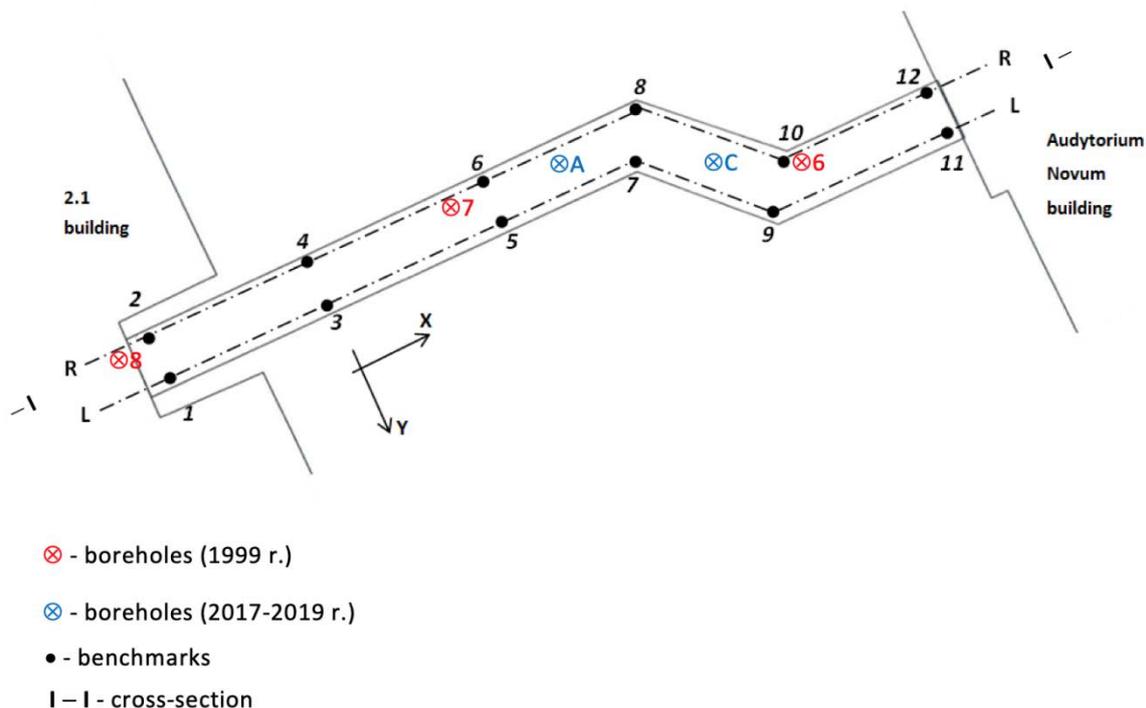
Systematic monitoring of the investigated object was initiated in July 2017 and continued over the year. Geodetic monitoring included both vertical displacements of supports as well as the vertical and horizontal displacements of the flooring of the overhead part of the passage. The terms of geodetic measurement and the thermal conditions of the object's external environment are presented in Table 1. The arrangement of the measurement network is shown in Figure 3.

As part of geotechnical monitoring, the properties of expansive soils were investigated and analyzed. Samples of the clayey soil were periodically taken from two test boreholes in the foundation zone in terms of close to geodetic measurements, presented in Table 1. Natural water content in the soil was determined by the oven drying method in accordance with EN ISO 17892-1: 2015 [15]. The plastic limit was tested in November 2017 in accordance with EN ISO 17892-12: 2004 [16]. The localization of testing boreholes is shown in Figure 3.

Figure 3. The network of control points.

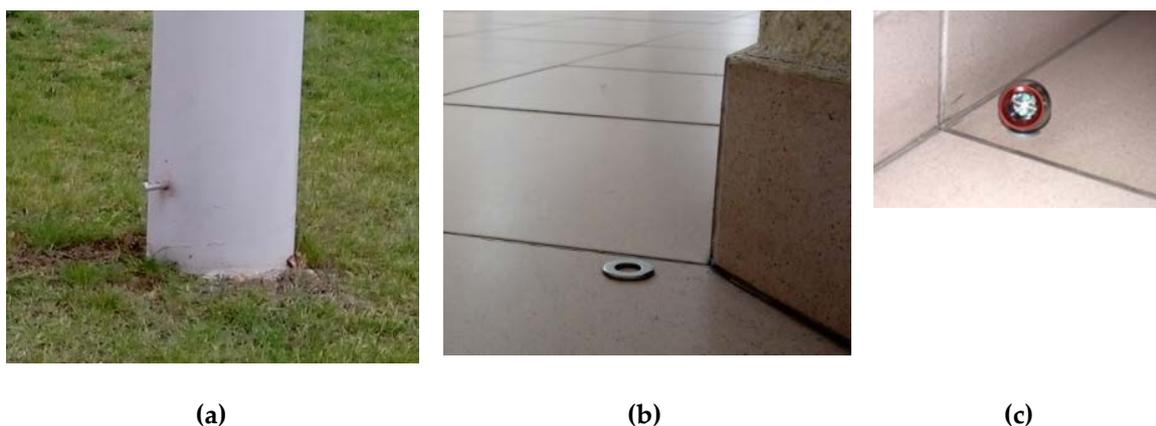
The vertical displacements of the control points located at the base of the pillars were made by using classical precision leveling. A view of the marks is shown in Figure 4a.

However, for the pillar vertices, which were defined as the pillar axis projections on the overhead passage floor, both vertical and horizontal displacements were examined. These points were marked permanently on the passage floor in the form of special sockets, adapted for mounting the measuring instrument, a precise measuring reflector. For measuring the displacement of the points network we used the Leica TDRA6000 coordinate laser station. A view of the marks is shown in Figure 4b. The use of precise measurement in the 1.5" RRR (Red-Ring Reflector) prism mode (Figure 4c) enabled the displacement determination of control points with the required accuracy. Previous studies have shown that this method is an excellent tool for monitoring engineering structures [17,18].

Figure 4. Measurement marks: (a) stabilization of outdoor marks at the base of the pillar; (b) stabilization of indoor marks on the floor of overhead passage; (c) view 1.5" RRR prism on the floor mark. Results.

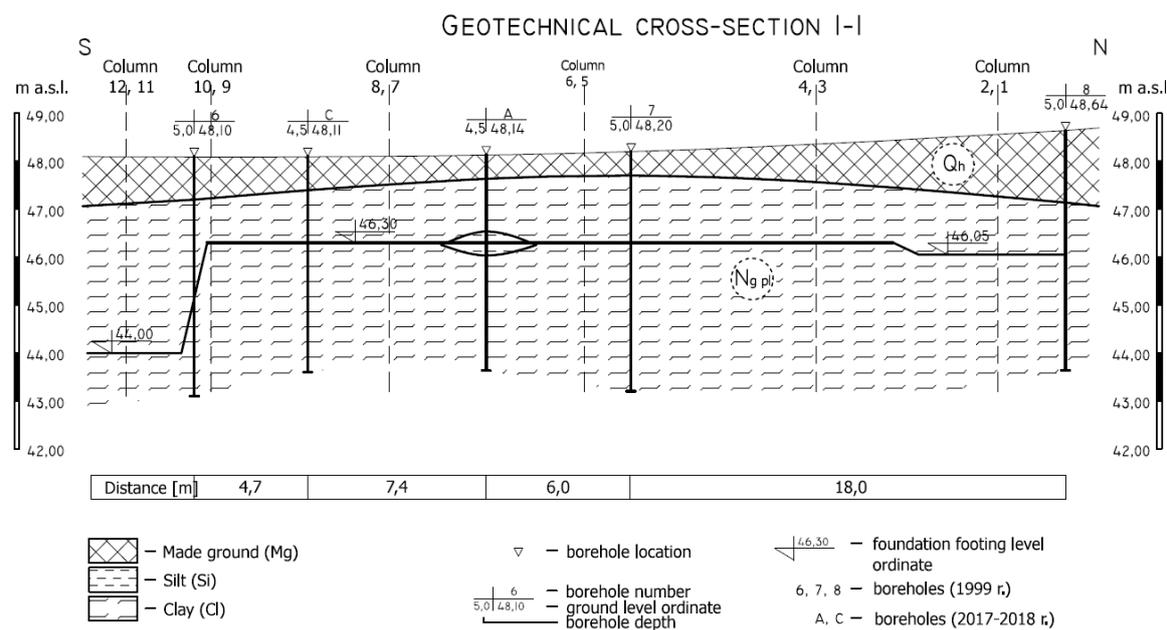
In the foundation level of the investigated object, expansive clays were found (Figure 5). These clays represent the Neogene clays, which occur in a large area of Poland, and are also typical for Bydgoszcz subsoil. These are calcium sodium montmorillonite clays, characterized by high and very

Figure 5. Geotechnical cross-section under the investigated overhead passage.

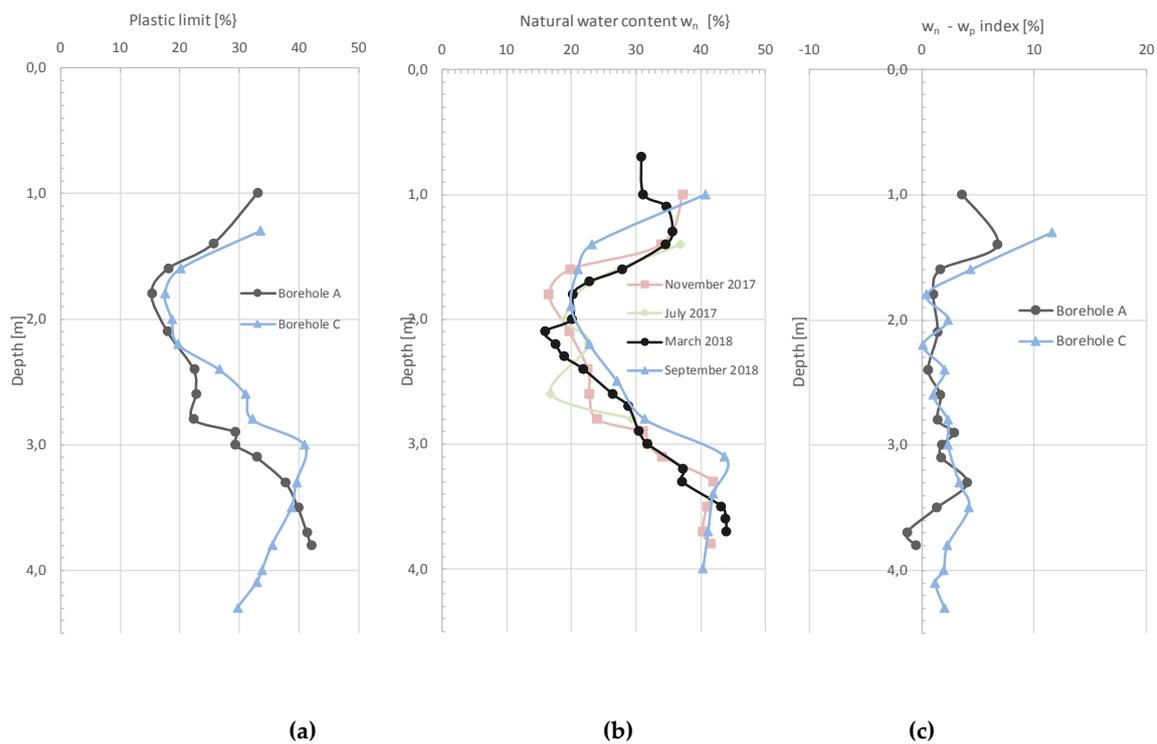
Results of the field and laboratory tests for clays are presented in Figure 6. In November 2017, the plastic limit was marked (Figure 6a). Natural water content seasonal fluctuations of the clayey soil in the foundation zone were investigated in the A-borehole in June and November 2017 and in March and September 2018 (Figure 6b,c). Tests were performed in accordance with [15,16].

The values of plasticity limits (w_p) depending on the depth varied in the range of 17%–42%. This variability is reflected in the natural water content (w_n) graphs, so the $w_n - w_p$ value (the difference between natural water content and plastic limit) was almost unchanged for the most of the studied profiles. During the monitoring period, noticeable fluctuations of natural water content (up to 10%) we noted at a depth of about 1.0 m b.g.l., near the clay surface. Below this level, the moisture of the subsoil did not show noticeable changes.

Figure 6. The monitored boreholes: (a) plastic limit in monitored boreholes (A, C), (b) fluctuations of the natural water content in the monitored period in borehole A, (c) $w_n - w_p$ index in monitored boreholes.

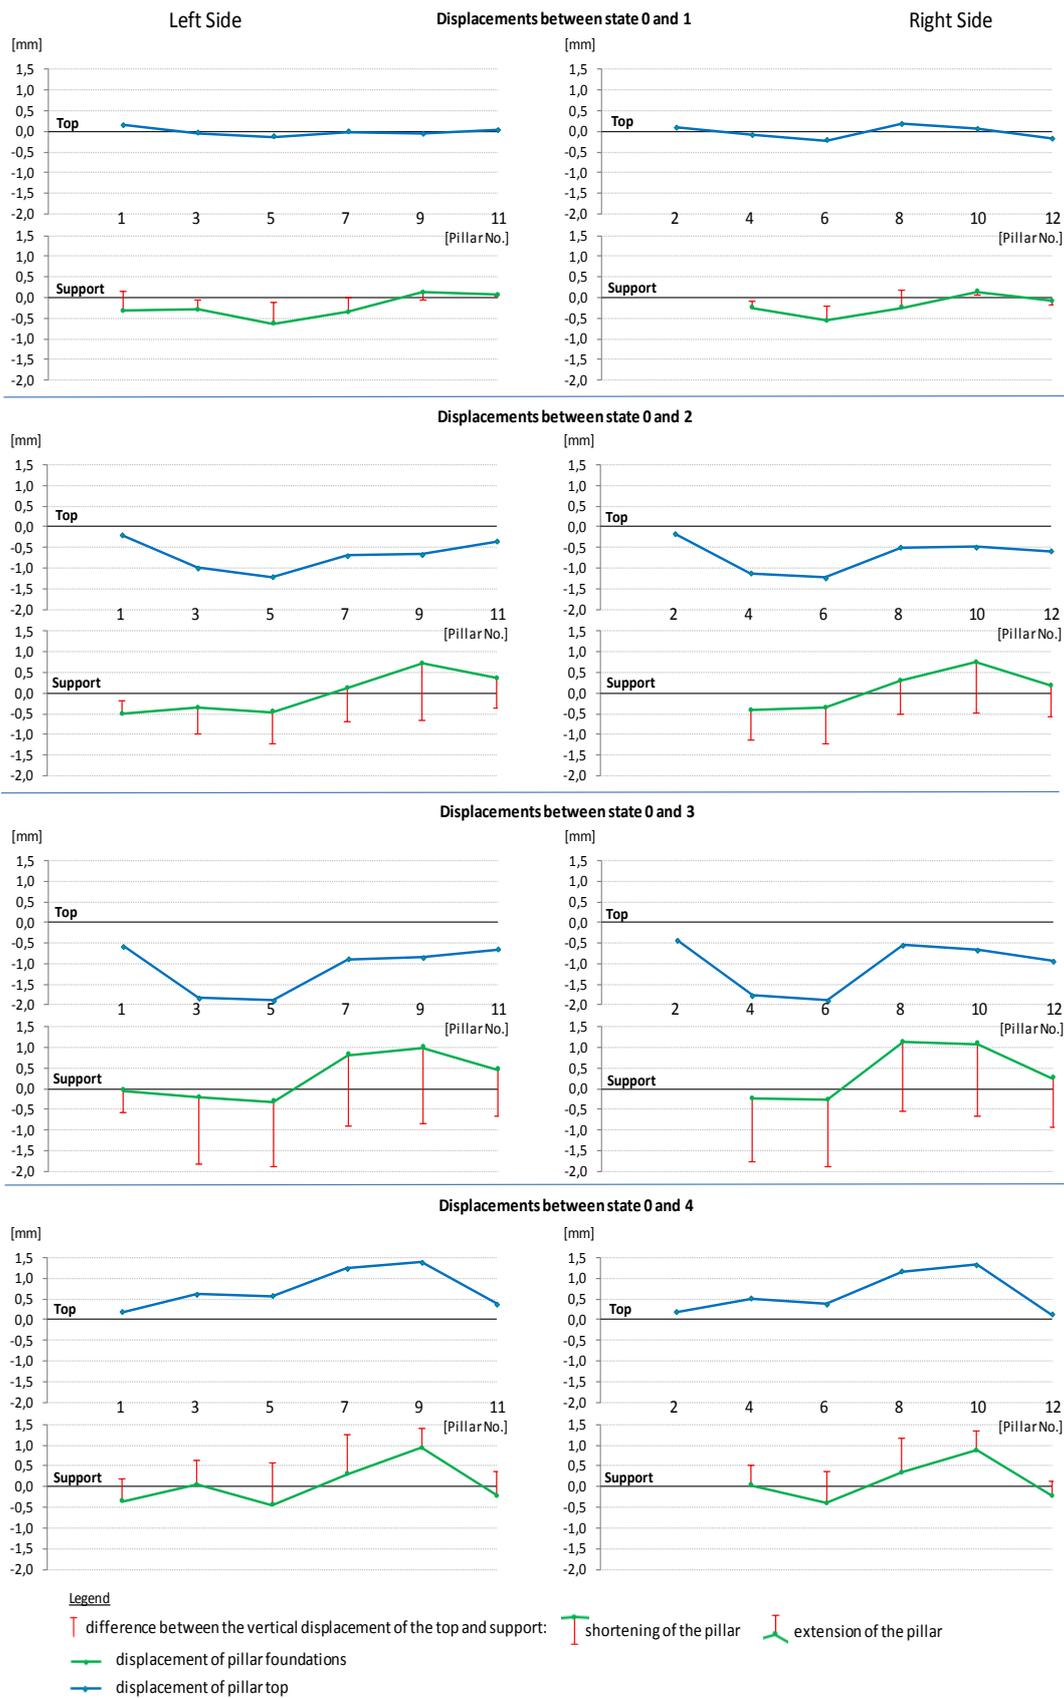
The applied geodetic method allowed us to measure the values of the vertical (Figure 7) and horizontal displacements (Figure 8) of the network of control points on the supports (columns) and of top control points on the flooring of the overhead part of the passage. The measurement taken at 21.07.2017 (measurement No. 0) was established as a reference state. In Figures 7 and 8, all displacements were presented with reference to measurement No. 0.

The vertical displacements shown in Figure 7 amounted to a maximum of just over 1 mm for bottom control points on pillars and over 2 mm for the overhead part of the structure whereas relative displacements (the difference between the support and the top control points) were up to 1.8 mm (at control point No. 9).

Figure 7. Vertical displacements of the control points.

In the analyzed case, any significant vertical displacements of the control points located on the supports are not observed (Figure 7). The vertical displacements of control points on the pillars do not show outstanding values. Higher dynamics of position changes were observed for benchmarks placed in the flooring of the overhead part of the object. This is shown for the points 5 and 7 in the near distance from the monitored geotechnical profile (Figure 9). This clearly indicates other than geotechnical reasons for the displacements and damage of the tested object.

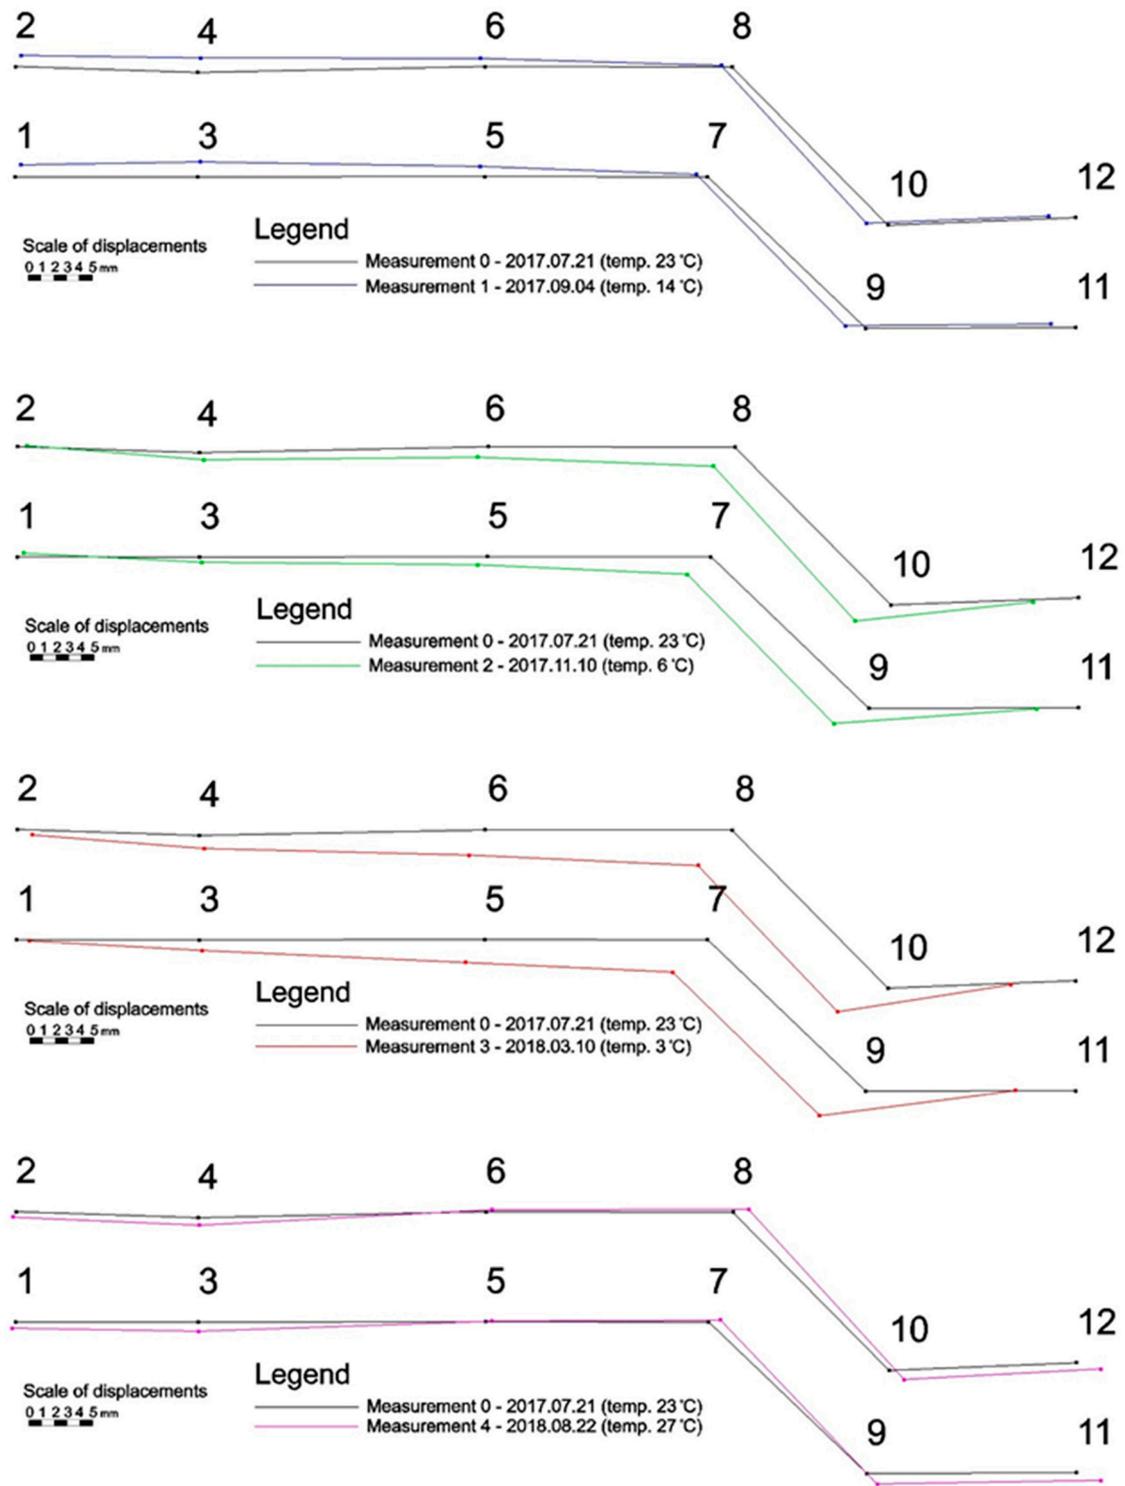
Figure 8. Horizontal displacements of top control points in the flooring of overhead part of passage.

There were also significant horizontal displacements of the flooring of the structure in the direction of the main axis, reaching up to 5.0 mm (Figure 8). Due to the characteristic shape of the structure (geometry breakdown at points 7, 8, 9, and 10), there were also displacements in the transverse direction, up to 2.8 mm at point 8. The maximum extension towards the X-axis was observed for the maximum temperature difference (between measurements 3 and 4) and was 8.2 mm.

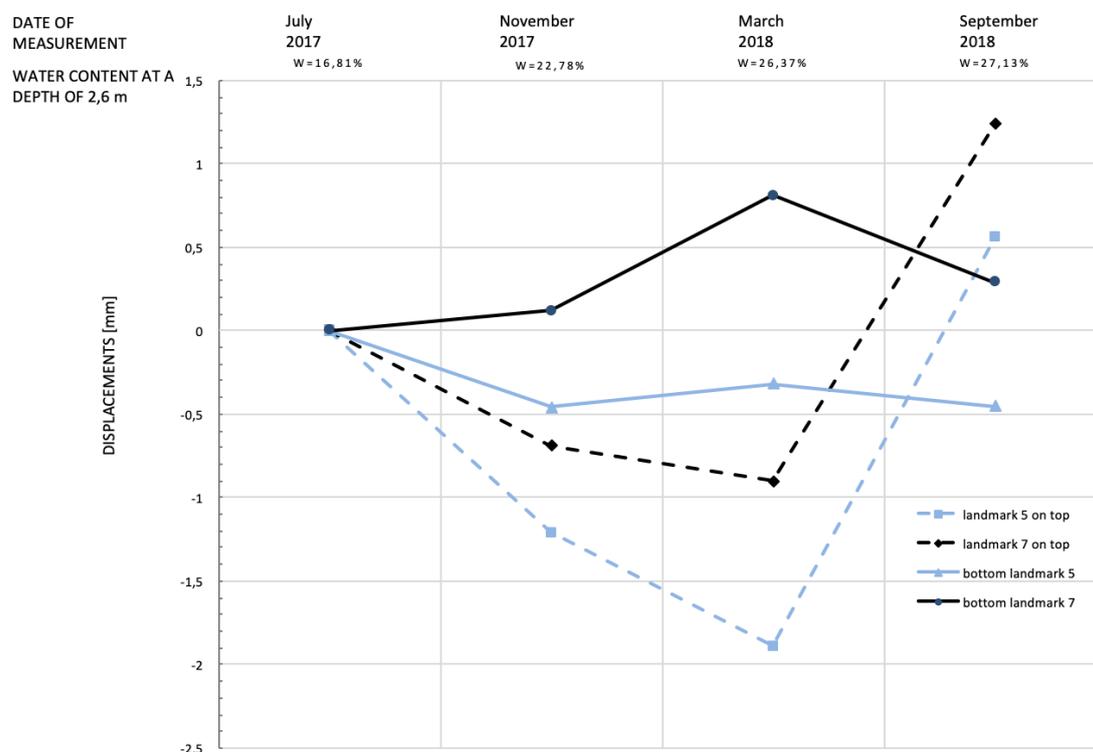
Figure 9. Vertical relative displacements’ dependence on the ambient temperature.

The analyses of the control points observations show the significant differences between relative displacements of top control points to bottom ones. Furthermore, both the vertical and horizontal displacements of top control points show a strong dependence on the ambient temperature. This may indicate the thermal expansion of the supporting pillars and also the overhead part of the passage. Thermal expansion can be the cause of significant horizontal displacement of the overhead construction in the direction of the main axis, and in the transverse direction. The dimensions change of the structure, following the temperature influence, is evidenced by the controlled points’ displacements along the X-axis (points No. 11. and No. 12). It is also visible almost the return of control points to the original position in the annual cycle in the horizontal plane (Figure 10).

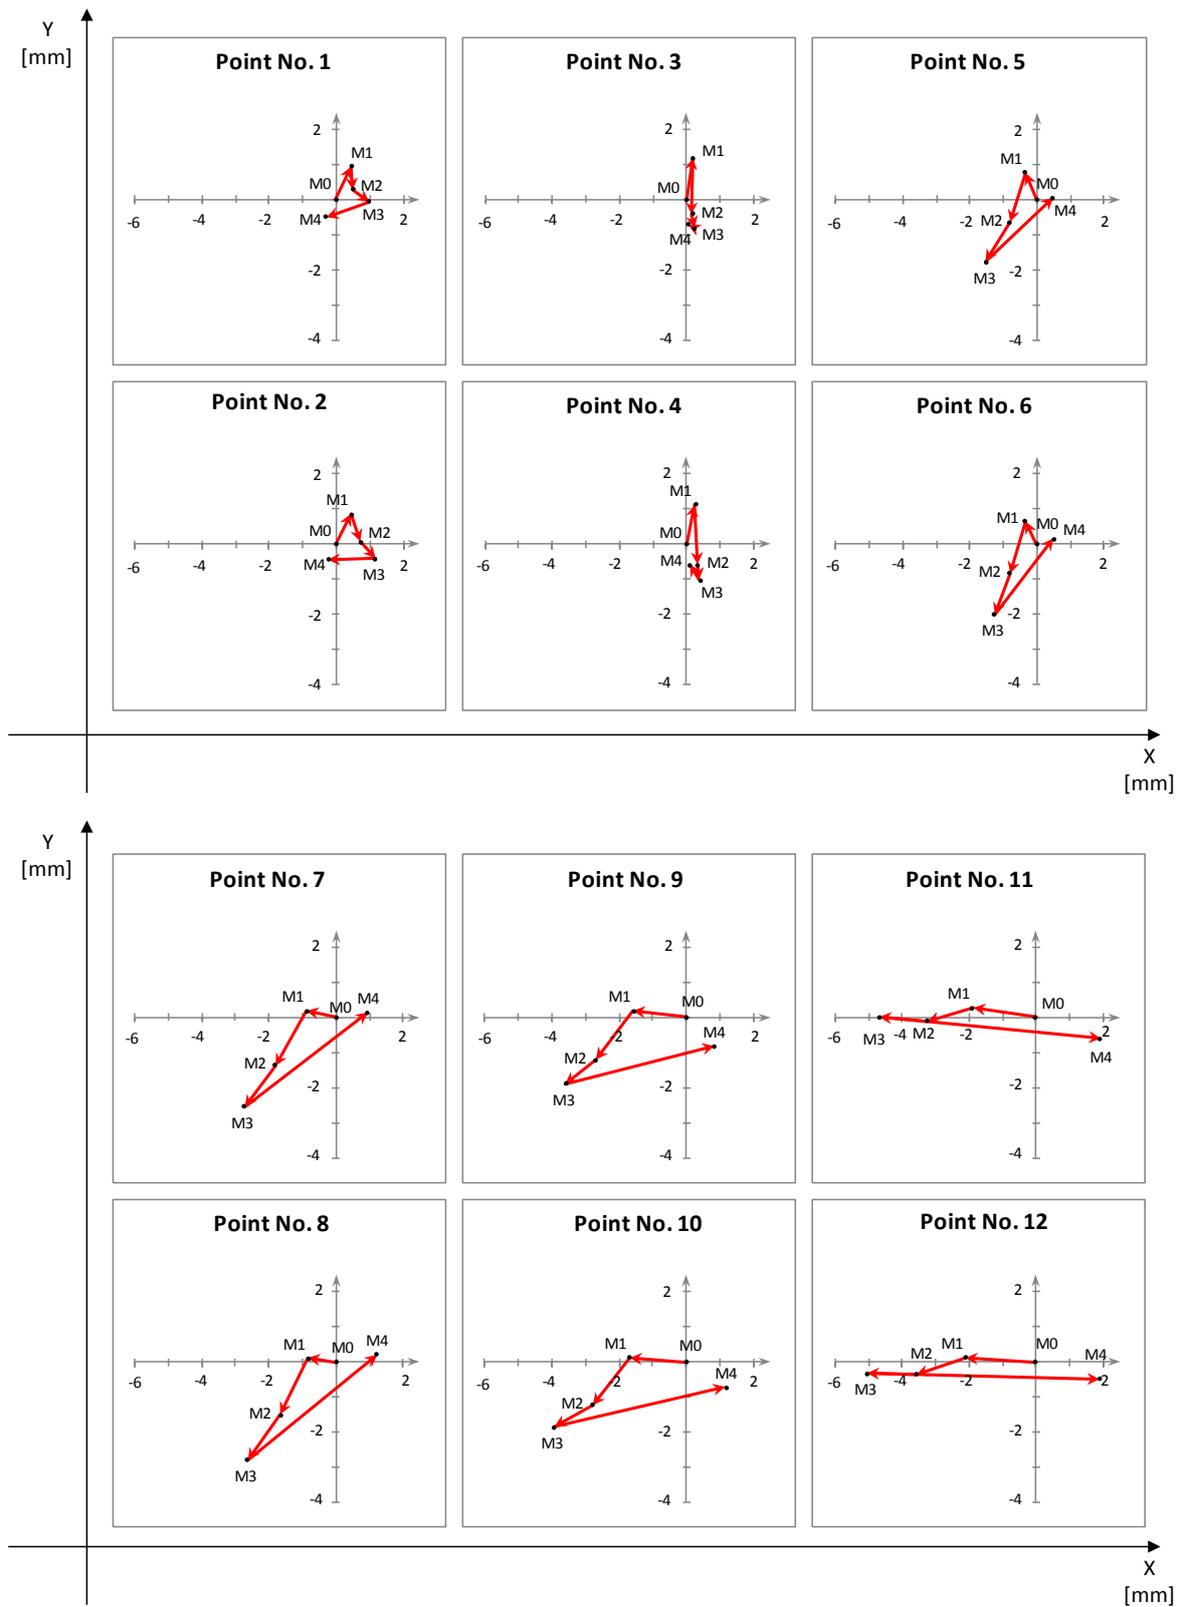
Figure 10. Horizontal displacements of top control points at different temperatures (measure terms), shown in Table 1.

The significant effect of temperature on the displacements and, consequently, damage to the examined object may be the result of its specific construction. The analyzed construction is relatively light and slender.
