# Rock Mass Characterization by UAV and Close-Range Photogrammetry: A Multiscale Approach Applied along the Vallone dell'Elva Road (Italy)

The so-called “Strada del Vallone” is located in the orographic left of the Maira Valley (Piedmont, Northern Italy) and directly connects the village of Elva (located at about 1637 m a.s.l.) with the Maira valley bottom road.

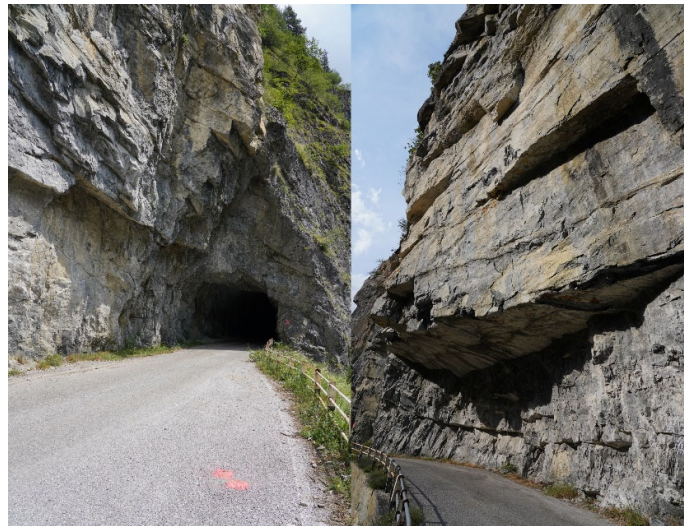
**Figure 1.** Photographs of the rock walls under study.

The road stretches for about 9 km of carriageway with overhanging rock walls and twelve tunnels excavated into the bare rock (Figure 1). Due to the numerous instability phenomena that have occurred since its construction (Table 1) along the entire road and after a large planar sliding in 2015, the road has been closed to traffic.

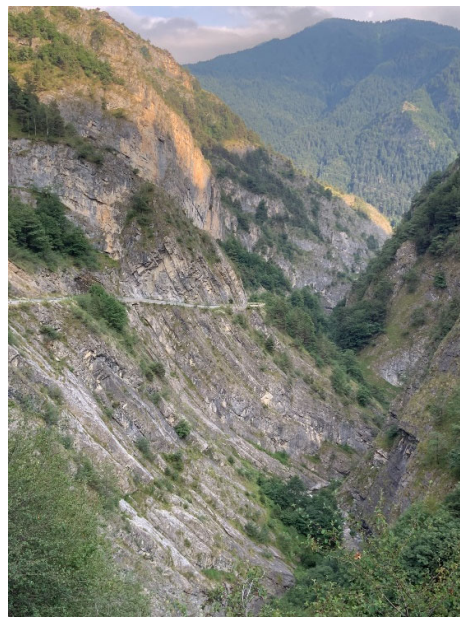
**Figure 2.** View of the hetometric fold: photo taken along the road looking south, and the road is visible on the right side of the slope.

The Elva Road is located in an area strongly tectonized with hectometric folds clearly visible in the panorama of Mount Bittone and delimited by a fault oriented toward N–S and passing through the right side of the valley itself (Figure 2). It is characterized (Figure 3 geological map extract) by dolomite rocks and light grey or black dolomitic limestones, in banks of considerable thickness, and interlayers of cinerites. Their formation took place in the Carnic and Noric Alps (Upper Triassic). These limestone–dolomitic carbonate rocks, cut from the road, are highly verticalized, with a high-angle westward immersion. This sedimentary rock is characterized by three systems, a highly persistent bedding plane and at least two more conjugated set joints, contained between, and perpendicular to, two continuous bedding planes. The orientation of the planes varies due to the presence of folds and faults, and for this reason different kinematic conditions are identified to also be linked to the variation of the orientation of the slopes along the road. The summit portion of the Valley near the town of Elva is instead set in the calcschists and micascists, with significant areas covered with soil that are the site of a deep gravitational slope deformation.

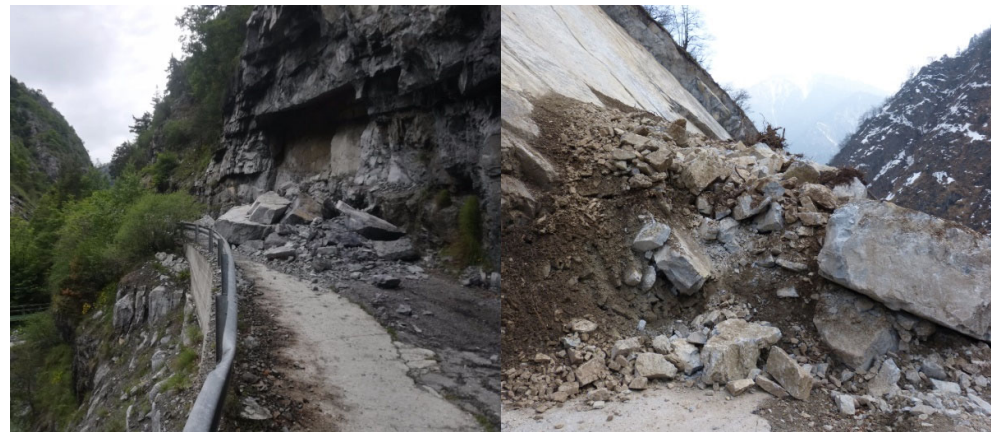
**Figure 4.** Instabilities of 2 June 2018 (about  $250 \text{ m}^3$ ) and 25 February 2015 (more than  $2000 \text{ m}^3$ ).

From the information collected, it is possible to distinguish widespread instability phenomena involving single blocks with volume variables between a few  $\text{cm}^3$  to about  $1 \text{ m}^3$  occurring along the entire road with a high temporal frequency. In addition, localized instability phenomena, with higher intensity in terms of unstable rock mass volume (variable between a few  $\text{m}^3$  to  $2500 \text{ m}^3$ ) was recorded by the public agency (Table 1), which led, in some cases, to the interruption of the traffic along the road (Figure 4).

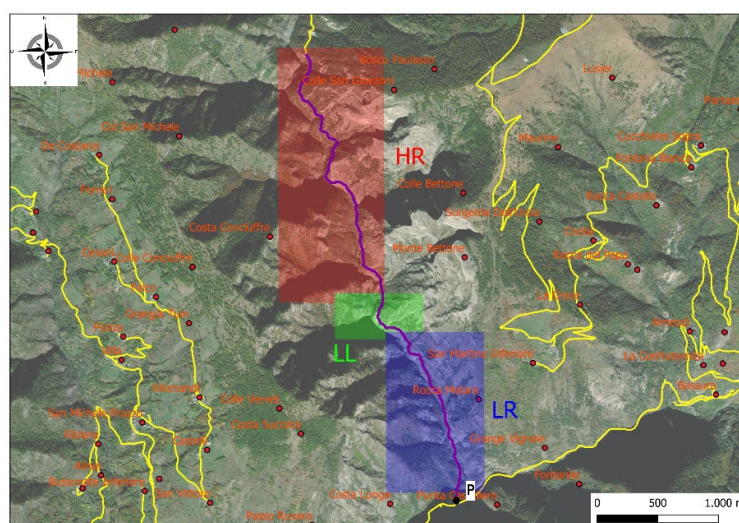
**Figure 5.** Representative surveys domains: High Road (HR), Large Landslide (LL), Low Road (LR), coordinates of point P (UTM zone 32T, 349,027.40 m E, 4,938,557.42 m N).

In order to cover all nine kilometres of the road, the survey was subdivided into three different domains, namely “High part of Road (HR)”, “Low part of Road (LR)” and “Large Landslide (LL)”, respectively, as shown in Figure 5.

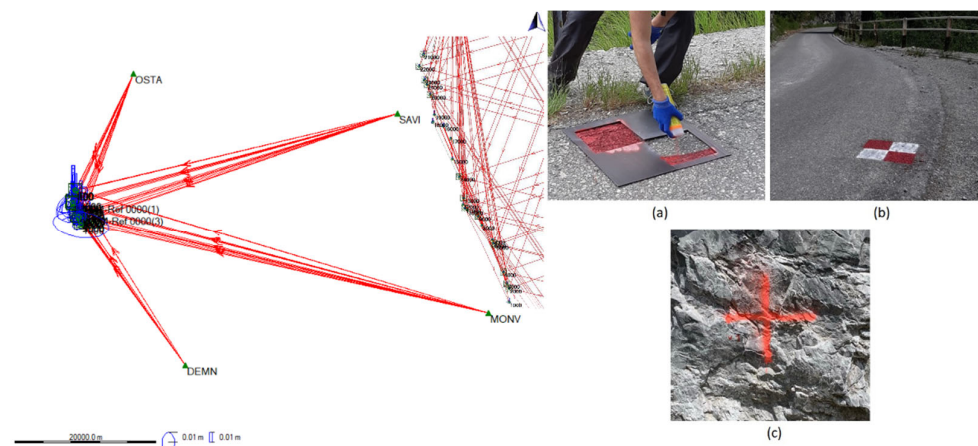
**Figure 6.** CORS constellations in Elva area and an example of the markers materialized along the road paving and rock outcropping: (a) colouring of highly visible markers ( $30 \times 30$  cm) along the street, using a specially made template; (b) a horizontal marker; (c) a vertical marker.

In order to georeference every digital model processed, a topographical network was designed. About 200 points were measured by GNSS or total station techniques, guaranteeing a high accuracy and precision ( $\sigma_{\max} = 3$  mm in vertical or horizontal directions): (i) 22 horizontal markers materialised along the road paving, where the coordinates were estimated considering a multibase solution (through the Leica Geo Office® software v.8.4) with the Ostana and Demonte permanent stations of the CORSs (Continuous Operating Reference Stations) network by the Piedmont district; (ii) 54 vertical markers and 120 natural targets along the rock outcropping (about 1 marker every 50 m) were acquired using total station instrument. In Figure 6, an example of the topographic marker acquisition surveys is shown.

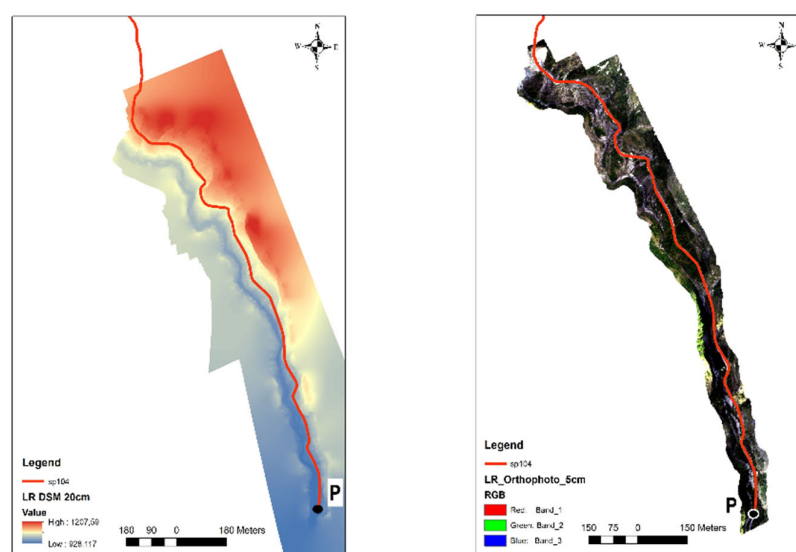
**Figure 7.** LR example of DSM and orthophoto; coordinates of point P (UTM zone 32T, 349,027.40 m E, 4,938,557.42 m N).

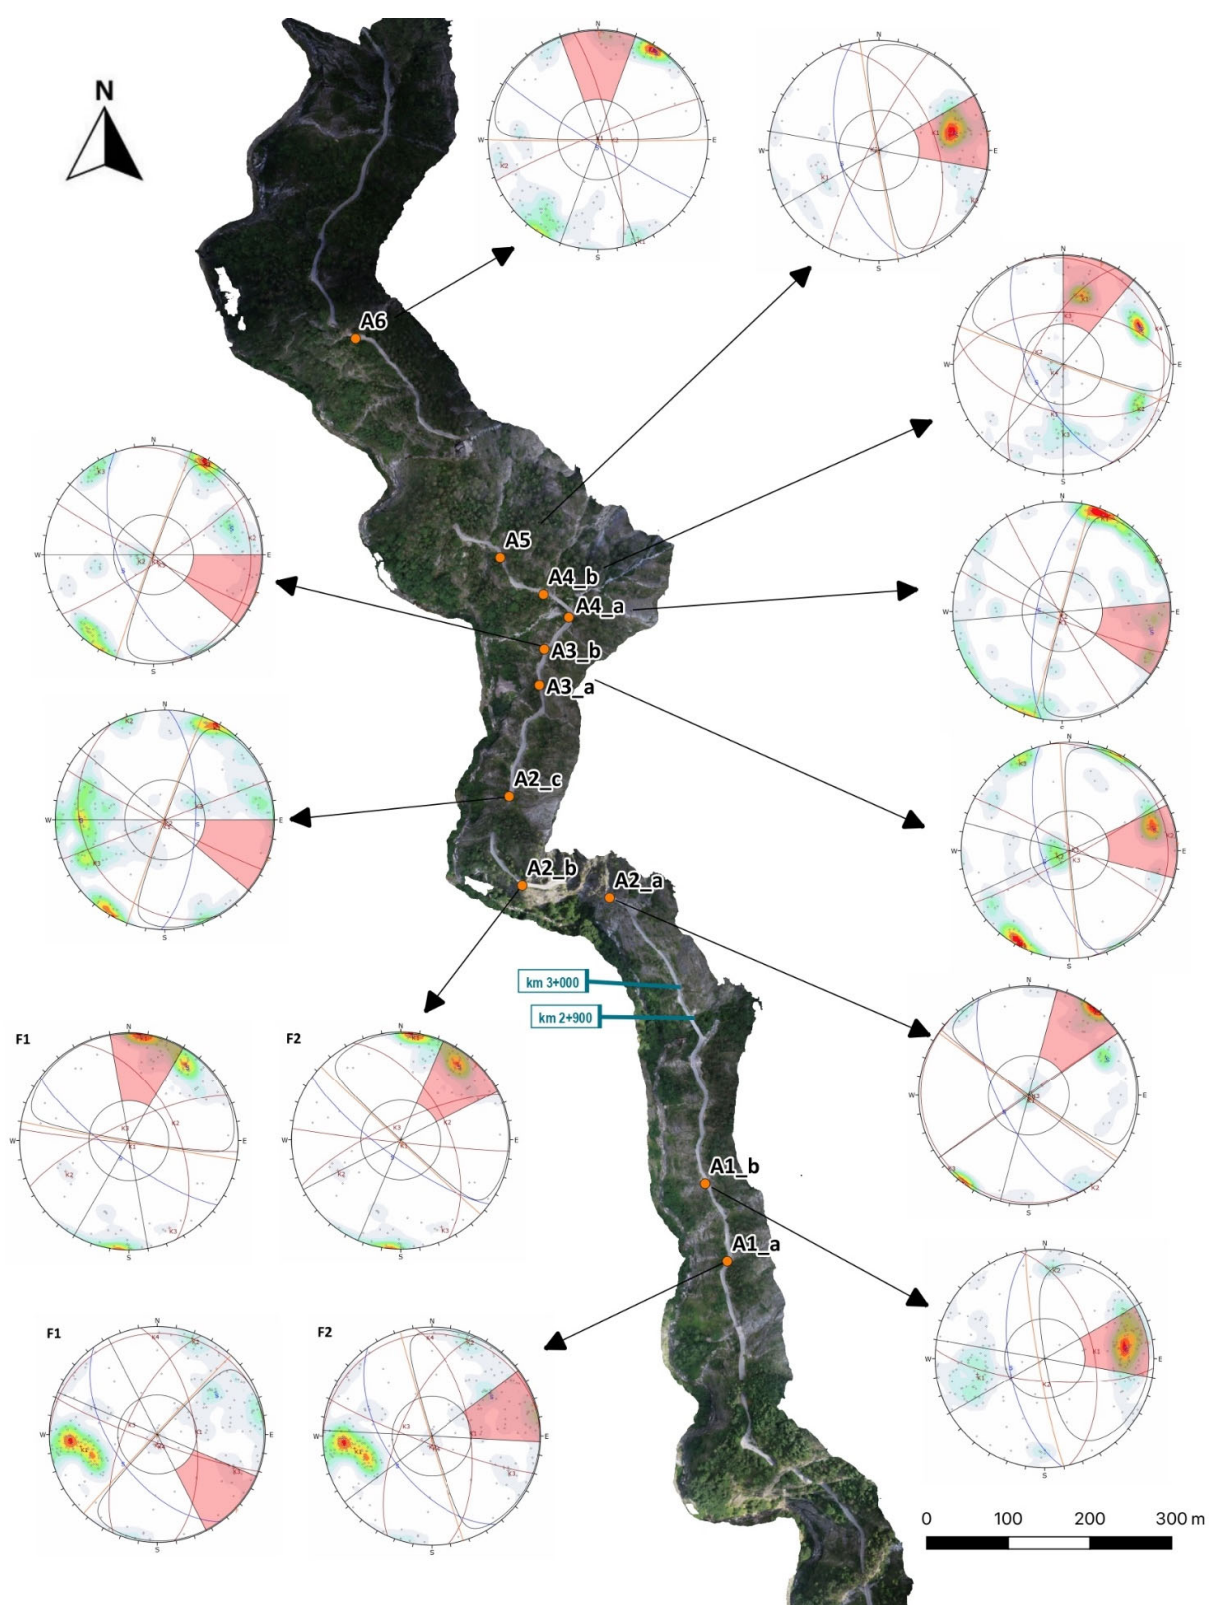
Figure 8. Orthophotos and results of kinematic analysis: High Road.

Twenty rock mass outcroppings located along the road were subject to geo-mechanical survey with both quick traditional and no-contact techniques: 11 along the HR, 9 along the LR and 1 at the LL. A detailed DSM was built in correspondence to each of the sites. Figures 8 and 9 at the end of this paper show the orthophotos in order to better visualize the position of all sectors.

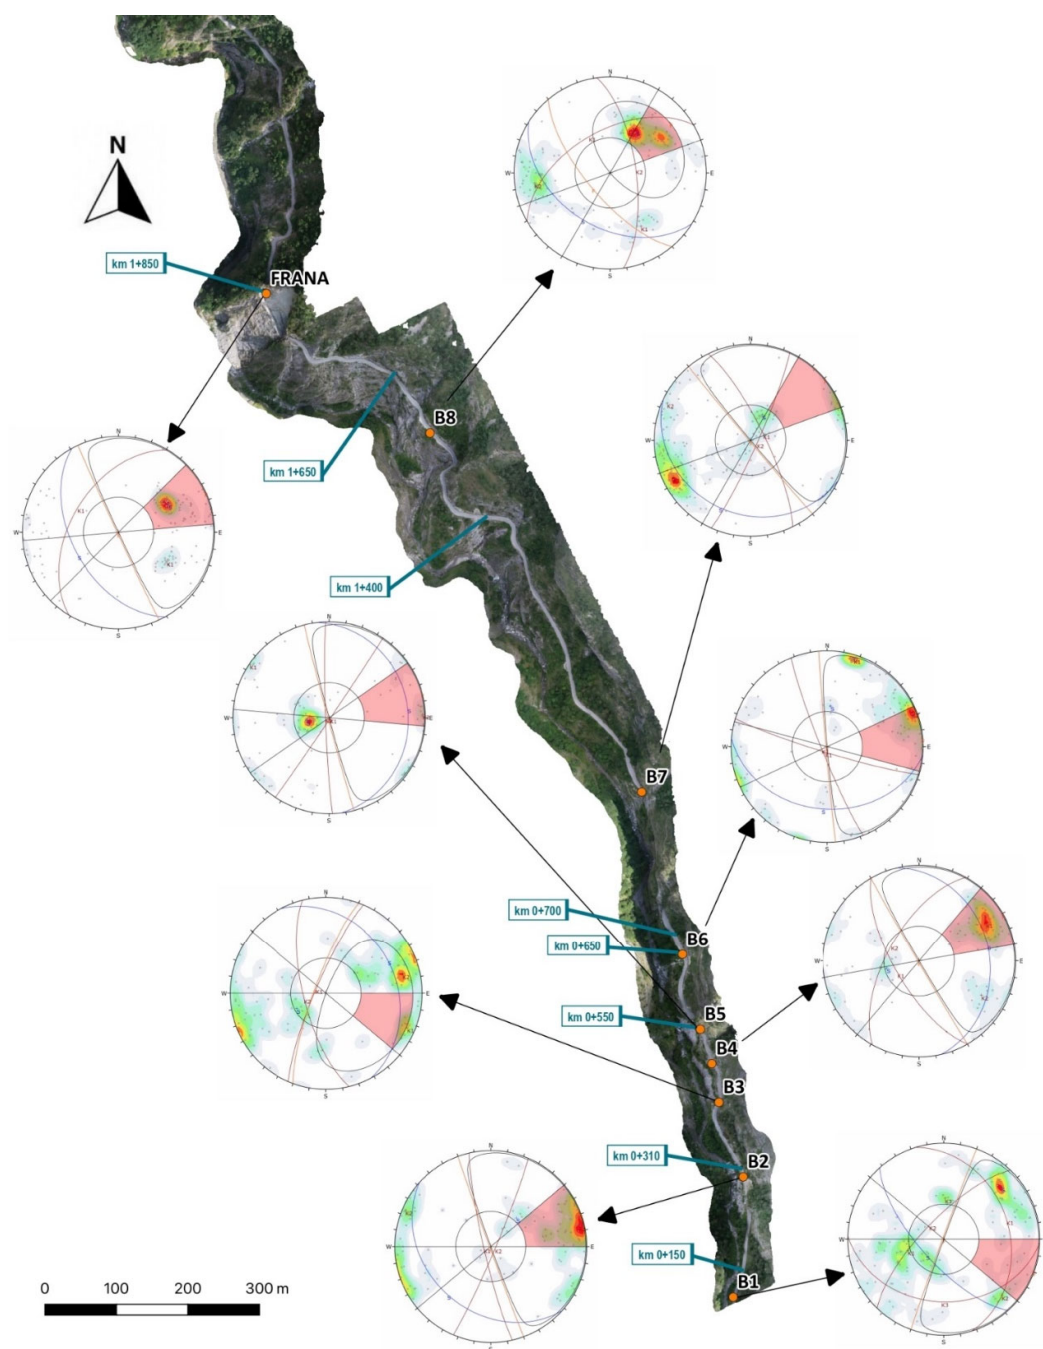
**Figure 9.** Orthophotos and results of kinematic analysis: Low Road and Large Landslide.

Analysing the spacing data, it can be noted that in the lower part of the road, at least in the first sector (sector B1, Figure 9), the average spacing of the bedding plane is between 80 and 115 cm, forming thick rock banks. This thickness decreases in the northern part of the low road, reaching an average spacing between 20 and 50 cm.

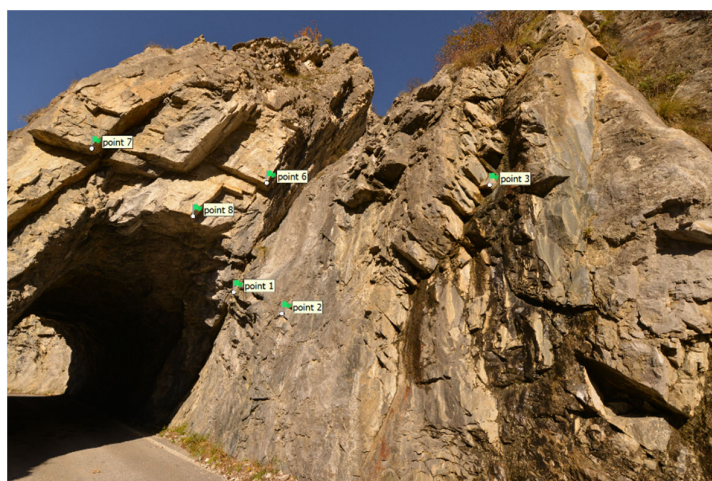
**Figure 10.** Examples of natural markers used for georeferencing the specific DSMs.

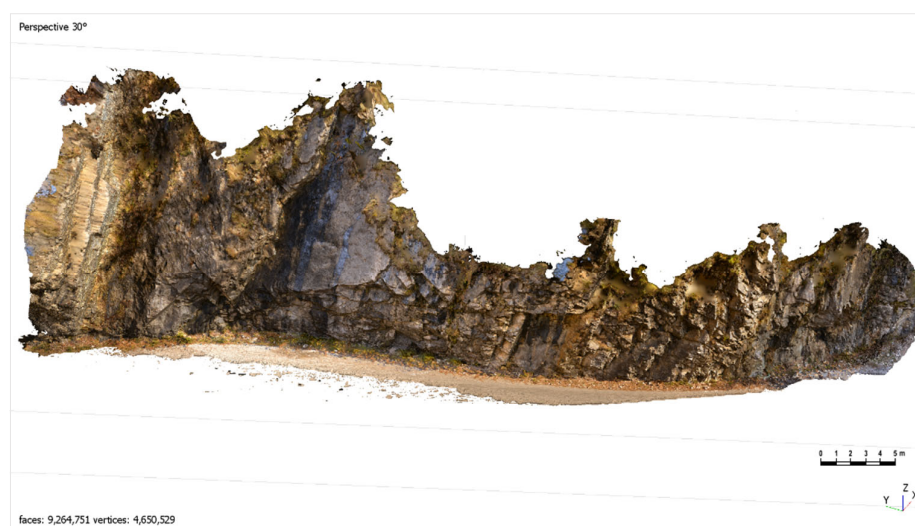
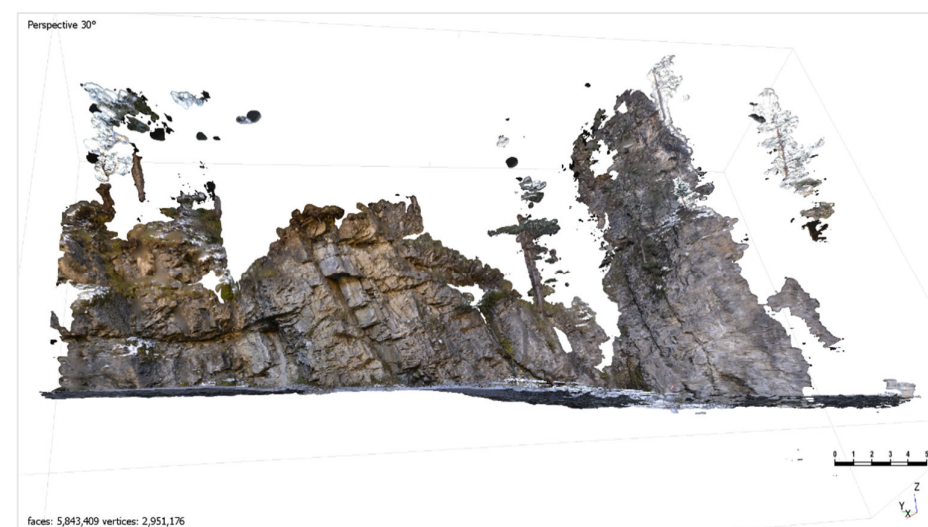
**Figure 11.** Three-dimensional mesh for sectors: (a) A1\_b and (b) A3\_b (Figure 8).

With the general survey, it was not possible to obtain a sufficient number of points, and with this aim, 20 detailed DSMs were built reproducing a portion of the rock slope with limited dimensions: about 30–40 m long and 15 m high; most of the surveyed rock masses did not include any GCPs or CPs, as reported in Table 3; for this reason, each DSM was georeferenced by recognizing and defining several natural points (e.g., markers in Figure 10) on the digital images and by obtaining their coordinates directly from the general DSM of the entire road. As an example, the results for two characteristic sectors considered are shown in Figure 11.

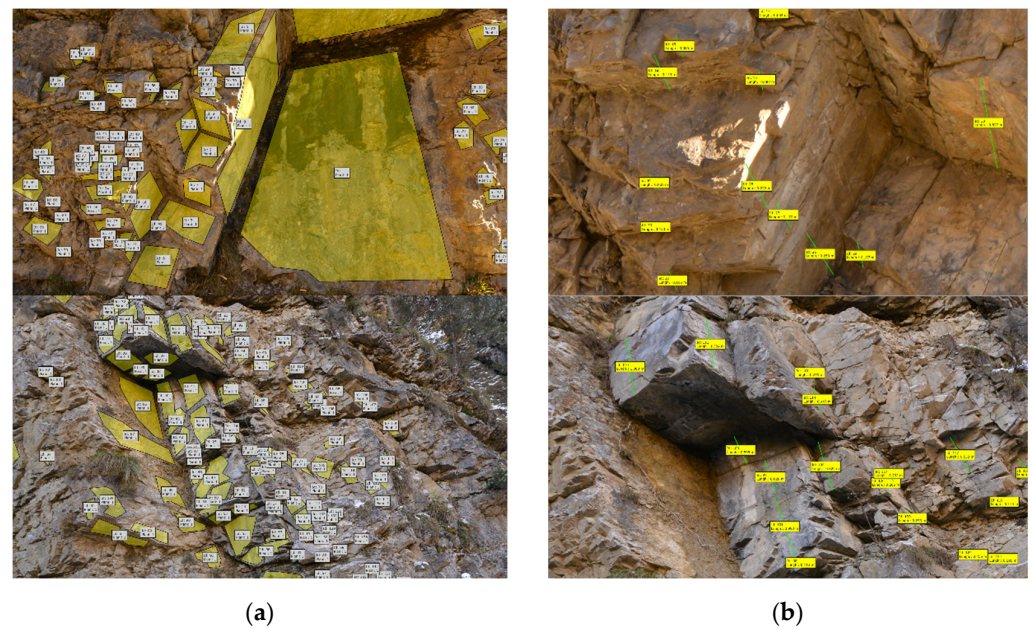
**Figure 12.** Discontinuity data collected by Rockscan software in portions of A1\_b (above) and A3\_b (below) sectors: (a) discontinuity planes and (b) spacing.

The DSMs, the oriented digital images and the calibration parameters of the camera were used in the Rockscan software [34], specifically developed for measuring the orientation and spacing of the plane (Figure 12).

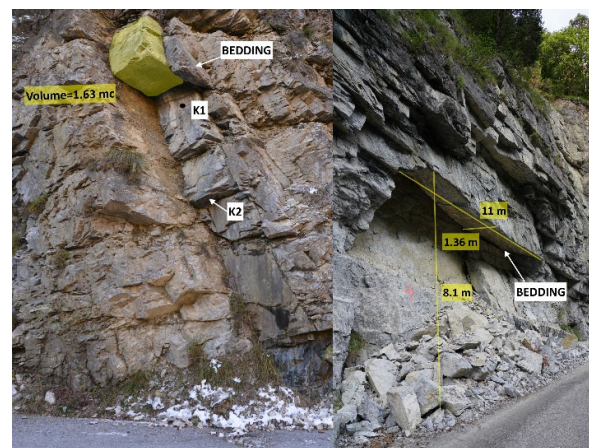
**Figure 13.** An example of distance measurements of unstable block and depletion.

Furthermore, it was possible to carry out spacing measurements between the joints belonging to the same discontinuity system. The possibility of making distance measurements is equally useful in situations where it is necessary to identify the dimensions of unstable blocks or depletions (Figure 13).

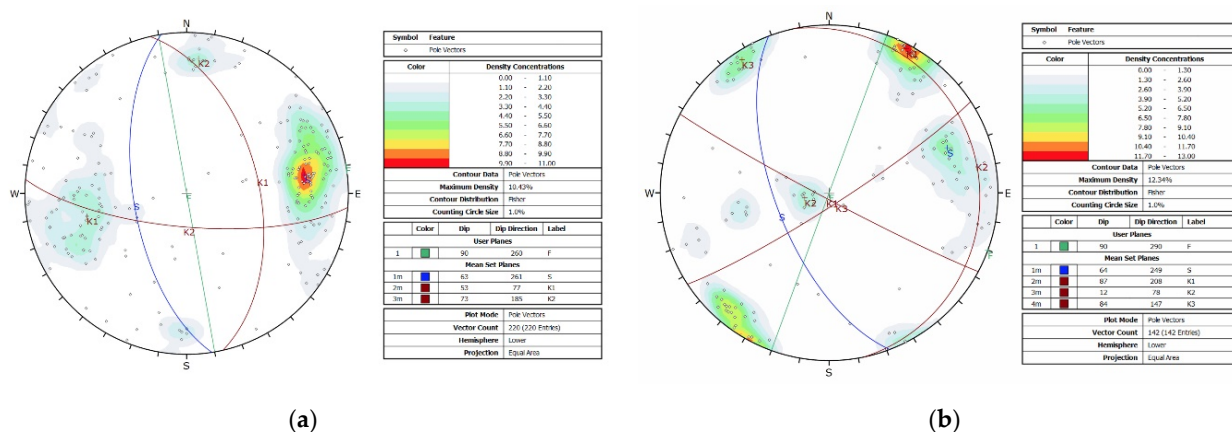
Figure 14. Stereogram for sectors (a) A1\_b and (b) A3\_b.

The identification of the discontinuity plans and the following kinematic analysis were carried out for each of the 20 sectors considered. In Figure 14, stereograms for sectors A1\_b and A3\_b are reported, while Table 6 indicates, for each sector, the number of planes detected and the mean orientation data of the discontinuity systems identified. In each sector, three main systems were identified in accordance with the geological evidence: a bedding planes (BP), the most persistent, and two conjugated systems (K1 and K2) perpendicular to the bedding plane with a limited persistence close to BP spacing. In some sectors, where the rock is more fractured, two other systems, K3 and K4, were identified.

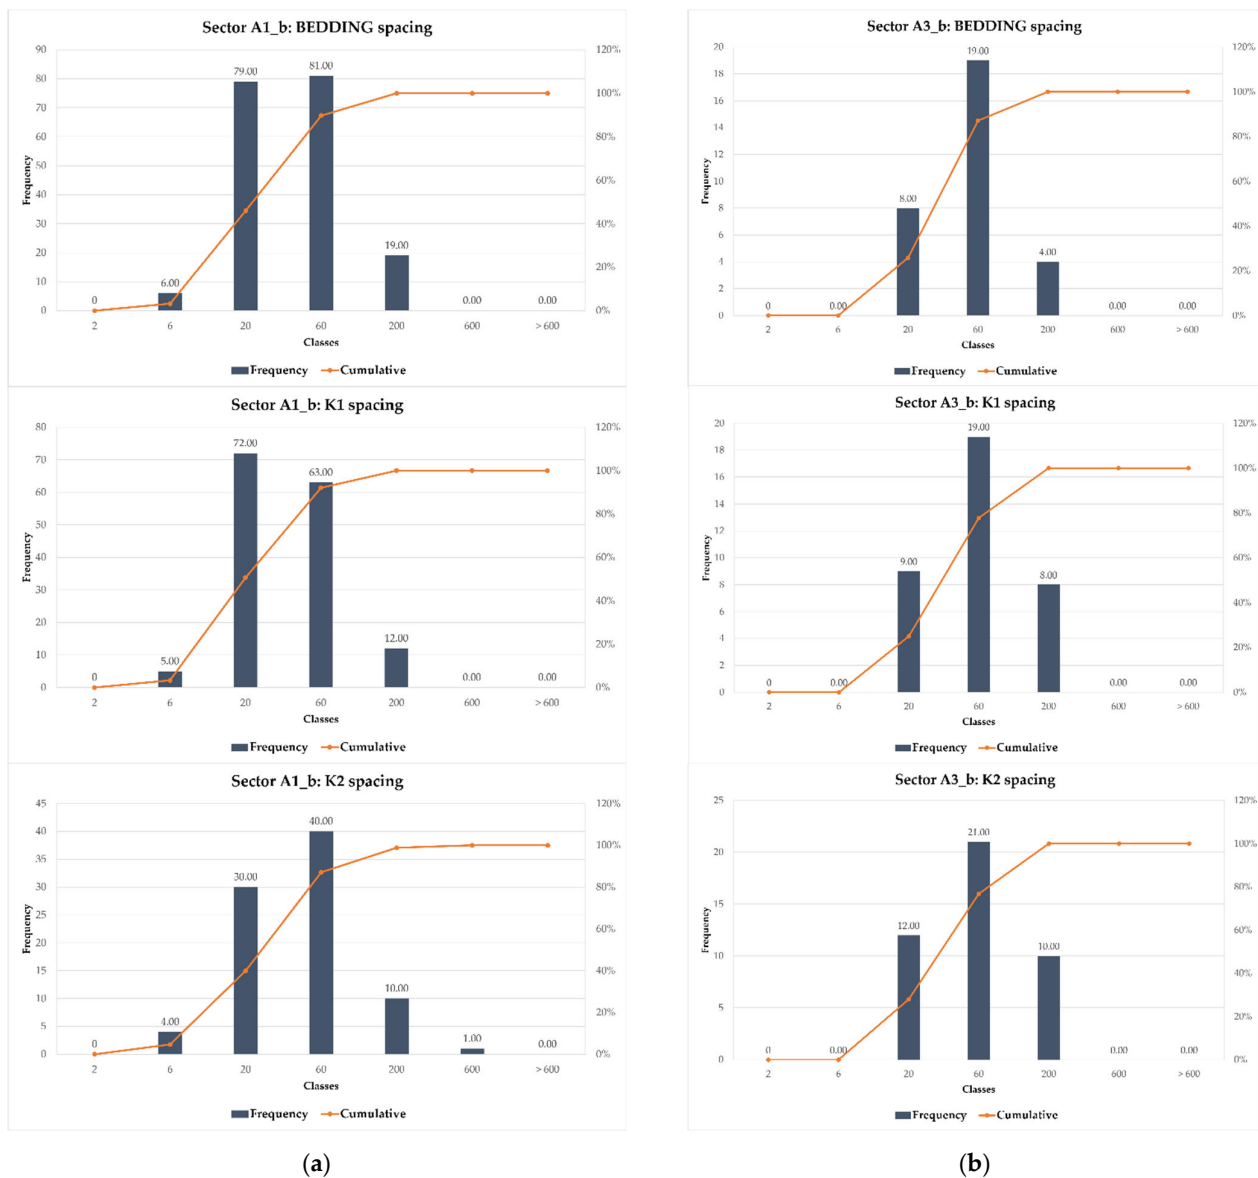
Figure 15. Frequency diagrams of the spacing data for sectors (a) A1\_b and (b) A3\_b.

Spacing data were analysed, system by system, through a frequency distribution analysis (Table 6), organizing the data into classes, as indicated in the ISRM [2]: less than 2 cm; from 2 to 6 cm; from 6 to 20 cm; from 20 to 60 cm; from 60 to 200 cm; from 200 to 600 cm and greater than 600 cm. Figure 15 reports the spacing frequency distribution and the cumulative frequency curve obtained for the sectors A1\_b and A3\_b, used as examples.

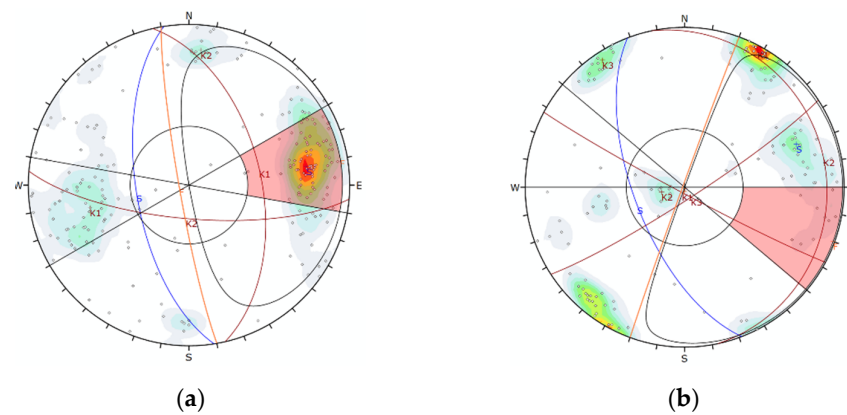
**Figure 16.** Markland test with Dips 7.0 for sectors (a) A1\_b and (b) A3\_b.

In each sector, the potential kinematic mechanisms were identified. As previously indicated, the analyses were performed by Dips7.0 [35], identifying the kinematic mechanisms that can occur, on the base of the planes and the slope orientation through the application of the Markland test [43]. Figure 16 shows the Markland test carried out for the A1\_b and A3\_b sectors; in Table 7 and in Figures 16 and 17, the results obtained in each sector are summarized. The prevailing kinematic mechanism is that of planar sliding but, in some cases, the discontinuity systems can form blocks, which can become unstable due to rockfall or toppling.

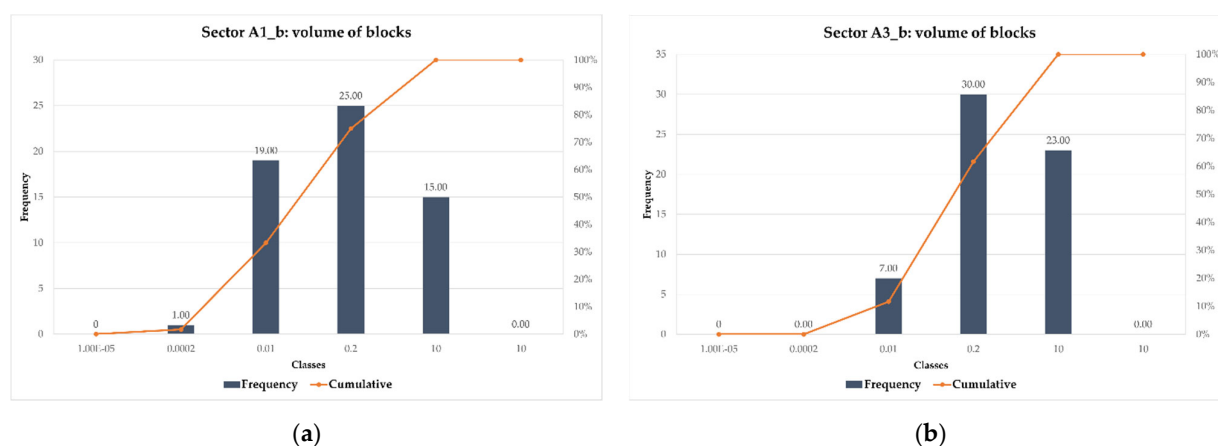
Figure 17. Frequency diagrams of volume distributions for sectors (a) A1\_b and (b) A3\_b.

A frequency distribution of the block volumes was obtained by the Palmstrøm [44] equation, considering only the presence of the three principal discontinuity systems (BP, K1 and K2) and a combination of their spacing statistical parameters: maximum, minimum, average and modal values. In each sector, 60 volume values were evaluated, and the frequency distribution and the cumulative distribution obtained in the A1\_b and A3\_b sectors are shown in Figure 17. The volume of the blocks defined as such is highly variable and ranges from 10 cm<sup>3</sup> to 40 m<sup>3</sup>. In this case, the classes considered for the frequency analysis are: less than 10 cm<sup>3</sup>; from 10 to 200 cm<sup>3</sup>; from 0.2 to 10 dm<sup>3</sup>; from 10 to 200 dm<sup>3</sup>; from 0.2 to 10 m<sup>3</sup> and greater than 10 m<sup>3</sup>. Table 8 summarizes the results in terms of volume values.

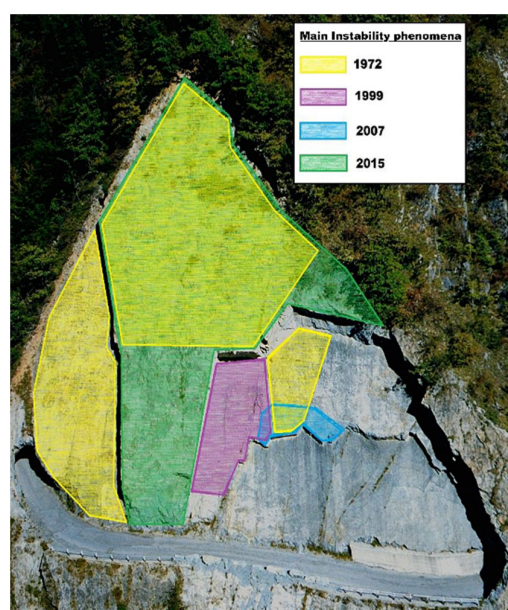
**Figure 18.** Chronology of the collapses in the LL sector (photo 2002).

The geometry of the road, connected with the natural stratification of the rock face, gives a dip slope morphology with the presence of disharmonious folds. Since the construction of the road and its widening, this site has exhibited phenomena of planar sliding that have progressively mobilized slabs or portions of slabs released at the foot precisely from the re-profiling of the slope made to allow the construction of the roadway. The natural slope, which was initially characterized by a morphological surface similar to the current lateral slopes that delimit the area of instability, has undergone progressive collapses of considerable magnitude that have resulted in its current morphology (Figure 18).
