# Soil Erosion and Landslide Susceptibility Mapping in Western Attica, Greece: A Rock Engineering System Approach

Nikolaos Tavoularis

Regional Authority of Attica/Directorate of Technical Works, Department of Technical Support of Attica's Region Municipal Islands, 185 45 Piraeus, Greece; ntavoularis@metal.ntua.gr

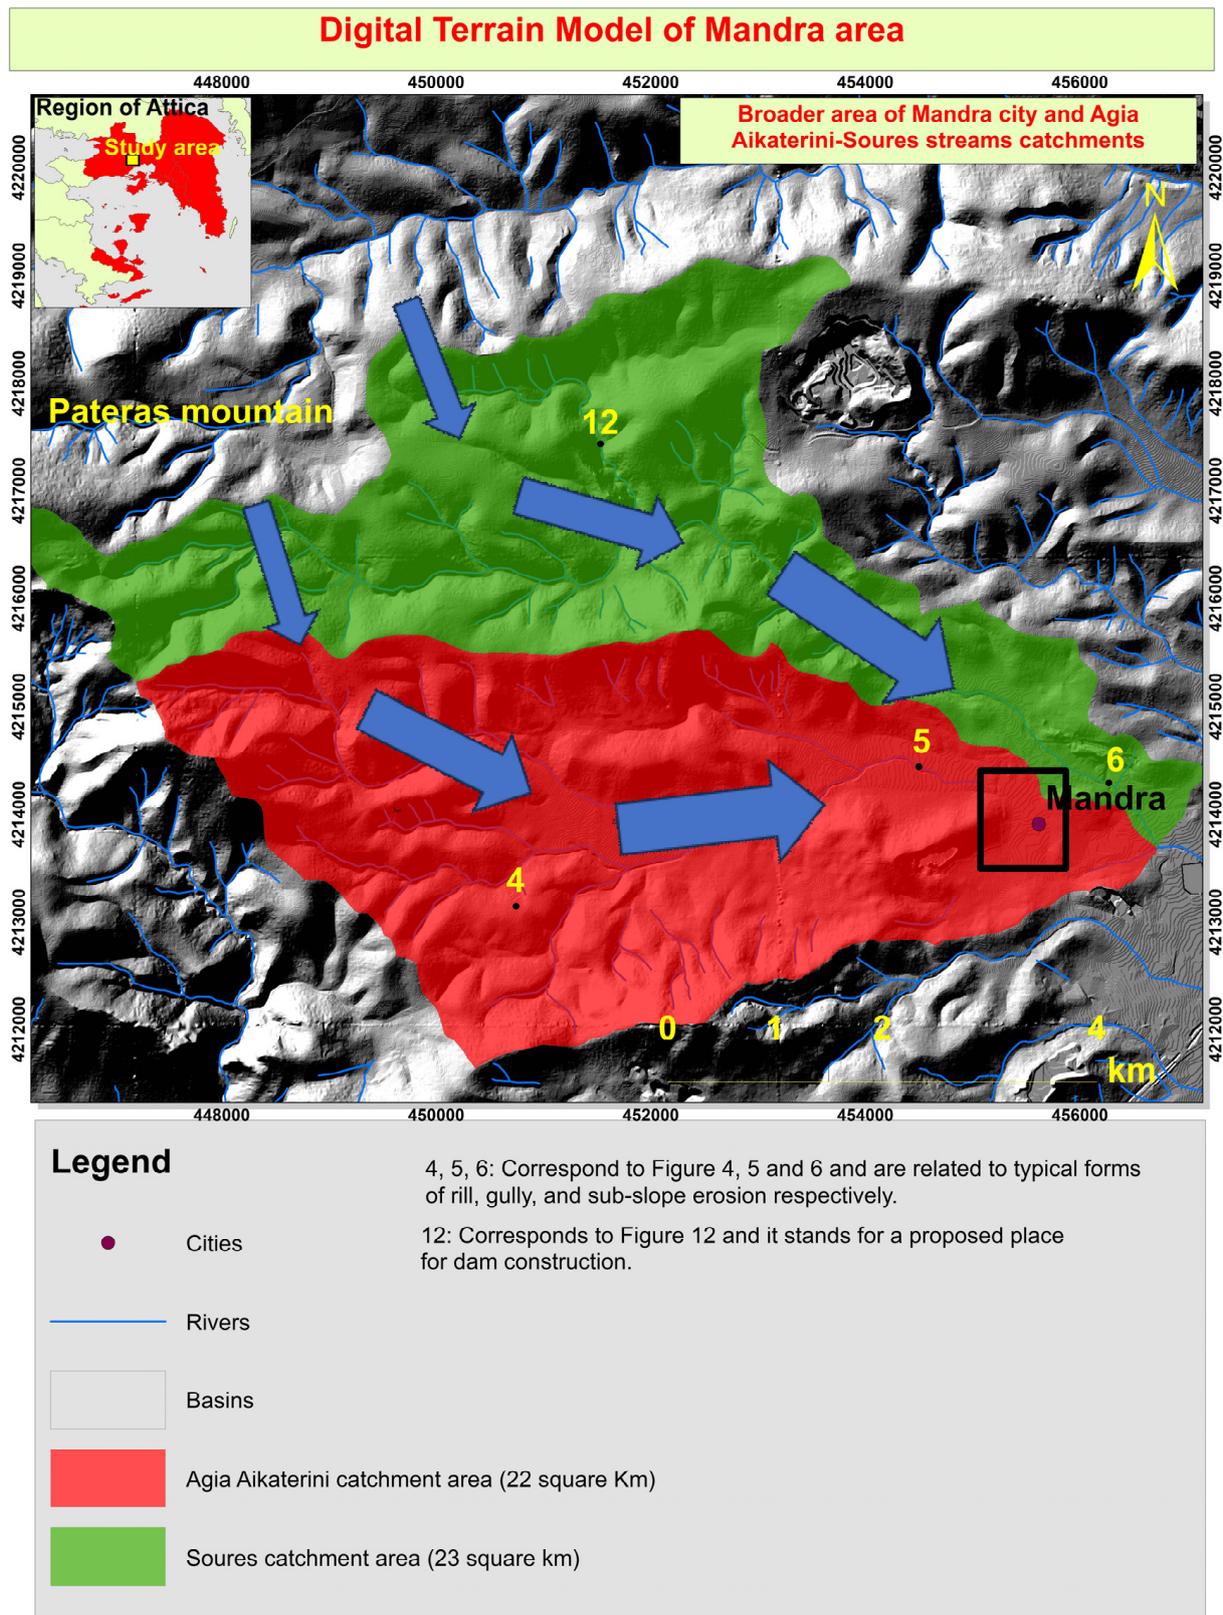
**Figure 1.** The case study of the Mandra fatal flash flood (2017). The boundaries of the catchment areas in the wider study area are presented “Adapted with permission from Ref. [61]. 2018, Regional Authority of Attica/Directorate of Technical Works, H.S.G.M.E.”. The flooded area of Mandra city is depicted in a rectangular shape. In addition, the characteristic paths of the water and debris flow row from the upper part of the Pateras Mountain towards the Mandra city are appeared by blue arrows.

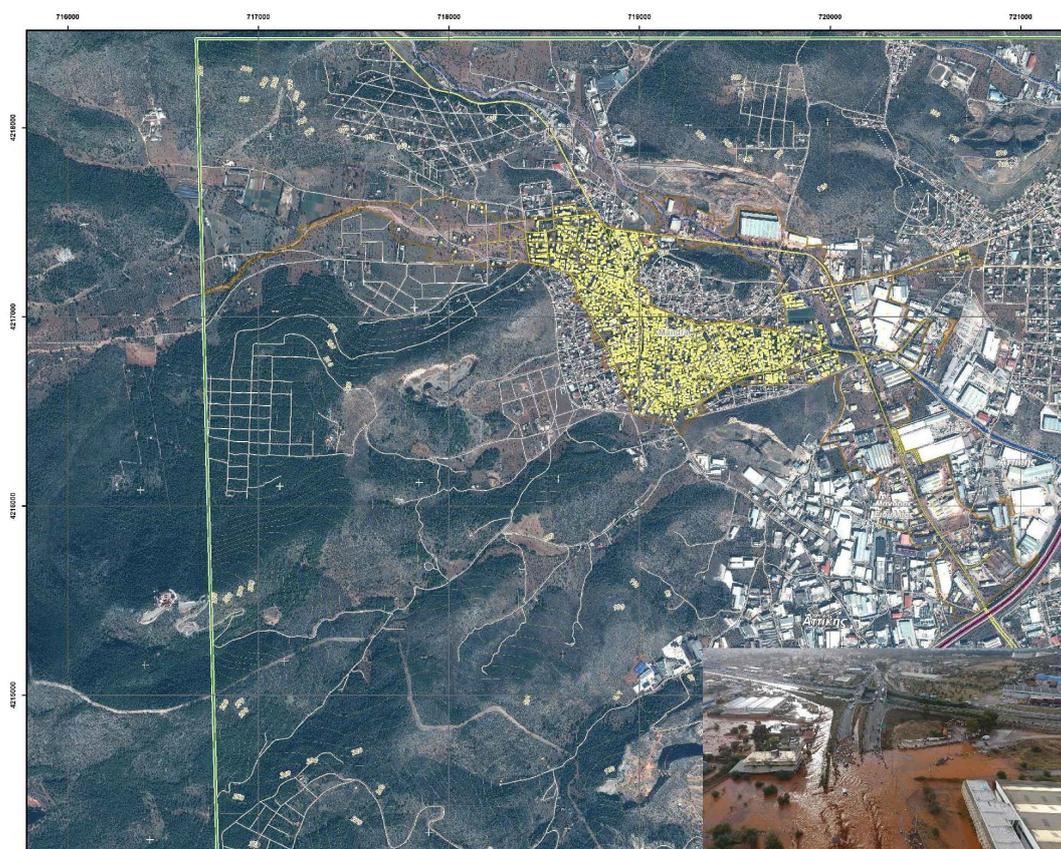
**Figure 2.** Two views from the study area. A picture of the broader area of Mandra city is depicted, “Adapted with permission from Ref. [63]. 2017, Copernicus Emergency Management Service Mapping” and on the bottom right a characteristic view of the flooded Mandra–Elefsina road “Adapted with permission from Ref. [64]. 2017, Newsletter of Environmental, Disaster and Crisis Management Strategies Issue No 5, Hellenic Republic National & Kapodistrian University of Athens”.

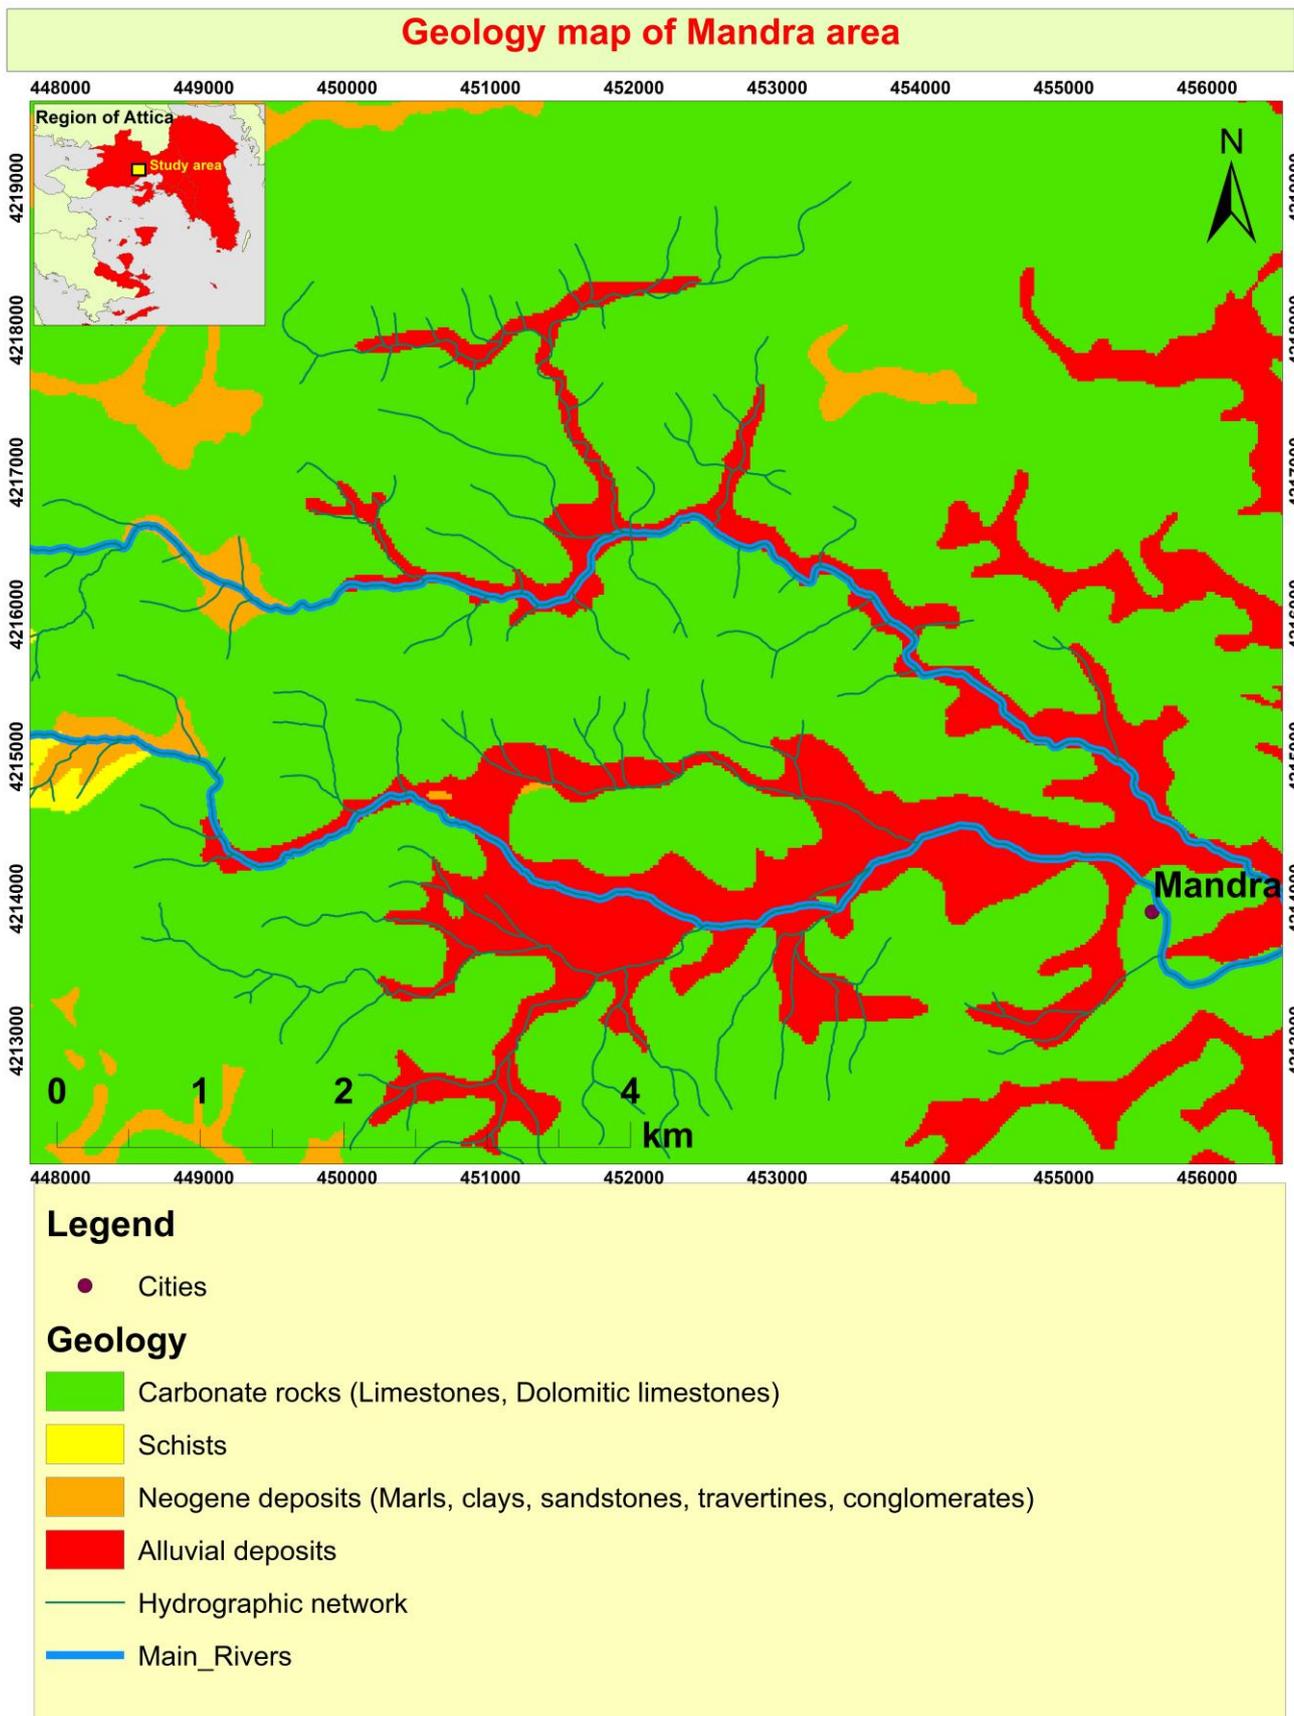
Figure 3. Geological map of the Mandra area.

The main lithostratigraphic characteristics of the formations found in the study area, listed from the most recent to the oldest, are as follows: (a) alluvial deposits; (b) modern lateral deposits; (c) old alluvial deposits; (d) marls, clays, sandstones, travertines, marly limestones and conglomerates; (e) limestones; (f) dolomitic limestones [61]. In addition, the study area contains some faults and a well-developed hydrographic network. The geological mapping of the catchments of the two streams that run through and north of the settlement of Mandra have provided useful information about the geological formations, their specific physical characteristics and their tectonic stress. This information is decisive for determining the extent of the contribution of each formation to the creation of flood conditions and the increased supply of sediments of various sizes in the area. More specifically, the largest part of the catchments, which is the mountainous part, is made up of dolomites and dolomitic limestones, which are highly fragmented, resulting in crumbling and mantles of alteration. The fractures and foliations of the fragmented rocks decrease their mechanical strength and increase their capacity to generate loose geomaterials, which lead to the formation of soil through the process of erosion. In addition, the erosivity of rainfall and runoff were the main causes for the loosening of the weathered mantle of decomposed–fragmented rocks, resulting in the weakening of the slopes and, as a result, leading to mass movements of solid and semisolid materials. All these materials can be easily eroded, and in the event of heavy rainfall they can provide materials for transport by water through streams.

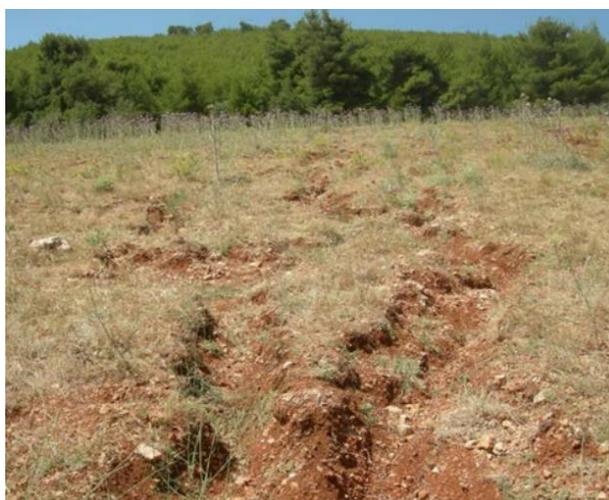
**Figure 4.** This photo shows rill erosion on Holocene deposits of the Mandra hydrological basin, and it is located in Figure 1 [67].

Rill erosion is the development of surface (sheet) erosion and is caused by the concentration of rainwater, which cannot percolate down to the subsoil, in small soil cavities, which progressively overflow and form irregular longitudinal surface runoff [61]. As the volume of runoff gradually increases, both the carrying capacity of the already extracted material and the potential for new material to be extracted along the water path increase. The erosive power of water depends on the volume, velocity, and rate of supply of surface runoff, slope gradient and soil erodibility. This creates many small and shallow (<1 m) rills that follow the direction of the maximum slope of the soil surface, forming water flow axes of usually triangular crosssections. The resulting sedimentary material is coarser than that produced by surface erosion and consists mainly of medium-sized gravels and coarse sand. The development of rill erosion in the catchment area of Mandra is particularly pronounced in areas structured by the engineering geological unit of Holocene deposits, where vegetation is also absent (Figure 4).

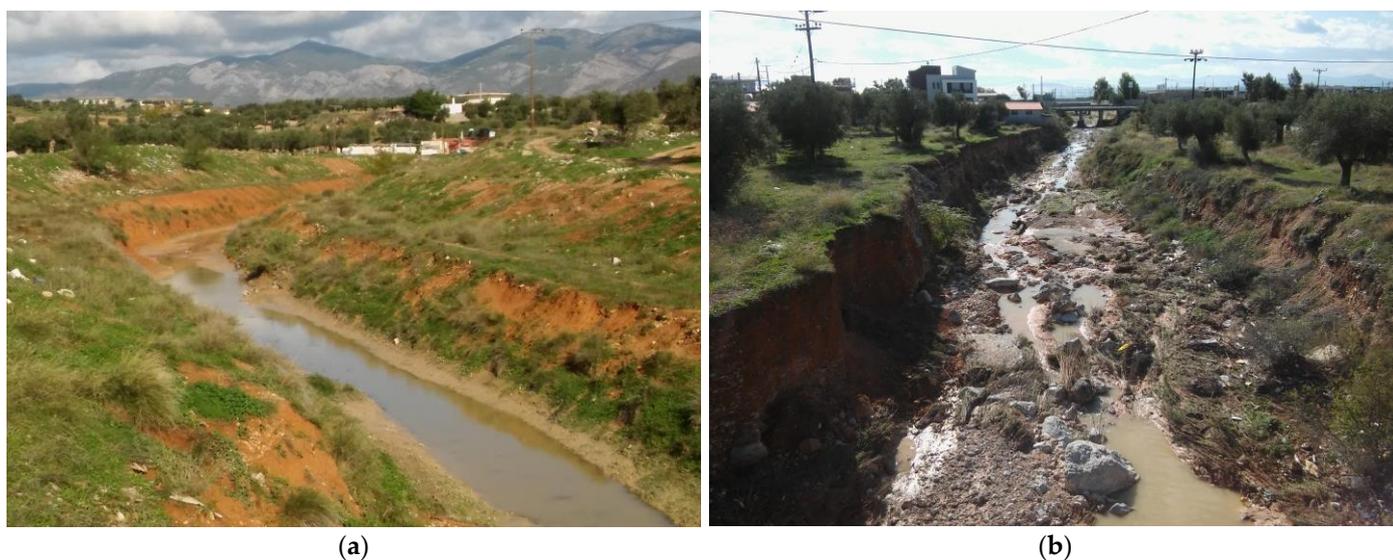
**Figure 5.** These photos (a,b) show typical forms of gully erosion developed on Holocene deposits of the Mandra hydrological basin also shown in Figure 1 [67].

(e.g., Agia Aikaterini and Soures), intense trench erosion developed after the heavy rainfall that occurred on 15 November 2017, which contributed significantly to the production of fine and medium-sized sediments. Gully erosion developed in the upper and mainly middle elevations of the two basins, especially along valleys with a strong gradient, where the increased water volume significantly increased its erosive energy. Typical forms of gully erosion in the Mandra catchments are shown, which were developed mainly within the Holocene deposits (Figure 5).

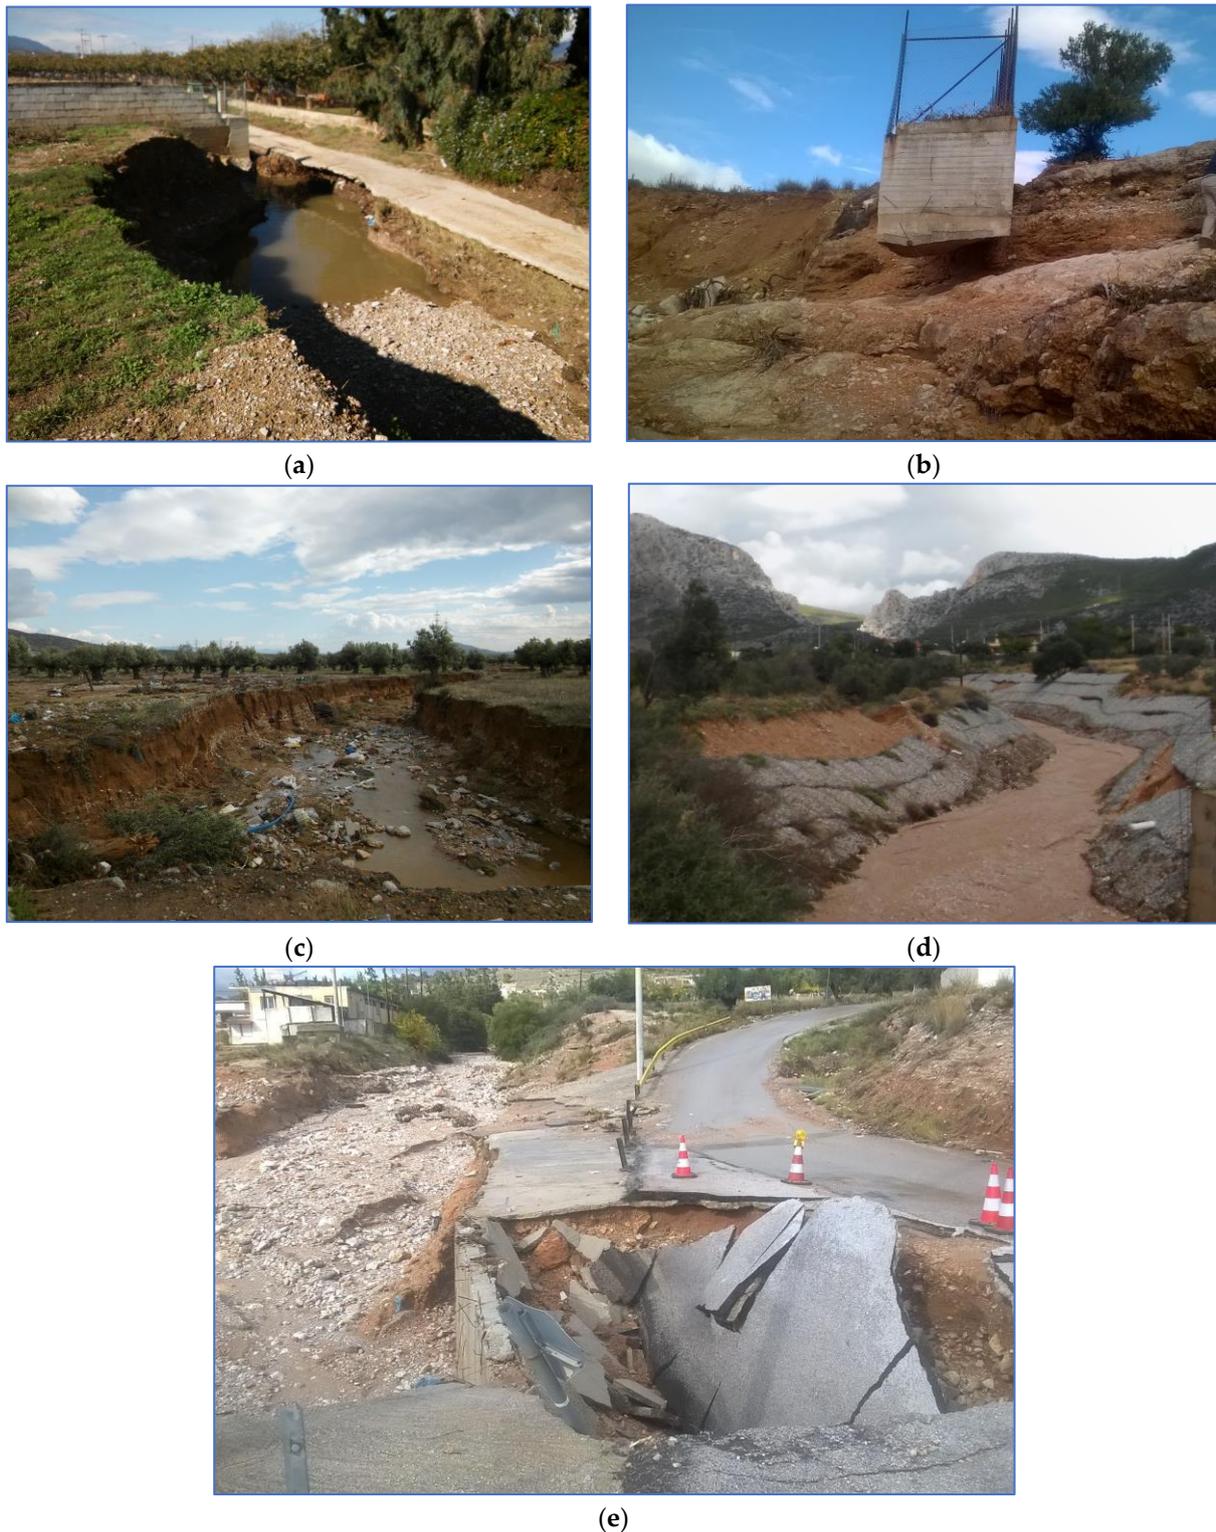
**Figure 6.** Those photos (a–e), show typical forms of slope and subslope erosion developed on Holocene deposits of the Mandra hydrological basin, and they are also shown in Figure 1 [67].

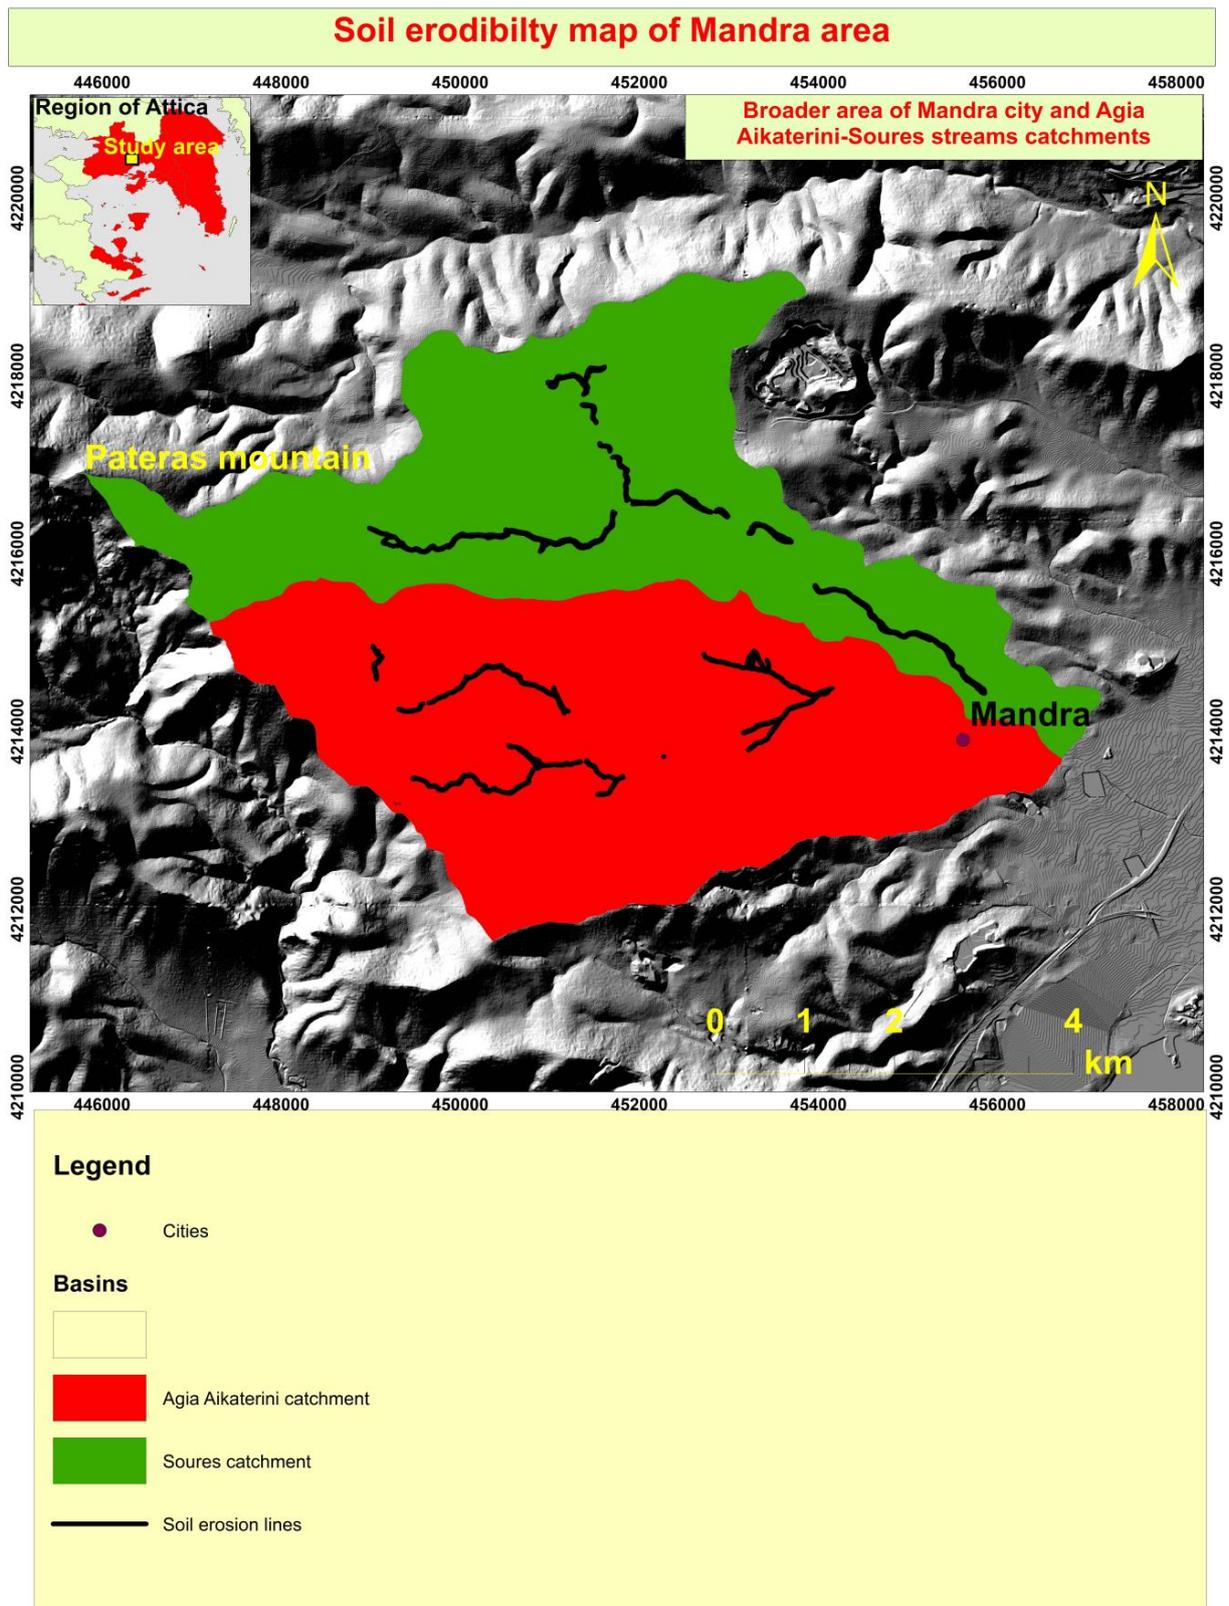
**Figure 7.** Soil erodibility map of the Mandra study area. Soil erosion lines were generated by the synthesis of three individual maps: (a) the engineering geological map, (b) the vegetation map, and (c) the morphological (slope) map “Adapted with permission from Ref. [61]. 2018, Hellenic Survey for Geology and Mineral Exploration (H.S.G.M.E.)”.

Concerning the first map, the engineering geological map examined and classified the formations that structure the area, according to their lithological composition and hydrogeological behavior. The influence of tectonics was considered using the existing hydrographic network. Geological data were taken from the literature and are supplemented by field surveys. For the soil erodibility map, the roles of lithological composition, infiltration capacity and permeability were considered.

Finally, considering the third (morphological/slope) map, the value of the slope was set as 5%, because this value is mentioned in the literature as the limit of the processes of deposition of fractional materials under conditions of diffuse flow (mudflow) and sedimentation on the surface of the earth (creation of cones of craters). The slope map distinguishes between areas with a slope of more than 5%, where erosion processes are more intensive, and areas with a slope of less than 5%, where erosion processes are less severe [61,68].

Thus, the susceptibility to erosion of the geological formations of Mandra was assessed based on the observations derived from technical geological mapping of the erosion phenomena observed and recorded in the wider catchment area (from technical site investigations in 2017 [67], 2018 [61], 2022 [62]), combined with the physical and mechanical characteristics of the geological formations. The grading of the units was carried out based on their physical and mechanical characteristics and estimated permeability.

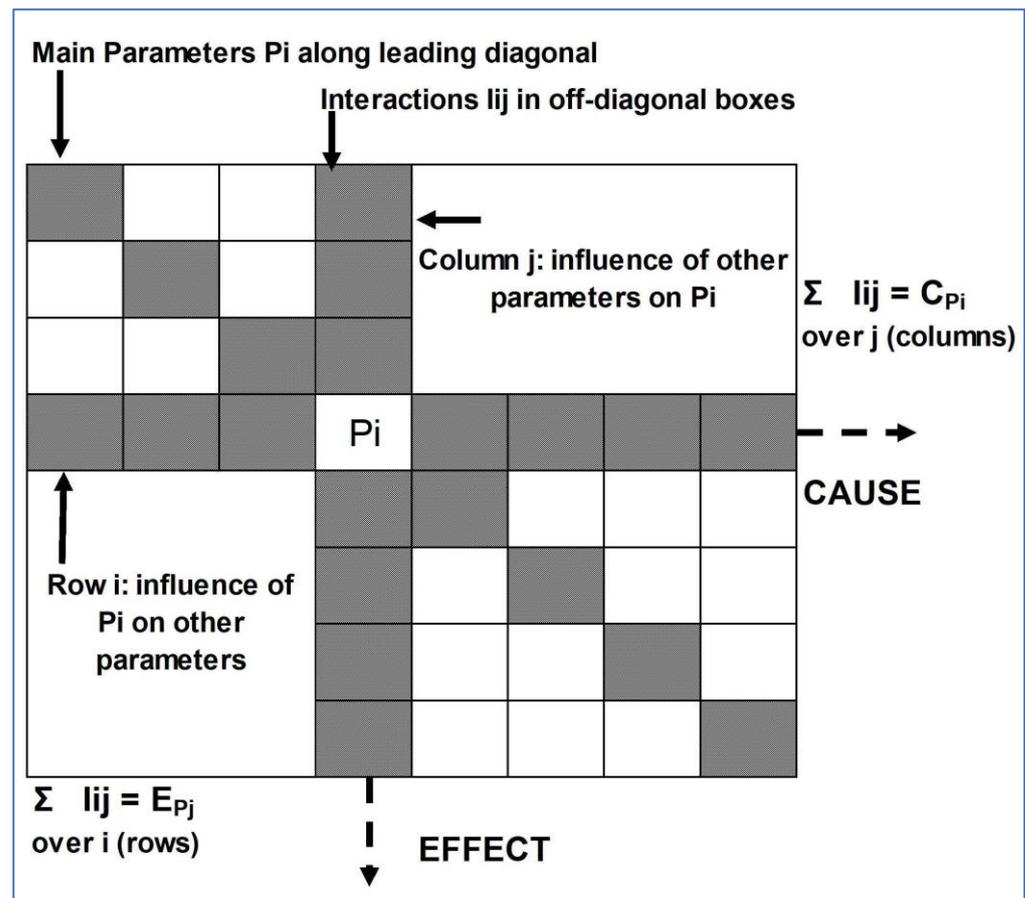
Figure 8. RES interaction matrix table [72,74,75].

This approach is mainly based on the correlation of mechanisms between landslide parameters through a matrix table and uses slope failure factors that can potentially be identified during the preparation phase of a civil engineering project. The purpose of using RES is to generate a landslide susceptibility map after the estimation of a landslide instability index [54]. RES is a semiquantitative approach, and the principal tool for representing the selected parameters and their interaction mechanisms (Figure 8). It is based on a matrix that depicts the key parameters as leading diagonal terms, and their binary interaction mechanisms as off-diagonal terms. The RES was developed by Hudson in 1992 [72] to determine the interaction of different rock engineering parameters and calculate the instability index for rock slopes. Since then, it has been applied to different aspects of geotechnical engineering such as rock stability problems, landslide susceptibility analysis and rock engineering [73]. Thus, by implementing the RES methodology, experts select the most important causative and triggering factors responsible for slope failures, rate their interactions, estimate their weighted coefficients, and calculate the instability index of the examined slope.

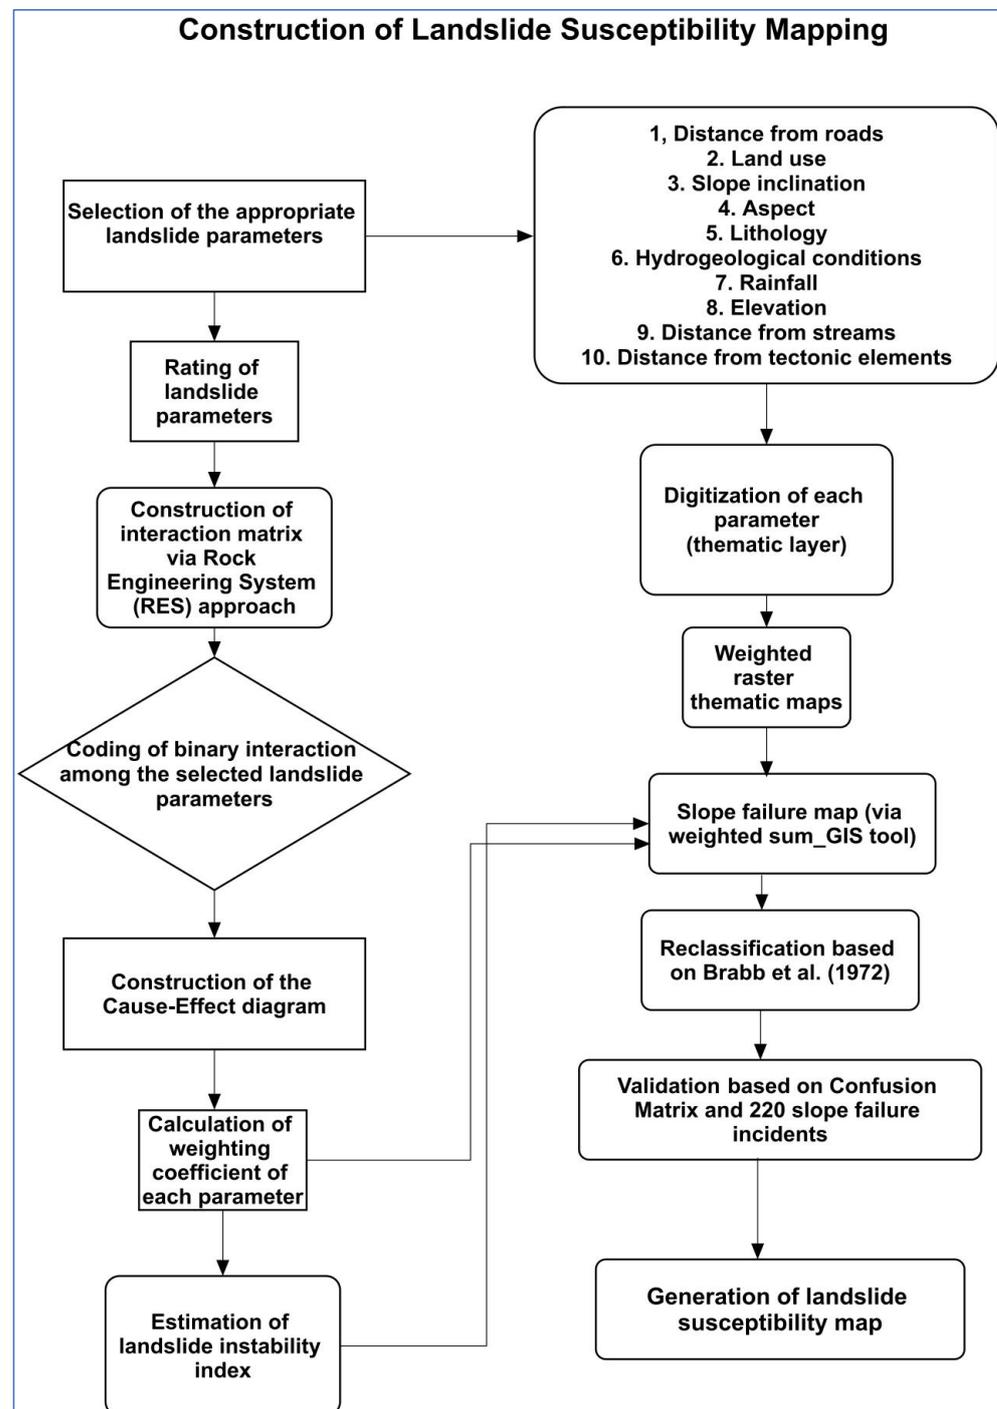
**Figure 9.** The overall methodology used for the compilation of the landslide susceptibility map of the Attica Region.

the main conclusion is that the higher the LSI is, the more susceptible the area is to landslides (instability index higher than 70%). The overall methodology is depicted in Figure 9.

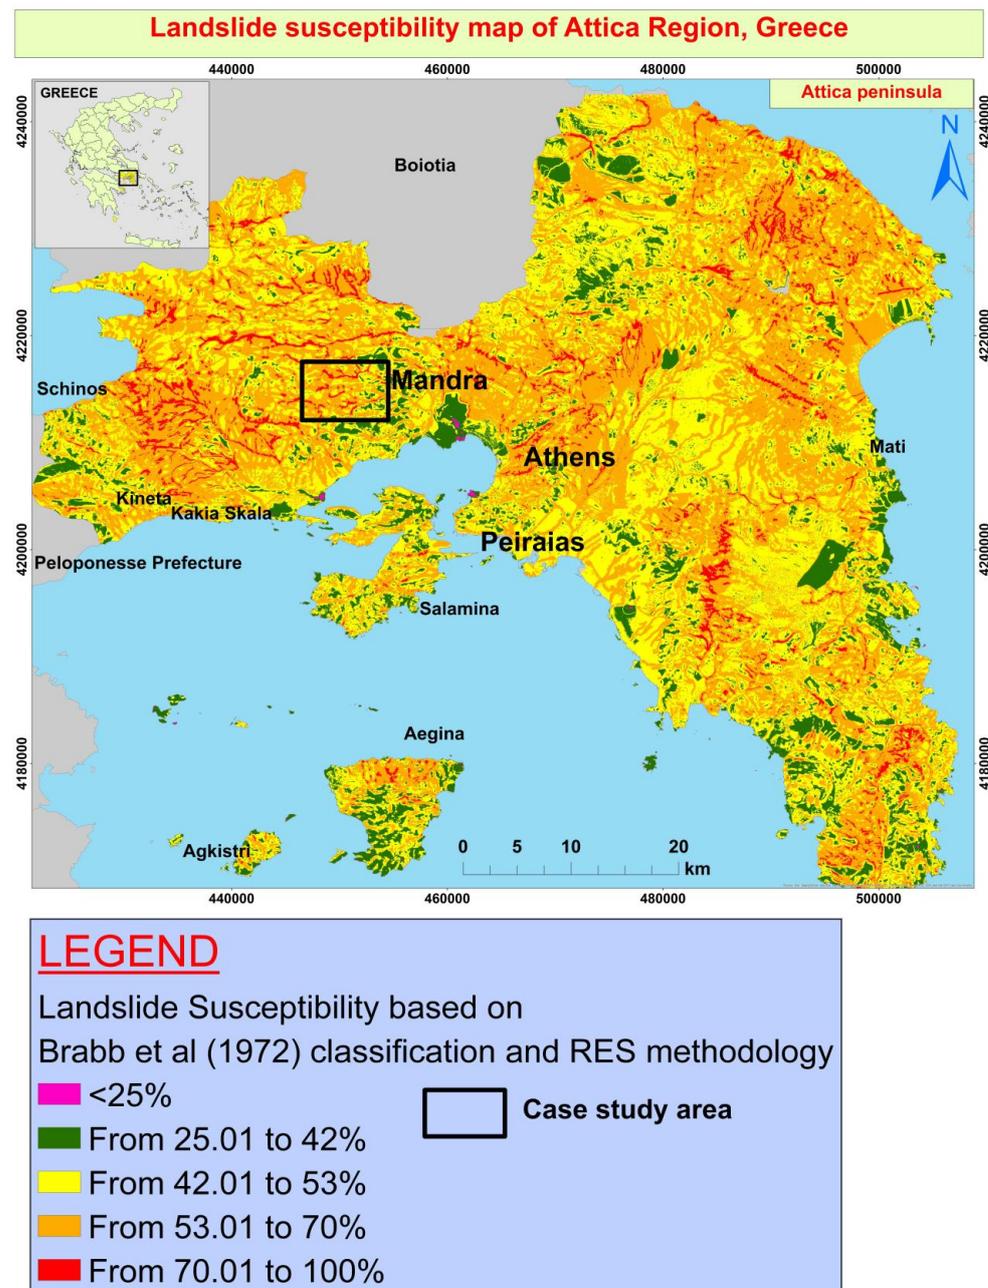
**Figure 10.** Landslide susceptibility map of the Attica Region. The landslide susceptibility index (LSI) values in the susceptibility map were classified into five categories [76]: “Low–Middle”, with instability

index ( $I_i$ ) < 25 (light green color zone in the map), “High” with  $25 < I_i < 42$  (green color zone), “Very High” with  $42 < I_i < 53$  (yellow color zone), “Extremely High” with  $53 < I_i < 70$  (orange color zone), and “Landslide” with  $I_i > 70\%$  (red color zone), [54]. The area inside the black rectangular scheme corresponds to the present study (Mandra area).

The landslide susceptibility map generated for the entire county of the Attica Region is shown in Figure 10. The map has been validated using a confusion matrix and 220 slope failures [54].

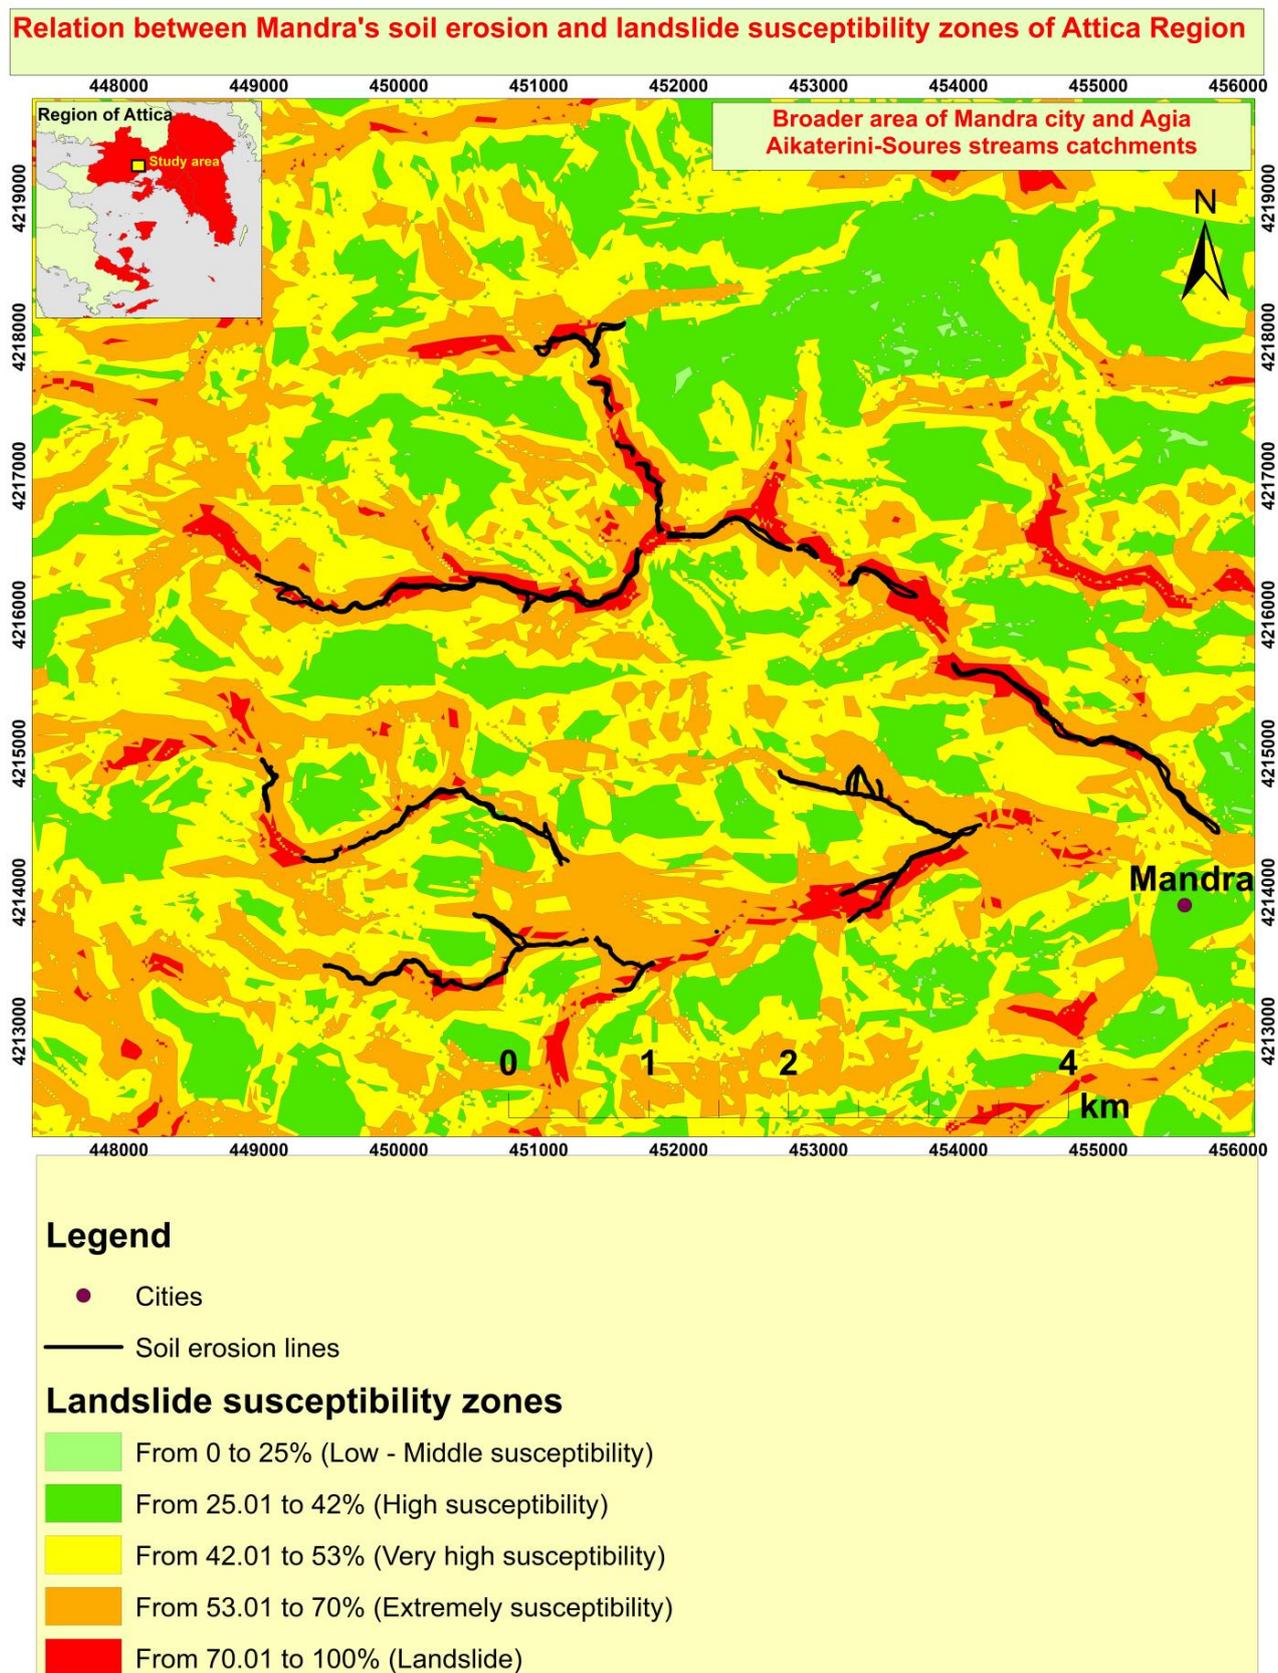
**Figure 11.** Close-up of the area depicted in the rectangular shape on the previous (landslide susceptibility) map. Relation between soil erosion lines in black and the “High”, “Very High” and “Landslide” susceptibility zones.

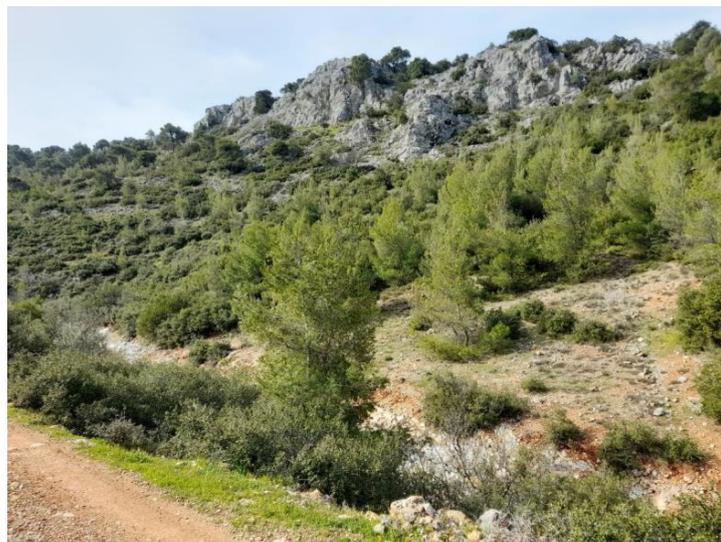
**Figure 12.** From a characteristic broader view of the Mandra area, a partly soil erosion-degraded area (located west of the capital city of Athens, Greece) where a small dam is going to be constructed to cope with future (flash) flood events [80].

Particularly, given that the purpose of the interventions is to reduce flood risk and prevent catastrophic events, it was considered appropriate to limit the proposed measures to small dams, which are mainly of a preventive nature and aim to manage runoff effectively. These measures were considered to be the most appropriate proposal for the area, at least because they meet the requirements of being as cheap as possible and having a very short implementation time. To be more specific, the types of recommended dams are as follows (Figure 12):

- (a) The sediment barriers are intended to be between 3 m and 8 m high, with a reinforced concrete or unreinforced concrete construction material. The purpose of these dams is to counteract the axial erosion of the bottom of the streambed, by reducing the drag force of the water and retaining the sediment;
- (b) Construction of graduation dams—slope stabilization—these dams are proposed to be made of concrete (reinforced or unreinforced) or of reinforced wire mesh (e.g., sarsenet). The construction of the dams will be carried out either in places where there is evidence of gradual erosion, or in places where there is axial erosion of the bottom of the bed, in combination with the abovementioned sediment barriers. The height of these dams according to the theoretical assessment carried out is proposed to be between 1 m and 2 m.
