Field Survey of 2018 Typhoon Jebi in Japan: Lessons for Disaster Risk Management

Abstract: Typhoon Jebi struck Japan on the 4 September 2018, damaging and inundating many coastal areas along Osaka Bay due to the high winds, a storm surge, and wind driven waves. In order to understand the various damage mechanisms, the authors conducted a field survey two days after the typhoon made landfall, measuring inundation heights and depths at several locations in Hyogo Prefecture. The survey results showed that 0.18–1.27 m inundation depths were caused by Typhoon Jebi. As parts of the survey, local residents were interviewed about the flooding, and a questionnaire survey regarding awareness of typhoons and storm surges, and their response to the typhoon was distributed. The authors also mapped the location of some of the containers that were displaced by the storm surge, aiming to provide information to validate future simulation models of container displacement. Finally, some interesting characteristics of the storm surge are summarized, such as possible overtopping at what had initially been thought to be a low risk area (Suzukaze town), and lessons learnt in terms of disaster risk manag

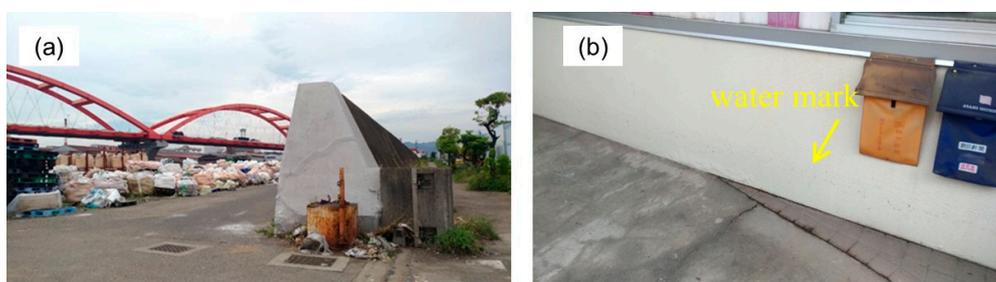
Mikageishi town at Higashinada ward, located at the easternmost side of Kobe City, is mostly composed of residential zones. The coastal defenses in the area is made up of a levee with a flood gate situated at the entrance of the port storage zone (Figure 6a). The gate was built in 1969 and has a length of 10 m and height of 1.4 m, and was closed at the time when the typhoon made landfall. No significant damage could be observed during the field survey, even in the port storage area situated outside of the gate. Nevertheless, one watermark (0.20 m from the ground) was found on the exterior wall of a residential structure (Figure 6b), approximately 200 m away from the flood gate. The authors interviewed a local resident regarding the flooding in this residential area, who reported that the water came from a nearby overflowing river (approximately 30 m away) and receded relatively quickly. Water in a pool near the water mark was found to have only 0.2% salinity. Considering these facts, the authors concluded that there was a high probability that the area suffered from fluvial flooding rather than a direct storm surge attack.

Figure 6. Photographs taken by the authors at Mikageishi town. (a) Coastal levee and gate at the entrance of the port storage zone; (b) Survey Point M1 (watermark is indicated by a yellow arrow).

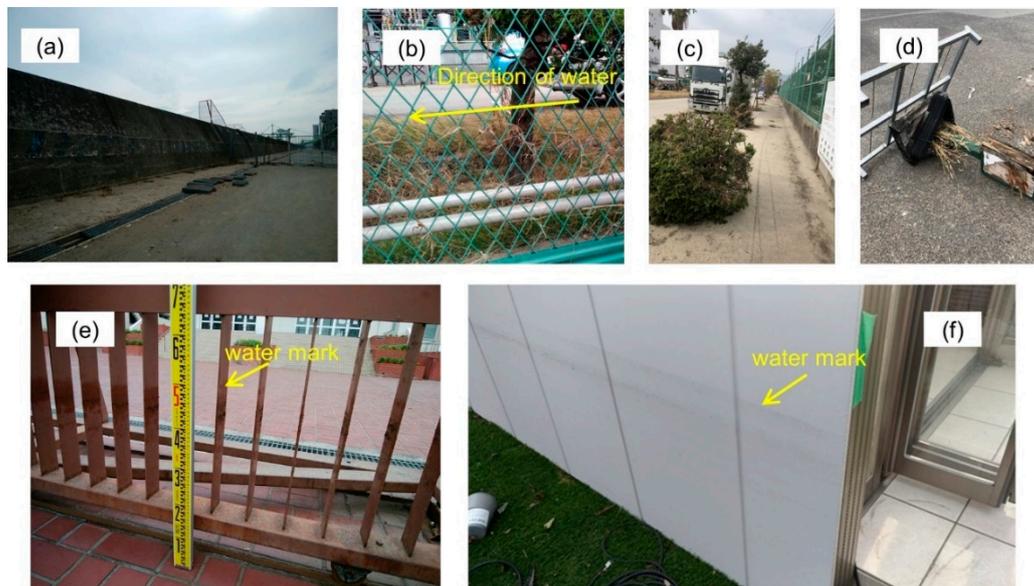
Fukaehama town is also located at Higashinada ward, east of Mikageishi town, with the reclaimed land next to the coast being mainly dedicated to industrial use. The area is protected by an approximately T.P. +5.4 m high dike [15] (Figure 7a).

Three measurements were taken in this area: (1) the fence of an oil factory plant (F1); (2) the gate of a high school (F2); and (3) a model house in front of a department store (F3). The presence of debris at the fence of the oil factory plant, which were measured to be at a height of 1.27 m above the road, showed that the direction of water was towards inland (i.e., south to north; Figure 7b). Other debris, such as uprooted trees and road signs that drifted with the water flow, were observed around the area during the survey (Figure 7c,d), though they could also have been scattered due to the high wind. Significant inundation heights were also measured at a high school (Figure 7e) and a model house (Figure 7f), as shown in Table 2. Although it is still not clear whether the dike

was overtopped by the storm surge or wind-driven waves, the observations indicate that the current level of coastal defenses could not completely protect this district from inundation.

Figure 7. Photographs taken by the authors at Fukaeahama town. (a) Coastal dike at Fukaeahama town, (b) Survey Point F1 indicates that the direction of debris was towards the inland, (c–d) Presence of debris at Fukaeahama town, (e) Survey Point F2 (watermark at school gate), (f) Survey Point F3 (watermark at a model house).

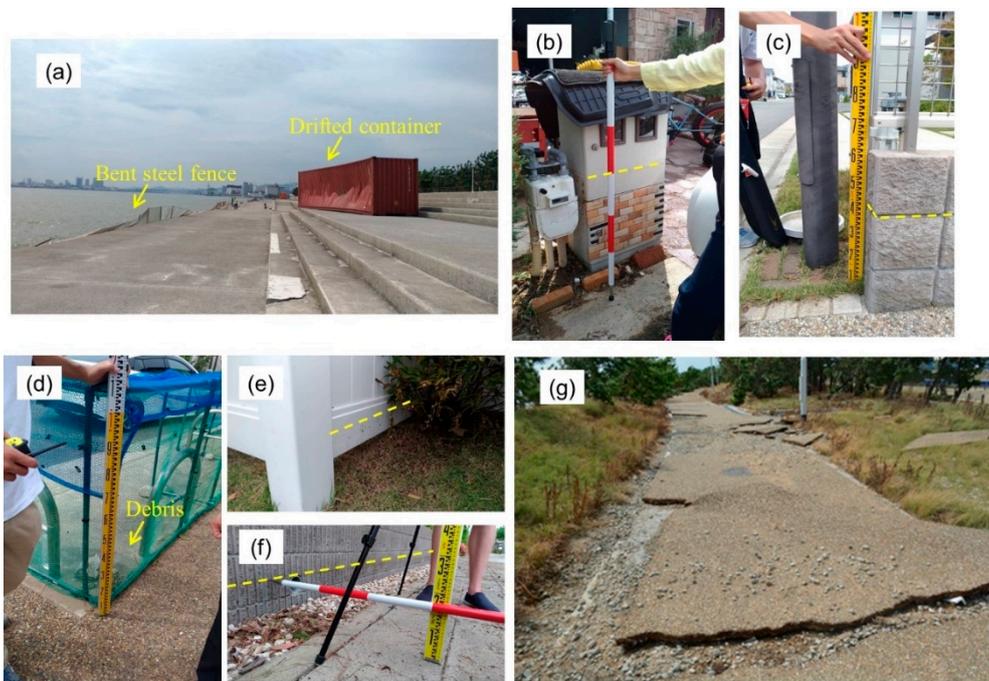
Although the area is protected by a high embankment with a crest level situated at approximately T.P. +5.6 m [15], relatively significant inundation took place. Shipping containers also drifted to the water front of this area, though none of them were found on the landward side of the embankment (i.e., residential area). A newspaper article [16] reported that a local resident had heard the sound of containers as they collided with the embankment. The pedestrian steel railings at the water edge of the embankment was bent towards the land side, probably due to the collision with the drifting containers (Figure 8a).

The five survey points (S1–5) are shown in Figure 8b–f. The maximum measured inundation depth was 0.64 m around the ground close to the sea (at Point S1), ranged from 0.33 m to 0.42 m at other points (S2 to S4) in the middle section of this community, and dropped to 0.18 m at the last survey point (S5). After correcting for tide levels, this represented levels of T.P. +3.78 m to +4.84 m. The pedestrian road near the top of embankment was severely eroded (See Figure 8g), and much sand was transported into the residential area (in fact, the authors observed that the transported sand was being cleaned while they conducted the survey). The locals whom the authors interviewed reported that a power outage took place after the water invaded the residential area.

Overall, the results indicate that the embankment height was not sufficiently high to protect the area against the flooding brought about by Typhoon Jebi. It is interesting to note that the sea water overtopped the road embankment (which had an elevation of T.P. +5.6 m), despite the fact that the maximum water level recorded at Osaka and Kobe tidal station were T.P. +3.29 m and +2.33 m, respectively. Based on field observations and the reports of local witnesses, this overtopping could have been caused by a combination of a storm surge and associated high waves. Local witnesses reported very strong winds in Suzukaze town before the seawater overtopped the embankment. Thus, the storm

surge height around this point should have been relatively high. However, as the measured inundation depths are not so large, the authors think that the storm surge height (tidal level) might not have exceeded the height of the embankment. Therefore, seawater intrusion to the landside area could have occurred due to a combination of an already high tidal level and wind waves, resulting in waves running up the slope of embankment and therefore overtopping it. However, in order to clarify this mechanism, it will be necessary to conduct a detailed numerical simulation of the storm surge, and to also consider the effect of wind waves.

Figure 8. Photographs taken by the authors at Suzukaze town. (a) Damaged steel barrier and drifted shipment container at the embankment; (b–f) Survey Points S1–S5, respectively (watermark is highlighted with a yellow dashed line); (g) Eroded pedestrian road near the coastal embankment.

to reconsider re-evaluating risk potentials in not only Suzukaze town, but perhaps also in other areas that have been previously considered to have minimum risks. The possible wave overtopping at Suzukaze has introduced a degree of uncertainty in currently available storm surge hazard maps around Osaka Bay. Reassessing the vulnerability and risk management at the local and regional scale would undoubtedly help in addressing the concerns and uncertainty left by Typhoon Jebi.

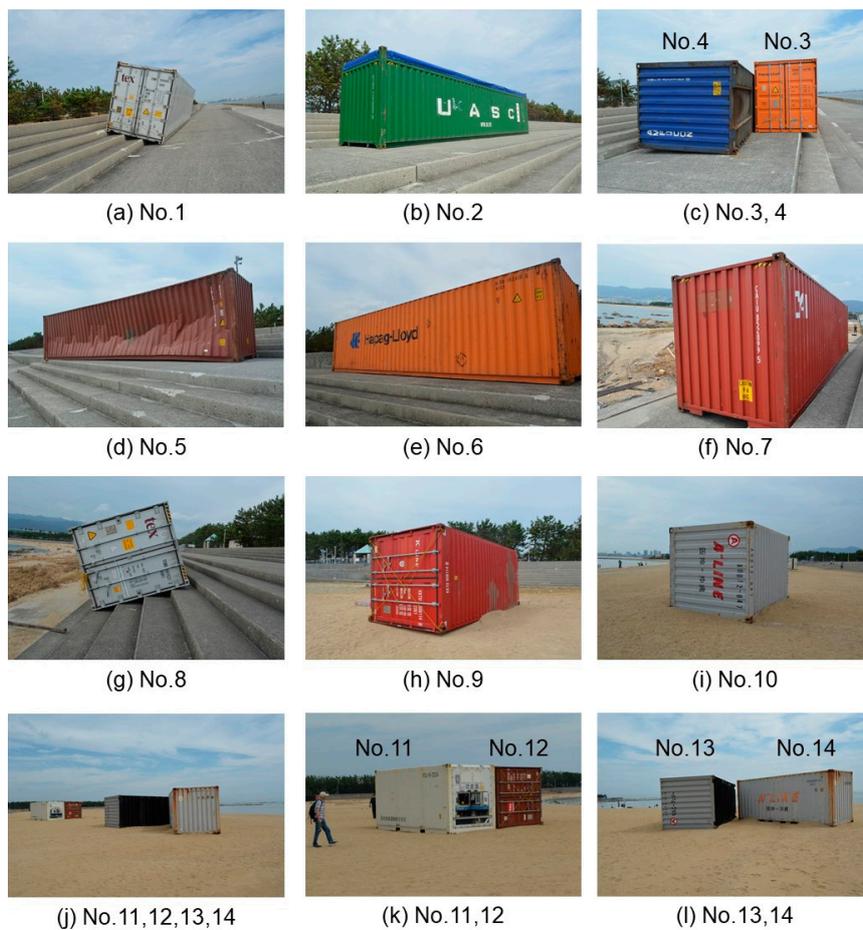
Figure 10. Photographs of the displaced containers. The numbers correspond to the identification numbers of each container shown in Table 3.
