Landslide Event on 24 June in Sichuan Province, China: Preliminary Investigation and Analysis

Abstract: This paper reports on a massive landslide event, in which 8 million cubic meters of earth and rocks slid down from the top of a mountain in the village of Xinmo, located in the county of Maoxian, in the province of Sichuan, China, on 24 June 2017. This landslide resulted in 10 fatalities and 73 people were reported as missing. This paper details the preliminary investigation, the joint-force rescue activity, and the analysis of the nearby topography, rainfall, and seismic fracture zone. The combined effects of large amounts of rainwater, steep topography, deep-seated sliding interface, and significant altitude difference between the highest point of the mountain and the Xinmo villagers' houses are considered as the main influencing factor that triggered this landslide event. To develop geological disaster-prone areas in the future, four main recommendations to reduce casualties and environmental impacts are provided in this paper.

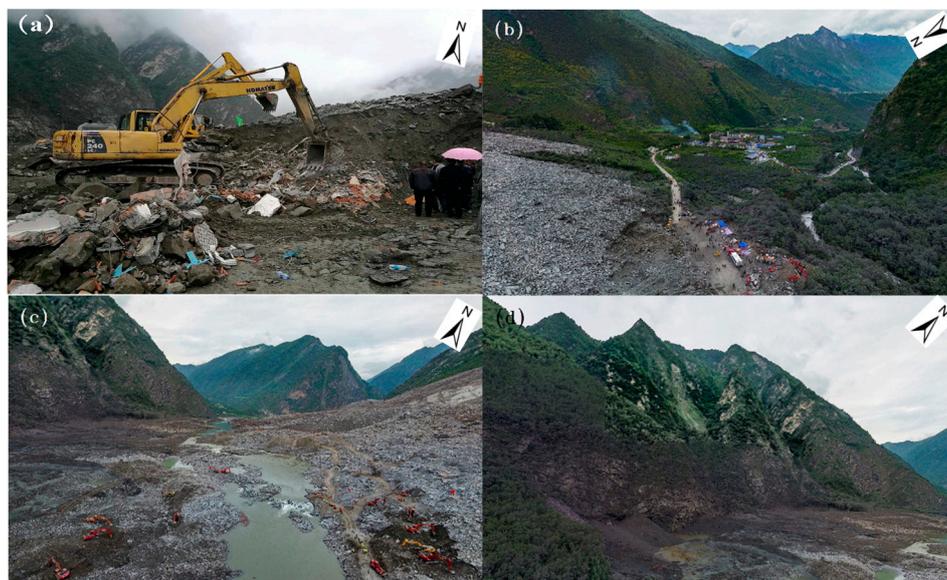
- Part A was the source of the landslide. The slope exposed after the landslide mainly ranged from 55 to 70 degrees, and the depth of the sliding interface reached about 60 m. A width of 350 m, a length of 450 m, and an average depth of about 23 m made up a volume of 3.6 million cubic meters.
- Part B slid down under the influence of Part A, and it has a relatively gentler slope angle ranging from 25 to 35 degrees. An average width of 360 m, a length of 945 m, and an average depth of about 14 m made up a volume of 4.8 million cubic meters.
- Part C received the earth and rocks slid from Part A and Part B. The villagers' houses at the toe of this slope and the Minjiang River were thus buried (see Figure 5a,b) and clogged (see Figure 5c,d).

Figure 5. Close view of the landslide site: (a) Excavators involved in the rescue operation. (b) Houses not affected by the landslide, and the set-up of the rescue operation headquarter. (c) River being dredged after the landslide. (d) Debris of the landslide accumulated at the foot of the mountain.

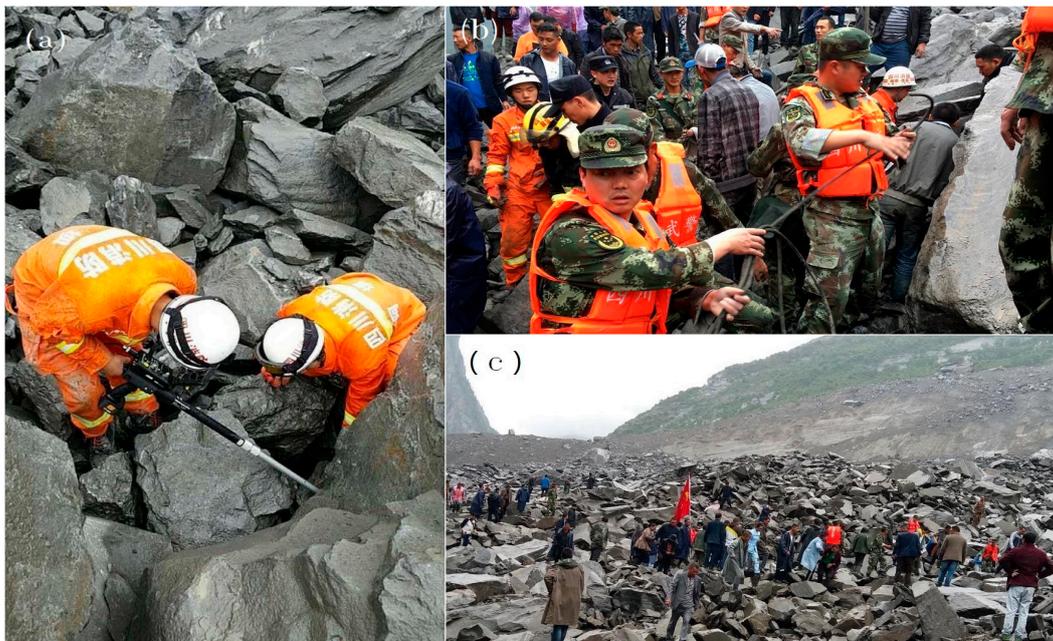
Figure 6. Joint-force rescue activity. (a) Firefighters who are detecting signs of life. (b) Armed police involved in the rescue. (c) People involved in the rescue.

vehicles (UAVs) attended the joint-force rescue activity and played a leading role in excavating and investigating the distress area. As shown in Figure 6, cobbles and gravels hurled by the landslide body, with a weight exceeding 100 kN piled up at the lower landslide body, which brought about considerable difficulty in undertaking rescue works. In addition, a secondary landslide hit the disaster site at 11 a.m. on 27 June 2017. Fortunately, the displacement was monitored by a slope synthetic aperture radar (S-SAR) [36,37,41], and the operators ordered an evacuation prior to the landslide event, resulting in no further casualties. The rescue lasted about a week, with 3 people rescued and 10 bodies recovered. One hundred fifty-four tourists were safely transferred to other areas unaffected by the landslide. The total cost for this rescue operation was difficult to estimate, as all the rescuers and machineries involved in this rescue came from various parts of the country, but is estimated to cost in the tens of millions (US Dollars). In addition, another 412.1 million RMB (60.6 million USD) has been planned to invest into the reconstruction.
