Article

Lake Nyos, a Multirisk and Vulnerability Appraisal

Abstract: Situated at the northern flank of the Oku Massif, Lake Nyos crater epitomizes landscape features originating from volcanic explosions during the Quaternary. The Cameroon Volcanic Line (CVL), to which it belongs, constitutes the most active volcanic region in Cameroon. In 1986, an outgas explosion occurred from beneath the lake and killed 1746 people in several neighbouring villages. The event influenced a radial area of 25 to 40 km wide, particularly in eastern and western direction. This was mainly due to: (1) the rugged nature of the landscape (fault fields), which enabled the heavier gas to follow valleys framed by faults corridors without affecting elevated areas; and (2) the seasonal dominating western wind direction, which channeled the gas along tectonic corridors and valleys. This paper assesses the geological risk and vulnerability in the Lake Nyos before and after several proposal to mitigate future outgas events. Remotely sensed data, together with GIS tools (topographic maps, aerial photographs), helped to determine and assess lineaments and associated risks. A critical grid combining severity and fr

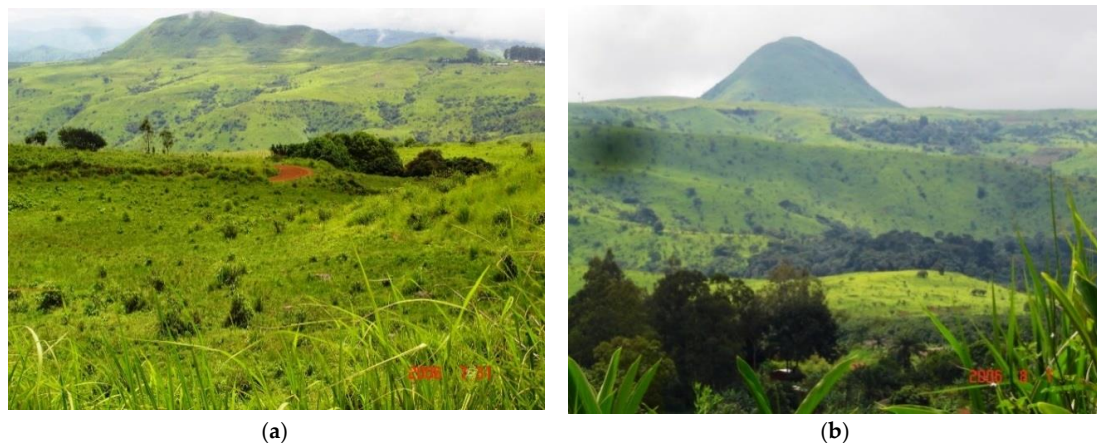
Figure 5. (a,b): The Nkambe basaltic plateau on the Ndu volcanic ridge. A stratovolcano eruptive cone at the left, and a volcanic dome overlooking the plateau at the right (August 2006).

The Ndu Volcanic Ridge (Figure 5A,B) that shelters Lake Nyo occupies the central position among the continental sector volcanoes of the Cameroon Volcanic Lines. Oku Mountains (3011 m a.s.l.) volcanism ranges from 31 Ma to 1 Ma [29]. The Ndu Volcanic ridge is characterized by a well-defined spectrum of rocks including basalt, mugearite, hawaiiite, trachyte and rhyolites in various proportions. The Oku Volcanic Field contains numerous small basaltic scoria cones, craters and maars including the Lake Nyo maar. The pyroclastic deposits constituting this maar's dam result from explosive volcanic or ultra-volcanic eruptions.

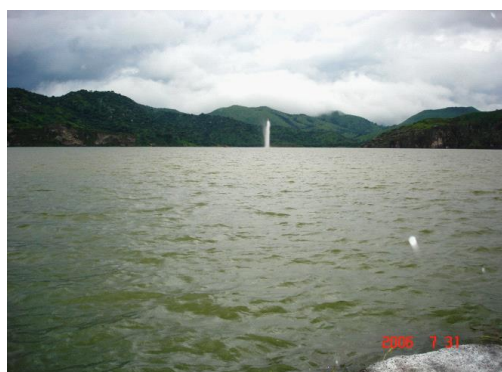
Figure 16. Lake Nyos degassing process (Source: fieldworks, July 2006).

Many polyethylene pipes, with an internal diameter of 102 mm for Lake Monoun and 140 mm for Lake Nyos, were used. As the depths of Lakes Monoun and Nyos at their deepest points are 100 m and 210 m, respectively, the intake depth of the pipe was set at 73 m at Lake Monoun and 203 m at Lake Nyos [51,52]. The water flow rates reach 70 and 50 L/s for Lakes Nyos and Monoun, respectively, resulting in an impressive fountain (Figure 16). The water jet rising and succeeding on the surface reaches 48 m in height propulsion over the platform [51]. This water is supersaturated, and consists of pure CO₂ [15].

As far as Lake Nyos is concerned, the gas removal rate by a single pipe was too low and was insufficient to reduce the gas content to a safe level within several years [10,11,52]. Two additional degassing pipes were added at Lake Nyos in late 2011 and early 2012 using funds from the EU to increase the degassing rate, and the water intake depth was deepened to 207–209 m, only a few meters above the lake bottom. However, the two additional degassing pipes have significantly increased the gas removal rate and helped to attain a safe level by 2015 [53,54]. As of today, due to these three large polyethylene degassing pipes that were installed in the lake, a total amount of the former 600,000 tons of CO₂ that was initially found in the lake before the degassing process (Figure 16) has been removed, reducing the risk of future gas explosion.

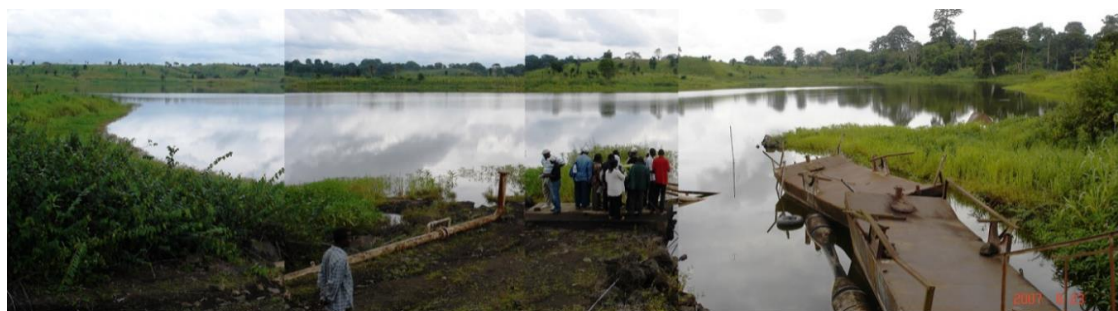
Figure 17. Lake Mamy Water with water rich in phosphorus. It is pumped by the plantations of Upper Penja (PHP) to water the banana, pineapple and papaw plantations, etc. (Source: Tchindjang, August 2007).

What could be the future expectations of scientists on this lake and others in Cameroon? The future lies in prevention. There are at least 39 lakes of volcanic origin distributed along the Cameroon Volcanic Line (CVL) [19,20,74], among which, some remain potential sites of limnic eruptions. Understanding the origin and the geochemistry of CVL magmas is essential. Apart from Nyos and Monoun, Lake Mamy Water located at 40 km north of the Douala City is potentially dangerous. A phreato magmatic eruption might have occurred one night in 1950. The survivors left the village, claiming that the goddess of water (hence the name Mamy Water given to the lake) was angry. This lake (Figure 17) is rich in phosphorus and nowadays, the *Plantations du Haut Penja* (PHP) pump the water from the lake (very rich in phosphorus) to water the banana, papaw and pineapple plantations of Njombe and Penja.
