# Review of Potential Risk Factors of Cultural Heritage Sites and Initial Modelling for Adaptation to Climate Change

Paul Carroll \* and Eeva Aarrevaara

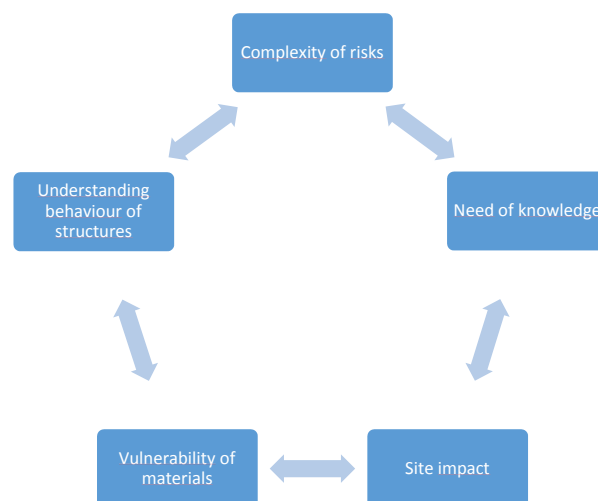
Figure 1. Elements having an impact on a practical-based model.

Then, by combining elements of the modelling methods outlined above, and illustrated in summary in Figure 1, the following scoring system from 1–10 (described in Table 2 above) is suggested as a means of evaluating the relative risks to different materials. The score in question can apply to either individual materials or to an entire structure or site, and takes into account both the vulnerability of the item in question and over how long a timescale potential damage to it may have an effect, as well as how severe this effect is likely to be.

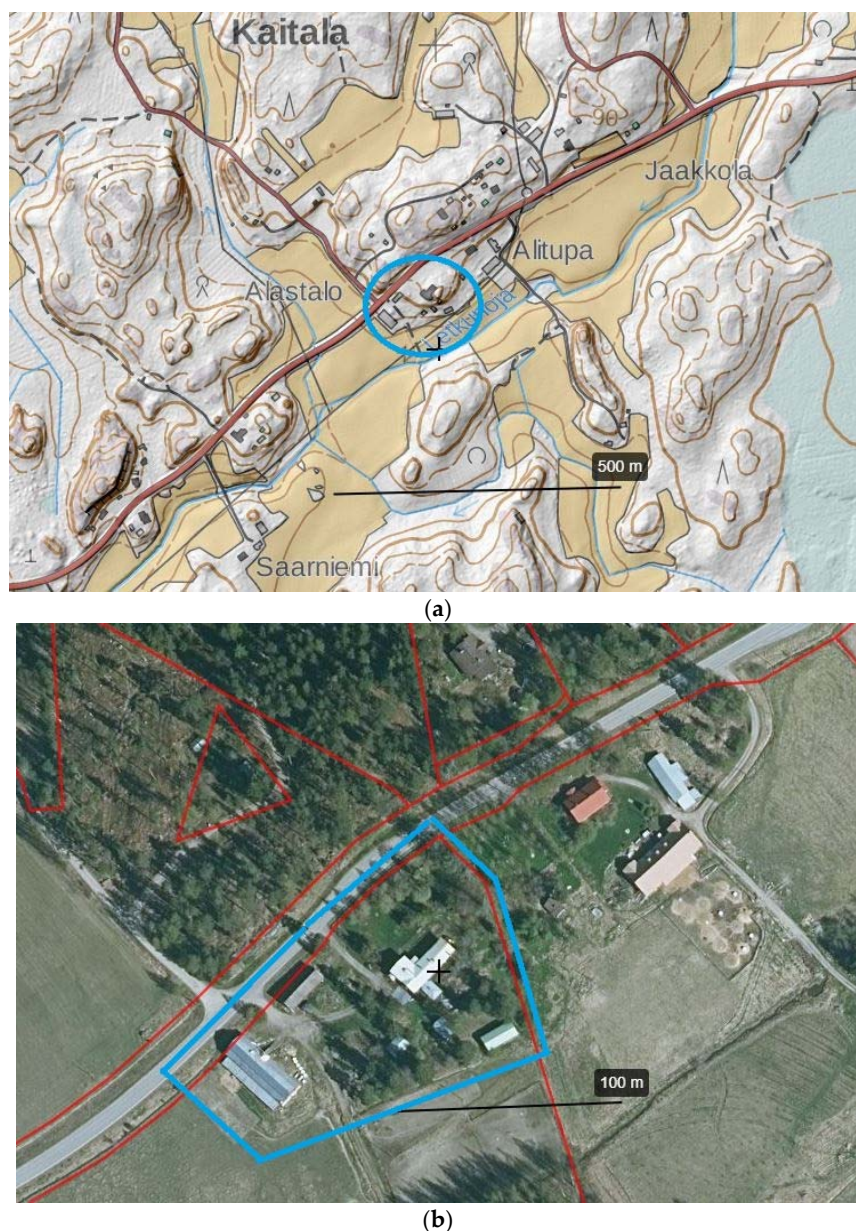
**Figure 2.** (a) The case study farm location in the village [20]. (b) Location of the case study buildings at the site [20].

As a case study, we present a Finnish farmhouse complex consisting of several buildings, the map location and aerial views of which can be seen in Figure 2a,b below respectively. The built environment is classified as part of a regionally valuable village and cultural landscape [19]. The residential building is built in several parts: the oldest part is a log construction from the 19th century and a two-storey addition was constructed in the 1930's with wooden frames. The façade consists of horizontal wooden panelling with double glazed windows. The residential building is situated on a hill and other buildings are on lower positions of the site or on slopes. Most of the storage buildings are also

horizontal log structures, except for a cow house built of cement brick in 1930. The roof materials are mostly steel and the largest storage hall has cement brick tiles. Similar traditional farmhouse complexes are quite usual in Finnish rural areas, and sometimes animal buildings are constructed of ordinary brick or granite stones. Natural granite stones have been used in the foundations of the residential building, but the stone surface has been covered with cement at a later phase. In the above table, the case study buildings and site are evaluated according to the proposed model and conclusions made dealing with the adaptability qualifications.
