Article

Deformation Modeling of Flexible Pavement in Expansive Subgrade in Texas

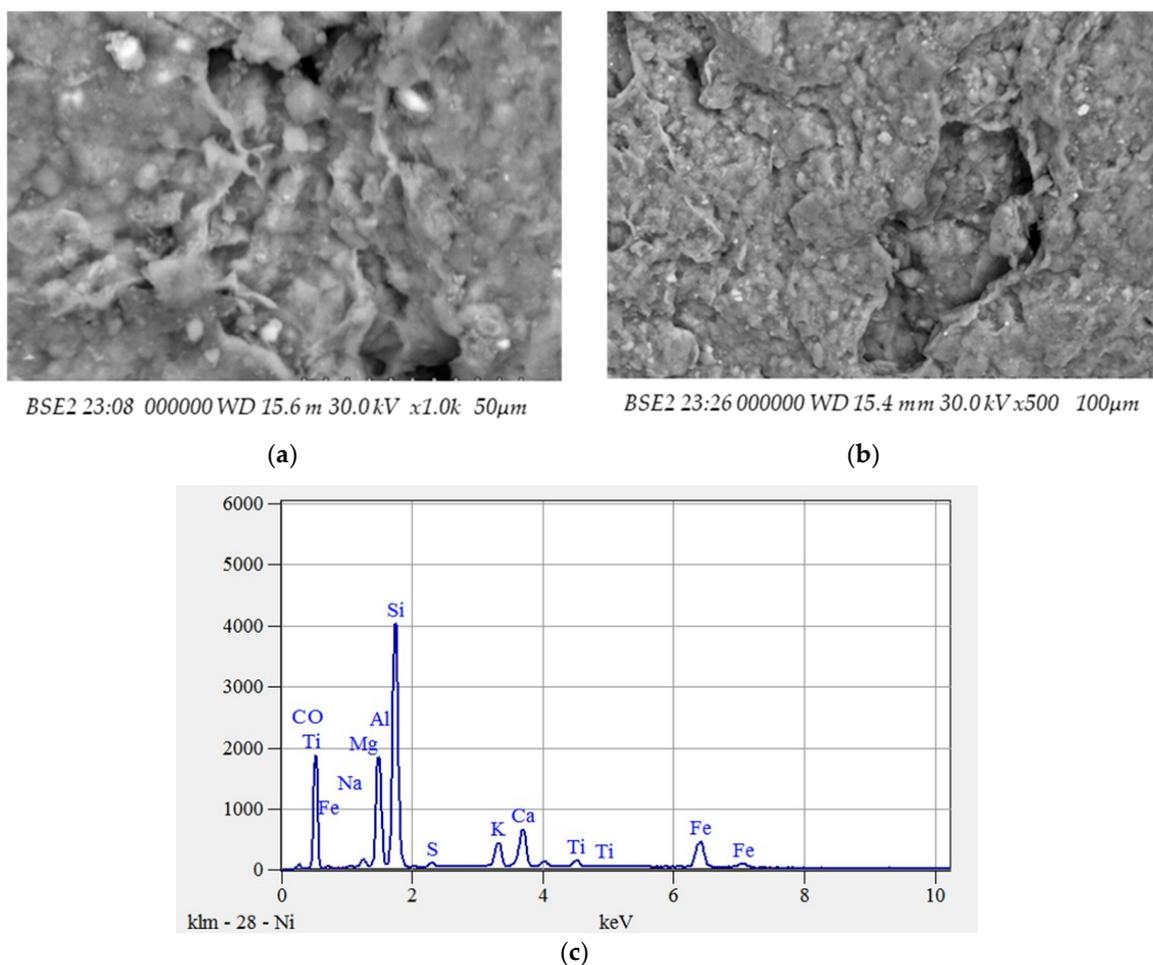
Figure 1. SEM micrographs of site soil at (a) 500 × magnification, (b) 1000 × magnification, and (c) EDX spectra of expansive soil (from several determinations).

Based on the SEM analysis, the soil sample exhibited typical expansive soil structure (Figure 1a,b). The resulting spectra (Figure 1c) exhibited ample amount of Silicon (data not presented) which is in well agreement with the expansive soil microstructure study of Reference [22]. In addition, the expansive soil morphology (Figure 1a,b) was also compared with previous studies and similarity was obtained with papers such as Reference [23].

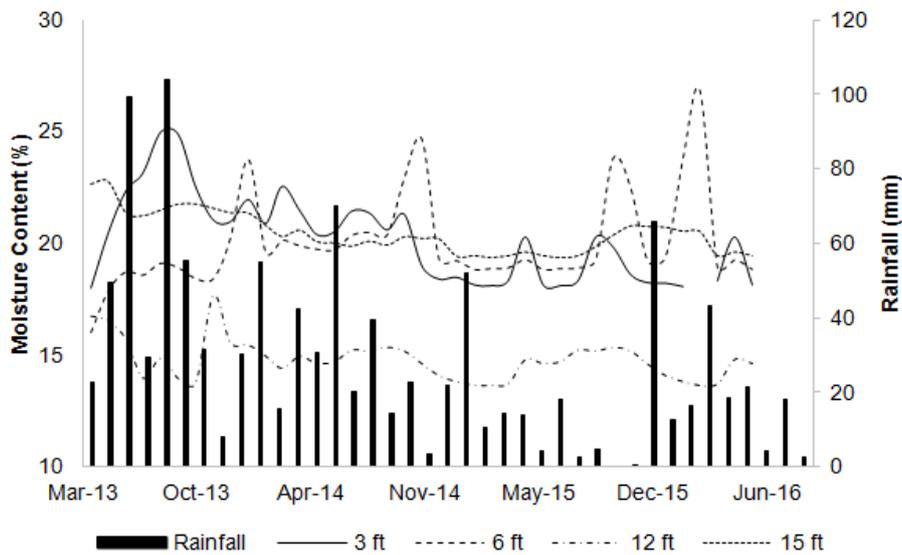
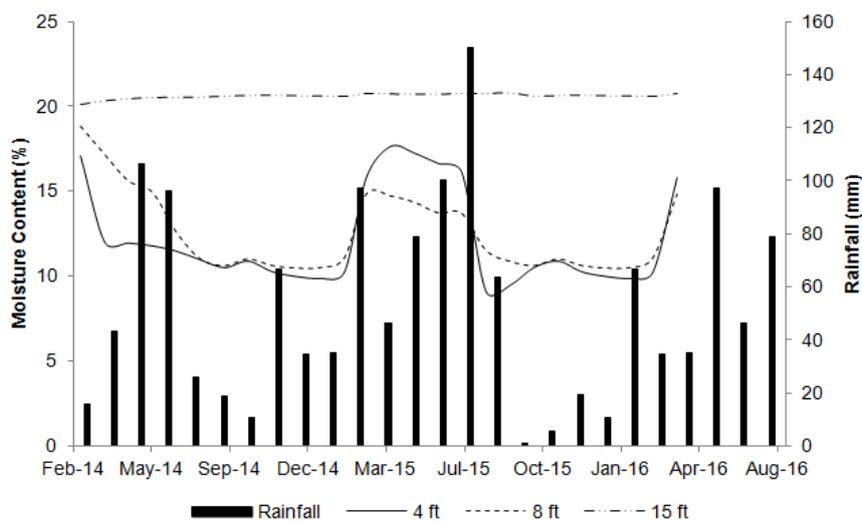
Figure 2. Moisture variation in (a) FM 2757 site and (b) SH 342 site.

Figure 2a depicts the variation of maximum moisture content in the borehole observed in the monitoring cycles. Highest moisture content was recorded at a depth of 6 ft and the lowest moisture content was recorded at a depth of 15 ft throughout the first phase. A similar pattern of moisture variation was observed for the remaining monitoring cycles. A minimal increase in maximum moisture variation curves was witnessed with the total rainfall as high as 4 inches from April to August 2013. The drop in maximum moisture curves was observed with decrease in rainfall. In general, the field monitoring results showed similar response to the rainfall events, the pattern of the maximum moisture variation curves and average moisture content values.

Figure 2b depicts the monthly change in average moisture content with the monthly cumulative rainfall for the sensors installed at different depth from 4 feet to 15 feet in the edge borehole. The change in moisture values with rainfall was observed for shallow sensors however, the deepest sensor exhibited constant moisture value of 21% throughout the monitoring period. The moisture variation at this level is restricted because of fully saturated condition. The observed minimal variation of moisture values for deep seated sensors is comparable to the observations made by References [24] and [13]. The sensors installed at 4 ft and 8 ft showed decline in moisture values in spite of the increase in precipitation by 3.6 inches. The sensor closer to the surface displayed 5% drop in average moisture values just from March to April while the deeper sensor exhibited gradual decrease. In August 2014, both the sensors data coincided with the 11% average moisture values. Moreover, the months from March to May in 2015 experienced increased rainfall events which resulted in increase moisture values up to 18% and 15% at 4 ft and 8 ft respectively. During summer 2015, the moisture values were dropped to 11% as recorded previously. The pattern was repeated again due to rainfall in March 2016 with the spike in moisture content.

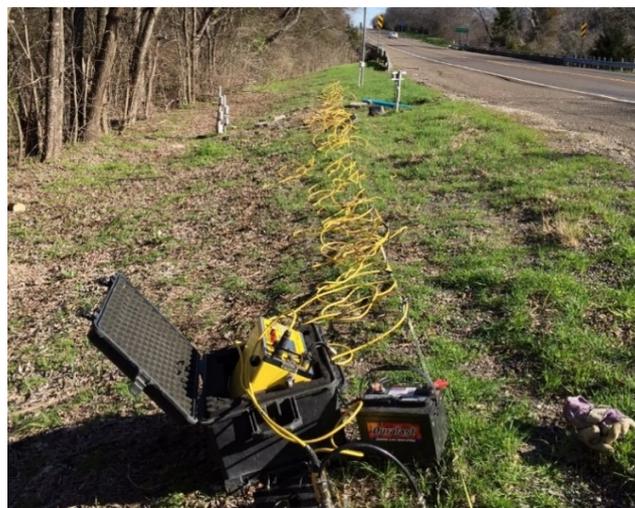
Figure 3. Resistivity set up at slope of SH 342.

The continuous image of the subgrade soil can be obtained with the Resistivity Imaging (RI) survey. The setup of the equipment is shown in Figure 3. It can produce moisture distribution at different levels and locations. Figure 4 shows the output from the resistivity imaging which can be interpreted with the resistivity values and its inverse relation to the moisture. The resistivity in the soil at different locations is indicated by the range of color from red to blue as seen in the figure. Higher resistivity corresponds to the low saturation while the lower resistivity represents the higher saturation in the soil. Figure 4a depicts the output from resistivity imaging performed during the months of May to October characterized by a high resistivity reading. This corresponds to the dry season of the year indicating more regions with less moisture. In contrast, the resistivity imaging performed during November to April which are the wet months gave image with low resistivity values as seen in Figure 4b. Moreover, RI was able to capture the area with cracks when performed immediately after the rainfall. In May 2016, the RI showed a region of low resistivity as seen in Figure 4c which was high resistivity region previously. This indicated the weakest region of subgrade soil from where the moisture intrusion takes place into the pavement system and needs maintenance.

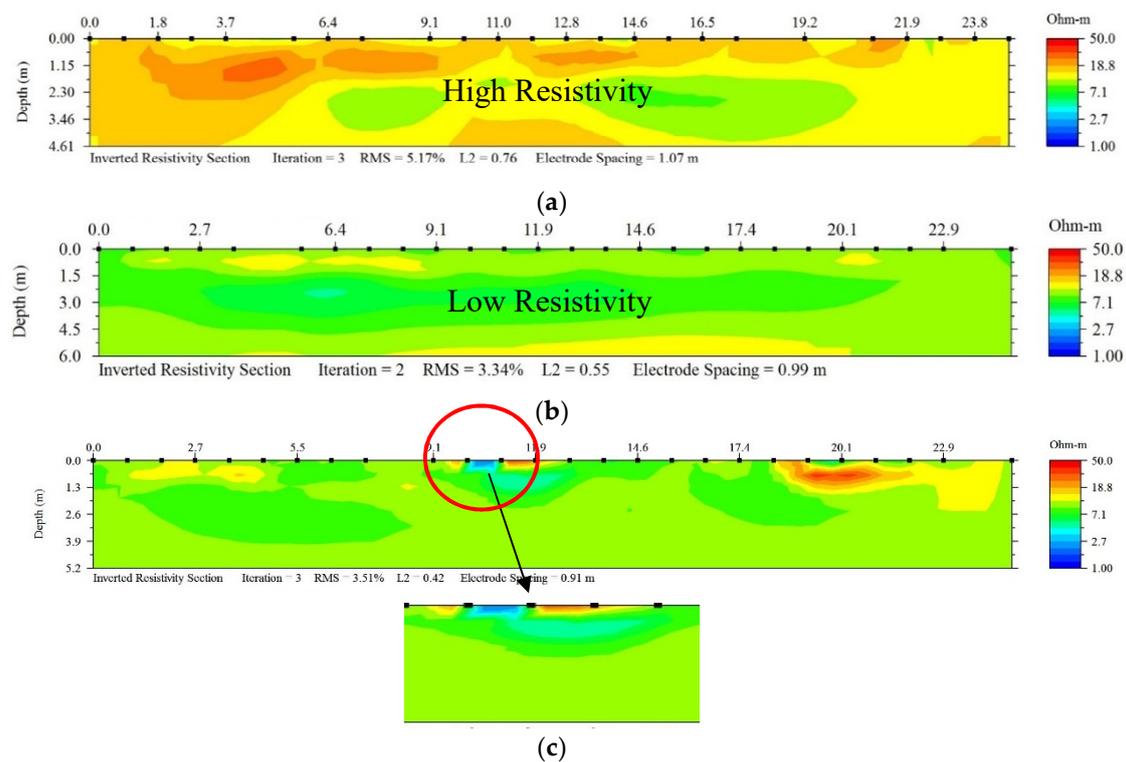
Figure 4. Resistivity variation in typical (a) dry period, (b) wet period, and (c) moisture intrusion through edge after rainfall.

The central section (at 12.8 m of Figure 4) of the resistivity profile was evaluated for one full cycle. Low resistivity of 7 to 13 Ohm m was observed between the months of November and April giving the high moisture values. This identified the period as the wet season. Reference [24] also identified the same period from November to April as wet period comparing the rainfall and evapotranspiration data. In the other hand, the dry season from May to October gave the resistivity value as high as 23 Ohm m. The moisture variation was found to follow the seasonal trend, which the moisture sensors were unable to capture. The resistivity does not seem to change significantly below 3 m identifying the depth as an active zone. This corroborates with the other studies performed in the same area which identified the depth from 3–3.66 m as an active depth [19]. Hence, the deformation is likely to take place in the active zone where the moisture and resistivity values changes during repeated drying and wetting period.

The D/H ratio of the trees in the State Highway was determined to be 0.91, with the height of trees approximately 34 ft and the distance of trees from the pavement cracks equal to 31 ft. Since the D/H ratio was close to 1, the site was experiencing the moisture depletion due to the presence of trees. With this, the summer period can be considered more critical when trees and grasses have more need for water and thus take up water from the soil resulting in desiccation of the expansive subgrade. This has also been observed in the result of resistivity imaging from May to July 2016. During this period, the resistivity has been found to increase, suggesting decrease in moisture content (Figure 4a,b).

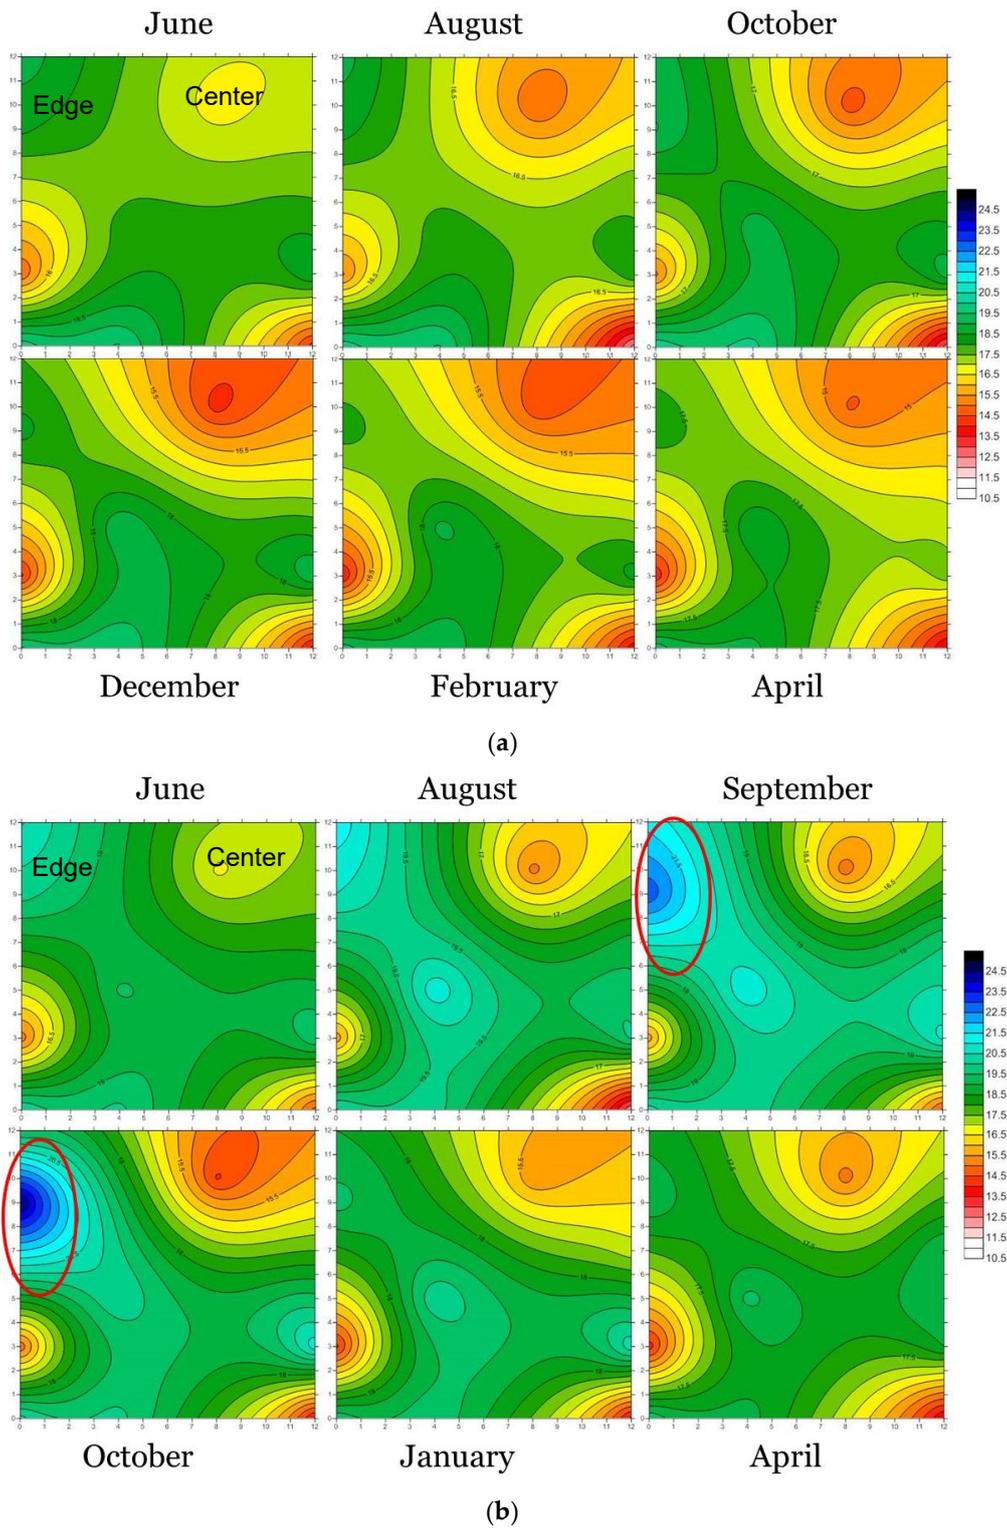
Figure 5. Bi-monthly (a) average moisture content and (b) maximum moisture content contour in pavement section.

The contour of the moisture distribution has also been plotted to have a better insight upon the moisture flow in the subgrade soil (Figure 5). With the average moisture values, the peak values were suppressed and hence were not visualized in the plot shown in Figure 5a. However, the maximum moisture contour depicts the moisture intrusion from the edge of the pavement represented by blue zone (Figure 5b). This moisture infiltration from the edge leads to significant edge drop in the pavement. Therefore, the period of rainfall after the long summer days is considered a critical time for pavement deformation. The already opened shrinkage cracks in summer provide the pathway for the rainwater to intrude into the system.

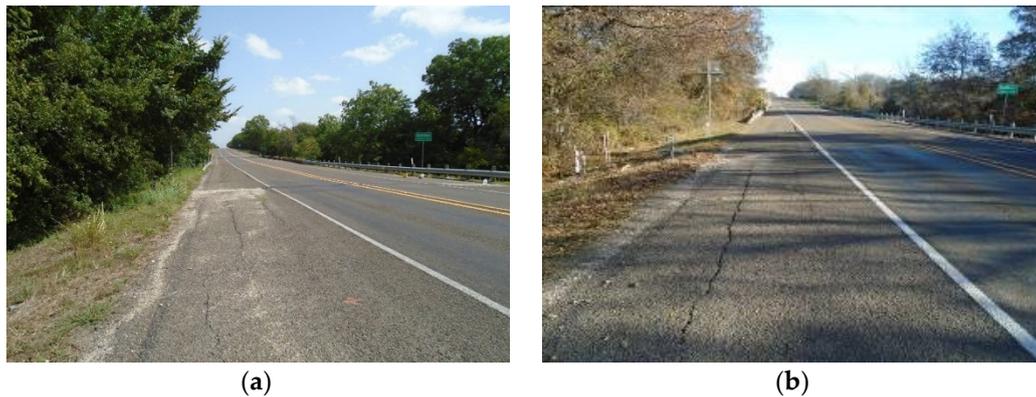
Figure 6. Comparison of roadside trees at SH 342 site in (a) summer and (b) winter.

In the current study, both of the selected sites were surrounded by dense trees. Nonetheless, only the result from SH 342 has been presented here as both the sites showed similar findings (Figure 6). The figure compares the greenery at different times of year, i.e., summer and winter.

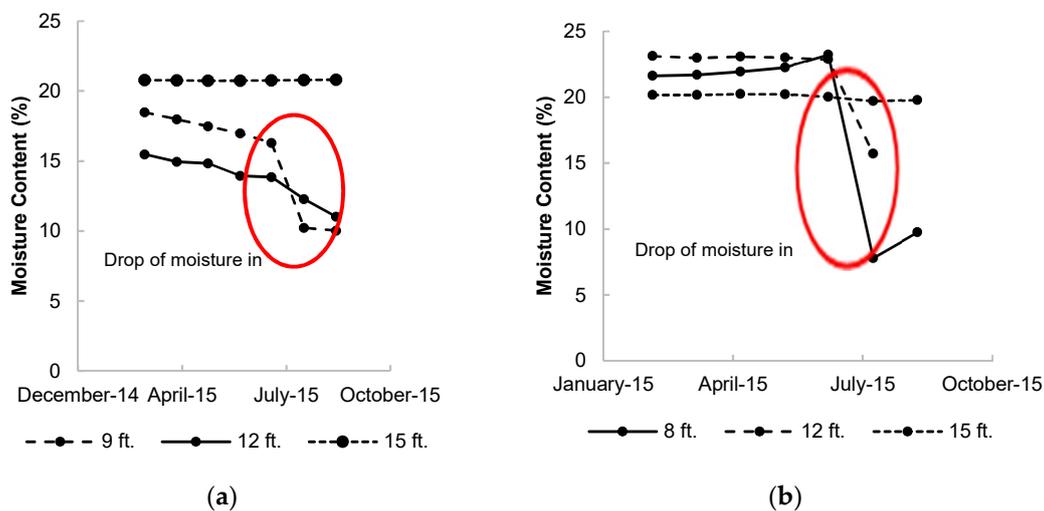
Figure 7. Drop of moisture content after summer at two boreholes of SH 342.

The trees’ roots on the side of the pavement can move underneath the pavement for water. This was witnessed in two of the boreholes with a decrease in maximum moisture content as shown in Figure 7. Therefore, the trees can be considered as one of the factors contributing to pavement cracking at both sites.

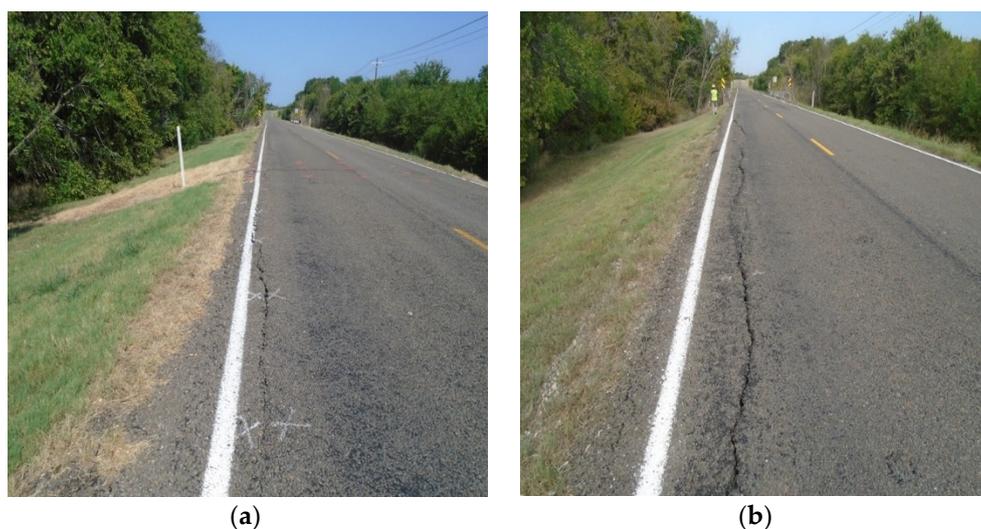
Figure 8. Crack after (a) Summer 2014 and (b) Summer 2015 at FM 2757 site.

The continuous monitoring of the pavement in FM 2757 indicated severe local deformations, along the edge of the pavement with the huge deformation recorded on a survey of September 22, 2013. The edge drop of 2 inches was observed during that time. This edge drop was followed by a huge crack. Similarly, the following summer of 2014 experienced edge drop in September. Moreover, the edge cracks were seen again in October 2015. The longitudinal cracks observed in the summer of 2014 and 2015 are shown in Figure 8. The crack depth was observed to be as deep as 7 inches.

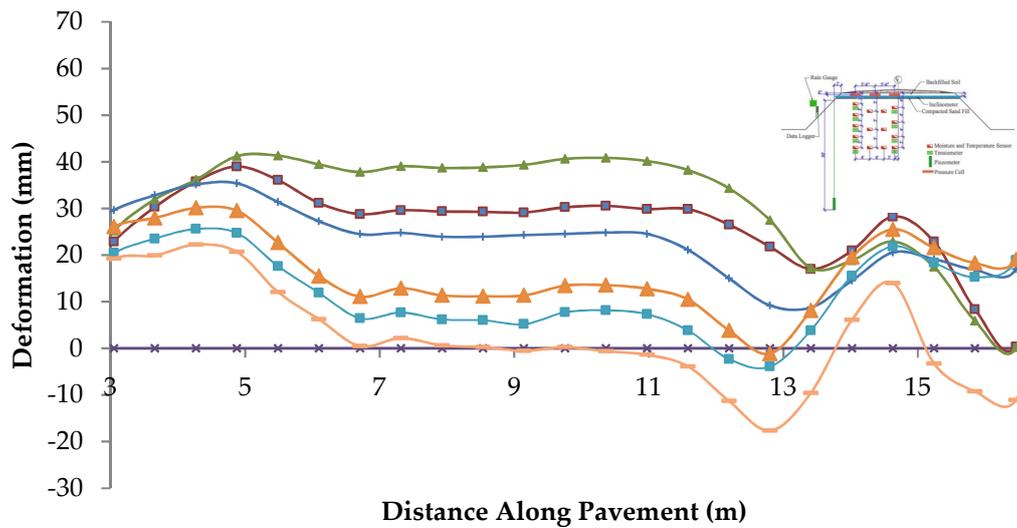
Figure 9. Variation of deformation along distance in central section in SH 342 site (from Inclinometer data).

The deformation of the pavement in State Highway 342 was obtained using inclinometer which is shown in Figure 9. The upward and downward movement in the plot corresponds to the swelling and shrinkage of the expansive subgrade soil. The continuous monitoring of the site revealed 38 mm of vertical movement across the pavement as can be seen in Figure 9. However, there is no significant edge drop observed at this site due to support from the shoulder. The shoulder hindered the initiation of crack at the edge and prevented the excessive deformation of the pavement. The swelling and shrinkage were in the range of ± 50 mm. Similar seasonal trend was observed in both the sites i.e., FM 2757 and SH 342. The difference was only the presence of shoulder in the state highway, which was likely to prevent the excessive deformation in the pavement.

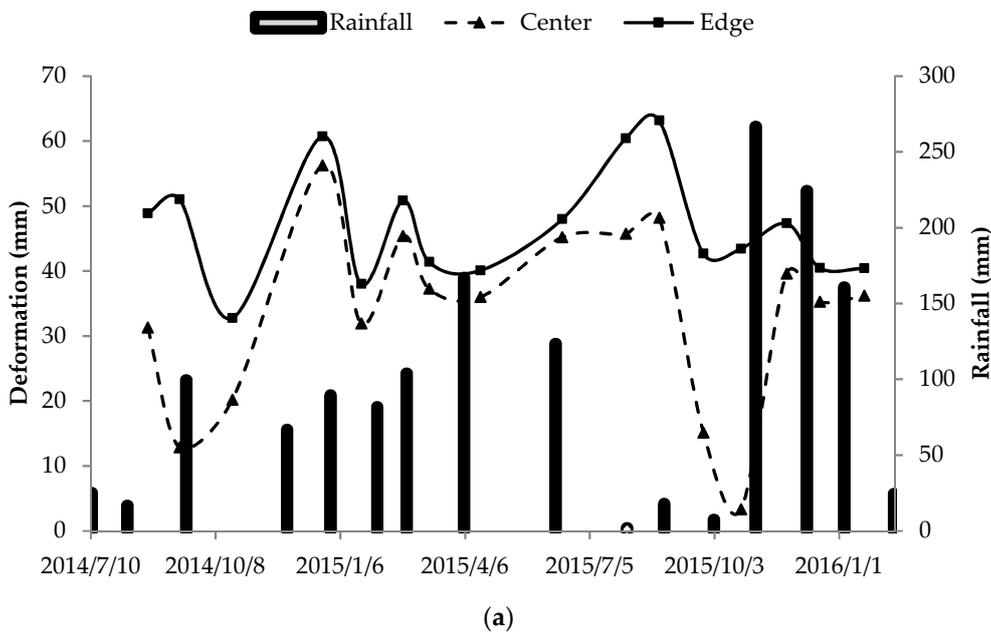
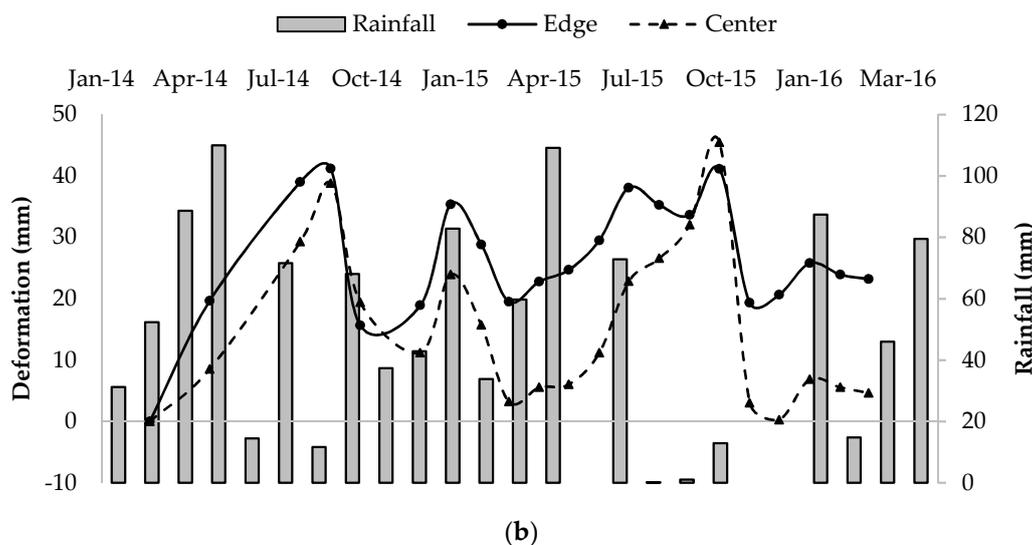
Figure 10. Deformation variation of edge and center with rainfall events at (a) FM 2757 and (b) SH 342 site.

Figure 10a shows the pavement elevation at two points along the cross-section i.e., at the center and the cracked edge in FM 2757. The elevation of the pavement exhibited sensitivity to rainfall events, as can be seen in the figure. The swelling and shrinkage of the expansive subgrade soil were seen during the monitoring from 2014 to 2016. The swelling up to 60 mm was observed with the huge rainfall events from March to May 2015. The same amount of drop was observed immediately when no rainfall occurred from June to August 2015. The pavement deformation is dependent on both seasonal variation and precipitation as stated in previous studies [11,27].

The movement of the subgrade soil with the rainfall is shown in Figure 10b at two locations, i.e., left edge and center of SH 342. In general, the pattern of movement of subgrade soil at both the points corresponded to the rainfall event indicating the swelling and shrinkage behavior. For example, the cumulative rainfall of 114.3 mm from March to May 2014 resulted in swelling of 38.1 mm, while a drop of nearly one inch was witnessed after the summer of the corresponding year. A similar trend of swelling was captured in January 2015—with rainfall of almost 50 mm—which experienced a drop after October 2015 as a result of less rainfall at the site.

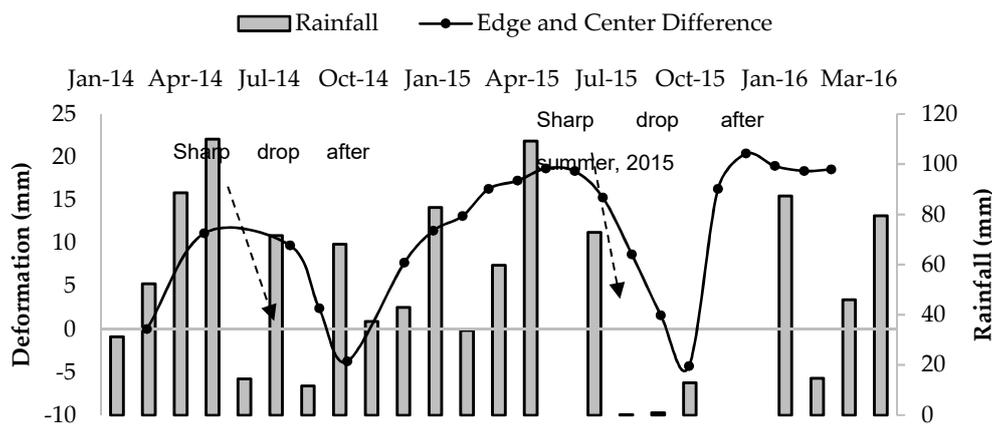
Figure 11. Edge drop at consecutive summer seasons at SH 342 site.

Figure 11 shows the plot between the difference of elevation between the left edge and centerline of SH 342 pavement with time and rainfall. Here, the monitoring results from 2014–16 are only presented for evaluating the cracking potential. The plot shows the highest drop corresponding to the period with less rainfall (12.5 mm) in August 2014 and September 2014 leading to edge drop. A similar drop was witnessed again after September 2015. This proves that the rainfall amount has great impact on the cracking potential and the pavement has highest cracking potential in August and September based on the observation of the two pavement sites. Reference [28] also stated that crack opening usually occurs in the months from August to October in Central Europe.

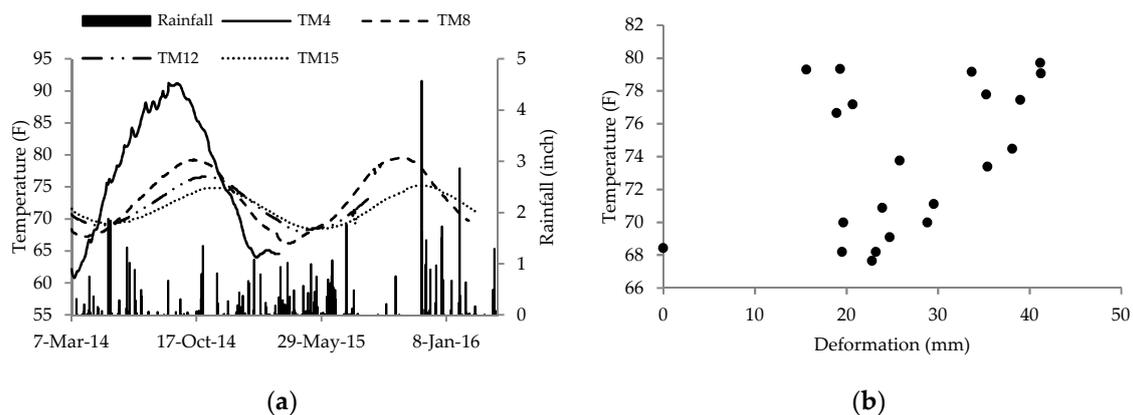
Figure 12. (a) Temperature variation in SH 342 site, and (b) Temperature and deformation plot for model development.

Temperature was then evaluated as a fit variable for using to predict deformation. Figure 12a depicts the change of temperature over several years for a single borehole. As can be seen, temperature was following more a seasonal trend than responding to rainfall. Pairs of temperature and corresponding deformation were assessed using both Pearson and Spearman correlation coefficient. The evaluation produced a Pearson coefficient of 0.438 and Spearman coefficient of 0.42. The p-value was found to be 0.047, which is less than 0.1 for a 10% confidence interval. This confirmed that the null hypothesis could be rejected that no significant relationship existed between the variables. For instance, Figure 12b, which presents the scatter plot between the variables, shows five different temperatures recorded for 20 mm deformation.

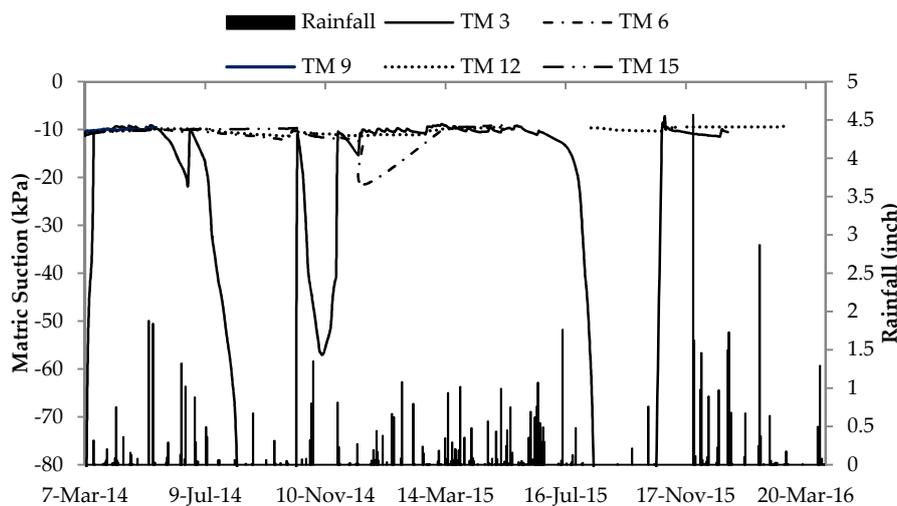
Figure 13. Matric suction at SH 342 site from 2014–16.

Suction values were then evaluated as a possible predictor variable and correlation with deformation was analyzed. There has always been a discussion regarding the reliability and longevity of suction sensors. Reference [26] stated that most of the water potential sensors measure the soil suction following the principle of thermal conductivity. This method relies on the potential energy of water in equilibrium with water in the soil [31]. A thermal conductivity sensor comprises of a porous ceramic block with temperature sensor and a heater. The water content of the block, which depends on the matric suction applied to the block by the surrounding soil, affects the thermal conductivity [32]. Since the two materials are then in equilibrium, the matric suction of the block will be same as of the surrounding soil. Previous research [26] shows the use of Fredlund Thermal Conductivity (FTC) sensor to measure field suction beneath a pavement slope. The author reported high failure rate of the sensors along with fragile ceramic used in the sensors. Another company manufactured water potential sensors to measure the matric suction of soil using the same principle but utilizing dielectric permittivity of solid matrix-porous ceramic disk. Air, solid ceramic and water have dielectric permittivity of 1, 5 and 80, respectively. The dielectric permittivity of the disk varies with the quantity of water present in the pore spaces of the disk. The ceramic used in MPS-1 sensor has a wide range of pore distribution. Thus, a substantial scale of moisture content can be covered by measuring the dielectric permittivity of the disk [31]. Nonetheless, the sensor can only record suction up to 10 kPa, which greatly limits the real-time actual field suction condition. References [33] and [34] stated that long-term suction monitoring is difficult and not reliable at times. References [33] and [34] thus predicted the ground movement based on water content. Additionally, the authors of Reference [27] reported field suction data for only ten months from March 2007 to June 2008, as other values were not available since the sensors had malfunctioned. Keeping in view all the above-mentioned findings, suction values were not considered as a predictor variable for model development. The authors of this manuscript also used suction sensors in field. As can be seen from Figure 13, most of the recorded values were clustered around 10 kPa for most of the time. Only sensors recorded at 3 ft depth exhibited some variation over time. The suction sensors was not responsive to rainfall like moisture sensors.

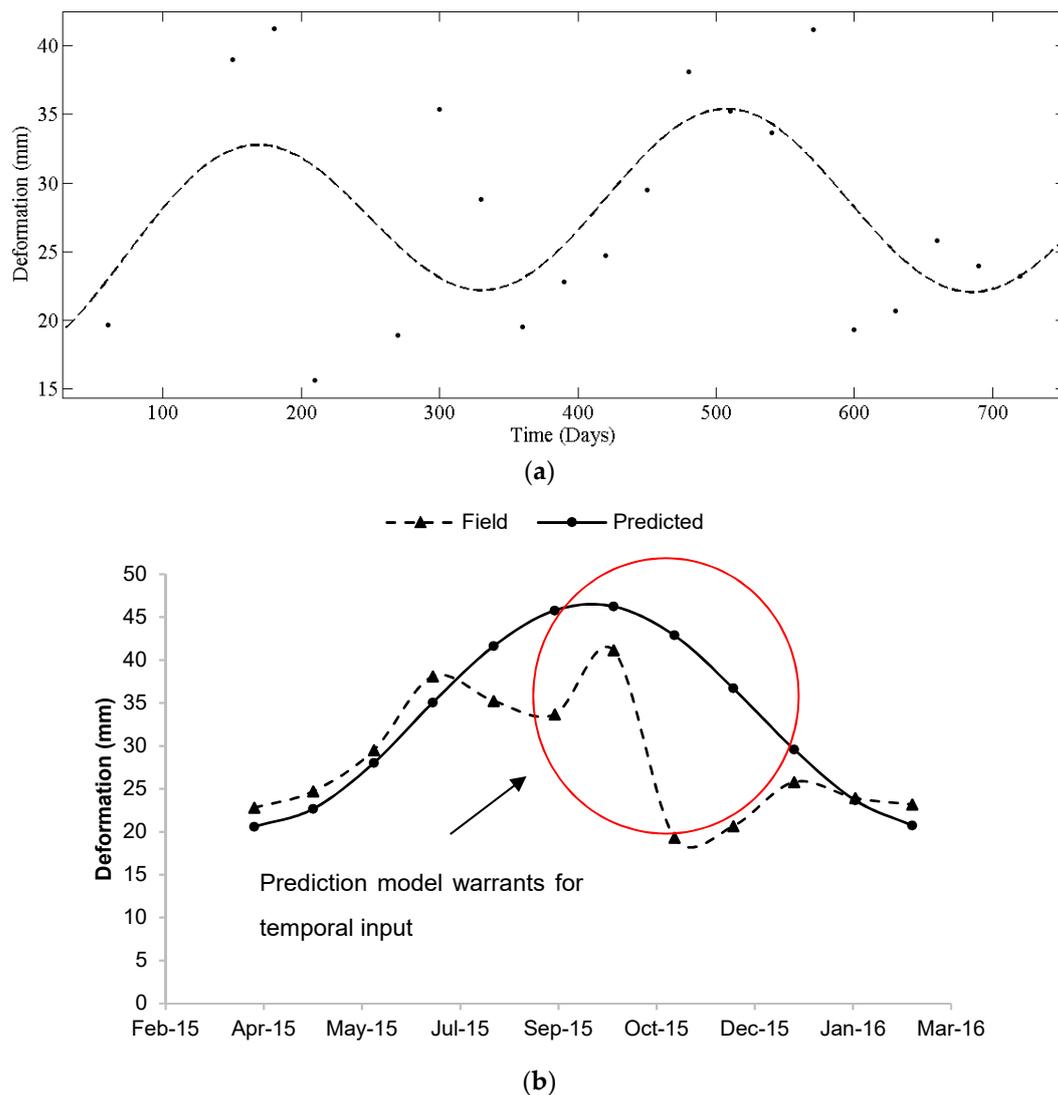
Figure 14. (a) Variation of the edge deformation in 2014–16 period (b) Predicted and field deformation in 2015–16 period.

As mentioned above, the edge being more susceptible to moisture intrusion, only the deformations along the edge were considered for analysis. The field deformations during 2014–16 were plotted as seen in Figure 14a. The plot shows an overall tendency of seasonal variation of deformation with response to rainfall. The seasonal trend, following numerous trials, was found to follow the first-degree Fourier series. The following equation by Reference [35] was solved to estimate the variables.

The model was developed using monitoring data from 2014–15, while the field data from 2015–16 was used to validate the developed model. Figure 14b shows the comparison between actual field data and model predicted values for 2015–16. The model could not predict the significant drop after the summer period, as shown in the figure. However, the typical seasonal change was perfectly depicted by the developed seasonal variation model. This finding points to the necessity of including short-term temporal change in moisture content to obtain better results. The difference in predicted and actual field deformation values suggests that the model should include the effect of rainfall as well.

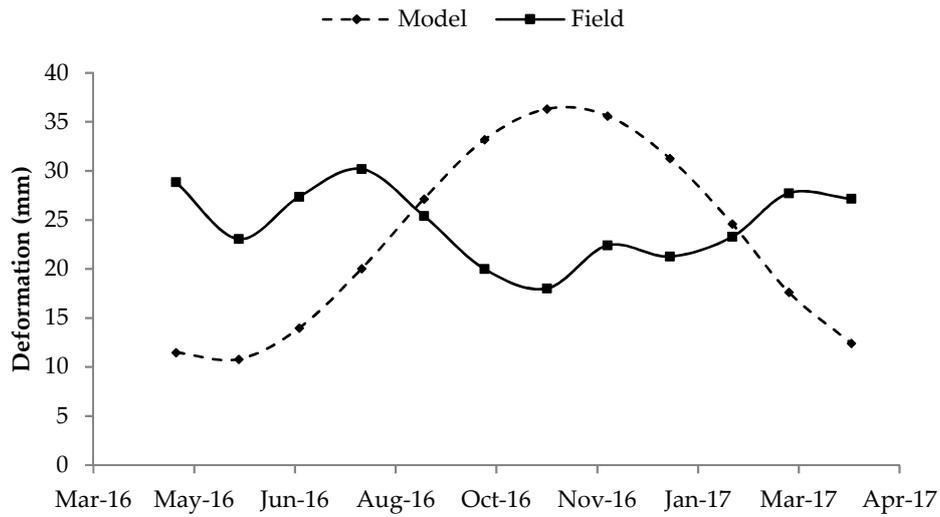
Figure 15. Comparison of model and field results with seasonal effects.

The modified model was validated using the edge deformation of 2016–17. Figure 15 shows the actual field deformations versus the model estimated deformation values. It can be pointed out that there is certain discrepancy in the model and field values for some months. This discrepancy was regarded to have a relation with the precipitation events. Hence, a rainfall factor was estimated by plotting the difference between model and field values on Y-axis and rainfall on X-axis.

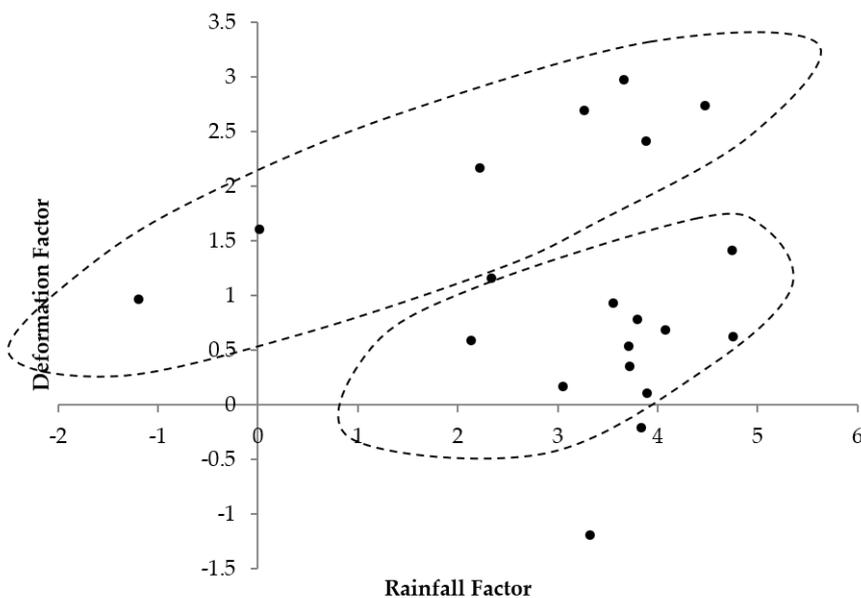
Figure 16. Rainfall factor for model modification.

The scatter plot (Figure 16) provided an initial impression of the relation. Starting with linear relation, exponential, power and quadratic relations were tried to estimate the correct rainfall factor. Since none of the trends generated any interpretable result, the log-function transformation was applied initially on both the X and Y axes. This resulted in a limited linear trend in the scatter plot. With a view to improving the accuracy, logarithmic of both squared difference and squared rainfall data were plotted on Y and X axes, respectively. Two different linear trends were detected, with one trend conforming to values when the deformation factor is more than 1, and the other trend being applicable for deformation factors less than 1. Both the equations exhibited coefficient of determination (R^2) more than 0.85. The linear trend equations for both the above-mentioned cases are as follows:

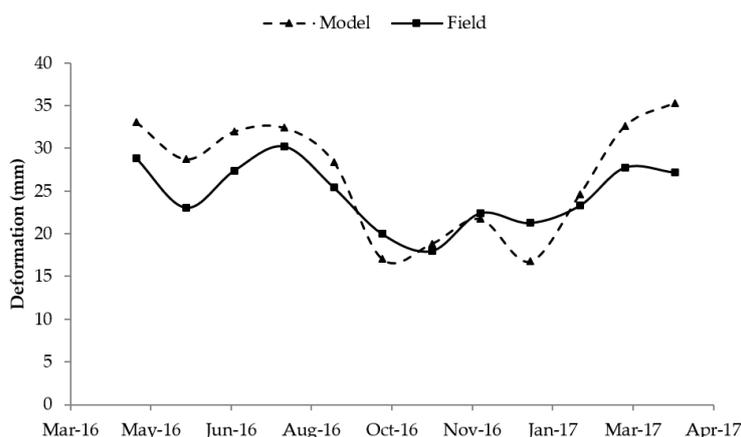
Figure 17. Comparison of model and field results on modified model.

For instance, the model predicted and actual field deformations in June 2016 were 10.8038 mm and 23.058 mm, respectively. Since the deformation factor was more than 1, the first equation was used. The rainfall in June 2016 (66.8 mm) was squared and the logarithmic value of the squared rainfall was put as 'x' in the equation. The deformation factor 'y' was calculated to be 2.64. Then, the difference in deformation was back-calculated to be 19.92 mm. After adding this factor to 10.80 mm, the final predicted deformation was estimated to be 30.72 mm, which is about 7 mm more than the actual deformation value. Similarly, modified predicted deformation values were also estimated for the remaining months using the same method. A validation plot was again made with final deformation model values and actual field deformations as shown in Figure 17.
