Article

Landslide Hazard and Risk Assessment for a Natural Gas Pipeline Project: The Case of the Trans Adriatic Pipeline, Albania Section

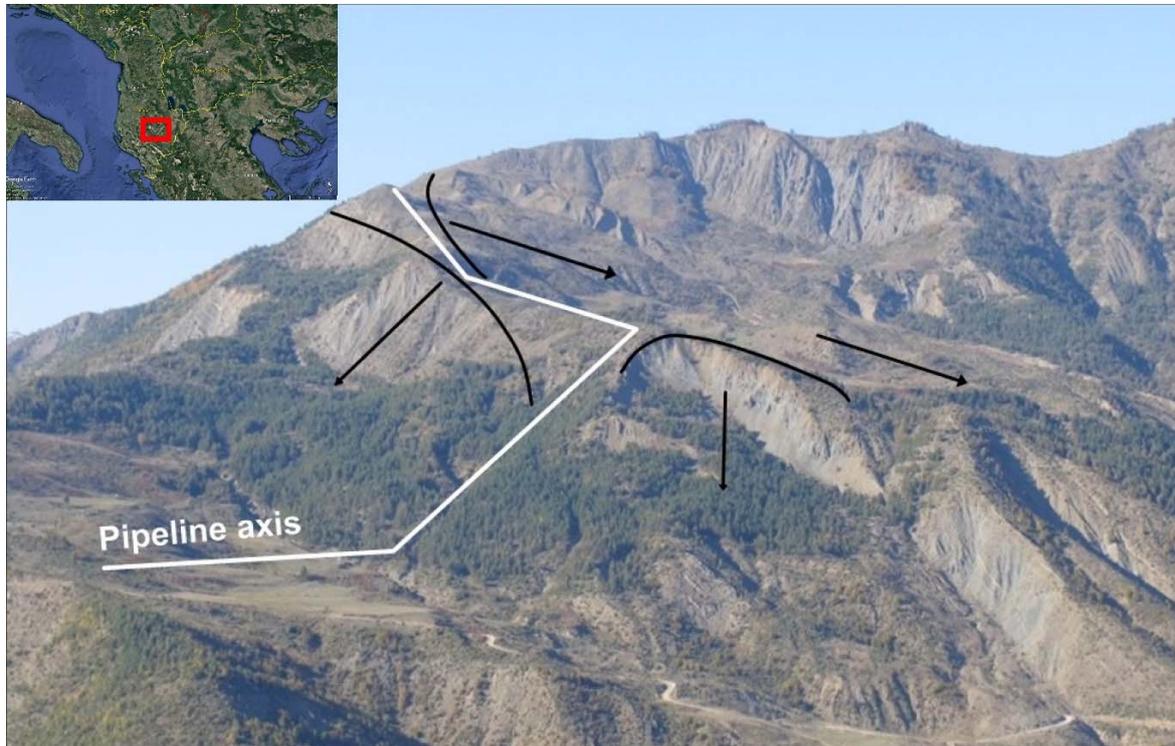
Figure 1. Pre-existing landslides (black lines) along Trans Adriatic Pipeline (TAP) pipeline Right of Way (RoW) in a mountainous region of central Albania. It is evident that landsliding constitutes to be a major risk factor for pipeline integrity.

Across Albania, the pipeline crosses the Pindus mountain range, a rather challenging environment for the construction of the project. We focus on the section that spans approximately 70 to 136 km (KP70-KP136), following the route from east to northwest. This 66 km long mountain section in Albania is probably the most challenging onshore section of the SCPX-TANAP-TAP pipeline system, due to the combination of narrow ridge crests, steep terrain, high seismicity, widespread active landslides, unstable side slopes and very limited access (Figure 1).

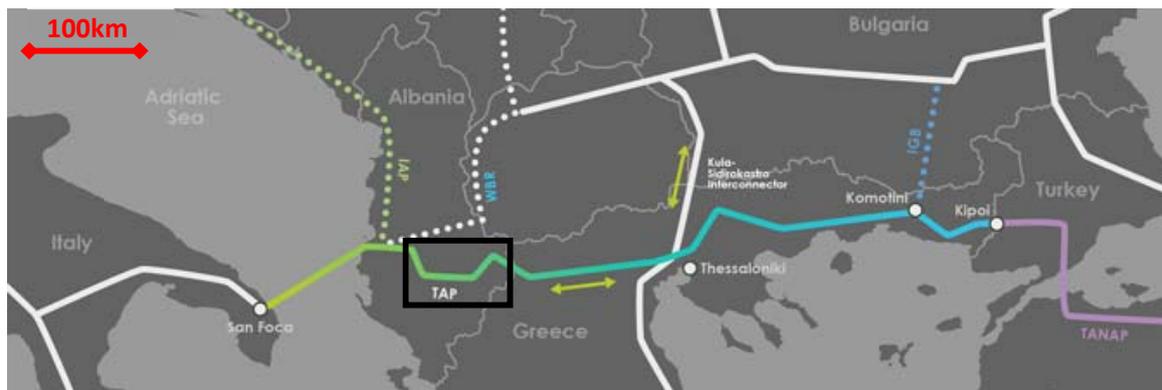
Figure 2. The schematic TAP route. The study area (shown with a black rectangle) spans approximately from 70 km to 136 km (KP70-KP136). (www.tap-ag.com).

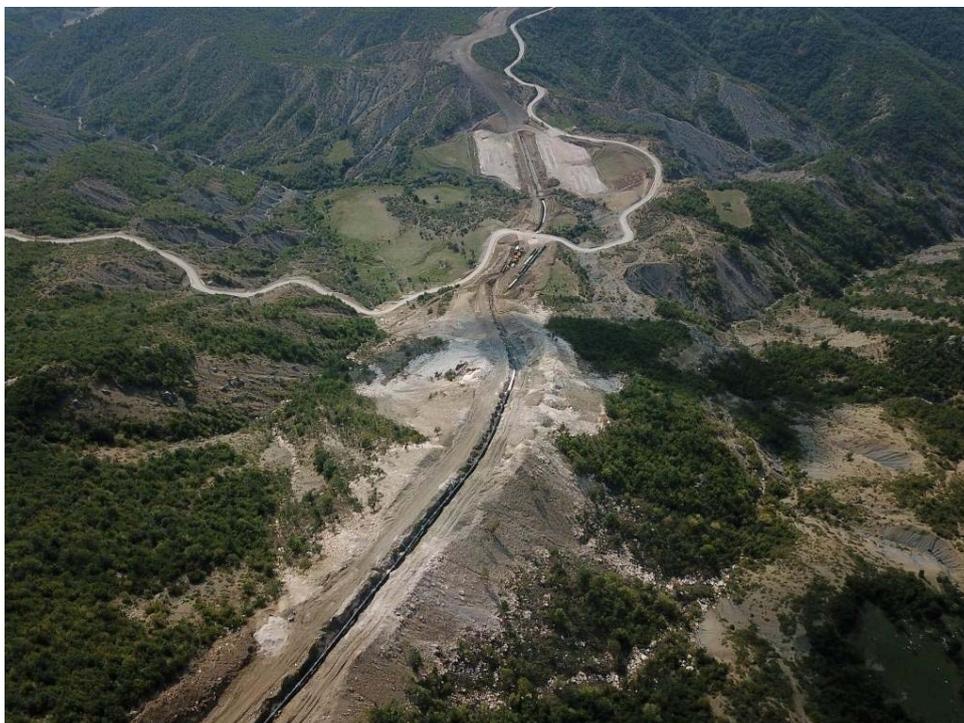
Figure 3. Right of Way (RoW) for major gas pipelines is a strip of land, usually between 18 and 36 m wide, containing one or more pipelines, used as access for inspection, maintenance, testing or emergency.

RoW for major gas pipelines is a strip of land, usually between 18 and 36 m wide, containing one or more pipelines, used as access for inspection, maintenance, testing or emergency (Figure 3). RoW also identifies the area where certain activities are prohibited to protect public safety and the integrity of the pipeline. Steel pipes are towed by truck to the site, where a trench is dug for the pipeline. Trenchless techniques may also be applied when necessary (e.g., avoidance of a landslide, river crossing, and other instances), using boring/jacking, auger bore, HDD (horizontal directional drilling) and micro-tunnelling.

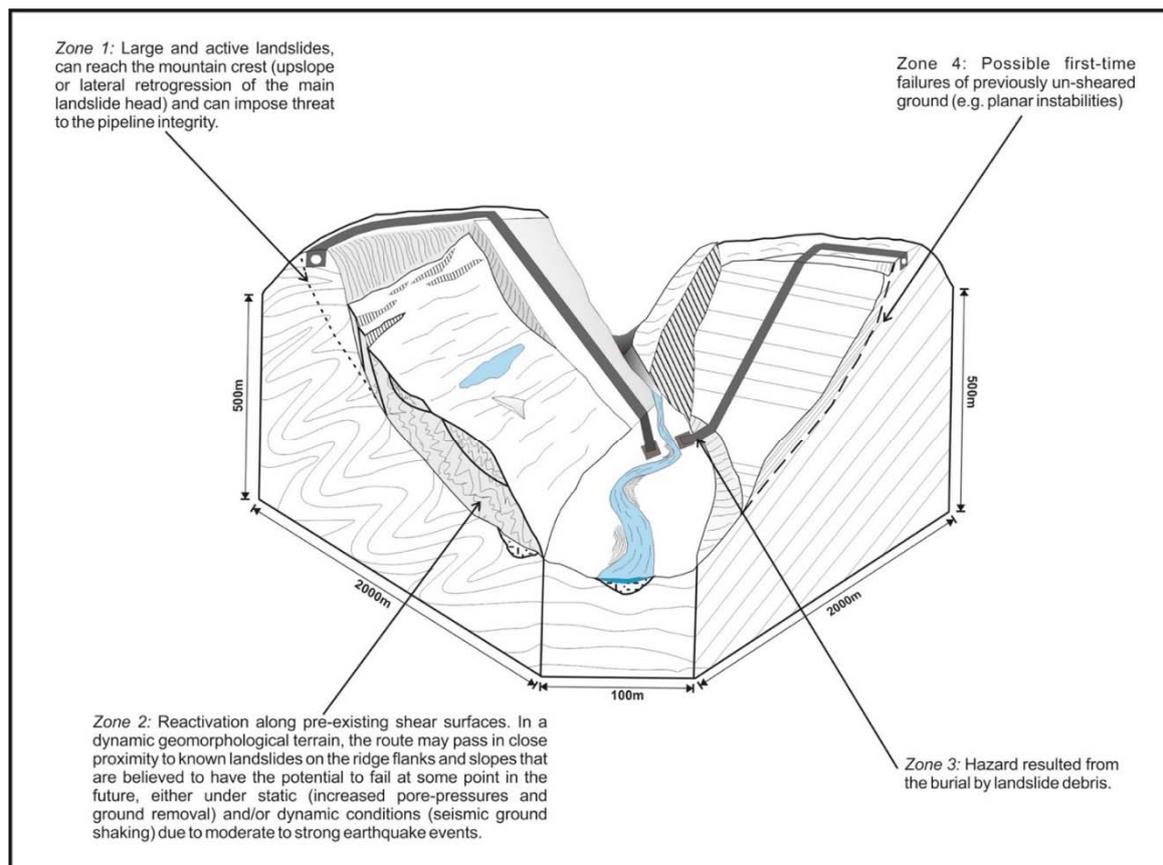
Figure 4. Possible failure event scenarios associated with pipeline rupture.

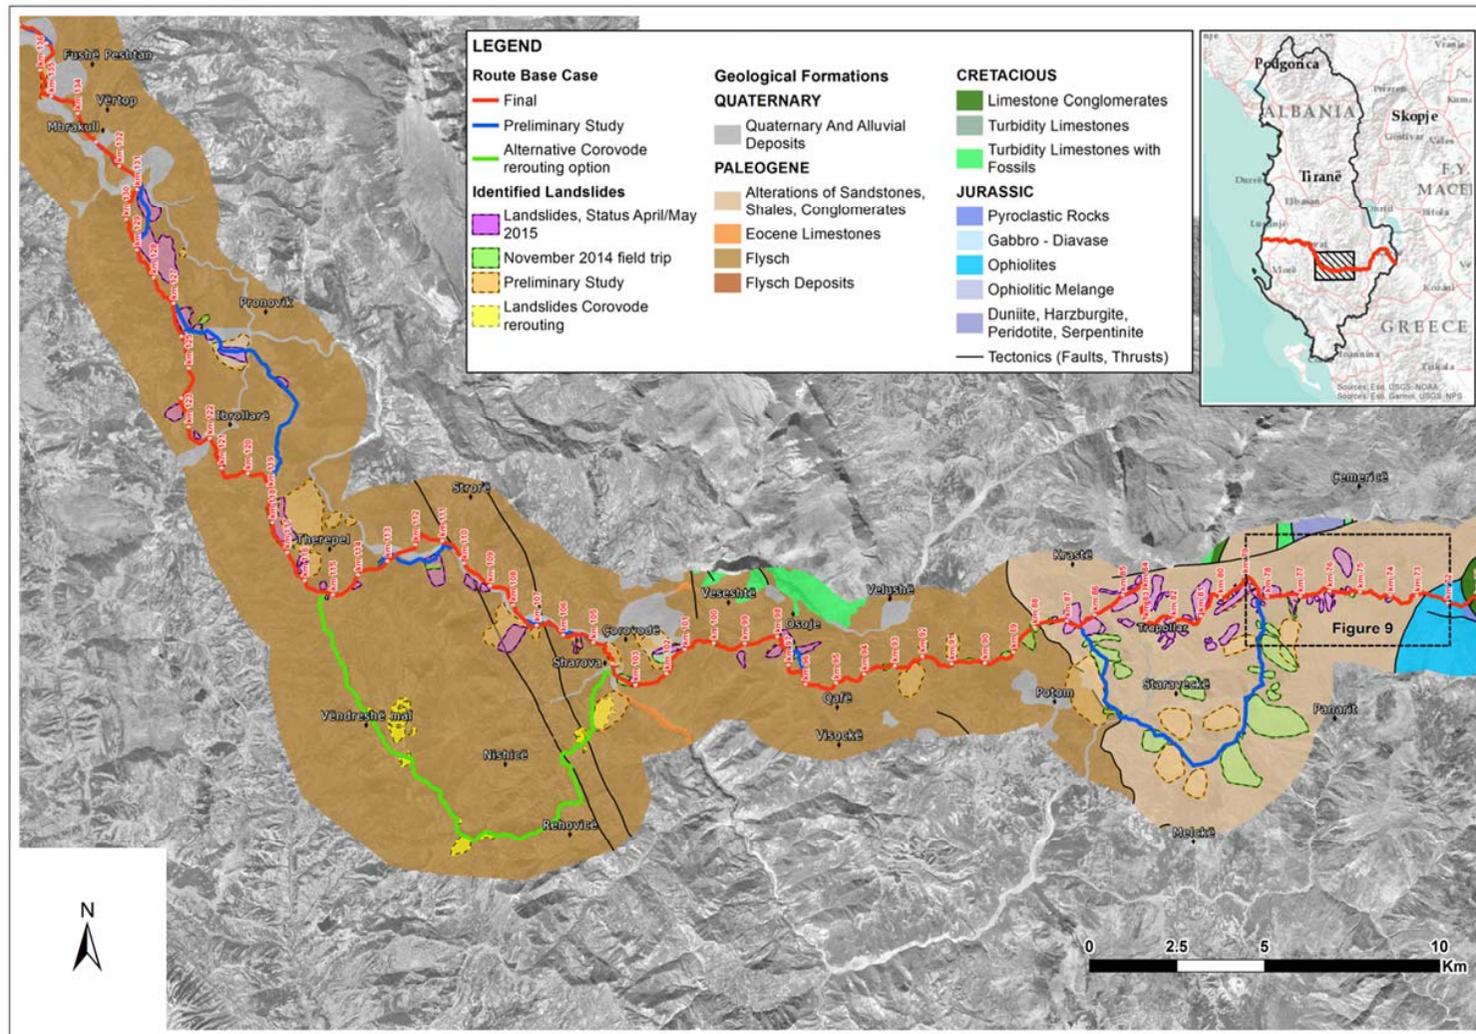
Figure 5. Geological conditions along the Trans Adriatic Pipeline (section 71–136 Km). The geological environment of the area is dominated by flysch formations. Limestones and ophiolites (peridotites) were also identified at the eastern edge.

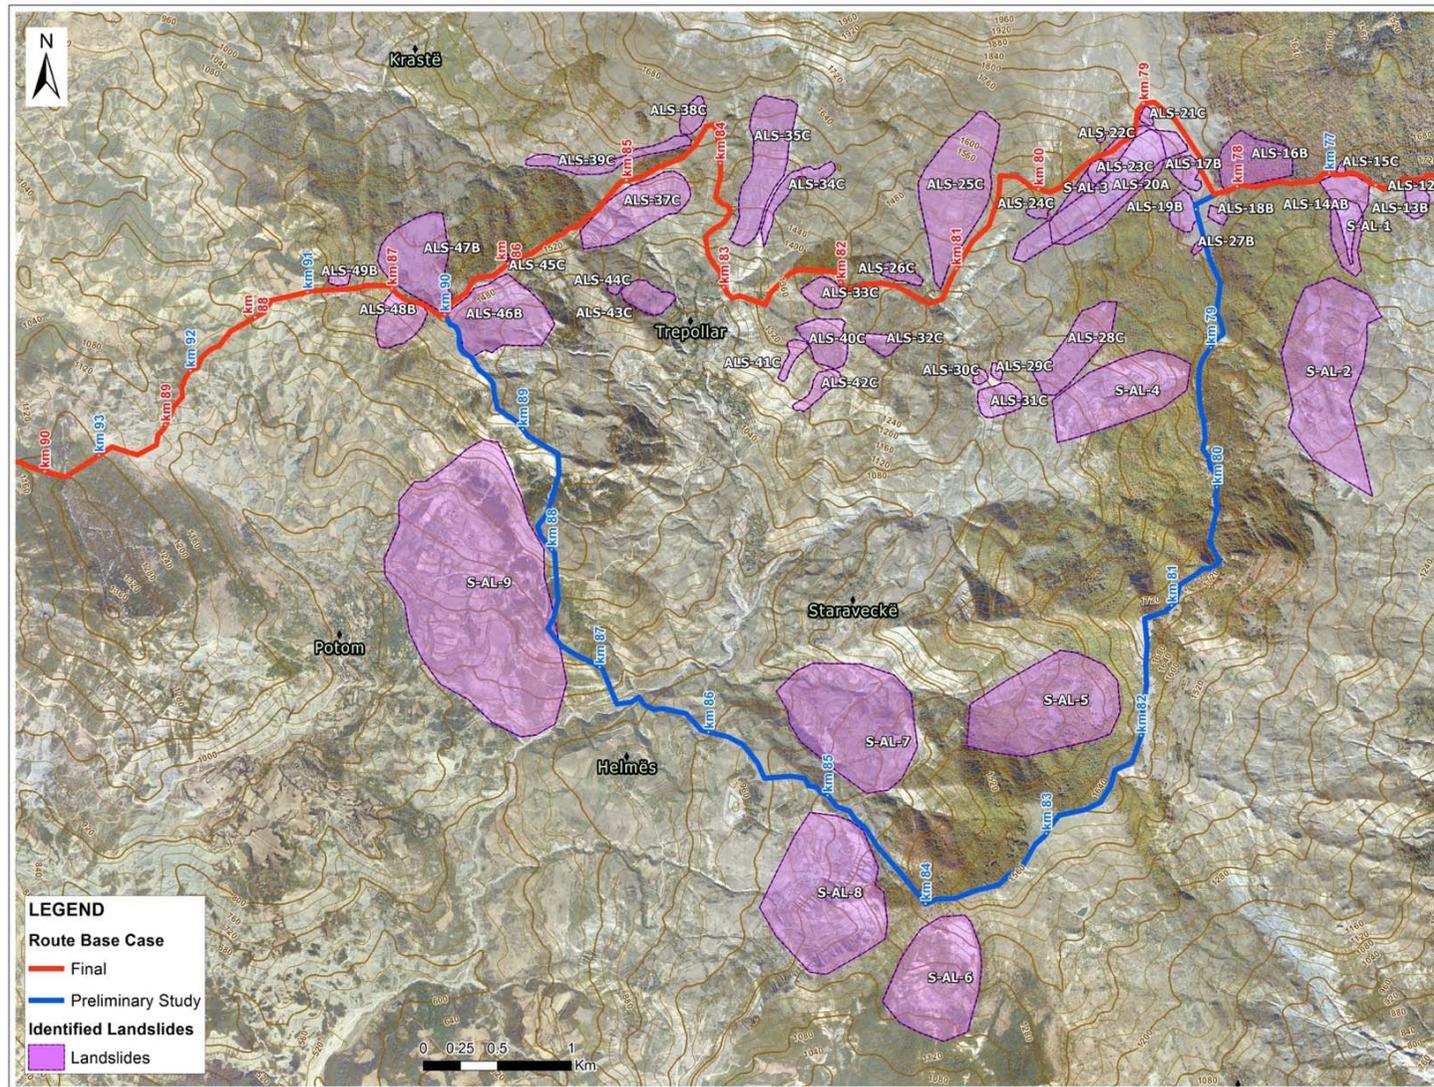
Figure 6. Combination of weak rocks, steep slopes, rainfall and snow melt and strong ground accelerations (earthquakes) creates an environment prone to landsliding.

A combination of weak rocks, steep slopes, rainfall and snowmelt, as well as strong expected ground accelerations from earthquakes creates a difficult environment, prone to landsliding for the study area (Figure 6). The TAP RoW in this area mainly lays along mountains ridges and is typical to run over steep to very steep slopes and areas delineated by landslides.

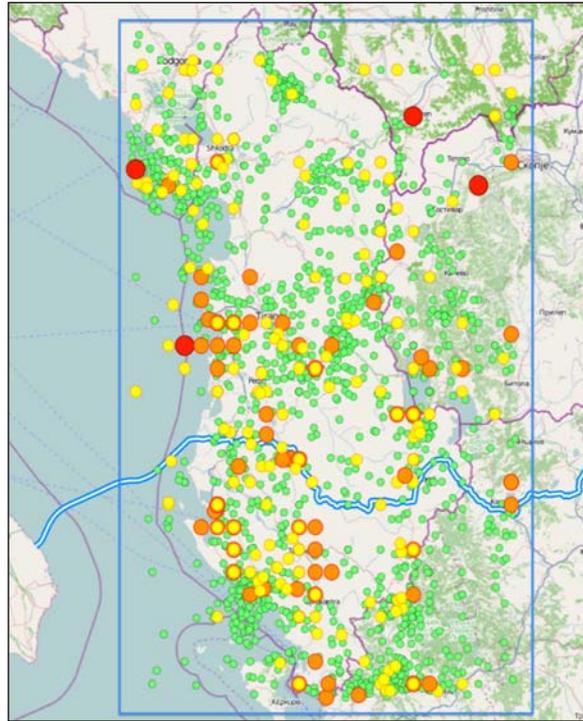
Figure 7. Seismicity for the Albanian sector of the TAP. Earthquakes with an MW 4.0–4.9 are plotted with green symbols, yellow symbols indicate events with an MW 5.0–5.9, the orange symbols MW 6.0–6.9, and the red symbols MW ≥ 7.0 [19].

The seismicity of the Albanian sector of the TAP is well documented in Figure 7. The peak ground bedrock acceleration (PGA) is 0.4 g, with a 10% probability of exceedance in 50 years (475 year return period), while the average annual rainfall ranges from 1500 to 2000 mm. Earthquakes are mainly distributed along the coast, and there are two earthquakes with an MW larger than, or equal to, 7.0 (red) in the area. The area around Durres and Tirana is seismically active with a large number of events with magnitude 6 and over (orange). Fortunately, the seismicity along the pipeline route seems to be generally lower than elsewhere, but there are some earthquakes of an MW 6 (orange) near the TAP corridor.

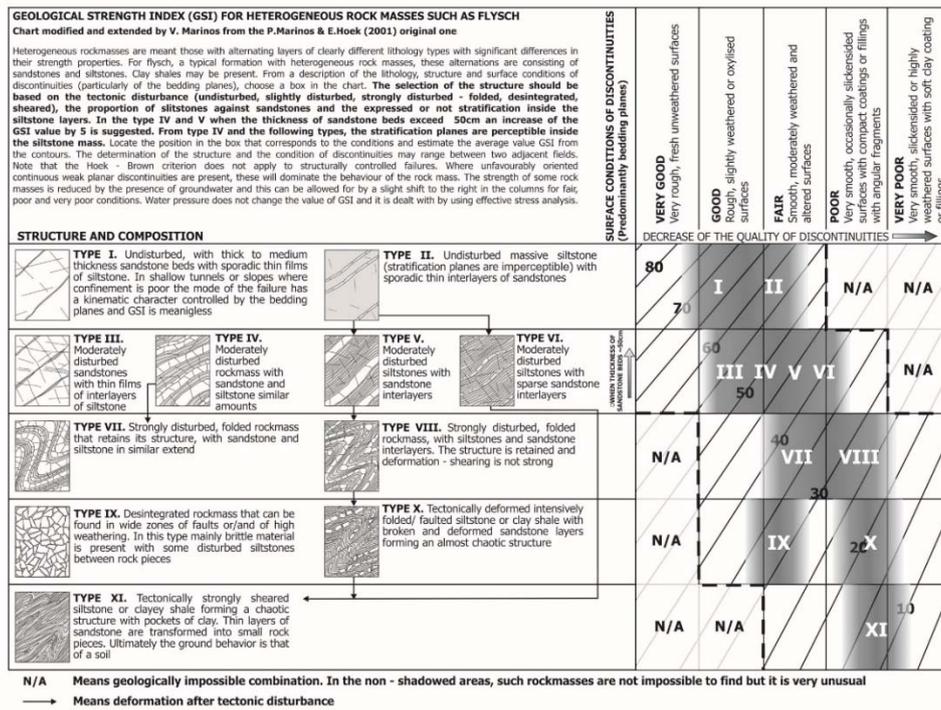
Figure 8. Geological strength index (GSI) chart for heterogeneous and structurally complex rock masses, such as flysch used for rock mass quality classification. N/A: Not applicable cases in nature.

Along the investigated route, the overall rock mass condition (lithology, structural disturbance, discontinuities) was evaluated from field observations and measurements and used for the engineering geological zonation of the investigated TAP route (shown in Figure 9).

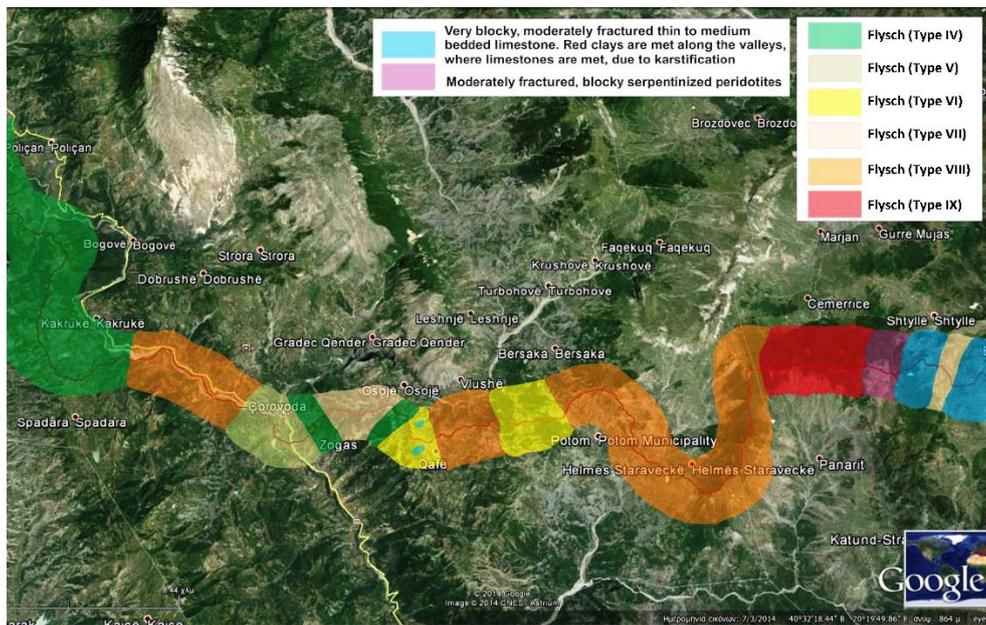
Figure 9. Zonation of the rock mass types and quality along the examined TAP route using the GSI (Figure 8) system for tectonically disturbed heterogeneous rock masses. The areas where most new identified landslides were encountered are characterised by the presence of flysch types VIII (i.e., strongly disturbed siltstones, folded rock mass, with sandstone interlayers) and IX (i.e., tectonically deformed, intensively folded/faulted siltstone with broken and deformed sandstone layers, forming an almost chaotic structure). Limestones (light blue) and ophiolites (peridotites) (purple) were also identified at the eastern edge. The little squares indicate the location of two photos in Figure 10.

As seen in Figure 9 and demonstrated in Figure 10, the areas where most new identified landslides were encountered are characterised by the presence of flysch types VIII (i.e., strongly disturbed siltstones, folded rock mass, with sandstone interlayers) and IX (i.e., tectonically deformed, intensively folded/faulted siltstone with broken and deformed sandstone layers, forming an almost chaotic structure).

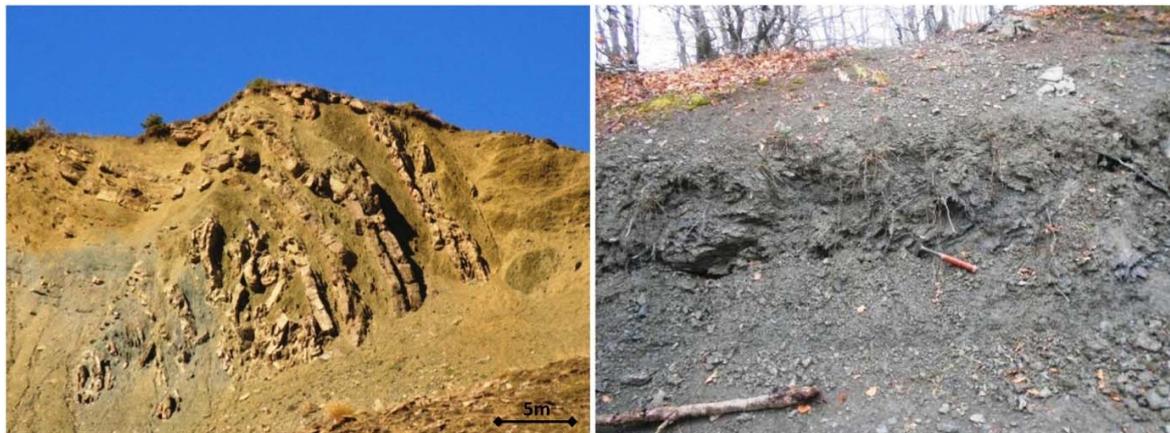
Figure 10. Typical examples of flysch type VIII (**left**) and flysch type IX (**right**) at landslide masses.

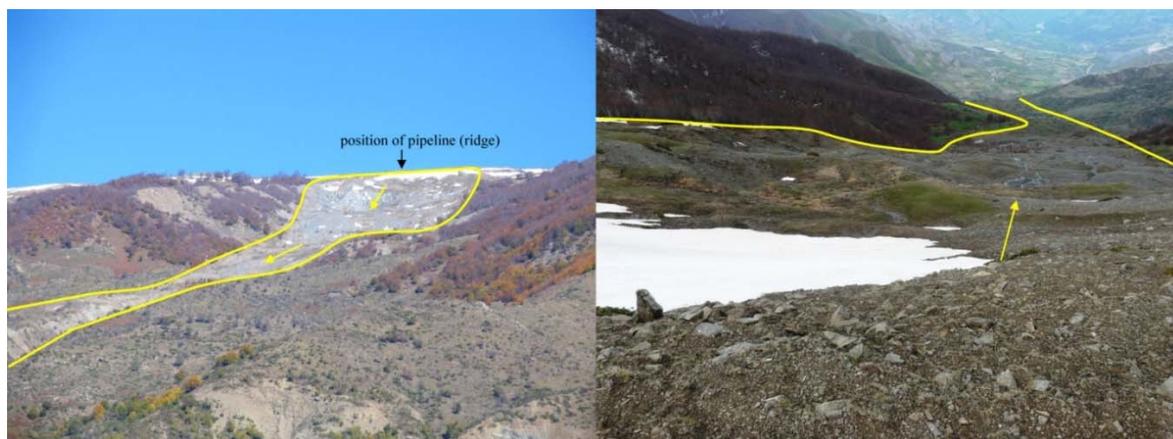
Figure 11. A view of landslide ALS-20A. Upslope view of the crest and landslide mass (**left**) and downslope view (**right**) taken from the pipeline RoW. The yellow lines show the landslide (earthflow according to the classification of [22]) boundaries, the yellow arrows the direction of movement and the black arrow indicates the position of the pipeline axis.

Several landslide geohazard areas were spatially extensive, showed recent landslide activity (Figure 11) and could fail even under static conditions. An inventory of landslides was compiled from satellite imagery and field inspection (see Figures 12 and 13). As a result of this mapping, two large re-routings and several small ones were considered for investigation.

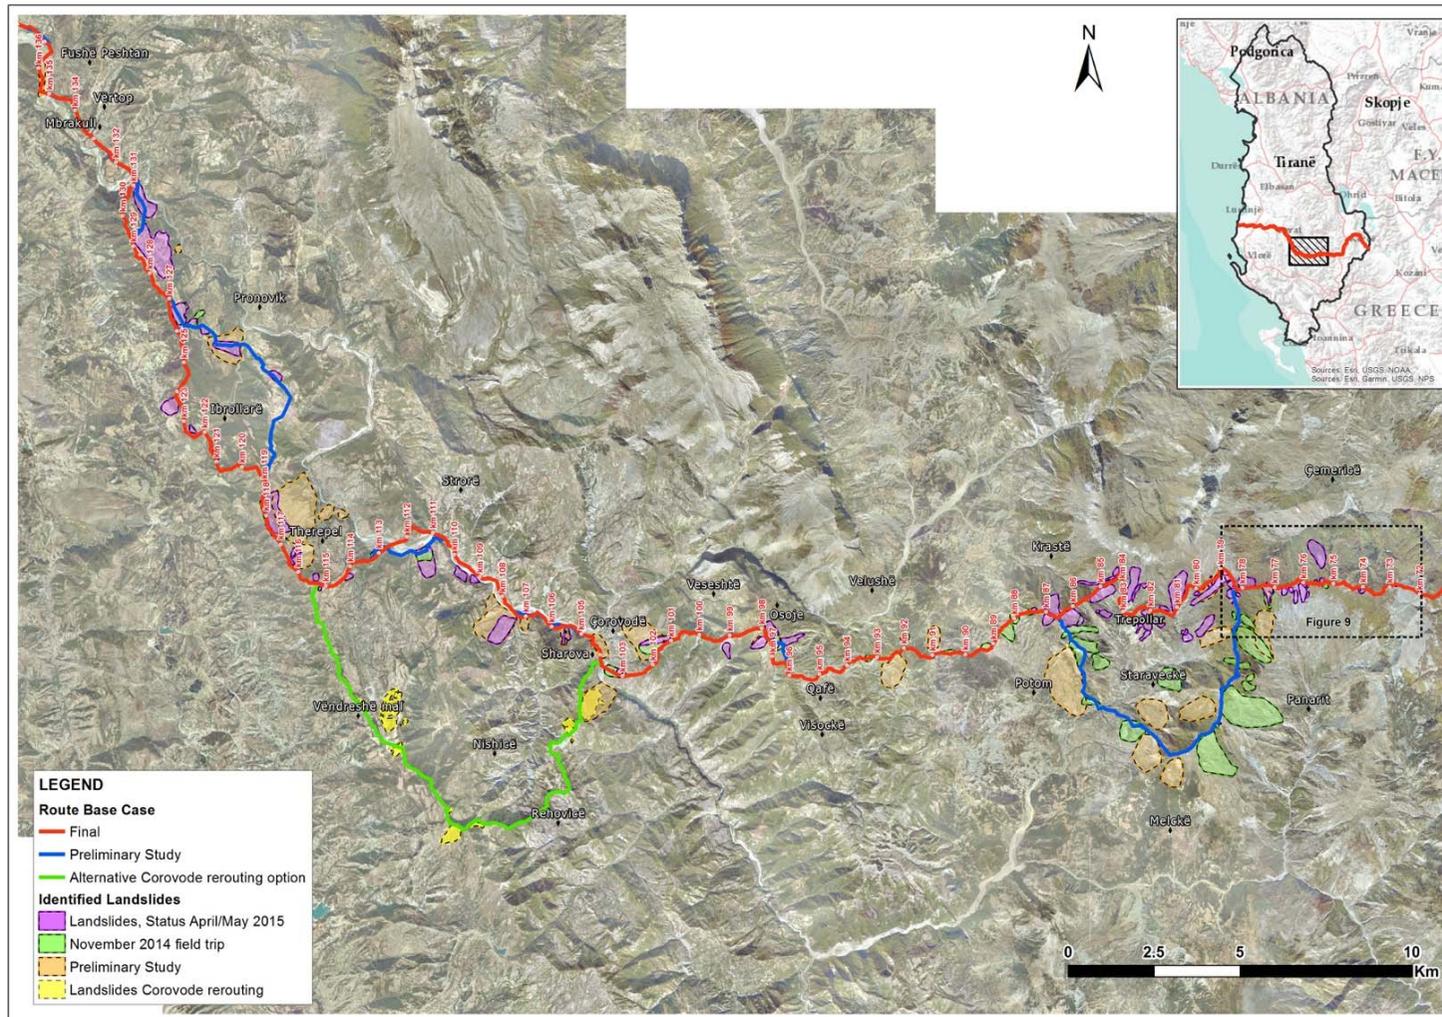
Figure 12. Inventory of 82 landslides compiled from satellite imagery and field survey. Landslides are depicted by polygons (colours indicate different study phases) for the whole area, verifying that landsliding was a major factor for the TAP pipeline route selection in this mountainous region. Different re-routings that were investigated in the field to avoid critical landslides are also presented.

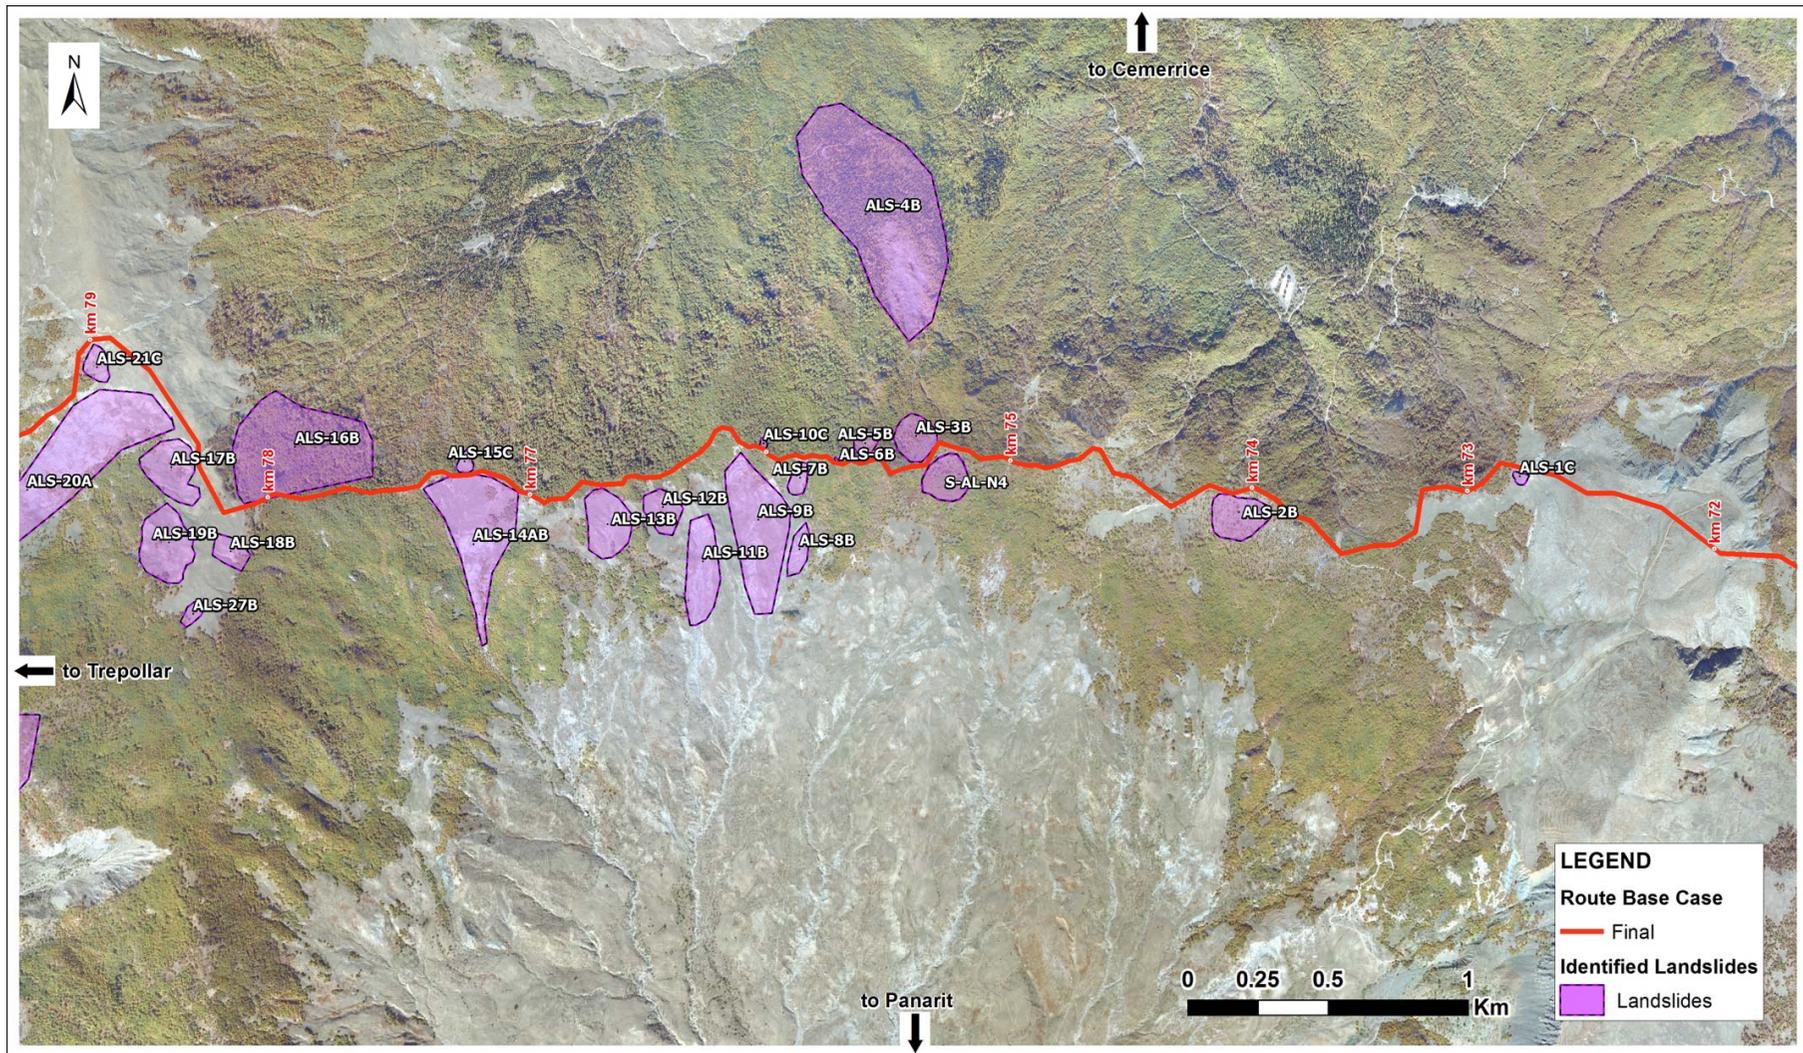
Figure 13. Landslide inventory for the TAP segment between 72 and 79 km, where several landslides are located close to the TAP RoW, threatening pipeline integrity.

Landslide ALS-14AB is a landslide approximately located at 77 km of the TAP route (Figures 13 and 17). It is a large (approx. 90,000 m²), medium depth landslide which is in contact with the pipeline (Figure 19). It is an active, translational landslide of poor ground quality (flysch type IX, Figure 8). The slope of the landslide is gentle. Evidence of activity has been identified on the surface in the form of fresh cracks and creeping evidence.

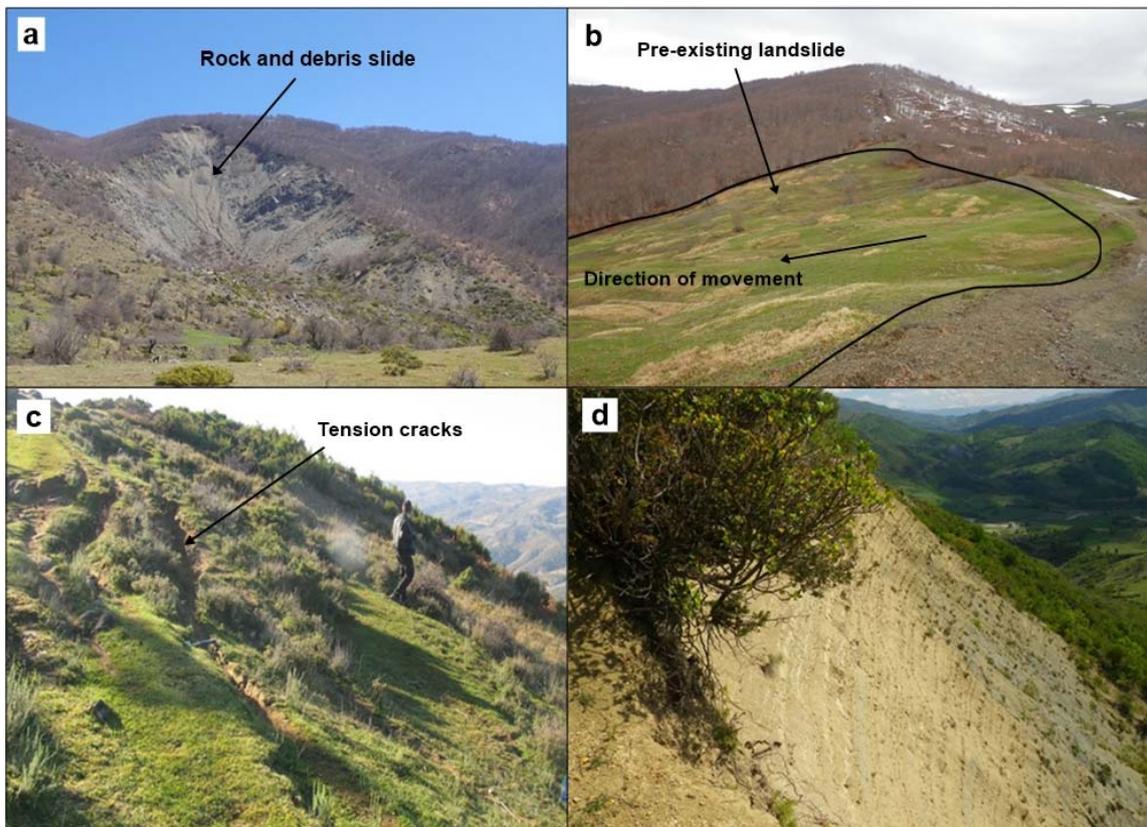
Figure 14. a: New failure (rock and debris slide) in the Potom valley (avoided by the re-route), b: Pre-existing landslide on the flank of a ridge, where a pipeline route runs, c: Tension cracks along a ridge flank, indicating potential for upslope retrogression of pre-existing landslides, d: Very steep landslide back scar extending to the ridge crest, with potential for further upslope retrogression.

Hazards associated with landslides are determined by the movement type expected to occur, as well as their potential to produce adverse consequences. Two main categories of landslide events can be recognized, all of which can occur in the studied Albanian mountains: (i) Reactivation of pre-existing landslides along pre-existing shear surfaces (Figure 14b), that may also involve upslope or lateral retrogression of the main landslide head (Figure 14a,d), or the downslope advance of debris lobes on the toe area, (ii) New failures of previously unsheared ground, often involving the mobilization of the peak material strength. Tension cracks show possible future landslide movement (Figure 14c).

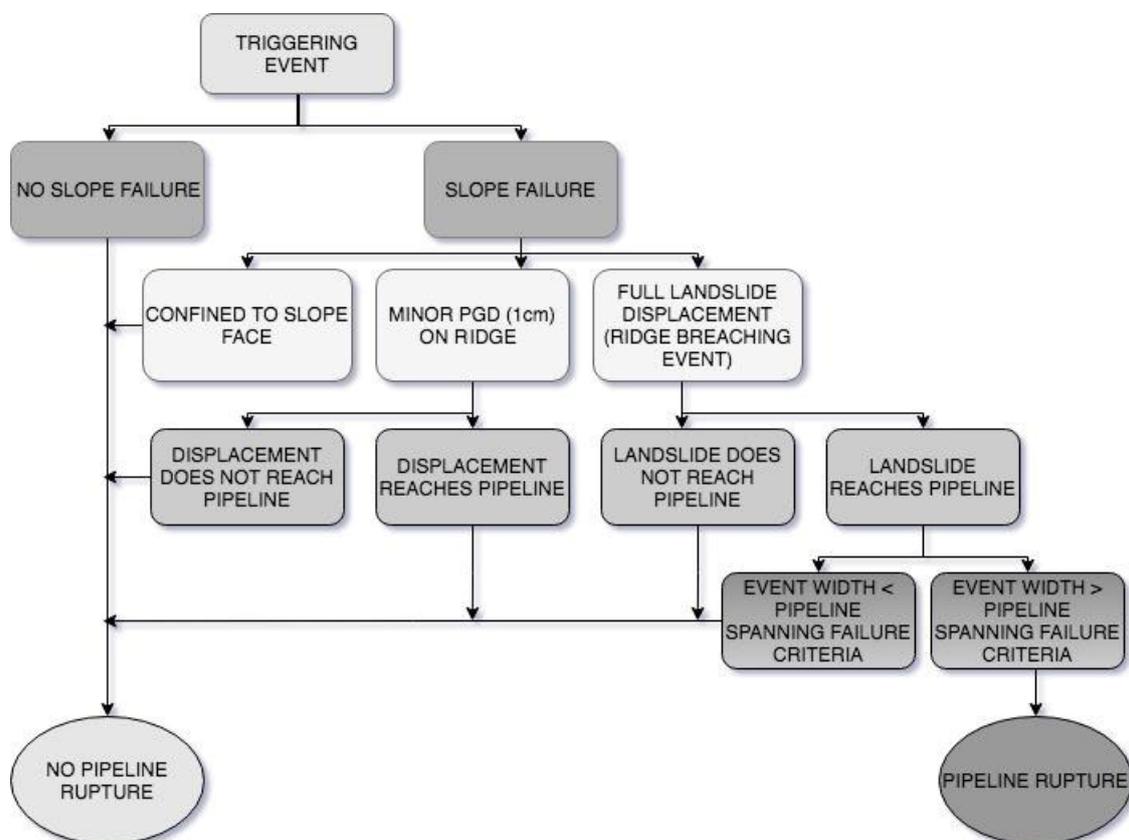
Figure 15. Event tree illustrating the event sequences involved in generating pipeline rupture considered for hazard assessment.

As illustrated in Figure 15, there is significant uncertainty for this event sequence. For example, it is not known whether a strong earthquake will actually cause a major landslide at a particular site. If a landslide occurs, it may be confined to the slope face and not affect the ridge crest, or simply cause minor ground displacement on the ridge crest. Even if the landslide affects the RoW, it may be too small to cause rupture through the development of an unsupported span or simply not reach the

pipeline. These uncertainties can be modelled conceptually by different branches of the event tree shown in Figure 15.

Figure 15 presents a simple logic tree risk model that incorporates all these key issues, leading to the “No” to “High” Risk classification of all the identified hotspots. The implemented risk assessment scheme was based on six evaluated parameters. Three parameters describe the potential impact of an event on the pipeline, namely the hazard potential: (i) Landslide area; (ii) Landslide depth, and (iii) Proximity to pipeline, while the other three are associated with the event likelihood (probability): (i) Landslide activity; (ii) Ground quality, and (iii) Slope. These parameters were each assigned a value from 1 to 3 and a weight factor, depending on their significance for the assessment (Table 3).

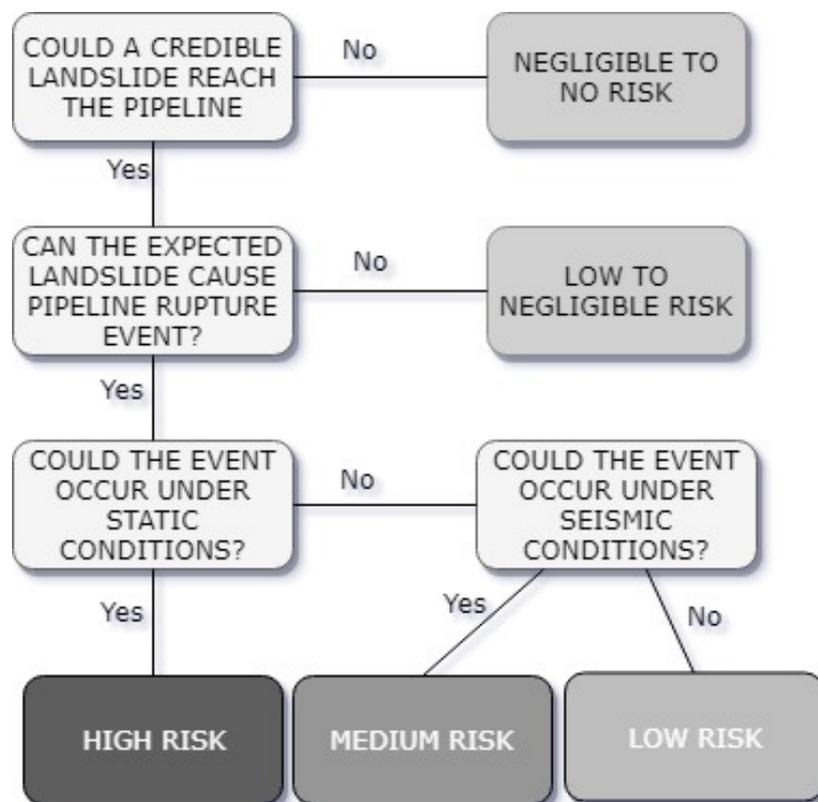
Figure 16. Landslide risk model employed developed in the present work.

provides the framework for estimating the chance of pipeline rupture at each of the 82 landslide sites in Albania (Figure 16). For the risk assessment, judgements were made for each site regarding several key issues:

- *Could a credible landslide event reach the pipeline?* (Figure 16) Answering this question requires a judgement to be made about the size and intensity of the “expected landslide event” that could occur at a particular site, based on the current knowledge of the geological and geomorphological conditions. Clearly, the farther the landslide is from the route, the larger the event would have to be, while in many cases it was not considered credible for a landslide to reach the pipeline RoW.

- *Given that the expected landslide has reached the pipeline, could the landslide cause a pipeline rupture event?* (Figure 16) This involves a judgement about the potential for the landslide to generate conditions that exceed the simple displacement or spanning failure criteria. At several sites, the expected landslide was judged to be too small or shallow to cause pipeline rupture. However, at sites where several major landslides are found that could impact the pipeline, the rupture is considered as very probable.

- *Given that a pipeline rupture event is possible, could the expected landslide be initiated under static conditions (i.e., triggered by climatic factors such as heavy rainfall or rapid snow melt)? If the site is stable under static conditions, could the expected landslide be initiated by a low-frequency strong earthquake (non-static conditions)?* (Figure 16) This judgement was based on the current knowledge of the geological and geomorphological conditions at a particular site, supported by the findings of static-case slope stability analyses at seven indicative sites. It is noted that for the static and non-static (seismic) stability analyses, landslides were assumed to be triggered in those cases where the Factor of Safety was less than 1.0, and, because of uncertainties about the ground conditions and groundwater levels, where the Factor of Safety was marginally above 1.

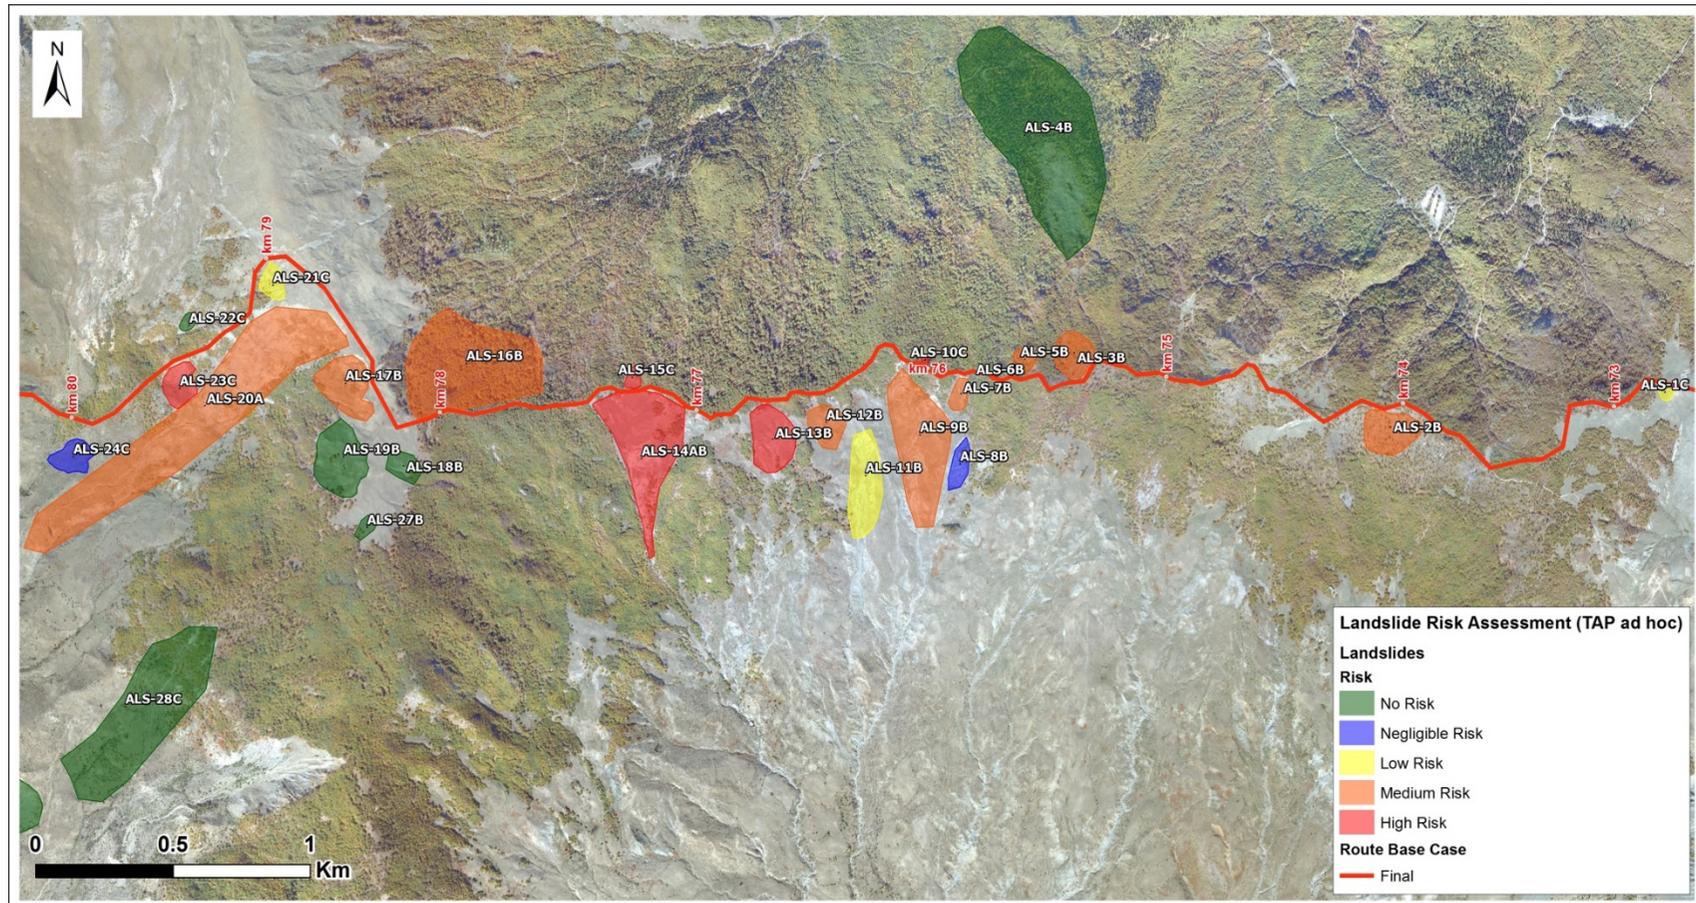
Figure 17. Landslide risk assessment results for the pipeline route from approximately 73 to 80km (area north of Panarit village). The later presented example of landslide ALS-14AB is shown at the centre-left part of the section (77 km).

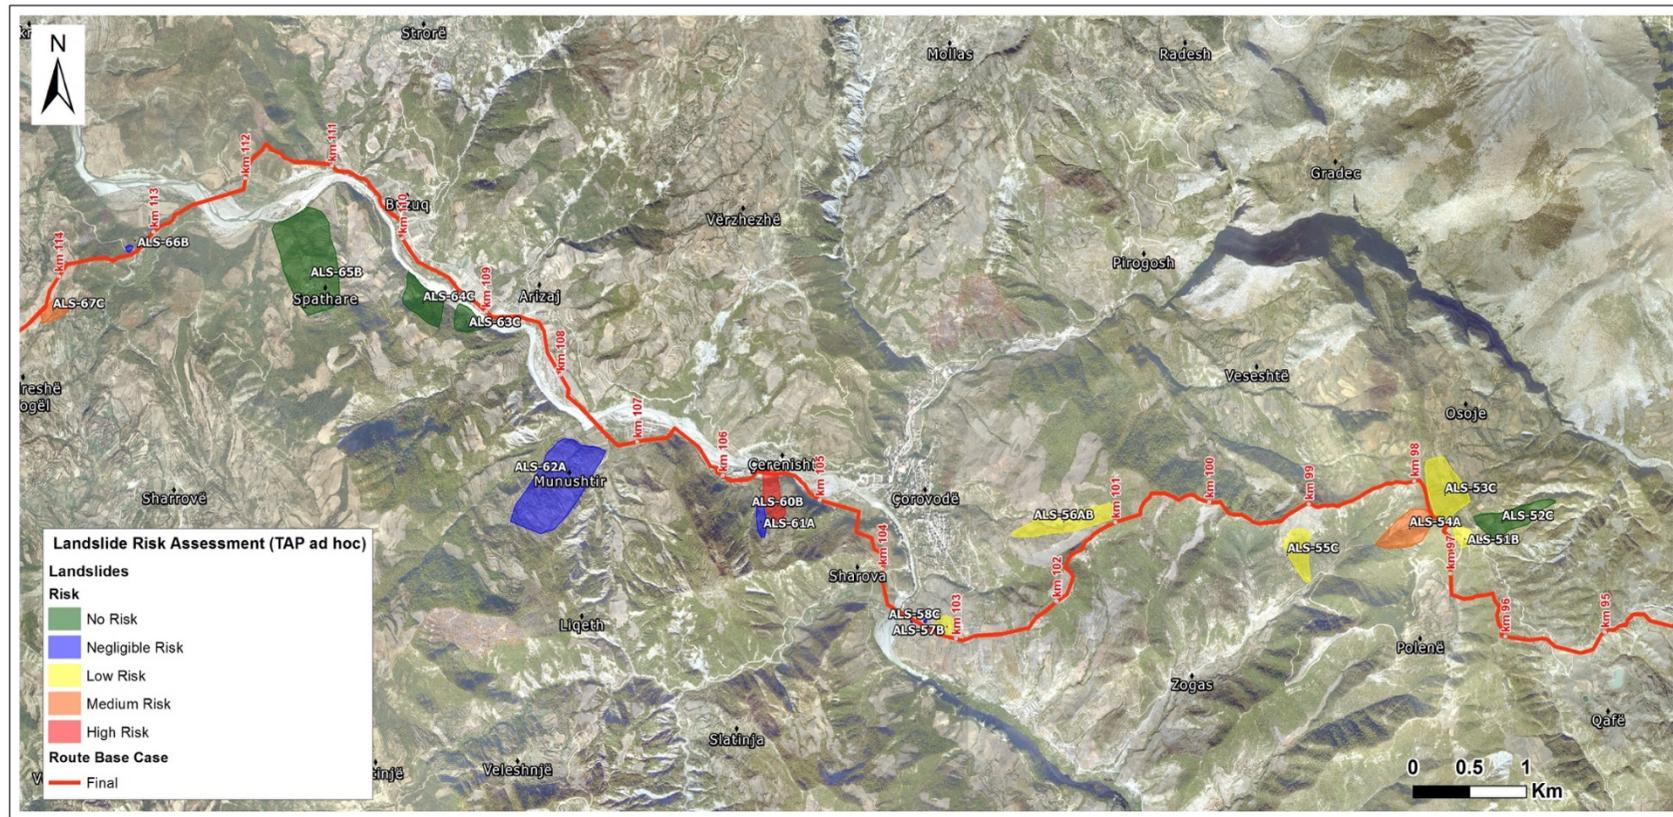
Figure 18. Landslide risk assessment results for the pipeline route from approximately 95 to 114 km. The later presented example of landslide ALS-60B is shown at the central part of the map (105–106 km).

Landslide ALS-60B is located roughly at the 105 km mark of the TAP route (Figure 18), above the bed of the Osumi River. It is a large (approx. 54,000 m²) and deep landslide, and it is in very close proximity to the pipeline. It is an active landslide with moderate steepness ($25^\circ < \text{Slope angle} \leq 45^\circ$) of poor ground quality, with the crest of the landslide almost reaching the top of the slope. From the morphological indications of the landslide crown, which is arch-shaped (Figure 20), the presence of fresh recent transverse cracks (Figure 21) and the back-tilt of the main body (and smaller ones) we assigned a circular failure surface (rotational landslide). Smaller slides were present within the whole sliding mass, a feature typically expected for such a large landslide.

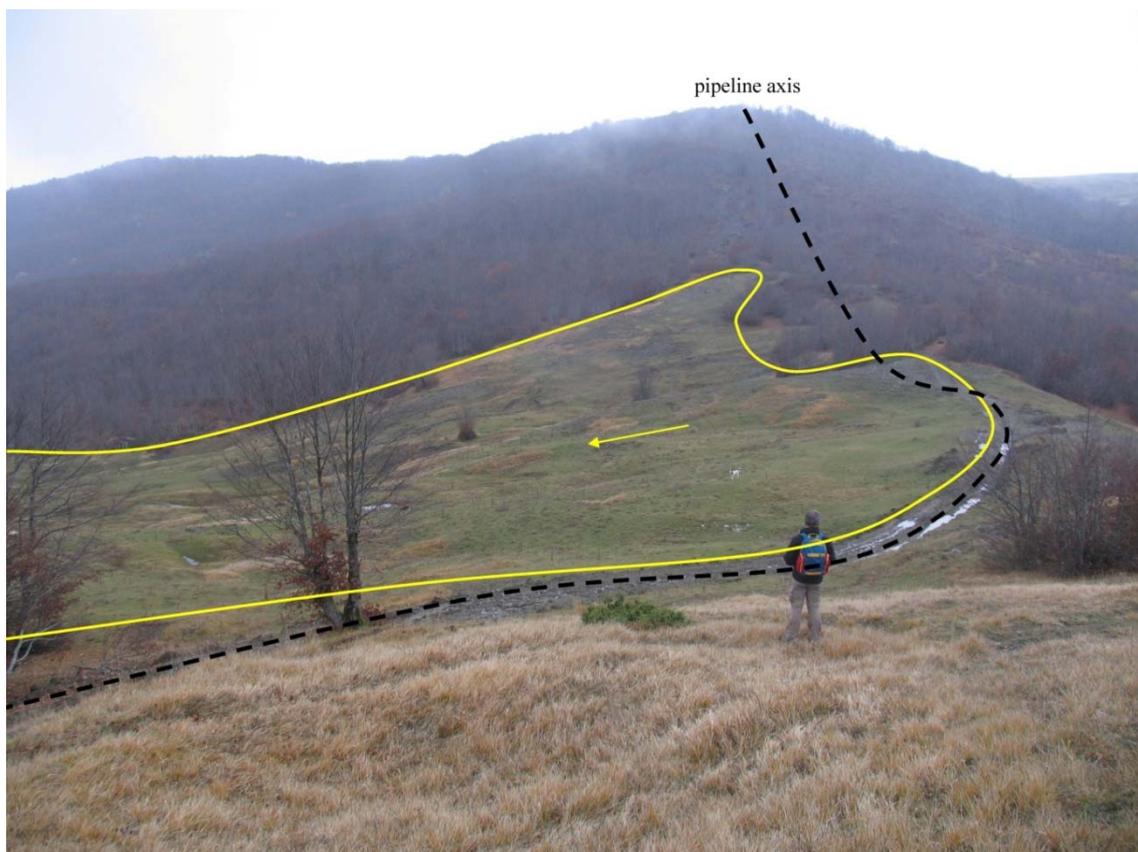
Figure 19. View of the slope at the location of ALS-14AB (Figures 9 and 13). The yellow line indicates the landslide boundaries (arrow pointing towards sliding direction), whereas the black line represents the position of the TAP pipeline axis.

The main hazard posed by this landslide is the reactivation of the sheared ground, resulting in loss of ridge crest and subsequent pipeline rupture.
