Article

Landslide Hazard and Risk Assessment for a Natural Gas Pipeline Project: The Case of the Trans Adriatic Pipeline, Albania Section

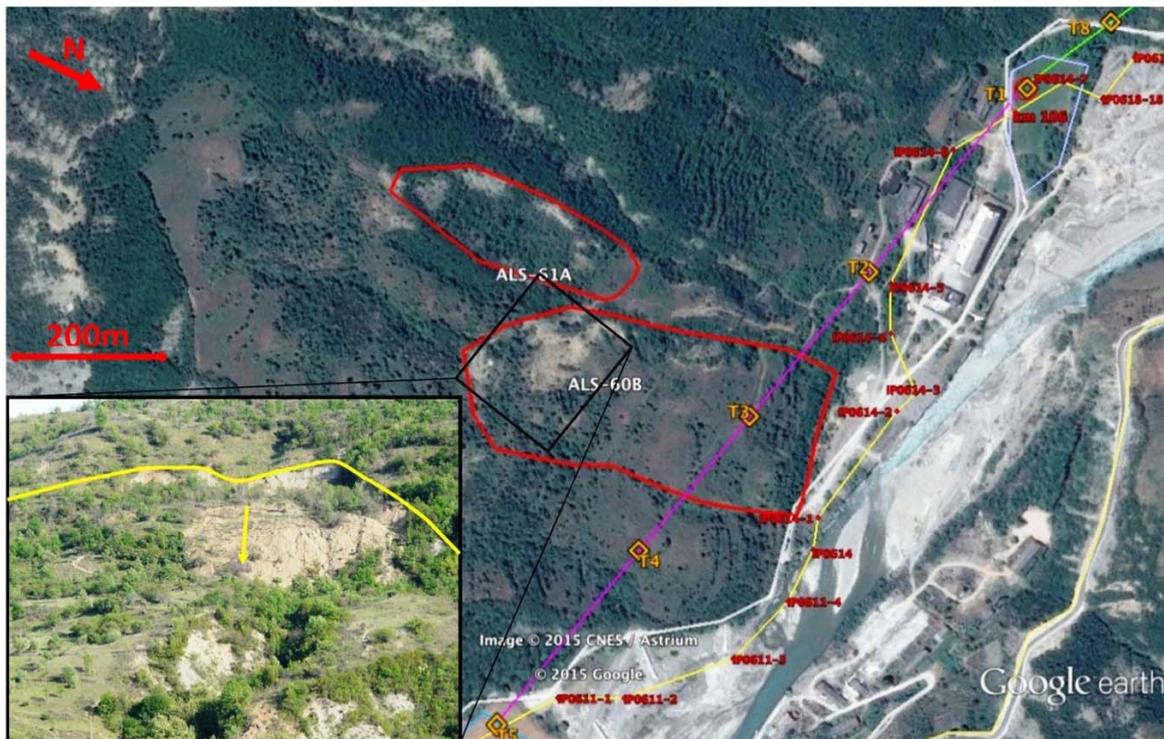
Figure 20. Initially proposed natural gas pipeline route (yellow line) relative to the active landslides ALS-60B (Figure 18) and ALS-61A, and proposed microtunnel (pink axis) solution designed to bypass beneath them, in Corovode area (Albania). The crest of landslide ALS-60B is shown in the inset picture.

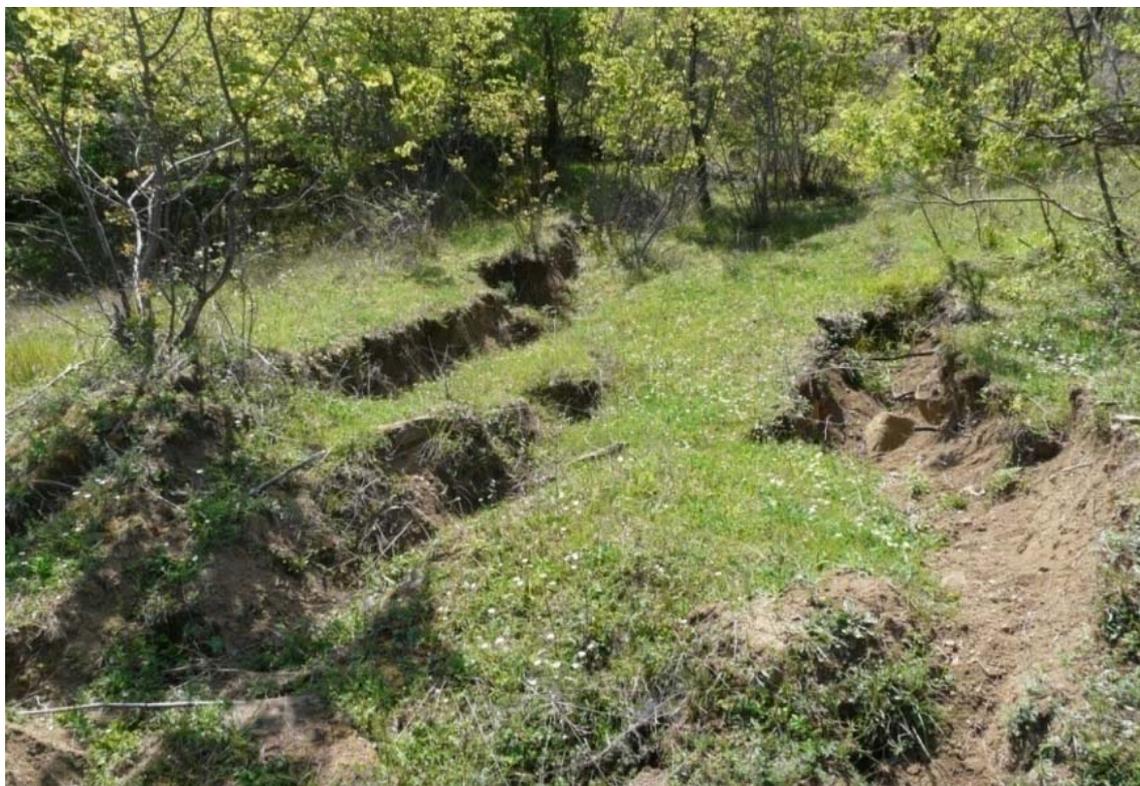
Figure 21. The activity of ALS-60B is manifested by large horizontal and vertical displacements (here some recent tensional cracks) within its mass.

Landslide ALS-60B is located roughly at the 105 km mark of the TAP route (Figure 18), above the bed of the Osumi River. It is a large (approx. 54,000 m²) and deep landslide, and it is in very close proximity to the pipeline. It is an active landslide with moderate steepness ($25^\circ < \text{Slope angle} \leq 45^\circ$) of poor ground quality, with the crest of the landslide almost reaching the top of the slope. From the morphological indications of the landslide crown, which is arch-shaped (Figure 20), the presence of fresh recent transverse cracks (Figure 21) and the back-tilt of the main body (and smaller ones) we assigned a circular failure surface (rotational landslide). Smaller slides were present within the whole sliding mass, a feature typically expected for such a large landslide.
