Article

# The Impact of Sea Shore Protection on Aeolian Processes Using the Example of the Beach in Rowy, N Poland

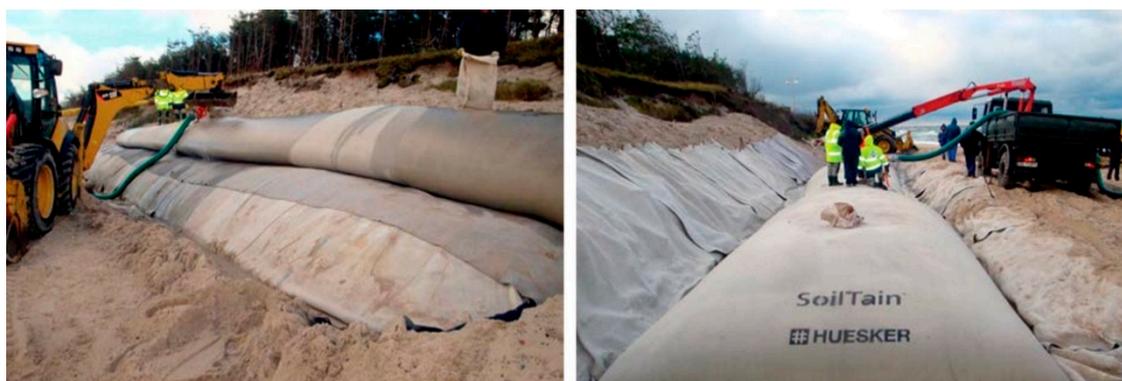
**Figure 1.** SoilTain® tube during construction works in Rowy, <https://www.huesker.co.uk>.

In Rowy, sea erosion has reduced the width of the western part of the beach to a few meters. Work has been undertaken to increase the width of the beach and protect the shore against marine erosion. The first element of shore protection in Rowy was securing the foredune with a SoilTain® tube (HUESKER Synthetic GmbH, Gescher, Germany). The works were carried out in 2012 [42]. They comprised placing two synthetic sleeves in front of the dune and filling them with sediments from the sea. Each of these two synthetic sleeves was 25 m long, 4.5 m wide, and 1.9 m high (Figure 1). Ultimately, they were to be covered with a layer of sand with a thickness of 0.5 m. After being covered, a small cliff was formed upon contact of the terrace and dunes [42].

Field tests were carried out on 27–29 May 2017, and sand samples were taken 11 months after the beach had been nourished. During field tests, sand samples were taken from the beach surface and from a depth of 20 cm. Samples were collected using a small spatula with a width 0.05 m. A total of 58 samples were collected, each of them weighing 0.2 kg. Sampling took place on the beach (46 samples), in the forest (15 samples), and in the holiday resort (7 samples). On the beach, sand was sampled from accumulations forming shadows and micro-shadows. In the forest growing on the foredune, it was sampled from aeolian covers, shadows, and drifts. In the holiday resort, samples were taken from aeolian tongues. Sand samples were taken according to the east-west arrangement (lower and upper beach and forest). Several samples were collected in the forest and at the holiday resorts where there were aeolian forms (aeolian tongues). Sampling points can be found in Figure 1.

Results of grain size analysis in 58 samples taken from sandy accumulative and deflation forms indicated sedimentological variation of sediments (Table 3). Figure 1 shows the location of sandy samples taken. Because several samples were collected at a short distance from each other, not all points are included in the figure. In most samples (56), sorting fell in the range of 0.3–1.0, indicating transport of sand under similar conditions (Figure 7). The mean grain diameter emphasized differentiation in grain size and sediment type. In this case, the largest number of samples (49 samples) fell in the range of 1.2–2.0 phi (logarithmic scale), which indicates large similarity of sediment. The sand coming from the surface of the beach (both bottom and erected) was fine and medium grained, moderately well and well sorted. Samples from the aeolian pavement were coarse grained and well sorted. Only the P1P1 sample, which came from the breaking wave zone, was very well sorted, and the coarse sand sample from point P1P7 was poorly sorted (Table 3). Samples taken from shadows and sand coverage contained fine-grained and medium-fine sand, which was well sorted. Samples from aeolian pavement in the vicinity of aeolian shadows were coarse and moderately and well sorted. Samples from the sand coverage in the holiday resort (Samples Nos. 41–44) did not differ in diameter and sort from other samples from the beach (14–17). This testifies to the homogeneous material found in the source of deflation: the nourished beach.

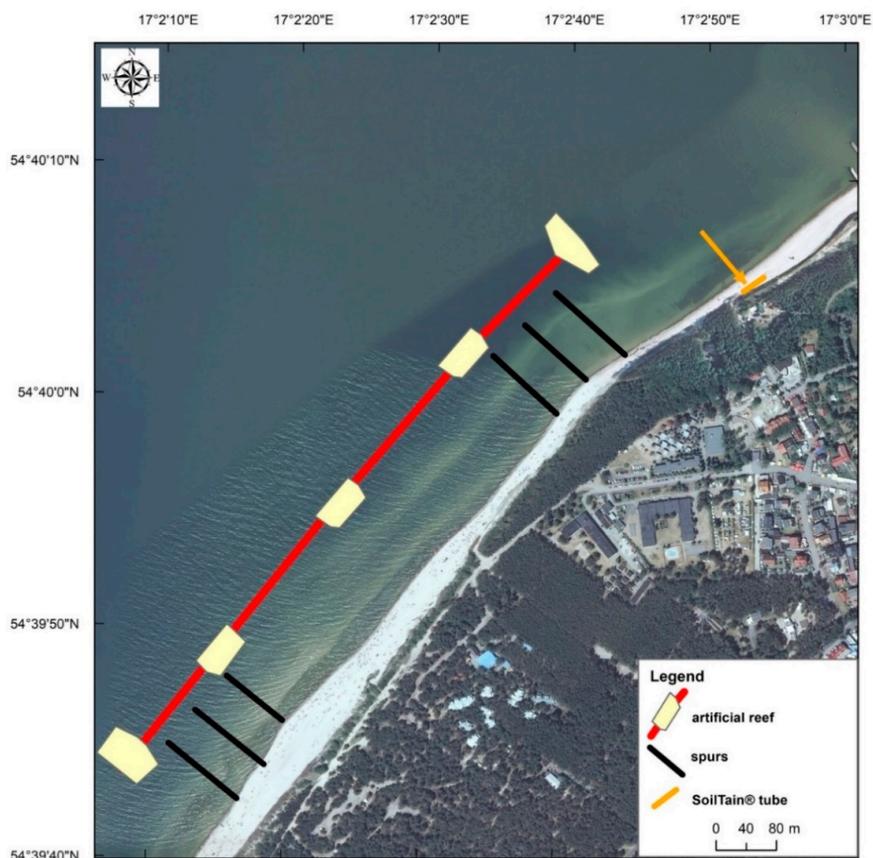
**Figure 2.** Types of protective elements used on the beach in Rowy.

Because the shore on the sides of the tube was still subject to erosion in 2015–2016, artificial reefs (breakwater) with a total length of 750 m (five sections of 150 m each) were laid in the shoreface at a depth of 3.5–4 m, at a distance of 170 m from the shoreline [29]. Three spurs were built, and beach reconstruction was also carried out (Figure 2). The beach level after reconstruction was 0.7 m higher than assumed when using a tube. The height of the upper part of the beach was 3.0 m, and the lack of a scarp and biotechnical protection at the beach and forest border resulted in increased aeolian transport of sand from the beach to the forest, to the access road, to holiday resorts, and to recreational areas (Figure 3A–C).

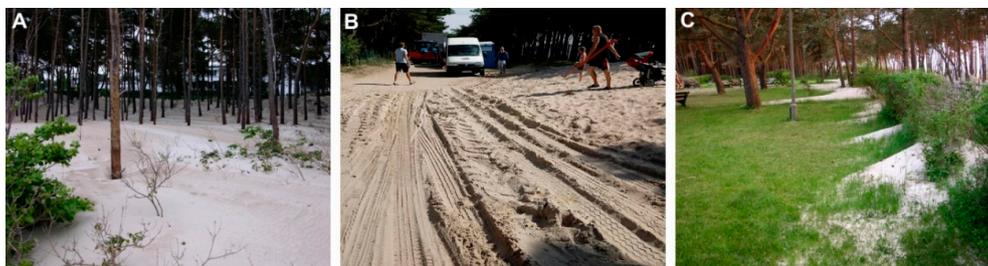
**Figure 3.** Examples of the effects of aeolian processes: (A) sand-covered forest, (B) sand-covered road, (C) shadows and sand cover in a holiday resort.

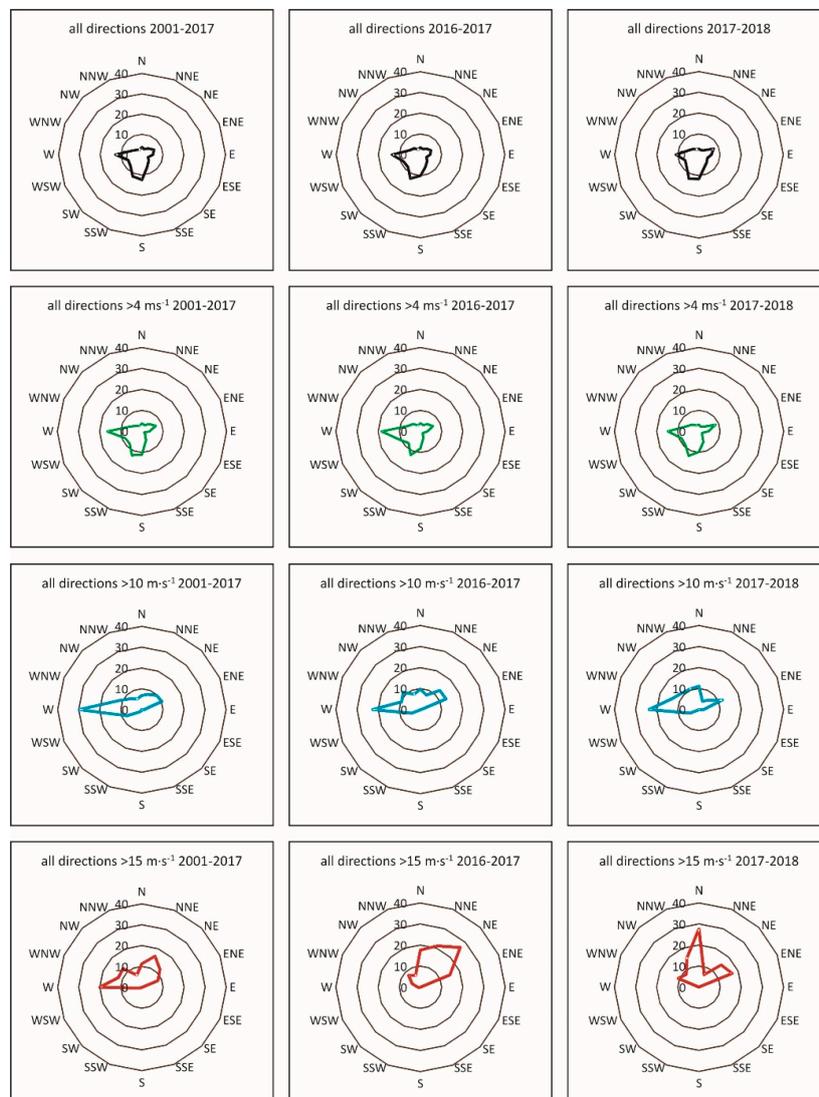
**Figure 5.** Percentage of all wind directions in the years 2001–2017 and in the long-term period of 15 June 2016–14 June 2017 (2016–2017) and 15 June 2017–14 June 2018 (2017–2018).

Winds from the 180°–225° and 270° sectors most often blew on the central Polish coast (near Ustka and Rowy) in the years 2001–2017 (Figure 5). Their share exceeded 10%. The least frequent winds came from the northern sector, with a share not exceeding 5%. Wind directions that were recorded in the periods 15–14 June 2017 and 15 June 2017–14 June 2018 were very close to the long-term period average (Figure 5). Despite the fact that winds from the 292.5°–45° sector were the least frequent, they had the highest morphogenetic velocities. In the long-term period, the highest wind speed was recorded on 18 November 2004. It came to 26 m·s<sup>-1</sup> for a direction of 300°. The maximum wind speed for the analyzed period (15 June 2016–14 June 2018) was 21 m·s<sup>-1</sup> on 5 October 2016 for the direction 48°–55°. In relation to the shoreline, this direction was onshore and, according to the adopted criteria, did not cause transport of sand into the land. The greatest gust of wind in the years 2001–2017 amounted to 35 m·s<sup>-1</sup> on 18 November 2004.

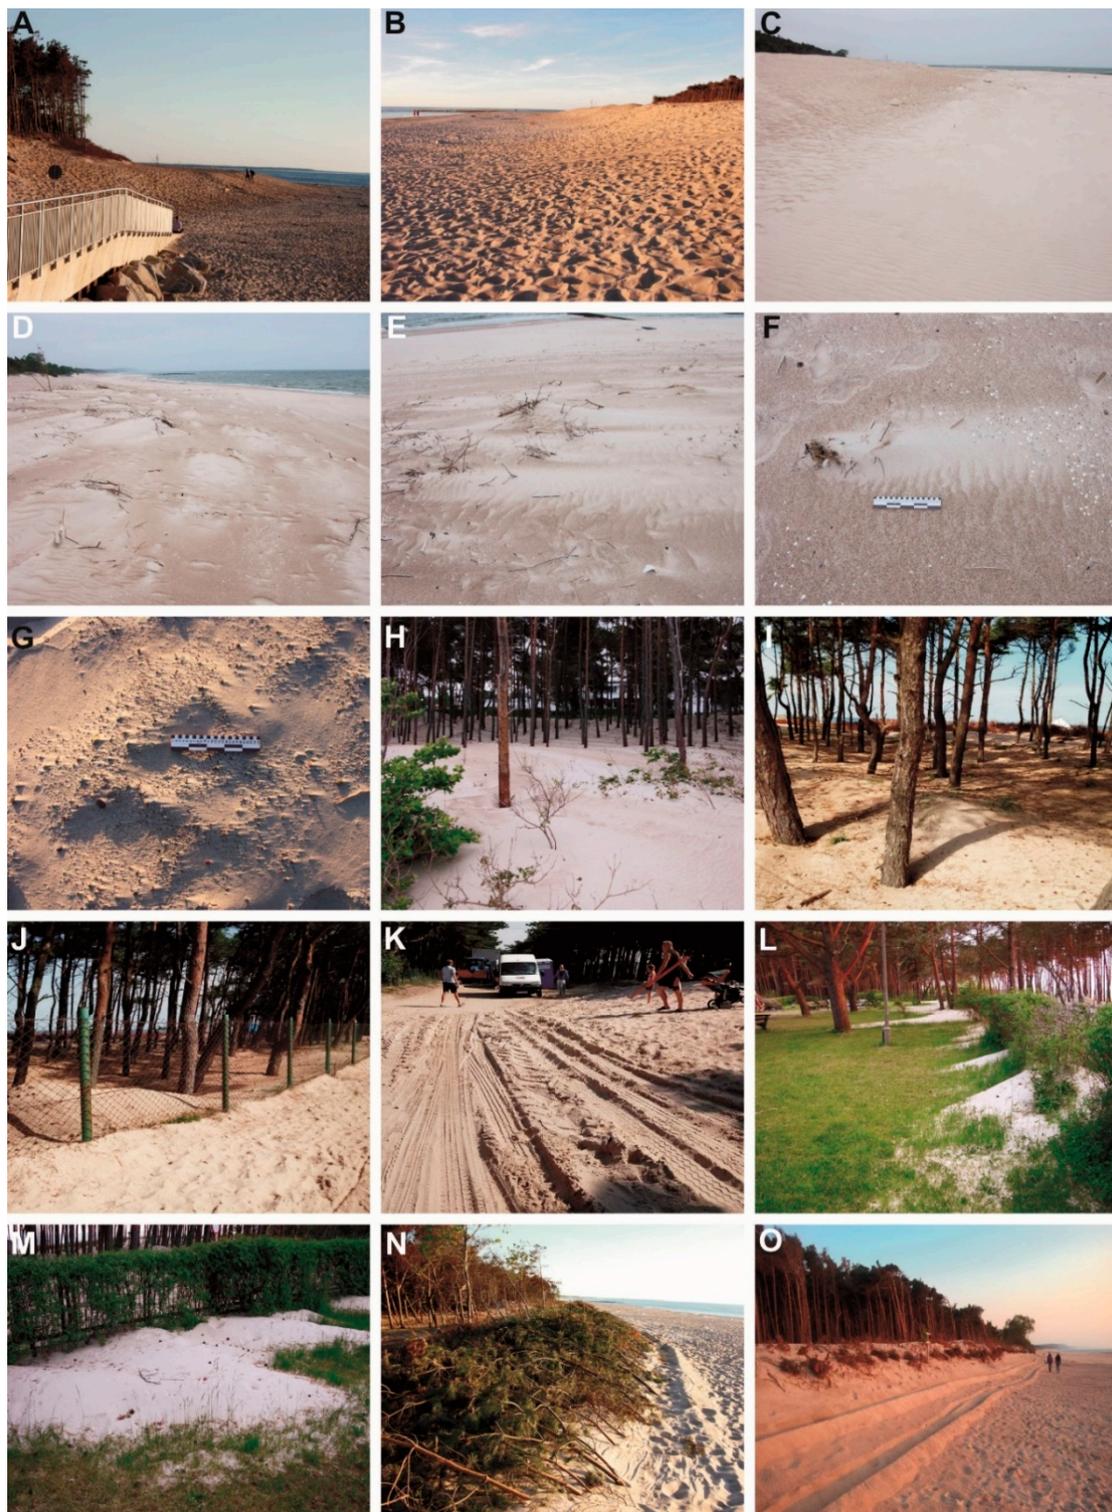
**Figure 6.** Morphology of the analyzed section of the beach and its surroundings (photographs taken on 27–28 May 2017). A–C—new beach, D–F—aeolian shadows, F–G—pavement, made of coarse sand and shells, H–J—sand coverage and aeolian drifts and shadows behind the trees, K—sand on the road, L–M—aeolian tongues in holiday resort, N–O—branches of coniferous and deciduous trees on the border between the beach and the forest.

On the new beach (Figure 6A–C), sand was accumulated in the form of aeolian shadows (Figure 6D–F), which formed behind clumps of vegetation, branches, and other obstacles. Aeolian shadows [50] reached a height of 0.1–0.5 m, a width of 0.2–1 m, and a length up to 2–3 m, depending on the obstacle's size and height. Micro-shadows formed anywhere with even the smallest obstacles (Figure 6G). They were formed by small stones, cones, or even shells. Dimensions of micro-shadows (width, length, and height) reached a maximum of 0.02–0.04 m. Aeolian shadows and micro-shadows are ephemeral forms. They quickly dissolve due to wind blowing from other directions. What is more, in the summer season, they are trampled and destroyed by tourists. Subsequent winds give rise to new forms.

There are also effects of aeolian erosion in the form of pavement, made of coarse sand and shells, which can be observed on the beach (Figure 6F,G). Surfaces covered with aeolian pavement were clearly visible on the beach surface due to grain size, as well as their mineral composition (Figure 6C,D,F). Hollows were formed before bigger obstacles, in other words deflation niches: traces of wind flowing around the obstacle. In the forest, behind the trees, aeolian drifts and shadows were found. They reached a length of 0.7 m–2 m and a width of 0.2 m–0.5 m. Most frequently, they were low forms with heights of 0.2–0.5 m (Figure 6H–J). The speed of wind blowing from inland directions and its long-lasting impact also led to backfilling of the road and the neighboring holiday resorts (Figure 6K–M). The total volume of sand blown and accumulated outside the beach was difficult to estimate, but it reached a value of around 50 m<sup>3</sup> only on a section of the buried road during one event. The average thickness of the sand coverage and accumulation in the forest was 0.3 m. In total, about 6000 m<sup>3</sup> of sand were found in the forest. The beach area has dropped as a result of aeolian processes by 0.17–0.25 m per year.

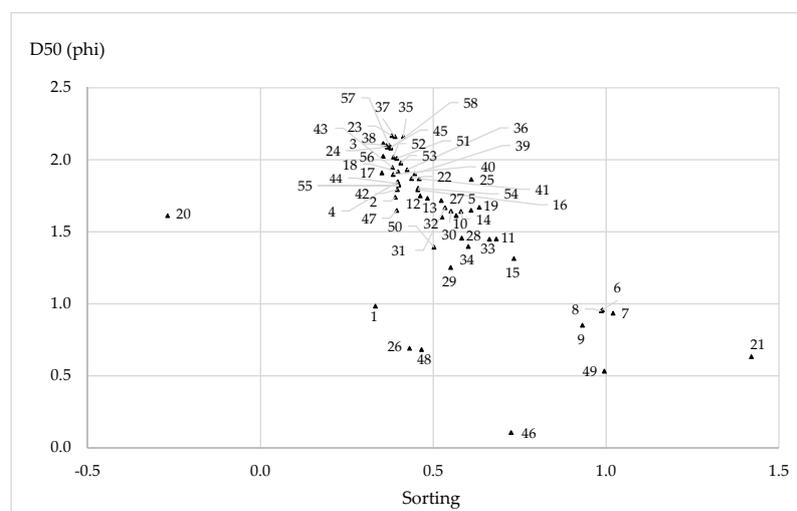
Figure 7. Sedimentological characteristics of analyzed sandy samples.

To sum up, the analysis of sedimentological indicators (Figure 7) showed that samples can be split into three groups. Only three samples (20, 21 and 46) did not make reference to similarities in sorting for other samples. When these groups were associated with accumulative forms, it can be seen that only Group 2 (Samples 2, 26, and 48) and Group 3 (Samples 6, 7, 8, 9, and 49) occurred in identical accumulative forms (Group 2, micro-shadows, Group 3, shadows). Samples from Group 1 (most numerous) derived from different forms (sand coverage, shadows, drifts, tongues). A similar distribution in these groups (Group 1) points to similar wind speeds. Transport distance and share of coarser sand fractions were factors significant for other groups.
