A Brief Report of Pingdi Landslide (23 July 2019) in Guizhou Province, China

Abstract: This short communication reports on a large landslide with a movement of 2 million m³ of soil and rock that occurred on 23 July, 2019 in the village of Pingdi, located in the county of Shuicheng, Guizhou Province, China. This landslide resulted in 42 deaths and 9 missing people. This report describes the preliminary investigation, rescue effort, and possible cause. The total rainfall in the 6 days prior to the landslide was 189.1 mm, which may be held responsible as the major cause. Some recommendations are proposed to reduce human casualties and property losses.

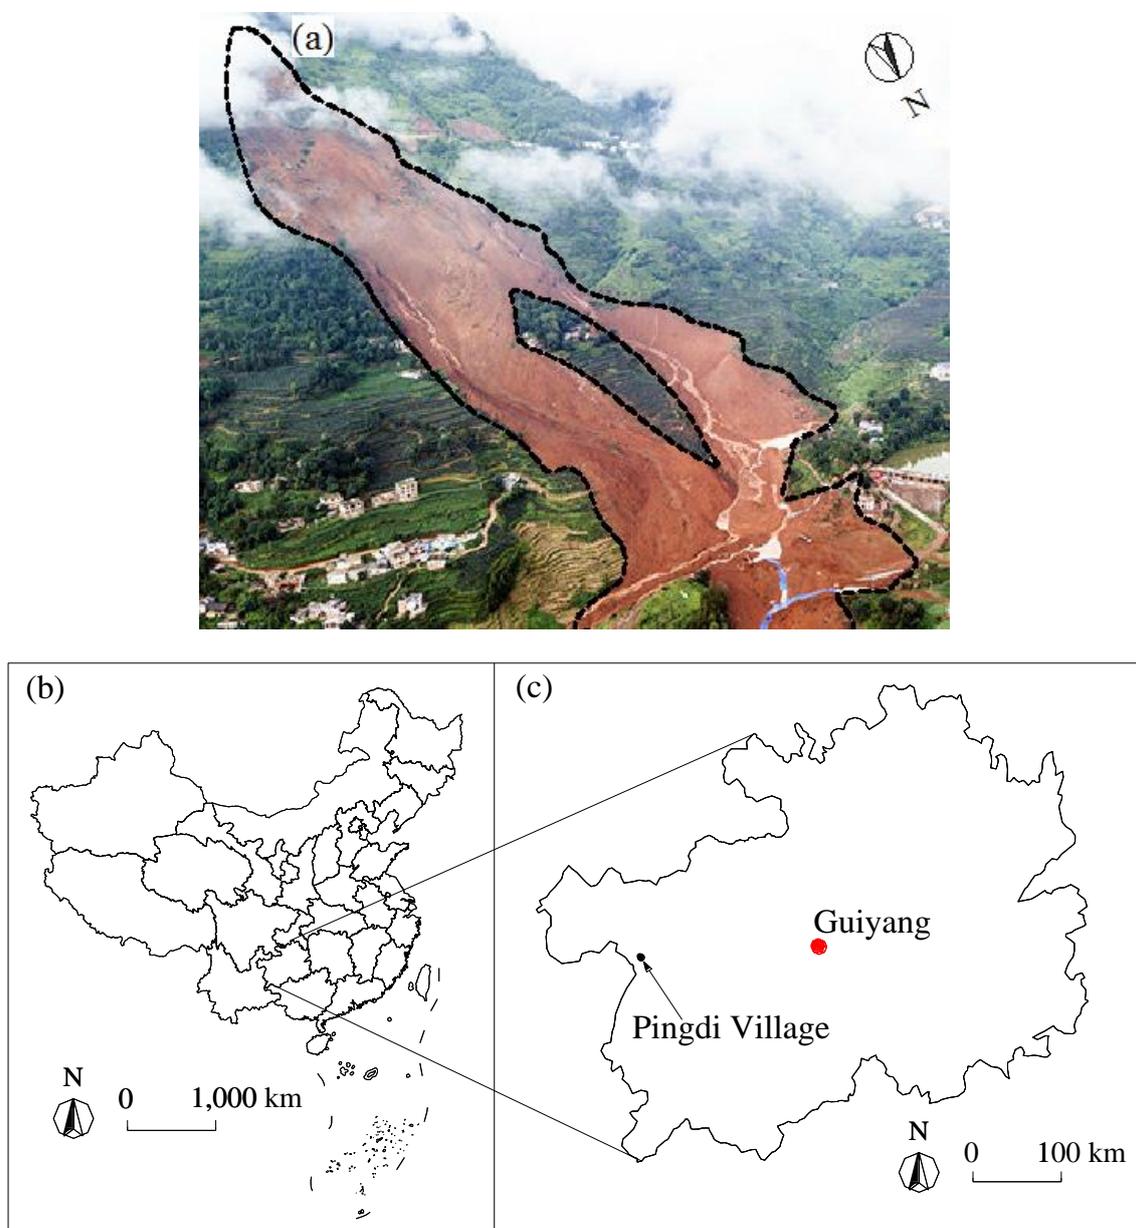
A large landslide occurred in Pingdi village at approximately 9:20 p.m. on 23 July (see Figure 1). Pingdi village, with a population of approximately 6000, is located in the west of Guiyang, the capital of Guizhou Province. In this landslide, approximately 2 million m³ of soil and rock moved down the mountain foot from a height of 500 m (the vertical distance between the highest point and toe of the landslide). The landslide destroyed 27 houses, of which 21 were buried and some were dislodged a distance of approximately 100 m. Figure 2a,b show the houses in a three-dimensional (3D) view from Google Earth before the landslide and a photograph captured after the landslide, respectively. The altitude of the landslide was located at a longitude of 104°40' E and latitude of 26°15' N, and its duration was estimated to be approximately 60 s.

Figure 1. (a) Pingdi village after the landslide (Source: <http://baijiahao.baidu.com/s?id=1639927165371855884>) (b) location of Guizhou, and (c) Location of Pingdi village.

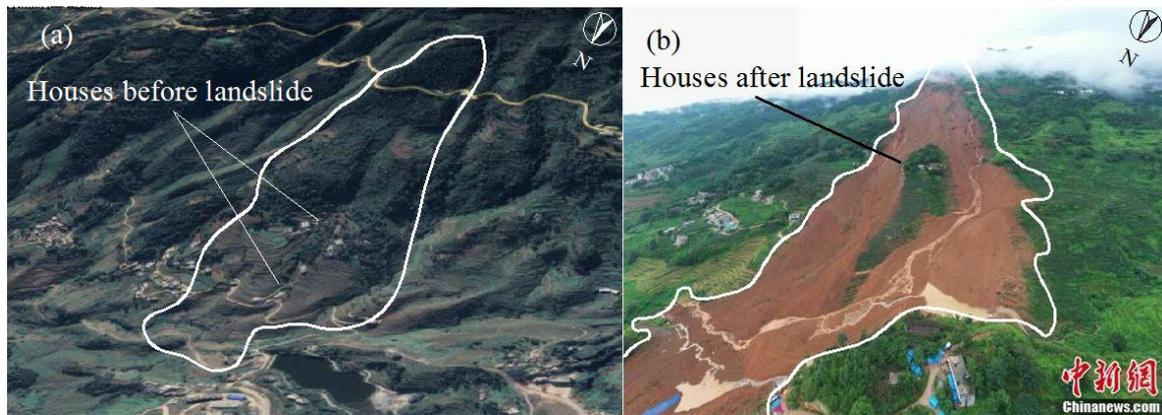
Figure 2. (a) Three-dimensional (3D) View from Google Earth before the landslide (b) Photo captured after the landslide (Source: <http://gz.people.com.cn/n2/2019/0724/c194849-33174976-7.html>).

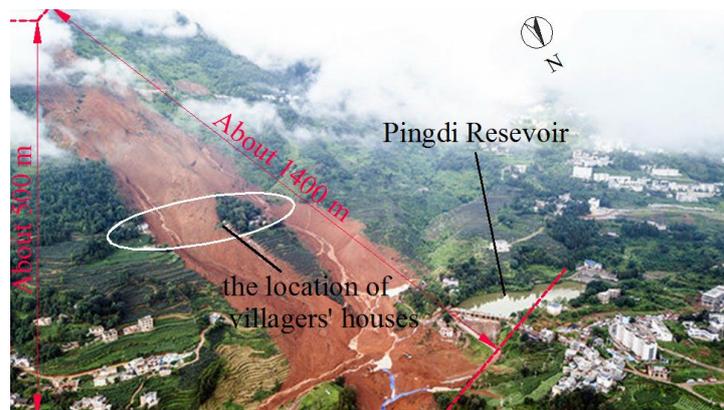
Figure 3 presents an overview of the site after the landslide. The vertical distance and sliding trajectory along the sliding surface of the landslide were approximately 500 m and 1400 m, respectively. The average slope of the landslide was 18° , and its average thickness was 5 m. In addition, barrier lakes were formed by the landslide, which could cause some secondary hazards and exacerbate the consequences of the landslide (see Figure 4). As of 23:00 on July 28, the landslide had resulted in 42 deaths and 9 missing persons.

Figure 3. Overview of the landslide (Source: <http://baijiahao.baidu.com/s?id=1639927165371855884>).

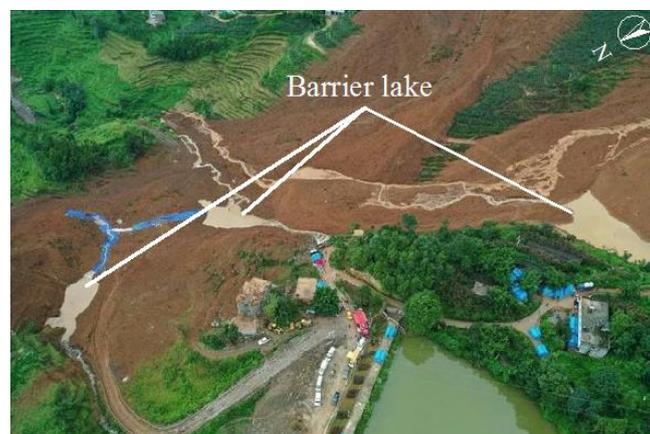
Figure 4. Barrier lakes formed after the landslide (Source: <http://www.chinanews.com/tp/hd2011/2019/07-24/893609.shtml>).

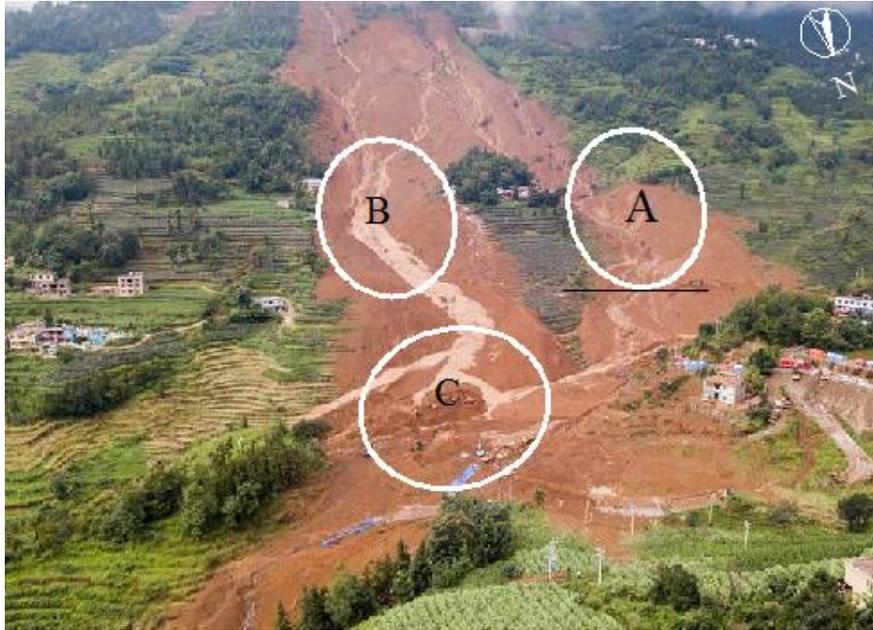
Figure 5 presents three points in the landslide where 21 houses were buried. Continuous rainfall caused another landslide occurrence in point B on July 25, whereas point C received the soil and rock sliding from points A and B. It was estimated that point C had a high risk of debris flow. Therefore, the rescue at point C was suspended on July 25.

Figure 5. Three points A, B, and C of the rescue areas (Source: <http://gz.people.com.cn/n2/2019/0724/c194849-33174976-2.html>).

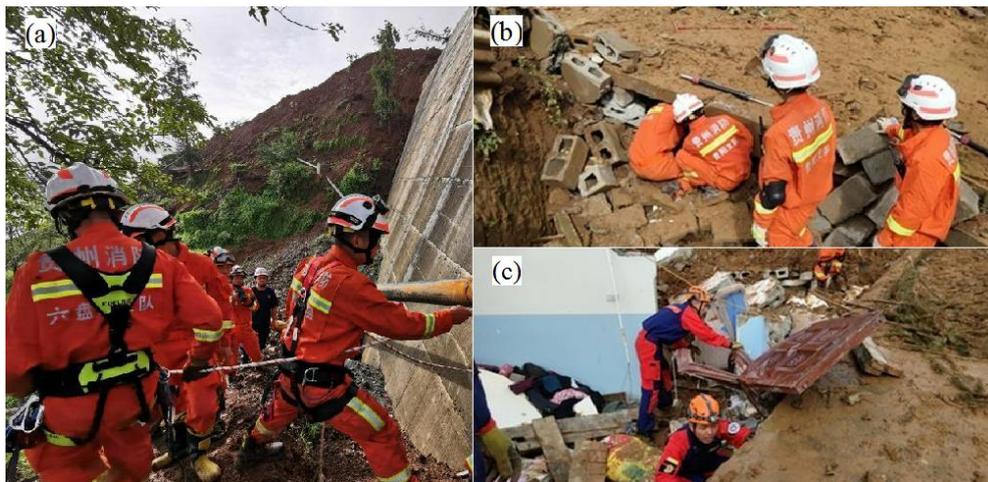
Figure 6. Rescue activities (a) Firefighters clearing a barrier (Source: <http://www.chinanews.com>) (b) Firefighters rescuing people from buried houses, and (c) Rescue team rescuing people from buried houses (Source: <http://www.360kuai.com/> (b,c))

More than 1500 people were on the site to rescue victims immediately after the landslide, and more rescue teams arrived in the following days including firefighters, police, mine rescue professionals, the Guiyang Tunnel Rescue Team, the Blue Sky Rescue Team, and other civilian rescue teams. On the day of the landslide, the Department of Emergency Management of Guizhou Province immediately dispatched 400 tents, 400 quilts, and 1000 raincoats, as well as lighting equipment, drinking water and food. Other rescue supplies began arriving in the following days. In addition, numerous vehicles and helicopters were involved in the rescue activities. Rescue teams used helicopters to transport the injured (including two children) to the Guizhou provincial hospital for treatment. As shown in Figure 6a, firefighters cleared the barrier at the site of the landslide and drained the barrier lake (see Figure 4) to prevent secondary disasters. However, another landslide occurred at point B (see Figure 5) on July 25, and a debris flow occurred at point C. Rescue operators had evacuated the people at these two points prior to the second landslide, resulting in no further casualties. The rescue efforts are currently continuing, with 11 people rescued. Figure 6b,c depict the rescue professionals saving people from buried houses. In addition, the government urgently allocated 30 million RMB for disaster relief, and a further 12 million RMB for investing in the rescue activities from the Guizhou Province.

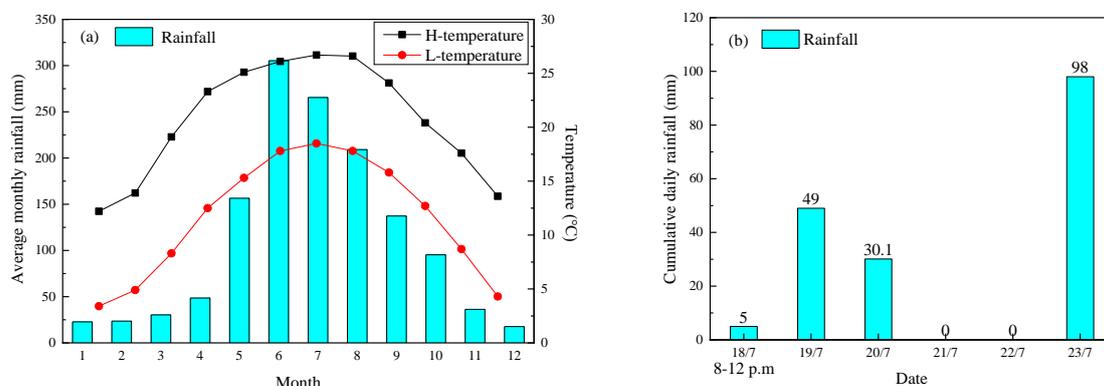
Shuicheng, located in the west of Guizhou Province, is a mountainous area bordering the Yunnan Province. The average annual rainfall in Shuicheng is 1347.9 mm, particularly in June and July, when it is 305.3 and 265.5 mm, respectively (see Figure 7a). Therefore, a landslide probably occurs in June and July. The cumulative rainfall has reached 288.9 mm since this July, and heavy rainfall was concentrated in the first 6 days before the landslide. The rainfall was 49 mm on July 19, 37.1 mm on July 20, and 98 mm on July 23. The total rainfall in the 6 days before the landslide was 189.1 mm (see Figure 7b), which may be blamed as the major cause for this landslide. By authors’ opinion, the landslide may be attributed to continuous heavy rainfall. Empirical evidence [17] strengthen this hypothesis as the rainfall peak of 23 July (98 mm in 24 h) is higher than almost all the rainfall thresholds for landslide initiation reported in a recent review at the global scale. The surface drainage was obstructed at some points where a large amount of stormwater was collected locally, resulting in sever water infiltrations [3,18]. The unit weight of soil increased significantly when it was saturated with water, resulting in an increase in the sliding force. Concurrently, the pore water pressure increased, significantly reducing the soil shear strength resulting in a reduction in the sliding resistance [19,20]. Finally, a catastrophic landslide occurred when the sliding force exceeded the sliding resistance.

Figure 7. (a) Average monthly rainfall, highest temperature (H-temperature), and lowest temperature (L-temperature) in Pingdi village and (b) the rainfall prior to the landslide.

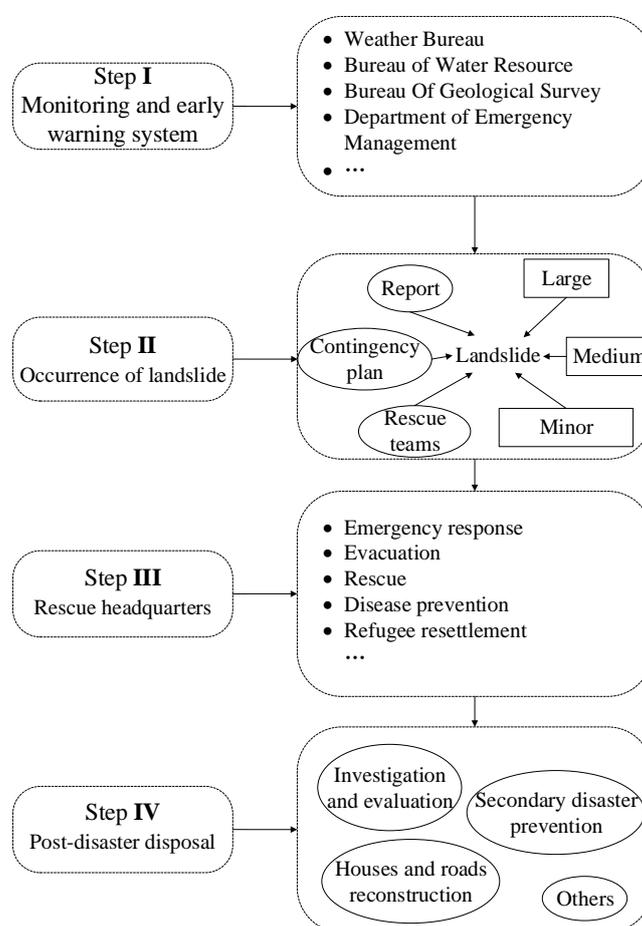
A landslide is considered as a most serious natural disaster, which leads to human casualties and enormous property losses. Numerous measures are used to monitor the occurrence of geological disasters. Instrument monitoring, manual monitoring, station observation and automatic remote sensing methods are commonly used in landslide monitoring [21]. According to the Ministry of Emergency Management of China (MEM), numerous locations remain that may be blind spots for the early warning of geological disasters [22]. Moreover, in the Emergency Response Law of the People’s Republic of China, an early warning of a geological disaster can only be sent to the county level [23]. However, there are numerous villages (particularly some in the mountainous area in the west of China) with poor communication. Therefore, the hazard management department of the county may be unable to inform every village in it [22]. In addition, in the disaster prevention of China, in geological disaster emergency treatment, villagers are not involved in the early warning and evacuation of geological disasters (see Figure 8).

Figure 8. Flow chart of geological disaster emergency treatment in China.

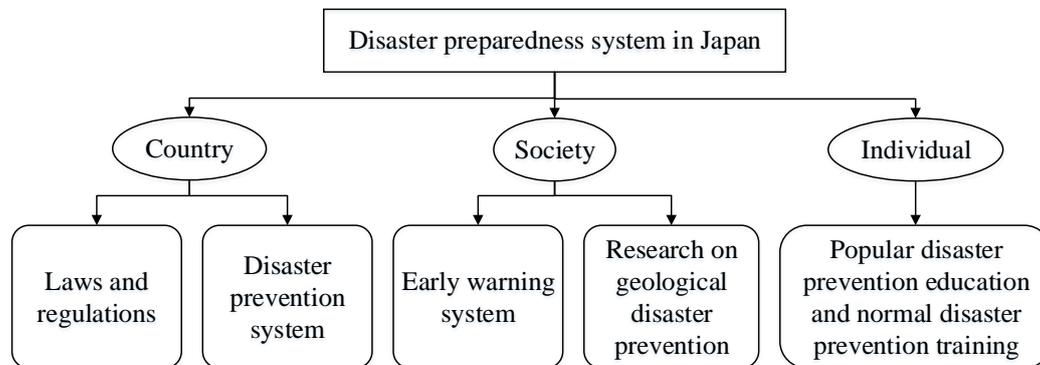
Figure 9 exhibits the disaster preparedness system in Japan. The laws and regulations may provide guidance for disaster prevention. Rescue teams can arrive at a site immediately in a geology disaster with disaster prevention system [24]. In addition, more research on geological disaster prevention may provide more methods to achieve early warning. The most important method to prevent geology disaster is to increase the resilience of citizens; therefore, disaster prevention education and disaster prevention training are necessary [25].

Figure 9. Disaster preparedness system in Japan.

According to the disaster preparedness system in Japan, some recommendations made should be adopted in the geology disasters in China. (1) The government should improve the existing emergency

management legislation and disaster prevention system to strengthen the efficiency and effectiveness of an early warning system. (2) The most important point is that the villagers should reinforce the awareness and knowledge of self-prevention and enhance their ability to save themselves when encountering a natural disaster. In addition, villagers should practice disaster prevention training and evacuation rehearsal regularly.
