Article

Mechanical Connectors to Enhance the Interfacial Debonding of Concrete Overlays

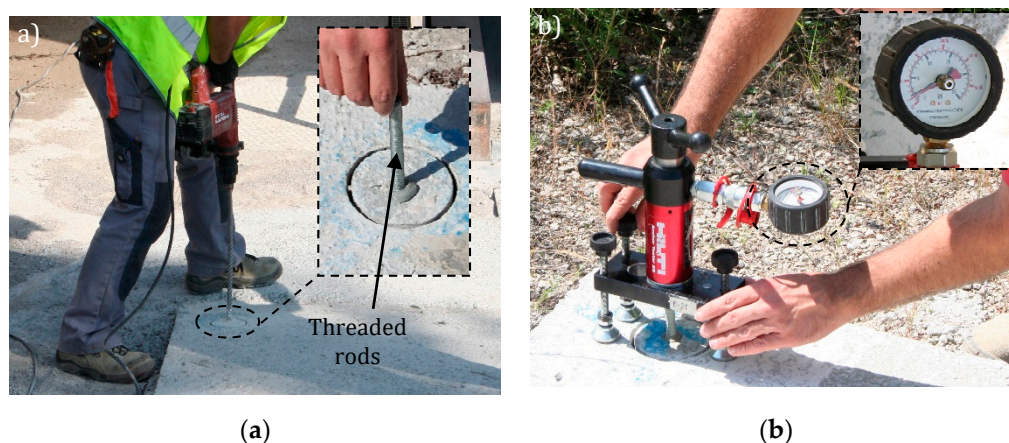
Figure 7. Pull-off test: drilling and placing of threaded rods (a) and anchor tester (b).

The pull-off tests to measure the tensile strength of the interfaces were performed on 7 points after 135 days. As observed in Figure 7a, the tests were carried out on 100 mm diameter cores drilled to the bottom layer of asphalt. Threaded rods were attached to drilled holes in the top side of the cores using an epoxy resin. After that, the rods were pulled using an anchor tester which indicated the maximum tensile force performed during the test with a nominal precision of $\pm 2.5\%$ (Figure 7b).

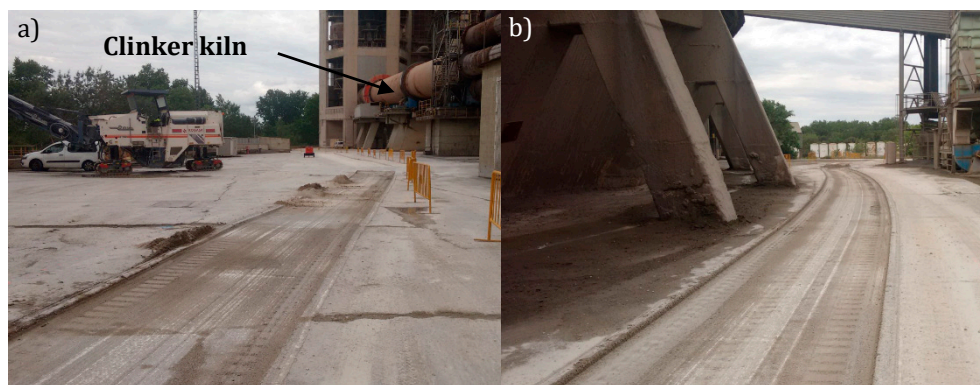
Figure 8. Original concrete pavement (a). The appearance of the cold-milled box (b).

The original pavement was cold-milled to leave a box with the width and thickness of the reinforcement (Figure 8b). Four rows of screws were arranged in the milled surface following the symmetrical scheme in Figure 9. Since normal and shear stresses due to direct and indirect loads mainly concentrate next to discontinuities, the double density of the screws were installed in the borders of the overlay.

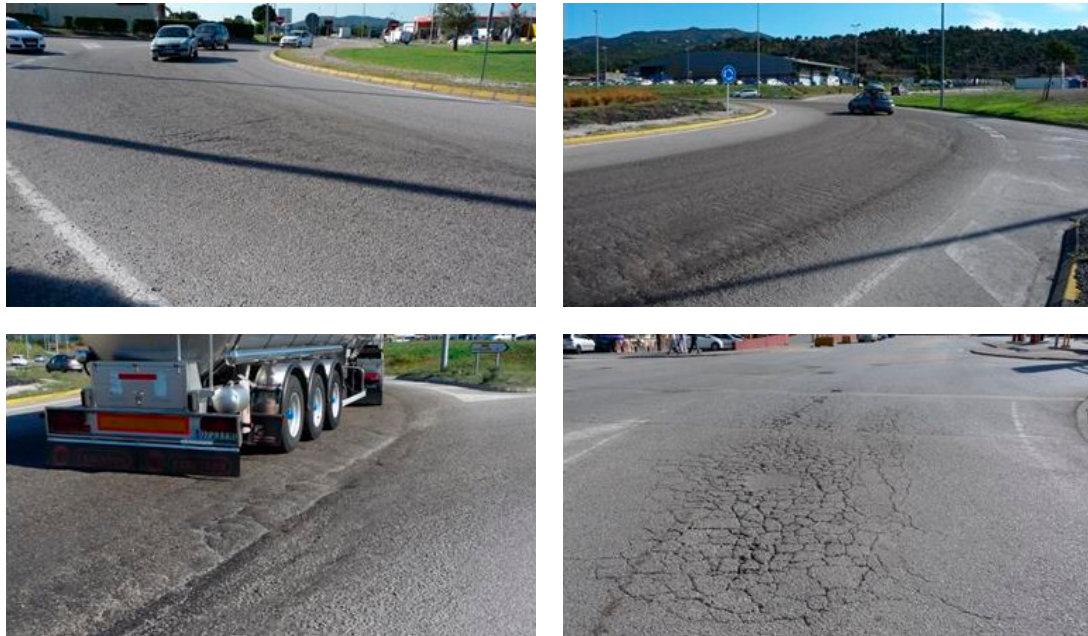
Figure 12. Previous pavement condition of the roundabouts.

Figure 12 shows the visual aspect of the pavement before restoration. The asphalt presented widespread and several damages due to fuel spills combined with traffic fatigue (bitumen loss, cracking, wheel path rutting, potholes, etc.). Visual inspection and load plate tests were performed on all four roundabouts to determine the most severely affected regions. Four areas were detected with an exceptionally low ballast coefficient (K_{60}), while for the rest of the pavement a Winkler coefficient of 391 MPa was assumed as a representative value.

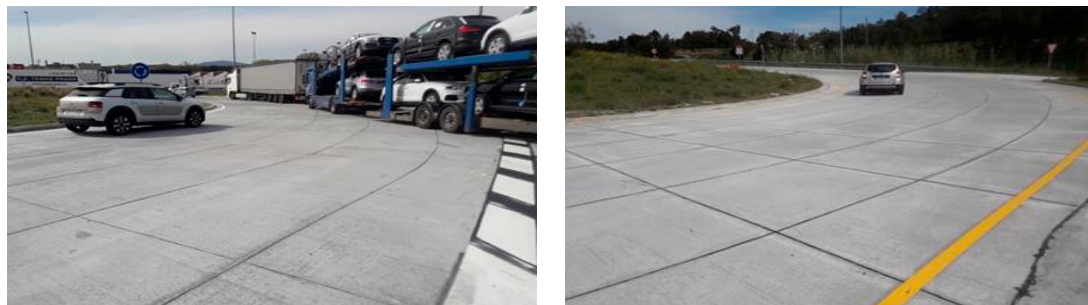
Figure 15. The final appearance of the roundabouts.

Figure 15 shows the finished whitetopping of the roundabouts with open traffic. The time between construction and opening to traffic was between 7 and 15 days to ensure that at least 80% of $f_{c,f} = 5.0$ MPa was achieved. Average depths measured with the sand patch test (UNE-EN 13036-1:2010) were larger than 1.10 mm, indicating that surface finishing was suitable even for speeds higher than 100 km/h.
