Article

ERS-1/2 and Sentinel-1 SAR Data Mining for Flood Hazard and Risk Assessment in Lima, Peru

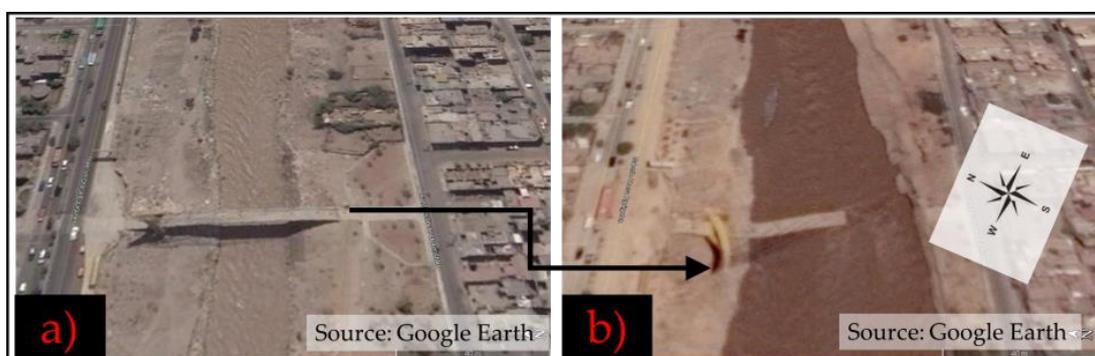
Figure 11. Google Earth imagery (© 2020 Maxar Technologies) acquired on (a) 28/01/2017 and (b) 21/03/2017 showing the Talavera Bridge prior and after the collapse due to the 16/03/2017 flood event, respectively. In (b) the increase of the water flow of the Rímac River is apparent.

Another example was found in the Talavera Bridge, in San Juan de Lurigancho. As also documented in a video published online [88], the part of the bridge collapsed down into the river water during the flood event occurred on 16/03/2017 (Figures 11 and 12). This bridge had been built only six and a half years before.

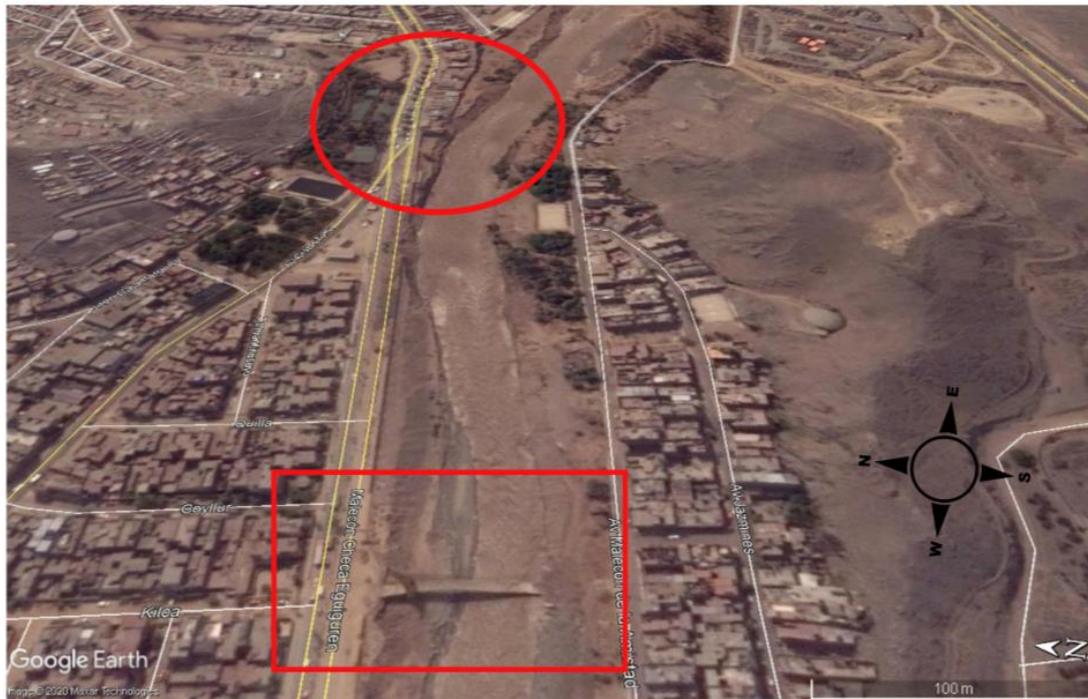
Figure 12. Google Earth synoptic view of the riverbank (red circle; see Figure 10e) and the Talavera Bridge (red square; see Figure 11) collapses on 26/03/2017.
