Article

Cyclic Behavior of Anchored Blind-Bolted Extended End-Plate Joints to CFST Columns

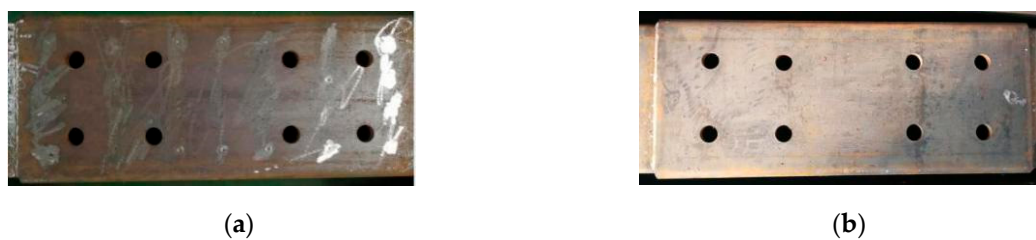
Figure 3. Connection mode of the C-channel. (a) With plug welding and (b) Without plug welding.

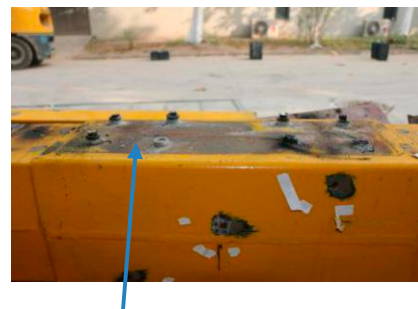
(e) Slight bulging at the bolt holes

(f) Slight outward deformation

Figure 8. Failure mode II (specimens with a weak end-plate). (a) SJ-3; (b) SJ-5; (c) SJ-6; (d) Welding fracture in specimen SJ-3; (e) Column wall in specimen SJ-3; (f) Column wall in specimen SJ-5.

For failure mode II, the following test phenomena were typically observed: the anchored blind bolts experienced shank rupture; the outward deformation of the steel tube wall was very small, and there was only slight bulging at the bolt holes; and the core concrete in the panel of the joint was also basically intact. Therefore, the bolts became the weakest component. Specimens SJ-3, SJ-4, SJ-5, SJ-6 and SJ-8 failed in this mode, as shown in Figures 8 and 9. As the drift ratio increased, a gap appeared between the end-plate and the steel tube column, but the corresponding gap was significantly smaller than that in the first failure mode, indicating that the gap in failure mode II was mainly due to the elongation of the bolt shank itself, whereas the gap in failure mode I was mainly due to the bolt pull-out after the anchorage failed.

For specimens SJ-3, SJ-5, and SJ-6 with thin end-plates, the thin end-plates underwent significant deformation, which was similar to that in SJ-1; when the inner row of blind bolts in the tension zone were ruptured, the transverse weld fractured at the interface between the end-plate near the outer bolts and the steel beam, as shown in Figure 8d. The outward deformation of the steel tube wall in specimen SJ-5 was slightly larger than that in SJ-3, as shown in Figure 8e,f. Local buckling was observed at the root of the beam compression flange in specimen SJ-6 with a weak beam. For specimens SJ-4 and SJ-8 with thick end-plates or end-plates reinforced by stiffeners, only slight end-plate deformation was observed, similar to that of SJ-2; the outer row of blind bolts ruptured, and there was no welding fracture, as shown in Figure 9. Because stiffeners were used to strengthen the end-plate, the end-plate deformation of specimen SJ-8 was notably different from that of SJ-6, and the plastic hinge of the steel beam shifted significantly outwards. Moreover, the bolts of specimens SJ-3, SJ-5, and SJ-6 fractured at a larger drift ratio, indicating that the use of the thinner end-plate and weaker steel beam had an improved effect on the deformation capacity.

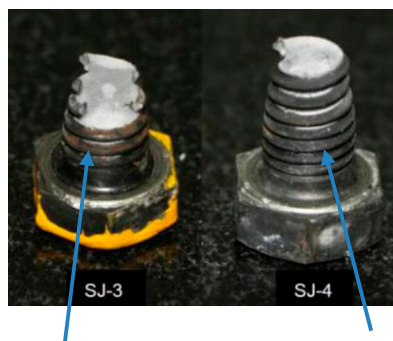
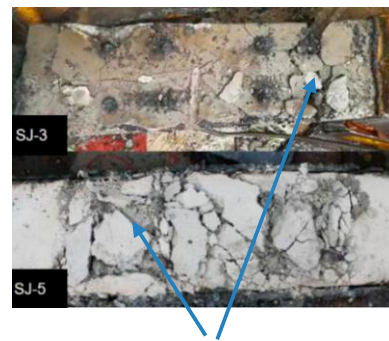
(a) Bending failure Tensile failure

(b) Local concrete crush

Figure 10. Internal damage of failure mode II. (a) Bolt fracture; (b) Core concrete.

The bolt failures in specimens SJ-3 and SJ-4 are compared in Figure 10a. The bolts in specimen SJ-3 failed in flexure-shear mode, whereas those in SJ-4 mainly failed in tension mode. The concrete exposed by cutting open the column is shown in Figure 10b. The concrete in the panel of specimen SJ-3 was basically intact except for local crushing around the expansive sleeve, whose surrounding concrete was likely to experience local cracking under tension. The anchored bolts were not loosened, meaning that the anchorage did not fail and that the concrete could effectively restrain the blind bolt from pulling out. The concrete damage in specimen SJ-4 was similar to that in SJ-3. For specimen SJ-5, some individual anchor bolts were slightly loosened, and the surface concrete was nearly completely crushed, indicating the local failure of the anchorage.

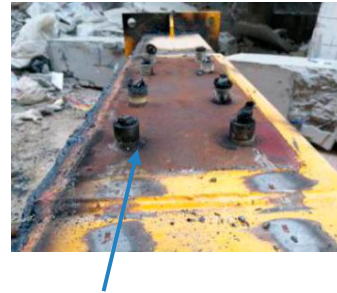
(a) Significant plastic hinge

(b) no significant outward deformation

Figure 11. Failure mode III. (a) SJ-7; (b) Column wall in specimen SJ-7.

For failure mode III, the following test phenomena were typically observed: the steel beam exhibited significant local buckling; there was basically no deformation in the end-plate, and the gap between the

end-plate and the column flange was especially small; no significant outward deformation of the steel tube wall was observed, and the blind bolts did not rupture; and the core concrete in the panel was also basically intact. Therefore, the steel beam became the weakest component. Specimen SJ-7 exhibited this failure mode, as shown in Figure 11. Because a plastic hinge at the root of the beam led to out-of-plane instability in the beam, the loading stopped at a larger drift ratio, demonstrating good deformability.

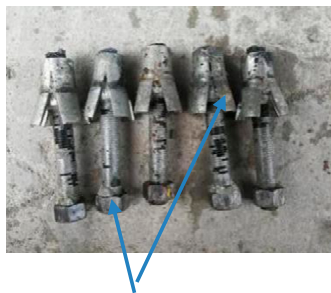
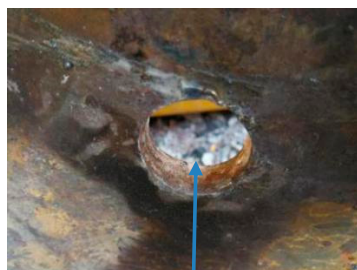
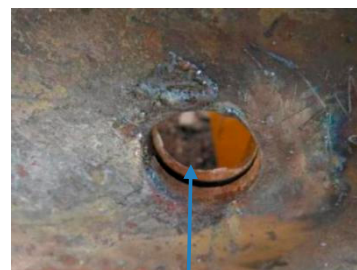
(a) Intact anchored part

(b) Notable scratches

(c) Closely fitting tubes

(d) A significant gap

Figure 12. Failure pattern of the components. (a) Embedded extension of blind bolt; (b) Anchor nut; (c) Bolt holes in specimen SJ-3; (d) Bolt holes in specimen SJ-5.

As shown in Figure 12a,b, for the failure modes described above, the anchored part of blind bolts in the concrete were basically intact, including the bolt sleeve, threaded cone, bolt shank, and anchor nut. There was no damage, such as breaking or bending, for the anchored part. However, notable scratches were found on the anchor nut, apparently caused by the interaction between the mechanical anchorage and the concrete. As shown in Figure 12c,d, for specimen SJ-5, there was a significant gap between the steel tube wall and the C-channel; in contrast, the steel tube and the C-channel fitted closely together for specimen SJ-3. This result implies that the steel tube wall and the C-channel can work well together when a plug weld was adopted between them.

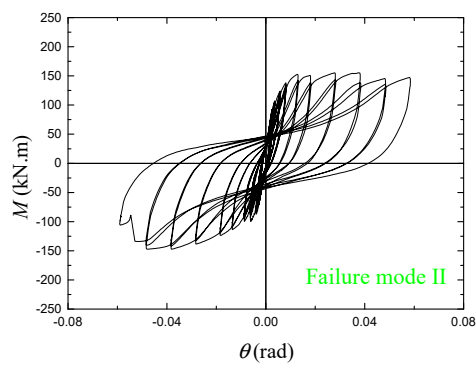
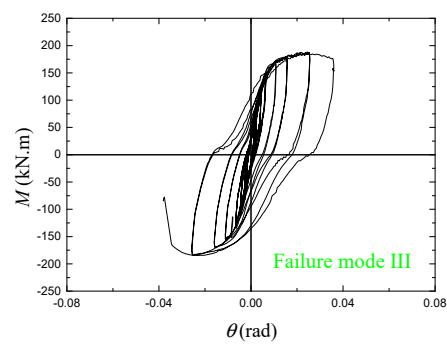
Figure 13. Moment (M) versus rotation (θ) hysteresis curves of the specimens.

The moment-rotation hysteresis curves of the test specimens are presented in Figure 13. The hysteresis curves of specimens SJ-1 through SJ-6 all exhibit a significant pinching effect, whereas those of specimens SJ-7 and SJ-8 exhibit a far smaller pinching effect. The pinching effect was caused by the bulging deformation of the steel tube face, the deformation of the end-plate, the slippage of the anchored bolts and the crushing of concrete. The moment-rotation curve of each specimen basically exhibited a linear relationship in the initial elastic stage. After entering the inelastic state, the hysteresis curve of the specimen gradually became plump. With increasing drift ratio, the pinching effect became more evident.

Specimens SJ-1, SJ-2, SJ-3, SJ-5, and SJ-6 all have a relatively plump hysteresis loop, demonstrating relatively strong hysteresis performance and seismic energy absorption capacities. The energy dissipation in specimens SJ-1 and SJ-2 was mainly realized by the crushing of concrete in the columns and the deformation of the steel tube walls, which was not an expected failure mode in engineering practice. Moreover, specimens SJ-1 and SJ-2, which experience failure mode I, exhibited particularly remarkable stiffness and strength degradation compared with the other specimens, which is attributed to the same reasons mentioned above. However, for specimens SJ-3, SJ-5, and SJ-6, which exhibit failure mode II, the stiffness and strength degradation were not significant.

Due to its failure mode with brittle bolt fracture, the hysteresis loop of specimen SJ-4 is flat, indicating the poor ductility and energy dissipation capacity of the joint. Due to the weak beam used in specimens SJ-7 and SJ-8, a plastic hinge was observed at the root of the beam end, and the hysteresis loop was very plump, reflecting the highest hysteresis performance of the overall joints and subsequently good seismic performance and energy dissipation capacity.

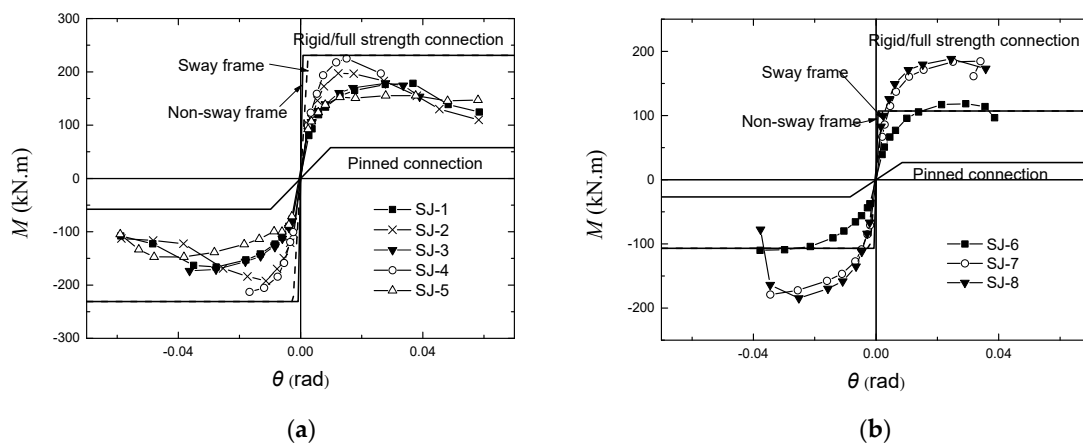
Figure 16. Classification of the specimens. (a) Specimens SJ-1 through SJ-5; (b) Specimens SJ-6 through SJ-8.

According to EC3 Part 1-8 [26], joints can be classified as rigid joints, nominal pinned joints, and semi-rigid joints in terms of their rotational stiffness. The detailed classifications are as follows: for a rigid connection, $K_i \geq k_b E_b I_b / L_b$; for a pinned connection, $K_i \leq 0.5 E_b I_b / L_b$; and for a semirigid connection, $0.5 E_b I_b / L_b < K_i < k_b E_b I_b / L_b$. Note that in these classifications, E_b is the elastic modulus of the steel beam, I_b is the second moment of area for the steel beam, L_b is the beam span, and $k_b = 8$ (for a braced frame) or 25 (for a non-braced frame). According to the flexural resistance, joints can be divided into full-strength joints, nominal pinned joints, and partial-strength joints. The detailed classifications are as follows: for a full-strength joint, $M_u \geq M_{bp}$; for a pinned joint, $M_u \leq 0.25 M_{bp}$; and for a partial-strength joint, $0.25 M_{bp} < M_u < M_{bp}$. Note that in these classifications, M_u is the flexural resistance of the joint and M_{bp} is the designed plastic moment resistance of the steel beam. The classification of the tested joints is shown in Figure 16. The results show that the anchored blind-bolted extended end-plate joints to CFST columns with a strong beam are classified as semi-rigid and partial-strength joints, whereas those with a weak beam are in the range of semi-rigid and full-strength.
