# Non-Destructive Tests for Damage Evaluation of Stone Columns: The Case Study of Sacro Monte in Ghiffa (Italy)

Alessandro Grazzini \*, Sara Fasana, Marco Zerbinatti and Giuseppe Lacidogna

Department of Structural Geotechnical and Building Engineering, Politecnico di Torino, 10138 Torino, Italy; sara.fasana@polito.it (S.F.); marco.zerbinatti@polito.it (M.Z.); giuseppe.lacidogna@polito.it (G.L.)

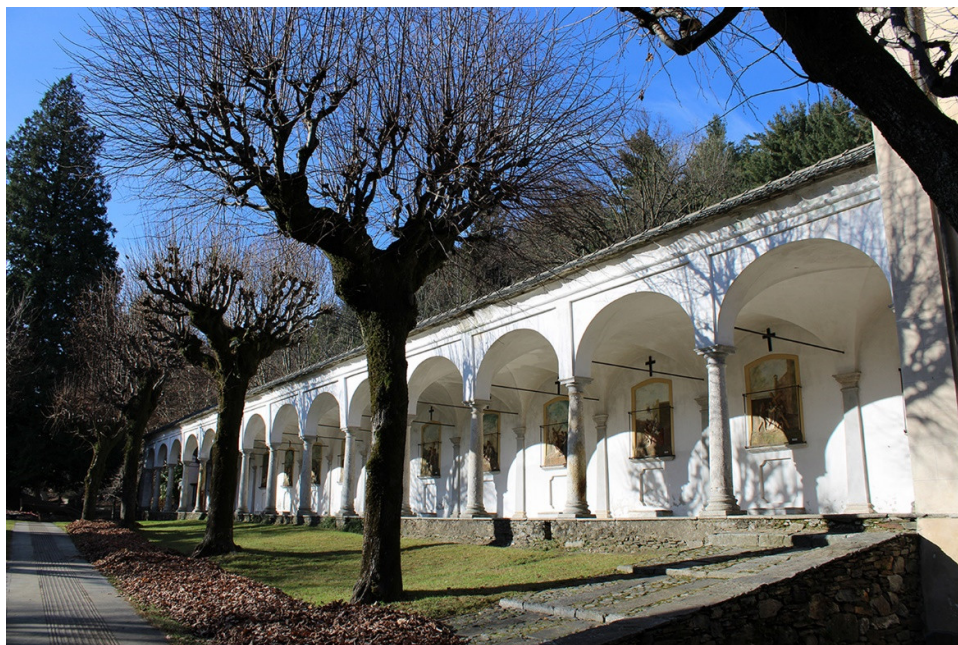
In the specific case of the Sacro Monte at Ghiffa, the Via Crucis portico (Figure 1) is supported by 13 stone columns with evident intense superficial material degradation. The portico was built between 1752 and 1761. It is marked by 14 spans and has columns and capitals made by stones derived both from local “granitic stones”. It is possible that the origin of the stone of columns is not from historical quarries but from erratic boulders found near the construction site (aplite is the current interpretation, but other investigations are in progress), referred to in slang as “trovanti”, while for the capitals there is a strong similarity with a serizzo quarried near Locarno (Valle Verzasca, Switzerland) (Figure 2). Considering a macroscopic mineralogical analysis with a 10x magnifying glass, the rock is mainly made up of more than 90% of crystalline clear silica minerals (quartz and feldspar), with little biotitic dark mica and rare light mica. The main accessory mineral is a small red-vined garnet that characterizes the stone. The veins present confirm the low quality of the stone, almost certainly extracted from makeshift material, greatly influencing the variability of mechanical characteristics. Perhaps, also for the lower quality, it is very prone to degradation phenomena, worsened by atmospheric moisture, the presence of salts, freeze–thaw cycles and thermal expansion, which is also due to strong summer radiation, which can produce erosion and exfoliation on the stone surface [24,25] (Figure 3). The material degradation is increasing from the inside to the outside of the structural section of the columns, and the result is a decay of their compressive strength, the residual value of which needs to be investigated.

**Figure 1.** The Via Crucis portico inside the Sacro Monte of Ghiffa (Piedmont, Italy).

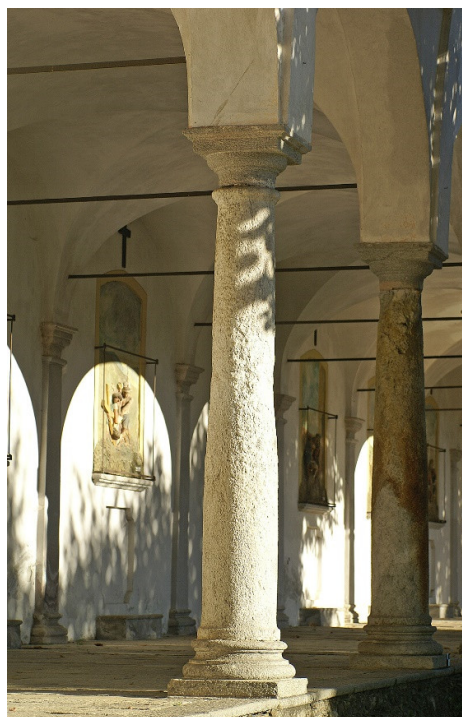
**Figure 2.** The stone columns of the Via Crucis portico in the Sacro Monte at Ghiffa.

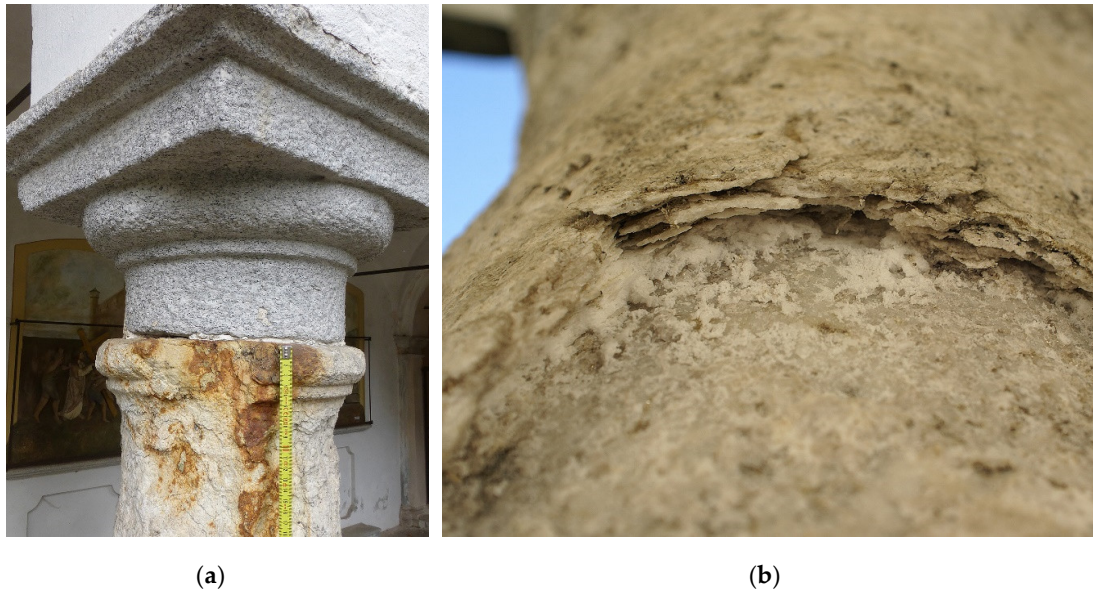
**Figure 3.** Examples of erosion (a), exfoliation and detachment (b) problems in stone columns of the Via Crucis portico. The reference lexicon is that of the "Ente Nazionale Italiano di Unificazione" (UNI) Standard rules 11182:2006.

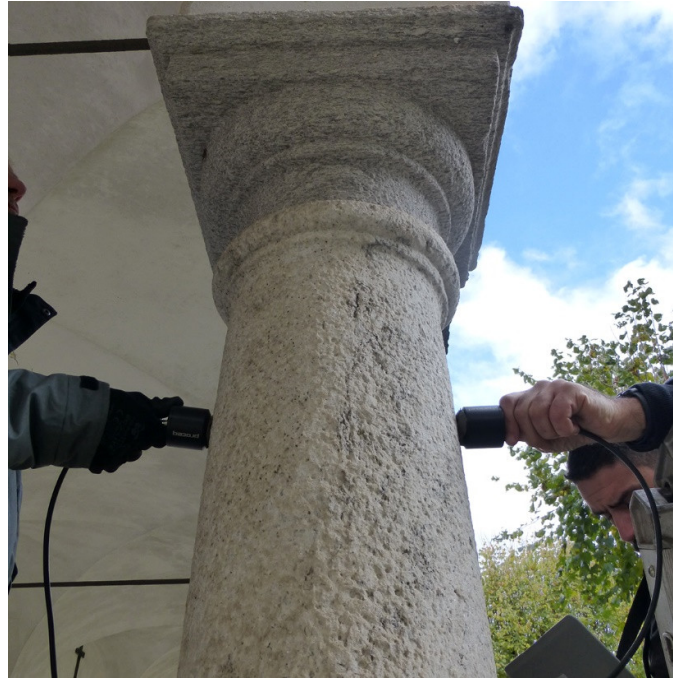
Direct tests were carried out by positioning the transducers on the two opposite faces of the element under investigation, as indicated in Figure 4. The coupling of the transducer on the stone surface was facilitated through the application of a thin layer of modeling clay in order to avoid air interpositions and facilitate the transmission of the wave in the material. The measurements were conducted in accordance with the methods proposed in American Society for Testing and Materials (ASTM) rules D2845 1995 and in Ente Nazionale Italiano di Unificazione, Comité Européen de Normalisation, (UNI EN) rules 12504-4: 2005 [26,27]. The tests are based on the determination of the propagation speed ( $v$ ) of the pulses of the ultrasonic longitudinal waves in the material, the values of which, in the first approximation, are related to the dynamic modulus ( $E_d$ ) of the material, which consequently is related to its mechanical strength [16]:

**Figure 4.** Ultrasonic test carried out on columns of Via Crucis, Ghiffa.

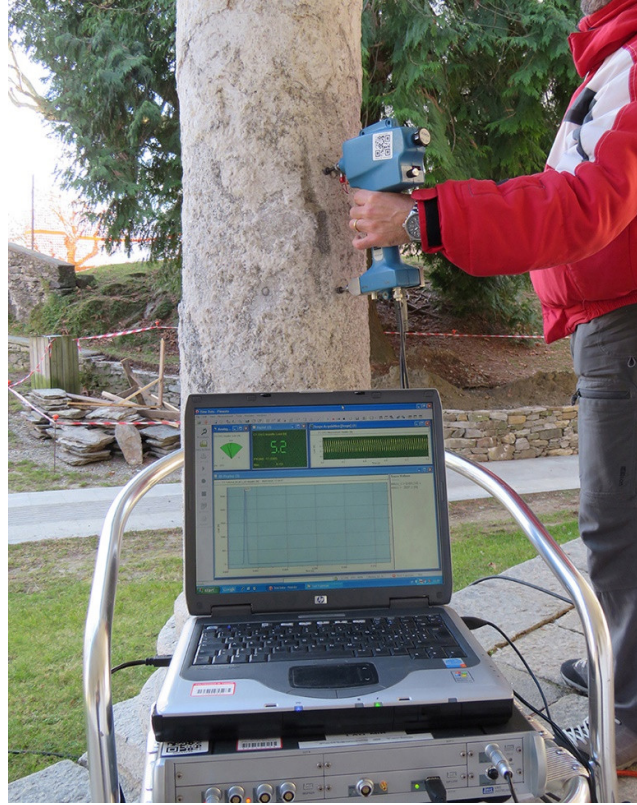
The electric impact hammer (Figure 5) is a device produced by Piezotronic PCB Inc Company (Depew, NY, USA). It is characterized by a variable force from 44.48 N to 4448.26 N, and a force sensor sensitivity of 2.47 mV/N. It performs the impact of a 10 mm diameter steel ball with a total mass of 207 grams, connected to a piezoelectric pulse transducer. The impact is generated by the hammer by means of a predetermined energy, characterized by a level of amplifier and impedance adapter. The acquisition is performed by a Pimento model multichannel LMS signal analyzer (Figure 5).

**Figure 5.** Setup of the impact test.

The hammer was positioned perpendicular to the surface to be investigated. Perpendicularity alignment was achieved thanks to four fixed metal brackets. The impact of the small impact mass was generated by pressing a trigger on the electric hammer. The intensity of the impact is very low and therefore not invasive even for surfaces of artistic value. The elastic modulus of the stone was determined according to the classical theory of the elastic collision between two bodies elaborated by Hertz [17,29–31], using the following equations:

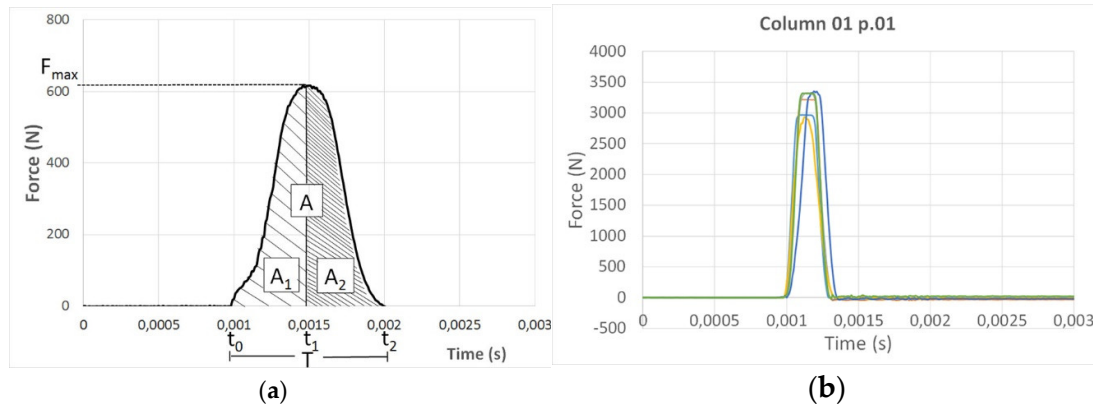
The parameters in Equations (2) and (3) are the following:  $A_1$  is the area beneath the diagram ( $F$ ,  $t$ ) (see Figure 6),  $T$  represents the time in which the contact occurs between the two surfaces;  $R$  is the radius of curvature (10 mm) of the impact mass  $m$  (0.207 Kg),  $E_0$  is the mass elastic modulus (222,000 MPa) and  $\nu_0$  is its Poisson's ratio (0.2), while, with regard to the stone material of the columns, a Poisson's ratio  $\nu$  of 0.18 was considered [28].

**Figure 6.** (a) Generic force–time diagram of an impact test; (b) test results by impact test on column 1 of the portico.

The instant  $t^*$ , corresponding to the maximum depth of the deformation  $\delta^*$  during the impact, referred to as time  $t_1$  in Figure 6a, is given by the following equation:

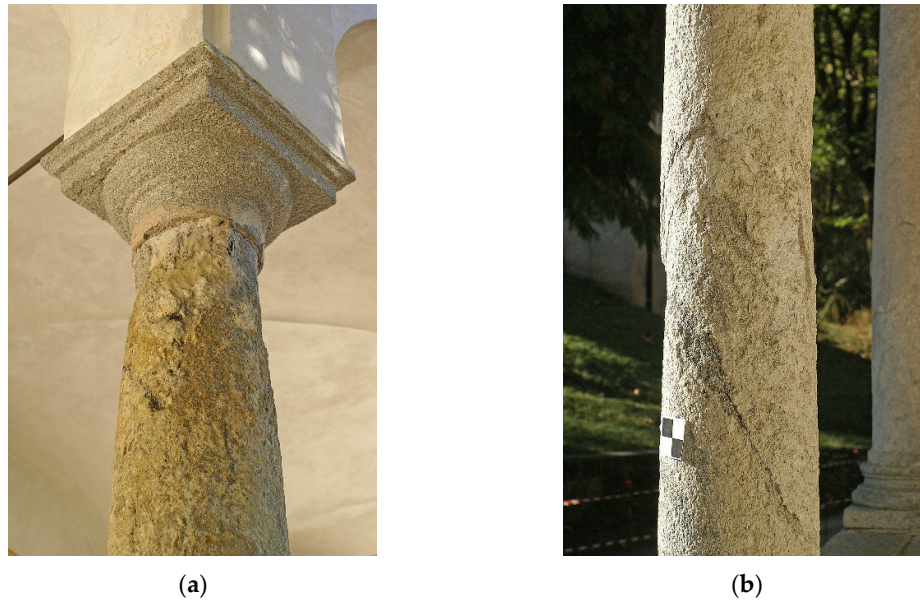
**Figure 7.** Different types of surface material degradation on the columns of the Via Crucis portico.

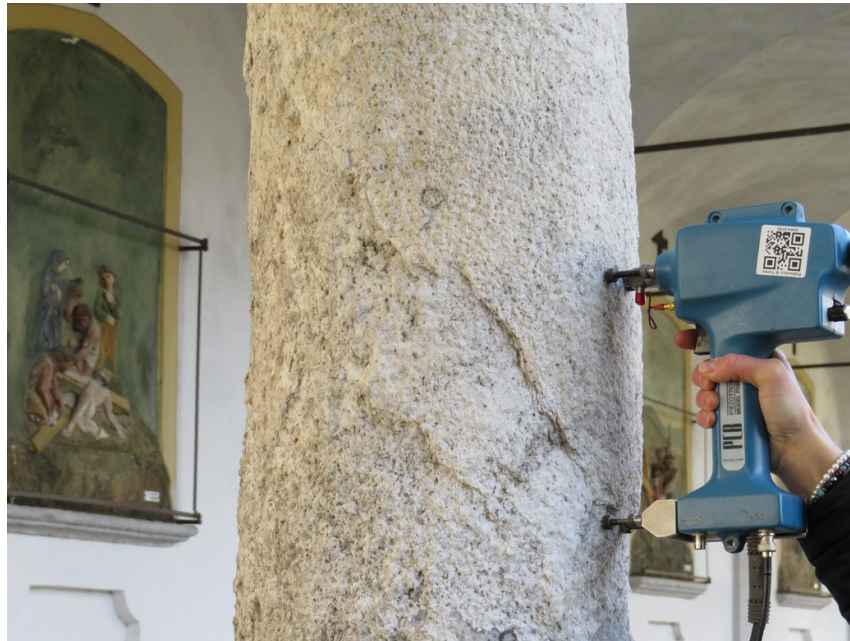
**Figure 8.** Impact test carried out on a column of Via Crucis portico.

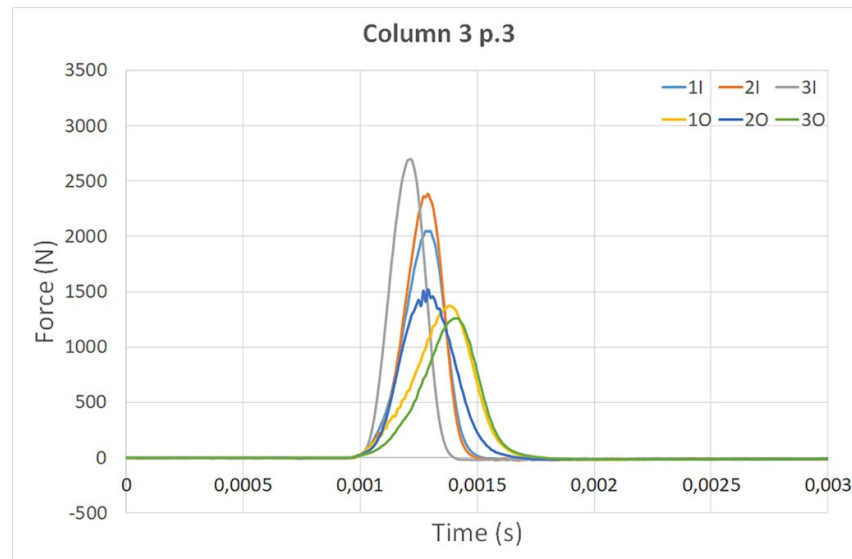
Figure 9 shows, for example, the time–force curves between two different points of the same test on column 3. In presence of surface degradation, the curves are characterized by lower peak force and wider response times. The ratio between the returned  $A_2$  and supplied energy  $A_1$  (Figure 6a) provided indications regarding the detachment of the degraded matter crust [17,33].

**Figure 9.** Time–force diagrams of third point of column 3 (I = point inside of the portico; O = outside of the portico).

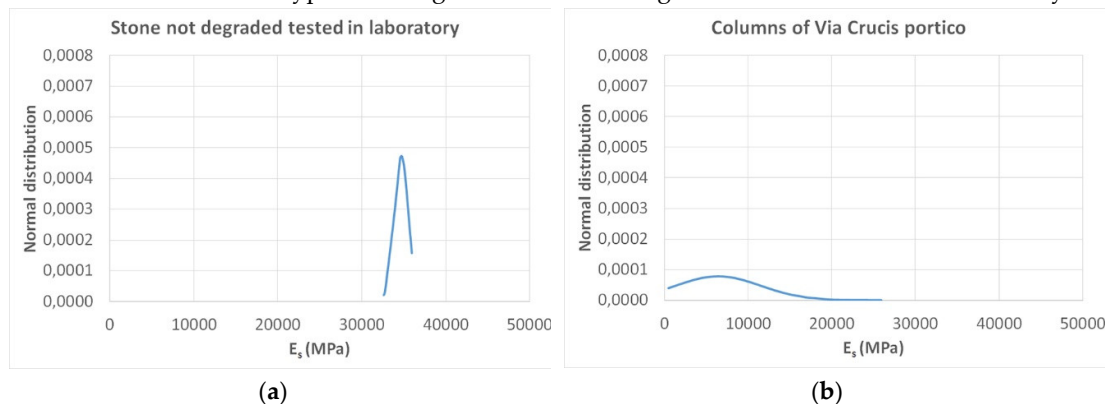
With reference to the values of the dynamic elastic modulus, Figure 10 reports, for example, the dispersion of the data collected in the impact tests on the columns at Ghiffa and the same comparison obtained from the similar type of homogeneous and non-degraded stone tested in the laboratory.

**Figure 10.** Gaussian distribution  $E_s$  of non-degraded stone (a) and of the same type of stone degraded in the columns of the Via Crucis portico at Ghiffa (b).

From Figure 10, a significant difference can be seen between the two Gaussian curves. The one relating to laboratory tests on a sample of new stone similar to that used in the Ghiffa columns revealed a significantly lower standard deviation  $\sigma$  than that detected with the impact tests performed in situ on the columns of the Via Crucis portico. The differences are due to the considerable diversification of the material degradation affecting the surface of the columns. Similarly, Table 2 shows the results provided by impact tests on the new stone in the laboratory and on the old in situ columns of the Via Crucis portico.

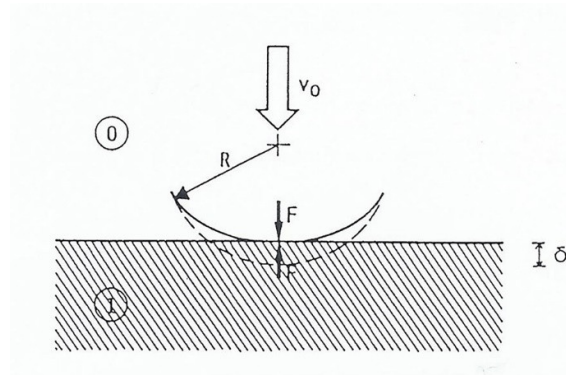
Hertz's theory of the elastic collision between two bodies in the absence of friction is modeled according to the scheme in Figure A1, where a sphere of radius  $R$  impacts with velocity  $v_0$  penetrating with a depth  $\delta$  in an elastic semi-infinite space [27]:

**Figure A1.** Impact between the moving mass and the elastic semi-infinite surface.
