# Application of USCCD on Girth Weld Defect Detection of Oil Pipelines

Circumferential Crack-Like Detection (USCCD) technology, based upon the pull test and in field data by PetroChina Pipeline Company (PPC) using GE PII 32" UltraScan™ CCD Tool.

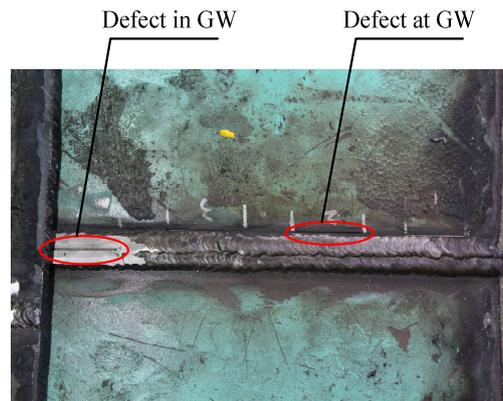
Figure 2. Set of test notches with different depths and lengths.

A variety of internal and external artificial defects (see Figure 2 and Appendix A) were manufactured by EDM (Electrical Discharge Machining) into the coupons (see Figure 3), located both upstream and downstream of the GWs' surface (at weld), as well as in the center of the GWs' surface (in weld), in order to test the inspection performance for sensitivity and repeatability. Test pipe is of X65 steel with outside diameter of 813 mm. Altogether 12 coupons were manufactured. Nominal Wall Thickness (WT) is 14.5 mm for all spools, apart from one spool which was 12.5 mm for WT change.

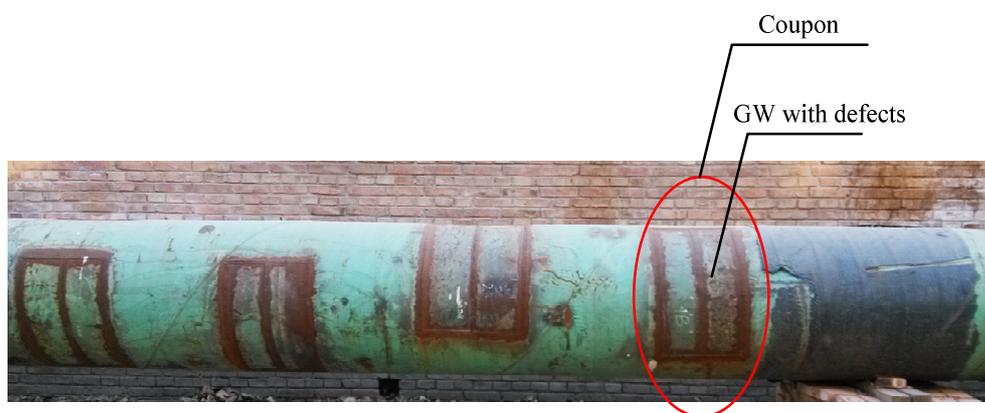
Figure 3. Circumferential crack-like pieces.

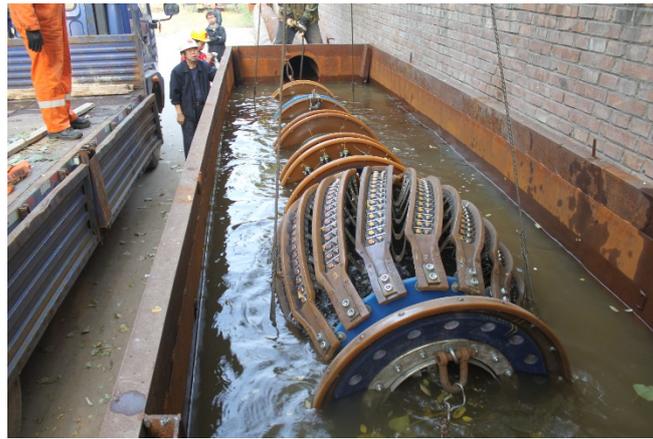
**Figure 5.** Pull test pipe facility and tool.

Diagrams of the pull test facility are shown in Figure 4. The Inline Inspection (ILI) tool is placed in the launch tray in full operation mode and connected with the pulling rope. The liquid level is high enough to ensure that the interior of the test pipe is completely filled with water. A series of 10 pull-throughs was executed to validate repeatability and reproducibility at the speed of approximately 0.1 m/s~0.5 m/s. Pictures of the facility are shown in Figure 5.

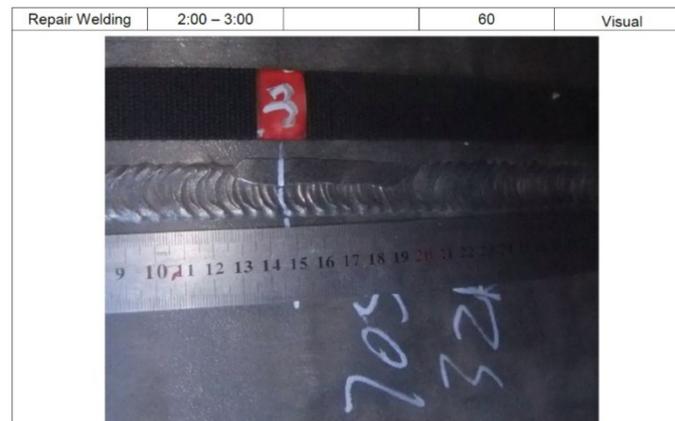
Figure 8. Picture of GW 7050.

Thirty-two-inch crude oil pipeline was inspected by the UltraScan™ CCD inspection tool of PII Pipeline Solutions. The analysis team prepared the first five inspection sheets that were considered to contain the most significant indications found in the ILI data during the course of ILI data analysis and needed excavations to help improving analysis of the UltraScan™ CCD ILI data. The reported external defects were found to be in all weld repairs during the first five excavations, as shown in Table 6 and Figures 6–12.

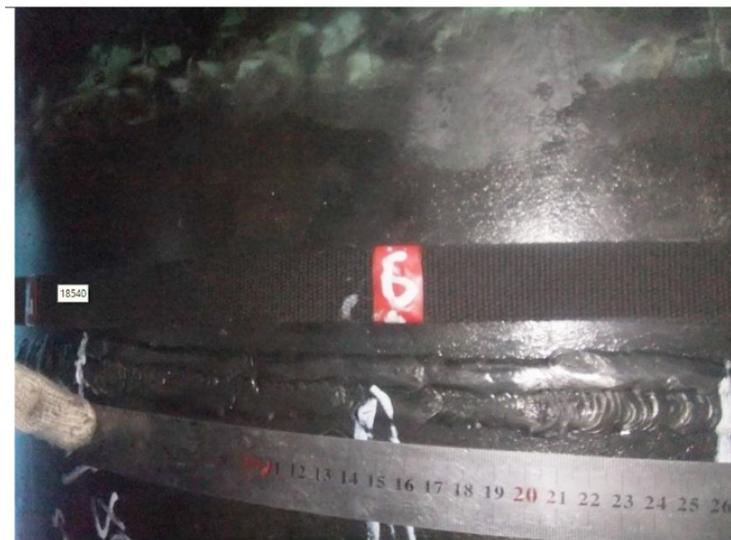
Figure 11. Picture of GW 18540.
