Article

Validation of Selected Optical Methods for Assessing Polyethylene (PE) Liners Used in High Pressure Vessels for Hydrogen Storage

Citation: Gašior, P.; Wachtarczyk, K.; Błachut, A.; Kaleta, J.; Yadav, N.; Ozga, M.; Baron, A. Validation of Selected Optical Methods for Assessing Polyethylene (PE) Liners Used in High Pressure Vessels for Hydrogen Storage. *Appl. Sci.* **2021**, *11*, 5667. <https://doi.org/10.3390/app11125667>

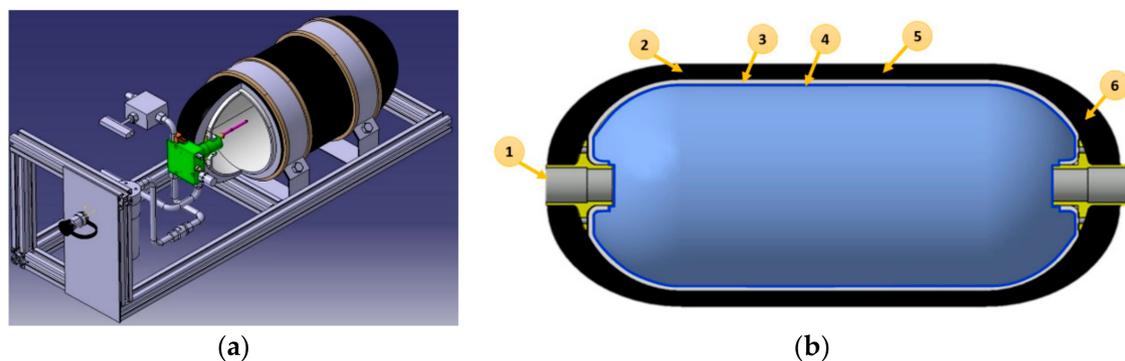
Figure 1. Scheme of a high-pressure hydrogen storage vessel. (a) A cross section and (b) a construction scheme: 1—inlet boss, 2—composite load carrying shell, 3—liner, 4—permeation reducing sol-gel coating, 5—cylindrical part, 6—dome with visible PE liner inside.

Composite vessels used for compressed gas storage are composed of two layers (Figure 1). The internal layer (the so-called liner) is responsible for gas accumulation and shaping the whole construction. It must form a barrier that is sufficiently strong to prevent gas particles from permeating outside the container. The liner can be made of metal (suitable steel type or aluminum alloys) or plastics (polymers). Currently, the latter solution tends to dominate. This results mainly from the following requirements, which modern liners must meet:

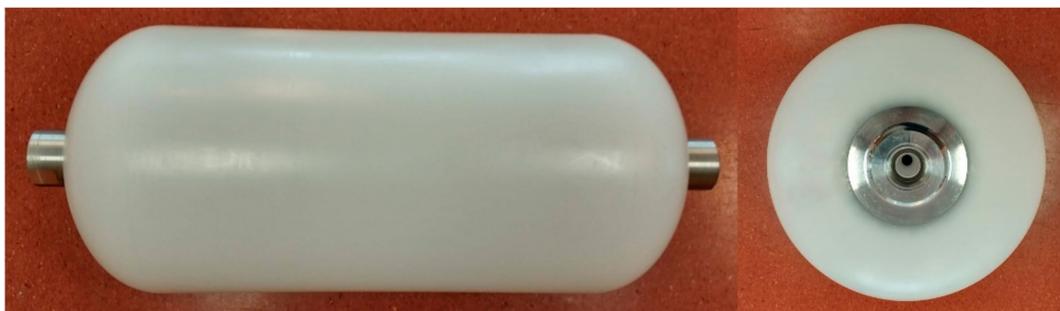
Figure 2. View of the exemplary HDPE liner for a hydrogen vessel, manufactured using rotomolding technology.

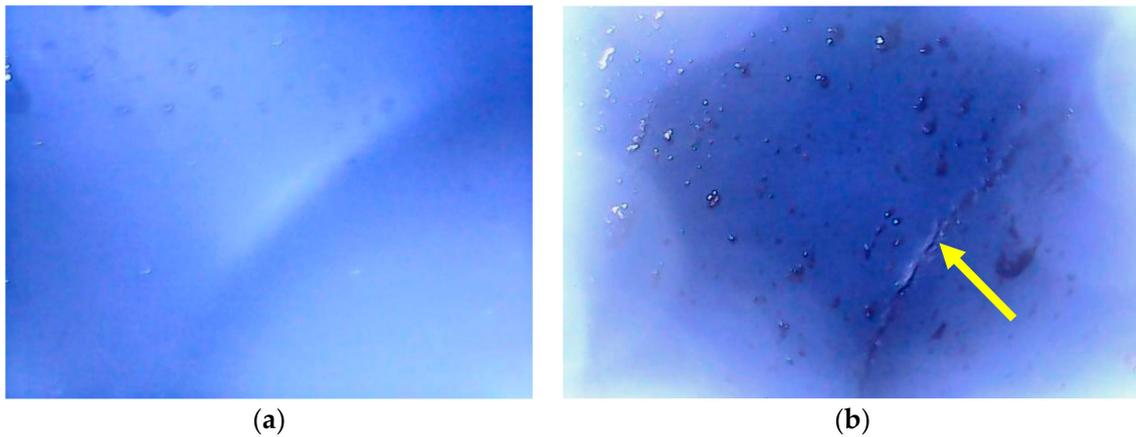
Figure 3. Endoscopy pictures of a defective liner. (a) The inlet dome area without visible cracks and (b) the outlet dome area with cracks around the boss–dome interface (marked by an arrow).

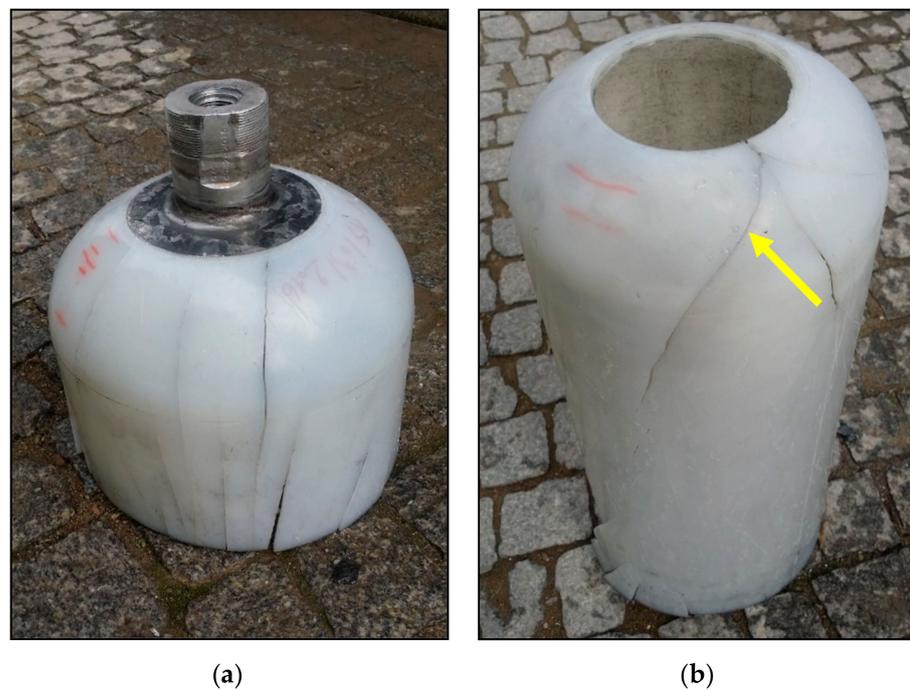
Figure 4. PE liner with major cracks extracted from a 700-bar hydrogen vessel after cyclic pressure test at low temperature. (a) Cut-off dome with the inlet boss and (b) the liner without the boss, which fell off due to the cracks at the liner material interface.

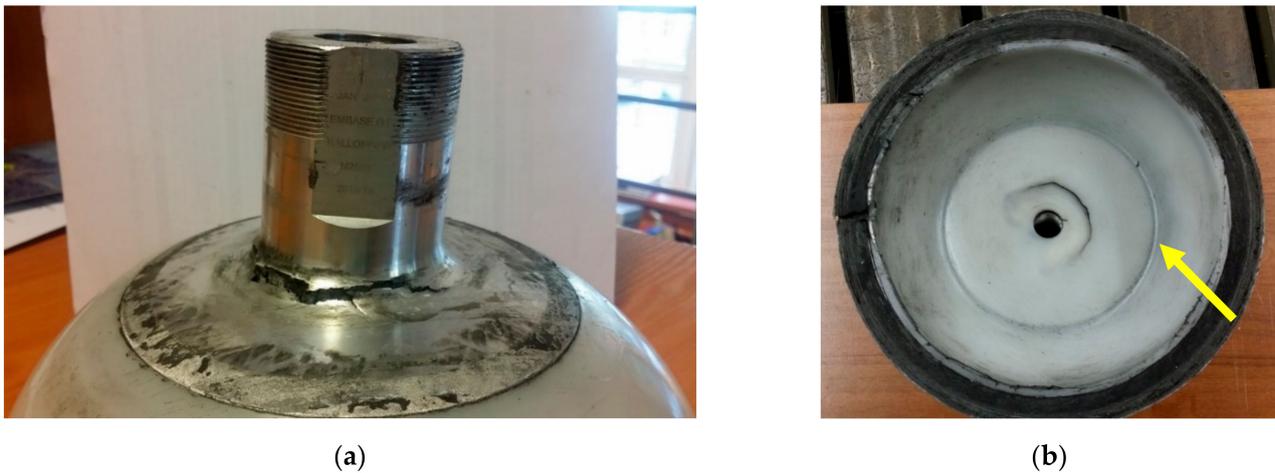
Figure 5. View of a damaged boss after fatigue testing. (a) Crack in the metallic boss and (b) crack in the inner side of the liner's dome.

- Air bubbles and other inclusions in the liner material;
- Non-homogeneity of liner geometry and wall thickness;
- Residual stress in the polymer after the liner production process;
- Cracks in the liner material resulting from cyclic loads (Figure 3);
- Cracks in the liner material resulting from low temperatures, below $-40\text{ }^{\circ}\text{C}$ (Figure 4);
- Defects in the area of the liner/boss joint;
- Fatigue cracks in the area of a metal boss (Figure 5).

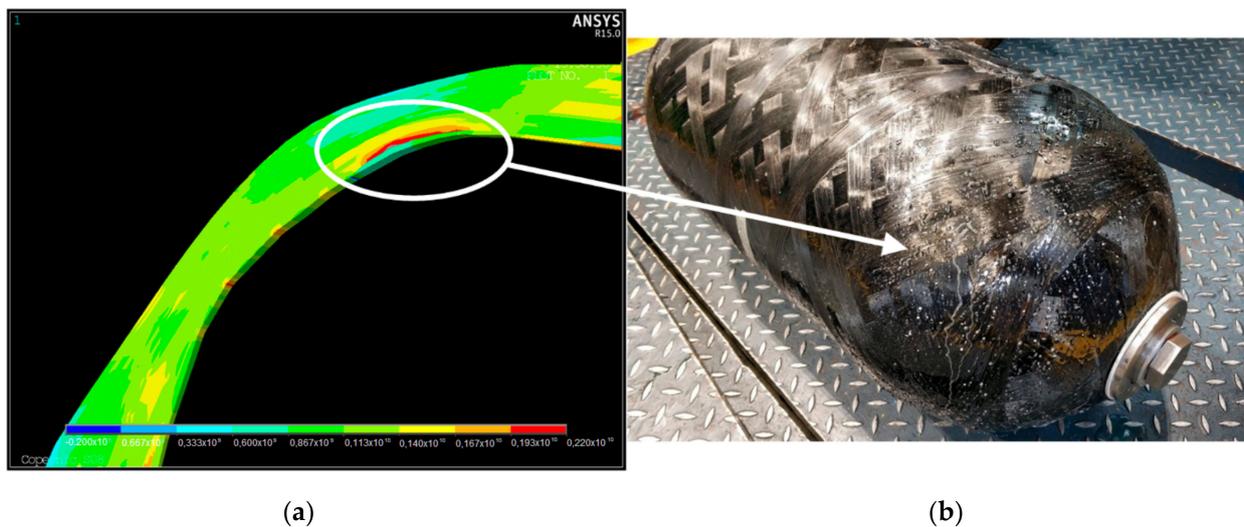
Figure 6. A 5-degree segment of the vessel model (ANSYS V15) presented normal stress (fiber orientation direction) in the composite material; (a) hotspot located in the dome area was the reason for liner damage and medium leakage [30]. (b) View of the leaking hydrogen vessel during the hydraulic test due to the cracks in the PE liner in the outlet dome area (water drops on the dome surface leaking through the pores in the composite shell).

At the development stage of new container construction, defects may be caused by both technological errors in the production of the liner itself or an incorrect design of the load-bearing overwrap. The non-uniform stress distribution in the composite layer of the construction may result in a local concentration of stress in the whole construction, which, in turn, can initiate cracks directly in the liner. In a previous study, unoptimized stress distribution in the geometry of a composite structure was observed and, as a consequence, the liner cracked during an ambient-temperature pressure cycle test in the 20–875-bar pressure range (Figure 6).

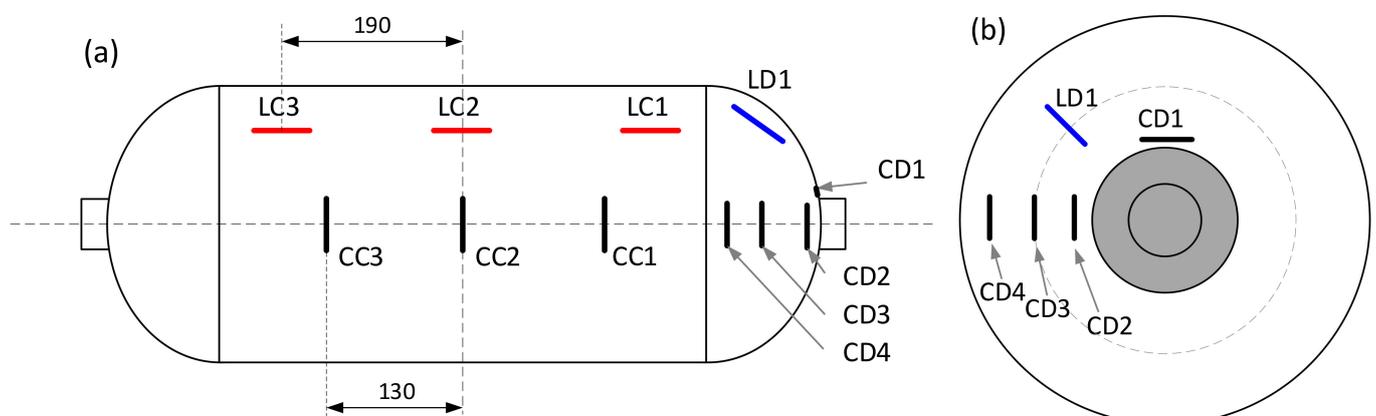
Figure 7. Placement of sensors on the liner. (a) Entire liner and (b) dome part. Colors are attributed to the different directions and locations of sensors: black—circumferential, red—longitudinal at the cylindrical part, blue—longitudinal at the dome.

The whole liner was covered with 11 sensors in total. The placement of the sensors is shown in Figure 7. The description of the placement is provided in Table 1. Six sensors were placed on the cylindrical part of the liner (three in the circumferential direction and three in the longitudinal direction). Five sensors were placed on the dome (four concentric and one longitudinal).

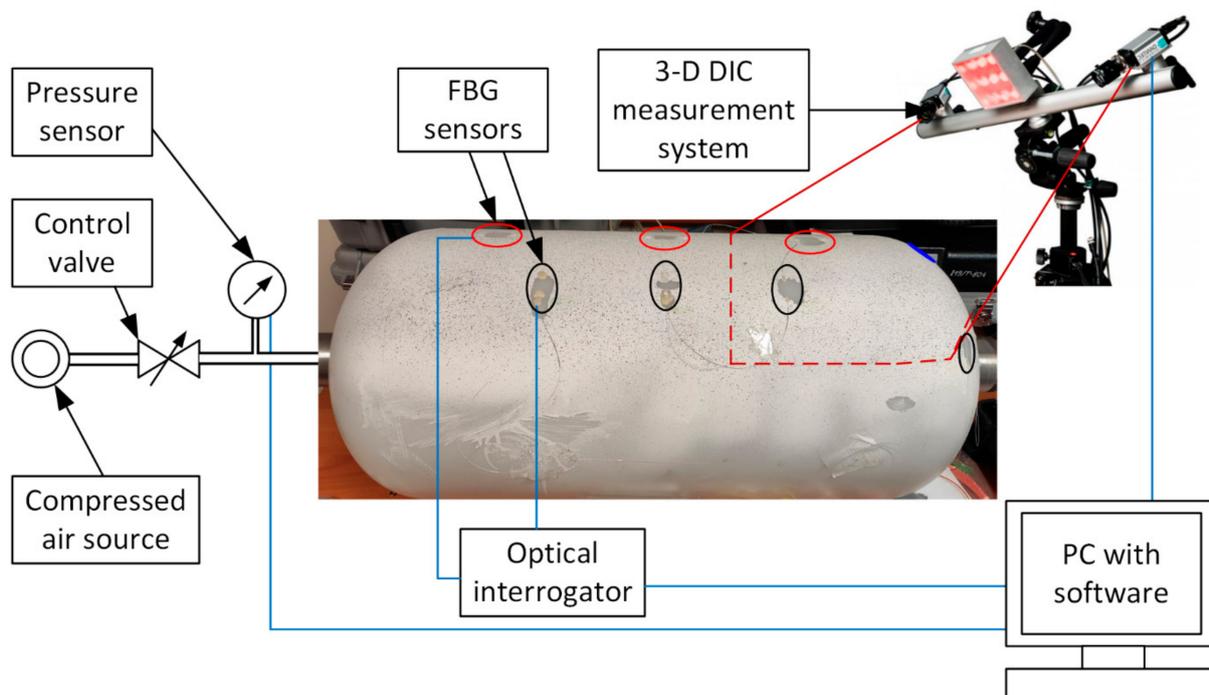
Figure 8. Experimental setup for liner testing using the DIC method and FBG sensors. Dashed line shows the part of the liner inspected using the DIC method.

As an additional measurement method, a 3D DIC system was used. The test setup is shown in Figure 8. The liner, after the placement of the sensors, was covered with a speckle pattern. The surface around the FBG sensors was cleaned so that the paint would not influence the sensor readouts. DIC system analysis was performed on a one-sided view of half the liner (one dome and 1/3 part of the cylindrical part, dashed line in Figure 8).

The cameras for the DIC measurement system were mounted on a tripod, approximately 120 cm away from the vessel. The 3D DIC system was composed of two AVT Stingray 16Mpx cameras, equipped with lenses with a focal length of 50 mm and a PC using

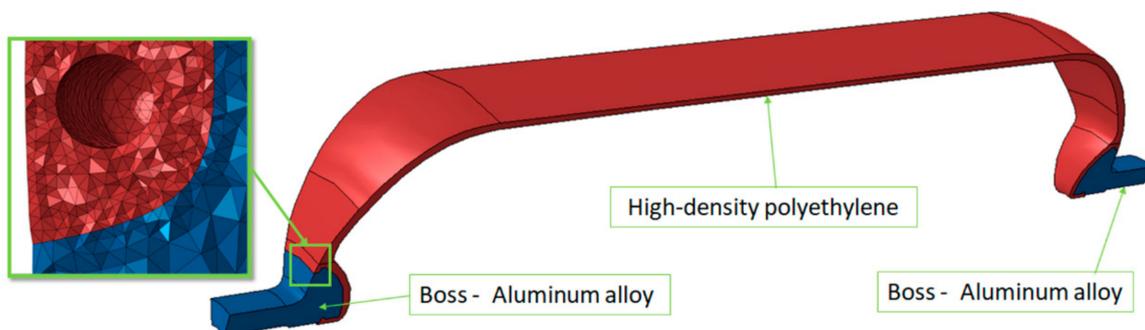
Figure 9. Liner model used in FEA with zoomed mesh around the porosity.

The FEA model was prepared in the Abaqus/CAE environment and solved using the Abaqus 2020 static linear solver. The geometry was created based on the measured thickness of the test object and a 20-degree portion of the liner was modeled. High-density polyethylene and aluminum alloy were considered as linear elastic materials in the described analysis. The interface between the boss and the polymer was established using common nodes. C3D10 named elements were used in the model (ten-node quadratic tetrahedron). In the polymer material, dome area (close to the boss) defects were modeled as a discontinuity in the material, shown in Figure 9. The wall thickness along the generating line was measured post-mortem using a calliper. The liner was cut along the locations of the FBG sensors (first cut along LD1-LC-LC3 and the second along CC1-CC3).

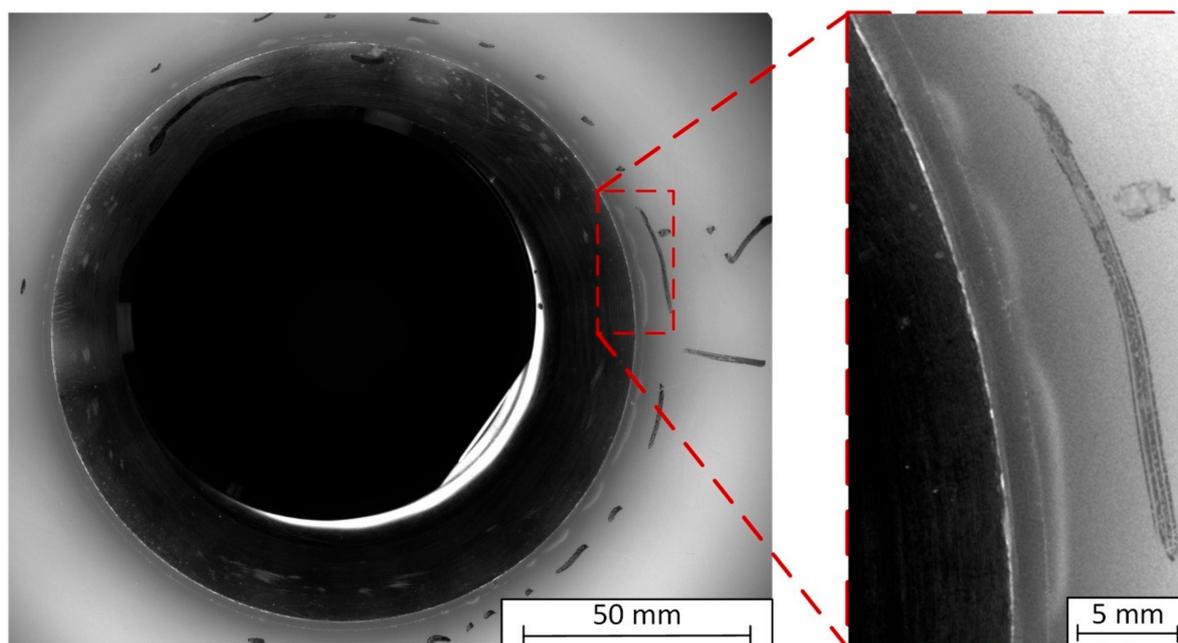
Figure 10. View of a liner's inlet with air chain located near the boss.

In the cylindrical part and domes, a few individual and small (<1 mm) air bubbles were found. No agglomerations of air bubbles were observed. In close proximity to the boss, there were numerous air bubble chains with diameters of about 2 mm. The defect is shown in Figure 10. For automating the process of detecting production defects, the automatic detection methods available in Keyence CV-X Machine Vision System were used.

Experience related to pressure container tests suggests that this defect may lead to container faults during cyclic hydraulic loading (fatigue defects, leaks near the boss/HDPE interface) or to hydrogen accumulation during exploitation of a container. To investigate the influence of this defect on the strain field around the boss, FBG sensors were attached close to the boss (one near the defect and one near a non-defective area) and FEA analysis of this point was performed.

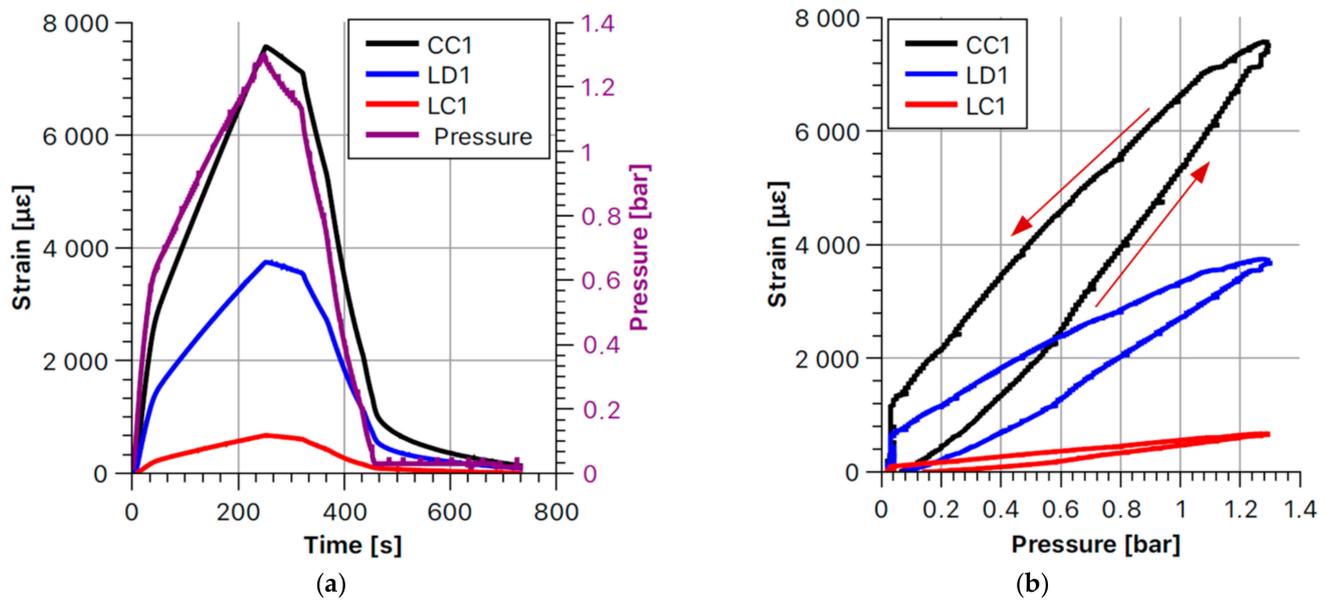
Figure 11. Deformation registered with selected FBG sensors. (a) Over time and (b) over pressure. Arrows show the direction of pressure increasing/decreasing.

In Figure 11a there is visible slow loading of the liner with pressured air, which ended after 220 s. After this, air was slowly released until 440 s of experiment time. A non-constant pressure rate was caused by manual control of the inlet valve.

After the air was released, in Figure 11a, one can observe the occurrence of a delay in the liner's return to its initial deformation state. This means that the value of its internal pressure regained the value of the atmospheric pressure, despite the fact that the non-zero deformations of the material were still visible. The effect could be observed for as long as two minutes after releasing the air. Figure 11b (strain–pressure plot) shows mechanical hysteresis, which is typical for a visco-elastic material, such as HDPE.

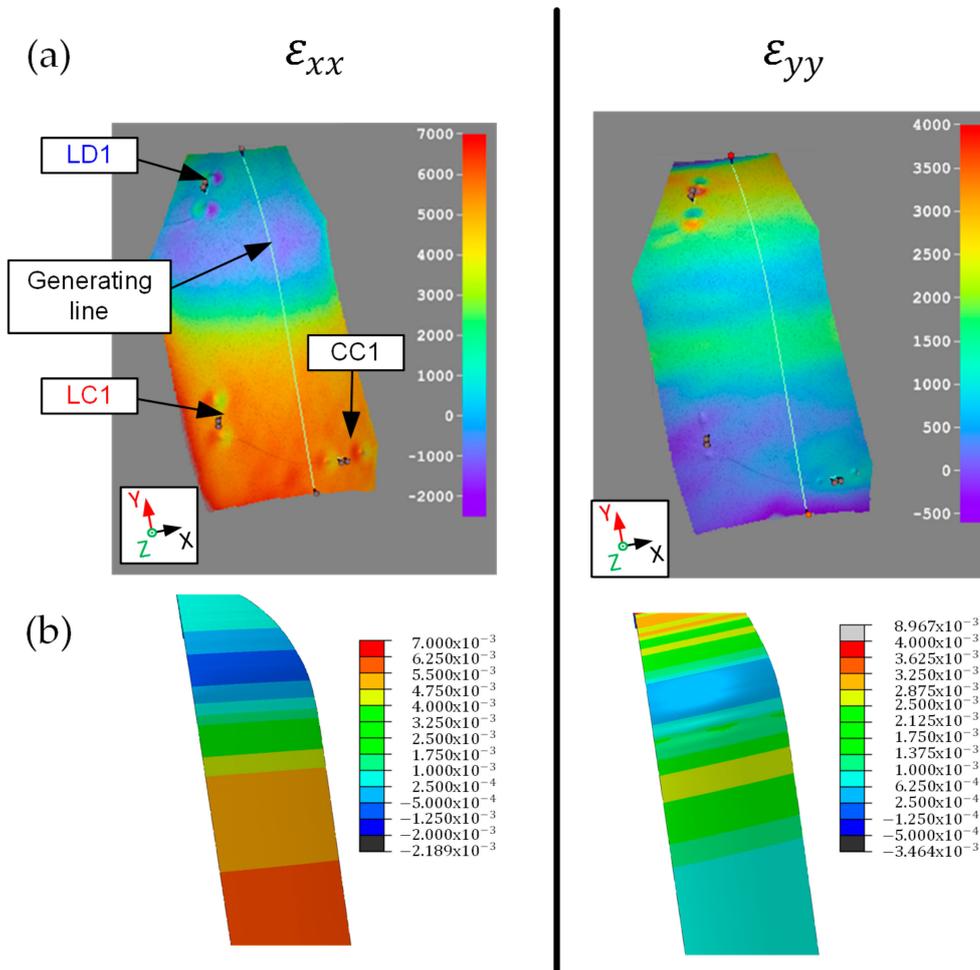
Figure 12. Deformation field in the circumferential and longitudinal direction at 1-bar pressure; (a) results of DIC tests and (b) FEM calculation.

The measurements taken using the DIC method were conducted in parallel to the measurements with FBG sensors while pumping air into the liner. The deformation field analyzed using the 3D-DIC system included a fragment of the dome and a fragment of the cylindrical part. The recorded deformation fields, ε_{xx} and ε_{yy} , at 1.0 bar are presented in

Figure 12. Along with the strain field obtained from the DIC method, the results from FEM are shown.

Strain in the circumferential direction, ϵ_{xx} . (Figure 12a), had the highest value of around 7000 $\mu\epsilon$ on the cylinder part, closest to the middle of the liner (the bottom part of the presented photos). The circumferential strain of a dome was significantly smaller (<1000 $\mu\epsilon$). Measurement shown area with negative circumferential strain in the dome area (amplitude up to 100 $\mu\epsilon$). Strain in longitudinal direction ϵ_{yy} (Figure 12b) had maximum values on the dome (about 3500 $\mu\epsilon$).

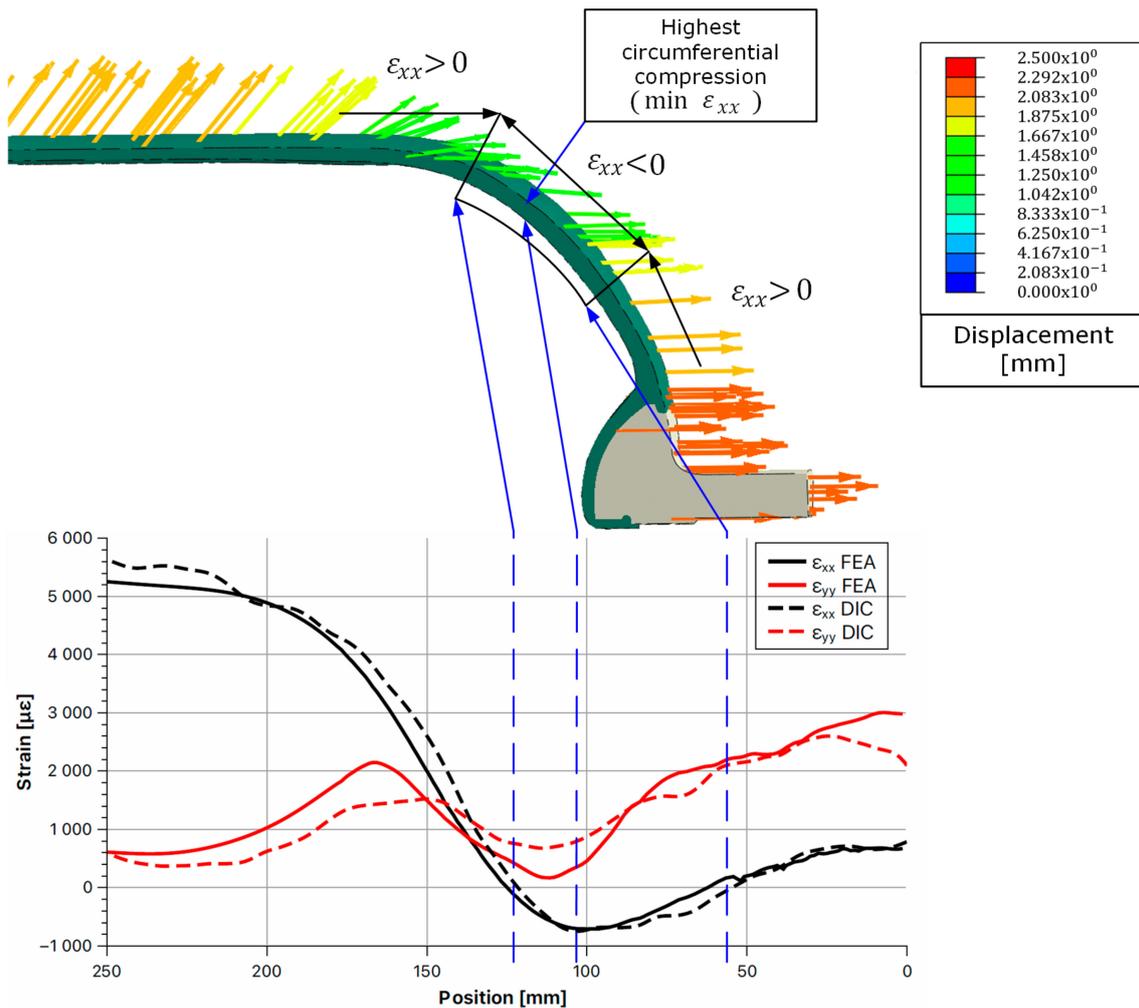
Figure 13. Strain in circumferential (ϵ_{xx}) and longitudinal (ϵ_{yy}) directions along the generating line using the DIC and FEM methods. Location of negative ϵ_{xx} area marked with arrows. Displacement of the liner shows collapse around this location.

The observation of compression in the circumferential direction was confirmed using FEA. Deformation of the liner from DIC and FEA along the generating line (marked in Figure 12) is shown in Figure 13.

Figure 13 shows good correlation between results from DIC and FEM for both ϵ_{xx} ϵ_{yy} and direction. Compression in circumferential direction was visible for both methods. The area of this behavior is present on the dome, close to the cylinder. Displacement around this area has almost two times lower deformation as the maximum deformation of cylinder and boss. It means that this behavior can be interpreted as the presence of the liner's collapse, which can potentially be a weak spot during vessel operation.

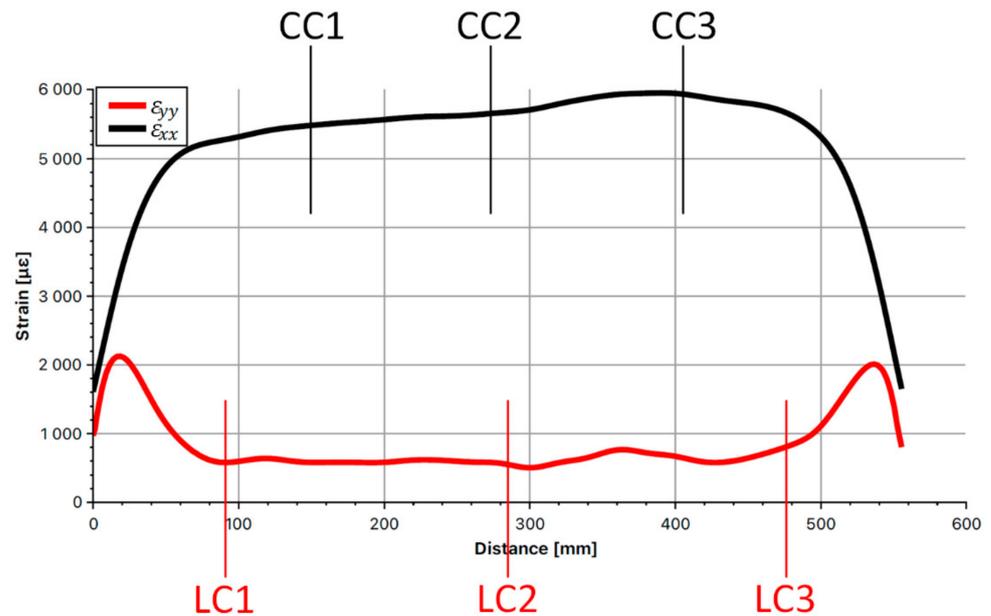
Figure 14. Strain along the cylinder part of the liner with FBG sensor location indication.

In Figure 14, strain along the cylinder part of the liner with FBG sensor location indications (ϵ_{xx} and ϵ_{yy}) and strain along the generating line of the cylinder, along with marked locations of sensors, are shown. Results of FBG strain measurements were combined with data from FEM and are given in Table 3. The strain in the location of the FBG sensors was comparable with the results of the FEA based on real thickness measurements of the cylinder. This means that differences of strain are explainable by wall thickness variation, and thus by the manufacturing method.

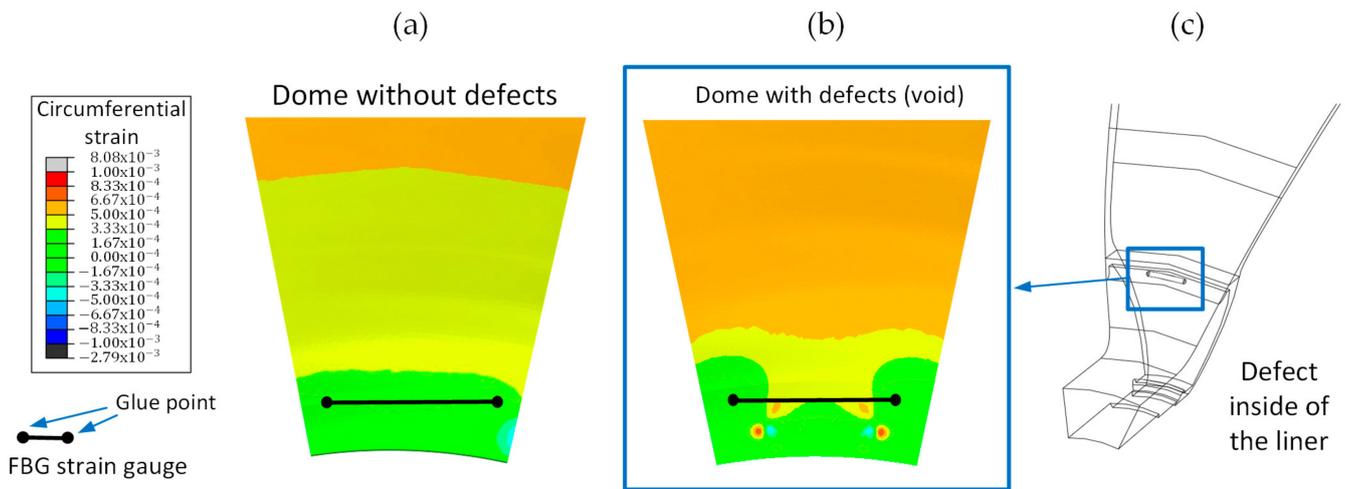
Figure 15. Strain field variations caused by the air-bubble chain located close to the boss: circumferential strain field distribution in the dome region model without defects (a) and with an internal defect in the form of the elliptical void (b), and location and geometry of the defect (c).

Authors investigated the influence of defects on the strain field in the area close to the dome: numerical simulation and point-wise strain measurements were used. Bragg sensors were glued about 7 mm from the liner's edge, the distance between the glue points was about 20 mm. The same area was analyzed by FEM using a tetrahedral mesh. Figure 15 shows the circumferential strain and the location of the strain sensor. The strain obtained from the numerical method was calculated based on the node displacement, of which locations correspond to the glue point and were compared with the strain measured by FBG (in Table 3). Figure 15a shows the circumferential strain for the dome without any defects; Figure 15b shows the circumferential strain for the dome with the defects modeled as an elliptical void. The location of the defect is shown in the wireframe model in Figure 15b,c.

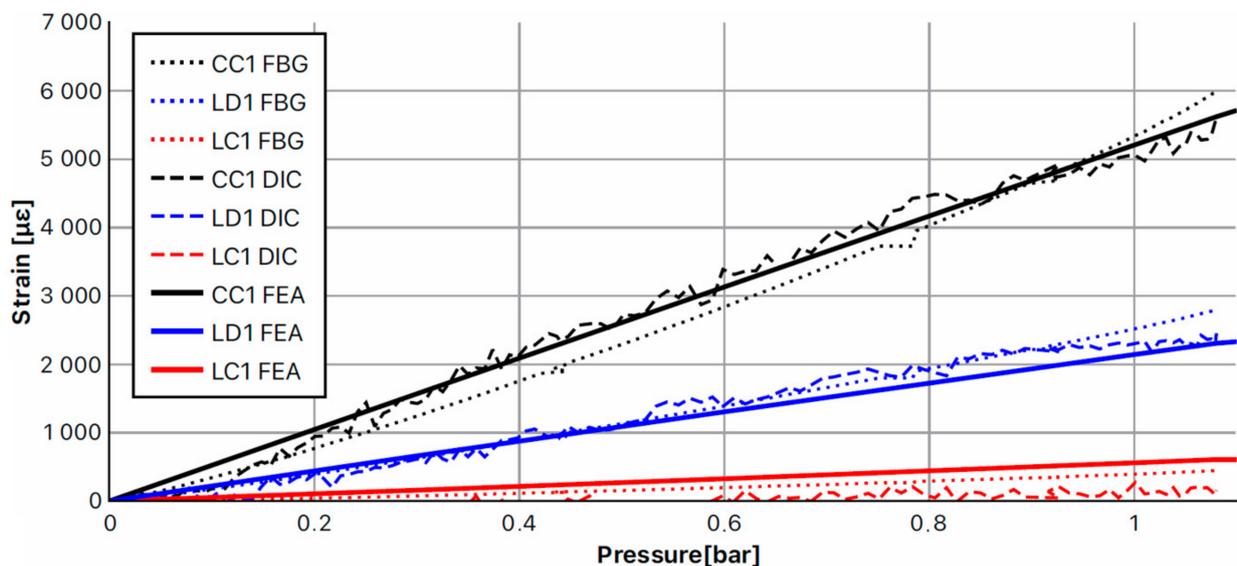
Figure 16. Chart presenting deformations recorded using FBG sensors, DIC method, and FEA model.

A comparison of the results of the deformation measurements recorded using all methods is presented in Figure 16. Correlation is visible regardless of the direction of the measurement. The biggest relative error is visible for the longitudinal direction on the cylindrical part of the liner (LC1). For the circumferential direction of the cylinder part (CC1), the maximum relative error does not exceed 5%.
