# Seismic and Energy Performance Evaluation of Large-Scale Curtain Walls Subjected to Displacement Control Fasteners

**Abstract:** Glass façade curtain walls in buildings is the façade system of choice in modern architecture of mid- to high-rise buildings. This study investigates the seismic and thermal insulation performance of curtain wall systems through structural analysis using the finite element method (FEM) and LBNL Window&Therm insulation analysis. The aim was to optimize the capability of the curtain wall module system and the fastener element technology to respond to displacement and vibration caused by dynamic seismic waves. Using the structural analysis of the optimization process, a curtain wall system capable of withstanding earthquake waves of 0.4 Hz, displacement of  $\pm 150$  mm or more, and capable of responding to three-axis (*X*, *Y*, and *Z*-axis) dynamic earthquakes, was fabricated. Then, a curtain wall system that satisfies not only the evaluation of seismic performance, but also the desired airtightness, watertightness, wind pressure, and insulation, which are essential requirements for field applications, was verified through an experiment. Based on this

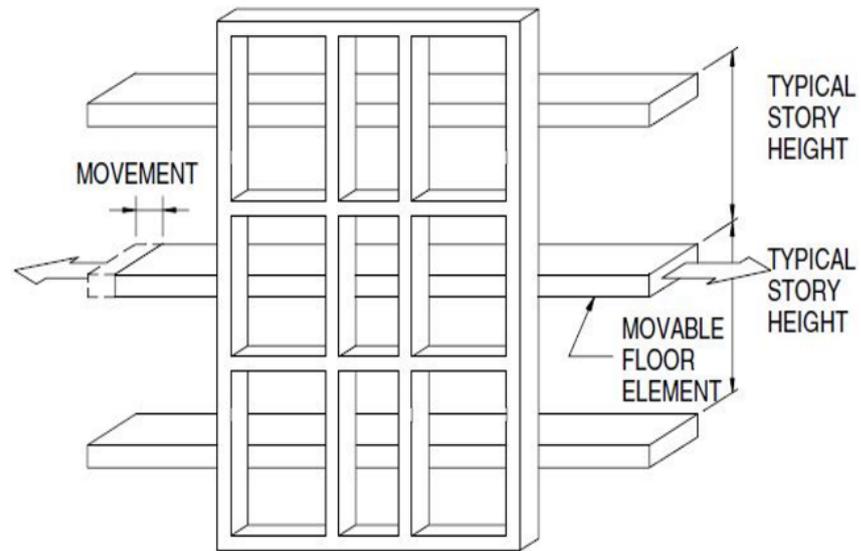
Figure 1. Test methods in the AAMA 501.4 standard.

In the static seismic performance test, as shown in Figure 1, the upper and lower rigid beams were firmly fixed to the curtain wall frame, and static displacement was applied in the horizontal direction using a 20-ton hydraulic cylinder and pump located on the middle rigid beam. Figure 2 shows the specimen used for the static seismic performance evaluation. The specimen outline is shown in Table 2.

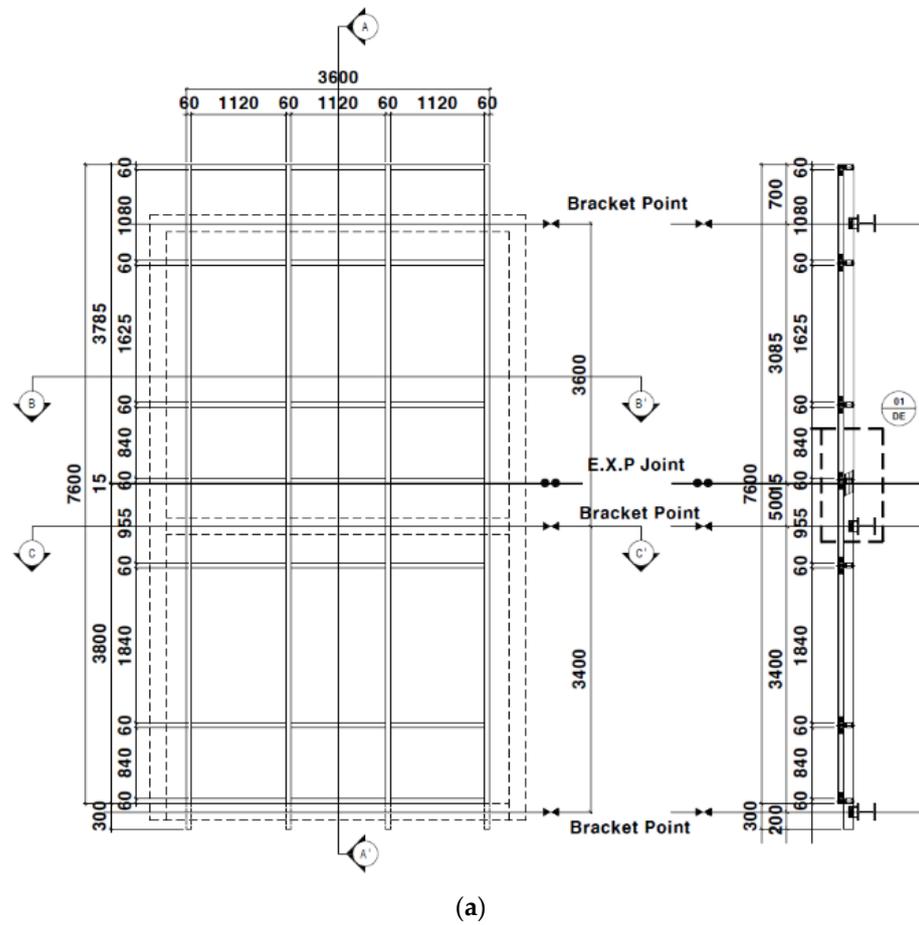
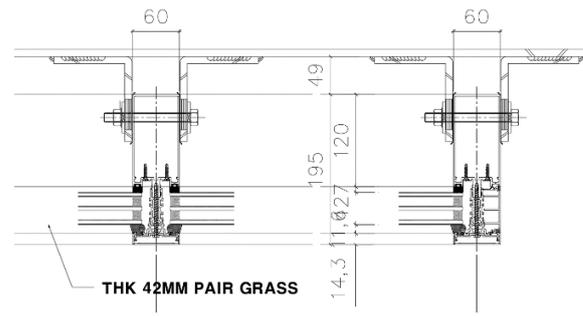
Figure 2. Conventional stick curtain wall system: (a) front view; (b) cross-section.

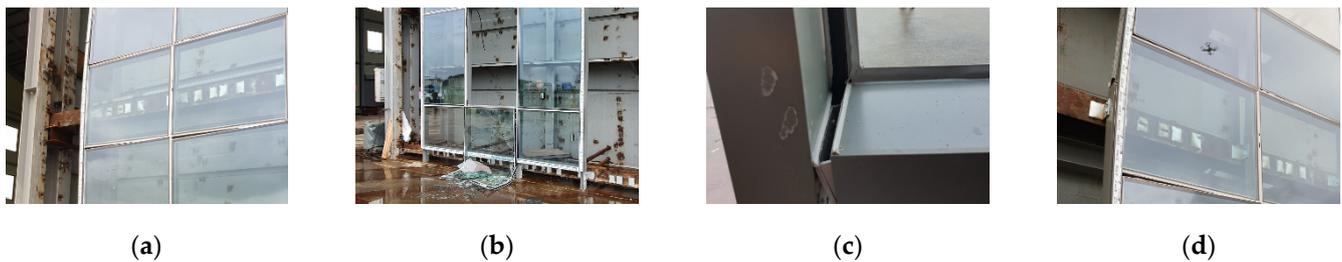
**Figure 4.** Main vulnerabilities of non-seismic curtain wall: (a) external weather sealant breakage; (b) glass fallout; (c) curtain wall frame breakage; (d) expansion joint breakage.

The examination results of the behavior of the curtain wall when applying the four levels of static displacement are as follows. When a displacement of 54 mm was applied, part of the weather sealant installed inside and outside of the curtain wall began to break, and the broken area and its range increased when a displacement of 72 mm was applied. It was confirmed that when the target displacement of this study, i.e., 150 mm, was applied, the glass was broken and fell due to residual deformation after the weather sealant was broken. Based on the test results, the main vulnerabilities of the curtain wall are summarized in Figure 4 and Table 3.

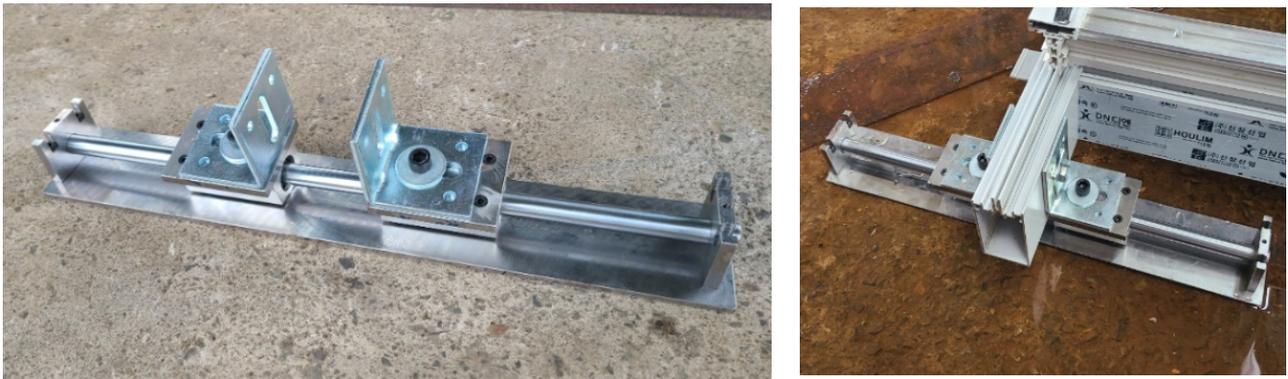
Figure 5. Seismic fastener prototype (X-axis).

In general, the curtain wall structure constitutes a groove so that the glass can be inserted into the frame. Here, there is a movable clearance between the grooves in which the glass is fitted. The spacing of the clearance is between approximately 5 and 20 mm, depending on the type of curtain wall. With this clearance, it is possible to buffer in the left and right directions when an earthquake occurs. However, in the event of earthquakes, seismic performance up to 150 mm must be achieved, depending on the seismic grade. Through the static seismic performance assessment, it was confirmed that the conventional curtain wall was too weak to ensure structural stability in the event of earthquakes. However, because earthquakes result in dynamic behavior rather than static behavior, verification was required. In the AAMA 501.6 standard, the performance assessment is only considered in the X-axis in-plane direction in the representative dynamic seismic performance test method. However, because displacement can occur in three directions (X-, Y-, and Z-axis) when earthquakes occur, verification of all cases is required, and a curtain wall system capable of responding to movement in three axes is required. Accordingly, in this study, as shown in Figure 5, a curtain wall system was designed to control the displacement during earthquakes via the use of seismic fasteners that can withstand a maximum displacement of 150 mm and can cope with three-axis displacement. A cross-sectional drawing of the prototype design is shown in Figure 6.

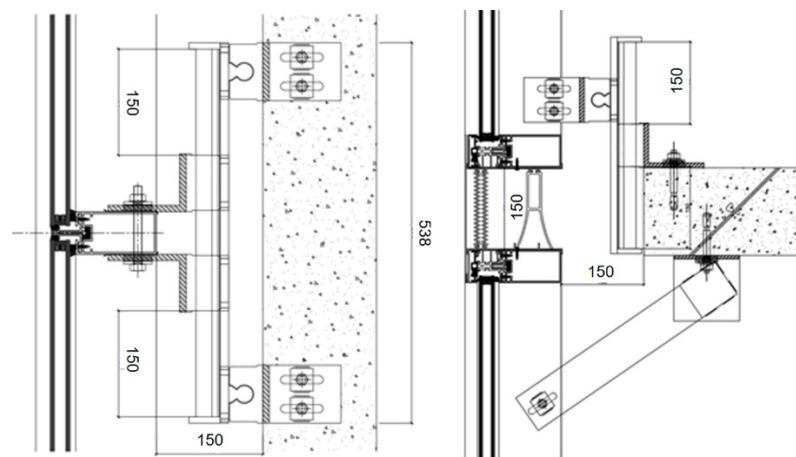
Figure 6. Developed fastener prototype design.

The design's structure connects the lower part of the upper frame to the floor slab so that the vibration of the building generated by the external force caused by earthquakes is not transmitted to the curtain wall. Thus, the curtain wall can slide in the longitudinal and transversal directions of the building, as shown in Figure 7. In addition, it is composed of a movable clip and a rail that can move left and right (X-axis) or up and down (Z-axis). The structure can be fixed to the structure by bolting or welding, and was designed so that a displacement of up to 150 mm can be absorbed by the fastener.

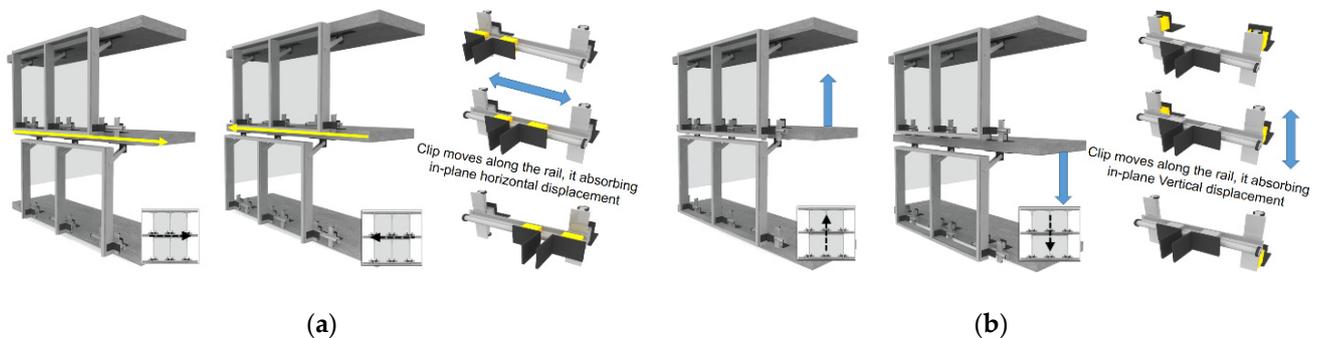
Figure 7. Displacement absorbing principle of seismic fastener: (a) X-axis movement; (b) Z-axis movement.

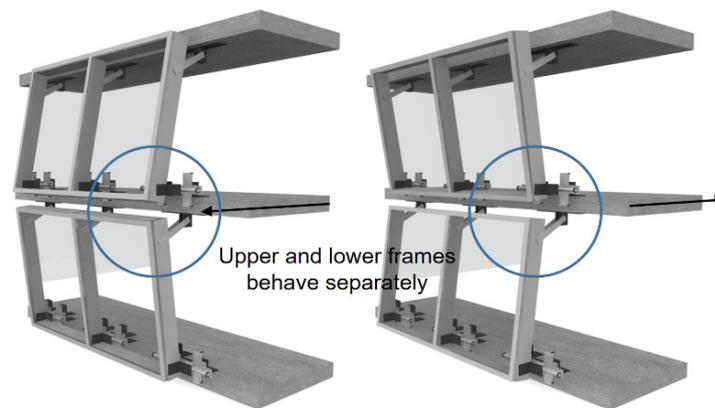
**Figure 8.** Displacement absorbing principle of the inter-story separated module.

In addition, to cope with the displacement in the Y-axis direction, a separate inter-story module was applied, as shown in Figure 8, so that it can be operated separately without restraint between the upper and lower frames. As a result, it is free from stress concentration and buckling when displacement in the Y-axis direction occurs.

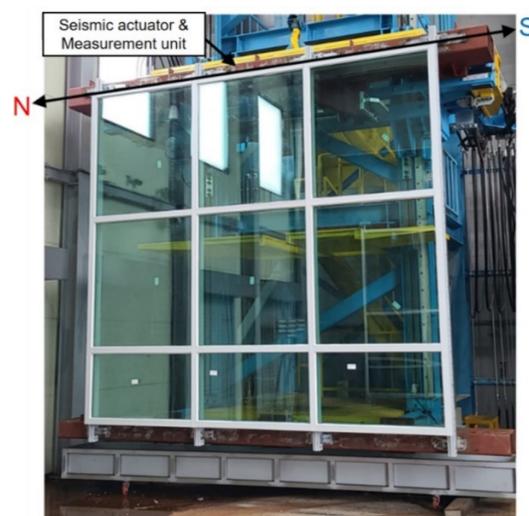
**Figure 9.** Dynamic seismic test method based on AAMA 501.6.

Currently, although the fastener design for three axes has been completed, the prototype is still in the production stage. Therefore, first, seismic fasteners that can respond only to the  $X$ -axis in-plane direction are currently manufactured. These fasteners can cope with a maximum displacement of 150 mm to the left and right. In this study, the dynamic seismic performance test, as shown in Figure 9, was performed based on the test method recommended by the AAMA 501.6 standard. In this test, the specimen fixes the upper and lower parts to the rigid beam, and only the rigid beam fixed to the upper part applies a dynamic displacement in the  $X$ -axis in-plane direction. A successful test of a particular curtain wall system assembly in which no glass fallout occurs, at the required percentage of drift, qualifies other assemblies, provided the following are satisfied by the other assemblies:

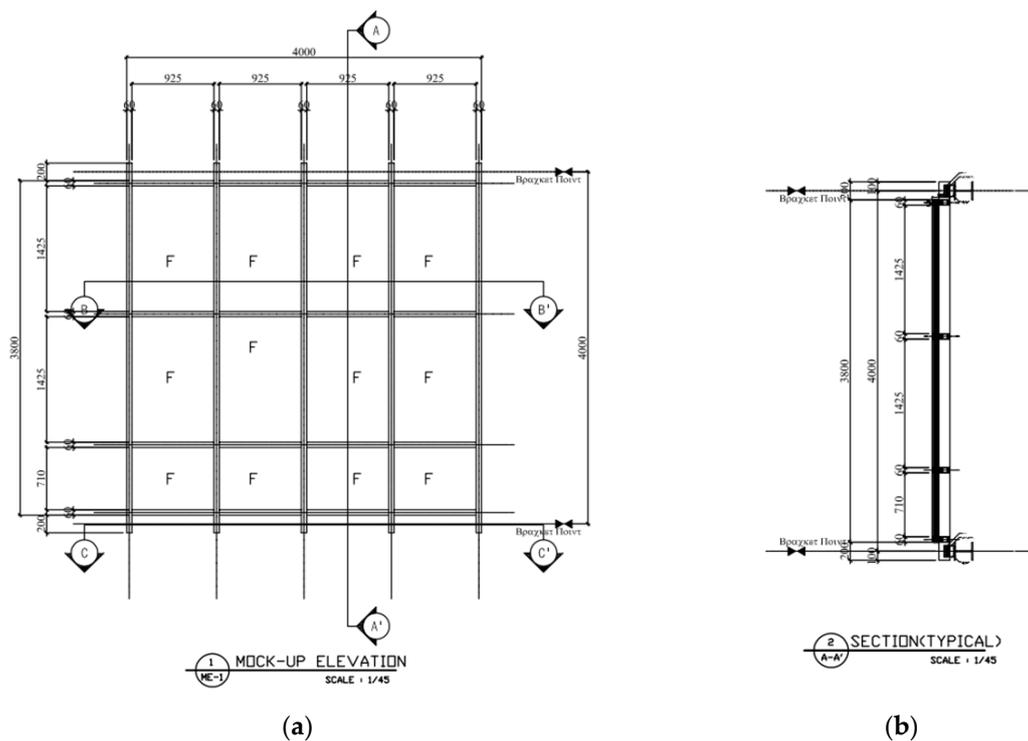
Figure 10. Non-seismic curtain wall specimen: (a) front view; (b) side view.

The dynamic seismic performance test was conducted on both non-seismic curtain walls, and seismic curtain walls to which mobile fasteners were applied, for comparison and analysis of the behavior of the curtain wall before and after the application of the seismic fastener. The detailed drawings and specifications of the non-seismic curtain wall specimen for the dynamic seismic performance test are shown in Figure 10 and Table 4, and the detailed drawings and specifications of the seismic curtain wall specimen are shown in Figure 11 and Table 5.

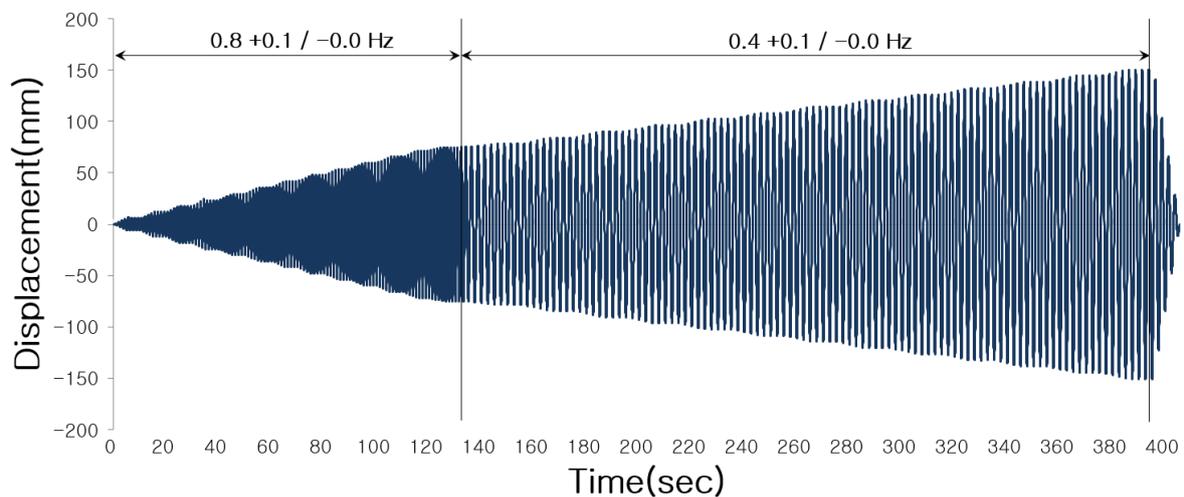
Figure 12. Dynamic seismic waveform applied to the AAMA 501.6 test method.

In the dynamic seismic performance test, a vibration of 0.8 Hz was applied up to the displacement of 75 mm, and vibration of 0.4 Hz was applied up to the displacement of 150 mm, as shown in Figure 12, according to the AAMA 501.6 standard. The test was conducted while gradually increasing the displacement by four cycles at intervals of 6 mm.

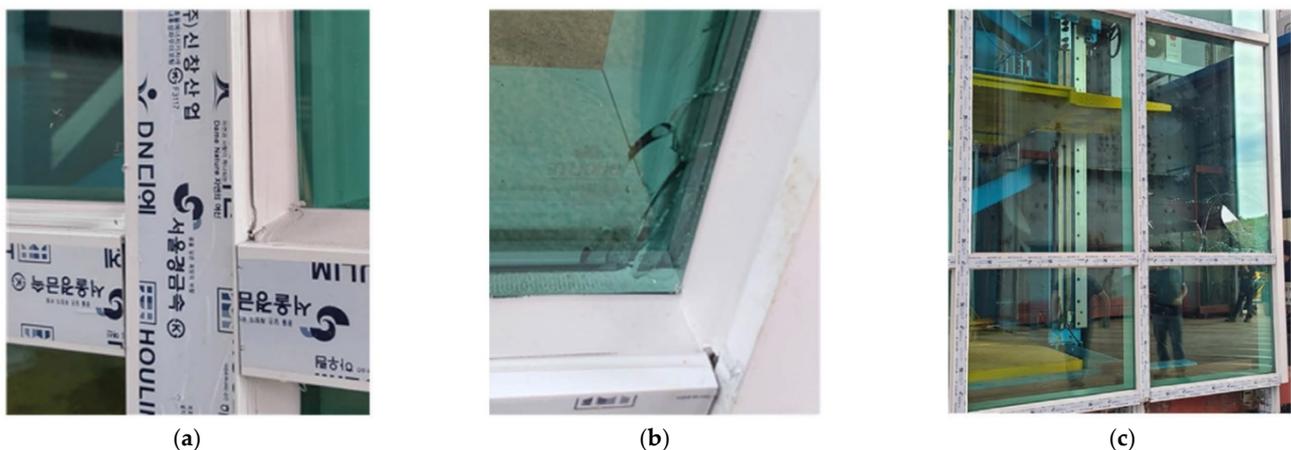
**Figure 13.** States of non-seismic curtain wall after the dynamic racking crescendo test: (a) silicone cracks (42 mm); (b) glass cracks (60 mm); (c) glass fallout (90 mm).

In the case of the non-seismic curtain wall test specimen, it was confirmed that the glass fallout occurred at a displacement of 90 mm due to severe damage to some members, as shown in Figure 13, in the static seismic performance test. However, in the case of the seismic curtain wall to which the mobile fastener was applied, no cracks, breakage, or fallout occurred in the entire frame following the test, as shown in Figure 14, and the upper fastener to which the dynamic displacement was applied had no abnormality.

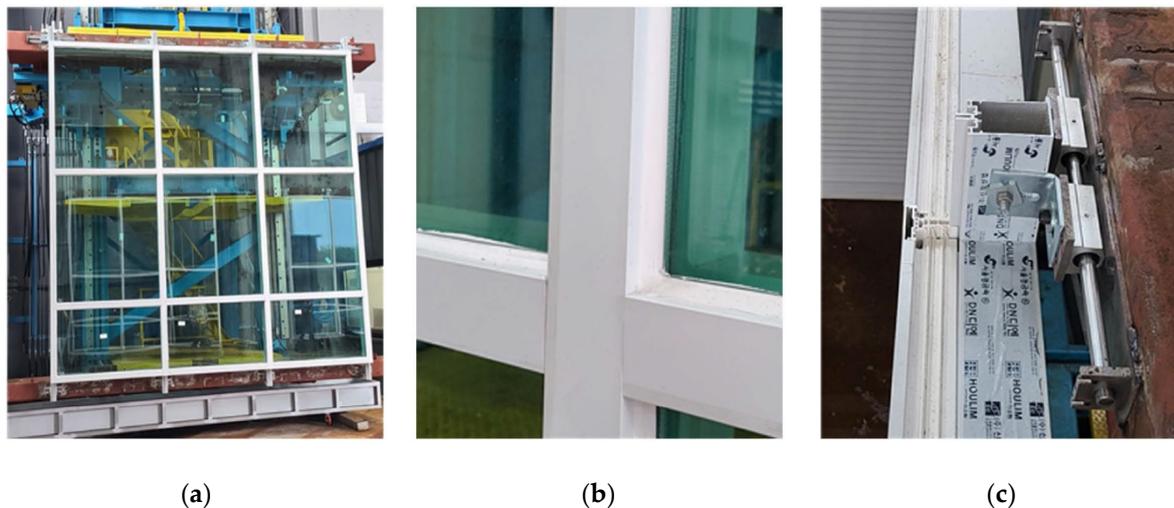
**Figure 14.** States of seismic curtain wall after the dynamic racking crescendo test: (a) no abnormalities detected in the front of the specimen; (b) no cracks or breakage of silicone; (c) no abnormalities detected in the upper fastener.

The comprehensive assessment of the results of the dynamic seismic performance test showed that due to the application of a fastener with a displacement control function, even if a dynamic racking crescendo is applied to the curtain wall, the wall can respond to earthquakes with a displacement of up to 150 mm, which is 3.75% of the floor height, thus ensuring the seismic performance.

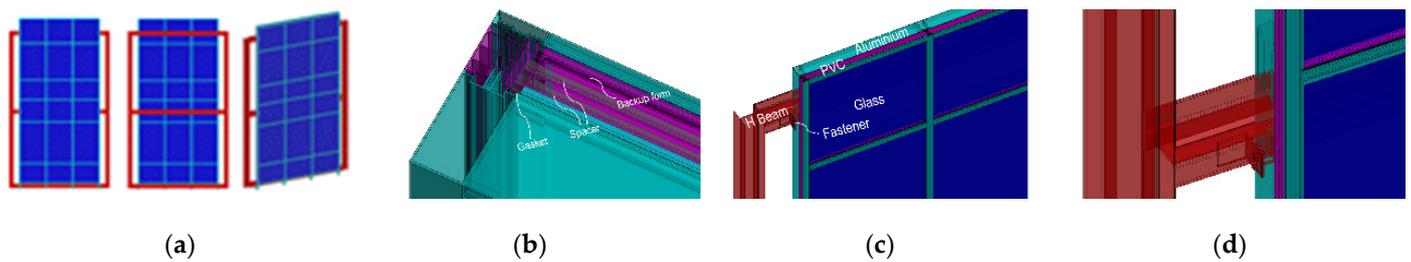
**Figure 15.** Details of full-frame FE model in solid form: (a) external shape of the FE model; (b) internal member detail; (c) chamber and aluminum frame; (d) anchor connection.

All materials were assumed to be constrained to behave within their elastic range. Glass is a brittle material and failure occurs when the deformation state reaches its limit. The stress level of aluminum is significantly lower than the strength of the material, so ductile deformation does not occur. Therefore, it is reasonable to limit the use of the elasticity theory. Nonlinear static analysis was performed on the behavior of the curtain wall under displacement control. The curtain wall model was displaced to produce the specified movements. When displacement is applied, it should consist of three full cycles. (Herein, a cycle is defined as a full displacement in one direction back to the originating point, full displacement in the opposite direction, and return to the originating point.) The horizontal displacement was applied to the mullion connected to the rigid beam located in the middle of the main structure, and the inter-story drift was calculated.

The boundary condition was set by fixing the vertical and horizontal displacements of the nodes at the connection between the aluminum frame and the fastener located at the top and bottom.

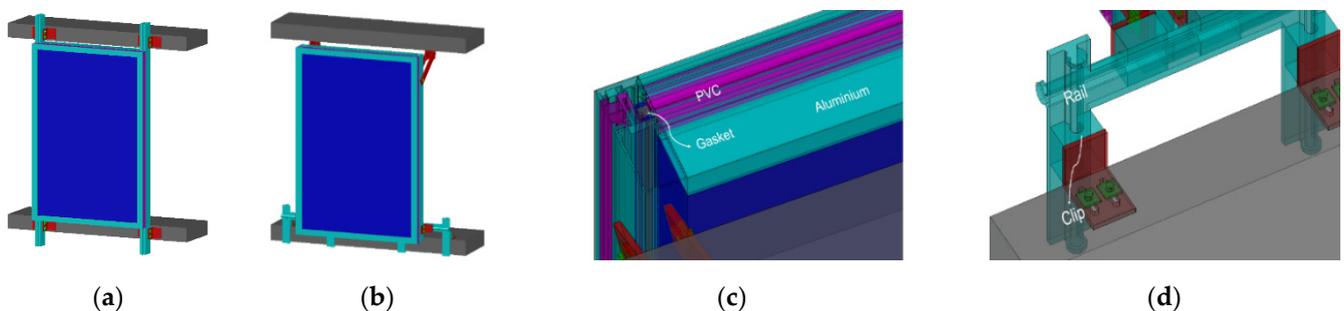
**Figure 16.** Details of the single-frame FE model in solid form: (a) FE model of conventional curtain wall; (b) FE model of seismic curtain wall; (c) internal member detail; (d) mobile fastener.

Based on the results of the FE analysis for the full-frame curtain wall discussed in Section 3.3, additional FE simulations were performed on numerical models that well represent the nominal components and interactions of the single-frame curtain wall. All components comprising the curtain wall were applied as noted in Section 3.1, and their material properties were also the same. However, unlike the full-frame, in the case of the single-frame model, boundary conditions were set by restraining the horizontal and vertical displacement of the aluminum frame connected to the lower rigid beam, whereas the upper rigid beam was set as the free end. Figure 16 shows the details of the FE model constructed for a single-frame curtain wall.

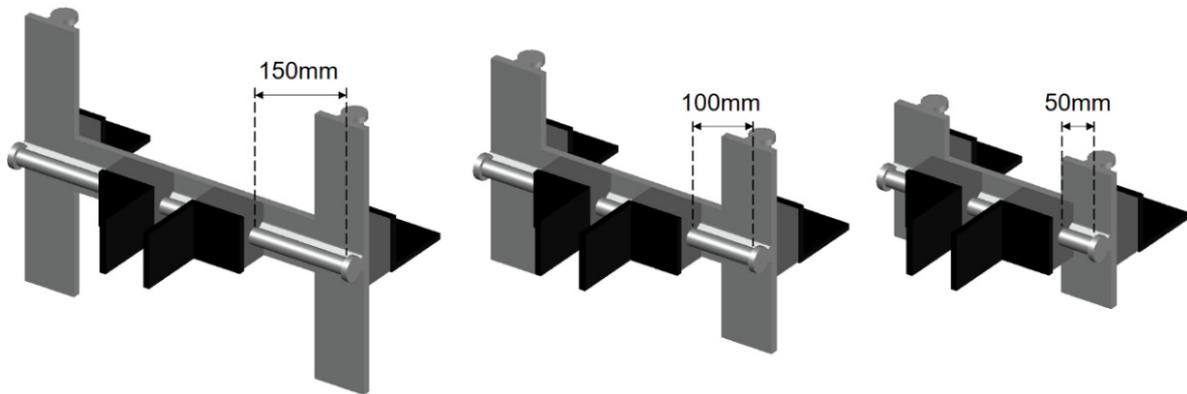
Figure 17. Designed model for each linear guide length.

performing numerical analysis of dynamic seismic performance, modeling was undertaken by dividing the length of the linear guide into 50, 100, and 150 mm among the components of the mobile fastener, as shown in Figure 17. This was undertaken to analyze the seismic performance of the mobile fastener according to the change in the length of the linear guide.

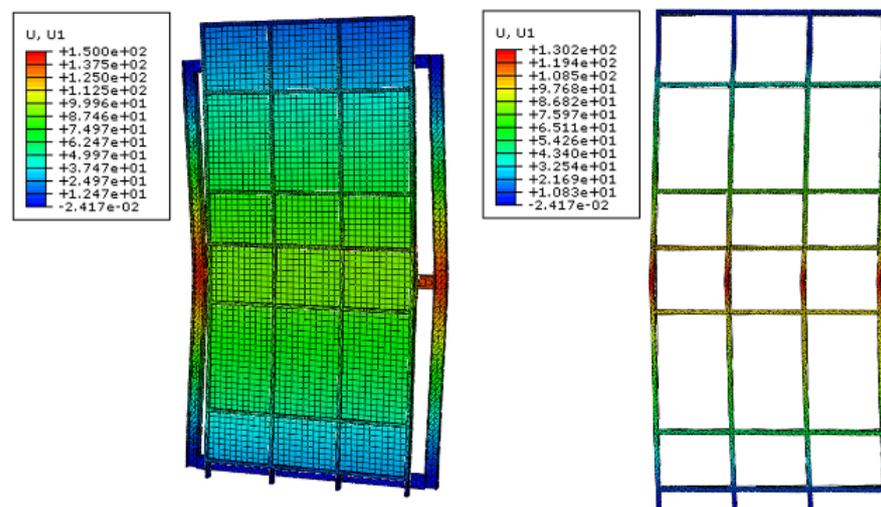
Figure 18. Response of the conventional curtain wall under static lateral drift.

The deformation when 150 mm of static lateral displacement was applied to the full-frame curtain wall is shown in Figure 18. Table 8 shows the major vulnerabilities of the full-frame curtain wall derived after performing the FE simulation. In particular, the gasket, which is a super-elastic material that restrains the glass façade, incurred a separation from the frame while applying a drift that exceeds the clearance. This indicates that the glass façade may break and fallout may occur. The vulnerabilities of the conventional curtain wall confirmed through the FE simulation showed similar results to the vulnerabilities confirmed through the experiment, as shown in Figure 19.

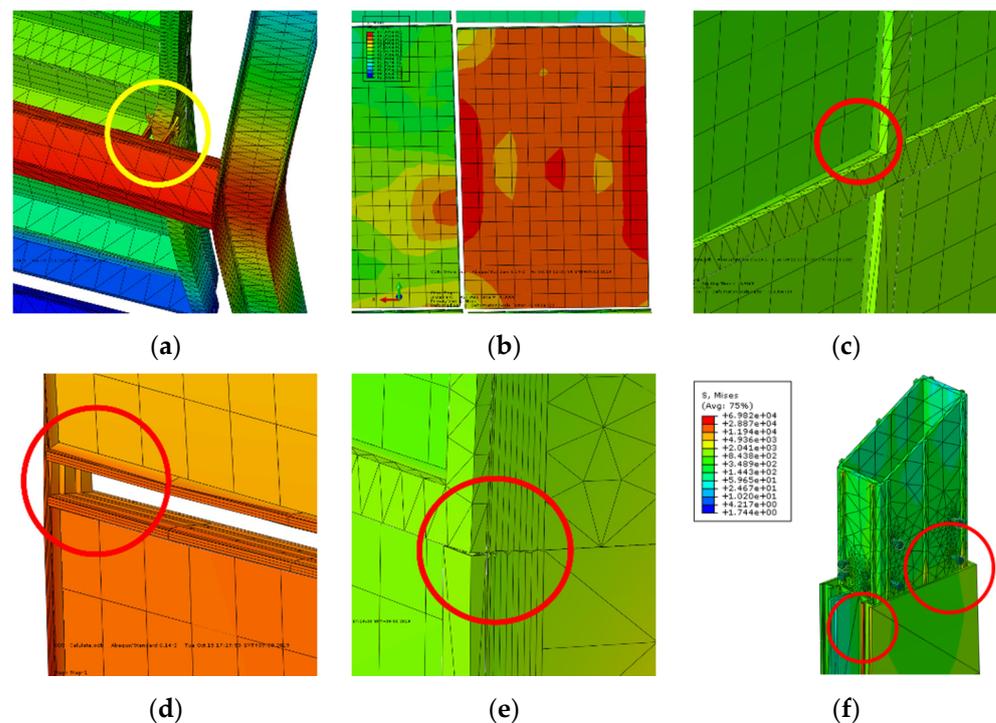
**Figure 19.** Major vulnerabilities of conventional curtain wall simulation: (a) mullion-to-fastener connection twist; (b) stress concentration on the edge of the glass; (c) aluminum frame fallout from the glass; (d) gasket twist; (e) expansion joint detachment; (f) stress concentration at expansion joint connection.

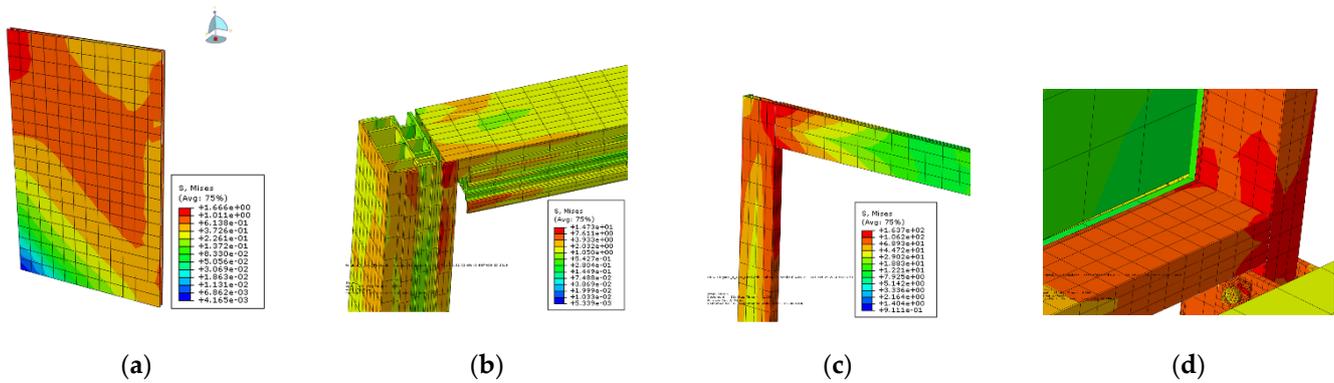
Figure 20. Stress distribution in each member of non-seismic curtain wall during X-axis drift: (a) glass; (b) mullion-to-transom; (c) PVC; (d) aluminum-to-glass.

Through FE analysis of the stress distribution applied to the non-seismic curtain wall that was subjected to simulated static displacements based on the AAMA 501.4 standard, it was confirmed that the yielding of the gasket caused the sliding trigger between the glass façade and the aluminum frame. That is, it was predicted that glass-to-frame collision occurs as the aluminum frame deforms and the gasket is distorted, which ultimately causes the glass façade to fall out.

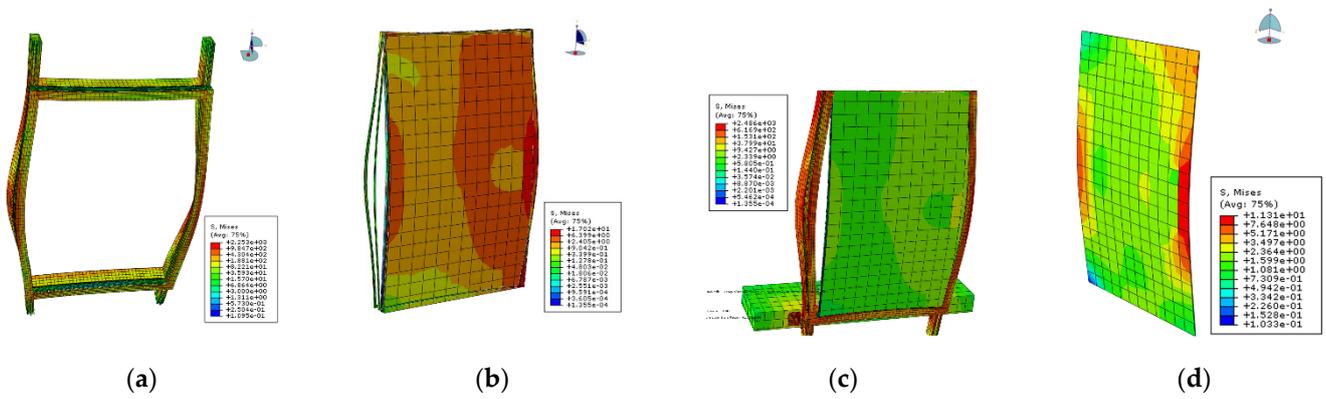
Figure 21. Stress distribution in each member of non-seismic curtain wall during Y-axis drift: (a) aluminum; (b) glass-to-gasket; (c) aluminum-to-glass; (d) glass.

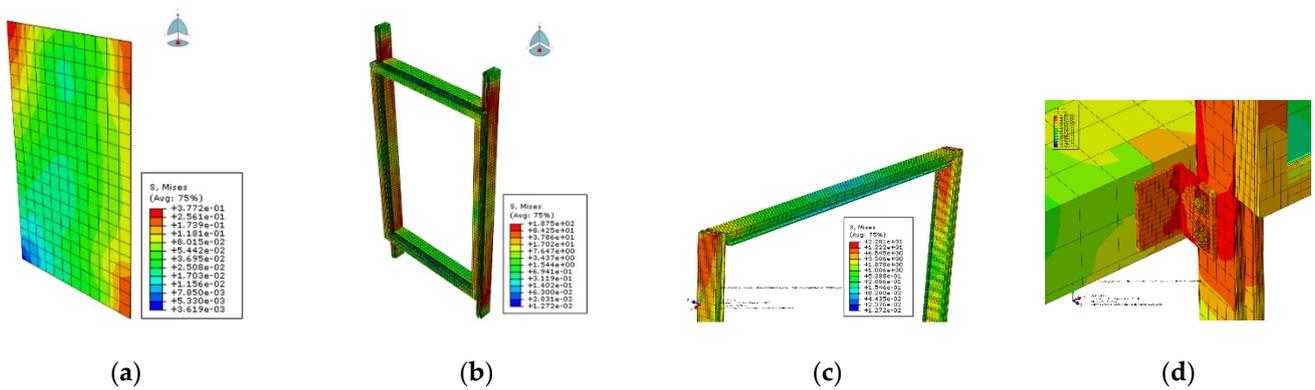
Figure 22. Stress distribution in each member of non-seismic curtain wall during Z-axis drift: (a) glass; (b) aluminum; (c) PVC; (d) aluminum-to-fastener.

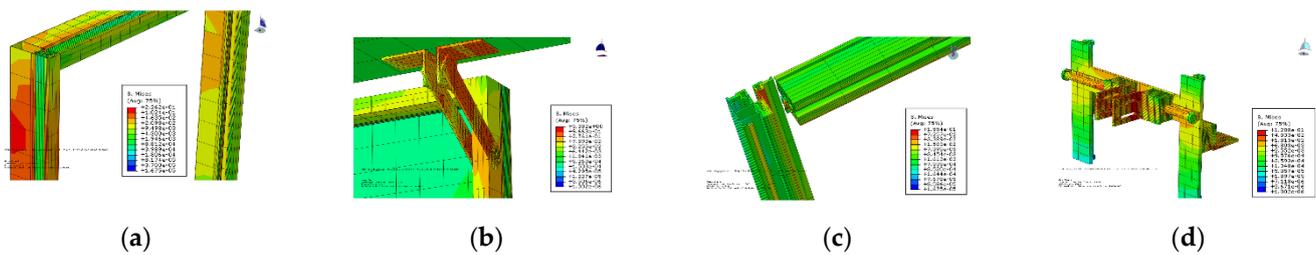
**Figure 23.** Stress distribution in each member of seismic curtain wall during X-axis drift: (a) aluminum; (b) upper kicker; (c) PVC; (d) linear guide-to-fastener connection part.

However, in the case of a seismic curtain wall to which the fastener model proposed in this study is applied, which can control the displacement up to a maximum displacement of 150 mm, it is possible to adapt to changes in the geometry of the curtain wall system and the inter-story drift. It was confirmed that there was no damage in the event of earthquakes because the displacement applied to the curtain wall through the proposed fastener was dissipated and the stress was not transmitted to other members.

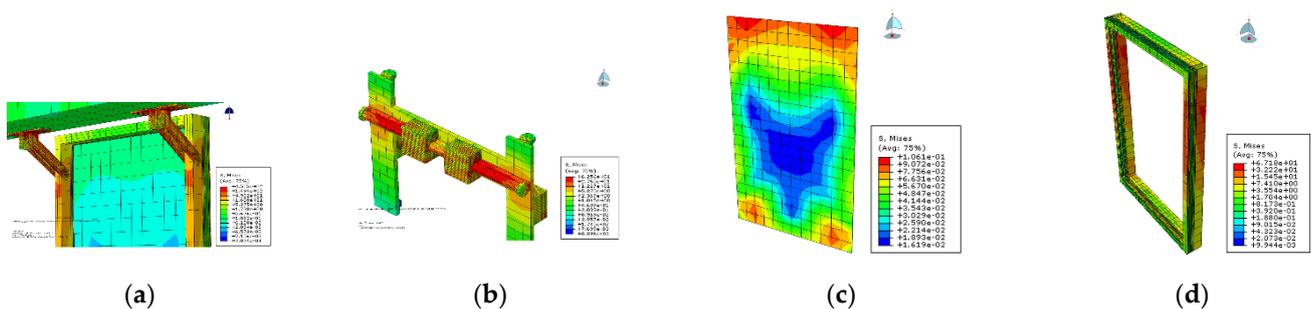
**Figure 24.** Stress distribution in each member of seismic curtain wall during Y-axis drift: (a) upper fastener-to-rigid beam connection part; (b) rail-to-moving clip connection part; (c) glass; (d) aluminum-to-PVC connection part.

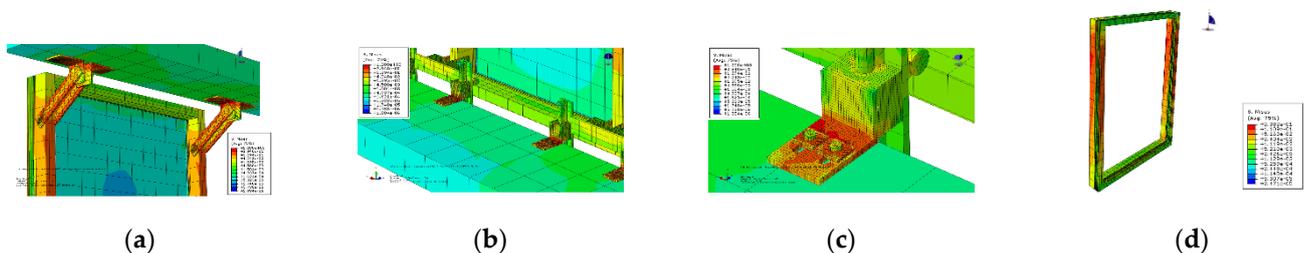
**Figure 25.** Stress distribution in each member of seismic curtain wall during Z-axis drift: (a) upper fastener-to-rigid beam connection part; (b) lower fastener-to-rigid beam connection part; (c) fastener-to-bolt connection part; (d) external aluminum frame.

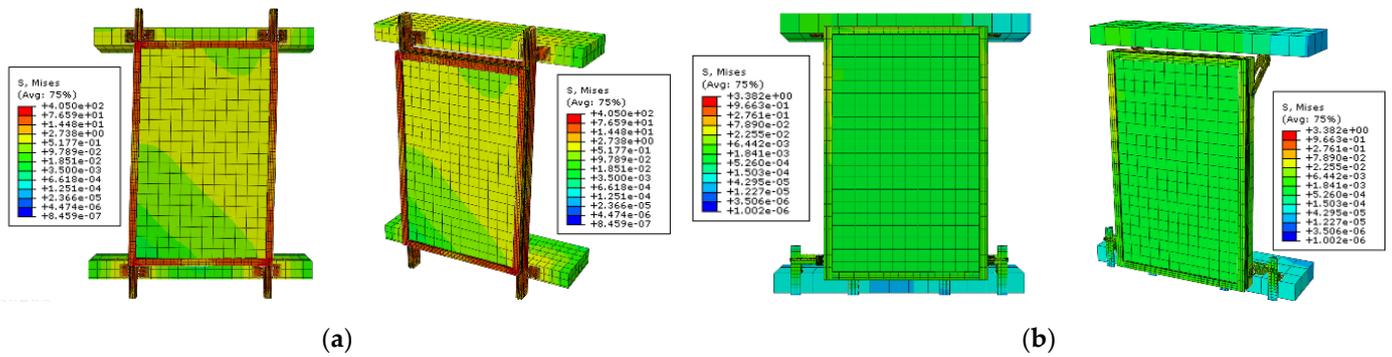
**Figure 26.** Comparison of appearance changes under applied X-axis inter-story drift: (a) non-seismic curtain wall module; (b) seismic curtain wall module.

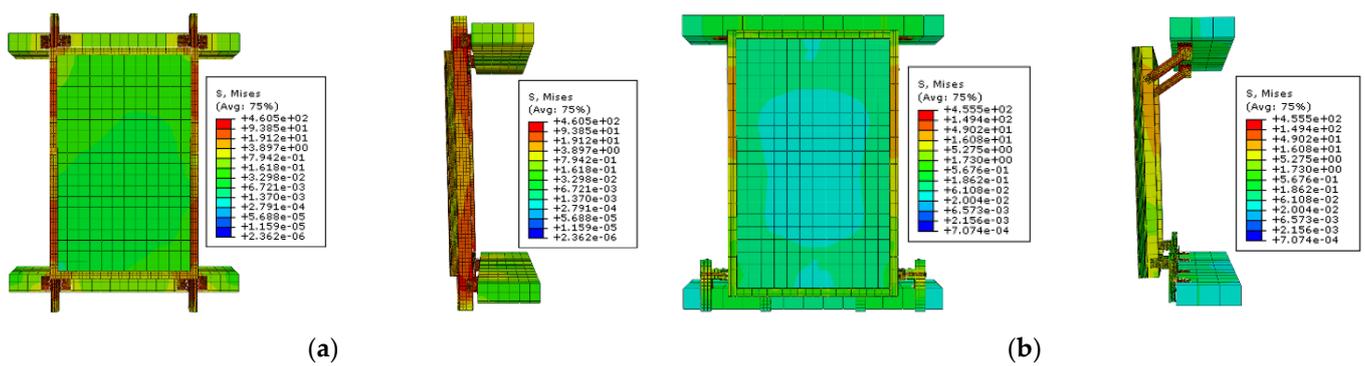
**Figure 27.** Comparison of appearance changes under applied Y-axis inter-story drift: (a) non-seismic curtain wall module; (b) seismic curtain wall module.

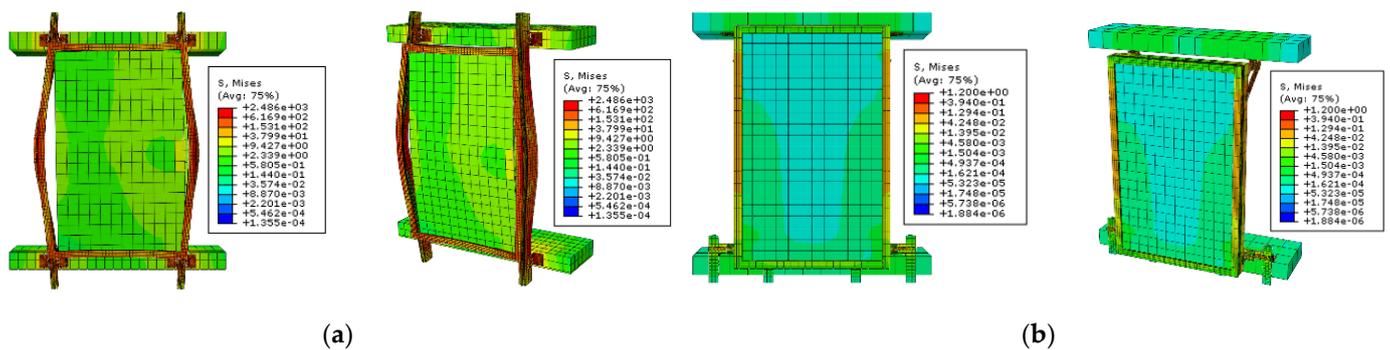
**Figure 28.** Comparison of appearance changes under applied Z-axis inter-story drift: (a) non-seismic curtain wall module; (b) seismic curtain wall module.

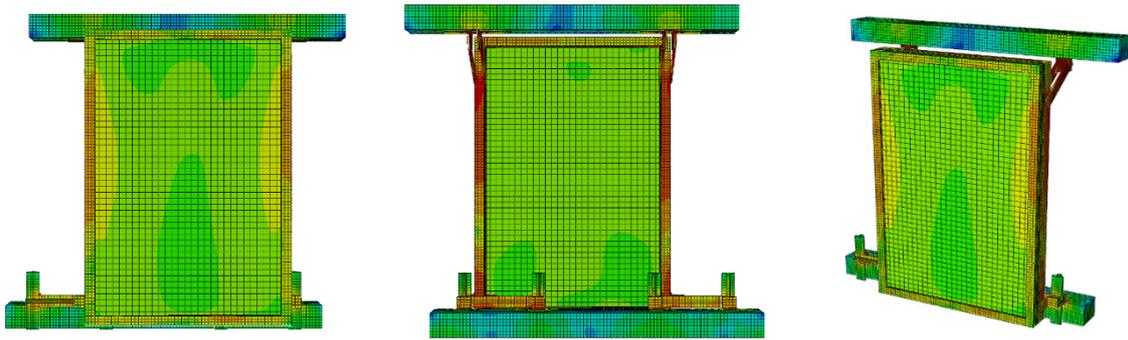
Figure 29. Seismic curtain wall deformation: linear guide length 150 mm.

In addition, to minimize the length of the linear guide, numerical models were additionally created in which the length of the linear guide was reduced to 100 and 50 mm based on the 150 mm, which is the basic shape of the curtain wall module introduced in the previous section. Then, according to the AAMA 501.6 standard, the behavior and seismic performance of the curtain wall according to the decrease in the linear guide length under dynamic drift were compared. Figures 29–34 show the results of finite element analysis, and compare the Von Mises stress distribution and the degree of deformation of the exterior material according to the linear guide length when AAMA 501.6 dynamic drift was applied.

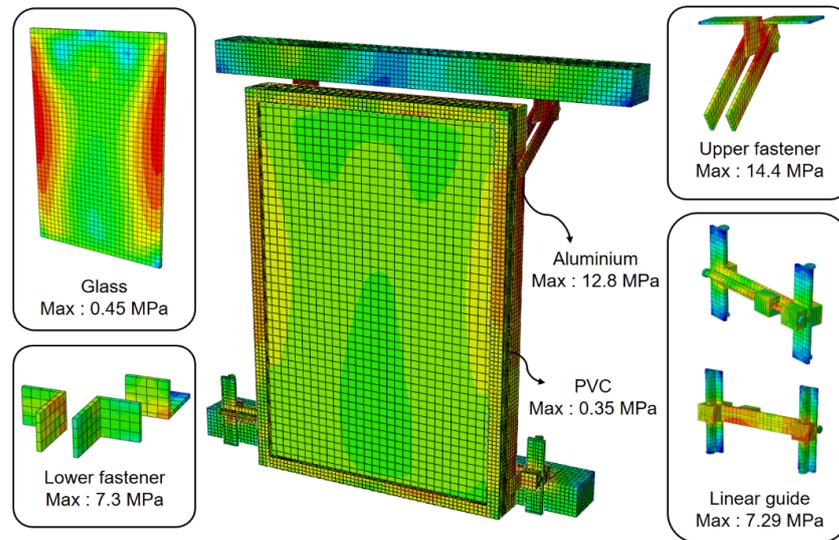
Figure 30. Stress distribution applied to each member: linear guide length 150 mm.

Table 10 shows the maximum stress generated in each member. According to the FE analysis results, it was found that the stress distribution in each member was greatest in the mullion when the dynamic drift was applied. When dynamic drift was applied, the displacement could be controlled because the moving clip of the linear guide moves along the rail in the axial direction in which the drift is applied. Based on this principle, the stress applied to the exterior material is absorbed and dissipated.

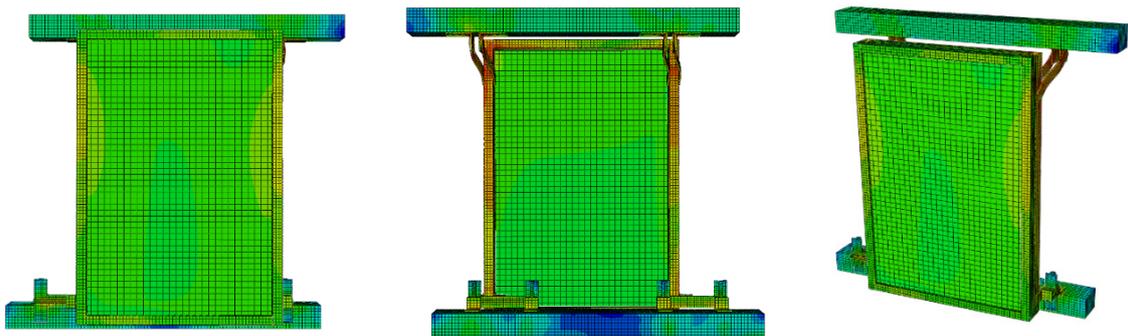
Figure 31. Seismic curtain wall deformation: linear guide length 100 mm.

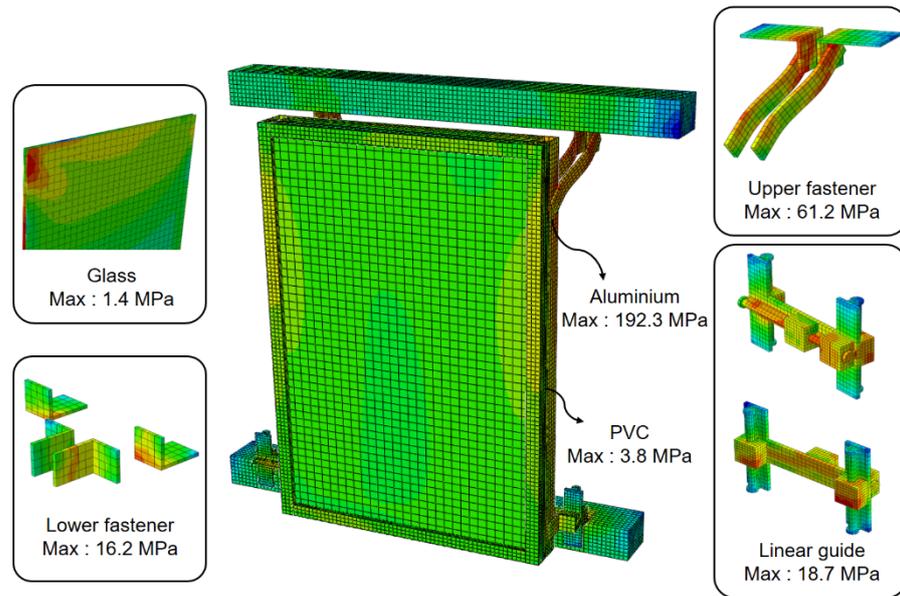
Figure 32. Stress distribution applied to each member: linear guide length 100 mm.

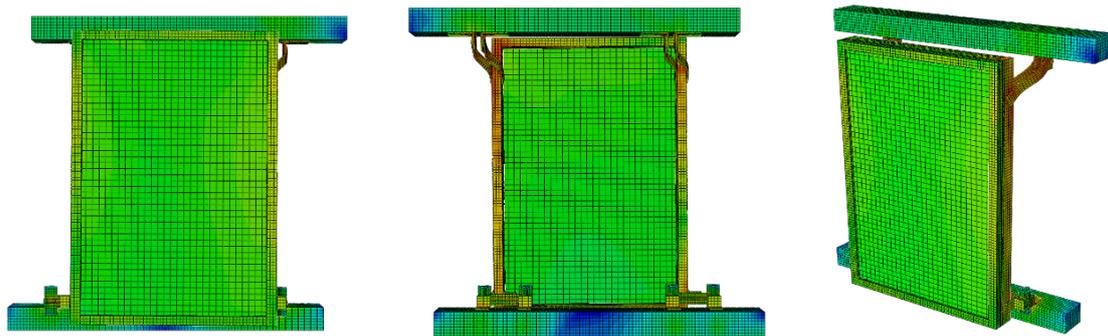
Figure 33. Seismic curtain wall deformation: linear guide length 50 mm.

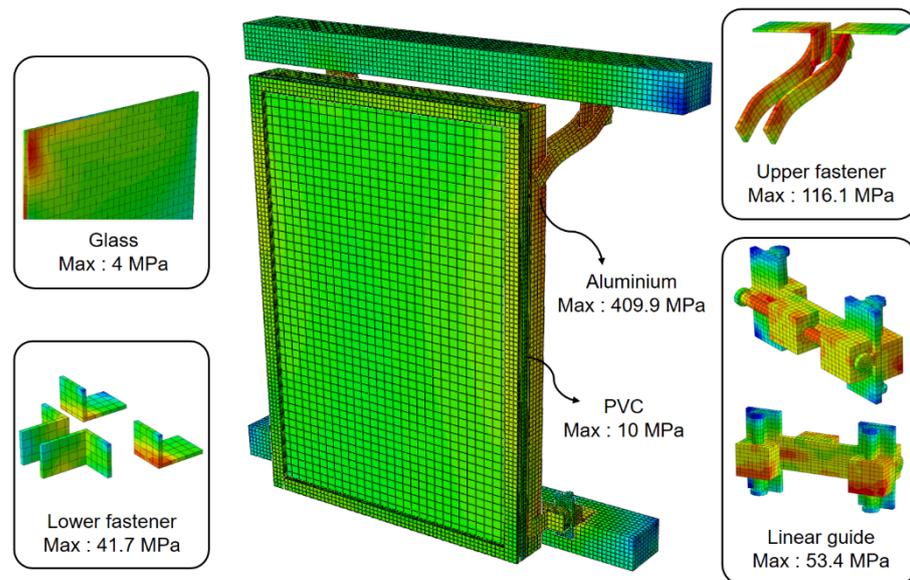
Figure 34. Stress distribution applied to each member: linear guide length 50 mm.

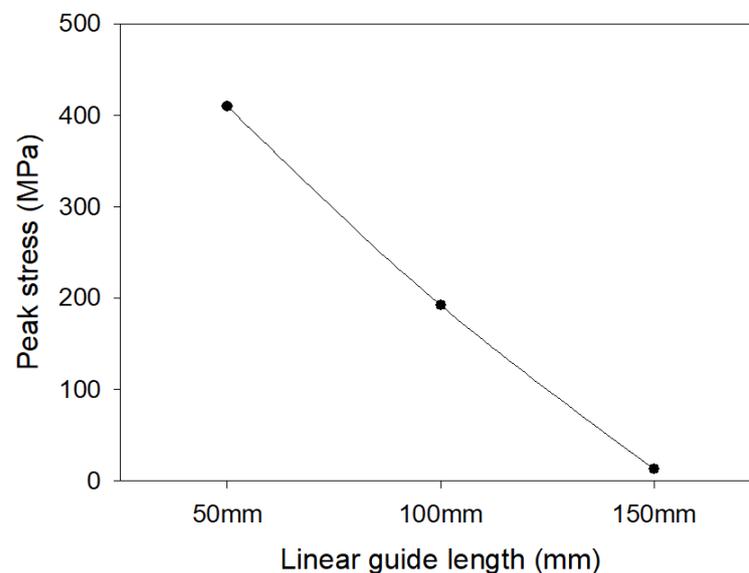
**Figure 35.** Relationship of linear guide length to maximum stress applied to the curtain wall.

The results according to the change in the length of the linear guide show there were no partial dropouts and breakages of each member as a whole. As the displacement absorption section decreased to 100 and 50 mm based on 150 mm, the stress applied to the curtain wall gradually increased. It was found that the stress increased linearly with the decrease in the length of the displacement absorption section, which is shown in Figure 35. When the length of the linear guide was reduced to 50 mm, there was no damage to the glass façade, as shown in Figure 36, but as the displacement increased, the upper fastener was deformed, and a slight gap was found in the member junction between aluminum and PVC. However, compared with the deformation of the non-seismic curtain wall shown in Figure 37, it was judged that even if the length of the linear guide is reduced to 50 mm, it has sufficient seismic performance in response to dynamic seismic waves.

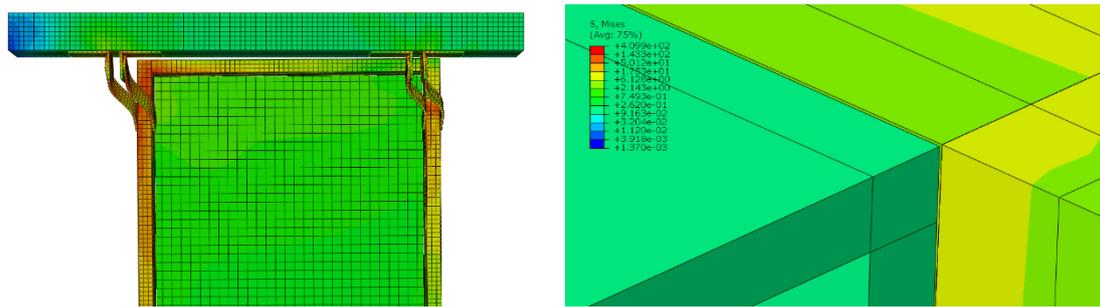
Figure 36. Deformation of weak areas when linear guide length of 50 mm is applied.

- (7) If the length of the linear guide was reduced to 50 mm, there was no damage to the glass casing. However, as the displacement increased, the upper fastener was deformed, and it was judged that reinforcement is necessary;

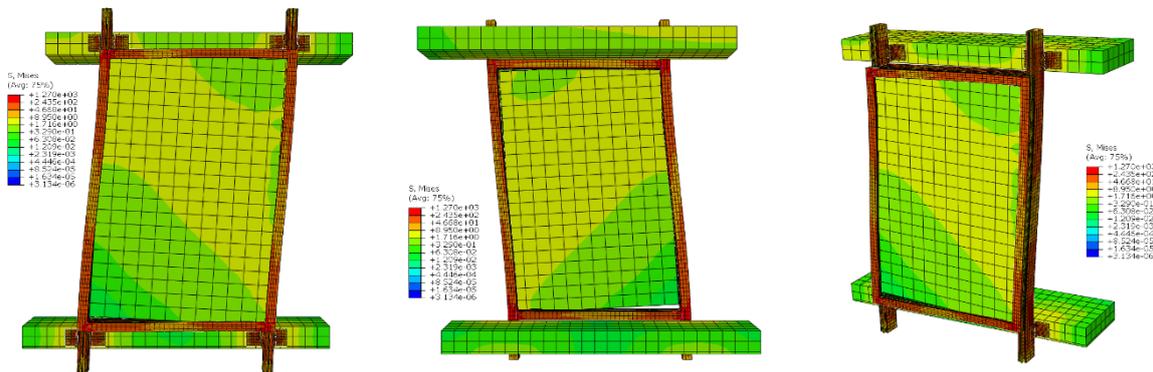
Figure 37. Non-seismic curtain wall deformation.

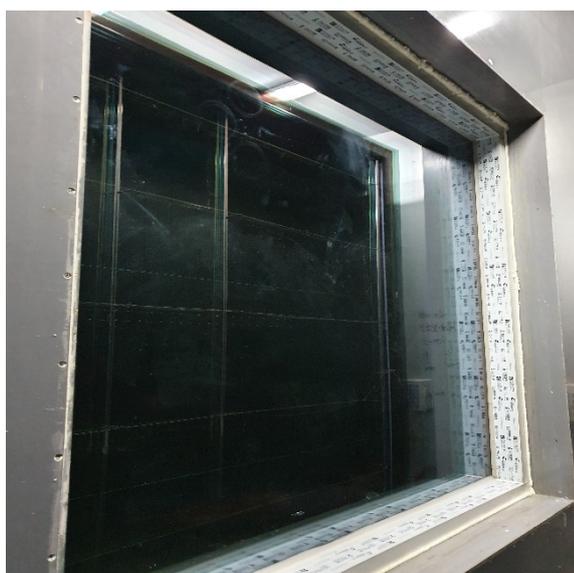
**Figure 38.** Specimens for evaluating insulation and airtightness performance: (a) insulation performance evaluation specimen; (b) airtightness performance evaluation specimen.

curtain wall frame as that of the seismic curtain wall. For the glass specification, 42 mm triple glass was applied, and the spacer was used as a synthetic resin insulating inter-story. The insulation and airtightness performance evaluation setup is shown in Figure 38.
